**Flood Control Project Maintenance  
Levee Inspections****LMA District Cover Sheet****Spring 2013 Levee Inspection Results****Reclamation District No. 2062 Stewart**

**Levee Inspection Report By Mile - Spring 2013**

**Reclamation District No. 2062 Stewart**

Waterway				Bank	Unit Miles	Inspection Start/End	Inspector	
Unit No. 01 San Joaquin River				Left	2.69	04/04/2013 04/04/2013	Maksim Khashchuk

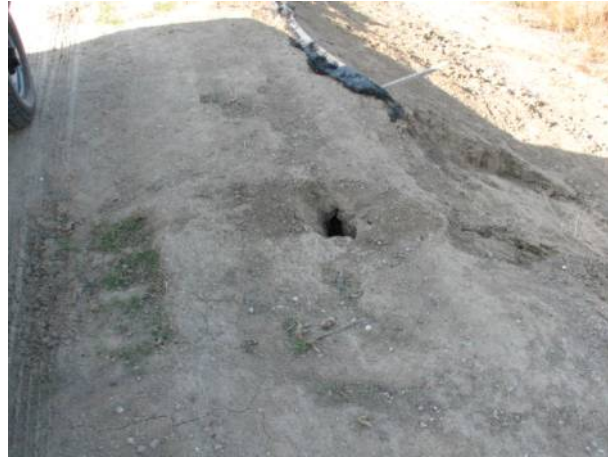
Levee Mile Report Line	4
Start Levee Mile	0.49
End Levee Mile	0.49
Location	Crown
Category	
Item	Animal Control
10/21/2011 Photo of burrow on crown, photo was taken day after inspection.	
mkhashch_s_20130225_402.jpg

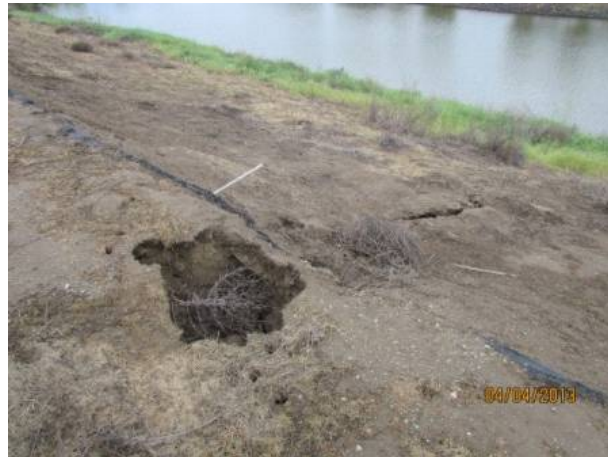
Levee Mile Report Line	5
Start Levee Mile	0.50
End Levee Mile	0.50
Location	Water Side
Category	
Item	Erosion / Bank Caving
View of the erosion at the waterside levee hinge.	
mkhashch_s_20130410_712.JPG

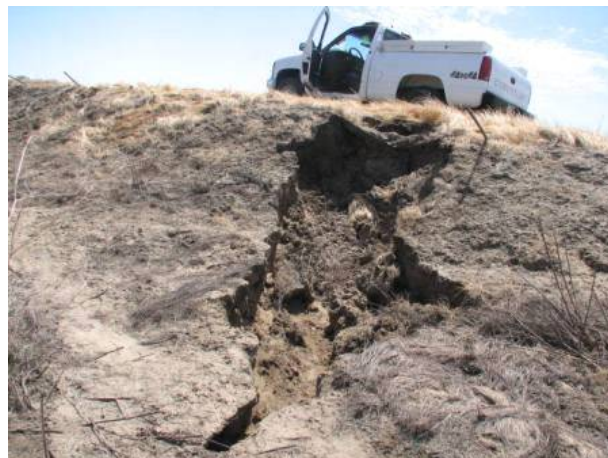
Levee Mile Report Line	6
Start Levee Mile	0.57
End Levee Mile	0.57
Location	Water Side
Category	
Item	Erosion / Bank Caving
05/11/2011 Erosion begins at crown, stakes shown in photo are supporting a silt fence. Silt fence is supporting soil and vegetation at crown.	
mkhashch_s_20130225_403.jpg

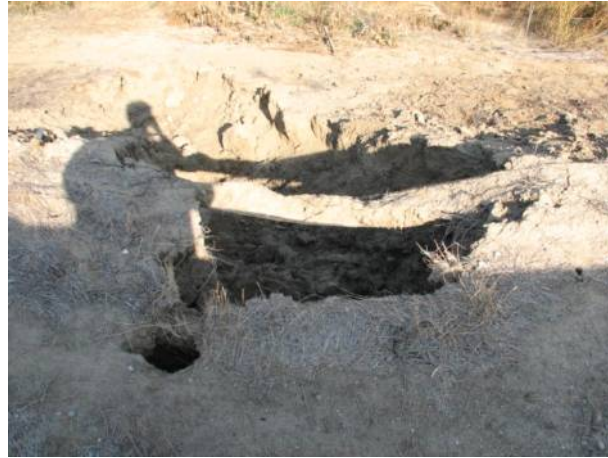
Levee Mile Report Line	6
Start Levee Mile	0.57
End Levee Mile	0.57
Location	Water Side
Category	
Item	Erosion / Bank Caving
10/21/2011 Photo is taken from levee crown, issue has still not been addressed. Issue was noted in the Spring 2011 inspection.	
mkhashch_s_20130225_404.jpg

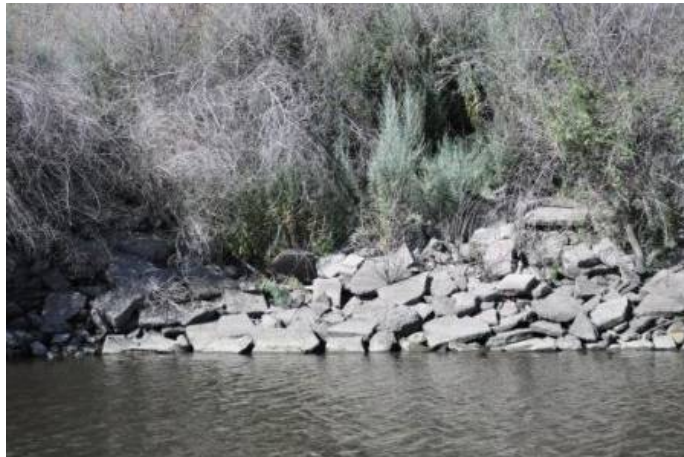
Levee Mile Report Line	8
Start Levee Mile	0.91
End Levee Mile	0.91
Location	Water Side
Category	Supplemental
Item	DWR Erosion Survey
Front view of the erosion site	
mkhashch_s_20130225_397.jpg

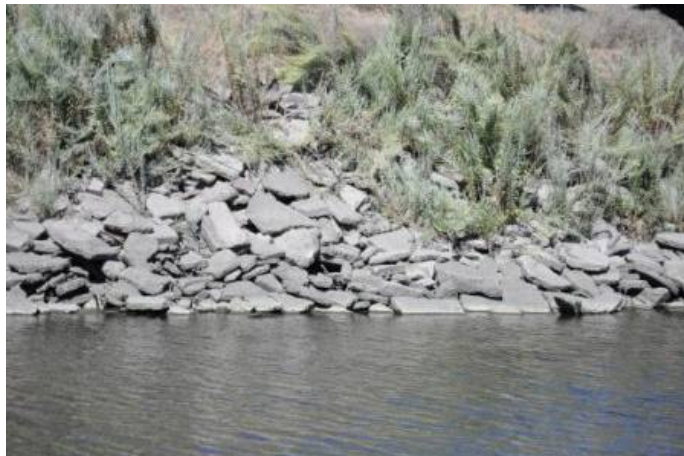
Levee Mile Report Line	8
Start Levee Mile	0.91
End Levee Mile	0.91
Location	Water Side
Category	Supplemental
Item	DWR Erosion Survey
Front view of the rip rap	
mkhashch_s_20130225_398.jpg

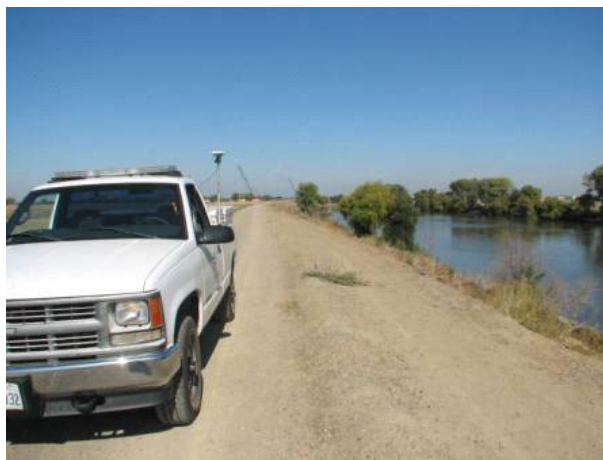
Levee Mile Report Line	9
Start Levee Mile	1.18
End Levee Mile	1.40
Location	Crown
Category	
Item	Crown Surface / Depressions / Rutting
10/20/2011 Berm is forming on the waterside edge of the crown. Berm is approximately 1' high in places.	
mkhashch_s_20130225_410.jpg

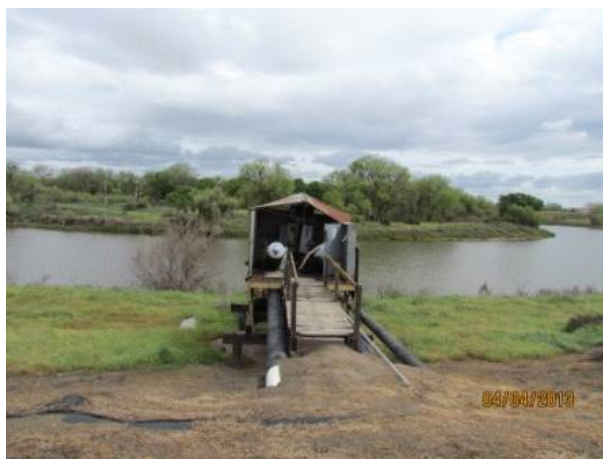
Levee Mile Report Line	10
Start Levee Mile	1.67
End Levee Mile	1.67
Location	Water Side
Category	
Item	Encroachments
View of the pipe penetrating the waterside levee slope.	
mkhashch_s_20130410_711.JPG

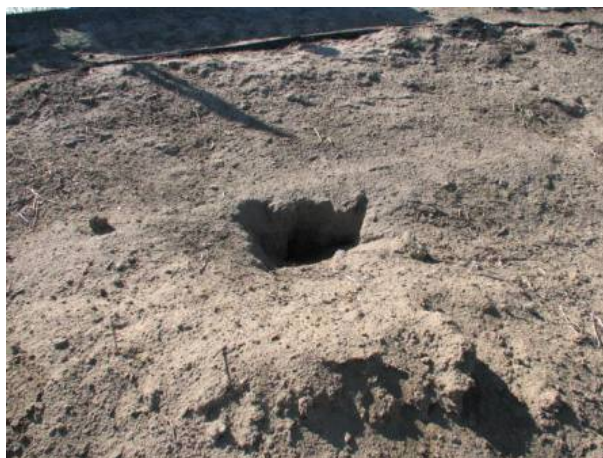
Levee Mile Report Line	11
Start Levee Mile	1.83
End Levee Mile	1.83
Location	Water Side
Category	
Item	Animal Control
10/20/2011 Large burrow located on waterside slope of levee.	
mkhashch_s_20130225_405.jpg

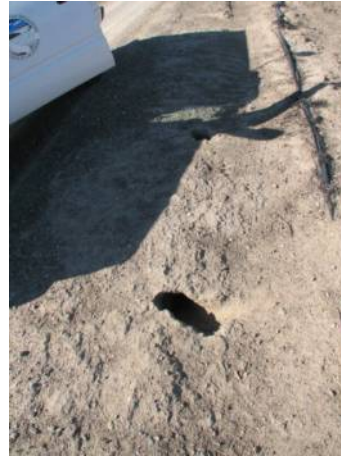
Levee Mile Report Line	11
Start Levee Mile	1.83
End Levee Mile	1.83
Location	Water Side
Category	
Item	Animal Control
10/20/2011 Large burrow located near crown on waterside slope of levee.	
mkhashch_s_20130225_406.jpg

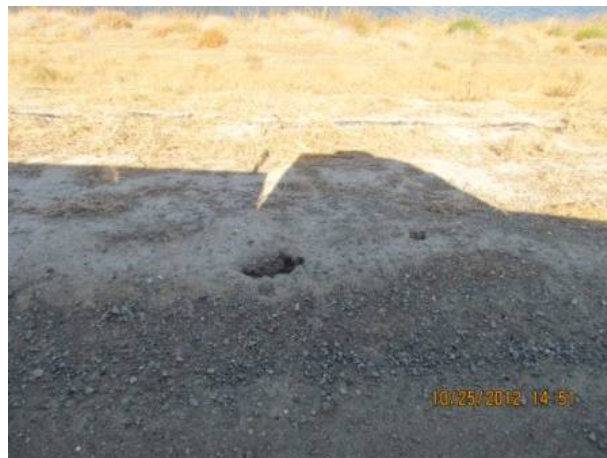
Levee Mile Report Line	11
Start Levee Mile	1.83
End Levee Mile	1.83
Location	Water Side
Category	
Item	Animal Control
View of large burrow on waterside slope.	
mkhashch_s_20130225_408.JPG

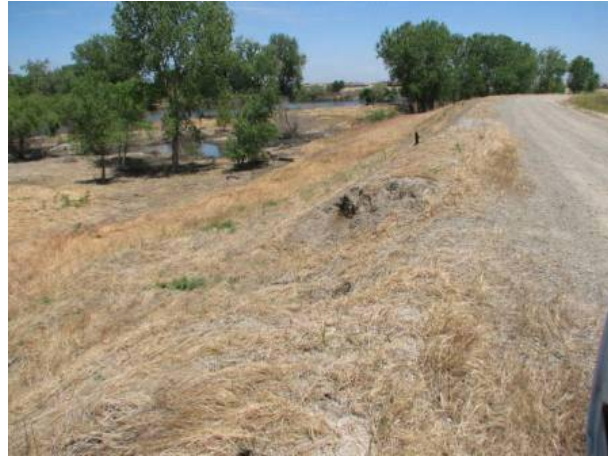
Levee Mile Report Line	15
Start Levee Mile	2.10
End Levee Mile	2.10
Location	Water Side
Category	
Item	Slope Stability
05/11/2011 Damage seen in photo continues down the slope as if area was being used by equipment to access the bank.	
mkhashch_s_20130225_409.jpg

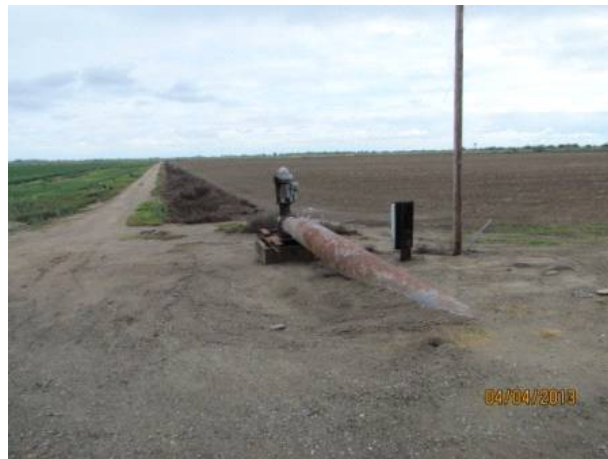
Levee Mile Report Line	2
Start Levee Mile	0.57
End Levee Mile	0.57
Location	Land Side
Category	
Item	Encroachments

View of the pipe day lighting at the landside levee toe.

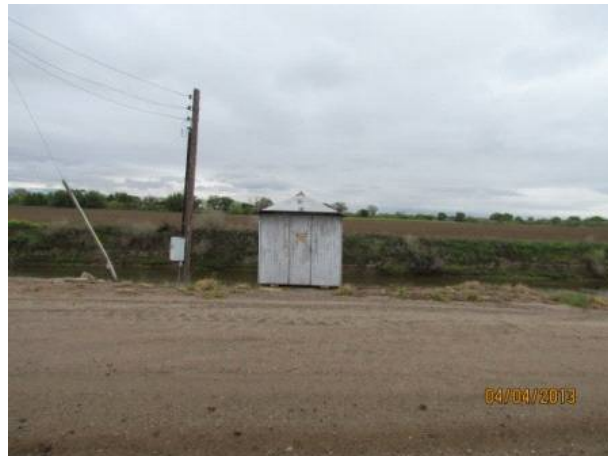
Levee Mile Report Line	3
Start Levee Mile	0.76
End Levee Mile	0.76
Location	Water Side
Category	
Item	Encroachments

View of the pump house at the waterside levee hinge.

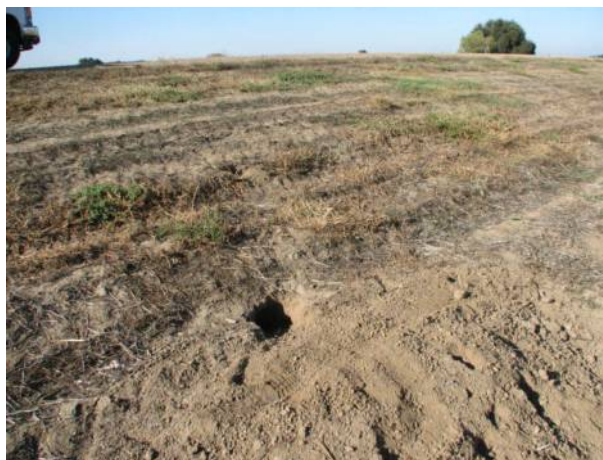
Levee Mile Report Line	8
Start Levee Mile	2.19
End Levee Mile	2.19
Location	Land Side
Category	
Item	Animal Control
10/20/211 Single large burrow on landside, appears to be active.	
mkhashch_s_20130225_425.jpg

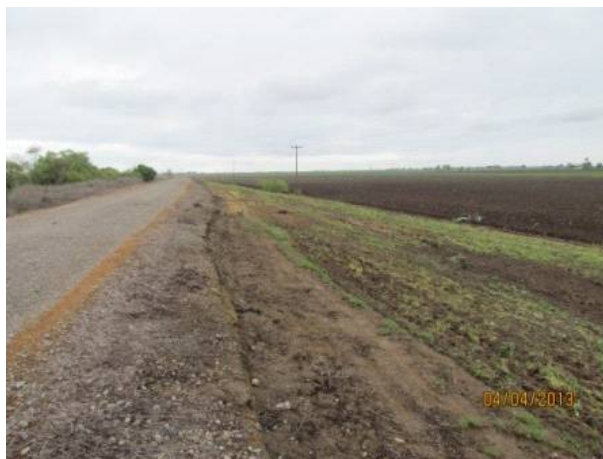
Levee Mile Report Line	10
Start Levee Mile	2.54
End Levee Mile	3.94
Location	Land Side
Category	
Item	Encroachments
View of the vertical scarp created by discing.	
mkhashch_s_20130410_708.JPG

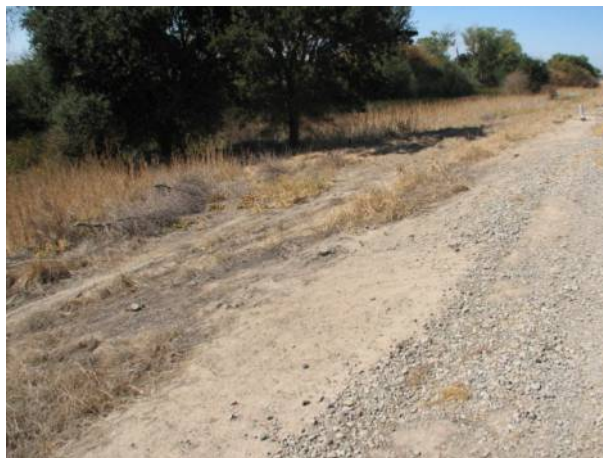
Levee Mile Report Line	12
Start Levee Mile	2.89
End Levee Mile	2.89
Location	Water Side
Category	
Item	Trim / Thin Trees
Three small stumps on levee slope.	
mkhashch_s_20130225_414.jpg

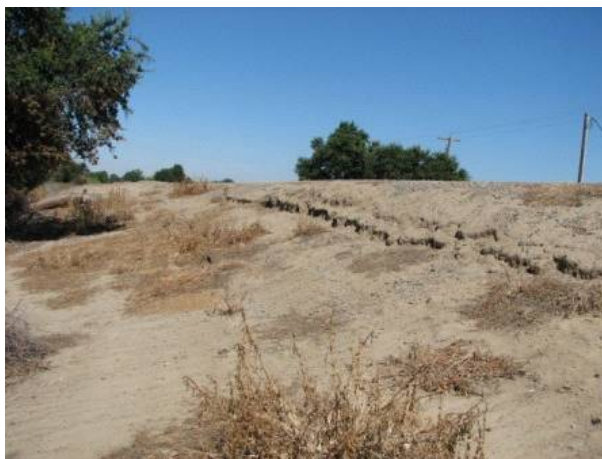
Levee Mile Report Line	17
Start Levee Mile	3.27
End Levee Mile	3.28
Location	Water Side
Category	Supplemental
Item	DWR Erosion Survey

Downstream view of scarp caused by a  
maintenance equipment.

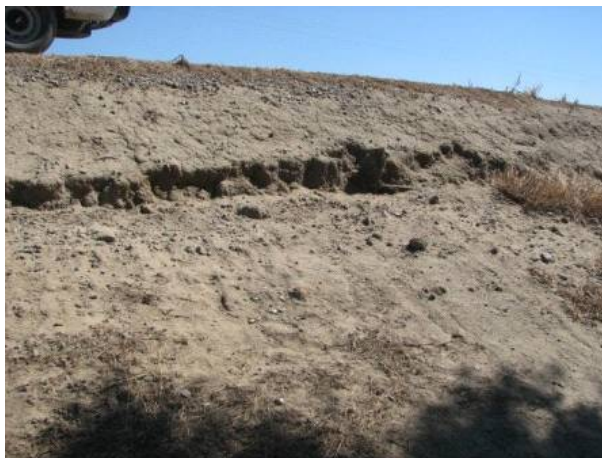
Levee Mile Report Line	17
Start Levee Mile	3.27
End Levee Mile	3.28
Location	Water Side
Category	Supplemental
Item	DWR Erosion Survey

Close view of scarp.

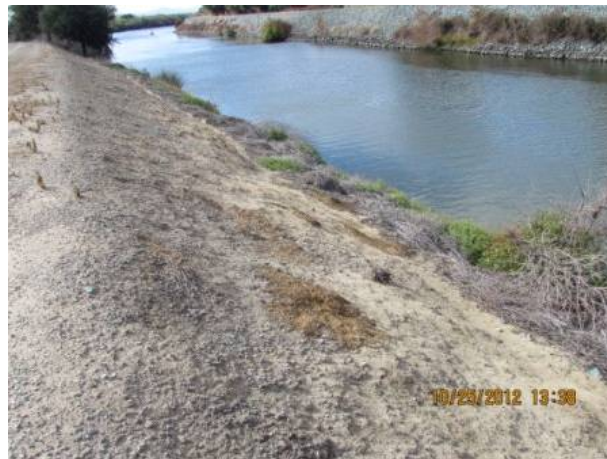
Levee Mile Report Line	2
Start Levee Mile	0.08
End Levee Mile	0.08
Location	Water Side
Category	
Item	Trim / Thin Trees

View of tree stumps on waterside slope.

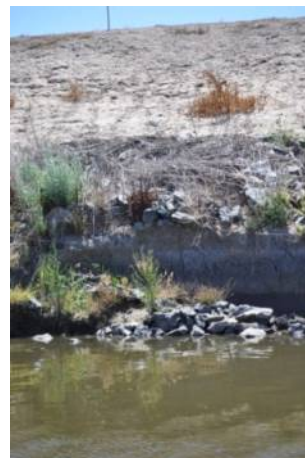
Levee Mile Report Line	3
Start Levee Mile	0.10
End Levee Mile	0.11
Location	Water Side
Category	Supplemental
Item	DWR Erosion Survey

close view of the site

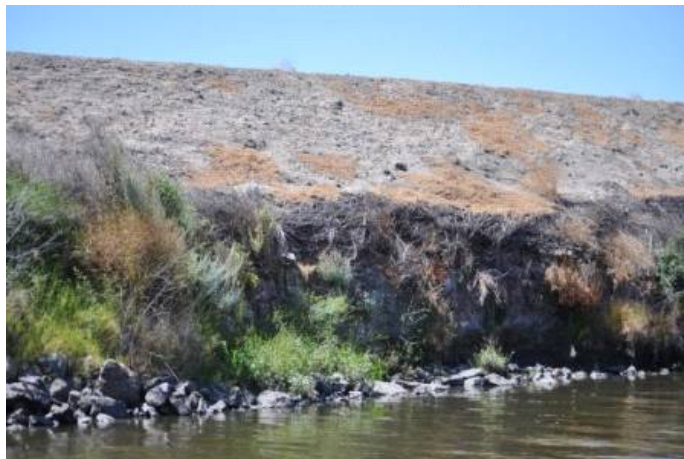
Levee Mile Report Line	6
Start Levee Mile	0.23
End Levee Mile	0.32
Location	Water Side
Category	Supplemental
Item	DWR Erosion Survey

Front view of the 5-ft vertical scarp .

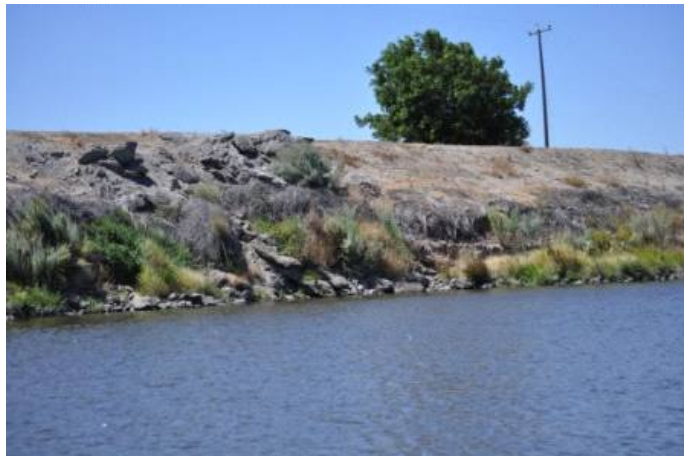
Levee Mile Report Line	8
Start Levee Mile	0.35
End Levee Mile	0.35
Location	Water Side
Category	Supplemental
Item	DWR Erosion Survey

Upstream view of the erosion.

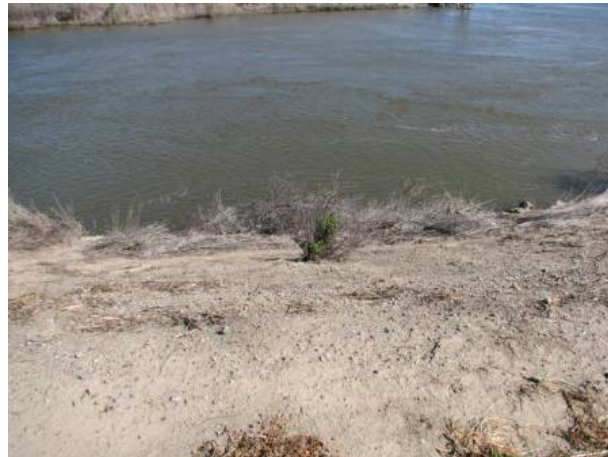
Levee Mile Report Line	12
Start Levee Mile	0.61
End Levee Mile	0.61
Location	Water Side
Category	
Item	Trim / Thin Trees

05/11/2011 Stump in slope, new growth in center of photo is at the location of the stump.

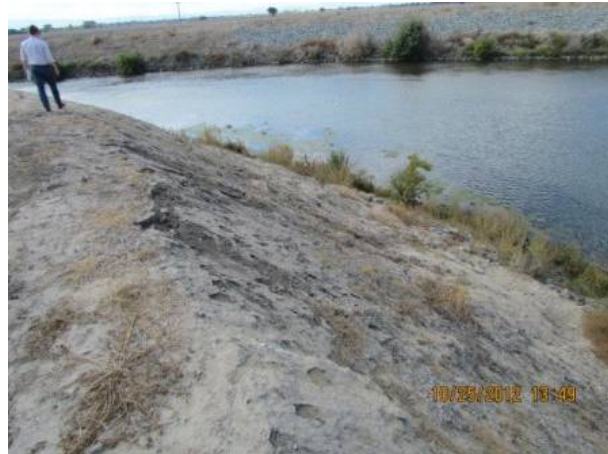
Levee Mile Report Line	14
Start Levee Mile	0.82
End Levee Mile	0.82
Location	Water Side
Category	
Item	Erosion / Bank Caving

View of slope erosion from foot traffic.

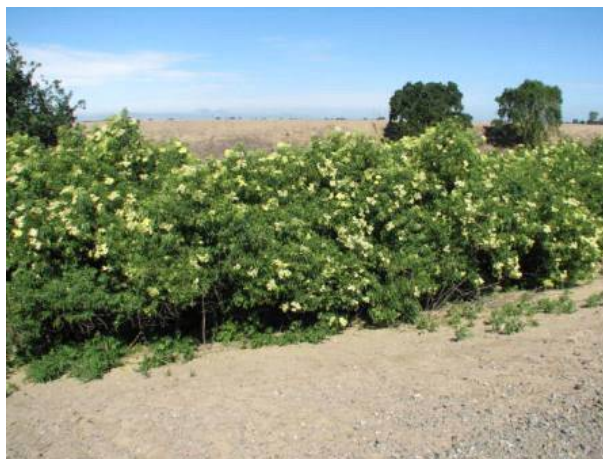
Levee Mile Report Line	16
Start Levee Mile	1.37
End Levee Mile	1.37
Location	Water Side
Category	
Item	Vegetation

05/11/2011 Elderberry bush on water side slope.

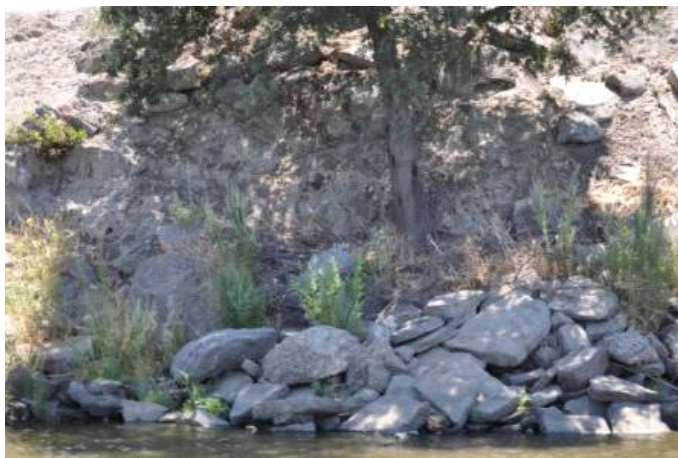
Levee Mile Report Line	17
Start Levee Mile	1.42
End Levee Mile	1.43
Location	Water Side
Category	Supplemental
Item	DWR Erosion Survey

Close view of the site where a small to medium sized Oak tree is located.

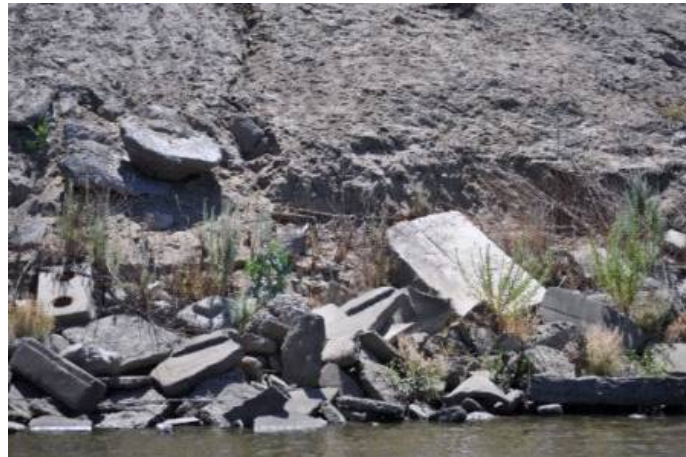
Levee Mile Report Line	17
Start Levee Mile	1.42
End Levee Mile	1.43
Location	Water Side
Category	Supplemental
Item	DWR Erosion Survey

Front view of the site. Note existing broken concrete on the upper slope as well as on the lower slope and at the toe.

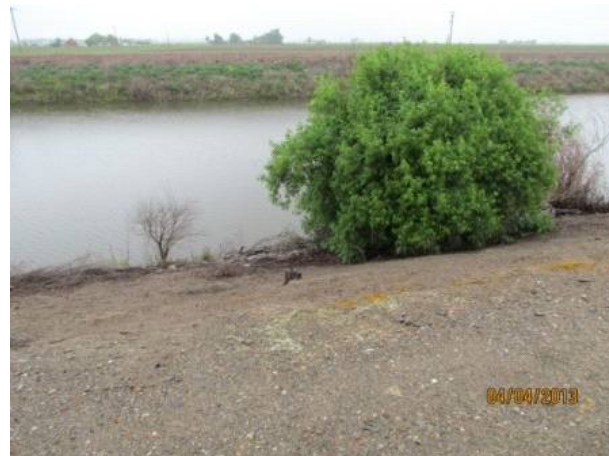
Levee Mile Report Line	19
Start Levee Mile	1.67
End Levee Mile	1.67
Location	Water Side
Category	
Item	Trim / Thin Trees

View of the tree stump on the waterside levee slope.

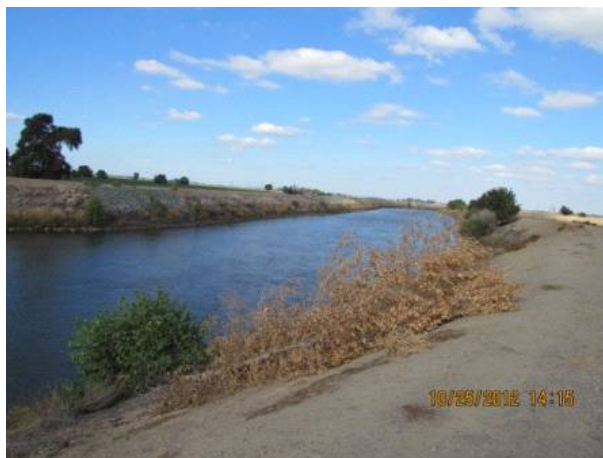
View of damaged tree by beaver on waterside slope.

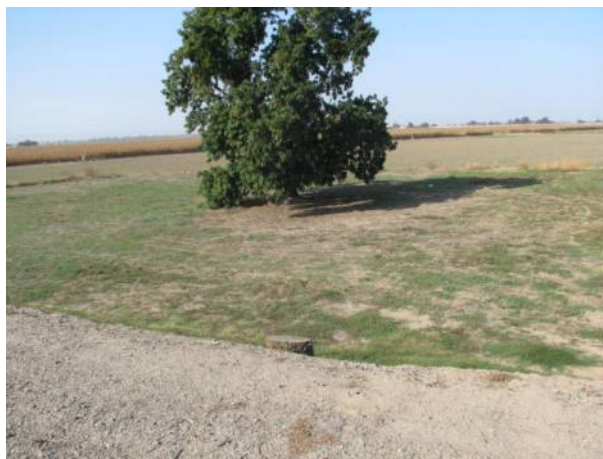
Levee Mile Report Line	31
Start Levee Mile	4.82
End Levee Mile	4.82
Location	Land Side
Category	
Item	Trim / Thin Trees

10/21/2011 Photo taken the next day. Stump can be seen in the lower center of the photo.

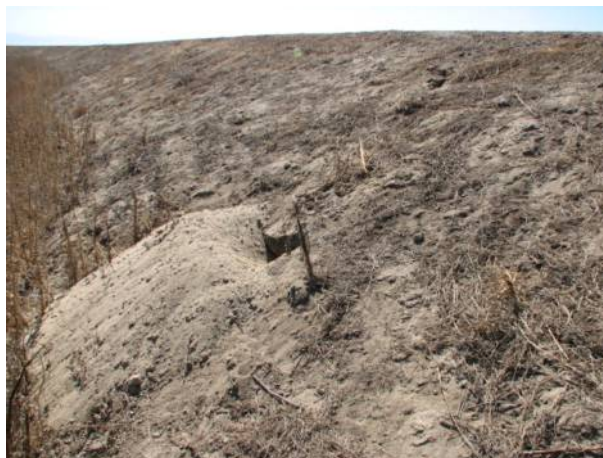
Levee Mile Report Line	32
Start Levee Mile	4.83
End Levee Mile	4.83
Location	Water Side
Category	
Item	Animal Control

Animal burrow on levee slope.
