**Flood Control Project Maintenance
Levee Inspections****LMA District Cover Sheet****Spring 2014 Levee Inspection Results****Reclamation District No. 2062 Stewart**

Spring 2014 Levee Inspection Results

Reclamation District No. 2062 Stewart

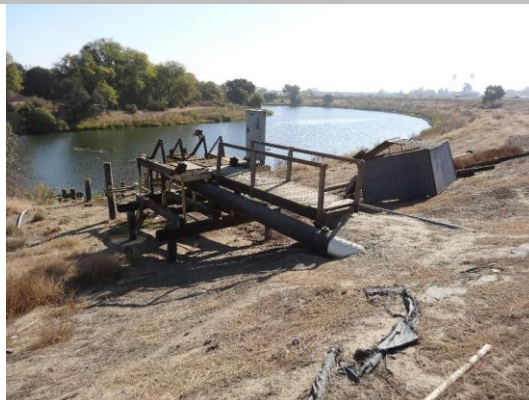
Photo 1 of 1 : UCIP_3227.jpg

LM Start	1.67	Rating **	M	Issue No.	1
LM End	1.67	Issue Type +	En	Location *	WS
Category	Supplemental			GPS Latitude/Longitude	
				Start	End
Item	DWR UCIP Field Study			37.793521 °	37.793521 °
				-121.315348 °	-121.315348 °
DWR ID	DWR_RD2062_01_s_2014_1				
Action/Comments					
Inspector Comments: FS_ID:22807 EP_NO: 12679 Repair Type: Crossing Status: UCIP Comments: - All 3 pipes on landside looks newPumps, pump house, and pipes removed from watersideLand development activities going on in this area.Needs to confirm from LMA or DWR Inspector about the crossing. FIELD_STRUCT_DESC: 1 of 3: Two 16-inch steel pipes, one 8-inch steel pipe, and three electric conduits through the levee 5.0 feet below the crown. Two slant pumps in the pump house on the waterward slope. Siphon breakers on the landward slope. (App. No. 16124) FS Date: 10/22/2013

WS view: pipes, walkway, and dismantled pumphouse (right).

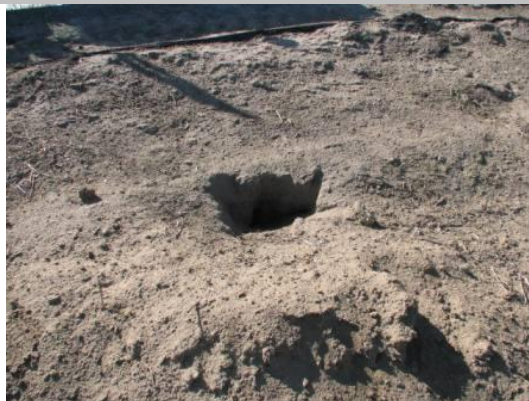
Photo 1 of 4 : mkhashch_s_20140428_00623.jpg

10/20/2011 Large burrow located on waterside slope of levee.

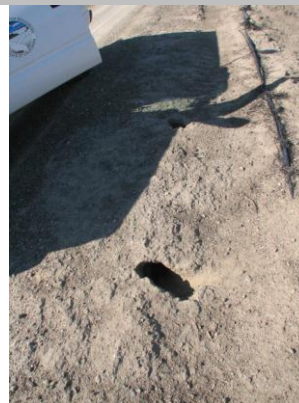
Photo 2 of 4 : mkhashch_s_20140428_00624.jpg

10/20/2011 Large burrow located near crown on waterside slope of

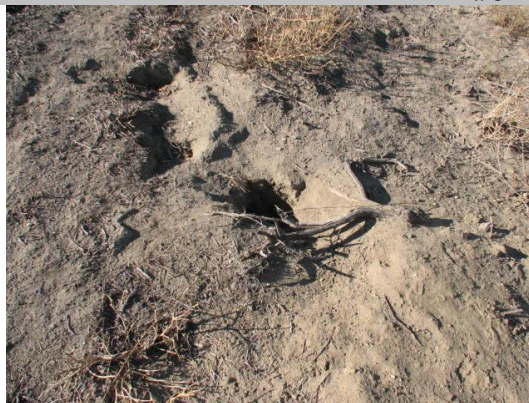
Photo 3 of 4 : mkhashch_s_20140428_00625.jpg

10/20/2011 Large burrow located on waterside slope of levee.

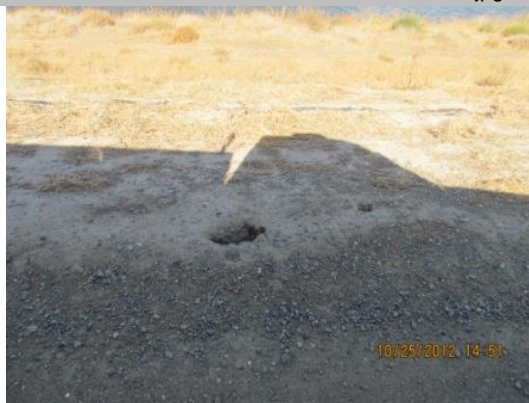
Photo 4 of 4 : mkhashch_s_20140428_00626.jpg

View of large burrow on waterside slope.

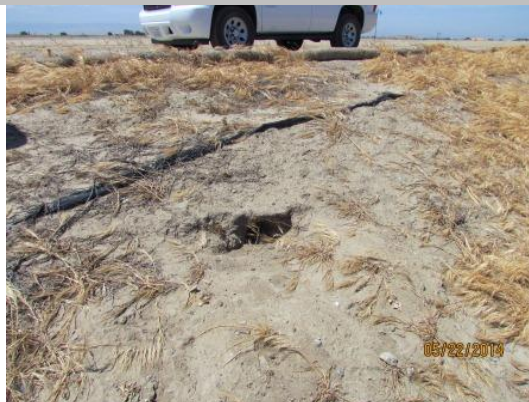
Photo 1 of 1 : mkhashch_s_20140527_01055.jpg

LM Start	1.84	Rating **	M	Issue No.	16
LM End	1.84	Issue Type +	Ma	Location *	WS
Category	Earthen Levee			GPS Latitude/Longitude	
				Start	End
Item	Animal Control			37.791887 °	37.791887 °
				-121.313178 °	-121.313178 °
DWR ID	DWR_RD2062_01_s _ 2012_16				
Action/Comments					
No rodents visible, but rodent burrows visible; need to backfill and compact or grout burrows.

View of a rodent hole on the waterside levee slope.

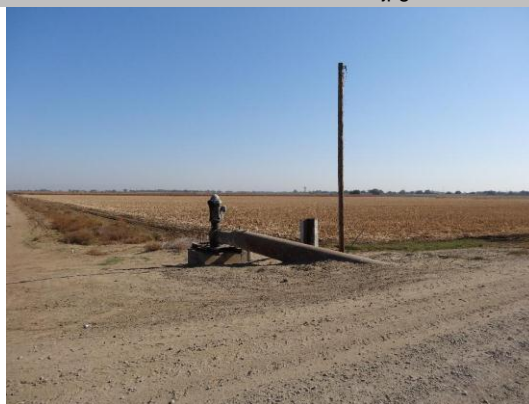
Photo 1 of 1 : UCIP_3342.jpg

LM Start	0.58	Rating **	M	Issue No.	6
LM End	0.58	Issue Type +	En	Location *	WS
Category	Supplemental			GPS Latitude/Longitude	
				Start	End
Item	DWR UCIP Field Study			37.784380 °	37.784380 °
				-121.338985 °	-121.338985 °
DWR ID	DWR_RD2062_02_s _ 2014_6				
Action/Comments					
Inspector Comments: FS_ID:23110					
EP_NO: N/A					
Repair Type:					
Crossing Status:					
UCIP Comments: Found on field with the help of USACE 2012 PI					
ReportNeeds proper abandonment.					
FIELD_STRUCT_DESC: Abandoned 24-inch steel pipe through the					
levee. Damaged siphon breaker on waterside levee slope. Pump on					
concrete sump on landside. Service pole on landside levee slope.					
Pump was disconnected from service pole.					
FS Date: 10/23/2013

LS view: exposed steel pipe and abandoned pump on levee slope.
Service pole and electric control box (right).

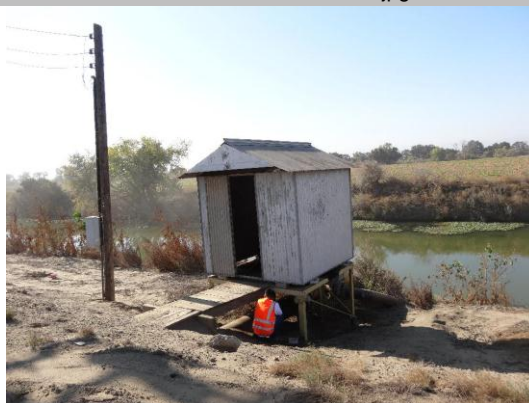
Photo 1 of 1 : UCIP_3363.jpg

LM Start	0.77	Rating **	M	Issue No.	7
LM End	0.77	Issue Type +	En	Location *	WS
Category	Supplemental			GPS Latitude/Longitude	
				Start	End
Item	DWR UCIP Field Study			37.786130 °	37.786130 °
				-121.341564 °	-121.341564 °
DWR ID	DWR_RD2062_02_s_2014_7				
Action/Comments					
Inspector Comments: FS_ID:23181					
EP_NO: 12427					
Repair Type:					
Crossing Status:					
UCIP Comments: - no siphon breaker foundevee toe erosion under walkway on waterside.erosion around concrete standpipe on landside- may be base of the standpipe was leaking.					
FIELD_STRUCT_DESC: 18-inch pipe through the levee 4.4 feet below the crown, pump house on the waterward slope, metal walkway from the pump house to the crown. Power pole on waterside. Flap gate and concrete distribution box on the landward slope. (App. No. 12427)					
FS Date: 10/23/2013

WS view: pipe, walkway, service pole, and pumphouse on levee slope.

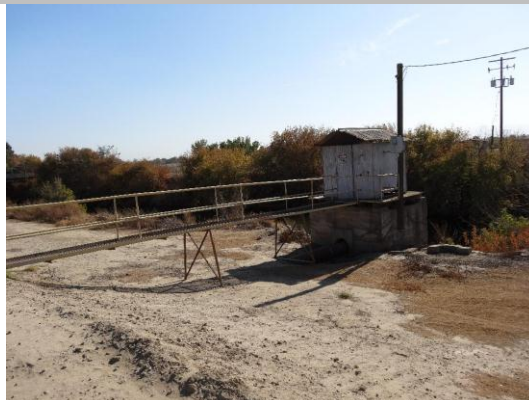
Photo 1 of 1 : UCIP_3326.jpg

LM Start	1.40	Rating **	M	Issue No.	16
LM End	1.40	Issue Type +	En	Location *	WS
Category	Supplemental			GPS Latitude/Longitude	
				Start	End
Item	DWR UCIP Field Study			37.791820 °	37.791820 °
				-121.350447 °	-121.350447 °
DWR ID	DWR_RD2062_02_s_2014_16				
Action/Comments					
Inspector Comments: FS_ID:23062					
EP_NO: N/A					
Repair Type:					
Crossing Status:					
UCIP Comments: - pumphouse on concrete sump in the channel.					
erosion under walkway on waterside.					
FIELD_STRUCT_DESC: 20-inch pipe through the levee 8 feet below					
the crown. Pump house on the waterward slope and a metal walkway					
from the pump house to the crown. Flap gate, air vent, and concrete					
distribution box on the landward slope.					
FS Date: 10/22/2013

WS view: pipe, walkway, and pumphouse on levee berm. Service pole on waterside.

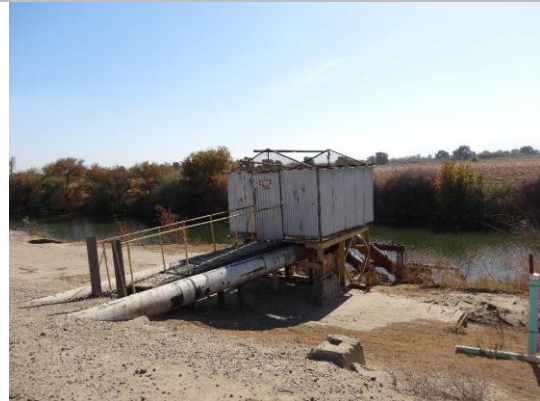
Photo 1 of 1 : UCIP_3318.jpg

LM Start	1.67	Rating **	M	Issue No.	21
LM End	1.67	Issue Type +	En	Location *	WS
Category	Supplemental			GPS Latitude/Longitude	
				Start	End
Item	DWR UCIP Field Study			37.794009 °	37.794009 °
				-121.354416 °	-121.354416 °
DWR ID	DWR_RD2062_02_s _ 2014_21				
Action/Comments					
Inspector Comments: FS_ID:23061					
EP_NO: 4305					
Repair Type:					
Crossing Status:					
UCIP Comments: - missing roof in pump house.no protection for siphon breakerhuge erosion under pumphouse and levee slope on waterside.					
FIELD_STRUCT_DESC: 1 of 2: Two 18-inch pipes through the levee 4.8 feet below the crown. Pump house on the waterward slope. Siphon breaker on the landward shoulder. Power pole on the landward shoulder. Concrete distribution box at the toe of the landward slope.					
(App. No. 4305)					
FS Date: 10/22/2013

WS view: pipes, walkway, and pumphouse with missing roof (right).

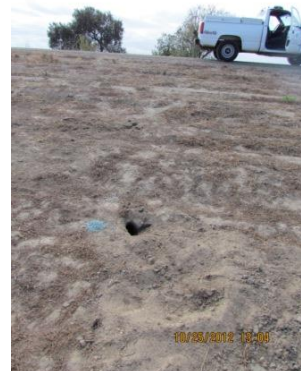
Photo 1 of 1 : mkhashch_s_20140428_00638.jpg

View of bait next to active burrow on landside slope.

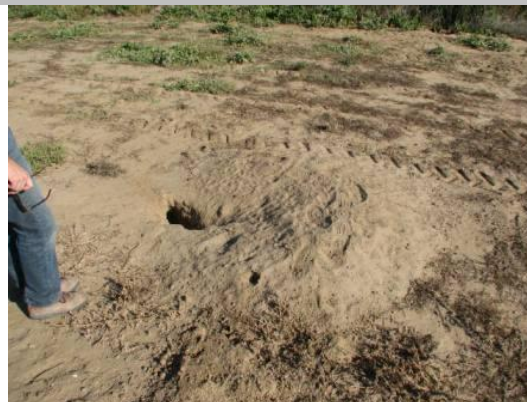
Photo 1 of 3 : mkhashch_s_20140428_00642.jpg

LM Start	2.10	Rating **	M	Issue No.	18
LM End	2.10	Issue Type +	Ma	Location *	LS
Category	Earthen Levee			GPS Latitude/Longitude	
				Start	End
Item	Animal Control			37.797558 °	37.797558 °
				-121.360815 °	-121.360815 °
DWR ID	DWR_RD2062_02_s _ 2012_18				
Action/Comments					
No rodents visible, but rodent burrows visible; need to backfill and compact or grout burrows. Inspector Comments: Multiple large burrows, appears to be active.

10/20/2011 Photo shows single large burrow, which appears to be active.

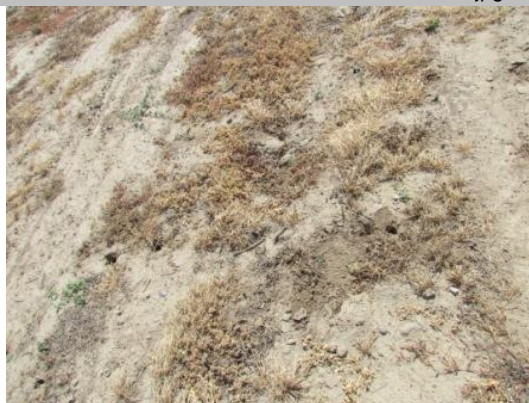
Photo 2 of 3 : mkhashch_s_20140428_00643.jpg

View of multiple burrow holes; the previously large burrow hole was not found at the time, but rodent activity is still present. 05/17/2012

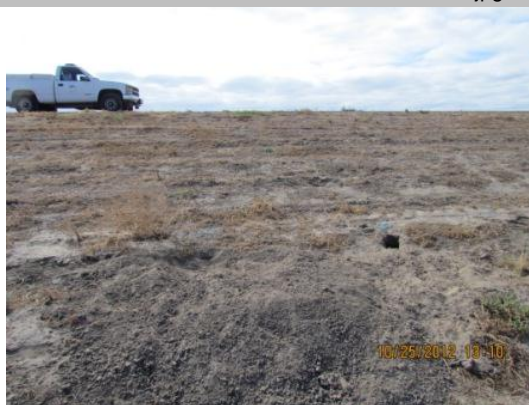
Photo 3 of 3 : mkhashch_s_20140428_00644.jpg

View of active burrows on landside slope.

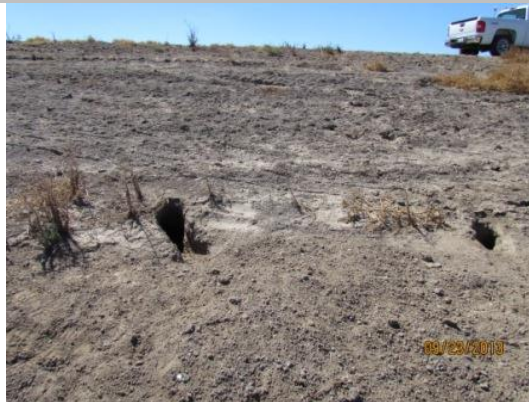
Photo 1 of 1 : mkhashch_s_20140428_00645.jpg

LM Start	2.19	Rating **	M	Issue No.	19
LM End	2.19	Issue Type +	Ma	Location *	LS
Category	Earthen Levee			GPS Latitude/Longitude	
				Start	End
Item	Animal Control			37.798304 °	37.798304 °
				-121.362138 °	-121.362138 °
DWR ID	DWR_RD2062_02_s _ 2012_19				
Action/Comments					
No rodents visible, but rodent burrows visible; need to backfill and

View of animal burrows on landside levee slope.

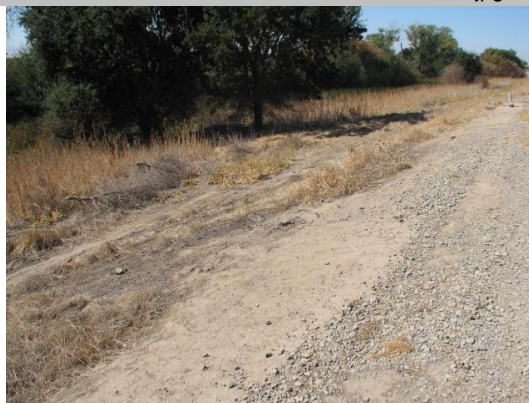
Photo 1 of 1 : mkhashch_s_20140428_00631.jpg

LM Start	2.89	Rating **	N	Issue No.	3
LM End	2.89	Issue Type +	Ma	Location *	WS
Category	Earthen Levee			GPS Latitude/Longitude	
				Start	End
Item	Trim / Thin Trees			37.803827 °	37.803827 °
				-121.372424 °	-121.372424 °
DWR ID	DWR_RD2062_02_s _ 2012_3				
Action/Comments					
Tree stumps. Inspector Comments: Three small tree stumps.

Three small stumps on levee slope.

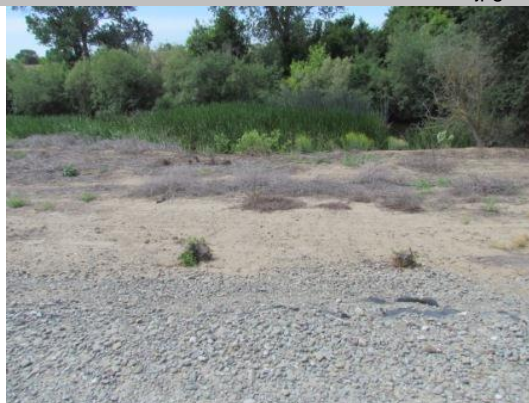
Photo 1 of 1 : mkhashch_s_20140428_00639.jpg

View of tree stumps on waterside slope. 05/17/2012

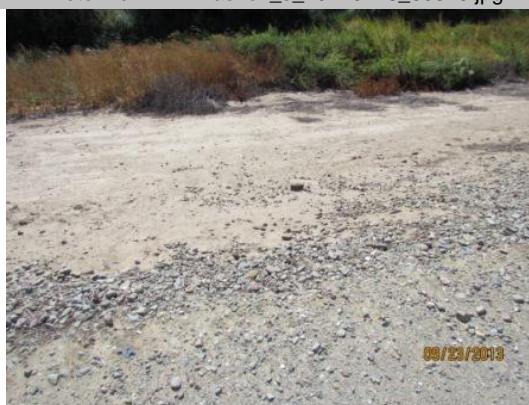
Photo 1 of 1 : mkhashch_s_20140428_00640.jpg

LM Start	3.03	Rating **	N	Issue No.	14
LM End	3.03	Issue Type +	Ma	Location *	WS
Category	Earthen Levee			GPS Latitude/Longitude	
				Start	End
Item	Trim / Thin Trees			37.804452 °	37.804452 °
				-121.374903 °	-121.374903 °
DWR ID	DWR_RD2062_02_s _ 2012_14				
Action/Comments					
Tree stumps.

View of the tree stump in the middle of the photo.

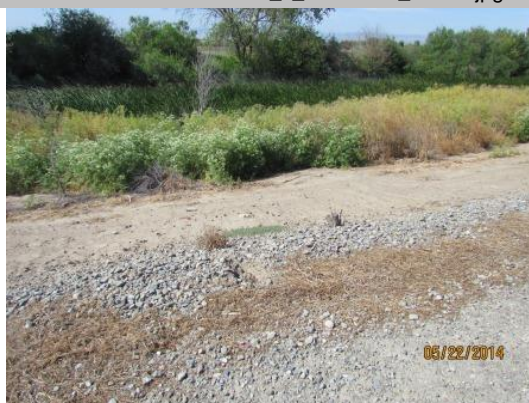
Photo 1 of 1 : mkhashch_s_20140527_01049.jpg

LM Start	3.07	Rating **	N	Issue No.	15
LM End	3.07	Issue Type +	Ma	Location *	WS
Category	Earthen Levee			GPS Latitude/Longitude	
				Start	End
Item	Trim / Thin Trees			37.804481 °	37.804481 °
				-121.375510 °	-121.375510 °
DWR ID	DWR_RD2062_02_s _ 2012_15				
Action/Comments					
Tree stumps.

View of the tree stumps on the waterside levee slope.

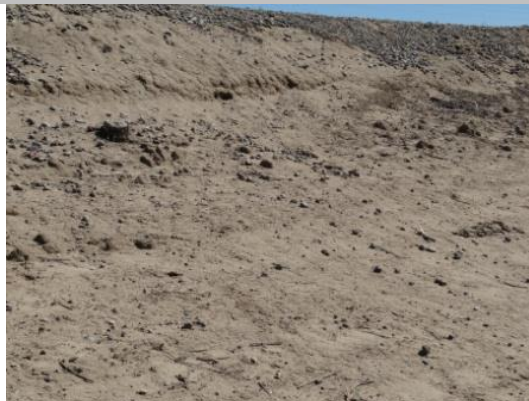
Photo 1 of 1 : mkhashch_s_20140428_00629.jpg

Inspector Comments: 08/28/2013: No significant change observed.
07/26/2012: Site was visited on 07/26/2012. No significant changes observed.
09/02/2011: No significant changes observed on site from last visit.
09/22/2010: No significant changes observed on site. The fencing located on the berm was removed. Levee slope and berm area 10 feet from the levee toe are bare of any vegetation. The 1- to 2 feet of near-vertical scarp on the levee toe is unchanged.
03/09/2010: As discussed with Michael Moncrief of MBK Engineer, the district will address the site this year.
7/27/2009: 1 to 2 feet of near-vertical scarp on the levee toe; damage was most likely caused by agricultural equipment during clearing or tilling operation; this is a maintenance-related issue. [2013 Site ID:RD2062U02RM2.14]

Close view of scarp.

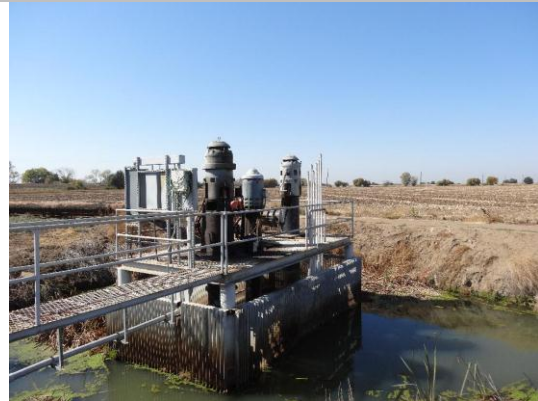
Photo 1 of 1 : UCIP_3374.jpg

LM Start	3.30	Rating **	M	Issue No.	23
LM End	3.30	Issue Type +	En	Location *	WS
Category	Supplemental			GPS Latitude/Longitude	
				Start	End
Item	DWR UCIP Field Study			37.804770 °	37.804770 °
				-121.379679 °	-121.379679 °
DWR ID	DWR_RD2062_02_s _ 2014_23				
Action/Comments					
Inspector Comments: FS_ID:23304					
EP_NO: 11524					
Repair Type:					
Crossing Status:					
UCIP Comments: - waterside pipe immersed into channel water.					
most of the pipe on landside exposed and siphon breaker on waterside not protected.					
FIELD_STRUCT_DESC: 1 of 3: One of 2x24-inch pipes through the levee 2.0 feet below the crown. 18-inch pipe through the levee 4.0 feet below the crown. Siphon breakers on waterward slope. Pump on steel platform in drainage ditch, 350 ft. from levee center off the the landward berm. (App. No. 11524)					
FS Date: 10/22/2013

LS view: walkway, three pumps on pump platform in drainage ditch, 350 ft. from the levee.

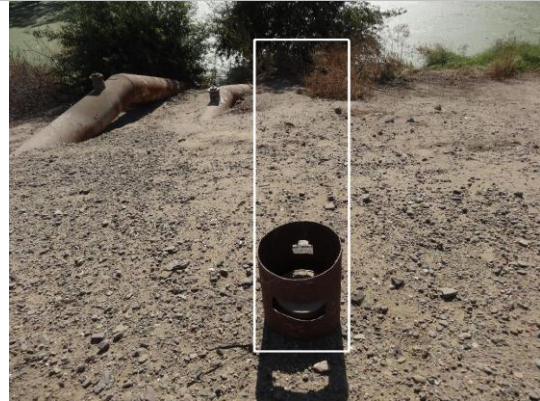
Photo 1 of 1 : UCIP_3377.jpg

LM Start	3.31	Rating **	M	Issue No.	25
LM End	3.31	Issue Type +	En	Location *	WS
Category	Supplemental			GPS Latitude/Longitude	
				Start	End
Item	DWR UCIP Field Study			37.804787 °	37.804787 °
				-121.379734 °	-121.379734 °
DWR ID	DWR_RD2062_02_s _ 2014_25				
Action/Comments					
Inspector Comments: FS_ID:23305					
EP_NO: 11524					
Repair Type:					
Crossing Status:					
UCIP Comments: - no associated pump or any other appurtenances found on landside.looks abandoned pipe. Needs proper abandonment.					
FIELD_STRUCT_DESC: 3 of 3: One of 2x24-inch pipe through the levee 2.0 feet below the crown. 18-inch pipe through the levee 4.0 feet below the crown. Siphon breakers on waterward slope. (App. No. 11524)					
FS Date: 10/22/2013

WS view: siphon breaker in steel pipe riser on levee slope.

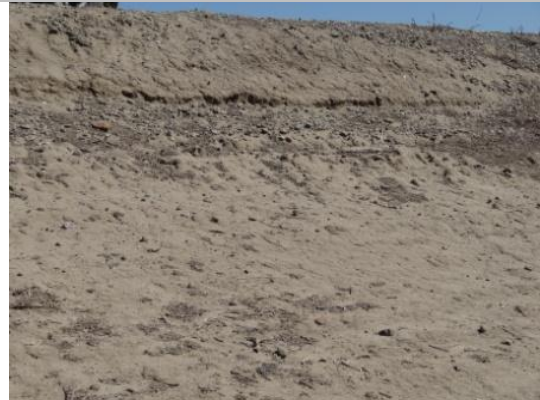
Photo 1 of 1 : mkhashch_s_20140428_00630.jpg

LM Start	3.44	Rating **	M	Issue No.	2
LM End	3.53	Issue Type +	Ma	Location *	WS
Category	Supplemental			GPS Latitude/Longitude	
				Start	End
Item	DWR Erosion Survey			37.805422 °	37.805422 °
				-121.383173 °	-121.383173 °
DWR ID	DWR_RD2062_02_s _ 2014_2				
Action/Comments					
Inspector Comments: 08/28/2013: No significant change observed. 07/31/2012: Site was visited on 07/26/2012. No significant change observed. 09/02/2011: No significant change observed. 09/22/2010: No significant changes observed. The foot-high near-vertical scarp still exists on levee toe. There is little to no vegetation on the slope. 03/09/2010: As discussed with Michael Moncrief of MBK, site will be addressed this year. 07/27/2009: 1 to 2 feet of near-vertical scarp on levee toe; damage was most likely caused by farming equipment during clearing or tilling operation; this is a maintenance-related issue. [2013 Site ID:RD2062U02RM1.94]

Front view of site.

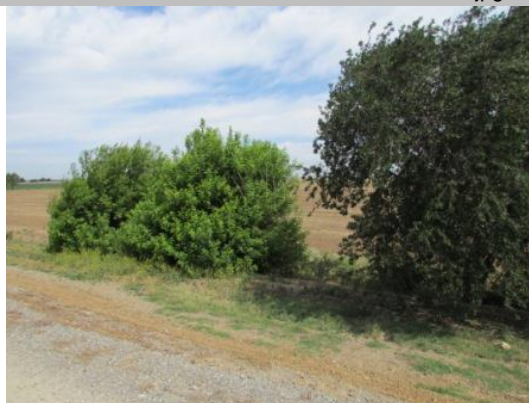
Photo 1 of 1 : mkhashch_s_20140428_00646.jpg

View of bushy trees at levee toe obstructing visibility. 05/17/2012

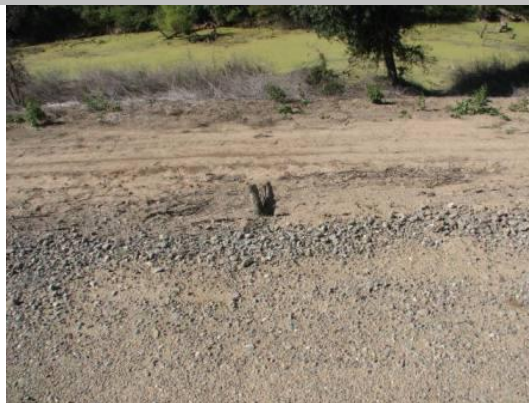
Photo 1 of 1 : mkhashch_s_20140428_00635.jpg

LM Start	3.68	Rating **	N	Issue No.	9
LM End	3.68	Issue Type +	Ma	Location *	WS
Category	Earthen Levee			GPS Latitude/Longitude	
				Start	End
Item	Trim / Thin Trees			37.806231 °	37.806231 °
				-121.386209 °	-121.386209 °
DWR ID	DWR_RD2062_02_s _ 2012_9				
Action/Comments					
Tree stumps.					
Inspector Comments: Small stump on slope.

05/11/2011 Small stump in waterside slope.

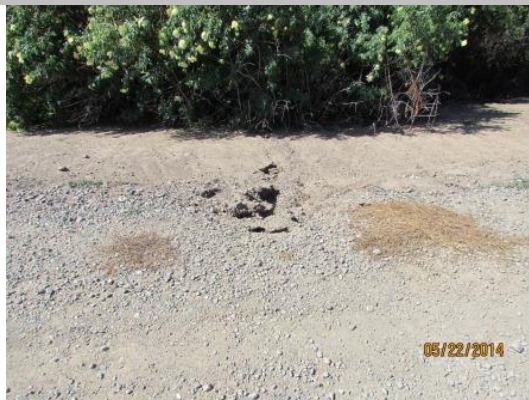
Photo 1 of 1 : mkhashch_s_20140527_01050.jpg

LM Start	3.71	Rating **	M	Issue No.	8
LM End	3.71	Issue Type +	Ma	Location *	WS
Category	Earthen Levee			GPS Latitude/Longitude	
				Start	End
Item	Erosion / Bank Caving			37.806347 °	37.806347 °
				-121.386692 °	-121.386692 °
DWR ID	DWR_RD2062_02_s _ 2014_8				
Action/Comments					
Schedule repair of erosion site prior to the next inspection.

View of the erosion from surface runoff on the waterside levee slope.

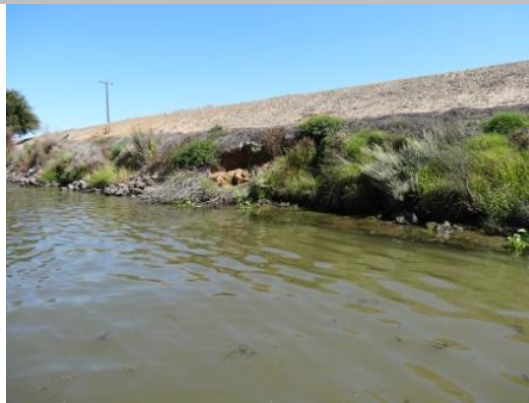
Photo 1 of 1 : mkhashch_s_20140428_00653.jpg

LM Start	0.00	Rating **	U	Issue No.	1
LM End	0.07	Issue Type +	Ma	Location *	WS
Category	Supplemental			GPS Latitude/Longitude	
				Start	End
Item	DWR Erosion Survey			37.809673 °	37.809673 °
				-121.390321 °	-121.390321 °
DWR ID	DWR_RD2062_03_s_2014_1				
Action/Comments					
Inspector Comments: 08/13/2013: No significant change observed. 08/07/2012: The site has been visited by boat survey. No significant change observed 08/23/2011: Site is at the upstream of a drainage ditch. [2013 Site ID:RD2062U03RM29.93]

Looking from downstream.

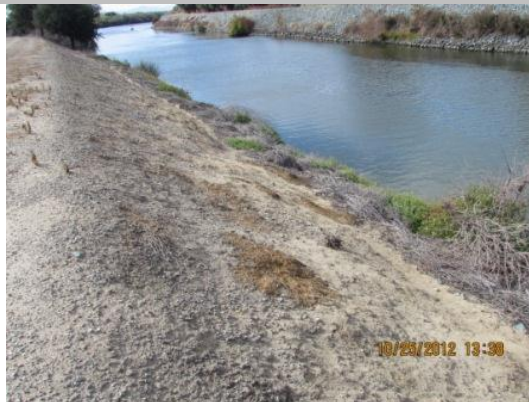
Photo 1 of 1 : mkhashch_s_20140428_00655.jpg

LM Start	0.08	Rating **	N	Issue No.	3
LM End	0.08	Issue Type +	Ma	Location *	WS
Category	Earthen Levee			GPS Latitude/Longitude	
				Start	End
Item	Trim / Thin Trees			37.809727 °	37.809727 °
				-121.389100 °	-121.389100 °
DWR ID	DWR_RD2062_03_f_2012_3				
Action/Comments					
Tree stumps.

View of tree stumps on waterside slope.

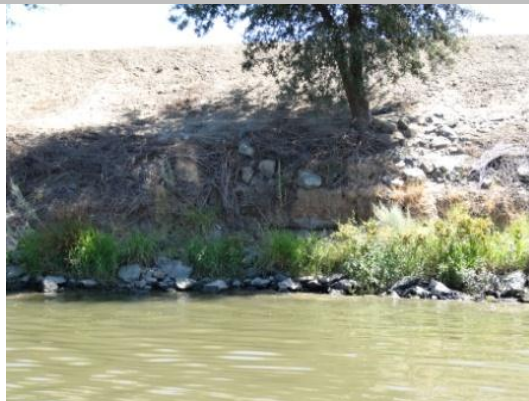
Photo 1 of 1 : mkhashch_s_20140428_00654.jpg

LM Start	0.10	Rating **	U	Issue No.	2
LM End	0.11	Issue Type +	Ma	Location *	WS
Category	Supplemental			GPS Latitude/Longitude	
				Start	End
Item	DWR Erosion Survey			37.810052 °	37.810052 °
				-121.388847 °	-121.388847 °
DWR ID	DWR_RD2062_03_s _ 2014_2				
Action/Comments					
Inspector Comments: 08/13/2013: No significant change observed. 08/07/2012: The site has been visited by boat survey. No significant change observed 08/23/2011: Hard to view the erosion because of the dense vegetation and trees on site. The site is under the bush, close to the tree. [2013 Site ID:RD2062U03RM30.02]

Front view of the site.

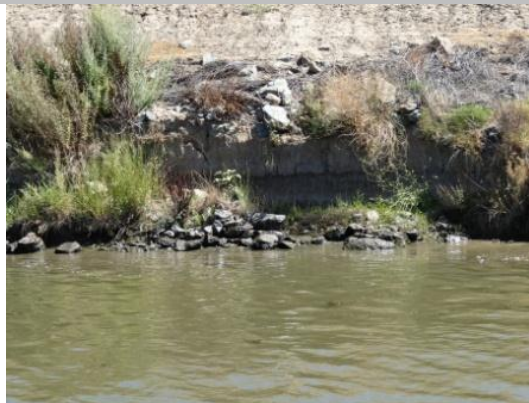
Photo 1 of 1 : mkhashch_s_20140428_00656.jpg

LM Start	0.18	Rating **	M	Issue No.	4
LM End	0.18	Issue Type +	Ma	Location *	WS
Category	Supplemental			GPS Latitude/Longitude	
				Start	End
Item	DWR Erosion Survey			37.810468 °	37.810468 °
				-121.387492 °	-121.387492 °
DWR ID	DWR_RD2062_03_s _ 2014_4				
Action/Comments					
Inspector Comments: 08/13/2013: No significant change observed. 08/07/2012: The site has been visited by boat survey. No significant change observed 08/23/2011: The protection at the levee toe has been washed away. [2013 Site ID:RD2062U03RM30.1]

Front view of the erosion.

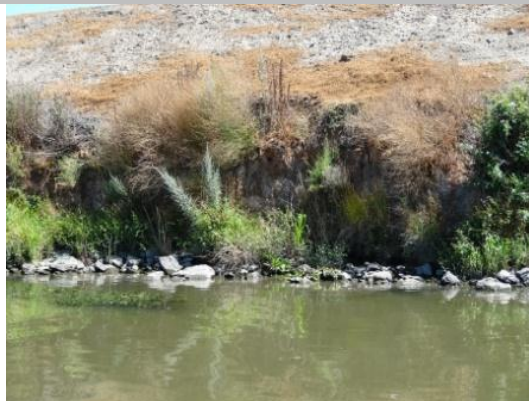
Photo 1 of 1 : mkhashch_s_20140428_00657.jpg

Inspector Comments: 08/13/2013: A new pocket erosion at the upper levee slope has been found directly above a large tree. The erosion might have been caused by internal pipe leakage or surface runoff. 08/07/2012: The site has been visited by boat survey. No significant change observed. 08/23/2011: No significant changes observed on site. Dense vegetation is visible along the water line. 09/07/2010: No significant changes observed on site. Much of the upper slope was recently cleared of vegetation by spraying. 4- to 6-foot vertical scarp and pocket erosions are lined along a span of 475 feet. In some sections, the vertical scarp encroaches into the levee prism. There is a lack of berm along this reach, exposing the levee slope to high flow velocities during normal and flood events. 08/06/2010: Recommended as local maintenance issue, per CLRO. 03/09/2010: As discussed with Michael Moncrief of MBK Engineers, the site will be 'addressed' later this year. 09/29/2009: No major change observed since last visit; pocket erosion and a vertical scarp forming; this site was combined with Site RM30.13 and 30.02 with a combined total erosion length of 475 feet; recommended as annual assessment and monitoring of site, per CLRO CES Evaluation 2008 Report; previously rated "M". 11/05/2008: Top of vertical scarp has rip rap that appears to be sliding; rodent holes; existing toe rip rap. [2013 Site ID:RD2062U03RM30.19]

Close view of the pocket erosion.

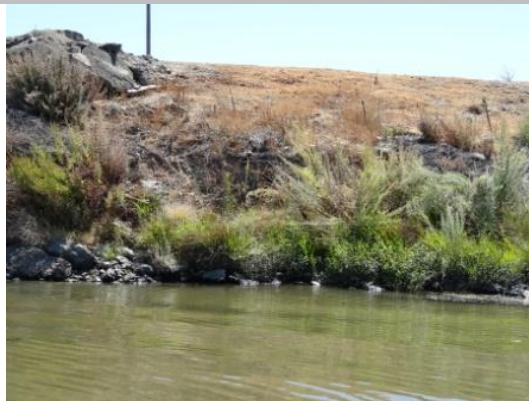
Photo 1 of 1 : mkhashch_s_20140428_00659.jpg

LM Start	0.35	Rating **	M	Issue No.	8
LM End	0.35	Issue Type +	Ma	Location *	WS
Category	Supplemental			GPS Latitude/Longitude	
				Start	End
Item	DWR Erosion Survey			37.811281 °	37.811281 °
				-121.384461 °	-121.384461 °
DWR ID	DWR_RD2062_03_s _ 2014_8				
Action/Comments					
Inspector Comments: 08/13/2013: No significant change observed. 08/07/2012: The site has been visited by boat survey. No significant change observed 08/23/2011: The site is right at the downstream of a river bend. [2013 Site ID:RD2062U03RM30.27]

Upstream view of the erosion.

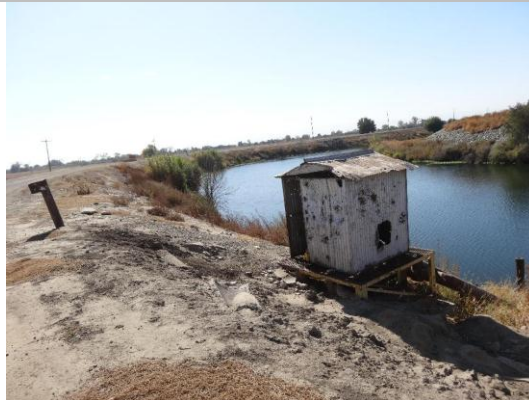
Photo 1 of 1 : UCIP_3382.jpg

LM Start	0.52	Rating **	M	Issue No.	24
LM End	0.52	Issue Type +	En	Location *	WS
Category	Supplemental			GPS Latitude/Longitude	
				Start	End
Item	DWR UCIP Field Study			37.812575 °	37.812575 °
				-121.382798 °	-121.382798 °
DWR ID	DWR_RD2062_03_s _ 2014_24				
Action/Comments					
Inspector Comments: FS_ID:23306					
EP_NO: 2029					
Repair Type:					
Crossing Status:					
UCIP Comments: - pits and holes on overflow pipe on waterside. underpinning at pump support.slope erosion on both sides of the levee2-inch electric conduit on waterside and power pole on landside.					
FIELD_STRUCT_DESC: 16-inch pipe through the levee 8 feet below the crown, siphon breaker on the landward slope. Pump house on the waterward slope. Distribution box on the landside. (App. No. 2029)					
FS Date: 10/22/2013

WS view: pump house on levee slope and soil erosion on levee slope.

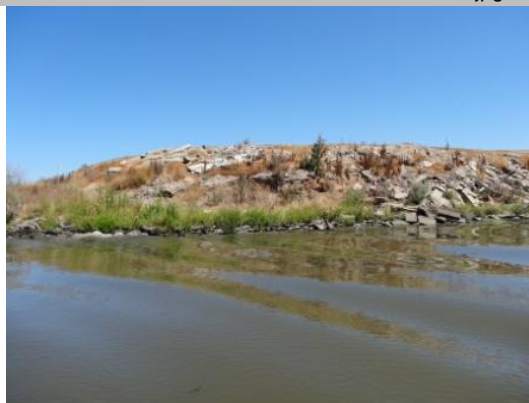
Photo 1 of 1 : mkhashch_s_20140428_00660.jpg

LM Start	0.56	Rating **	M	Issue No.	9
LM End	0.57	Issue Type +	Ma	Location *	WS
Category	Supplemental			GPS Latitude/Longitude	
				Start	End
Item	DWR Erosion Survey			37.813070 °	37.813070 °
				-121.383100 °	-121.383100 °
DWR ID	DWR_RD2062_03_s _ 2014_9				
Action/Comments					
Inspector Comments: 08/13/2013: No significant change observed. 08/07/2012: The site has been visited by boat survey. No significant change observed. 08/23/2011: No significant changes observed on site. 09/07/2010: No significant changes observed on site. Much of the placed rip rap revetment has slid. It is no longer adequately protecting the slope. 08/06/2010: Recommended as local maintenance issue, per CLRO Report. 03/09/2010: As discussed with Michael Moncrief of MBK, site will be 'addressed' this year. 09/29/2009: No major change observed since last visit; a section of the rip rap has slipped, exposing a levee section that has eroded; recommended as local maintenance issue, per CLRO CES Evaluation 2008 Report; Site # is the same as RM30.43,LM0.63; previously rated "U". 11/05/2008: Site is located inside of a bend; scarp looks to be into the levee prism; piles of concrete chunks placed on the slope, with some of them already starting to slide. [2013 Site ID:RD2062U03RM30.43]

Close view of the site.

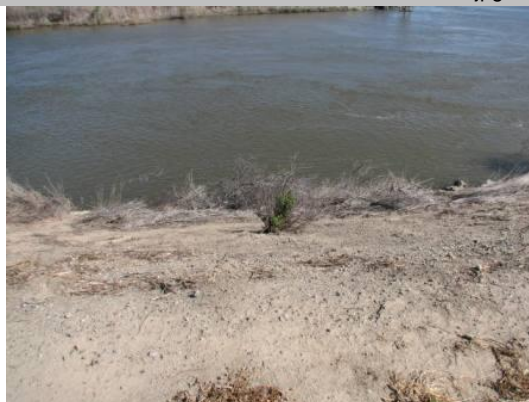
Photo 1 of 1 : mkhashch_s_20140428_00661.jpg

LM Start	0.61	Rating **	N	Issue No.	10
LM End	0.61	Issue Type +	Ma	Location *	WS
Category	Earthen Levee			GPS Latitude/Longitude	
				Start	End
Item	Trim / Thin Trees			37.813570 °	37.813570 °
				-121.382094 °	-121.382094 °
DWR ID	DWR_RD2062_03_s _ 2012_10				
Action/Comments					
Tree stumps. Inspector Comments: Stump in slope.

05/11/2011 Stump in slope, new growth in center of photo is at the location of the stump.

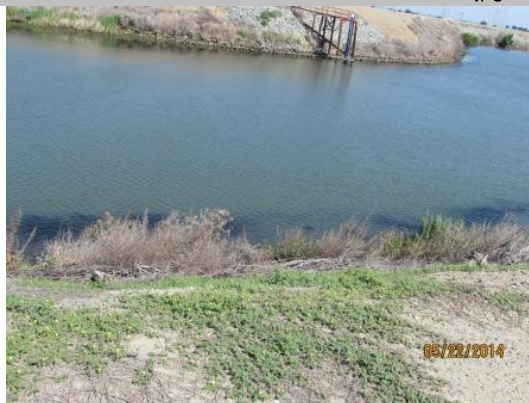
Photo 1 of 1 : mkhashch_s_20140527_01051.jpg

View of the tree stumps on the waterside levee slope.

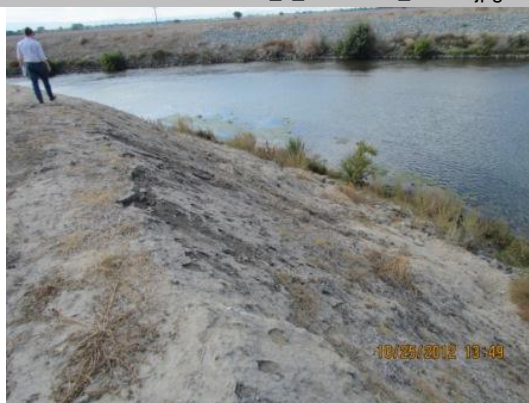
Photo 1 of 2 : mkhashch_s_20140428_00662.jpg

LM Start	0.82	Rating **	M	Issue No.	11
LM End	0.82	Issue Type +	Ma	Location *	WS
Category	Earthen Levee			GPS Latitude/Longitude	
				Start	End
Item	Erosion / Bank Caving			37.816315 °	37.816315 °
				-121.381587 °	-121.381587 °
DWR ID	DWR_RD2062_03_s _ 2012_11				
Action/Comments					
Schedule repair of erosion site prior to the next inspection. Inspector Comments: Cracking developing along the waterside levee hinge.

View of slope erosion from foot traffic.

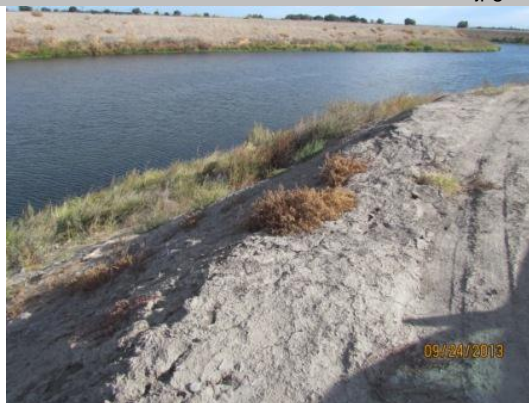
Photo 2 of 2 : mkhashch_s_20140428_00663.jpg

View of cracking at waterside levee hinge.

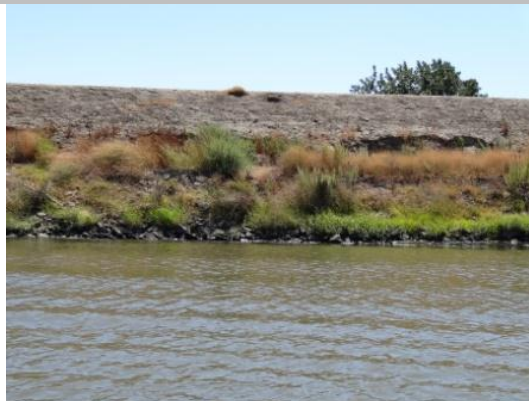
Photo 1 of 1 : mkhashch_s_20140428_00664.jpg

LM Start	1.20	Rating **	U	Issue No.	13
LM End	1.21	Issue Type +	Ma	Location *	WS
Category	Supplemental			GPS Latitude/Longitude	
				Start	End
Item	DWR Erosion Survey			37.819290 °	37.819290 °
				-121.378880 °	-121.378880 °
DWR ID	DWR_RD2062_03_s _ 2014_13				
Action/Comments					
Inspector Comments: 08/13/2013: No significant change observed.

Front view of the site. Existing scalloped erosion is immediately downstream of rip rap section.

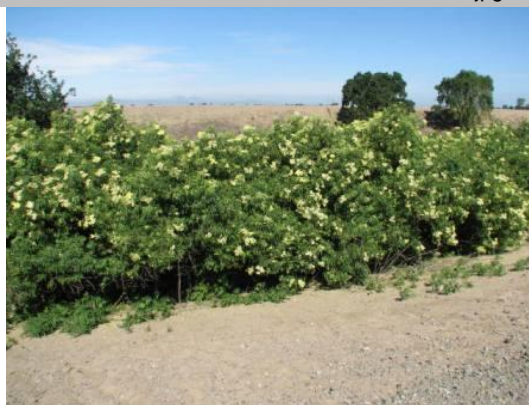
Photo 1 of 1 : mkhashch_s_20140428_00666.jpg

05/11/2011 Elderberry bush on water side slope.

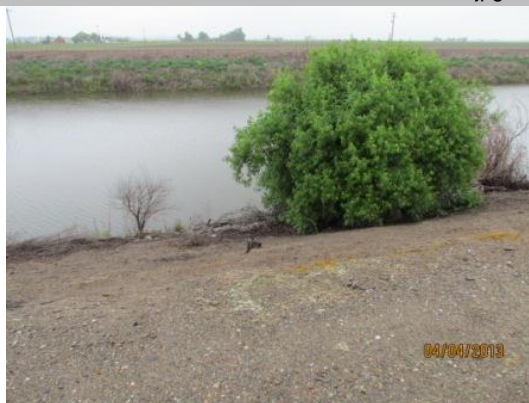
Photo 1 of 1 : mkhashch_s_20140428_00665.jpg

View of the tree stump on the waterside levee slope.

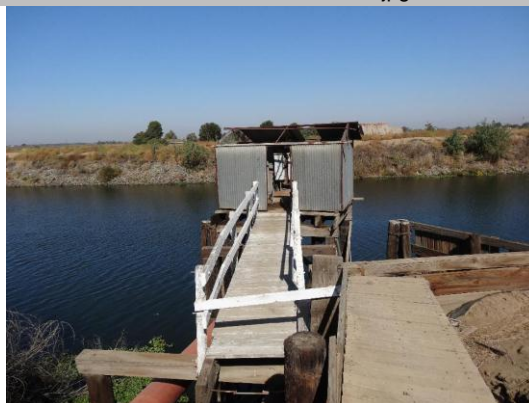
Photo 1 of 1 : UCIP_3394.jpg

WS view: wooden walkway to pumphouse, pumphouse on wooden pile structure in the stream.

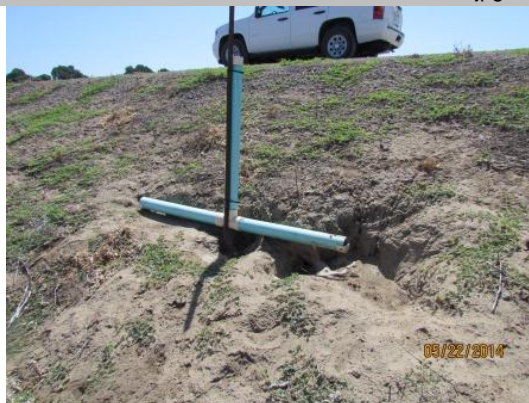
Photo 1 of 1 : mkhashch_s_20140527_01052.jpg

View of the rodent holes on the waterside levee slope.

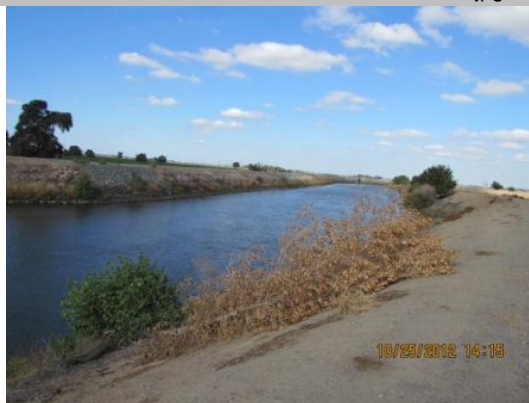
Photo 1 of 1 : mkhashch_s_20140428_00674.jpg

View of damaged tree by beaver on waterside slope.

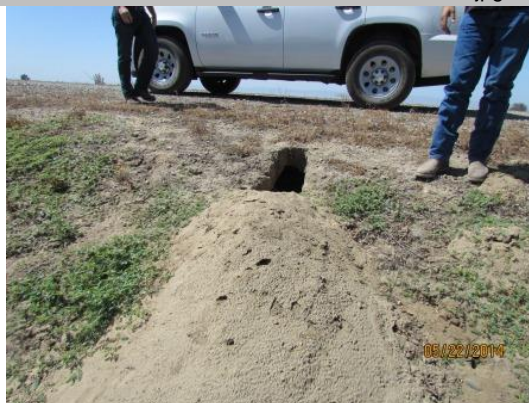
Photo 1 of 1 : mkhashch_s_20140527_01053.jpg

View of the large rodent hole on the waterside levee slope.

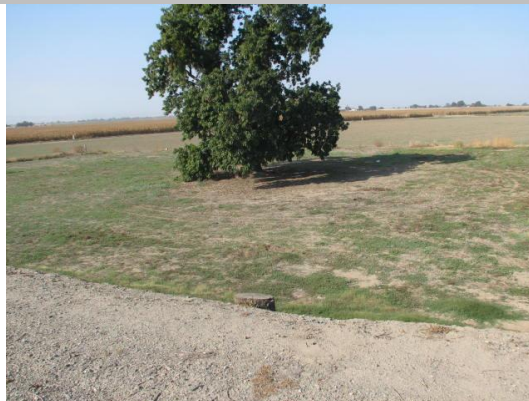
Photo 1 of 1 : mkhashch_s_20140428_00658.jpg

10/21/2011 Photo taken the next day. Stump can be seen in the lower center of the photo.

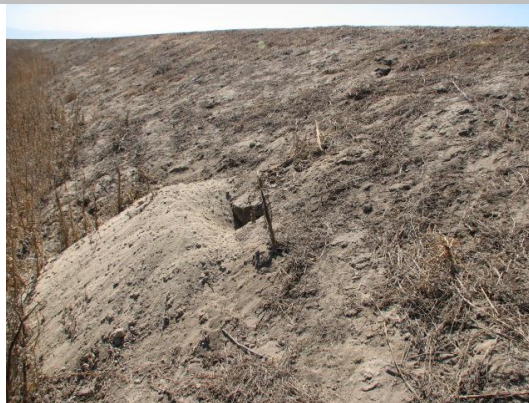
Photo 1 of 2 : mkhashch_s_20140428_00671.jpg

Animal burrow on levee slope.

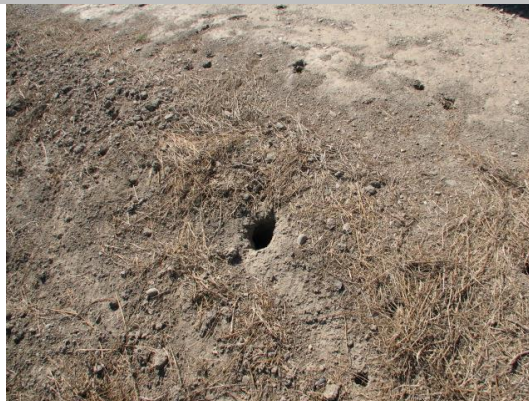
Photo 2 of 2 : mkhashch_s_20140428_00672.jpg

Animal burrows on levee slope.

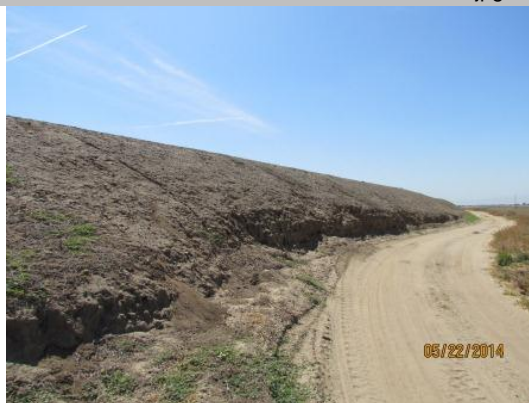
Photo 1 of 1 : mkhashch_s_20140527_01054.jpg

View of a 2-3 feet vertical cut at the landside levee toe.
