**Flood Control Project Maintenance  
Levee Inspections****LMA District Cover Sheet****Spring 2015 Levee Inspection Results****Reclamation District No. 2062 Stewart**

**Spring 2015 Levee Inspection Results**

**Reclamation District No. 2062 Stewart**

Waterway			Bank	Unit Miles
Unit No. 01 San Joaquin River			Left	2.64
	Spring (March - May)	Summer (June - August)	(September - November) Fall	Winter (December - February)
Unit Maintenance Rating (Fall Only)				
Date of Inspection	05/21/2015 - 05/21/2015			
DWR Inspector	Maksim Khashchuk			
Accompanied By	Lin Hale RD2062

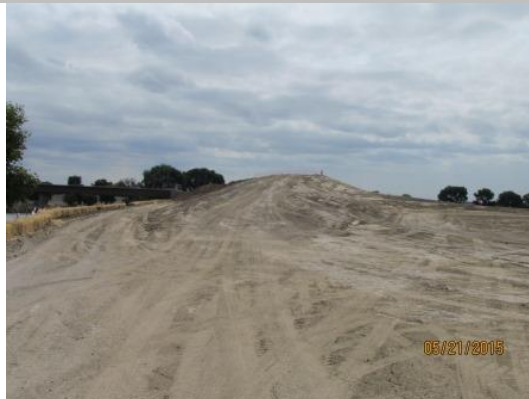
Photo 1 of 1 : SP\_2015\_RD2062\_309\_6\_20150526\_00003.jpg

LM Start	0.72	Rating **	A/W	Issue No.	6
LM End	0.72	Issue Type +	Ma	Location *	WS
Category	Earthen Levee			GPS Latitude/Longitude	
				Start	End
Item	Crown Surface / Depressions / Rutting			37.805138 °	37.805138 °
				-121.316420 °	-121.316420 °
DWR ID	DWR_RD2062_01_s _ 2015_6				
Action/Comments					
Add appropriate gravel or road base. Grade and compact. Inspector Comments: New levee patrol road is being installed. Make sure all-weather access is available before next flood season.

View of the new patrol road installation in process.

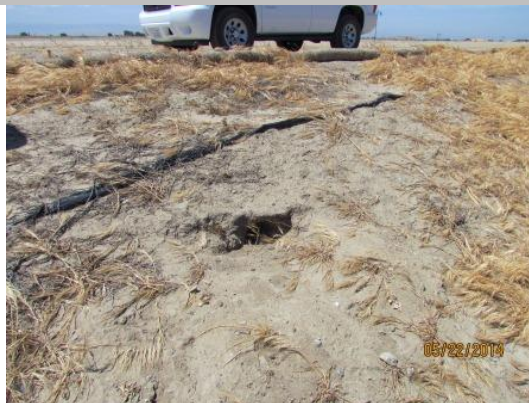
Photo 1 of 1 : SP\_2015\_RD2062\_309\_12\_20150317\_00001.jpg

LM Start	1.82	Rating **	A/W	Issue No.	12
LM End	1.82	Issue Type +	Ma	Location *	WS
Category	Earthen Levee			GPS Latitude/Longitude	
				Start	End
Item	Animal Control			37.791798 °	37.791798 °
				-121.312904 °	-121.312904 °
DWR ID	DWR_RD2062_01_s _ 2012_12				
Action/Comments					
No rodents visible, but rodent burrows visible; need to backfill and compact or grout burrows.

View of a rodent hole on the waterside levee slope.

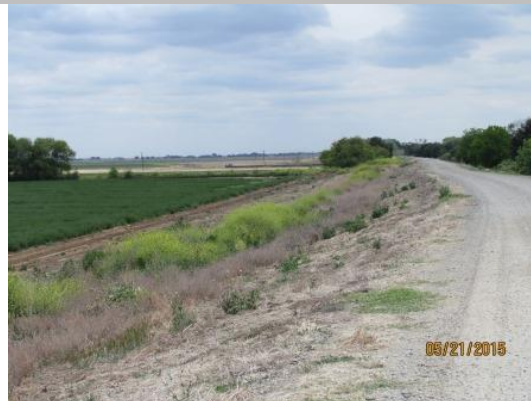
Photo 1 of 1 : SP\_2015\_RD2062\_310\_11\_20150526\_00012.jpg

View of the vegetation on the landside levee slope.

Action/Comments					
Control annual grass and weeds on the levee slopes and easements.

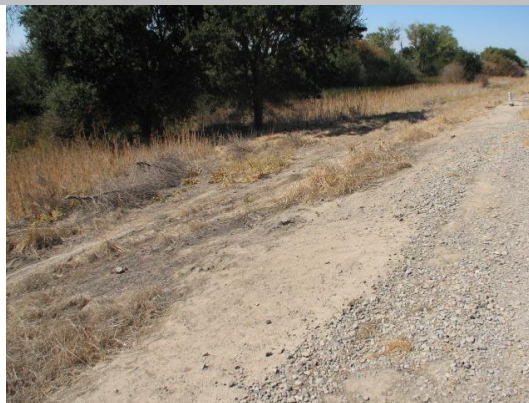
Photo 1 of 1 : SP\_2015\_RD2062\_310\_3\_20150317\_00001.jpg

LM Start	2.84	Rating **	N	Issue No.	3
LM End	2.84	Issue Type +	Ma	Location *	WS
Category	Earthen Levee			GPS Latitude/Longitude	
				Start	End
Item	Trim / Thin Trees			37.803827 °	37.803827 °
				-121.372424 °	-121.372424 °
DWR ID	DWR_RD2062_02_s _ 2012_3				
Action/Comments					
Tree stumps.					
Inspector Comments: Three small tree stumps.

Three small stumps on levee slope.

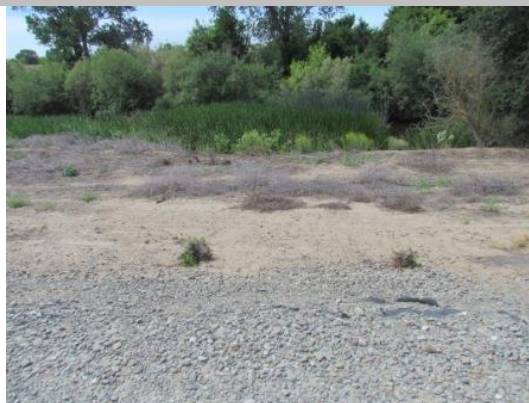
Photo 1 of 1 : SP\_2015\_RD2062\_310\_13\_20150317\_00003.jpg

LM Start	2.88	Rating **	N	Issue No.	13
LM End	2.88	Issue Type +	Ma	Location *	WS
Category	Earthen Levee			GPS Latitude/Longitude	
				Start	End
Item	Trim / Thin Trees			37.804060 °	37.804060 °
				-121.373245 °	-121.373245 °
DWR ID	DWR_RD2062_02_s _ 2012_13				
Action/Comments					
Tree stumps.					
Inspector Comments: Four small oak stumps on levee slope.

View of tree stumps on waterside slope. 05/17/2012

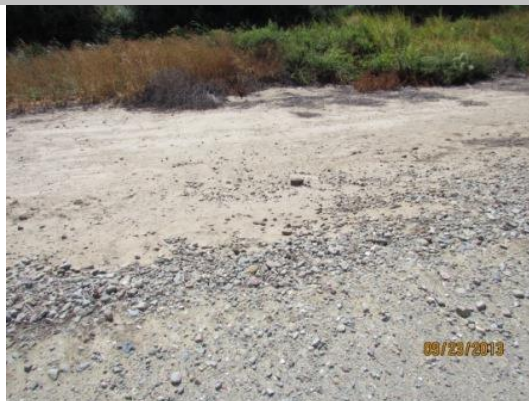
Photo 1 of 1 : SP\_2015\_RD2062\_310\_14\_20150317\_00004.jpg

LM Start	2.98	Rating **	N	Issue No.	14
LM End	2.98	Issue Type +	Ma	Location *	WS
Category	Earthen Levee			GPS Latitude/Longitude	
				Start	End
Item	Trim / Thin Trees			37.804452 °	37.804452 °
				-121.374903 °	-121.374903 °
DWR ID	DWR_RD2062_02_s _ 2012_14				
Action/Comments					
Tree stumps.

View of the tree stump in the middle of the photo.

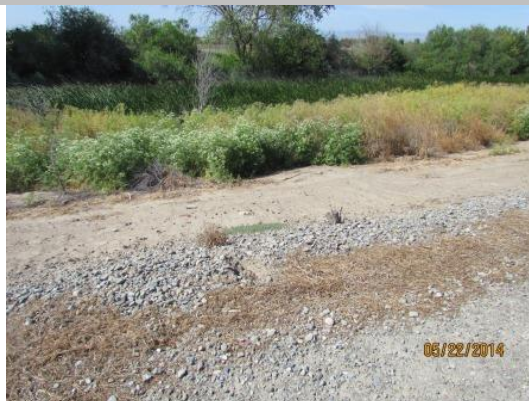
Photo 1 of 1 : SP\_2015\_RD2062\_310\_15\_20150317\_00005.jpg

LM Start	3.01	Rating **	N	Issue No.	15
LM End	3.01	Issue Type +	Ma	Location *	WS
Category	Earthen Levee			GPS Latitude/Longitude	
				Start	End
Item	Trim / Thin Trees			37.804481 °	37.804481 °
				-121.375510 °	-121.375510 °
DWR ID	DWR_RD2062_02_s_2012_15				
Action/Comments					
Tree stumps.

View of the tree stumps on the waterside levee slope.

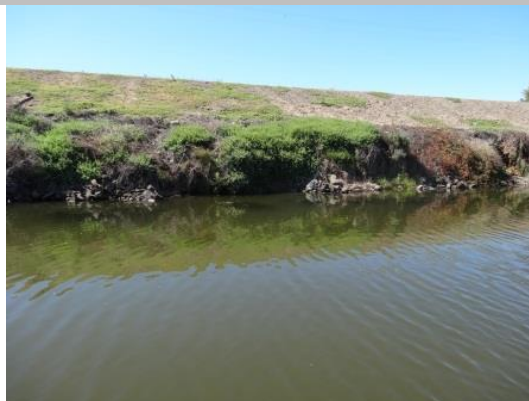
Photo 1 of 1 : SP\_2015\_RD2062\_311\_1\_20150317\_00001.jpg

LM Start	0.02	Rating **	U	Issue No.	1
LM End	0.02	Issue Type +	Ma	Location *	WS
Category	Supplemental			GPS Latitude/Longitude	
				Start	End
Item	DWR Erosion Survey			37.809673 °	37.809673 °
				-121.390321 °	-121.390321 °
DWR ID	DWR_RD2062_03_s_2015_1				
Action/Comments					
Inspector Comments: 07/02/2014: No significant change observed. 08/13/2013: No significant change observed. 08/07/2012: The site has been visited by boat survey. No significant change observed 08/23/2011: Site is at the upstream of a drainage ditch. [2014 Site ID:RD2062U03RM29.93]

Front view of the erosion.

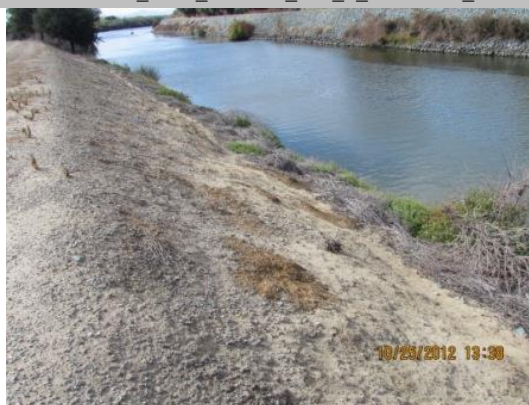
Photo 1 of 1 : SP\_2015\_RD2062\_311\_3\_20150317\_00003.jpg

LM Start	0.08	Rating **	N	Issue No.	3	
LM End	0.08	Issue Type +	Ma	Location *	WS	
Category	Earthen Levee			GPS Latitude/Longitude		
				Start		End
Item	Trim / Thin Trees			37.809727 °		37.809727 °
				-121.389100 °		-121.389100 °
DWR ID	DWR_RD2062_03_f_2012_3					
Action/Comments						
Tree stumps.

View of tree stumps on waterside slope.

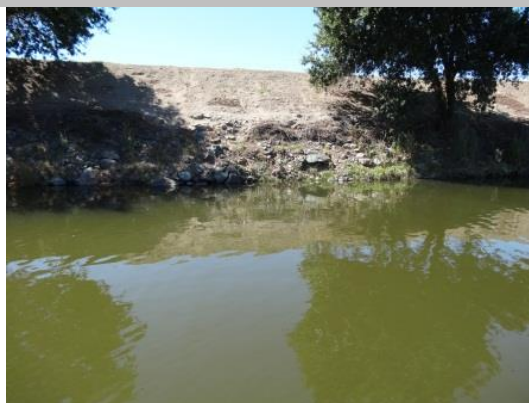
Photo 1 of 1 : SP\_2015\_RD2062\_311\_2\_20150317\_00002.jpg

LM Start	0.10	Rating **	U	Issue No.	2
LM End	0.10	Issue Type +	Ma	Location *	WS
Category	Supplemental			GPS Latitude/Longitude	
				Start	End
Item	DWR Erosion Survey			37.810052 °	37.810052 °
				-121.388847 °	-121.388847 °
DWR ID	DWR_RD2062_03_s_2015_2				
Action/Comments					
Inspector Comments: 07/02/2014: No significant change observed. 08/13/2013: No significant change observed. 08/07/2012: The site has been visited by boat survey. No significant change observed 08/23/2011: Hard to view the erosion because of the dense vegetation and trees on site. The site is under the bush, close to the tree. [2014 Site ID:RD2062U03RM30.02]

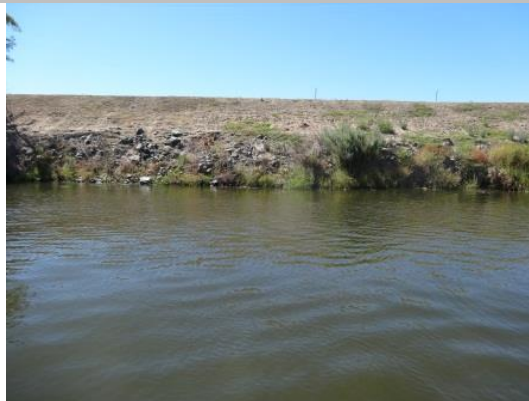
Photo 1 of 1 : SP\_2015\_RD2062\_311\_4\_20150317\_00004.jpg

LM Start	0.18	Rating **	M	Issue No.	4
LM End	0.18	Issue Type +	Ma	Location *	WS
Category	Supplemental			GPS Latitude/Longitude	
				Start	End
Item	DWR Erosion Survey			37.810468 °	37.810468 °
				-121.387492 °	-121.387492 °
DWR ID	DWR_RD2062_03_s _ 2015_4				
Action/Comments					
Inspector Comments: 07/02/2014: No significant change observed. 08/13/2013: No significant change observed. 08/07/2012: The site has been visited by boat survey. No significant change observed 08/23/2011: The protection at the levee toe has been washed away. [2014 Site ID:RD2062U03RM30.1]

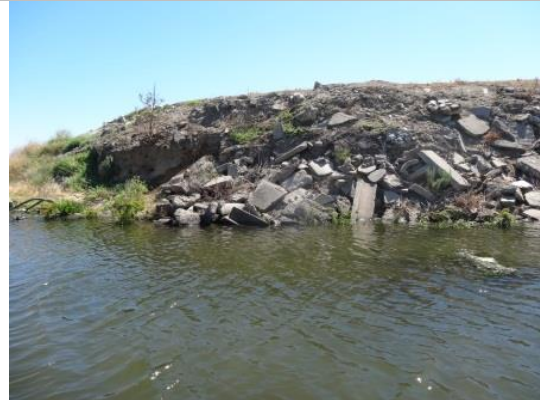
Photo 1 of 1 : SP\_2015\_RD2062\_311\_9\_20150317\_00008.jpg

Action/Comments					
Inspector Comments: 07/02/2014: No significant change observed. 08/13/2013: No significant change observed. 08/07/2012: The site has been visited by boat survey. No significant change observed. 08/23/2011: No significant change observed on site. 09/07/2010: No significant change observed on site. Much of the placed rip rap revetment has slid. It is no longer adequately protecting the slope. 08/06/2010: Recommended as local maintenance issue, per CLRO Report. 03/09/2010: As discussed with Michael Moncrief of MBK, site will be 'addressed' this year. 09/29/2009: No major change observed since last visit; a section of the rip rap has slipped, exposing a levee section that has eroded; recommended as local maintenance issue, per CLRO CES Evaluation 2008 Report; Site # is the same as RM30.43,LM0.63; previously rated "U". 11/05/2008: Site is located inside of a bend; scarp looks to be into the levee prism; piles of concrete chunks placed on the slope, with some of them already starting to slide. [2014 Site ID:RD2062U03RM30.43]

Front view of the site. Rip rap no longer adequately protecting levee slope.

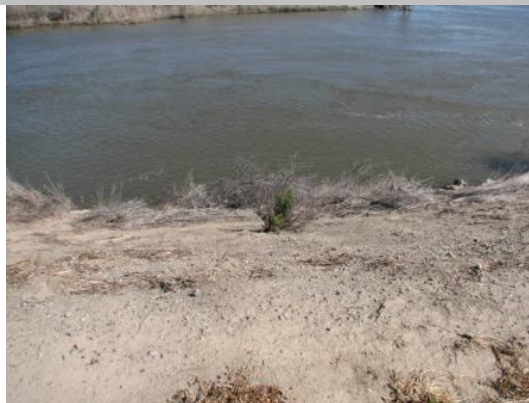
Photo 1 of 1 : SP\_2015\_RD2062\_311\_10\_20150317\_00009.jpg

05/11/2011 Stump in slope, new growth in center of photo is at the location of the stump.

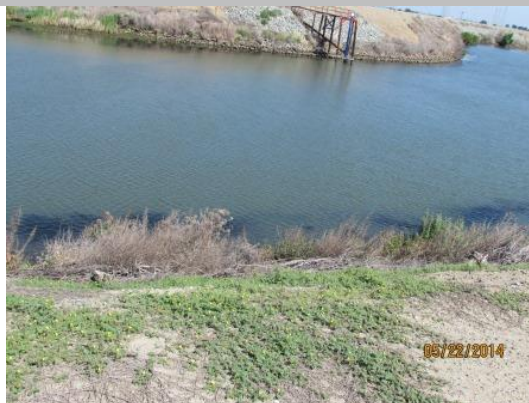
Photo 1 of 1 : SP\_2015\_RD2062\_311\_12\_20150317\_00012.jpg

LM Start	0.64	Rating **	N	Issue No.	12
LM End	0.64	Issue Type +	Ma	Location *	WS
Category	Earthen Levee			GPS Latitude/Longitude	
				Start	End
Item	Trim / Thin Trees			37.813894 °	37.813894 °
				-121.381680 °	-121.381680 °
DWR ID	DWR_RD2062_03_s _ 2012_12				
Action/Comments					
Tree stumps. Inspector Comments: 2 stumps on waterside slope.

View of the tree stumps on the waterside levee slope.

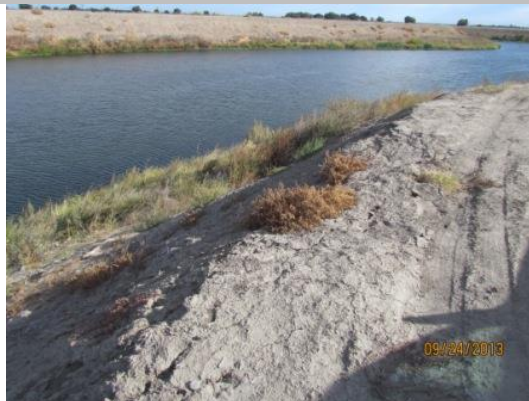
Photo 1 of 2 : SP\_2015\_RD2062\_311\_11\_20150317\_00010.jpg

LM Start	0.81	Rating **	A/W	Issue No.	11
LM End	0.81	Issue Type +	Ma	Location *	WS
Category	Earthen Levee			GPS Latitude/Longitude	
				Start	End
Item	Erosion / Bank Caving			37.816315 °	37.816315 °
				-121.381587 °	-121.381587 °
DWR ID	DWR_RD2062_03_s _ 2012_11				
Action/Comments					
Schedule repair of erosion site prior to the next inspection. Inspector Comments: Cracking developing along the waterside levee hinge.

View of cracking at waterside levee hinge.

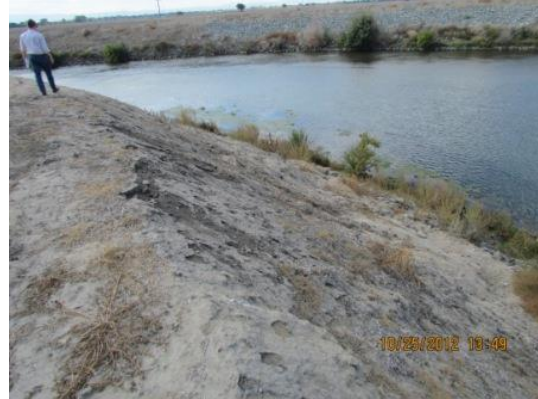
Photo 2 of 2 : SP\_2015\_RD2062\_311\_11\_20150317\_00011.jpg

LM Start	0.81	Rating **	A/W	Issue No.	11 (cont)	
LM End	0.81	Issue Type +	Ma	Location *	WS	
Category	Earthen Levee			GPS Latitude/Longitude		
				Start		End
Item	Erosion / Bank Caving			37.816315 °	37.816315 °	
				-121.381587 °	-121.381587 °	
DWR ID	DWR_RD2062_03_s _ 2012_11					
Action/Comments						
Schedule repair of erosion site prior to the next inspection. Inspector Comments: Cracking developing along the waterside levee hinge.

View of slope erosion from foot traffic.

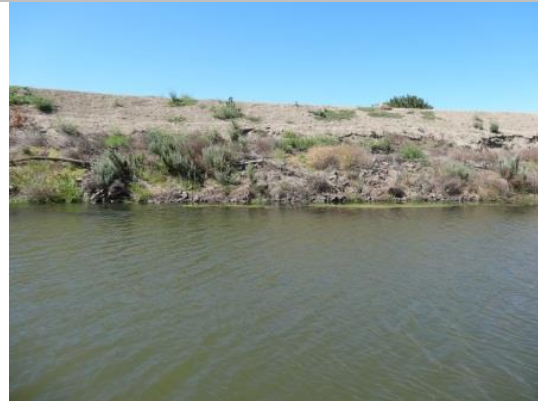
Photo 1 of 1 : SP\_2015\_RD2062\_311\_13\_20150317\_00013.jpg

LM Start	1.18	Rating **	U	Issue No.	13
LM End	1.18	Issue Type +	Ma	Location *	WS
Category	Supplemental			GPS Latitude/Longitude	
				Start	End
Item	DWR Erosion Survey			37.819290 °	37.819290 °
				-121.378880 °	-121.378880 °
DWR ID	DWR_RD2062_03_s _ 2015_13				
Action/Comments					
Inspector Comments: 07/02/2014: No significant change observed. 08/13/2013: No significant change observed. 08/07/2012: The site has been visited by boat survey. No significant change observed 08/23/2011: No significant change observed on site. 09/07/2010: No significant change observed on site. Much of the seasonal grass along the slope was cleared. Site consists of an existing scalloped erosion approximately 30 feet long by 5 feet wide at its widest opening. The lateral crack is extended outwards along the middle slope. There is a 1 to 2 feet of differential settlement that could further develop into a shallow slide. 08/06/2010: Recommended as local maintenance issue, per CLRO. 03/09/2010: As discussed with Michael Moncrief of MBK Engineer, site will be 'addressed' this year. 09/28/2009: No major change observed; section of rip rap has slipped, creating a terraced effect; dense vegetation growth; recommended as a local maintenance issue, per CLRO CES Evaluation 2008 Report; Site # is the same as RM31.12,LM1.25; previously rated "U". 09/14/2006: 1-2' into prism. [2014 Site ID:RD2062U03RM31.12]

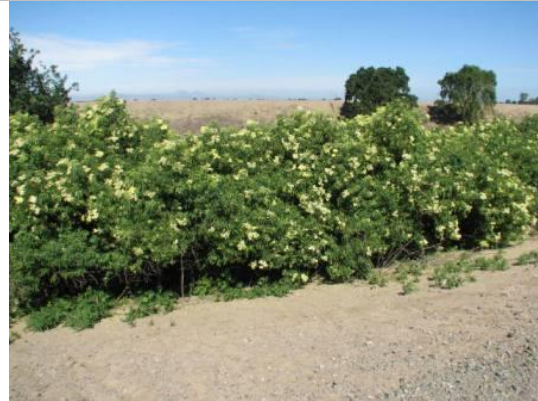
Photo 1 of 1 : SP\_2015\_RD2062\_311\_18\_20150317\_00015.jpg

05/11/2011 Elderberry bush on water side slope.

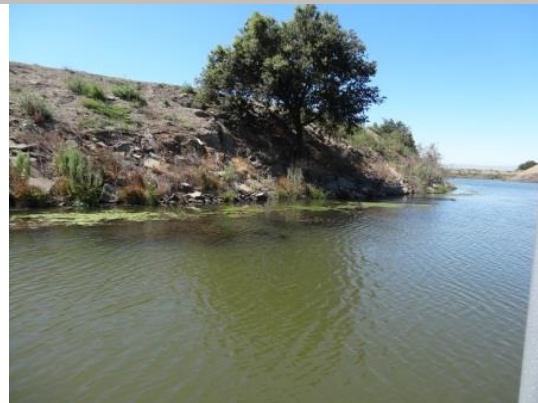
Photo 1 of 1 : SP\_2015\_RD2062\_311\_20\_20150317\_00017.jpg

LM Start	1.39	Rating **	U	Issue No.	20
LM End	1.39	Issue Type +	Ma	Location *	WS
Category	Supplemental			GPS Latitude/Longitude	
				Start	End
Item	DWR Erosion Survey			37.821380 °	37.821380 °
				-121.376900 °	-121.376900 °
DWR ID	DWR_RD2062_03_s _ 2015_20				
Action/Comments					
Inspector Comments: 07/02/2014: No significant change observed. 08/13/2013: No significant change observed. 08/07/2012: The site has been visited by boat survey. No significant change observed 08/23/2011: No significant change observed on site. 09/07/2010: No significant change observed on site. There is a small-to medium sized Oak tree on the mid-slope just above rip rap. Some of the rip rap has collapsed, creating a pocket erosion just above the existing toe rip rap and upstream of the Oak tree. 08/06/2010: Recommended as local maintenance issue, per CLRO. 03/09/2010: As discussed with Michael Moncrief of MBK Engineer, site will be 'addressed' in 2010. 09/29/2009: No major change since last visit; sliding of the rip rap at the base of the lone tree; there is noticeable man-made trail and foot traffic extending from the crown to the toe; much of the broken concrete used as temporary rip rap has slid, exposing portion of the bare levee slope; recommended as local maintenance issue, per CLRO CES Evaluation 2008 Report; Site # is the same as RM31.3, LM1.45; previously rated "M". 11/05/2008: Portion of rip rap collapsing. 09/14/2006: Portion of rip rap along the slope has collapsed; exposed levee section is starting to erode, exposing roots from the nearby tree. [2014 Site ID:RD2062U03RM31.28]

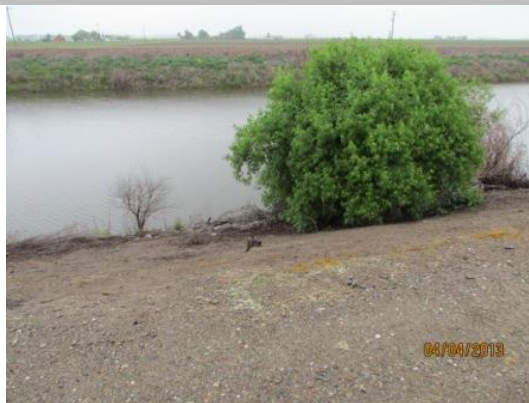
Photo 1 of 1 : SP\_2015\_RD2062\_311\_15\_20150317\_00014.jpg

View of the tree stump on the waterside levee slope.

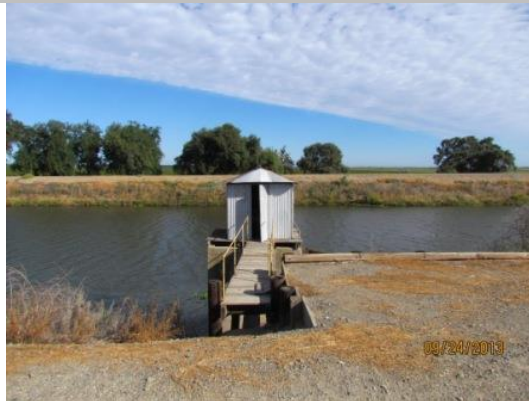
Photo 1 of 1 : SP\_2015\_RD2062\_311\_19\_20150317\_00016.jpg

View of the pump house on the waterside levee slope.

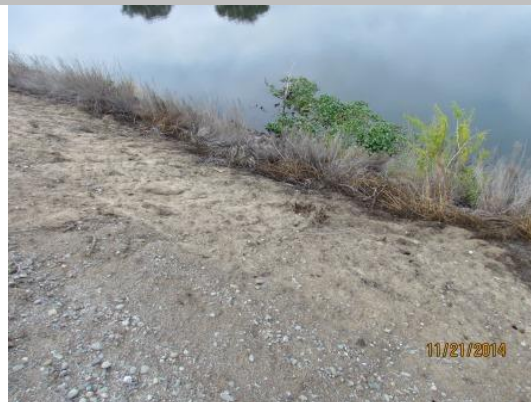
Photo 1 of 1 : SP\_2015\_RD2062\_311\_26\_20150317\_00019.jpg

View of the tree stump on the waterside levee slope.

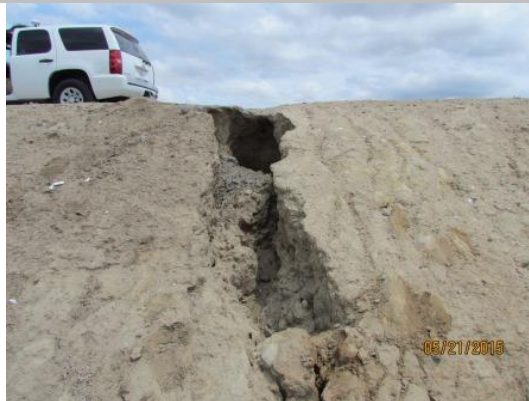
Photo 1 of 1 : SP\_2015\_RD2062\_311\_32\_20150526\_00026.jpg

LM Start	3.44	Rating **	U	Issue No.	32
LM End	3.44	Issue Type +	Ma	Location *	LS
Category	Earthen Levee			GPS Latitude/Longitude	
				Start	End
Item	Erosion / Bank Caving			37.818694 °	37.818694 °
				-121.345124 °	-121.345124 °
DWR ID	DWR_RD2062_03_s _ 2015_32				
Action/Comments					
Schedule repair of erosion site prior to the next inspection.

View of the erosion of the landside levee slope.

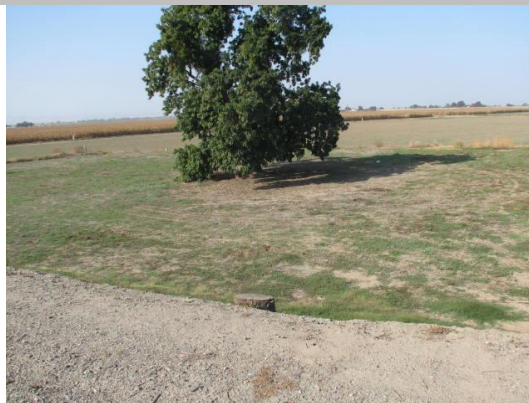
Photo 1 of 1 : SP\_2015\_RD2062\_311\_7\_20150317\_00006.jpg

10/21/2011 Photo taken the next day. Stump can be seen in the lower center of the photo.

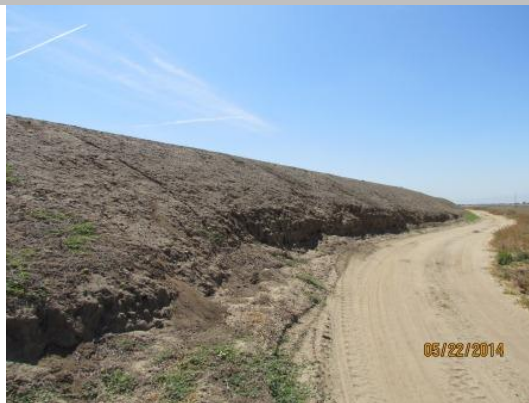
Photo 1 of 1 : SP\_2015\_RD2062\_311\_35\_20150317\_00020.jpg

LM Start	4.88	Rating **	M	Issue No.	35
LM End	4.88	Issue Type +	Ma	Location *	LS
Category	Earthen Levee			GPS Latitude/Longitude	
				Start	End
Item	Erosion / Bank Caving			37.812225 °	37.812225 °
				-121.336112 °	-121.336112 °
DWR ID	DWR_RD2062_03_f_2014_35				
Action/Comments					
Note and monitor erosion site. Inspector Comments: 2 to 3 feet vertical cut possibly caused by previous floods.

View of a 2-3 feet vertical cut at the landside levee toe.
