**Flood Control Project Maintenance  
Levee Inspections**  
**LMA District Cover Sheet**  
**Spring 2016 Levee Inspection Results**

**Reclamation District No. 2062 Stewart**

**Spring 2016 Levee Inspection Results**

Waterway	Bank	Unit Miles
Unit No. 01 San Joaquin River	Left	2.64

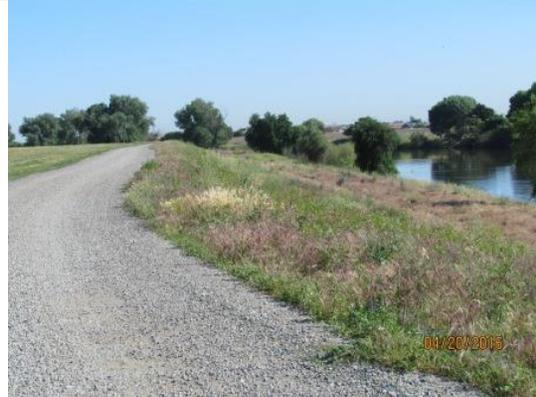
Photo 1 of 1 : SP\_2016\_RD2062\_309\_7\_20160421\_00011.jpg

View of the vegetation on the waterside levee slope.

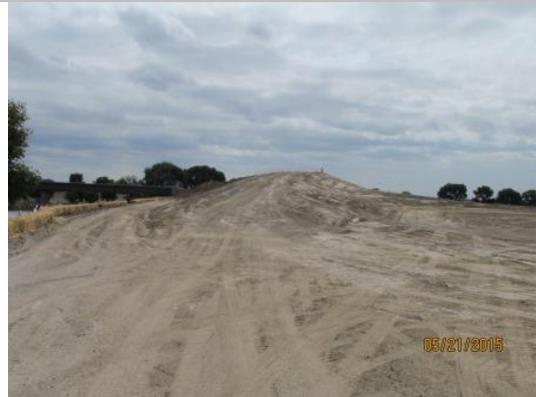
Photo 1 of 1 : SP\_2016\_RD2062\_309\_6\_20160229\_00001.jpg

LM Start	<b>0.72</b>	Rating **	A/W	Issue No.	<b>6</b>
LM End	<b>0.72</b>	Issue Type +	Ma	Location *	WS
Category	Earthen Levee		GPS Latitude/Longitude		
			Start	End	
Item	Crown Surface / Depressions / Rutting		37.805138 °	37.805138 °	
			-121.316420 °	-121.316420 °	
DWR ID	DWR_RD2062_01_s_2015_6				
Comment Code					
C3 : Add appropriate gravel or road base. Grade and compact.					
Inspector Comment					
New levee patrol road is being installed. Make sure all-weather access is available before next flood season.

View of the new patrol road installation in process.

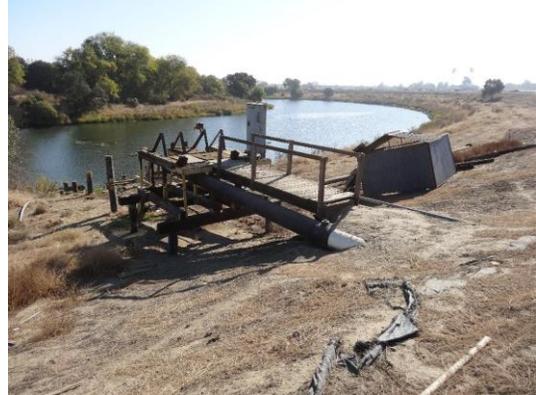
Photo 1 of 2 : UCIP\_SP\_2016\_22807\_38905.jpg

LM Start	<b>1.64</b>	Rating **	M	Issue No.	<b>9</b>
LM End	<b>1.64</b>	Issue Type +	En	Location *	WS
Category	Supplemental			GPS Latitude/Longitude	
				Start	End
Item	DWR UCIP Field Study			37.793521 °	37.793521 °
				-121.315348 °	-121.315348 °
DWR ID					
Comment Code					
Inspector Comment					
FS_ID:22807 DS_ID:19177 EP_NO: 12679 Repair Type: Non-Urgent Crossing Status: Found UCIP Comments: - All 3 pipes on landside looks new.- Pumps, pump house, and pipes removed from waterside.- Land development activities going on in this area.- Needs to confirm from LMA or DWR Inspector about the crossing. FIELD_STRUCT_DESC: 1 of 3: Two 16-inch steel pipes, one 8-inch steel pipe, and three electric conduits through the levee 5.0 feet below the crown. Two slant pumps in the pump house on the waterward slope. Siphon breakers on the landward slope. (App. No. 16124) FS Date: 10/22/2013

WS view: pipes, walkway, and dismantled pumphouse (right).

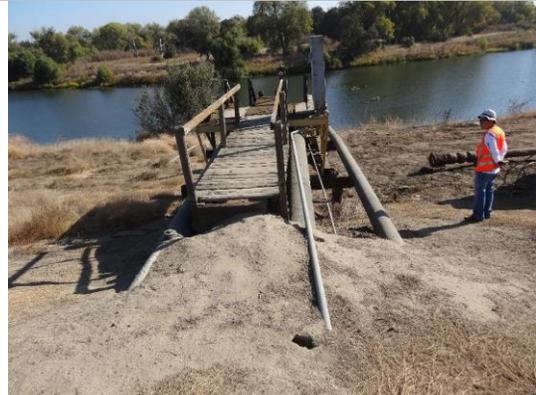
Photo 2 of 2 : UCIP\_SP\_2016\_22807\_38904.jpg

WS view: 16-inch pipes on both sides of walkway and 10-inch pipe (on right) away from walkway.

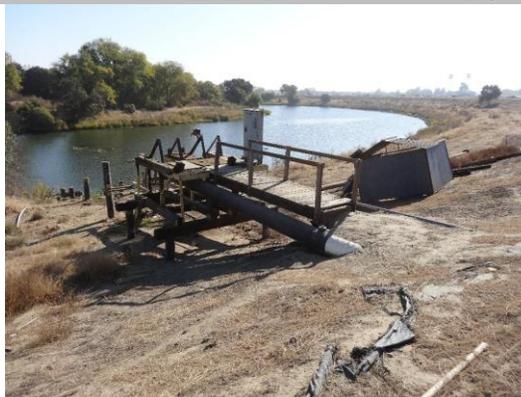
Photo 1 of 2 : UCIP\_SP\_2016\_22809\_38913.jpg

LM Start	<b>1.64</b>	Rating **	M	Issue No.	<b>10</b>
LM End	<b>1.64</b>	Issue Type +	En	Location *	WS
Category	Supplemental			GPS Latitude/Longitude	
				Start	End
Item	DWR UCIP Field Study			37.793510 °	37.793510 °
				-121.315345 °	-121.315345 °
DWR ID					
Comment Code					
Inspector Comment					
FS_ID:22809 DS_ID:19183 EP_NO: 12679 Repair Type: Non-Urgent Crossing Status: Found UCIP Comments: - All 3 pipes on landside looks new.- Pumps, pump house, and pipes removed from waterside.- Land development activities going on in this area.- Needs to confirm from LMA or DWR Inspector about the crossing. FIELD_STRUCT_DESC: 2 of 3: Two 16-inch steel pipes, one 8-inch steel pipe, and three electric conduits through the levee 5.0 feet below the crown. Two slant pumps in the pump house on the waterward slope. Siphon breakers on the landward slope. (App. No. 16124) FS Date: 10/22/2013

WS view: pipes, walkway, and dismantled pumphouse (right).

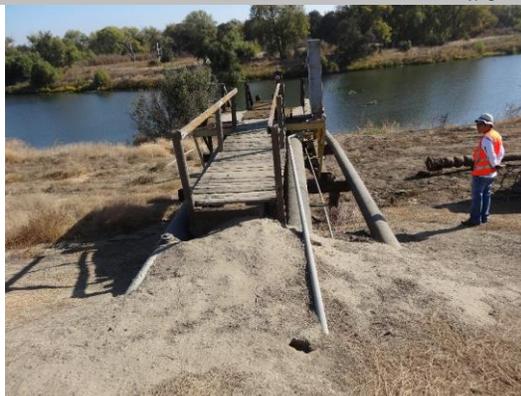
Photo 2 of 2 : UCIP\_SP\_2016\_22809\_38912.jpg

WS view: 16-inch pipes on both sides of walkway and 10-inch pipe (on right) away from walkway.

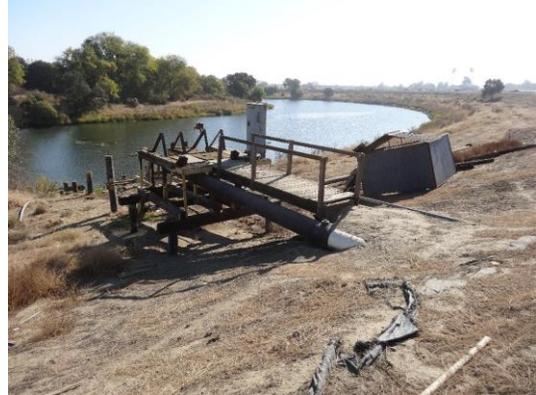
Photo 1 of 2 : UCIP\_SP\_2016\_22810\_38918.jpg

Item	DWR UCIP Field Study			37.793497 °	37.793497 °
				-121.315340 °	-121.315340 °
DWR ID					
Comment Code					
Inspector Comment					
FS_ID:22810 DS_ID:19184 EP_NO: 12679 Repair Type: Non-Urgent Crossing Status: Found UCIP Comments: - All 3 pipes on landside looks new. No pump associated with 8-inch pipe.- Pumps, pump house, and pipes removed from waterside.- Land development activities going on in this area.- Needs to confirm from LMA or DWR Inspector about the crossing. FIELD_STRUCT_DESC: 3 of 3: one 8-inch pipe, two 16-inch pipes, and three electric conduits through the levee 8.0 feet below the crown. Two slant pumps in the pump house on the waterward slope. Siphon breakers on the landward slope. Installed by the United States Army Corps of Engineers, 1961. (App. No. 12679) FS Date: 10/22/2013

WS view: pipes, walkway, and dismantled pumphouse (right).

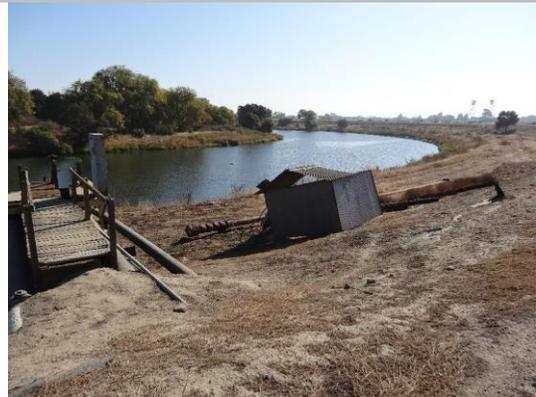
Photo 2 of 2 : UCIP\_SP\_2016\_22810\_38917.jpg

WS view: electric conduit and 10-inch pipe (right). Dismantled/removed pipe and pumphouse (far right).

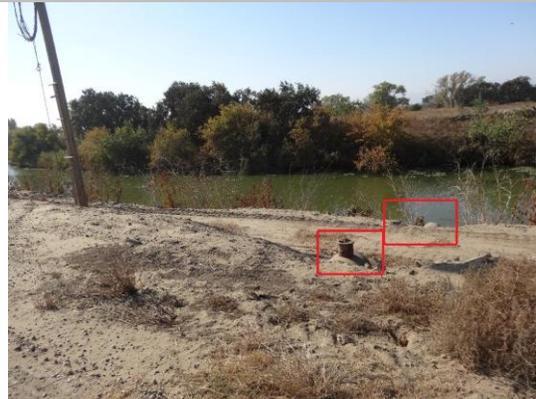
Photo 1 of 2 : UCIP\_SP\_2016\_23110\_39398.jpg

LM Start	<b>0.56</b>	Rating **	M	Issue No.	<b>24</b>
LM End	<b>0.56</b>	Issue Type +	En	Location *	WS
Category	Supplemental			GPS Latitude/Longitude	
				Start	End
Item	DWR UCIP Field Study			37.784380 °	37.784380 °
				-121.338985 °	-121.338985 °
DWR ID					
Comment Code					
Inspector Comment					
FS_ID:23110 DS_ID:24697 EP_NO: N/A Repair Type: Non-Urgent Crossing Status: Found UCIP Comments: Found on field with the help of USACE 2012 PI Report. Needs proper abandonment. FIELD_STRUCT_DESC: Abandoned 24-inch steel pipe through the levee. Damaged siphon breaker on waterside levee slope. Pump on concrete sump on landside. Service pole on landside levee slope. Pump was disconnected from service pole. FS Date: 10/23/2013

WS view: power pole (left), siphon breaker (marked- left), and steel pipe (right) on levee slope.

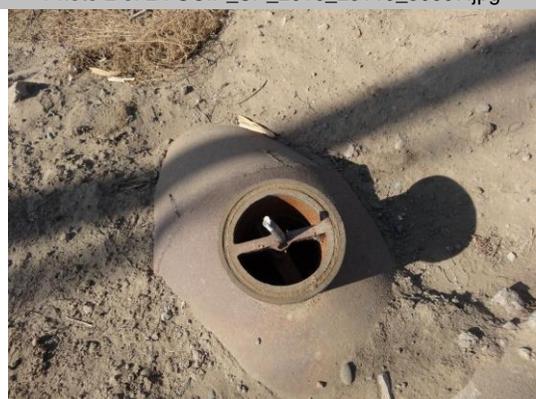
Photo 2 of 2 : UCIP\_SP\_2016\_23110\_39397.jpg

WS view: exposed steel pipe and damaged siphon breaker on levee slope.

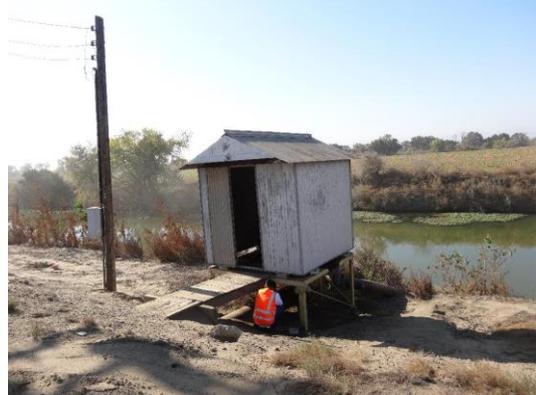
Photo 1 of 2 : UCIP\_SP\_2016\_23181\_39792.jpg

LM Start	<b>0.75</b>	Rating **	M	Issue No.	<b>25</b>
LM End	<b>0.75</b>	Issue Type +	En	Location *	WS
Category	Supplemental			GPS Latitude/Longitude	
				Start	End
Item	DWR UCIP Field Study			37.786130 °	37.786130 °
				-121.341564 °	-121.341564 °
DWR ID					
Comment Code					
Inspector Comment					
FS_ID:23181 DS_ID:19192 EP_NO: 12427 Repair Type: Non-Urgent Crossing Status: Found UCIP Comments: - no siphon breaker found- levee toe erosion under walkway on waterside.- erosion around concrete standpipe on landside- may be base of the standpipe was leaking. FIELD_STRUCT_DESC: 18-inch pipe through the levee 4.4 feet below the crown, pump house on the waterward slope, metal walkway from the pump house to the crown. Power pole on waterside. Flap gate and concrete distribution box on the landward slope. (App. No. 12427) FS Date: 10/23/2013

WS view: pipe, walkway, service pole, and pumphouse on levee slope.

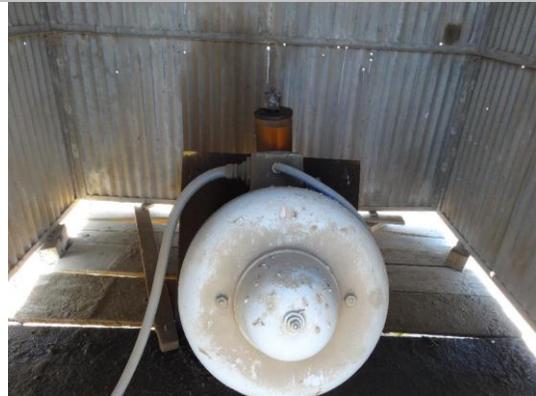
Photo 2 of 2 : UCIP\_SP\_2016\_23181\_39791.jpg

WS view: leaky slant pump in pumphouse on levee slope.

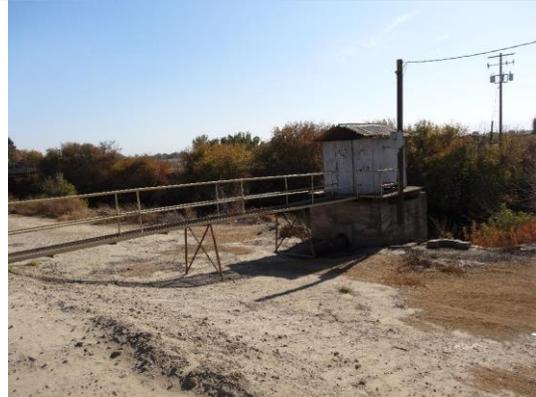
Photo 1 of 2 : UCIP\_SP\_2016\_23062\_39195.jpg

LM Start	<b>1.37</b>	Rating **	M	Issue No.	<b>23</b>
LM End	<b>1.37</b>	Issue Type +	En	Location *	WS
Category	Supplemental			GPS Latitude/Longitude	
				Start	End
Item	DWR UCIP Field Study			37.791821 °	37.791821 °
				-121.350448 °	-121.350448 °
DWR ID					
Comment Code					
Inspector Comment					
FS_ID:23062 DS_ID:19193 EP_NO: N/A Repair Type: Non-Urgent Crossing Status: Found UCIP Comments: - pumphouse on concrete sump in the channel.- erosion under walkway on waterside. FIELD_STRUCT_DESC: 20-inch pipe through the levee 8 feet below the crown. Pump house on the waterward slope and a metal walkway from the pump house to the crown. Flap gate, air vent, and concrete distribution box on the landward slope. FS Date: 10/22/2013

WS view: pipe, walkway, and pumphouse on levee berm. Service pole on waterside.

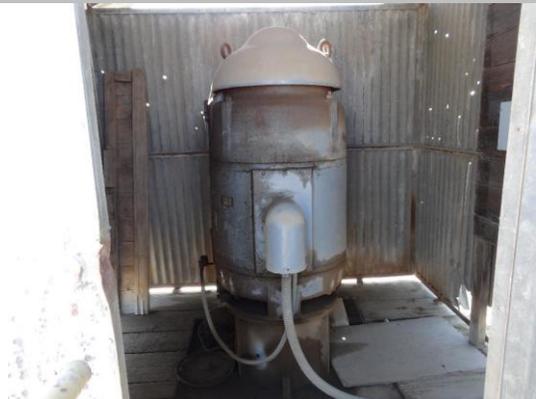
Photo 2 of 2 : UCIP\_SP\_2016\_23062\_39194.jpg

WS view: leaky pump and control box in pumphouse.

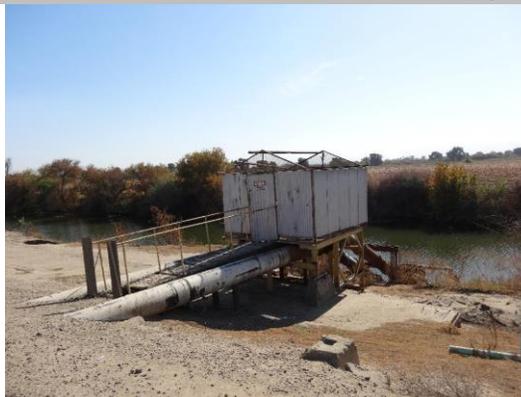
Photo 1 of 2 : UCIP\_SP\_2016\_23061\_39187.jpg

LM Start	<b>1.64</b>	Rating **	U	Issue No.	<b>22</b>
LM End	<b>1.64</b>	Issue Type +	En	Location *	WS
Category	Supplemental			GPS Latitude/Longitude	
				Start	End
Item	DWR UCIP Field Study			37.794009 °	37.794009 °
				-121.354417 °	-121.354417 °
DWR ID					
Comment Code					
Inspector Comment					
FS_ID:23061 DS_ID:19194 EP_NO: 4305 Repair Type: Urgent Crossing Status: Found UCIP Comments: - missing roof in pump house.- no protection for siphon breaker- huge erosion under pumphouse and levee slope on waterside. FIELD_STRUCT_DESC: 1 of 2: Two 18-inch pipes through the levee 4.8 feet below the crown. Pump house on the waterward slope. Siphon breaker on the landward shoulder. Power pole on the landward shoulder. Concrete distribution box at the toe of the landward slope. (App. No. 4305) FS Date: 10/22/2013

WS view: pipes, walkway, and pumphouse with missing roof (right).

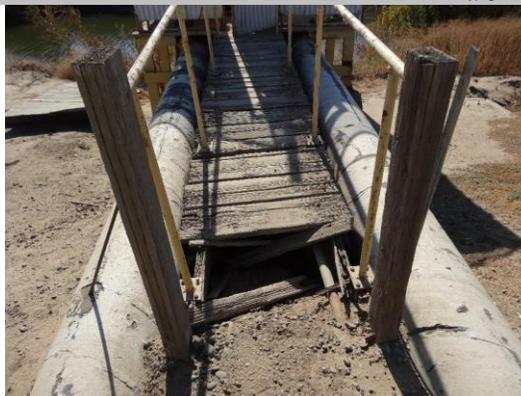
Photo 2 of 2 : UCIP\_SP\_2016\_23061\_39186.jpg

WS view: walkway to pumphouse. Walkway in poor condition.

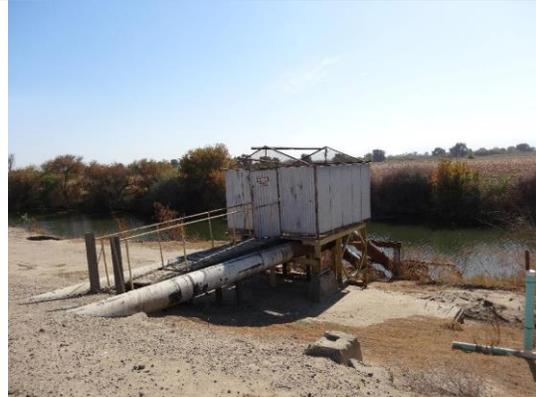
Photo 1 of 2 : UCIP\_SP\_2016\_23059\_39176.jpg

LM Start	<b>1.64</b>	Rating **	U	Issue No.	<b>21</b>
LM End	<b>1.64</b>	Issue Type +	En	Location *	WS
Category	Supplemental			GPS Latitude/Longitude	
				Start	End
Item	DWR UCIP Field Study			37.794014 °	37.794014 °
				-121.354434 °	-121.354434 °
DWR ID					
Comment Code					
Inspector Comment					
FS_ID:23059 DS_ID:19197 EP_NO: 4305 Repair Type: Urgent Crossing Status: Found UCIP Comments: - missing roof in pump house.- no protection for siphon breaker- huge erosion under pumphouse and levee slope on waterside. FIELD_STRUCT_DESC: 2 of 2: Two 18-inch pipes through the levee 4.8 feet below the crown. Pump house on the waterward slope. Siphon breaker on the landward shoulder. Power pole on the landward shoulder. Concrete distribution box at the toe of the landward slope. (App. No. 4305) FS Date: 10/22/2013

WS view: pipes, walkway, and pumphouse with missing roof (right).

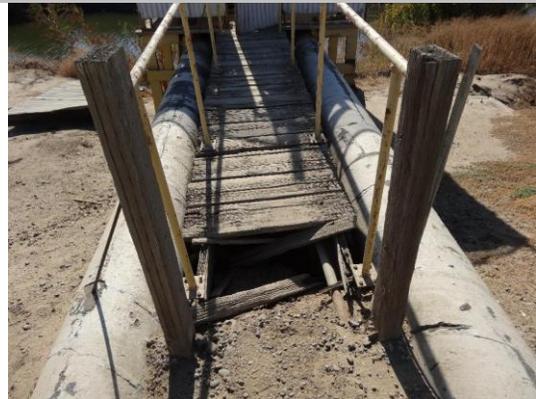
Photo 2 of 2 : UCIP\_SP\_2016\_23059\_39175.jpg

WS view: walkway in poor condition, to pumphouse.

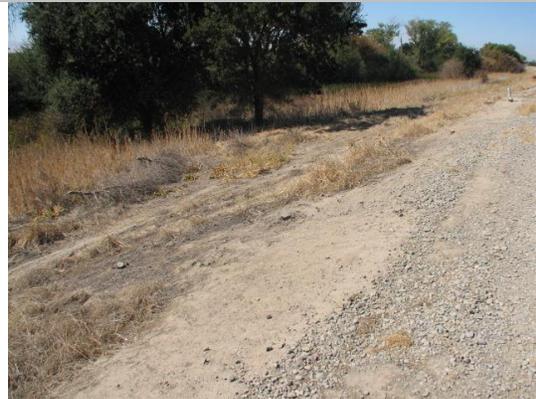
Photo 1 of 1 : SP\_2016\_RD2062\_310\_3\_20160229\_00001.jpg

Three small stumps on levee slope.

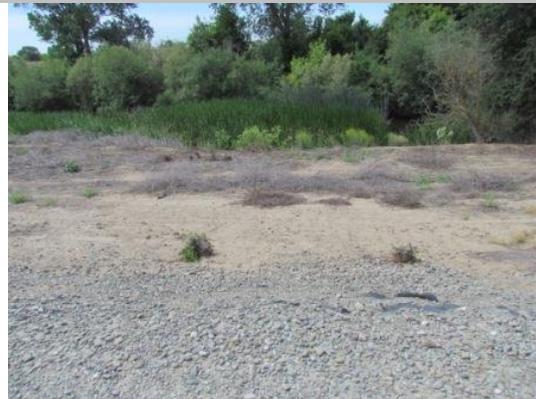
Photo 1 of 1 : SP\_2016\_RD2062\_310\_13\_20160229\_00003.jpg

View of tree stumps on waterside slope. 05/17/2012

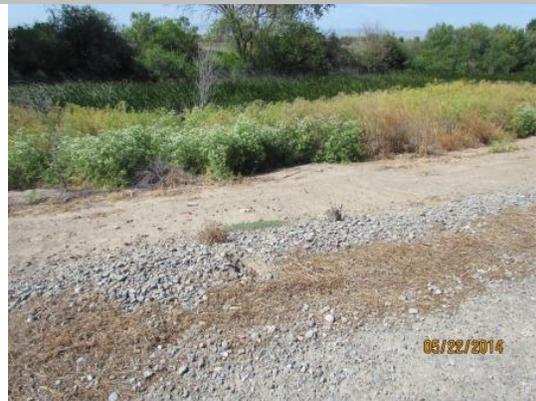
Photo 1 of 1 : SP\_2016\_RD2062\_310\_15\_20160229\_00005.jpg

View of the tree stumps on the waterside levee slope.

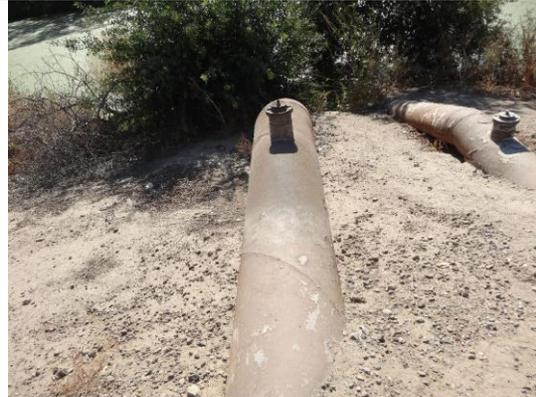
Photo 1 of 2 : UCIP\_SP\_2016\_23304\_40147.jpg

LM Start	<b>3.24</b>	Rating **	M	Issue No.	<b>19</b>
LM End	<b>3.24</b>	Issue Type +	En	Location *	LS
Category	Supplemental		GPS Latitude/Longitude		
			Start	End	
Item	DWR UCIP Field Study		37.804770 °	37.804770 °	
			-121.379679 °	-121.379679 °	
DWR ID					
Comment Code					
Inspector Comment					
FS_ID:23304 DS_ID:19199 EP_NO: 11524 Repair Type: Non-Urgent Crossing Status: Found UCIP Comments: - waterside pipe immersed into channel water.- most of the pipe on landside exposed and siphon breaker on waterside not protected. FIELD_STRUCT_DESC: 1 of 3: One of 2x24-inch pipes through the levee 2.0 feet below the crown. 18-inch pipe through the levee 4.0 feet below the crown. Siphon breakers on waterward slope. Pump on steel platform in drainage ditch, 350 ft. from levee center off the the landward berm. (App. No. 11524) FS Date: 10/22/2013

WS view: 24-inch steel pipe (left) with siphon breaker on levee slope. 18-inch pipe on right.

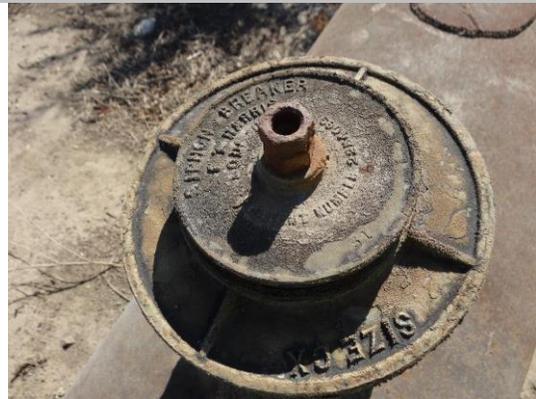
Photo 2 of 2 : UCIP\_SP\_2016\_23304\_40146.jpg

WS view: leaky siphon breaker on levee slope.

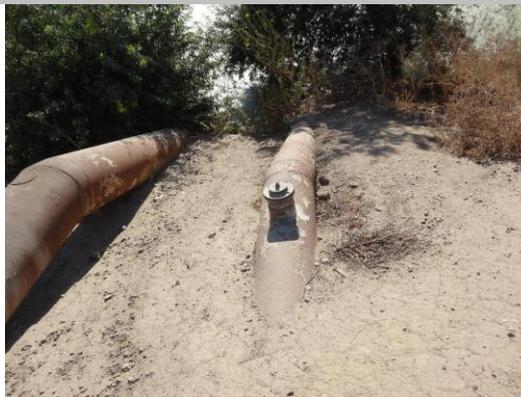
Photo 1 of 2 : UCIP\_SP\_2016\_23023\_39082.jpg

Item	DWR UCIP Field Study		37.804777 °	37.804777 °	
			-121.379704 °	-121.379704 °	
DWR ID					
Comment Code					
Inspector Comment					
FS_ID:23023 DS_ID:19198 EP_NO: 11524 Repair Type: Non-Urgent Crossing Status: Found UCIP Comments: - 18-inch pipe bifurcated near the pump and two gate valves installed.- waterside pipe immersed into channel water.- most of the pipe on landside exposed and siphon breaker on waterside not protected. FIELD_STRUCT_DESC: 2 of 3: 18-inch pipe through the levee 4.0 feet below the crown. 2x24-inch pipes through the levee 2.0 feet below the crown. Siphon breakers on waterward slope. Pump on steel platform in drainage ditch, 350 ft. from levee center off the the landward berm. (App. No. 11524) FS Date: 10/22/2013

WS view: exposed 18-inch pipe with siphon breaker on levee slope. Exposed 24-inch pipe (left).

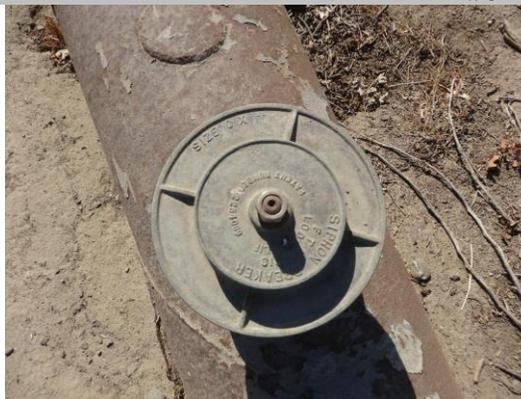
Photo 2 of 2 : UCIP\_SP\_2016\_23023\_39081.jpg

WS view: closer view of 18-inch pipe with siphon breaker on levee slope.

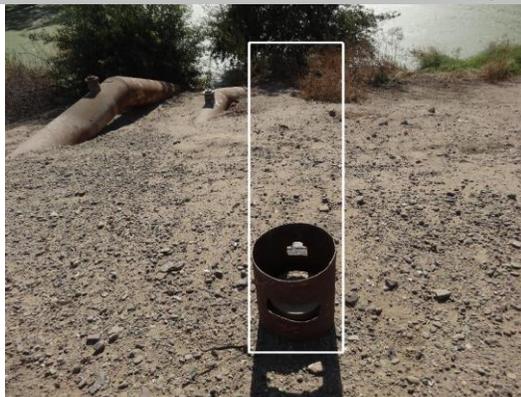
Photo 1 of 2 : UCIP\_SP\_2016\_23305\_40153.jpg

LM Start	<b>3.24</b>	Rating **	M	Issue No.	<b>18</b>
LM End	<b>3.24</b>	Issue Type +	En	Location *	LS
Category	Supplemental		GPS Latitude/Longitude		
			Start	End	
Item	DWR UCIP Field Study		37.804787 °	37.804787 °	
			-121.379734 °	-121.379734 °	
DWR ID					
Comment Code					
Inspector Comment					
FS_ID:23305 DS_ID:19195 EP_NO: 11524 Repair Type: Non-Urgent Crossing Status: Found UCIP Comments: - no associated pump or any other appurtenances found on landside.- looks abandoned pipe. Needs proper abandonment. FIELD_STRUCT_DESC: 3 of 3: One of 2x24-inch pipe through the levee 2.0 feet below the crown. 18-inch pipe through the levee 4.0 feet below the crown. Siphon breakers on waterward slope. (App. No. 11524) FS Date: 10/22/2013

WS view: siphon breaker in steel pipe riser on levee slope.

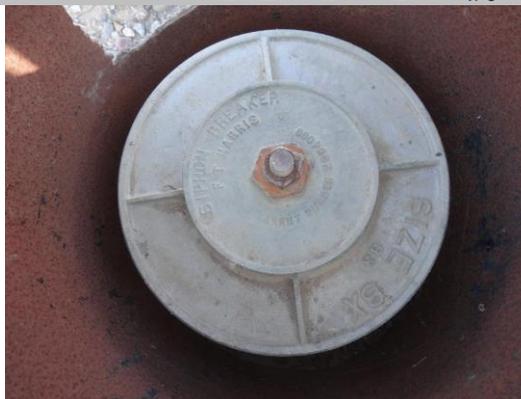
Photo 2 of 2 : UCIP\_SP\_2016\_23305\_40152.jpg

WS view: closer view of siphon breaker in steel pipe riser on levee slope.

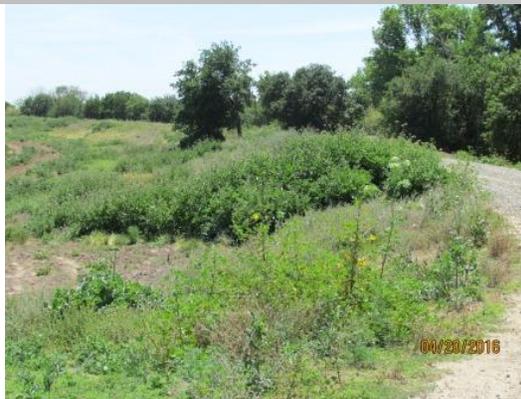
Photo 1 of 1 : SP\_2016\_RD2062\_310\_11\_20160421\_00030.jpg

View of the vegetation on the landside levee slope.

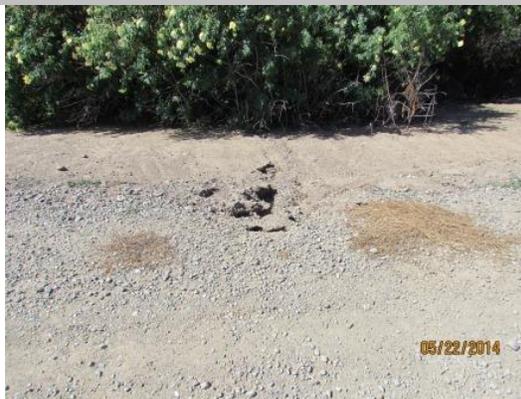
Photo 1 of 1 : SP\_2016\_RD2062\_310\_8\_20160229\_00002.jpg

LM Start	<b>3.64</b>	Rating **	M	Issue No.	<b>8</b>
LM End	<b>3.64</b>	Issue Type +	Ma	Location *	WS
Category	Earthen Levee		GPS Latitude/Longitude		
			Start	End	
Item	Erosion / Bank Caving		37.806347 °	37.806347 °	
			-121.386692 °	-121.386692 °	
DWR ID	DWR_RD2062_02_s_2014_8				
Comment Code					
E2 : Schedule repair of erosion site prior to the next inspection.					
Inspector Comment

View of the erosion from surface runoff on the waterside levee slope.

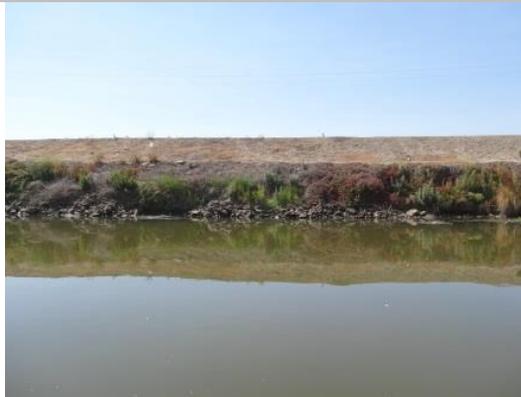
Photo 1 of 3 : SP\_2016\_RD2062\_311\_8\_20160229\_00013.jpg

LM Start	<b>0.00</b>	Rating **	U	Issue No.	<b>8</b>
LM End	<b>0.09</b>	Issue Type +	Ma	Location *	WS
Category	Supplemental			GPS Latitude/Longitude	
				Start	End
Item	DWR Erosion Survey			37.809673 °	37.809673 °
				-121.390321 °	-121.390321 °
DWR ID	DWR_RD2062_03_s_2016_8				
Comment Code					
Inspector Comment					
06/25/2015: No significant change observed. 07/02/2014: No significant change observed. 08/13/2013: No significant change observed. 08/07/2012: The site has been visited by boat survey. No significant change observed 08/23/2011: Site is at the upstream of a drainage ditch. [2015 Site ID:RD2062U03RM29.93]

Front view of the erosion.

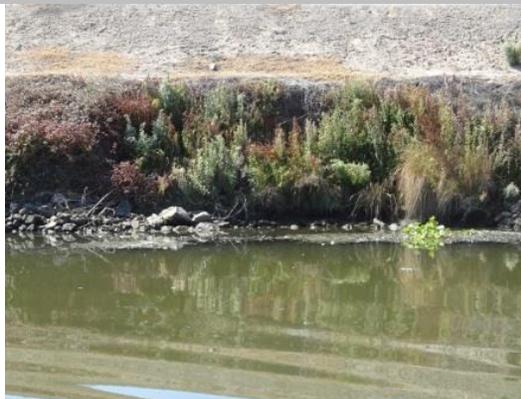
Photo 3 of 3 : SP\_2016\_RD2062\_311\_8\_20160229\_00015.jpg

Front view of the erosion.

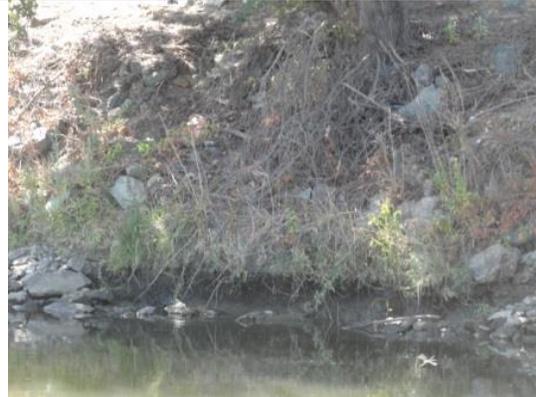
Photo 1 of 3 : SP\_2016\_RD2062\_311\_9\_20160229\_00016.jpg

Close view of the site. Note the vegetation.

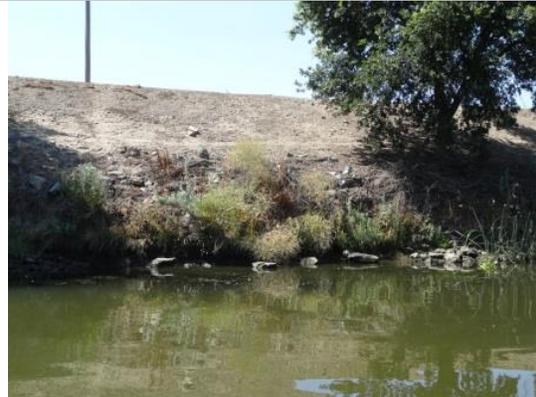
Photo 2 of 3 : SP\_2016\_RD2062\_311\_9\_20160229\_00017.jpg

Front view of the site.

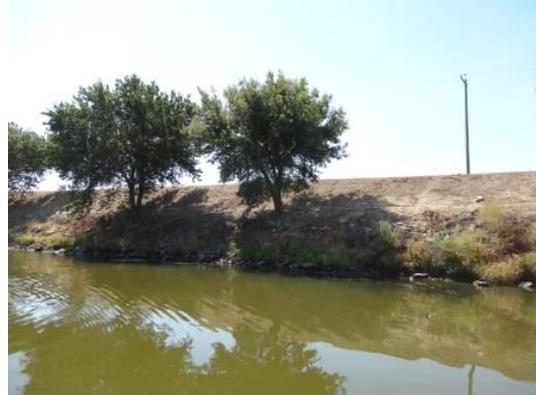
Photo 3 of 3 : SP\_2016\_RD2062\_311\_9\_20160229\_00018.jpg

View of the site from downstream.

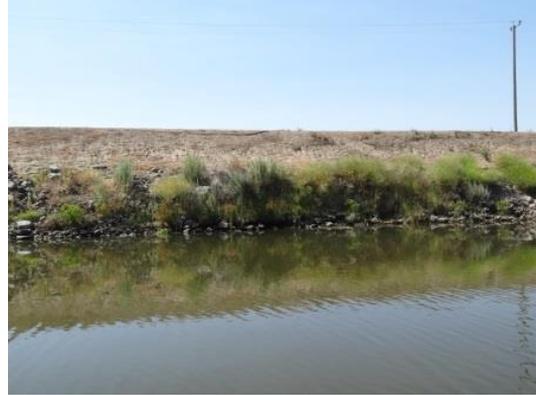
Photo 1 of 2 : SP\_2016\_RD2062\_311\_13\_20160229\_00023.jpg

Direct view of the site.

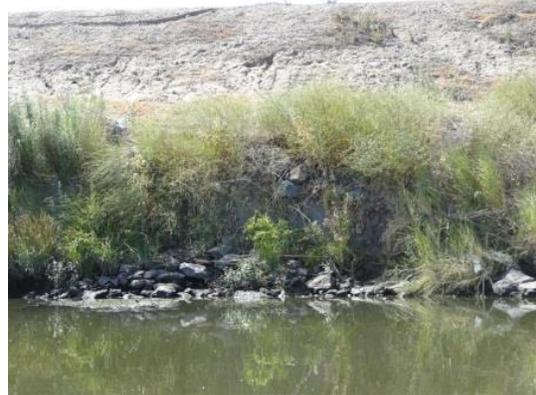
Photo 2 of 2 : SP\_2016\_RD2062\_311\_13\_20160229\_00024.jpg

Close view of the erosion.

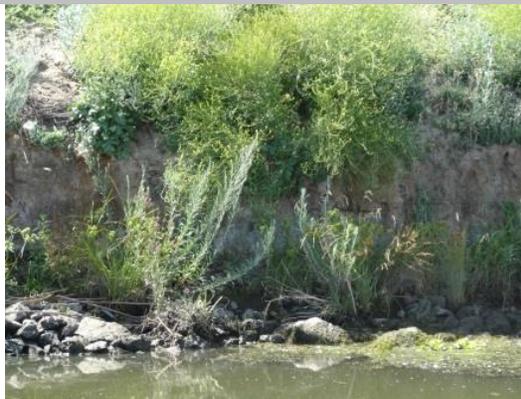
Photo 3 of 3 : SP\_2016\_RD2062\_311\_17\_20160229\_00028.jpg

Close view of the pocket erosion.

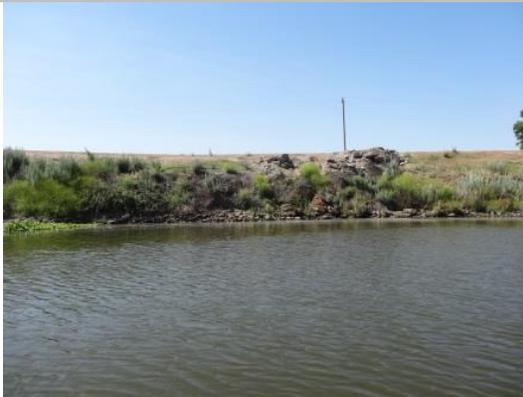
Photo 1 of 2 : SP\_2016\_RD2062\_311\_1\_20160229\_00001.jpg

Front view of the erosion.

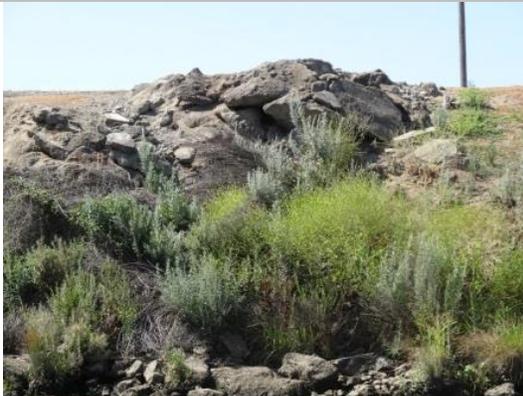
Photo 2 of 2 : SP\_2016\_RD2062\_311\_1\_20160229\_00002.jpg

Close view of the site. Note the piled concrete debris.

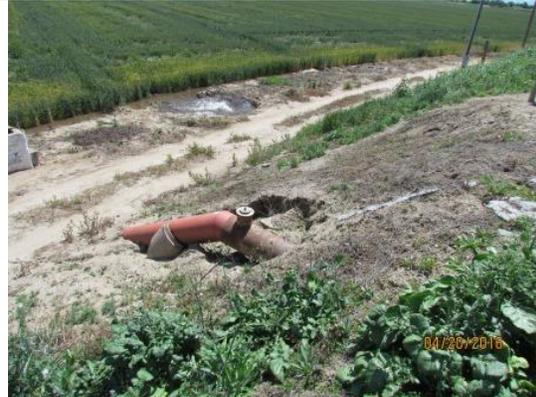
Photo 1 of 1 : SP\_2016\_RD2062\_311\_38\_20160421\_00053.jpg

View of the landside levee slope erosion around the pipe.

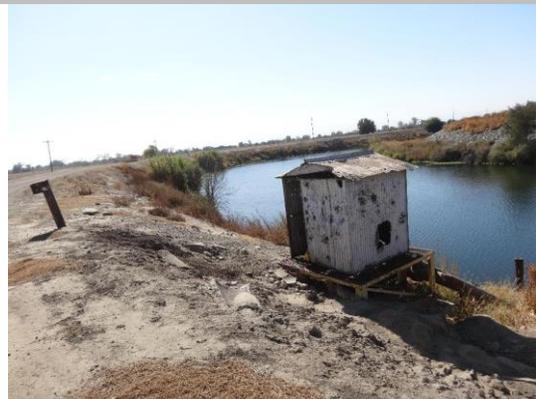
Photo 1 of 2 : UCIP\_SP\_2016\_23306\_40158.jpg

WS view: pump house on levee slope and soil erosion on levee slope.

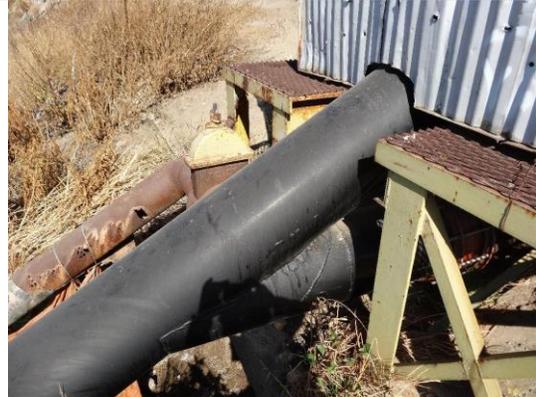
Photo 2 of 2 : UCIP\_SP\_2016\_23306\_40157.jpg

WS view: pump house on levee slope and holes-pits on corroded overflow pipe (left).

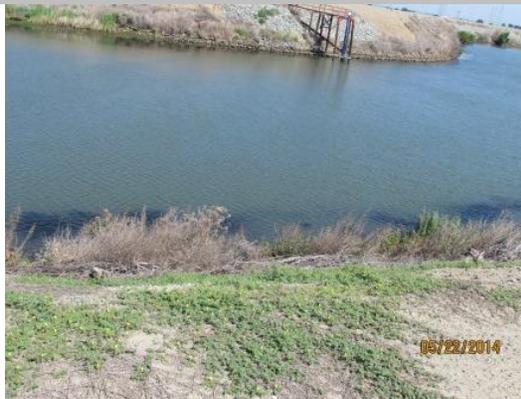
Photo 1 of 1 : SP\_2016\_RD2062\_311\_12\_20160229\_00022.jpg

View of the tree stumps on the waterside levee slope.

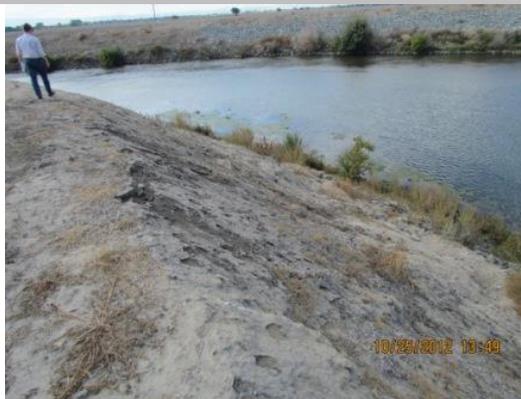
Photo 1 of 2 : SP\_2016\_RD2062\_311\_11\_20160229\_00020.jpg

View of slope erosion from foot traffic.

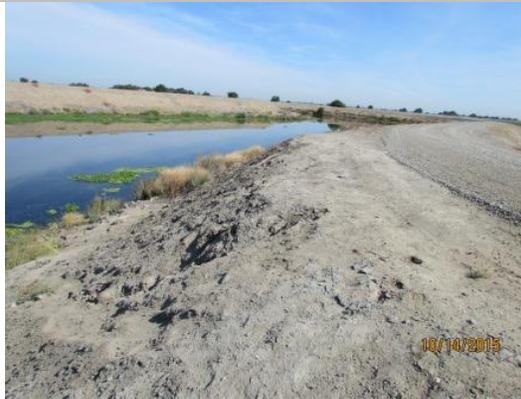
Photo 2 of 2 : SP\_2016\_RD2062\_311\_11\_20160229\_00021.jpg

View of cracking at waterside levee hinge.

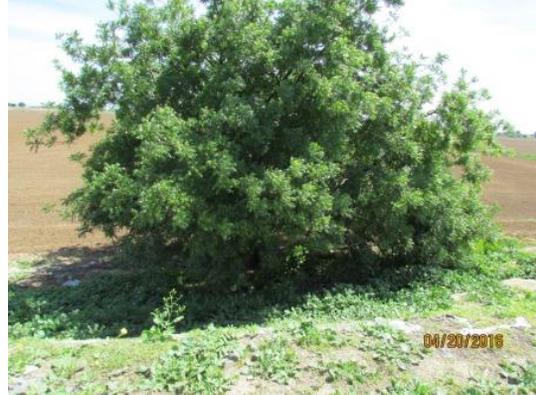
Photo 1 of 1 : SP\_2016\_RD2062\_311\_36\_20160421\_00054.jpg

View of the tree at the landside levee toe.

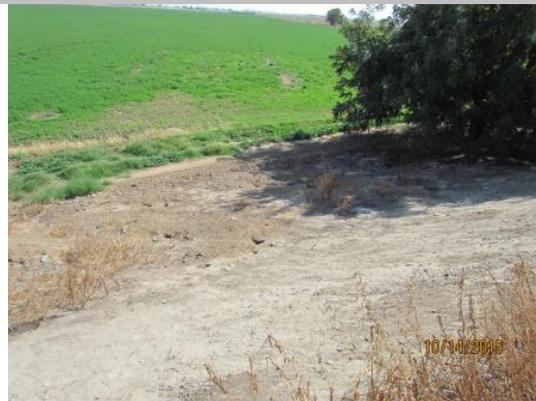
Photo 1 of 1 : SP\_2016\_RD2062\_311\_34\_20160229\_00033.jpg

View of the rodent burrows at the landside levee toe.

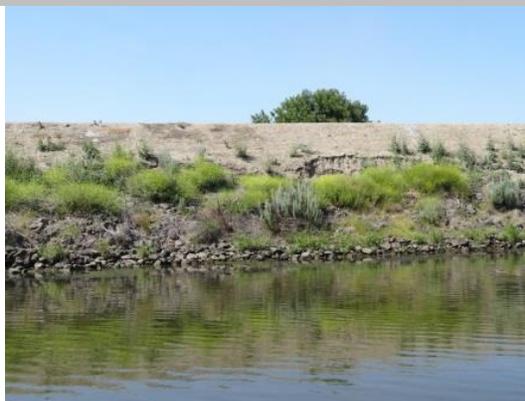
Photo 2 of 2 : SP\_2016\_RD2062\_311\_4\_20160229\_00008.jpg

Front view of the site.

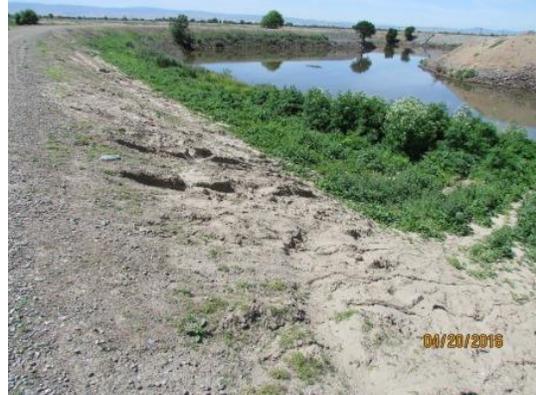
Photo 1 of 1 : SP\_2016\_RD2062\_311\_32\_20160421\_00052.jpg

View of the tire tracks on the waterside levee slope.

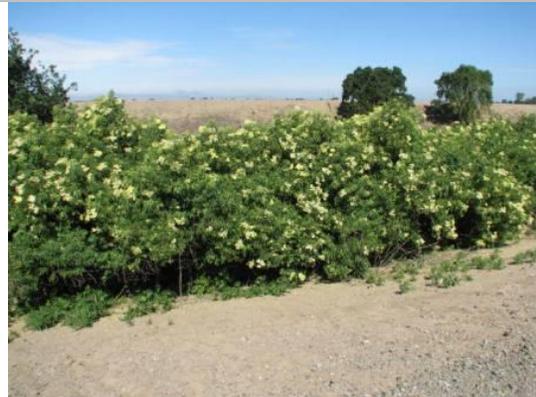
Photo 1 of 1 : SP\_2016\_RD2062\_311\_18\_20160229\_00029.jpg

05/11/2011 Elderberry bush on water side slope.

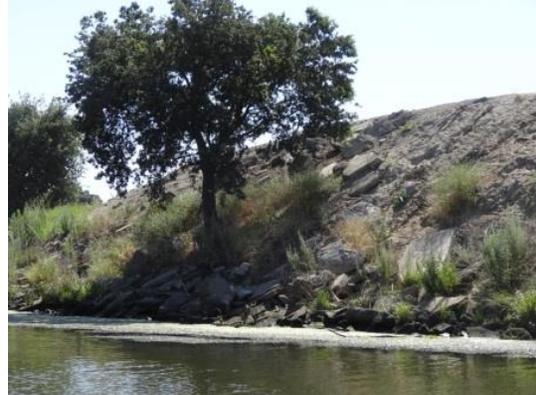
Photo 1 of 3 : SP\_2016\_RD2062\_311\_5\_20160229\_00009.jpg

Front view of the site. Note existing broken concrete on the upper slope as well as on the lower slope and at the toe.

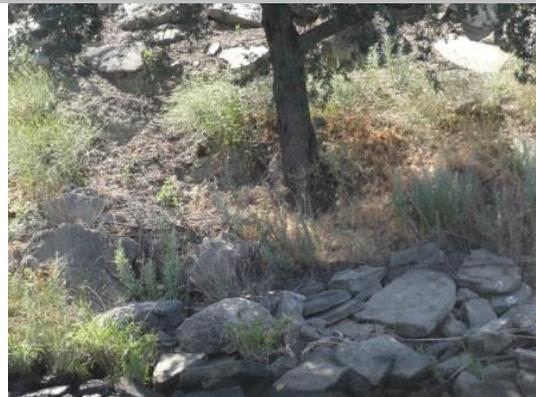
Photo 2 of 3 : SP\_2016\_RD2062\_311\_5\_20160229\_00010.jpg

A closer view of the site.

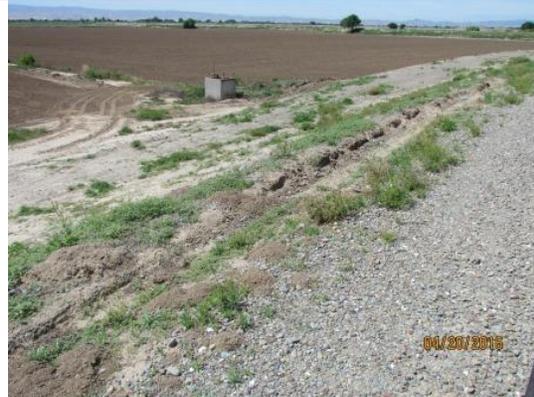
Photo 1 of 1 : SP\_2016\_RD2062\_311\_29\_20160421\_00051.jpg

View of a tire rut on the landside levee hinge.

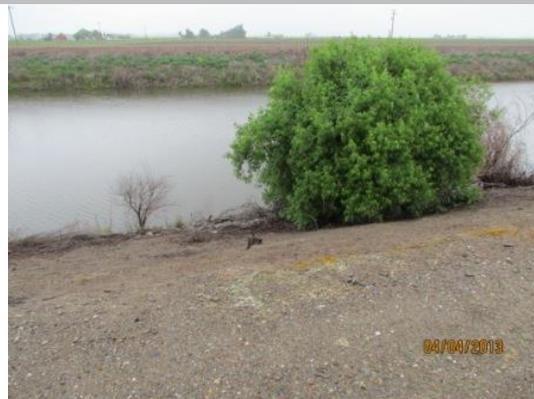
Photo 1 of 1 : SP\_2016\_RD2062\_311\_15\_20160229\_00025.jpg

View of the tree stump on the waterside levee slope.

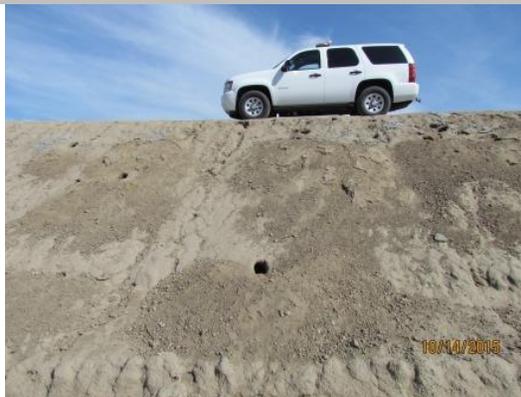
Photo 1 of 1 : SP\_2016\_RD2062\_311\_30\_20160229\_00031.jpg

View of the rodent hole on the landside levee slope.

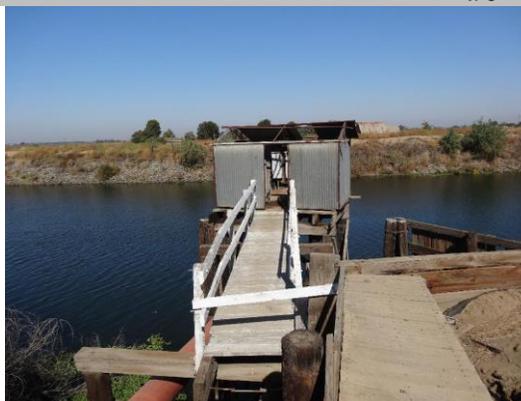
Photo 1 of 2 : UCIP\_SP\_2016\_23311\_40175.jpg

WS view: wooden walkway to pumphouse, pumphouse on wooden pile structure in the stream.

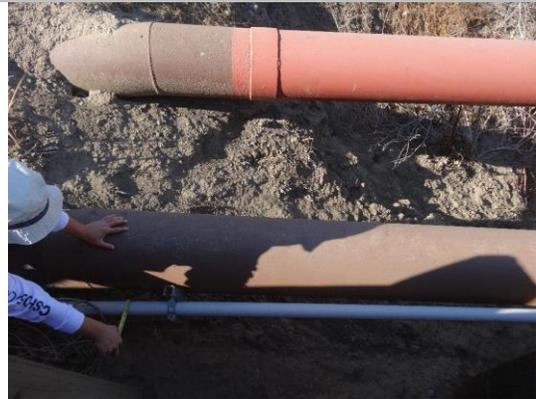
Photo 2 of 2 : UCIP\_SP\_2016\_23311\_40174.jpg

WS view: exposed steel pipes and an electric conduit on levee slope.

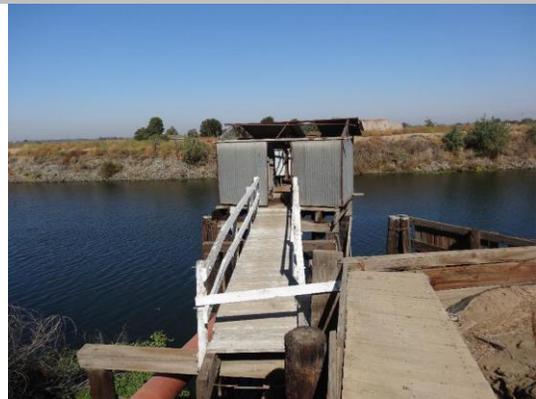
Photo 1 of 2 : UCIP\_SP\_2016\_23312\_40181.jpg

WS view: wooden walkway to pumphouse, pumphouse on wooden pile structure in the stream.

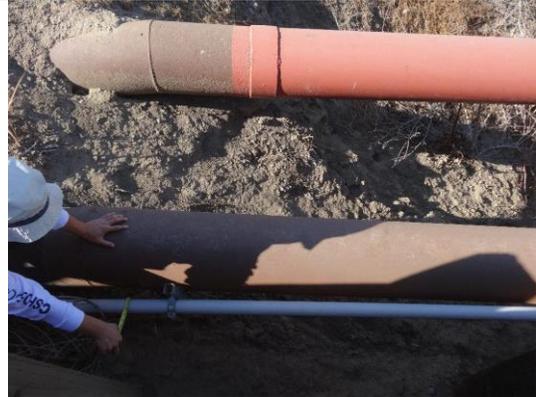
Photo 2 of 2 : UCIP\_SP\_2016\_23312\_40179.jpg

WS view: exposed steel pipes and a electric conduit on levee slope.

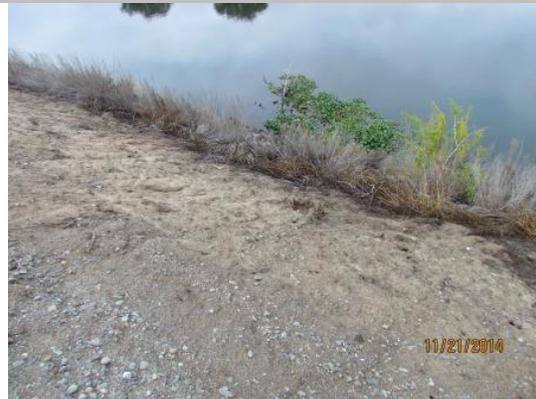
Photo 1 of 1 : SP\_2016\_RD2062\_311\_26\_20160229\_00030.jpg

View of the tree stump on the waterside levee slope.

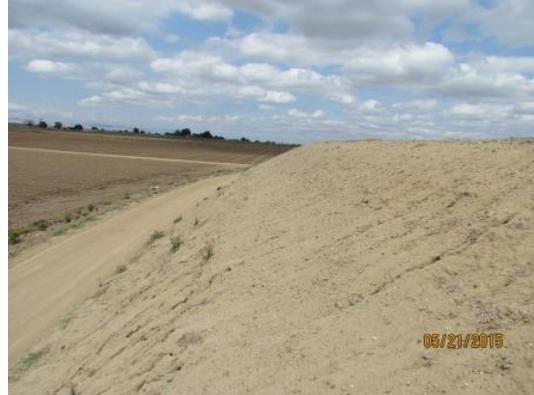
Photo 1 of 1 : SP\_2016\_RD2062\_311\_31\_20160229\_00032.jpg

View of the eroded landside levee toe.

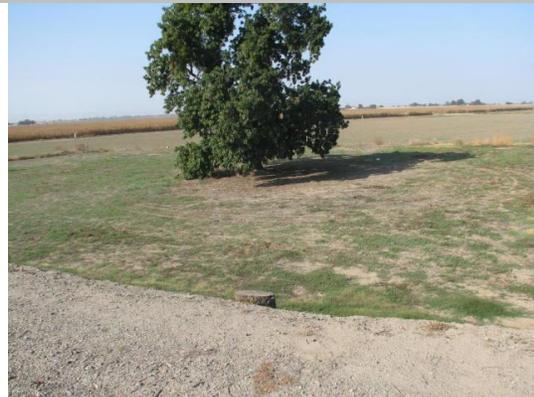
Photo 1 of 1 : SP\_2016\_RD2062\_311\_7\_20160229\_00012.jpg

10/21/2011 Photo taken the next day. Stump can be seen in the lower center of the photo.

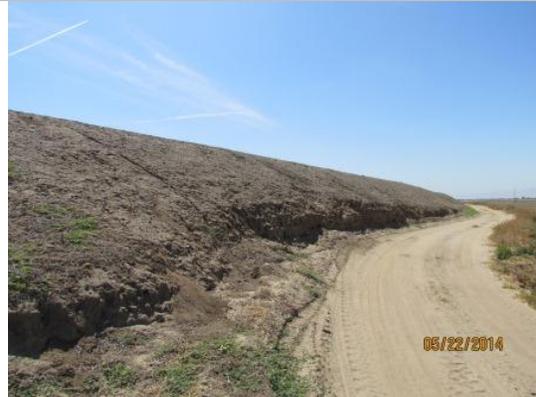
Photo 1 of 1 : SP\_2016\_RD2062\_311\_35\_20160229\_00034.jpg

View of a 2-3 feet vertical cut at the landside levee toe.

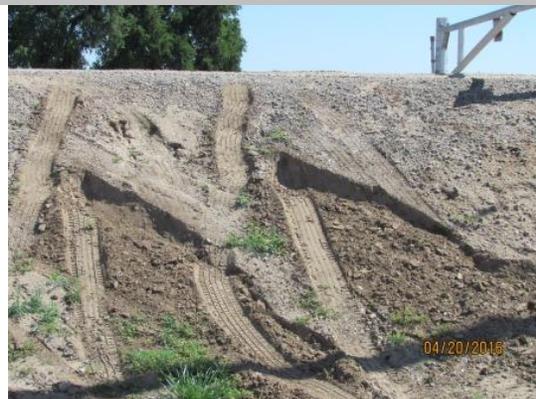
Photo 1 of 1 : SP\_2016\_RD2062\_311\_28\_20160421\_00050.jpg

View of the vehicle tracks on the landside levee slope.

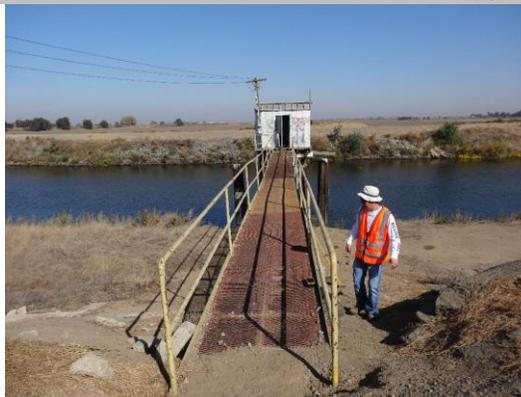
Photo 1 of 2 : UCIP\_SP\_2016\_23142\_39549.jpg

WS view: steel walkway to pump house in the stream.

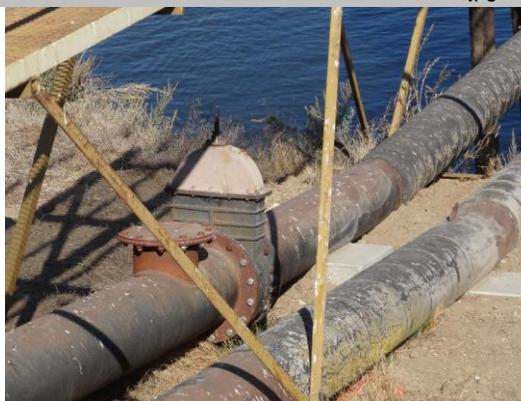
Photo 2 of 2 : UCIP\_SP\_2016\_23142\_39548.jpg

WS view: two 16-inch pipes under walkway. Gate valve without handle on one of the pipes.

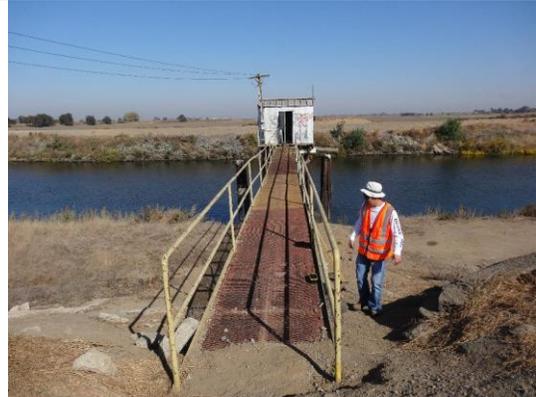
Photo 1 of 2 : UCIP\_SP\_2016\_23140\_39531.jpg

WS view: steel walkway to pump house in the stream.

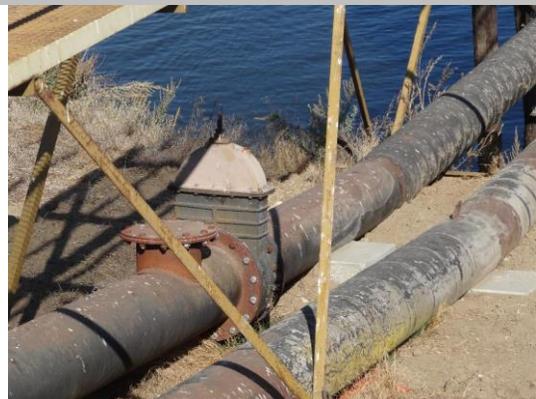
Photo 2 of 2 : UCIP\_SP\_2016\_23140\_39530.jpg

WS view: two 16-inch pipes under walkway. Gate valve without handle on one of the pipes.
