**Flood Control Project Maintenance
Levee Inspections**
LMA District Cover Sheet
Spring 2017 Levee Inspection Results

Reclamation District No. 2062 Stewart

Spring 2017 Levee Inspection Results

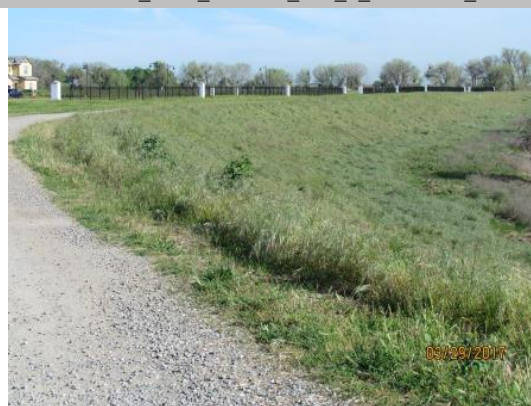
Photo 1 of 1 : SP_2017_RD2062_309_7_20170405_00012.jpg

View of the vegetation on the levee slope.

LM Start	0.72	Rating **	C	Issue No.	6
LM End	0.72	Issue Type +	Ma	Location *	WS
Category	Earthen Levee			GPS Latitude/Longitude	
				Start	End
Item	Crown Surface / Depressions / Rutting			37.805138 °	37.805138 °
				-121.316420 °	-121.316420 °
DWR ID	DWR_RD2062_01_s_2015_6				
Comment Code					
C3 : Add appropriate gravel or road base. Grade and compact.					
Inspector Comment					
New levee patrol road is being installed. Make sure all-weather access is available before next flood season.

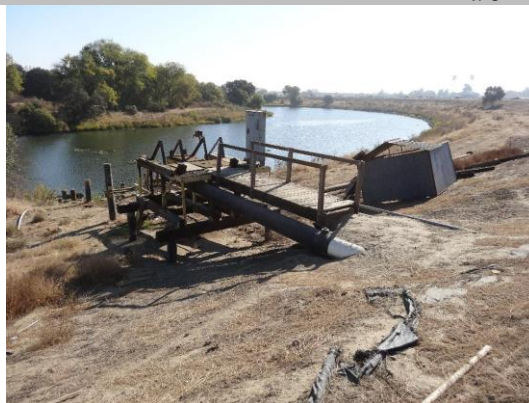
Photo 1 of 3 : UCIP_SP_2017_22807_38905.jpg

Comment Code					
Inspector Comment					
FS_ID:22807					
DS_ID:19177					
EP_NO: 12679					
Repair Type: Non-Urgent					
Crossing Status: Found					
UCIP Comments: - All 3 pipes on landside looks new.- Pumps, pump house, and pipes removed from waterside.- Land development activities going on in this area.- Needs to confirm from LMA or DWR Inspector about the crossing.					
FIELD_STRUCT_DESC: 1 of 3: Two 16-inch steel pipes, one 8-inch steel pipe, and three electric conduits through the levee 5.0 feet below the crown. Two slant pumps in the pump house on the waterward slope. Siphon breakers on the landward slope. (App. No. 16124)					
FS Date: 10/22/2013

WS view: pipes, walkway, and dismantled pump house (right).

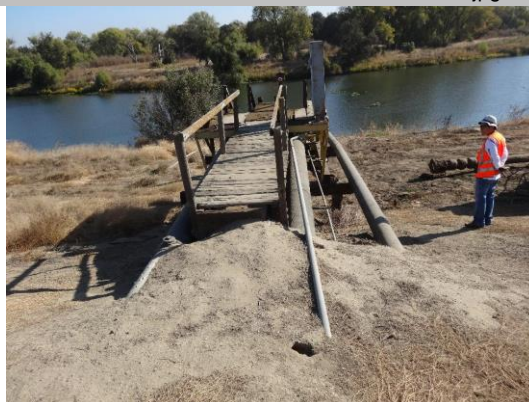
Photo 2 of 3 : UCIP_SP_2017_22807_38904.jpg

WS view: 16-inch pipes on both sides of walkway and 10-inch pipe (on right) away from walkway.

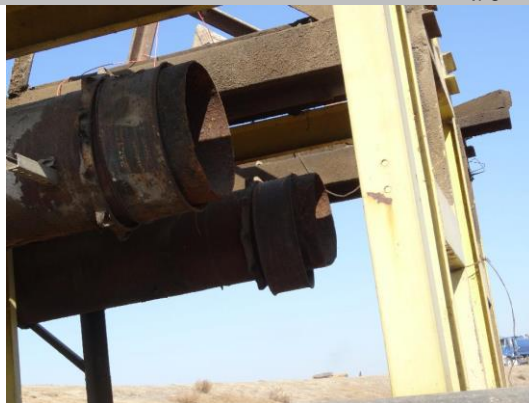
Photo 3 of 3 : UCIP_SP_2017_22807_38903.jpg

LM Start	1.64	Rating **	M	Issue No.	10 (cont)
LM End	1.64	Issue Type +	En	Location *	WS
Category	Supplemental			GPS Latitude/Longitude	
				Start	End
Item	DWR UCIP Field Study			37.793521 °	37.793521 °
				-121.315348 °	-121.315348 °
DWR ID					
Comment Code					
Inspector Comment					
FS_ID:22807 DS_ID:19177 EP_NO: 12679 Repair Type: Non-Urgent Crossing Status: Found UCIP Comments: - All 3 pipes on landside looks new.- Pumps, pump house, and pipes removed from waterside.- Land development activities going on in this area.- Needs to confirm from LMA or DWR Inspector about the crossing. FIELD_STRUCT_DESC: 1 of 3: Two 16-inch steel pipes, one 8-inch steel pipe, and three electric conduits through the levee 5.0 feet below the crown. Two slant pumps in the pump house on the waterward slope. Siphon breakers on the landward slope. (App. No. 16124) FS Date: 10/22/2013

WS view: two 16-inch pipes. Pumps were removed. Pumphouse dismantled.

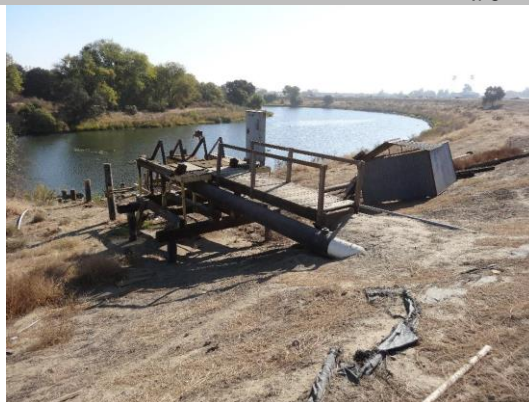
Photo 1 of 3 : UCIP_SP_2017_22809_38913.jpg

LM Start	1.64	Rating **	M	Issue No.	11
LM End	1.64	Issue Type +	En	Location *	WS
Category	Supplemental			GPS Latitude/Longitude	
				Start	End
Item	DWR UCIP Field Study			37.793510 °	37.793510 °
				-121.315345 °	-121.315345 °
DWR ID					
Comment Code					
Inspector Comment					
FS_ID:22809 DS_ID:19183 EP_NO: 12679 Repair Type: Non-Urgent Crossing Status: Found UCIP Comments: - All 3 pipes on landside looks new.- Pumps, pump house, and pipes removed from waterside.- Land development activities going on in this area.- Needs to confirm from LMA or DWR Inspector about the crossing. FIELD_STRUCT_DESC: 2 of 3: Two 16-inch steel pipes, one 8-inch steel pipe, and three electric conduits through the levee 5.0 feet below the crown. Two slant pumps in the pump house on the waterward slope. Siphon breakers on the landward slope. (App. No. 16124) FS Date: 10/22/2013

WS view: pipes, walkway, and dismantled pumphouse (right).

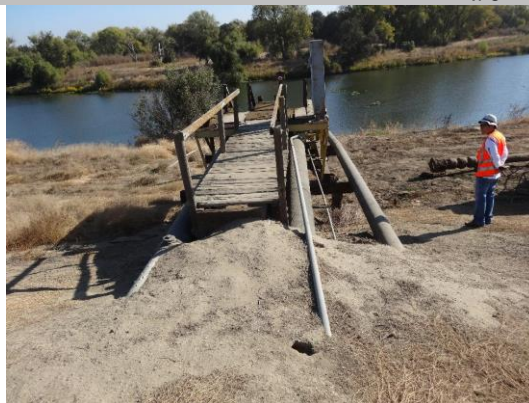
Photo 2 of 3 : UCIP_SP_2017_22809_38912.jpg

Comment Code						
Inspector Comment						
FS_ID:22809						
DS_ID:19183						
EP_NO: 12679						
Repair Type: Non-Urgent						
Crossing Status: Found						
UCIP Comments: - All 3 pipes on landside looks new.- Pumps, pump house, and pipes removed from waterside.- Land development activities going on in this area.- Needs to confirm from LMA or DWR Inspector about the crossing.						
FIELD_STRUCT_DESC: 2 of 3: Two 16-inch steel pipes, one 8-inch steel pipe, and three electric conduits through the levee 5.0 feet below the crown. Two slant pumps in the pump house on the waterward slope. Siphon breakers on the landward slope. (App. No. 16124)						
FS Date: 10/22/2013

WS view: 16-inch pipes on both sides of walkway and 10-inch pipe (on right) away from walkway.

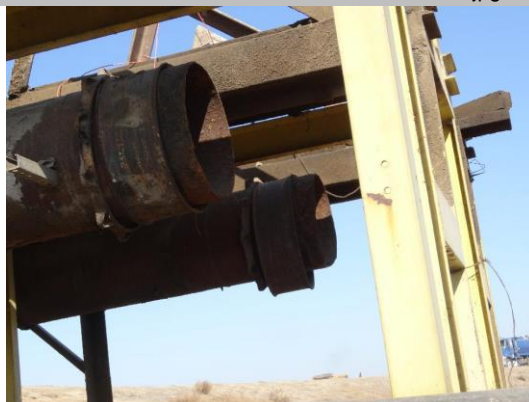
Photo 3 of 3 : UCIP_SP_2017_22809_38911.jpg

WS view: two 16-inch pipes under walkway; pumps were removed.

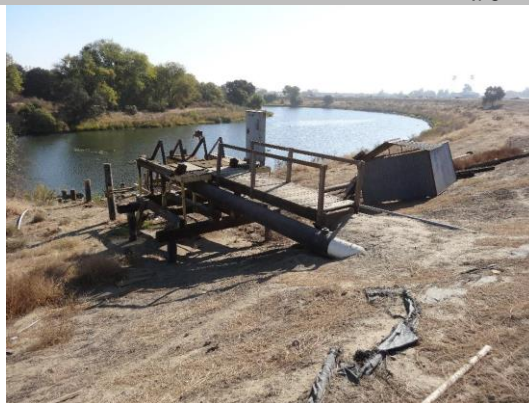
Photo 1 of 3 : UCIP_SP_2017_22810_38918.jpg

Comment Code					
Inspector Comment					
FS_ID:22810					
DS_ID:19184					
EP_NO: 12679					
Repair Type: Non-Urgent					
Crossing Status: Found					
UCIP Comments: - All 3 pipes on landside looks new. No pump associated with 8-inch pipe.- Pumps, pump house, and pipes removed from waterside.- Land development activities going on in this area.- Needs to confirm from LMA or DWR Inspector about the crossing.					
FIELD_STRUCT_DESC: 3 of 3: one 8-inch pipe, two 16-inch pipes, and three electric conduits through the levee 8.0 feet below the crown. Two slant pumps in the pump house on the waterward slope. Siphon breakers on the landward slope. Installed by the United States Army Corps of Engineers, 1961. (App. No. 12679)					
FS Date: 10/22/2013

WS view: pipes, walkway, and dismantled pump house (right).

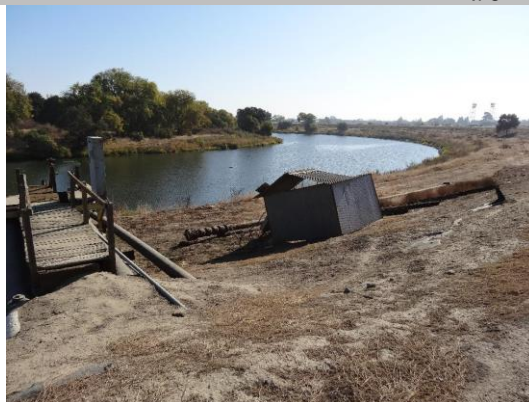
Photo 2 of 3 : UCIP_SP_2017_22810_38917.jpg

WS view: electric conduit and 10-inch pipe (right). Dismantled/removed pipe and pump house (far right).

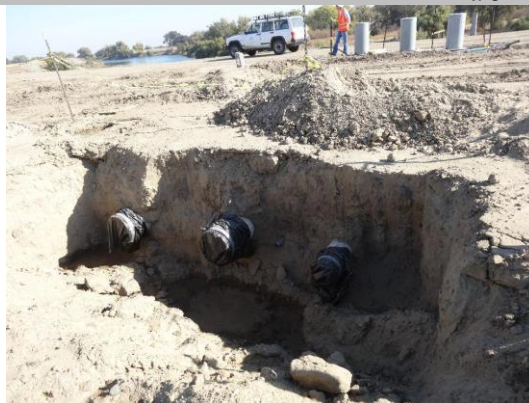
Photo 3 of 3 : UCIP_SP_2017_22810_38916.jpg

Comment Code						
Inspector Comment						
FS_ID:22810 DS_ID:19184 EP_NO: 12679 Repair Type: Non-Urgent Crossing Status: Found UCIP Comments: - All 3 pipes on landside looks new. No pump associated with 8-inch pipe.- Pumps, pump house, and pipes removed from waterside.- Land development activities going on in this area.- Needs to confirm from LMA or DWR Inspector about the crossing. FIELD_STRUCT_DESC: 3 of 3: one 8-inch pipe, two 16-inch pipes, and three electric conduits through the levee 8.0 feet below the crown. Two slant pumps in the pump house on the waterward slope. Siphon breakers on the landward slope. Installed by the United States Army Corps of Engineers, 1961. (App. No. 12679) FS Date: 10/22/2013

LS view: two 16-inch pipes (left) and one 10-inch pipe (right) in ditch.
Concrete box removed.

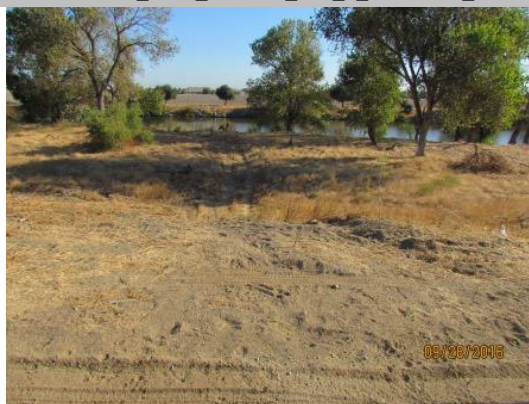
Photo 1 of 1 : SP_2017_RD2062_309_9_20170313_00002.jpg

LM Start	2.14	Rating **	M	Issue No.	9
LM End	2.14	Issue Type +	Ma	Location *	WS
Category	Earthen Levee			GPS Latitude/Longitude	
				Start	End
Item	Slope Stability			37.793991 °	37.793991 °
				-121.308524 °	-121.308524 °
DWR ID	DWR_RD2062_01_f_2016_9				
Comment Code					
S3 : Repair the levee slope damaged by vehicle traffic and prevent access where possible.					
Inspector Comment					
It is recommended to control levee access to prevent possible future damage to the levee slopes.

View of the waterside levee slope erosion due to vehicles driving on the slope.

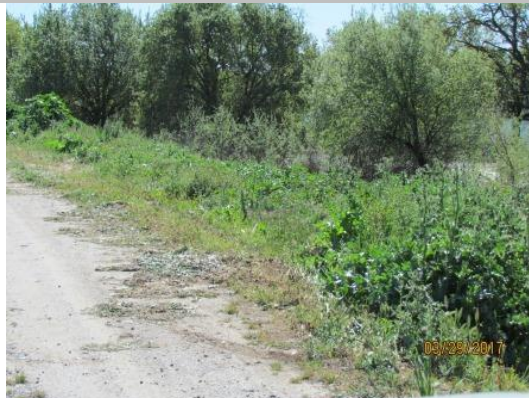
Photo 1 of 1 : SP_2017_RD2062_310_11_20170405_00027.jpg

View of the vegetation on the levee slope.

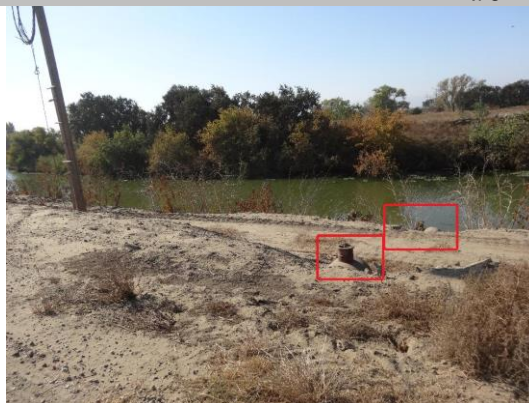
Photo 1 of 3 : UCIP_SP_2017_23110_39398.jpg

LM Start	0.56	Rating **	M	Issue No.	12
LM End	0.56	Issue Type +	En	Location *	WS
Category	Supplemental			GPS Latitude/Longitude	
				Start	End
Item	DWR UCIP Field Study			37.784380 °	37.784380 °
				-121.338985 °	-121.338985 °
DWR ID					
Comment Code					
Inspector Comment					
FS_ID:23110					
DS_ID:24697					
EP_NO: N/A					
Repair Type: Non-Urgent					
Crossing Status: Found					
UCIP Comments: Found on field with the help of USACE 2012 PI Report.Needs proper abandonment.					
FIELD_STRUCT_DESC: Abandoned 24-inch steel pipe through the levee. Damaged siphon breaker on waterside levee slope. Pump on concrete sump on landside. Service pole on landside levee slope. Pump was disconnected from service pole.					
FS Date: 10/23/2013

WS view: power pole (left), siphon breaker (marked- left), and steel pipe (right) on levee slope.

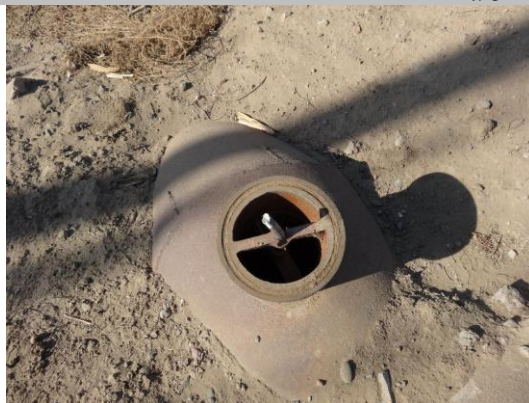
Photo 2 of 3 : UCIP_SP_2017_23110_39397.jpg

LM Start	0.56	Rating **	M	Issue No.	12 (cont)
LM End	0.56	Issue Type +	En	Location *	WS
Category	Supplemental			GPS Latitude/Longitude	
				Start	End
Item	DWR UCIP Field Study			37.784380 °	37.784380 °
				-121.338985 °	-121.338985 °
DWR ID					
Comment Code					
Inspector Comment					
FS_ID:23110					
DS_ID:24697					
EP_NO: N/A					
Repair Type: Non-Urgent					
Crossing Status: Found					
UCIP Comments: Found on field with the help of USACE 2012 PI					
Report.Needs proper abandonment.					
FIELD_STRUCT_DESC: Abandoned 24-inch steel pipe through the					
levee. Damaged siphon breaker on waterside levee slope. Pump on					
concrete sump on landside. Service pole on landside levee slope.					
Pump was disconnected from service pole.					
FS Date: 10/23/2013

WS view: exposed steel pipe and damaged siphon breaker on levee slope.

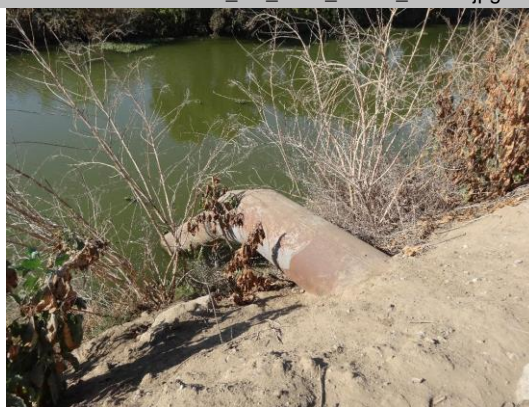
Photo 3 of 3 : UCIP_SP_2017_23110_39396.jpg

WS view: exposed steel pipe on channel bank and also immersed into channel water.

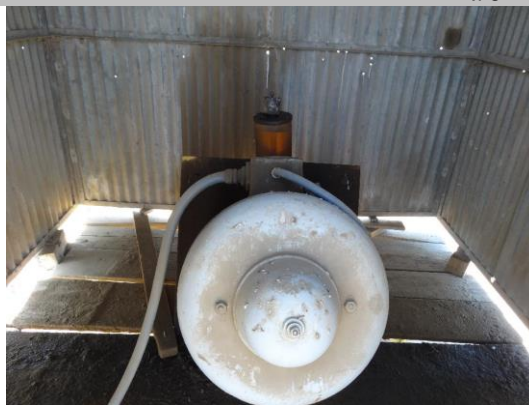
Photo 2 of 3 : UCIP_SP_2017_23181_39791.jpg

LM Start	0.75	Rating **	M	Issue No.	13
LM End	0.75	Issue Type +	En	Location *	WS
Category	Supplemental			GPS Latitude/Longitude	
				Start	End
Item	DWR UCIP Field Study			37.786130 °	37.786130 °
				-121.341564 °	-121.341564 °
DWR ID					
Comment Code					
Inspector Comment					
FS_ID:23181 DS_ID:19192 EP_NO: 12427 Repair Type: Non-Urgent Crossing Status: Found UCIP Comments: - no siphon breaker found- levee toe erosion under walkway on waterside.- erosion around concrete standpipe on landside- may be base of the standpipe was leaking. FIELD_STRUCT_DESC: 18-inch pipe through the levee 4.4 feet below the crown, pump house on the waterward slope, metal walkway from the pump house to the crown. Power pole on waterside. Flap gate and concrete distribution box on the landward slope. (App. No. 12427) FS Date: 10/23/2013

WS view: leaky slant pump in pumphouse on levee slope.

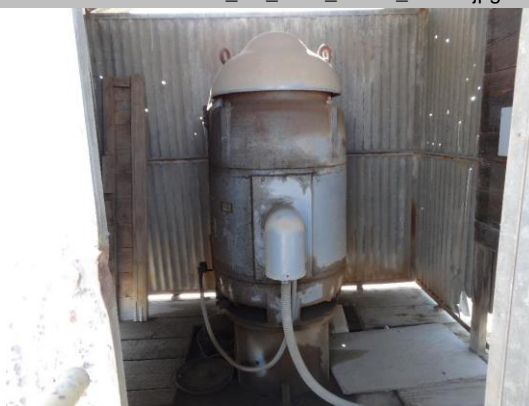
Photo 2 of 3 : UCIP_SP_2017_51468_39194.jpg

FS_ID:51468
DS_ID:19193
EP_NO: N/A
Repair Type: Non-Urgent
Crossing Status: Found
UCIP Comments: 04/05/2017:Pipe has been plugged as a flood fight measure and is likely to be replaced under a permit. MBK (Michael Moncrief) is working on the permit. Photo and update courtesy of Max Khashchuk as part of his 2017 Spring Inspection. (K. Fazel - UCIP)10/22/2013:- pumphouse on concrete sump in the channel.- erosion under walkway on waterside. (P. Amatya - DWR)
FIELD_STRUCT_DESC: 20-inch steel irrigation pipe through the levee, 8 feet below the crown. Pump house on the waterside (WS) slope and a metal walkway from the pump house to the crown. Flap gate, air vent, and concrete distribution box on the landside (LS) slope. [Additional Reference(s): DWR Levee Log, 2007].
FS Date: 4/6/2017

WS view: leaky pump and control box in pumphouse.

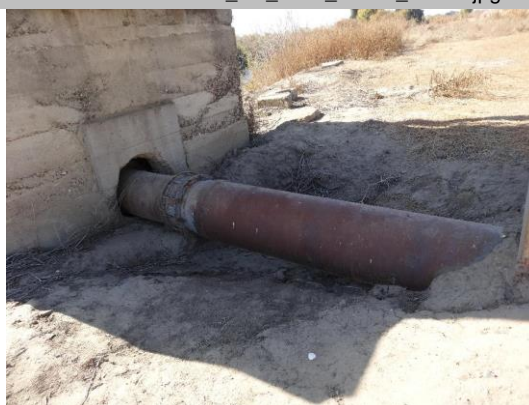
Photo 3 of 3 : UCIP_SP_2017_51468_39193.jpg

WS view: exposed steel pipe under walkway. Soil erosion under walkway. This may be due to leaky pipe joint.

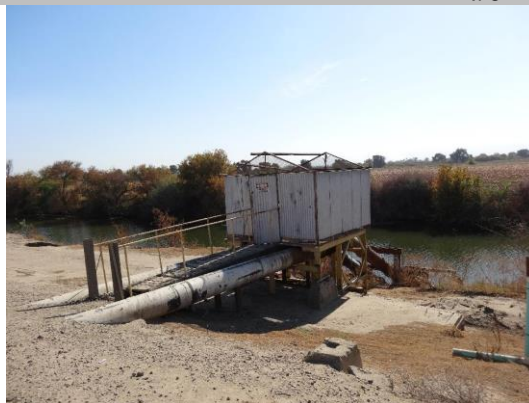
Photo 1 of 3 : UCIP_SP_2017_50452_39187.jpg

FS_ID:50452
DS_ID:19194
EP_NO: 4305
Repair Type: Urgent
Crossing Status: Found
UCIP Comments: 08/31/2016: Heavy sloughing and sink hole remains at the WS slope in alignment with pipe. Though sloughing is not affecting levee prism, it is still an indication of a pipe integrity problem. Oil leak at the pump but does not appear to impact the levee. (K. Fazel - UCIP)10/22/2013:- missing roof in pump house.- no protection for siphon breaker- huge erosion under pumphouse and levee slope on waterside. (P. Amatya - DWR)
FIELD_STRUCT_DESC: 1 of 2: 18-inch steel irrigation pipe through the levee, 4.8 feet below the crown. Pump house on the waterside (WS) slope. Siphon breaker on the landside (LS) shoulder. Power pole on the LS shoulder. Concrete distribution box at the LS toe. (Permit No. 4305, 1964 - Island Reclamation District No. 2062) [Additional Reference(s): DWR Levee Log, 2007].
FS Date: 8/31/2016

WS view: pipes, walkway, and pumphouse with missing roof (right).

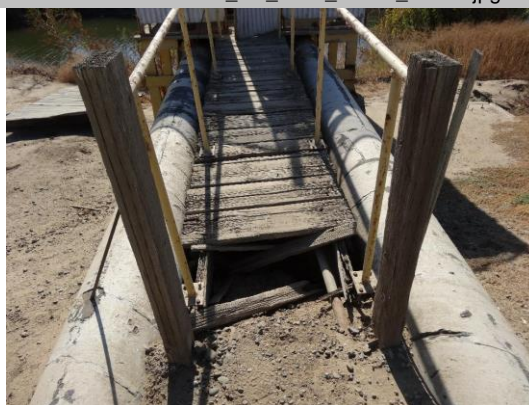
Photo 2 of 3 : UCIP_SP_2017_50452_39186.jpg

WS view: walkway to pumphouse. Walkway in poor condition.

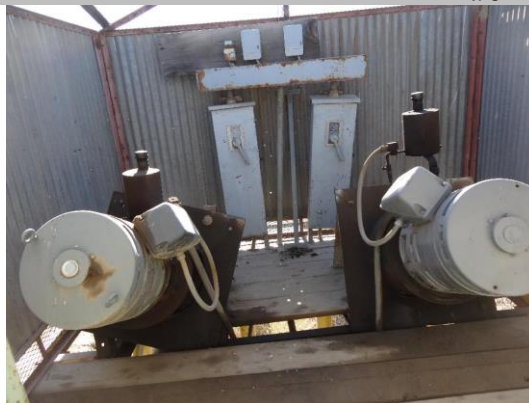
Photo 3 of 3 : UCIP_SP_2017_50452_39185.jpg

FS_ID:50452
 DS_ID:19194
 EP_NO: 4305
 Repair Type: Urgent
 Crossing Status: Found
 UCIP Comments: 08/31/2016: Heavy sloughing and sink hole remains at the WS slope in alignment with pipe. Though sloughing is not affecting levee prism, it is still an indication of a pipe integrity problem. Oil leak at the pump but does not appear to impact the levee. (K. Fazel - UCIP)10/22/2013:- missing roof in pump house.- no protection for siphon breaker- huge erosion under pumphouse and levee slope on waterside. (P. Amatya - DWR)
 FIELD_STRUCT_DESC: 1 of 2: 18-inch steel irrigation pipe through the levee, 4.8 feet below the crown. Pump house on the waterside (WS) slope. Siphon breaker on the landside (LS) shoulder. Power pole on the LS shoulder. Concrete distribution box at the LS toe. (Permit No. 4305, 1964 - Island Reclamation District No. 2062) [Additional Reference(s): DWR Levee Log, 2007].
 FS Date: 8/31/2016

WS view: two leaky slant pumps in pumphouse with missing roof.

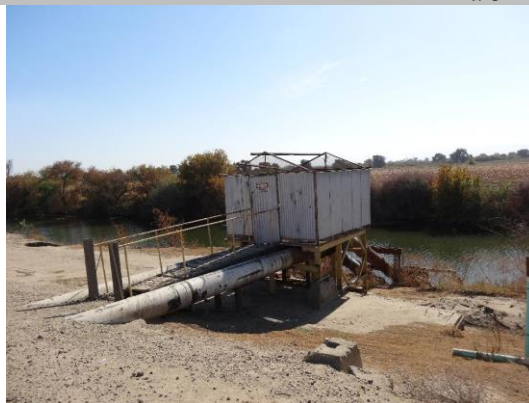
Photo 1 of 3 : UCIP_SP_2017_50454_39176.jpg

FS_ID:50454
DS_ID:19197
EP_NO: 4305
Repair Type: Urgent
Crossing Status: Found
UCIP Comments: 08/31/2016: Heavy sloughing and sink hole remains at the WS slope in alignment with pipes. Though sloughing is not affecting levee prism, it is still an indication of a pipe integrity problem. Oil leak at the pump but does not appear to impact levee. (K. Fazel - UCIP)10/22/2013:- missing roof in pump house.- no protection for siphon breaker- huge erosion under pumphouse and levee slope on waterside. (P. Amatya - DWR)
FIELD_STRUCT_DESC: 2 of 2: 18-inch steel irrigation pipe through the levee, 4.8 feet below the crown. Pump house on the waterside (WS) slope. Siphon breaker on the landside (LS) shoulder. Power pole on the LS shoulder. Concrete distribution box at the LS toe. (Permit No. 4305, 1964 - Island Reclamation District No. 2062) [Additional Reference(s): DWR Levee Log, 2007].
FS Date: 8/31/2016

WS view: pipes, walkway, and pumphouse with missing roof (right).

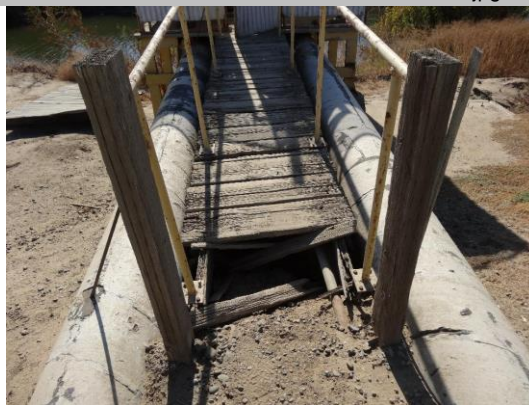
Photo 2 of 3 : UCIP_SP_2017_50454_39175.jpg

WS view: walkway in poor condition, to pumphouse.

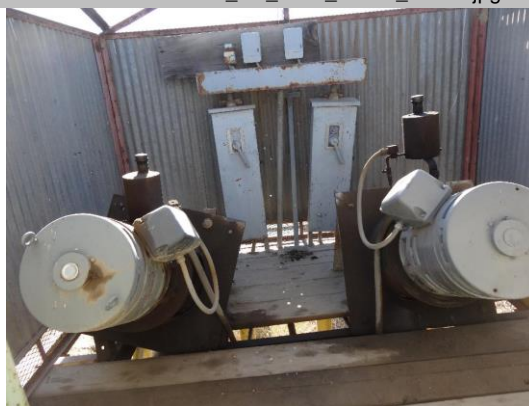
Photo 3 of 3 : UCIP_SP_2017_50454_39174.jpg

Comment Code						
Inspector Comment						
FS_ID:50454 DS_ID:19197 EP_NO: 4305 Repair Type: Urgent Crossing Status: Found UCIP Comments: 08/31/2016: Heavy sloughing and sink hole remains at the WS slope in alignment with pipes. Though sloughing is not affecting levee prism, it is still an indication of a pipe integrity problem. Oil leak at the pump but does not appear to impact levee. (K. Fazel - UCIP)10/22/2013:- missing roof in pump house.- no protection for siphon breaker- huge erosion under pumphouse and levee slope on waterside. (P. Amatya - DWR) FIELD_STRUCT_DESC: 2 of 2: 18-inch steel irrigation pipe through the levee, 4.8 feet below the crown. Pump house on the waterside (WS) slope. Siphon breaker on the landside (LS) shoulder. Power pole on the LS shoulder. Concrete distribution box at the LS toe. (Permit No. 4305, 1964 - Island Reclamation District No. 2062) [Additional Reference(s): DWR Levee Log, 2007]. FS Date: 8/31/2016

WS view: two leaky slant pumps in pumphouse with missing roof.

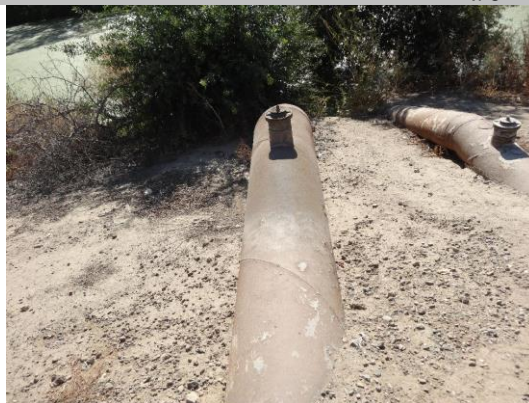
Photo 1 of 3 : UCIP_SP_2017_23304_40147.jpg

LM Start	3.24	Rating **	M	Issue No.	17
LM End	3.24	Issue Type +	En	Location *	WS
Category	Supplemental			GPS Latitude/Longitude	
				Start	End
Item	DWR UCIP Field Study			37.804770 °	37.804770 °
				-121.379679 °	-121.379679 °
DWR ID					
Comment Code					
Inspector Comment					
FS_ID:23304 DS_ID:19199 EP_NO: 11524 Repair Type: Non-Urgent Crossing Status: Found UCIP Comments: - waterside pipe immersed into channel water.- most of the pipe on landside exposed and siphon breaker on waterside not protected. FIELD_STRUCT_DESC: 1 of 3: One of 2x24-inch pipes through the levee 2.0 feet below the crown. 18-inch pipe through the levee 4.0 feet below the crown. Siphon breakers on waterward slope. Pump on steel platform in drainage ditch, 350 ft. from levee center off the the landward berm. (App. No. 11524) FS Date: 10/22/2013

WS view: 24-inch steel pipe (left) with siphon breaker on levee slope. 18-inch pipe on right.

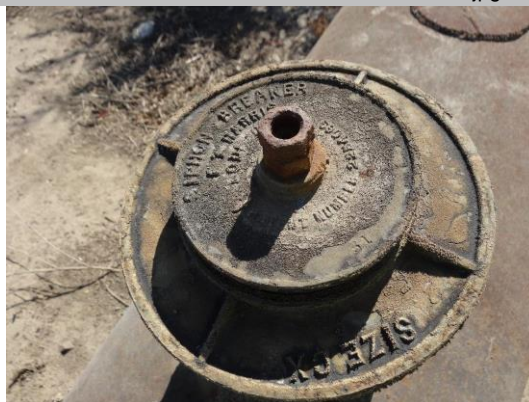
Photo 2 of 3 : UCIP_SP_2017_23304_40146.jpg

WS view: leaky siphon breaker on levee slope.

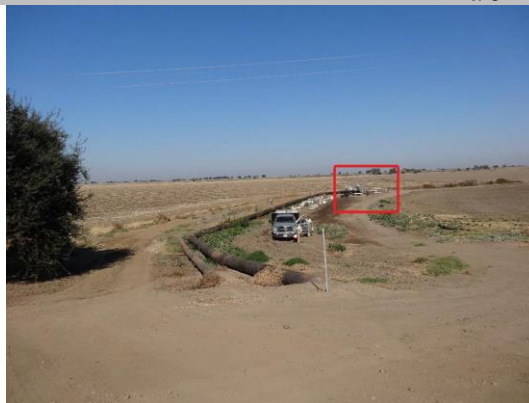
Photo 3 of 3 : UCIP_SP_2017_23304_40148.jpg

LM Start	3.24	Rating **	M	Issue No.	17 (cont)	
LM End	3.24	Issue Type +	En	Location *	WS	
Category	Supplemental			GPS Latitude/Longitude		
				Start		End
Item	DWR UCIP Field Study			37.804770 °		37.804770 °
				-121.379679 °		-121.379679 °
DWR ID						
Comment Code						
Inspector Comment						
FS_ID:23304 DS_ID:19199 EP_NO: 11524 Repair Type: Non-Urgent Crossing Status: Found UCIP Comments: - waterside pipe immersed into channel water.- most of the pipe on landside exposed and siphon breaker on waterside not protected. FIELD_STRUCT_DESC: 1 of 3: One of 2x24-inch pipes through the levee 2.0 feet below the crown. 18-inch pipe through the levee 4.0 feet below the crown. Siphon breakers on waterward slope. Pump on steel platform in drainage ditch, 350 ft. from levee center off the the landward berm. (App. No. 11524) FS Date: 10/22/2013

LS view: overview of pipes on levee berm and pump platform (marked - right) off the berm 350 ft from the levee.

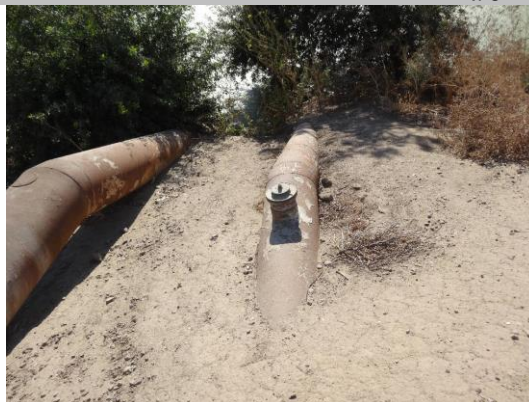
Photo 1 of 3 : UCIP_SP_2017_23023_39082.jpg

LM Start	3.24	Rating **	M	Issue No.	18
LM End	3.24	Issue Type +	En	Location *	WS
Category	Supplemental			GPS Latitude/Longitude	
				Start	End
Item	DWR UCIP Field Study			37.804777 °	37.804777 °
				-121.379704 °	-121.379704 °
DWR ID					
Comment Code					
Inspector Comment					
FS_ID:23023 DS_ID:19198 EP_NO: 11524 Repair Type: Non-Urgent Crossing Status: Found UCIP Comments: - 18-inch pipe bifurcated near the pump and two gate valves installed.- waterside pipe immersed into channel water.- most of the pipe on landside exposed and siphon breaker on waterside not protected. FIELD_STRUCT_DESC: 2 of 3: 18-inch pipe through the levee 4.0 feet below the crown. 2x24-inch pipes through the levee 2.0 feet below the crown. Siphon breakers on waterward slope. Pump on steel platform in drainage ditch, 350 ft. from levee center off the the landward berm. (App. No. 11524) FS Date: 10/22/2013

WS view: exposed 18-inch pipe with siphon breaker on levee slope.
Exposed 24-inch pipe (left).

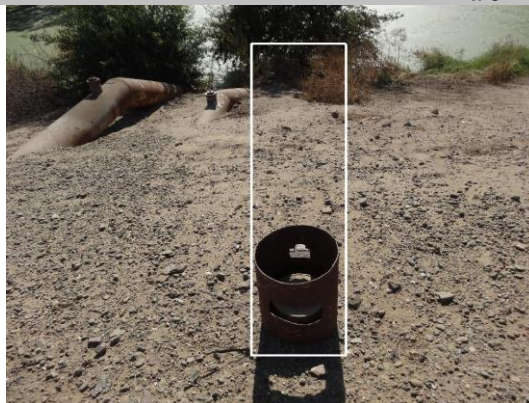
Photo 1 of 3 : UCIP_SP_2017_23305_40153.jpg

LM Start	3.24	Rating **	M	Issue No.	19
LM End	3.24	Issue Type +	En	Location *	WS
Category	Supplemental			GPS Latitude/Longitude	
				Start	End
Item	DWR UCIP Field Study			37.804787 °	37.804787 °
				-121.379734 °	-121.379734 °
DWR ID					
Comment Code					
Inspector Comment					
FS_ID:23305					
DS_ID:19195					
EP_NO: 11524					
Repair Type: Non-Urgent					
Crossing Status: Found					
UCIP Comments: - no associated pump or any other appurtenances found on landside.- looks abandoned pipe. Needs proper abandonment.					
FIELD_STRUCT_DESC: 3 of 3: One of 2x24-inch pipe through the levee 2.0 feet below the crown. 18-inch pipe through the levee 4.0 feet below the crown. Siphon breakers on waterward slope. (App. No. 11524)					
FS Date: 10/22/2013

WS view: siphon breaker in steel pipe riser on levee slope.

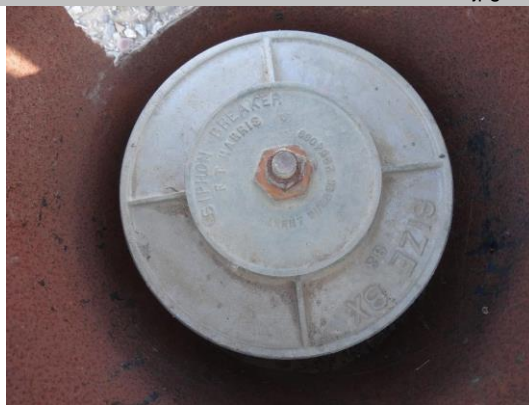
Photo 2 of 3 : UCIP_SP_2017_23305_40152.jpg

WS view: closer view of siphon breaker in steel pipe riser on levee slope.

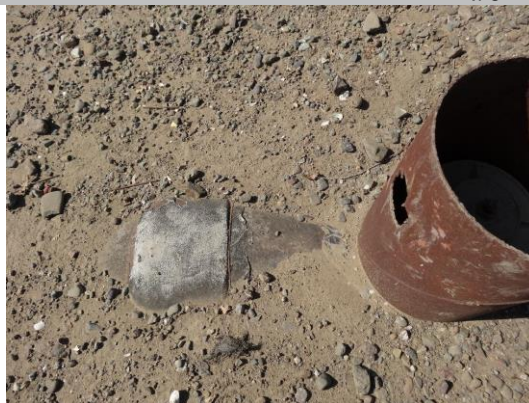
Photo 3 of 3 : UCIP_SP_2017_23305_40151.jpg

WS view: exposed pipe and steel pipe riser on levee slope.

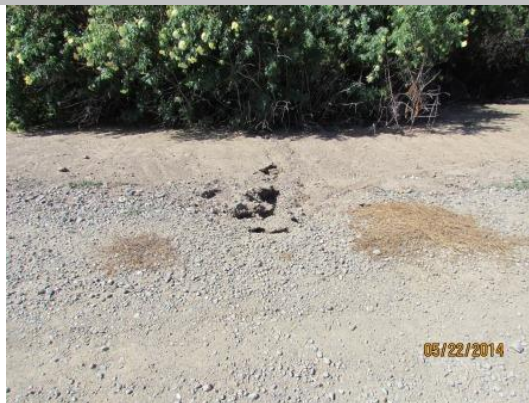
Photo 1 of 1 : SP_2017_RD2062_310_8_20170313_00001.jpg

View of the erosion from surface runoff on the waterside levee slope.

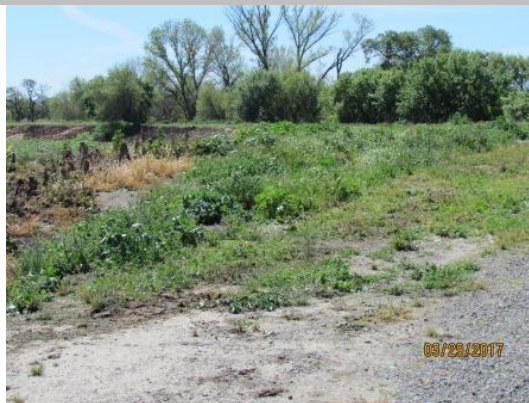
Photo 1 of 1 : SP_2017_RD2062_310_10_20170405_00026.jpg

View of the vegetation on the levee slope.

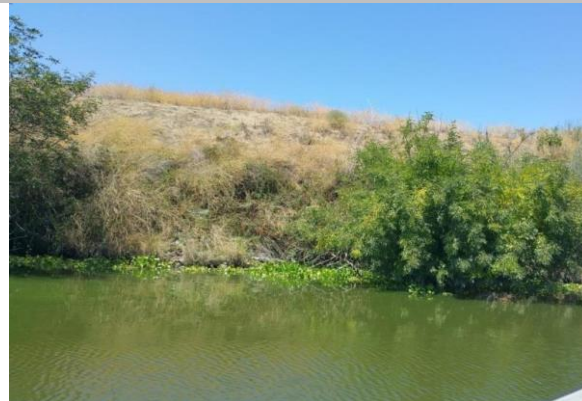
Photo 1 of 2 : SP_2017_RD2062_311_1_20170313_00001.jpg

Front view of the erosion.

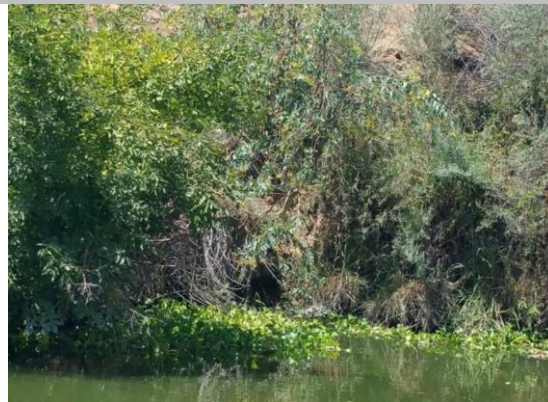
Photo 2 of 2 : SP_2017_RD2062_311_1_20170313_00002.jpg

Close view of the erosion.

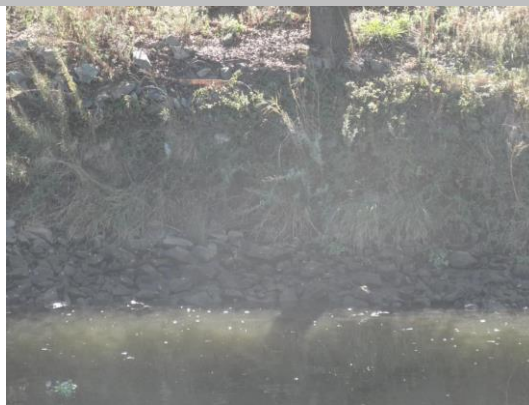
Photo 2 of 2 : SP_2017_RD2062_311_2_20170313_00004.jpg

Close view of the erosion.

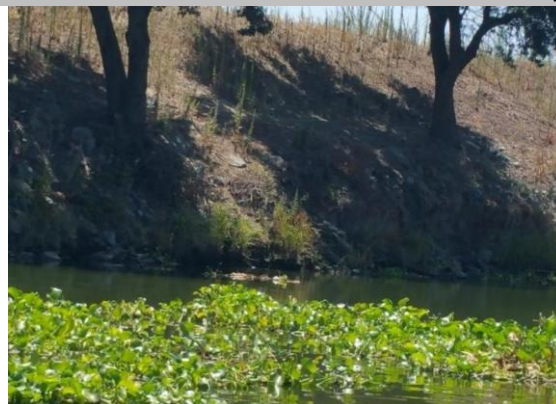
Photo 2 of 2 : SP_2017_RD2062_311_4_20170313_00006.jpg

Close view of the site. Note vegetation at the site.

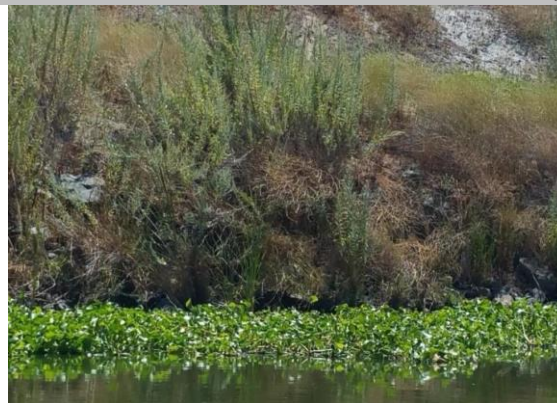
Photo 2 of 2 : SP_2017_RD2062_311_5_20170313_00008.jpg

Close view of the erosion.

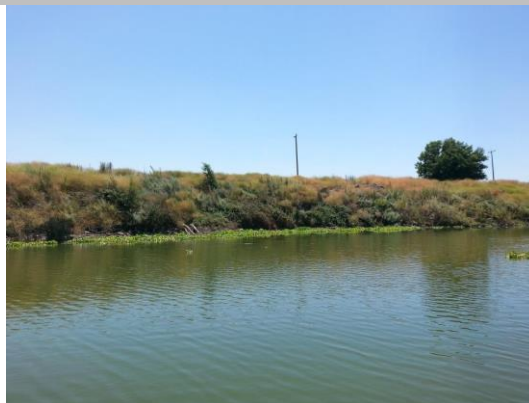
Photo 1 of 3 : SP_2017_RD2062_311_9_20170313_00011.jpg

Front view of the erosion.

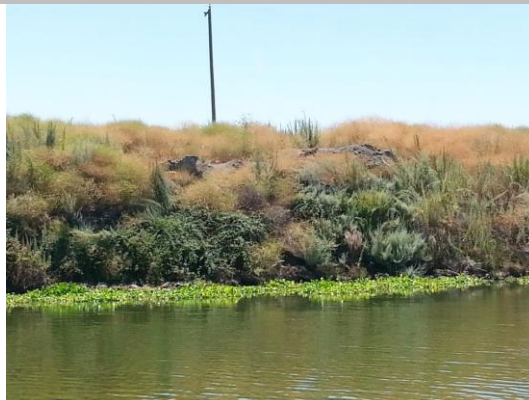
Photo 2 of 3 : SP_2017_RD2062_311_9_20170313_00012.jpg

Close view of the site. Note the dense vegetation at the site.

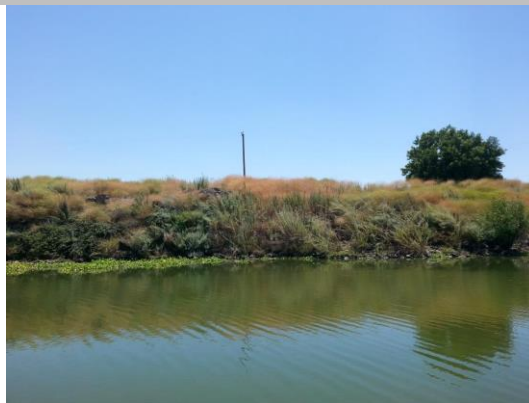
Photo 3 of 3 : SP_2017_RD2062_311_9_20170313_00013.jpg

Front view of the erosion.

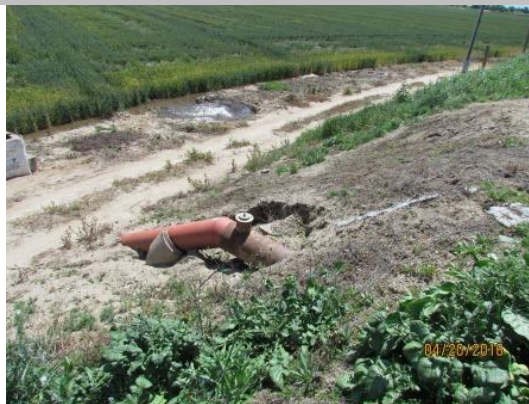
Photo 1 of 1 : SP_2017_RD2062_311_38_20170313_00023.jpg

View of the landside levee slope erosion around the pipe.

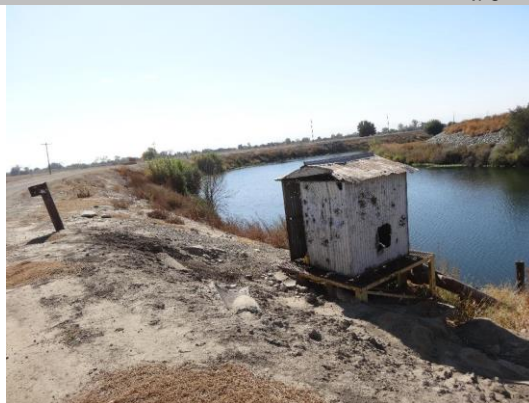
Photo 1 of 3 : UCIP_SP_2017_50455_40158.jpg

WS view: pump house on levee slope and soil erosion on levee slope.

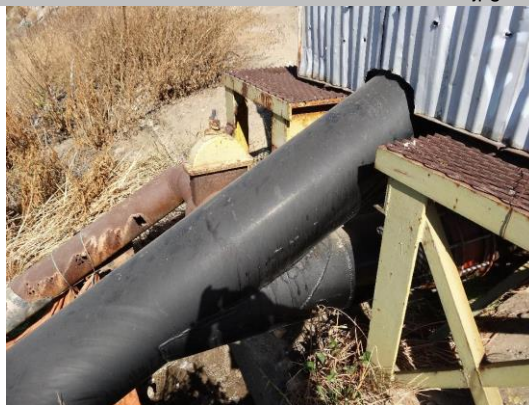
Photo 2 of 3 : UCIP_SP_2017_50455_40157.jpg

WS view: pump house on levee slope and holes-pits on corroded overflow pipe (left).

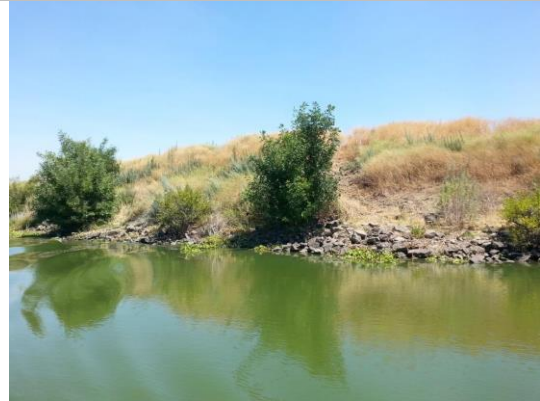
Photo 1 of 2 : SP_2017_RD2062_311_13_20170313_00014.jpg

Front view of the site. Previously placed rip rap slipped, exposing the underlying soils and creating a pocket.

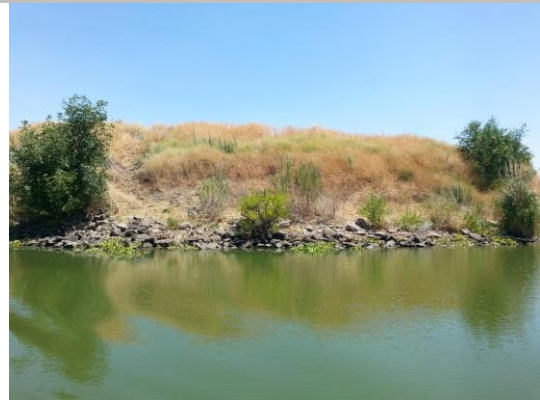
Photo 2 of 2 : SP_2017_RD2062_311_13_20170313_00015.jpg

Front view of the site. Rip rap is no longer adequately protecting levee slope.

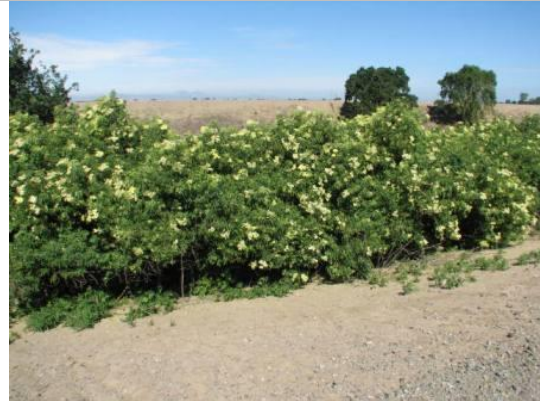
Photo 1 of 1 : SP_2017_RD2062_311_18_20170313_00017.jpg

05/11/2011 Elderberry bush on water side slope.

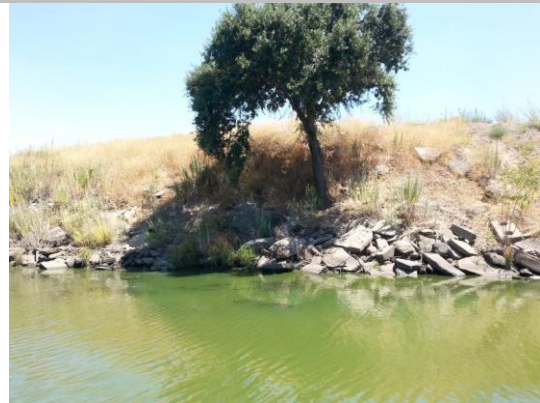
Photo 1 of 2 : SP_2017_RD2062_311_43_20170313_00027.jpg

Front view of the erosion site.

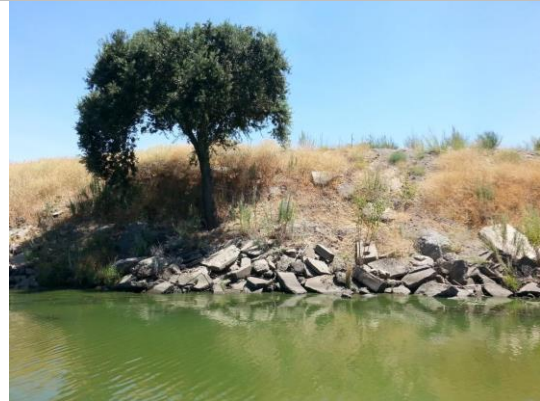
Photo 2 of 2 : SP_2017_RD2062_311_43_20170313_00028.jpg

Front view of the site. Note the existing broken concrete on the upper levee slope as well as on the lower slope and at the toe.

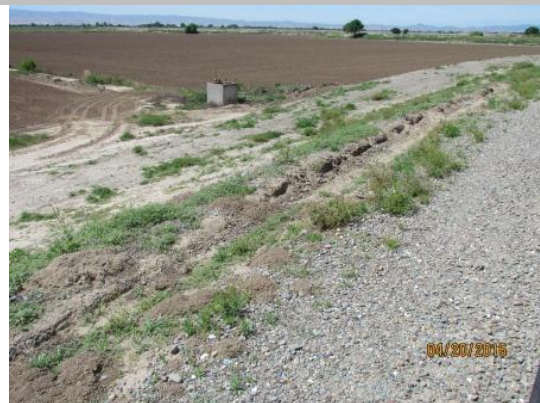
Photo 1 of 1 : SP_2017_RD2062_311_29_20170313_00018.jpg

View of a tire rut on the landside levee hinge.

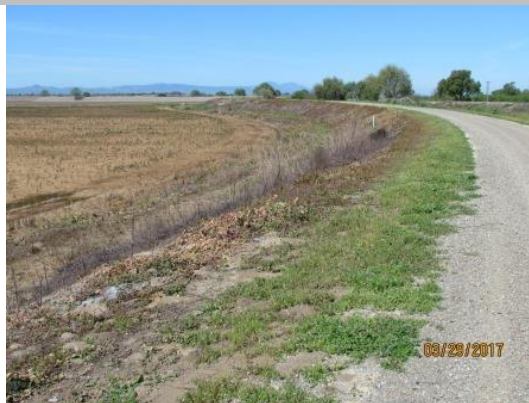
Photo 1 of 1 : SP_2017_RD2062_311_41_20170405_00047.jpg

View of the vegetation on the landside levee slope.

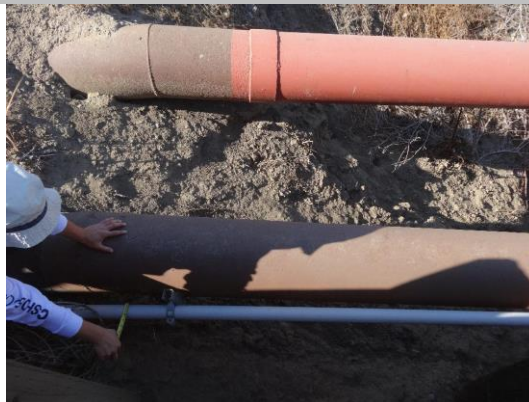
Photo 2 of 3 : UCIP_SP_2017_23311_40174.jpg

WS view: exposed steel pipes and an electric conduit on levee slope.

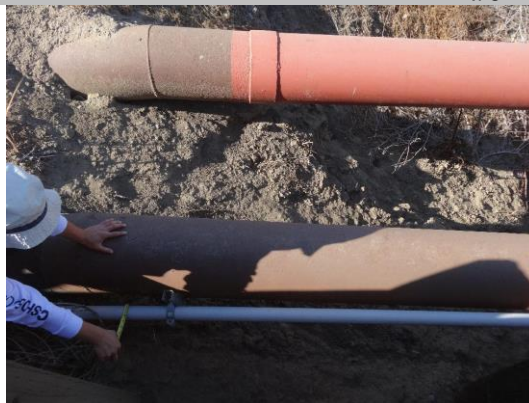
Photo 2 of 3 : UCIP_SP_2017_23312_40179.jpg

WS view: exposed steel pipes and a electric conduit on levee slope.

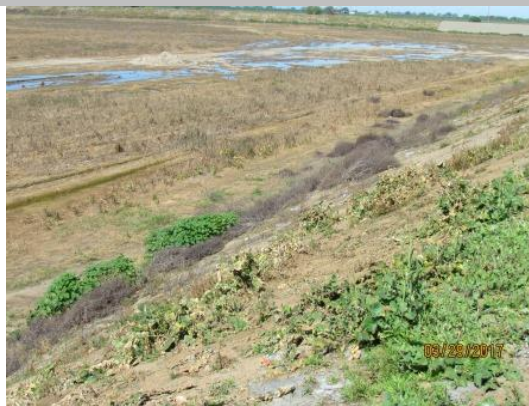
Photo 1 of 1 : SP_2017_RD2062_311_39_20170405_00045.jpg

View of the vegetation at the landside levee toe.

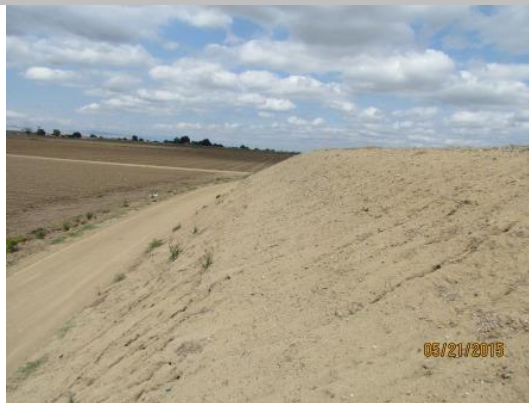
Photo 1 of 1 : SP_2017_RD2062_311_31_20170313_00019.jpg

View of the eroded landside levee toe.

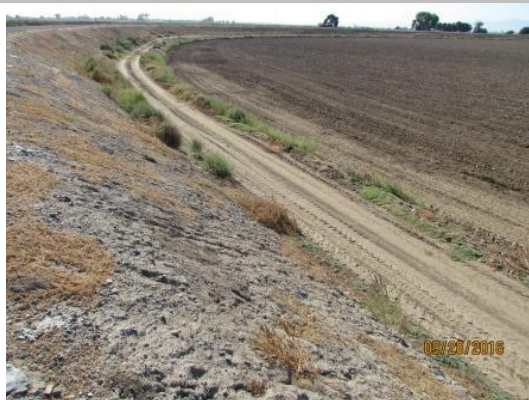
Photo 1 of 1 : SP_2017_RD2062_311_37_20170313_00022.jpg

View of the toe road encroaching into the levee prism.

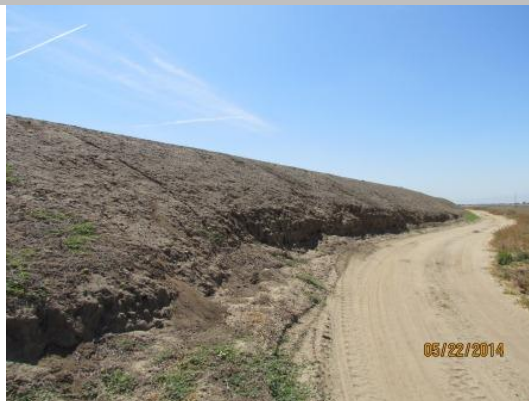
Photo 1 of 1 : SP_2017_RD2062_311_35_20170313_00020.jpg

View of a 2-3 feet vertical cut at the landside levee toe.

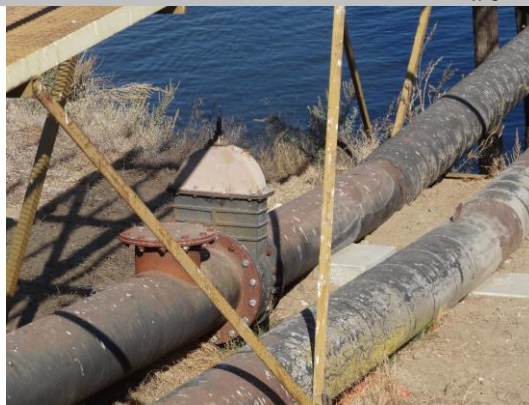
Photo 2 of 3 : UCIP_SP_2017_23142_39548.jpg

WS view: two 16-inch pipes under walkway. Gate valve without handle on one of the pipes.
