**Flood Control Project Maintenance  
Levee Inspections**  
**LMA District Cover Sheet**  
**Spring 2018 Levee Inspection Results**

**Reclamation District No. 2062 Stewart**

**Levee Inspection Report By Mile - Spring 2018**

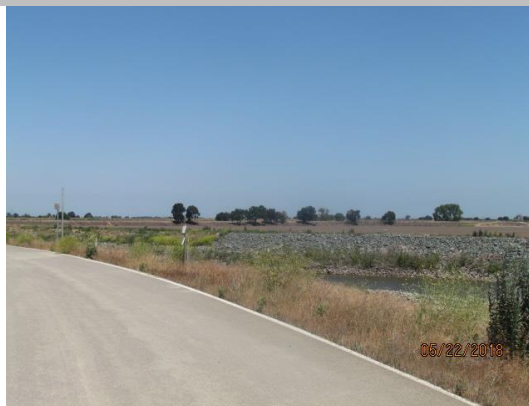
Photo 1 of 1 : SP\_2018\_RD2062\_309\_7\_20180523\_00010.jpg

Looking upstream at typical view of waterward slope.

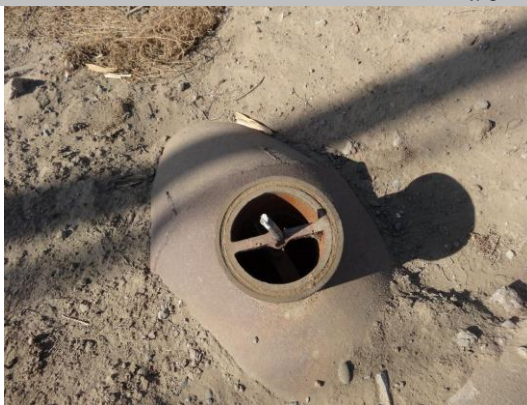
Photo 2 of 3 : UCIP\_SP\_2018\_23110\_39397.jpg

LM Start	0.56	Rating **	M	Issue No.	16	
LM End	0.56	Issue Type +	En	Location *		
Category	Supplemental			GPS Latitude/Longitude		
				Start	End	
Item	DWR UCIP Field Study			37.784380 °	37.784380 °	
				-121.338985 °	-121.338985 °	
DWR ID						
Comment Code						
Inspector Comment						
FS_ID:23110						
DS_ID:24697						
EP_NO: N/A						
Repair Type: Non-Urgent						
Crossing Status: Found						
UCIP Comments: Found on field with the help of USACE 2012 PI						
Report.Needs proper abandonment.						
FIELD_STRUCT_DESC: *ABANDONED* 24-inch steel irrigation						
discharge pipe through the levee, at an unknown depth. Damaged						
siphon breaker on the waterside (WS) slope. Pump on a concrete sump						
in an irrigation ditch on the landside (LS). Service pole on the LS slope.						
Pump disconnected from the service pole.						
FS Date: 10/23/2013

WS view: exposed steel pipe and damaged siphon breaker on levee slope.

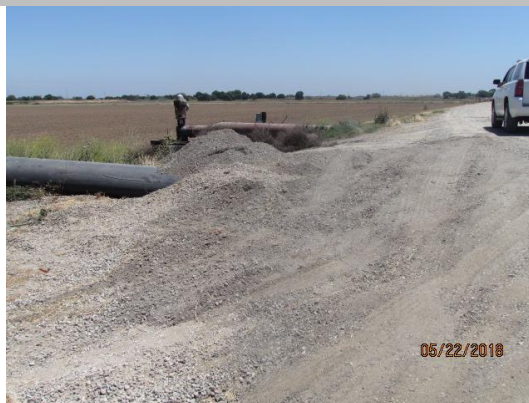
Photo 4 of 4 : SP\_2018\_RD2062\_310\_15\_20180523\_00029.jpg

LM Start	<b>0.57</b>	Rating **	U	Issue No.	<b>15 (cont)</b>
LM End	<b>0.57</b>	Issue Type +	En	Location *	CR

Looking south at ramp on levee crown. (Spring 2018)

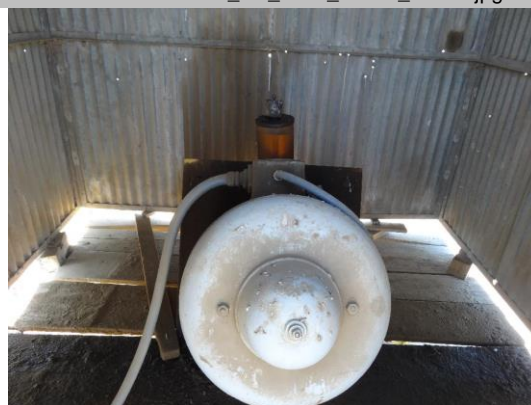
Photo 2 of 3 : UCIP\_SP\_2018\_23181\_39791.jpg

FS\_ID:23181  
DS\_ID:19192  
EP\_NO: 12427  
Repair Type: Non-Urgent  
Crossing Status: Found  
UCIP Comments: - no siphon breaker found- levee toe erosion under walkway on waterside.- erosion around concrete standpipe on landside- may be base of the standpipe was leaking.  
FIELD\_STRUCT\_DESC: 18-inch irrigation discharge pipe of an unknown material through the levee, 4.4 feet below the crown. Pump house on the waterside (WS) slope. Metal walkway from the pump house to the crown. Service pole on the WS. Flap gate, siphon breaker, and concrete distribution box on the landside (LS) slope. (Emergency plans to replace an existing 18-inch discharge pipe through the levee authorized under Permit No. 12427, 1978 - Reclamation District No. 2062). [Additional Reference(s): DWR Levee Log, 2007, 16-inch pipe referenced. USACE San Joaquin O&M Manual 9, April 1964, (HLM 0.76)].  
FS Date: 10/23/2013

WS view: leaky slant pump in pumphouse on levee slope.

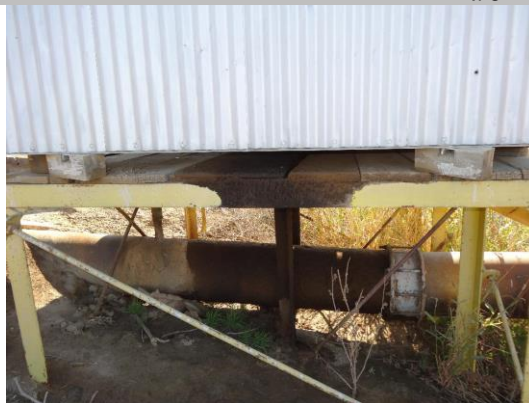
Photo 3 of 3 : UCIP\_SP\_2018\_23181\_39790.jpg

Comment Code						
Inspector Comment						
FS_ID:23181 DS_ID:19192 EP_NO: 12427 Repair Type: Non-Urgent Crossing Status: Found UCIP Comments: - no siphon breaker found- levee toe erosion under walkway on waterside.- erosion around concrete standpipe on landside- may be base of the standpipe was leaking. FIELD_STRUCT_DESC: 18-inch irrigation discharge pipe of an unknown material through the levee, 4.4 feet below the crown. Pump house on the waterside (WS) slope. Metal walkway from the pump house to the crown. Service pole on the WS. Flap gate, siphon breaker, and concrete distribution box on the landside (LS) slope. (Emergency plans to replace an existing 18-inch discharge pipe through the levee authorized under Permit No. 12427, 1978 - Reclamation District No. 2062). [Additional Reference(s): DWR Levee Log, 2007, 16-inch pipe referenced. USACE San Joaquin O&M Manual 9, April 1964, (HLM 0.76)]. FS Date: 10/23/2013

WS view: oil leakage from slant pump. Pipe under pump house.

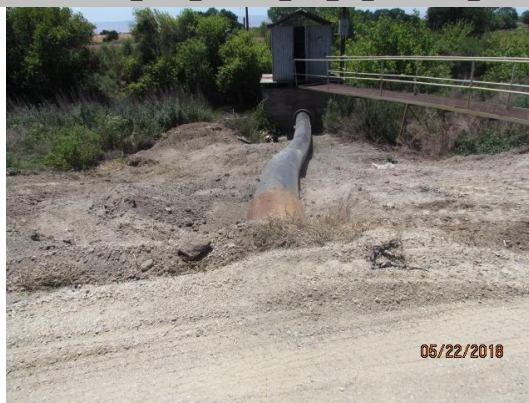
Photo 1 of 4 : SP\_2018\_RD2062\_310\_14\_20180523\_00031.jpg

Looking east at pumphouse and pipe on waterward slope. (Spring 2018)

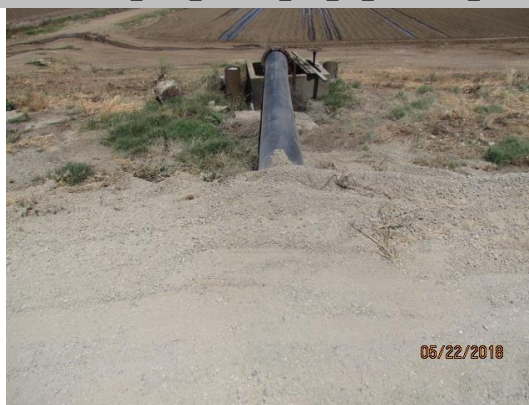
Photo 3 of 4 : SP\_2018\_RD2062\_310\_14\_20180523\_00030.jpg

Looking west at installation (pipe) on landward slope. (Spring 2018)

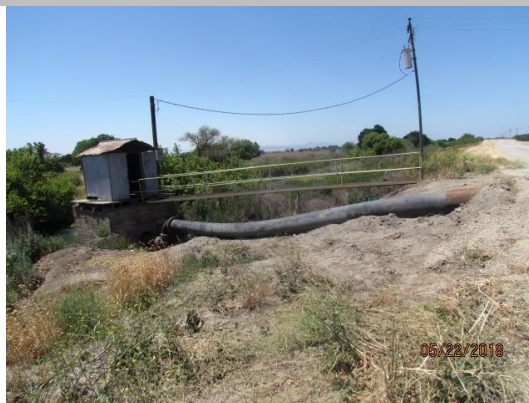
Photo 4 of 4 : SP\_2018\_RD2062\_310\_14\_20180523\_00033.jpg

LM Start	<b>1.37</b>	Rating **	U	Issue No.	<b>14 (cont)</b>
LM End	<b>1.37</b>	Issue Type +	Ma	Location *	CR

Looking south at installation (pipe) on waterward slope. (Spring 2018)

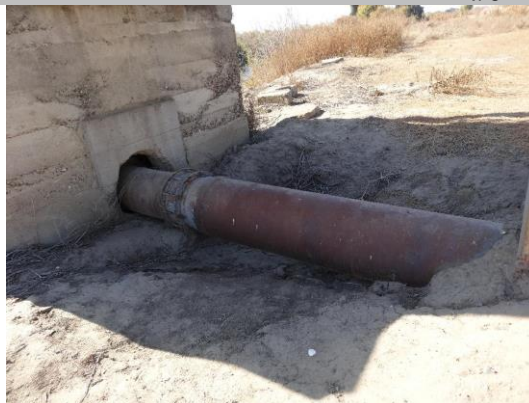
Photo 3 of 3 : UCIP\_SP\_2018\_51468\_39193.jpg

Comment Code						
Inspector Comment						
FS_ID:51468 DS_ID:19193 EP_NO: N/A Repair Type: Non-Urgent Crossing Status: Found UCIP Comments: 04/05/2017:Pipe has been plugged as a flood fight measure and is likely to be replaced under a permit. MBK (Michael Moncrief) is working on the permit. Photo and update courtesy of Max Khashchuk as part of his 2017 Spring Inspection. (K. Fazel - UCIP)10/22/2013:- pumphouse on concrete sump in the channel.- erosion under walkway on waterside. (P. Amatya - DWR) FIELD_STRUCT_DESC: 20-inch steel irrigation discharge pipe through the levee, 8 feet below the crown. Pump house on the waterside (WS) slope. Metal walkway from the pump house to the crown. Flap gate, siphon breaker, and concrete distribution box on the landside (LS) slope. [Additional Reference(s): DWR Levee Log, 2007, 18-inch pipe referenced. USACE San Joaquin O&M Manual 9, April 1964, (HLM 1.40), 18-inch pipe referenced]. FS Date: 4/6/2017

WS view: exposed steel pipe under walkway. Soil erosion under walkway. This may be due to leaky pipe joint.

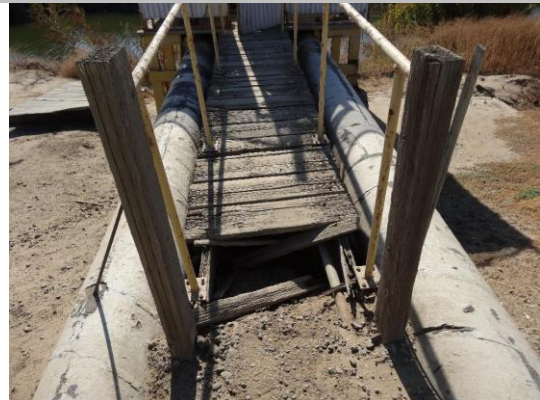
Photo 2 of 3 : UCIP\_SP\_2018\_50452\_39186.jpg

WS view: walkway to pumphouse. Walkway in poor condition.

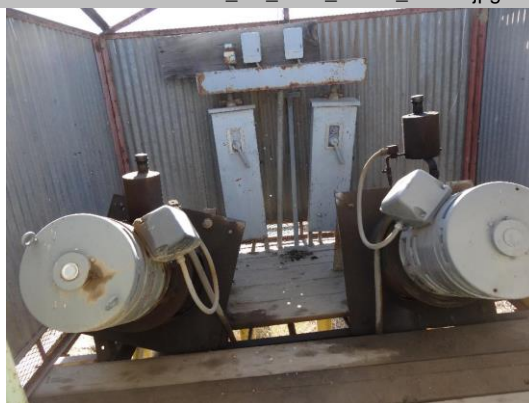
Photo 3 of 3 : UCIP\_SP\_2018\_50454\_39174.jpg

Comment Code						
Inspector Comment						
FS_ID:50454						
DS_ID:19197						
EP_NO: 4305						
Repair Type: Urgent						
Crossing Status: Found						
UCIP Comments: 08/31/2016: Heavy sloughing and sink hole remains at the WS slope in alignment with pipes. Though sloughing is not affecting levee prism, it is still an indication of a pipe integrity problem. Oil leak at the pump but does not appear to impact levee. (K. Fazel - UCIP)10/22/2013:- missing roof in pump house.- no protection for siphon breaker- huge erosion under pumphouse and levee slope on waterside. (P. Amatya - DWR)						
FIELD_STRUCT_DESC: 2 of 2: 18-inch steel irrigation discharge pipe through the levee, 4.8 feet below the crown. Pump house on the waterside (WS) slope. Siphon breaker on the landside (LS) shoulder. Service pole on the LS shoulder. Concrete distribution box at the LS toe. (Plans for installation of two irrigation pumps on the bank to replace an old centrifugal pumping plant at the same location authorized under Permit No. 4305, 1963 - Reclamation District No. 2062) [Additional Reference(s): DWR Levee Log, 2007. USACE San Joaquin O&M Manual 9, April 1964, (HLM 1.67)].

WS view: two leaky slant pumps in pumphouse with missing roof.

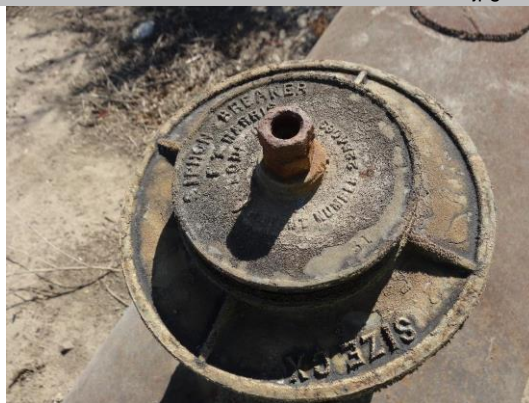
Photo 2 of 3 : UCIP\_SP\_2018\_23304\_40146.jpg

Comment Code					
Inspector Comment					
FS_ID:23304 DS_ID:19199 EP_NO: 11524 Repair Type: Non-Urgent Crossing Status: Found UCIP Comments: - waterside pipe immersed into channel water.- most of the pipe on landside exposed and siphon breaker on waterside not protected. FIELD_STRUCT_DESC: 1 of 3: 24-inch coated steel drainage discharge pipe through the levee, 2 feet below the crown. Siphon breaker on the waterside (WS) slope. Pump on a steel platform in a drainage ditch, 350 feet from the levee centerline off the landward berm. (Plans to install a drainage pump and 24-inch discharge line through the levee at existing main drainage pump authorized under Permit No. 11524, 1976 - Reclamation District No. 2062). [Additional Reference(s): DWR Levee Log, 2007. USACE San Joaquin O&M Manual 9, April 1964, (HLM 3.29)]. FS Date: 10/22/2013

WS view: leaky siphon breaker on levee slope.

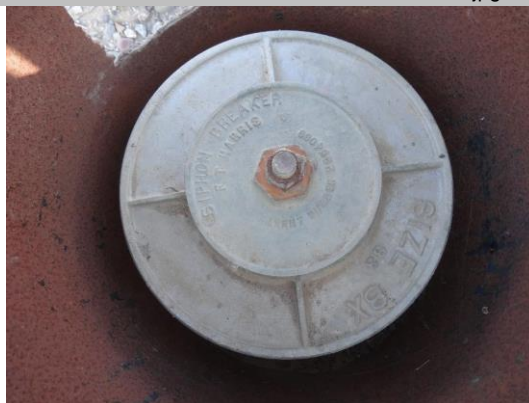
Photo 2 of 3 : UCIP\_SP\_2018\_23305\_40152.jpg

WS view: closer view of siphon breaker in steel pipe riser on levee slope.

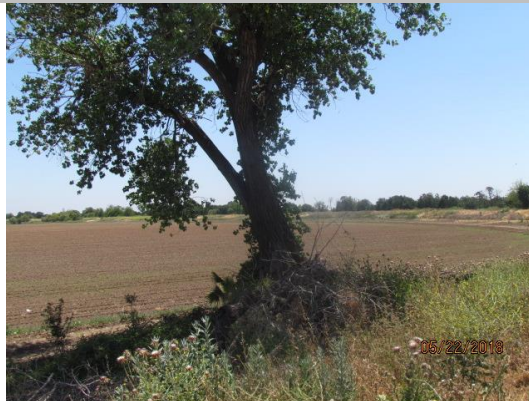
Photo 1 of 1 : SP\_2018\_RD2062\_310\_12\_20180523\_00034.jpg

Looking at broken tree branch on landward slope. (Spring 2018)

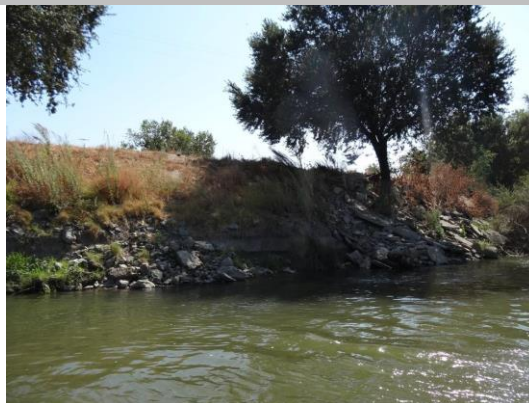
Photo 1 of 4 : SP\_2018\_RD2062\_311\_1\_20180503\_00001.jpg

Front view of the erosion site. Note the large tree above the erosion.

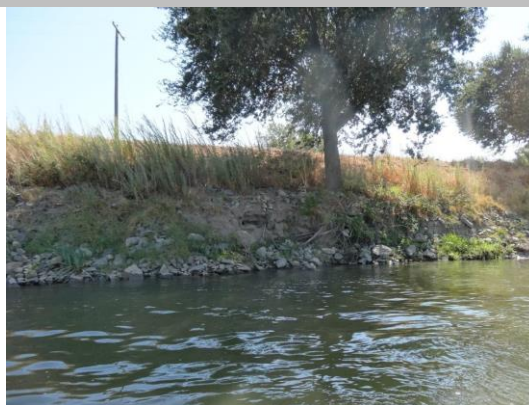
Photo 2 of 4 : SP\_2018\_RD2062\_311\_1\_20180503\_00002.jpg

Close view of the erosion.

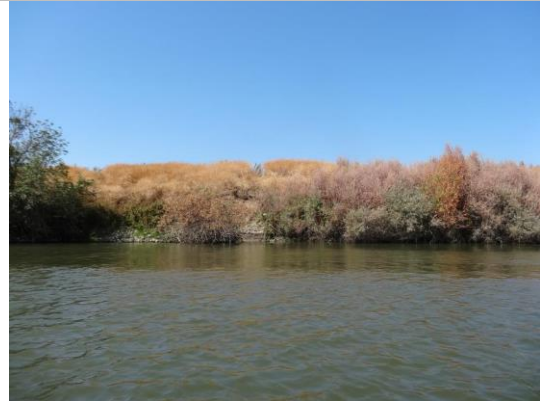
Photo 4 of 4 : SP\_2018\_RD2062\_311\_1\_20180503\_00004.jpg

Close view of the erosion.

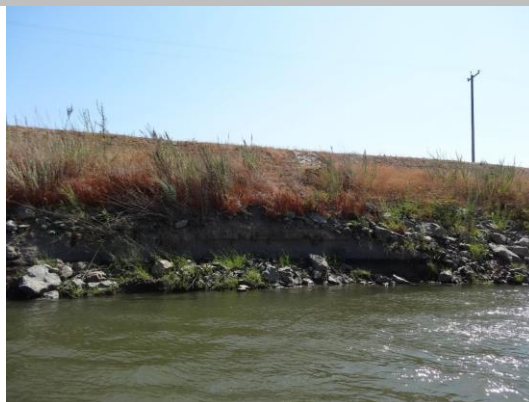
Photo 2 of 3 : SP\_2018\_RD2062\_311\_3\_20180503\_00010.jpg

Close view of the erosion.

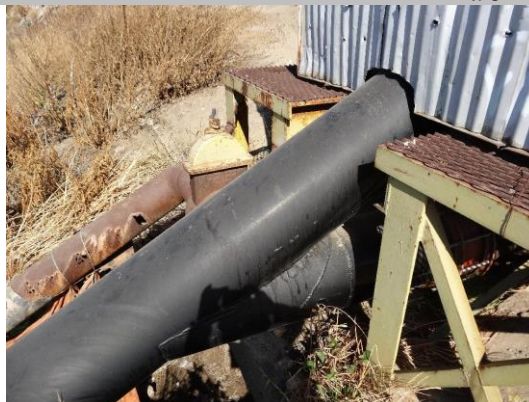
Photo 2 of 3 : UCIP\_SP\_2018\_50455\_40157.jpg

WS view: pump house on levee slope and holes-pits on corroded overflow pipe (left).

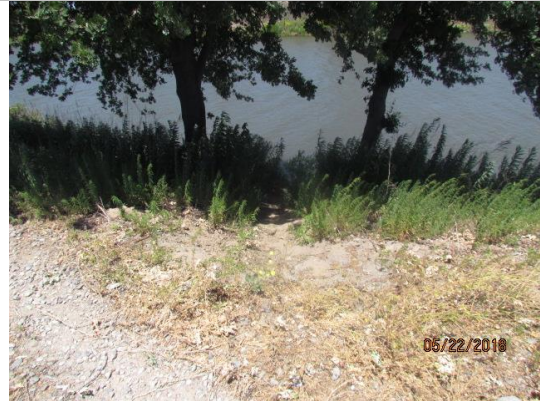
Photo 1 of 1 : SP\_2018\_RD2062\_311\_20\_20180523\_00053.jpg

Looking west at slope damage (foot traffic) on waterward slope. (Spring 2018)

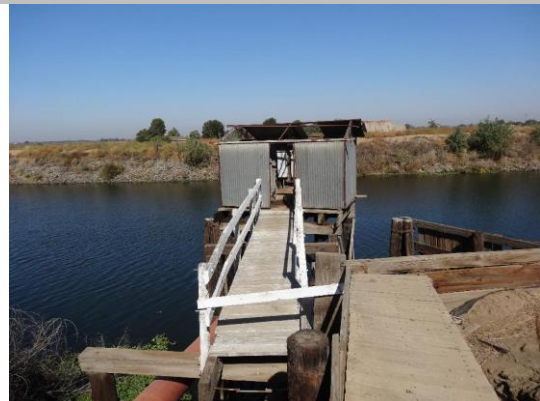
Photo 1 of 3 : UCIP\_SP\_2018\_23311\_40175.jpg

WS view: wooden walkway to pumphouse, pumphouse on wooden pile structure in the stream.

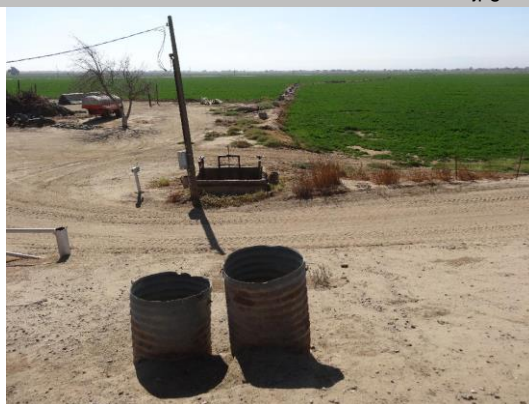
Photo 3 of 3 : UCIP\_SP\_2018\_23311\_40173.jpg

LS view: two CMP risers on levee slope, concrete distribution box, and service pole across the dirt road, off the levee toe.

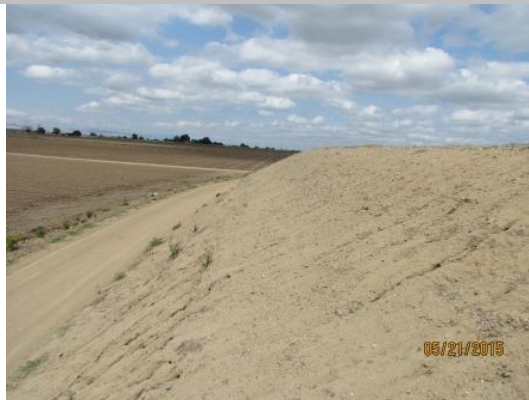
Photo 1 of 1 : SP\_2018\_RD2062\_311\_31\_20180503\_00033.jpg

View of the eroded landside levee toe.

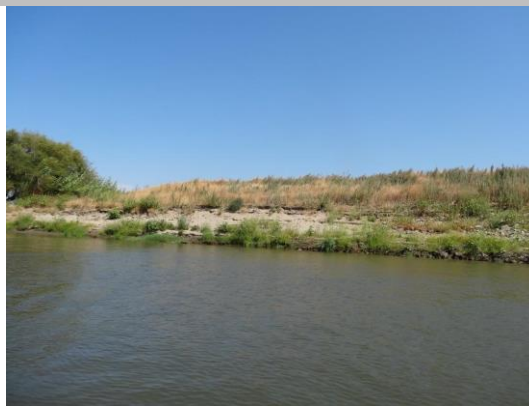
Photo 1 of 3 : SP\_2018\_RD2062\_311\_10\_20180503\_00029.jpg

Front view of the erosion located at the inside of a sharp river bend.

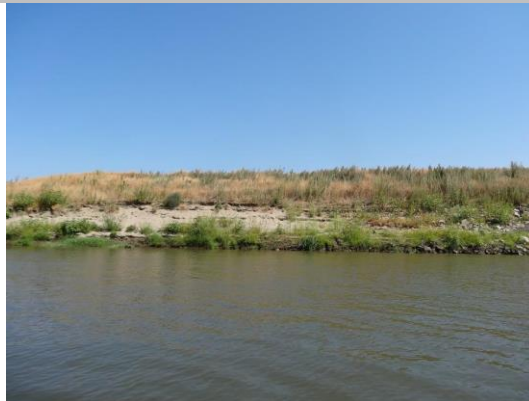
Photo 2 of 3 : SP\_2018\_RD2062\_311\_10\_20180503\_00030.jpg

Close view of the erosion.

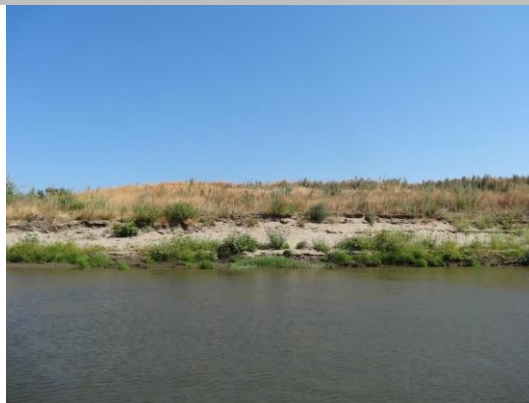
Photo 3 of 3 : SP\_2018\_RD2062\_311\_10\_20180503\_00031.jpg

Close view of the erosion. Note the sandy material of the river bank at the erosion site.

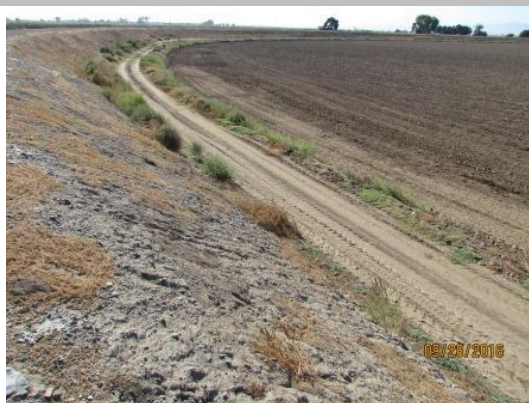
Photo 1 of 1 : SP\_2018\_RD2062\_311\_37\_20180503\_00035.jpg

View of the toe road encroaching into the levee prism.

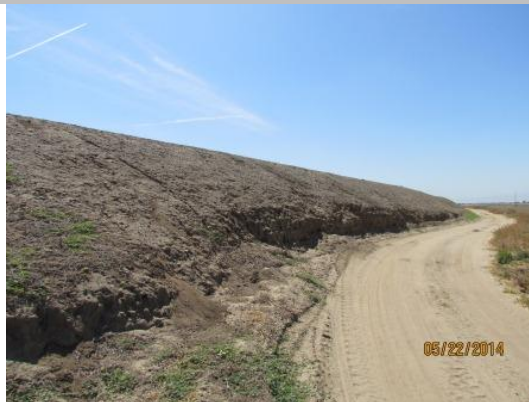
Photo 1 of 1 : SP\_2018\_RD2062\_311\_35\_20180503\_00034.jpg

View of a 2-3 feet vertical cut at the landside levee toe.

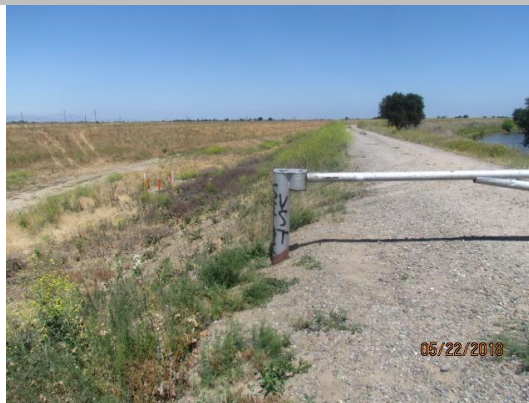
Photo 1 of 1 : SP\_2018\_RD2062\_311\_17\_20180523\_00054.jpg

Looking north at gate (lock mechanism) should be replace or fixed. (Spring 2018)

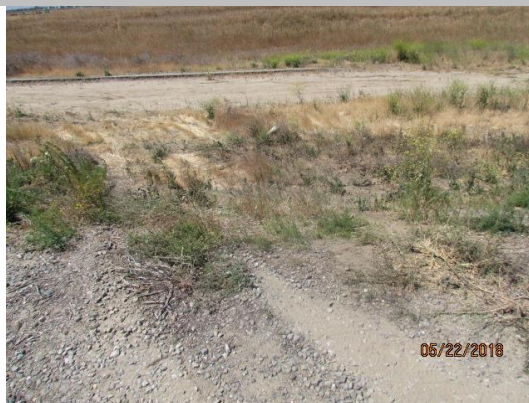
Photo 1 of 1 : SP\_2018\_RD2062\_311\_19\_20180523\_00055.jpg

Looking west slope damage due to vehicle traffic. (Spring 2018)
