**Flood Control Project Maintenance
Levee Inspections**
LMA District Cover Sheet
Spring 2019 Levee Inspection Results

Reclamation District No. 2062 Stewart

Spring 2019 Levee Inspection Results

Waterway			Bank	Unit Miles
Unit No. 01 San Joaquin River			Left	2.64
	Spring (March - May)	Summer (June - August)	(September - November) Fall	Winter (December - February)
Unit Maintenance Rating (Fall Only)				
Date of Inspection	5/21/2019 - 5/21/2019			
DWR Inspector	Alberto De Leon			
Accompanied By	Tim Mello RD2062

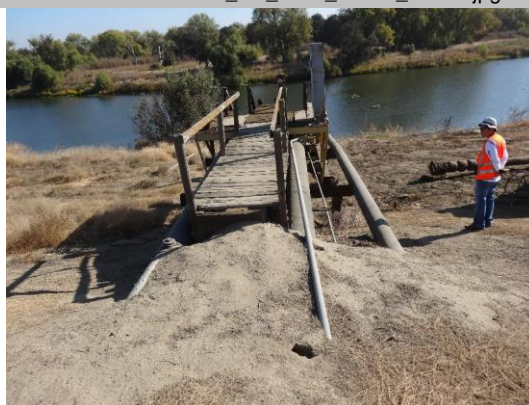
Photo 2 of 3 : UCIP_SP_2019_22807_38904.jpg

WS view: 16-inch pipes on both sides of walkway and 10-inch pipe (on right) away from walkway.

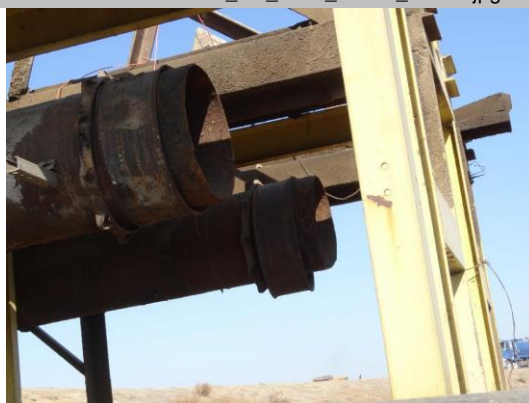
Photo 3 of 3 : UCIP_SP_2019_22807_38903.jpg

Comment Code						
Inspector Comment						
FS_ID:22807 DS_ID:19177 EP_NO: 12679 Repair Type: Non-Urgent Crossing Status: Found UCIP Comments: - All 3 pipes on landside looks new.- Pumps, pump house, and pipes removed from waterside.- Land development activities going on in this area.- Needs to confirm from LMA or DWR Inspector about the crossing. FIELD_STRUCT_DESC: 1 of 3: 16-inch steel irrigation discharge pipe through the levee, 5 feet below the crown. Electrical conduit through the levee. Slant pump in a pump house on the waterside (WS) slope. Siphon breaker on the landside (LS) slope. Service pole and concrete gate valve box at the landside (LS) toe. Installed by USACE in 1961. (Plans to replace rusted portions of two 16-inch irrigation pipes through the levee authorized under Permit No. 16124, 1993 - Reclamation District No. 2062). [Additional Reference(s): DWR Levee Log, 2007. USACE San Joaquin O&M Manual 9, April 1964, (HLM 1.65)]. FS Date: 10/22/2013

WS view: two 16-inch pipes. Pumps were removed. Pumphouse dismantled.

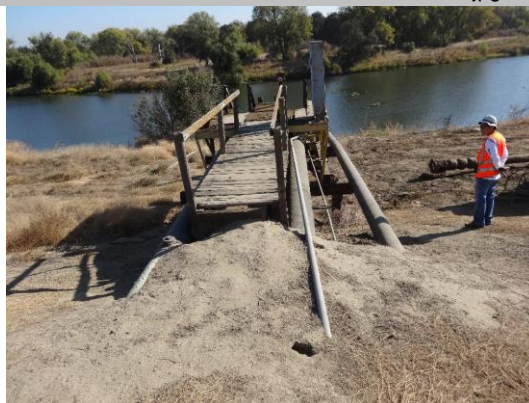
Photo 2 of 3 : UCIP_SP_2019_22809_38912.jpg

WS view: 16-inch pipes on both sides of walkway and 10-inch pipe (on right) away from walkway.

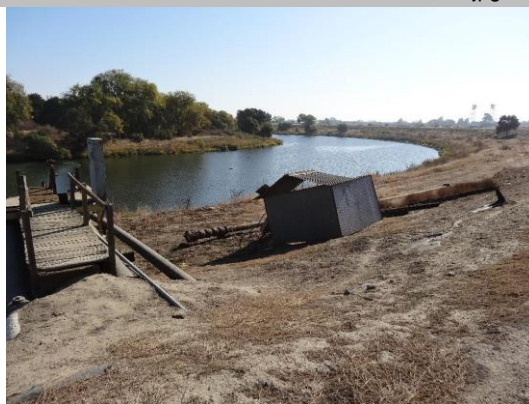
Photo 2 of 3 : UCIP_SP_2019_22810_38917.jpg

FS_ID:22810
DS_ID:19184
EP_NO: 12679
Repair Type: Non-Urgent
Crossing Status: Found
UCIP Comments: - All 3 pipes on landside looks new. No pump associated with 8-inch pipe.- Pumps, pump house, and pipes removed from waterside.- Land development activities going on in this area.- Needs to confirm from LMA or DWR Inspector about the crossing.
FIELD_STRUCT_DESC: 3 of 3: 8-inch steel irrigation discharge pipe through the levee, 8 feet below the crown. Electrical conduit through the levee. Slant pump in a pump house on the waterside (WS) slope. Siphon breaker on the landside (LS) slope. Service pole and concrete gate valve box at the landside (LS) toe. (Plans to install a 75-horsepower pump on the bank with a 10-inch steel discharge pipe through the levee authorized under Permit No. 12679, 1979 - Reclamation District No. 2062). [Additional Reference(s): DWR Levee Log, 2007].
FS Date: 10/22/2013

WS view: electric conduit and 10-inch pipe (right). Dismantled/removed pipe and pump house (far right).

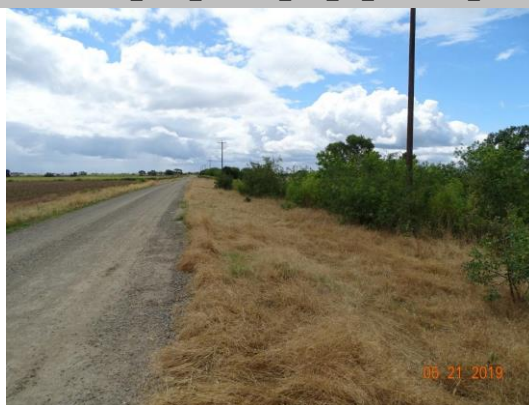
Photo 1 of 1 : SP_2019_RD2062_310_11_20190521_00037.jpg

Typical view of vegetation on waterside slope. (Spring 2019)

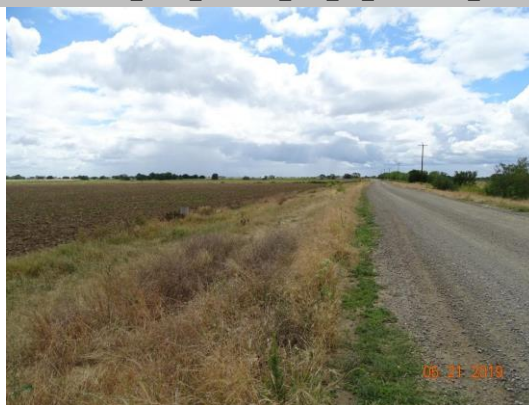
Photo 1 of 1 : SP_2019_RD2062_310_10_20190521_00038.jpg

LM Start	0.03	Rating **	M	Issue No.	10
LM End	3.93	Issue Type +	Ma	Location *	LS
Category	Earthen Levee			GPS Latitude/Longitude	
				Start	End
Item	Vegetation			37.778189 °	37.808790 °
				-121.333377 °	-121.390462 °
DWR ID	DWR_RD2062_02_s_2019_10				
Comment Code					
V1 : Control annual grass and weeds on the levee slopes and easements.					
Inspector Comment					
Annual vegetation is scheduled to be mowed in the month of June.

Typical view of vegetation on landside slope. (Spring 2019)

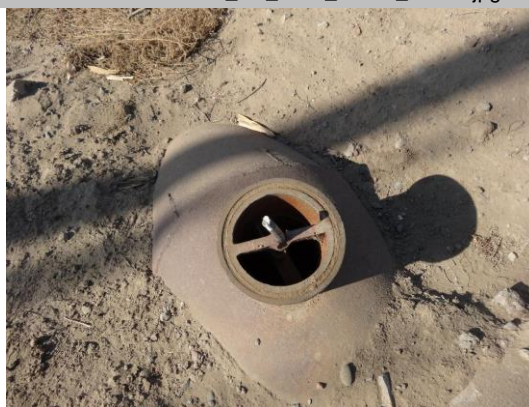
Photo 2 of 3 : UCIP_SP_2019_23110_39397.jpg

LM Start	0.56	Rating **	M	Issue No.	23	
LM End	0.56	Issue Type +	En	Location *		
Category	Supplemental			GPS Latitude/Longitude		
				Start	End	
Item	DWR UCIP Field Study			37.784380 °	37.784380 °	
				-121.338985 °	-121.338985 °	
DWR ID	24697					
Comment Code						
Inspector Comment						
FS_ID:23110						
DS_ID:24697						
EP_NO: N/A						
Repair Type: Non-Urgent						
Crossing Status: Found						
UCIP Comments: Found on field with the help of USACE 2012 PI						
Report.Needs proper abandonment.						
FIELD_STRUCT_DESC: *ABANDONED* 24-inch steel irrigation						
discharge pipe through the levee, at an unknown depth. Damaged						
siphon breaker on the waterside (WS) slope. Pump on a concrete sump						
in an irrigation ditch on the landside (LS). Service pole on the LS slope.						
Pump disconnected from the service pole.						
FS Date: 10/23/2013

WS view: exposed steel pipe and damaged siphon breaker on levee slope.

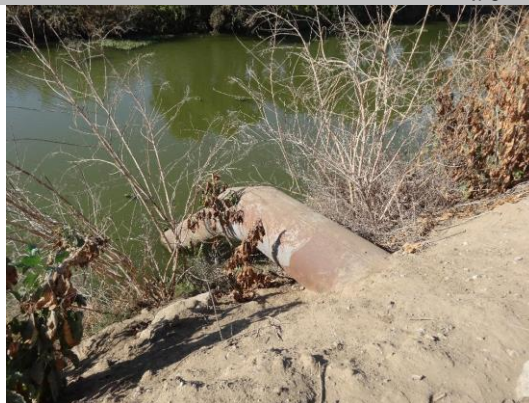
Photo 3 of 3 : UCIP_SP_2019_23110_39396.jpg

LM Start	0.56	Rating **	M	Issue No.	23 (cont)	
LM End	0.56	Issue Type +	En	Location *		
Category	Supplemental			GPS Latitude/Longitude		
				Start	End	
Item	DWR UCIP Field Study			37.784380 °	37.784380 °	
				-121.338985 °	-121.338985 °	
DWR ID	24697					
Comment Code						
Inspector Comment						
FS_ID:23110 DS_ID:24697 EP_NO: N/A Repair Type: Non-Urgent Crossing Status: Found UCIP Comments: Found on field with the help of USACE 2012 PI Report.Needs proper abandonment. FIELD_STRUCT_DESC: *ABANDONED* 24-inch steel irrigation discharge pipe through the levee, at an unknown depth. Damaged siphon breaker on the waterside (WS) slope. Pump on a concrete sump in an irrigation ditch on the landside (LS). Service pole on the LS slope. Pump disconnected from the service pole. FS Date: 10/23/2013

WS view: exposed steel pipe on channel bank and also immersed into channel water.

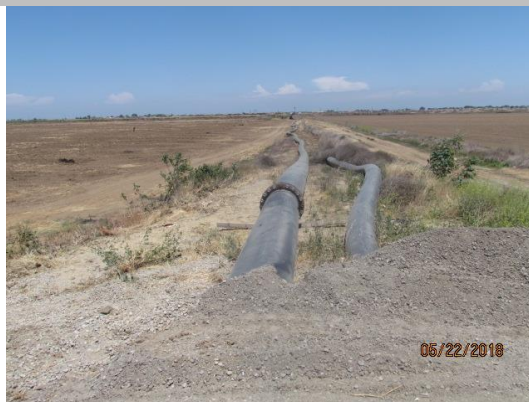
Photo 1 of 4 : SP_2019_RD2062_310_15_20190313_00008.jpg

LM Start	0.57	Rating **	U	Issue No.	15
LM End	0.57	Issue Type +	En	Location *	CR
Category	Interior Drainage & Piping Systems			GPS Latitude/Longitude	
				Start	End
Item	Encroachments			37.784488 °	37.784488 °
				-121.339098 °	-121.339098 °
DWR ID	DWR_RD2062_02_s_2018_15				
Comment Code					
Inspector Comment					
There is unauthorized pipe installation at this location.

Looking west at pipes on landward slope. (Spring 2018)

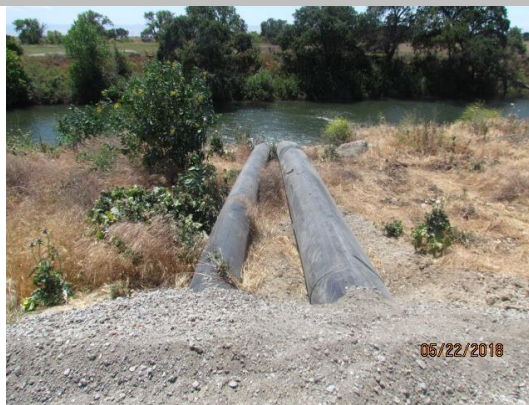
Photo 3 of 4 : SP_2019_RD2062_310_15_20190313_00010.jpg

Looking east at pipes on waterward slope. (Spring 2018)

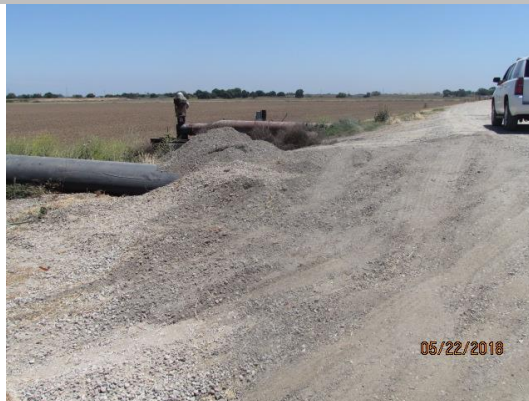
Photo 4 of 4 : SP_2019_RD2062_310_15_20190313_00011.jpg

LM Start	0.57	Rating **	U	Issue No.	15 (cont)
LM End	0.57	Issue Type +	En	Location *	CR

Looking south at ramp on levee crown. (Spring 2018)

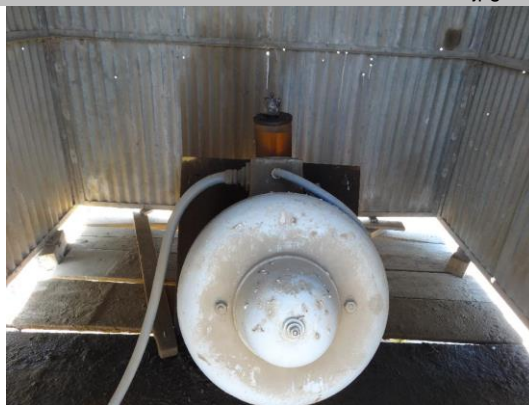
Photo 2 of 3 : UCIP_SP_2019_23181_39791.jpg

Comment Code						
Inspector Comment						
FS_ID:23181 DS_ID:19192 EP_NO: 12427 Repair Type: Non-Urgent Crossing Status: Found UCIP Comments: - no siphon breaker found- levee toe erosion under walkway on waterside.- erosion around concrete standpipe on landside- may be base of the standpipe was leaking. FIELD_STRUCT_DESC: 18-inch irrigation discharge pipe of an unknown material through the levee, 4.4 feet below the crown. Pump house on the waterside (WS) slope. Metal walkway from the pump house to the crown. Service pole on the WS. Flap gate, siphon breaker, and concrete distribution box on the landside (LS) slope. (Emergency plans to replace an existing 18-inch discharge pipe through the levee authorized under Permit No. 12427, 1978 - Reclamation District No. 2062). [Additional Reference(s): DWR Levee Log, 2007, 16-inch pipe referenced. USACE San Joaquin O&M Manual 9, April 1964, (HLM 0.76)]. FS Date: 10/23/2013

WS view: leaky slant pump in pumphouse on levee slope.

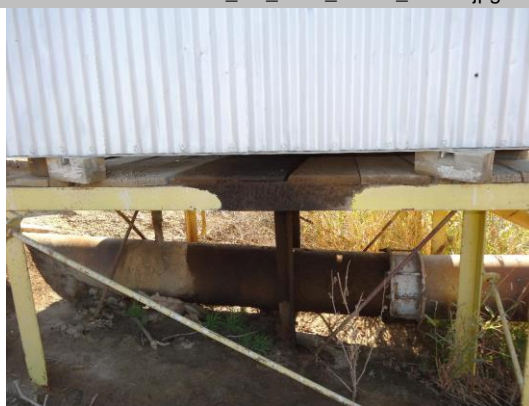
Photo 3 of 3 : UCIP_SP_2019_23181_39790.jpg

Comment Code						
Inspector Comment						
FS_ID:23181 DS_ID:19192 EP_NO: 12427 Repair Type: Non-Urgent Crossing Status: Found UCIP Comments: - no siphon breaker found- levee toe erosion under walkway on waterside.- erosion around concrete standpipe on landside- may be base of the standpipe was leaking. FIELD_STRUCT_DESC: 18-inch irrigation discharge pipe of an unknown material through the levee, 4.4 feet below the crown. Pump house on the waterside (WS) slope. Metal walkway from the pump house to the crown. Service pole on the WS. Flap gate, siphon breaker, and concrete distribution box on the landside (LS) slope. (Emergency plans to replace an existing 18-inch discharge pipe through the levee authorized under Permit No. 12427, 1978 - Reclamation District No. 2062). [Additional Reference(s): DWR Levee Log, 2007, 16-inch pipe referenced. USACE San Joaquin O&M Manual 9, April 1964, (HLM 0.76)]. FS Date: 10/23/2013

WS view: oil leakage from slant pump. Pipe under pump house.

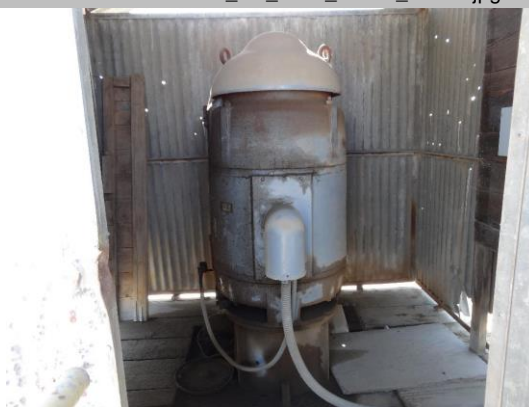
Photo 2 of 3 : UCIP_SP_2019_51468_39194.jpg

Comment Code						
Inspector Comment						
FS_ID:51468 DS_ID:19193 EP_NO: N/A Repair Type: Non-Urgent Crossing Status: Found UCIP Comments: 04/05/2017:Pipe has been plugged as a flood fight measure and is likely to be replaced under a permit. MBK (Michael Moncrief) is working on the permit. Photo and update courtesy of Max Khashchuk as part of his 2017 Spring Inspection. (K. Fazel - UCIP)10/22/2013:- pumphouse on concrete sump in the channel.- erosion under walkway on waterside. (P. Amatya - DWR) FIELD_STRUCT_DESC: 20-inch steel irrigation discharge pipe through the levee, 8 feet below the crown. Pump house on the waterside (WS) slope. Metal walkway from the pump house to the crown. Flap gate, siphon breaker, and concrete distribution box on the landside (LS) slope. [Additional Reference(s): DWR Levee Log, 2007, 18-inch pipe referenced. USACE San Joaquin O&M Manual 9, April 1964, (HLM 1.40), 18-inch pipe referenced]. FS Date: 4/6/2017

WS view: leaky pump and control box in pumphouse.

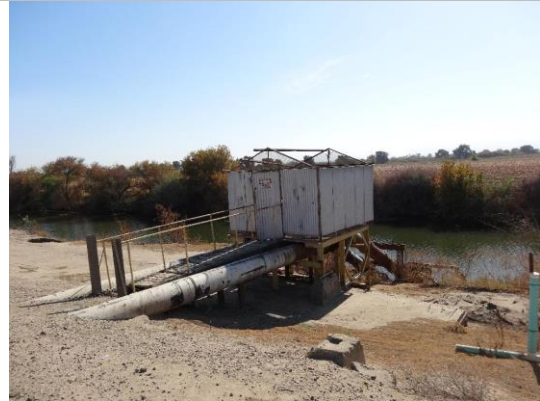
Photo 1 of 3 : UCIP_SP_2019_53375_39187.jpg

Comment Code						
Inspector Comment						
FS_ID:53375 DS_ID:19194 EP_NO: 4305 Repair Type: Urgent Crossing Status: Found UCIP Comments: 10/10/2018 Extremely overgrown vegetation did not allow visual inspection of WS levee erosion; however, there are indications based on vegetation growth patterns that the erosion is still present, so keeping crossing as Urgent (D. Sanoski - DWR UCIP).08/31/2016: Heavy sloughing and sink hole remains at the WS slope in alignment with pipe. Though sloughing is not affecting levee prism, it is still an indication of a pipe integrity problem. Oil leak at the pump but does not appear to impact the levee. (K. Fazel - UCIP)10/22/2013:- missing roof in pump house.- no protection for siphon breaker- huge erosion under pumphouse and levee slope on waterside. (P. Amatya - DWR) FIELD_STRUCT_DESC: 1 of 2: 18-inch steel irrigation discharge pipe through the levee, 4.8 feet below the crown. Pump house on the waterside (WS) slope. Siphon breaker on the landside (LS) shoulder. Service pole on the LS shoulder. Concrete distribution box at the LS toe. (Plans for installation of two irrigation pumps on the bank to replace an old centrifugal pumping plant at the same location authorized under Permit No. 4305, 1963 - Reclamation District No. 2062) [Additional Reference(s): DWR Levee Log, 2007. USACE San Joaquin O&M Manual 9, April 1964, (HLM 1.67)]. FS Date: 10/10/2018 11:02:00 AM

WS view: pipes, walkway, and pumphouse with missing roof (right).

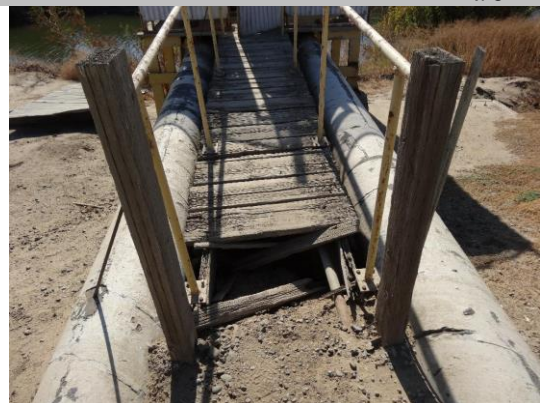
Photo 2 of 3 : UCIP_SP_2019_53375_39186.jpg

WS view: walkway to pumphouse. Walkway in poor condition.

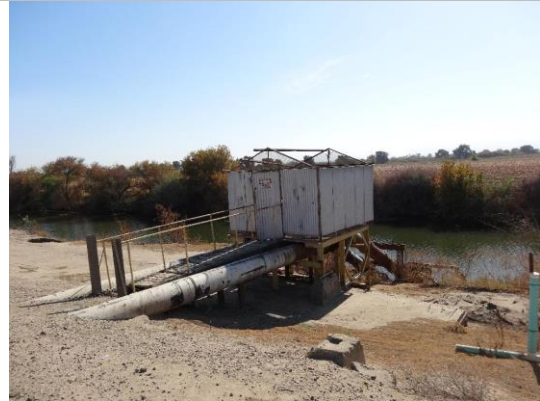
Photo 1 of 3 : UCIP_SP_2019_53376_39176.jpg

Comment Code						
Inspector Comment						
FS_ID:53376 DS_ID:19197 EP_NO: 4305 Repair Type: Urgent Crossing Status: Found UCIP Comments: 10/10/2018 Extremely overgrown vegetation did not allow visual inspection of WS levee erosion; however, there are indications based on vegetation growth patterns that the erosion is still present, so keeping crossing as Urgent (D. Sanoski - DWR UCIP).08/31/2016: Heavy sloughing and sink hole remains at the WS slope in alignment with pipes. Though sloughing is not affecting levee prism, it is still an indication of a pipe integrity problem. Oil leak at the pump but does not appear to impact levee. (K. Fazel - UCIP)10/22/2013:- missing roof in pump house.- no protection for siphon breaker- huge erosion under pumphouse and levee slope on waterside. (P. Amatya - DWR) FIELD_STRUCT_DESC: 2 of 2: 18-inch steel irrigation discharge pipe through the levee, 4.8 feet below the crown. Pump house on the waterside (WS) slope. Siphon breaker on the landside (LS) shoulder. Service pole on the LS shoulder. Concrete distribution box at the LS toe. (Plans for installation of two irrigation pumps on the bank to replace an old centrifugal pumping plant at the same location authorized under Permit No. 4305, 1963 - Reclamation District No. 2062) [Additional Reference(s): DWR Levee Log, 2007. USACE San Joaquin O&M Manual 9, April 1964, (HLM 1.67)]. FS Date: 10/10/2018 11:20:00 AM

WS view: pipes, walkway, and pumphouse with missing roof (right).

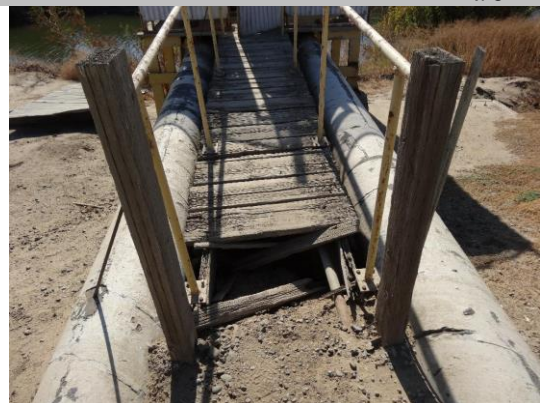
Photo 2 of 3 : UCIP_SP_2019_53376_39175.jpg

WS view: walkway in poor condition, to pumphouse.

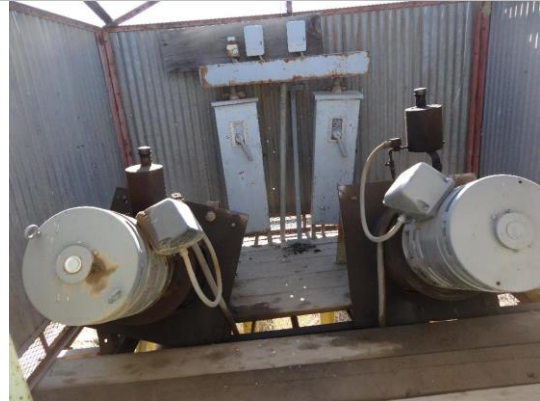
Photo 3 of 3 : UCIP_SP_2019_53376_39174.jpg

Comment Code						
Inspector Comment						
FS_ID:53376 DS_ID:19197 EP_NO: 4305 Repair Type: Urgent Crossing Status: Found UCIP Comments: 10/10/2018 Extremely overgrown vegetation did not allow visual inspection of WS levee erosion; however, there are indications based on vegetation growth patterns that the erosion is still present, so keeping crossing as Urgent (D. Sanoski - DWR UCIP).08/31/2016: Heavy sloughing and sink hole remains at the WS slope in alignment with pipes. Though sloughing is not affecting levee prism, it is still an indication of a pipe integrity problem. Oil leak at the pump but does not appear to impact levee. (K. Fazel - UCIP)10/22/2013:- missing roof in pump house.- no protection for siphon breaker- huge erosion under pumphouse and levee slope on waterside. (P. Amatya - DWR) FIELD_STRUCT_DESC: 2 of 2: 18-inch steel irrigation discharge pipe through the levee, 4.8 feet below the crown. Pump house on the waterside (WS) slope. Siphon breaker on the landside (LS) shoulder. Service pole on the LS shoulder. Concrete distribution box at the LS toe. (Plans for installation of two irrigation pumps on the bank to replace an old centrifugal pumping plant at the same location authorized under Permit No. 4305, 1963 - Reclamation District No. 2062) [Additional Reference(s): DWR Levee Log, 2007. USACE San Joaquin O&M Manual 9, April 1964, (HLM 1.67)]. FS Date: 10/10/2018 11:20:00 AM

WS view: two leaky slant pumps in pumphouse with missing roof.

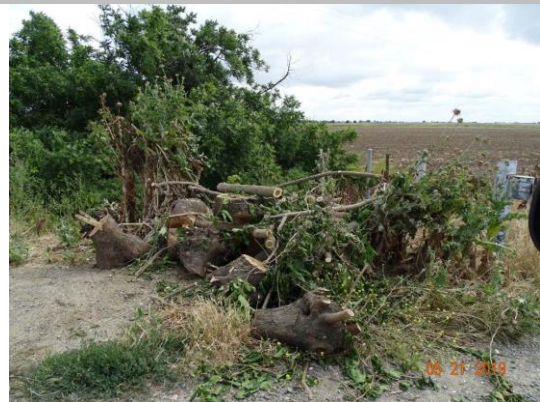
Photo 1 of 1 : SP_2019_RD2062_310_22_20190521_00036.jpg

View of pruning pile on landside slope. (Spring 2019)

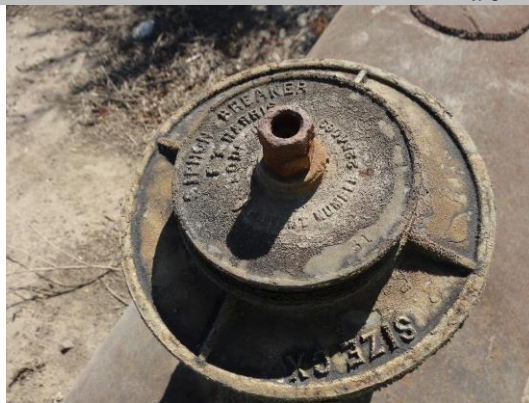
Photo 2 of 3 : UCIP_SP_2019_23304_40146.jpg

WS view: leaky siphon breaker on levee slope.

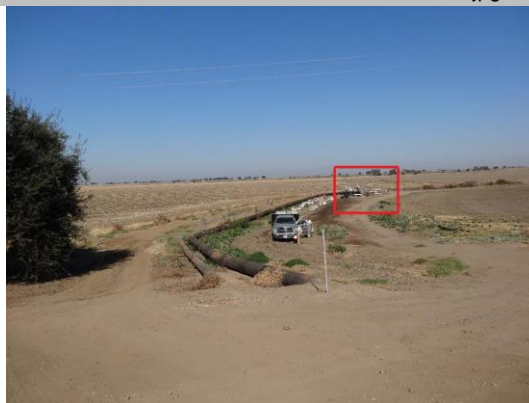
Photo 3 of 3 : UCIP_SP_2019_23304_40148.jpg

LS view: overview of pipes on levee berm and pump platform (marked - right) off the berm 350 ft from the levee.

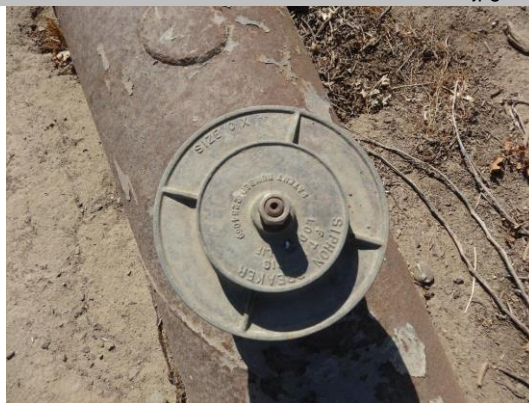
Photo 2 of 3 : UCIP_SP_2019_23023_39081.jpg

WS view: closer view of 18-inch pipe with siphon breaker on levee slope.

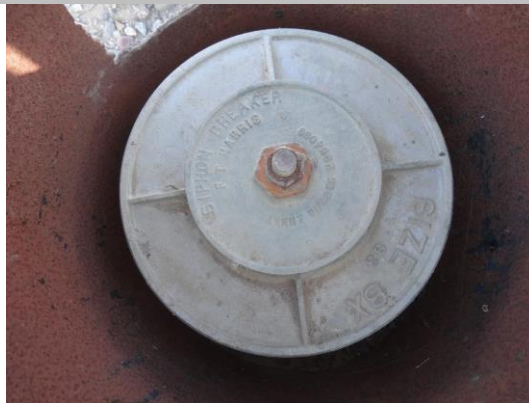
Photo 2 of 3 : UCIP_SP_2019_23305_40152.jpg

WS view: closer view of siphon breaker in steel pipe riser on levee slope.

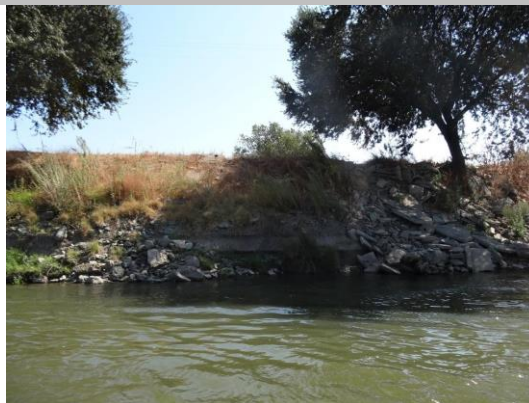
Photo 3 of 4 : SP_2019_RD2062_311_1_20190313_00003.jpg

Close view of the erosion.

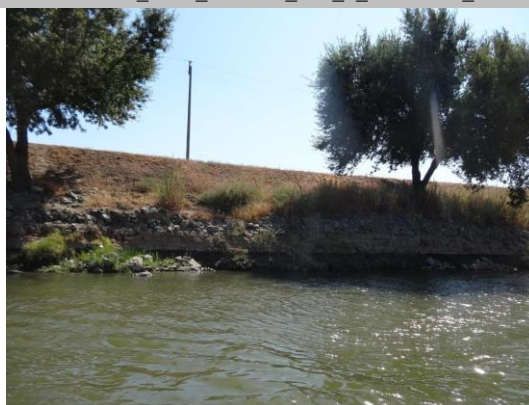
Photo 2 of 4 : SP_2019_RD2062_311_2_20190313_00006.jpg

Close view of the erosion. Note signs of animal activities at the site.

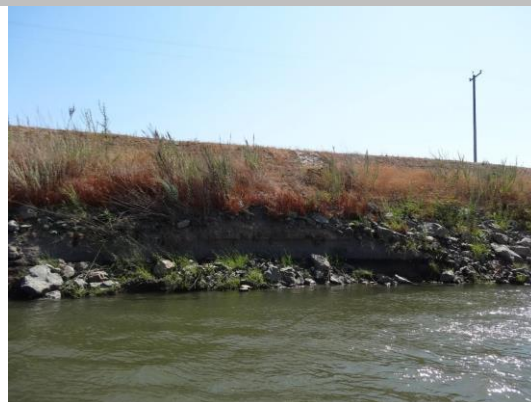
Photo 2 of 3 : SP_2019_RD2062_311_3_20190313_00010.jpg

Close view of the erosion.

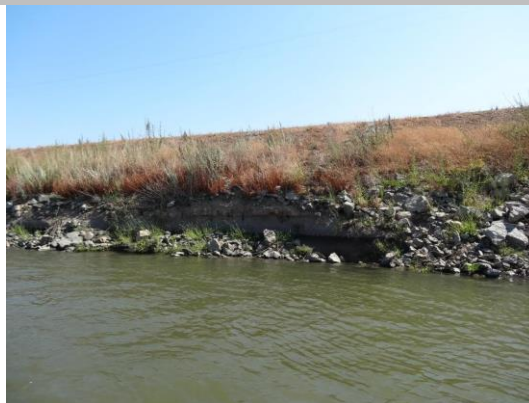
Photo 3 of 3 : SP_2019_RD2062_311_3_20190313_00011.jpg

Close view of the erosion.

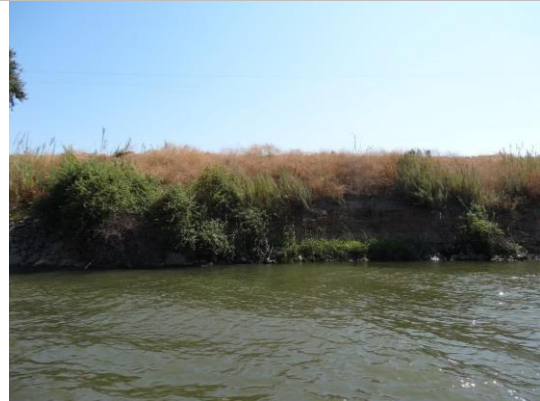
Photo 2 of 4 : SP_2019_RD2062_311_4_20190313_00013.jpg

Close view of the pocket erosion. Note the dense vegetation at the site.

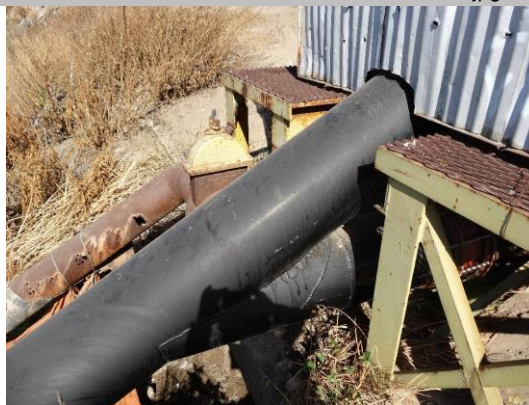
Photo 2 of 3 : UCIP_SP_2019_53377_40157.jpg

WS view: pump house on levee slope and holes-pits on corroded overflow pipe (left).

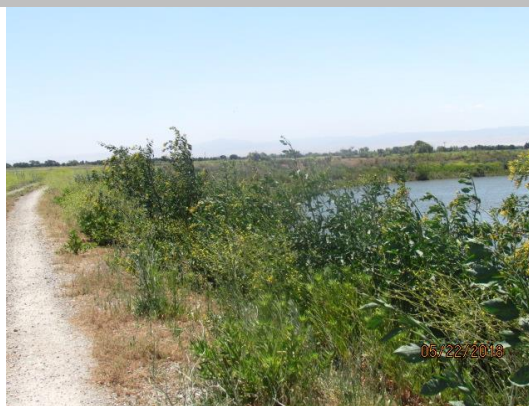
Photo 1 of 3 : SP_2019_RD2062_311_22_20190313_00035.jpg

Looking southwest at dense vegetation (Tobacco plants) on waterward slope. (Spring 2018)

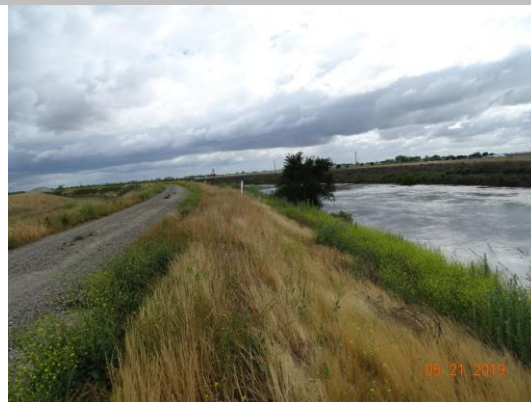
Photo 1 of 1 : SP_2019_RD2062_311_15_20190521_00058.jpg

Typical view of vegetation on waterside slope. (Spring 2019)

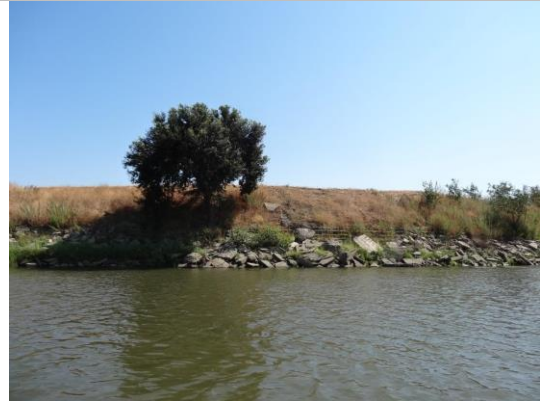
Photo 1 of 4 : SP_2019_RD2062_311_9_20190313_00025.jpg

Front view of the erosion site.

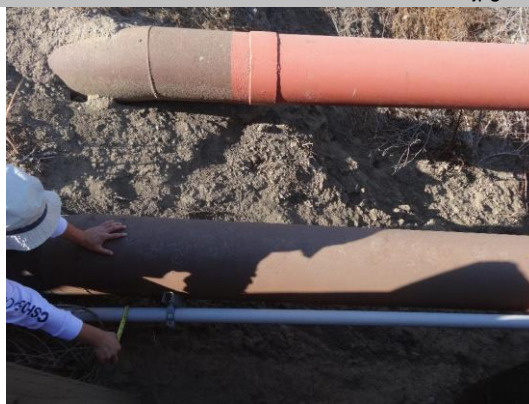
Photo 2 of 3 : UCIP_SP_2019_23311_40174.jpg

WS view: exposed steel pipes and an electric conduit on levee slope.

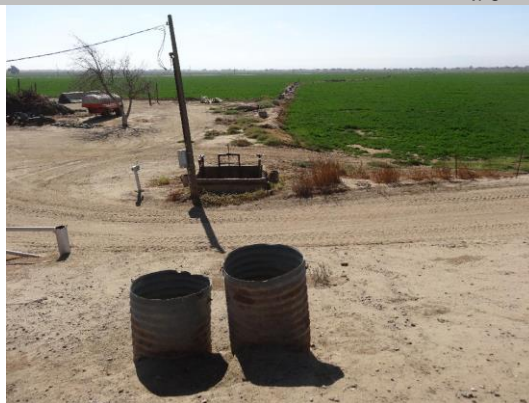
Photo 3 of 3 : UCIP_SP_2019_23311_40173.jpg

LS view: two CMP risers on levee slope, concrete distribution box, and service pole across the dirt road, off the levee toe.

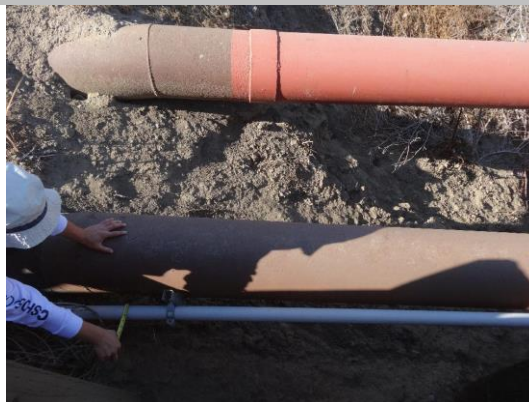
Photo 2 of 3 : UCIP_SP_2019_23312_40179.jpg

WS view: exposed steel pipes and a electric conduit on levee slope.

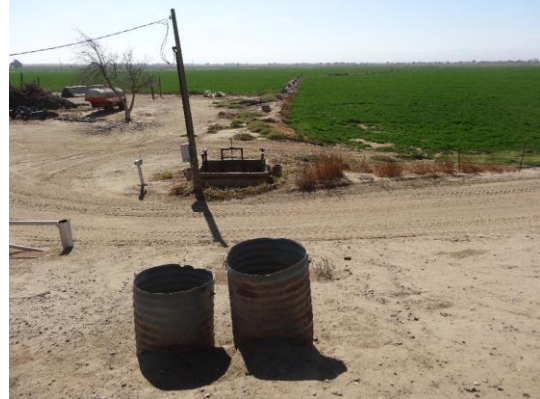
Photo 3 of 3 : UCIP_SP_2019_23312_40180.jpg

LS view: two CMP risers on levee slope, concrete distribution box, and service pole across the dirt road, off the levee toe.

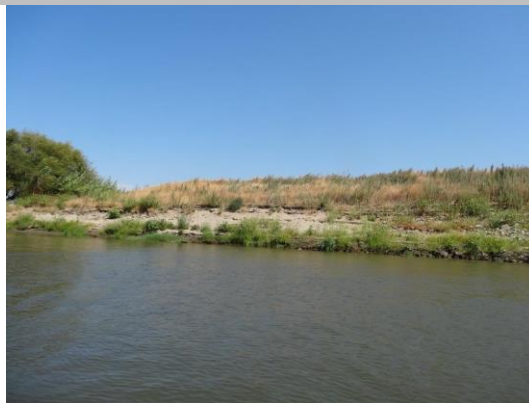
Photo 1 of 3 : SP_2019_RD2062_311_10_20190313_00029.jpg

Front view of the erosion located at the inside of a sharp river bend.

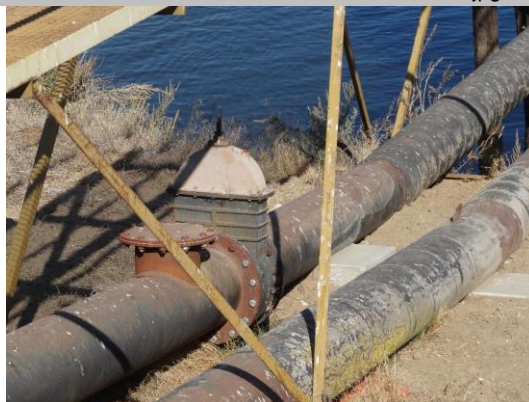
Photo 2 of 3 : UCIP_SP_2019_23142_39548.jpg

WS view: two 16-inch pipes under walkway. Gate valve without handle on one of the pipes.

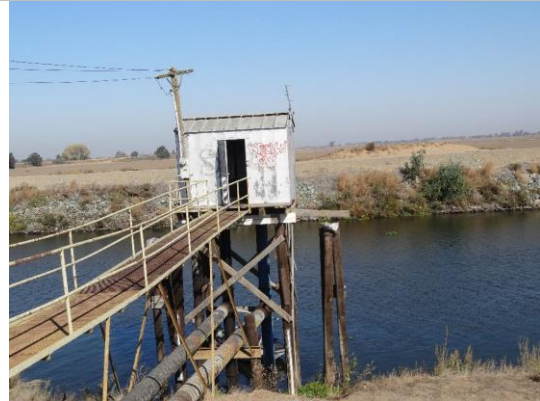
Photo 3 of 3 : UCIP_SP_2019_23142_39547.jpg

WS view: pump house on wooden pipe structure in the stream. Two steel pipes under the walkway.

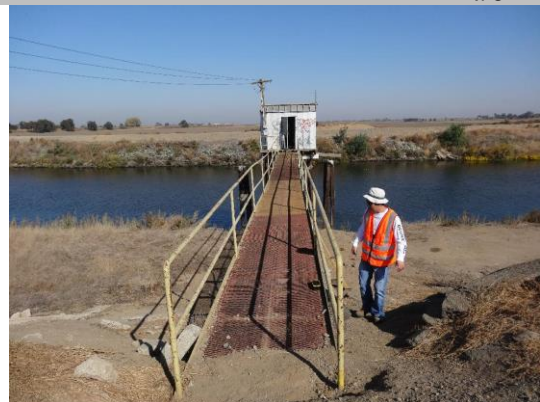
Photo 1 of 3 : UCIP_SP_2019_23140_39531.jpg

WS view: steel walkway to pump house in the stream.

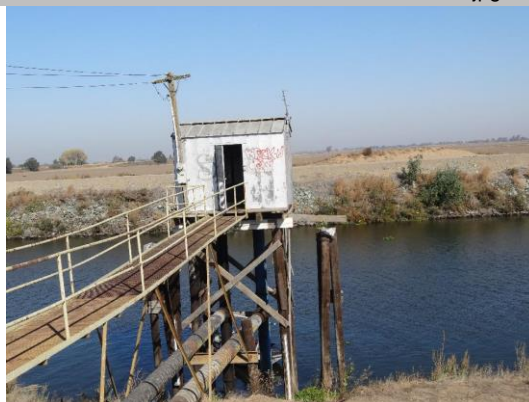
Photo 3 of 3 : UCIP_SP_2019_23140_39529.jpg

WS view: pump house on wooden pipe structure in the stream. Two steel pipes under the walkway.
