**Flood Control Project Maintenance  
Levee Inspections**  
**LMA District Cover Sheet**  
**Spring 2020 Levee Inspection Results**

**Reclamation District No. 2062 Stewart**

| Waterway | | | Bank | Unit Miles |
|--|---|---|---|---|
| Unit No. 01 San Joaquin River | | | Left | 2.64 |

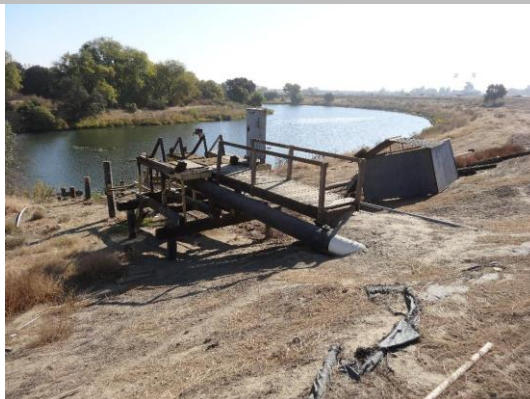
Photo 1 of 3 : UCIP\_SP\_2020\_22807\_38905.jpg

DS\_ID:19177  
FS\_ID:22807  
EP\_NO: 12679  
Repair Type: Non-Urgent  
Crossing Status: Found  
UCIP Comments: - All 3 pipes on landside looks new.- Pumps, pump house, and pipes removed from waterside.- Land development activities going on in this area.- Needs to confirm from LMA or DWR Inspector about the crossing.  
FIELD\_STRUCT\_DESC: 1 of 3: 16-inch steel irrigation discharge pipe through the levee, 5 feet below the crown. Electrical conduit through the levee. Slant pump in a pump house on the waterside (WS) slope. Siphon breaker on the landside (LS) slope. Service pole and concrete gate valve box at the landside (LS) toe. Installed by USACE in 1961. (Plans to replace rusted portions of two 16-inch irrigation pipes through the levee authorized under Permit No. 16124, 1993 - Reclamation District No. 2062). [Additional Reference(s): DWR Levee Log, 2007. USACE San Joaquin O&M Manual 9, April 1964, (HLM 1.65)].

WS view: pipes, walkway, and dismantled pumphouse (right).

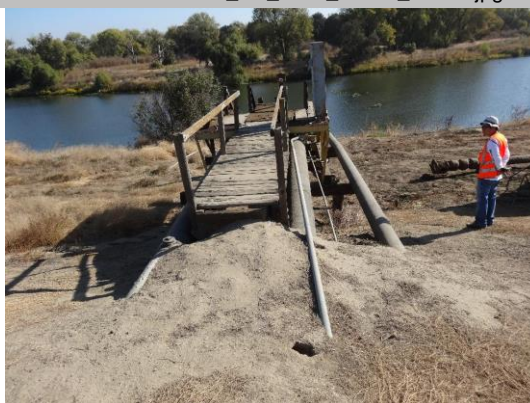
Photo 2 of 3 : UCIP\_SP\_2020\_22807\_38904.jpg

WS view: 16-inch pipes on both sides of walkway and 10-inch pipe (on right) away from walkway.

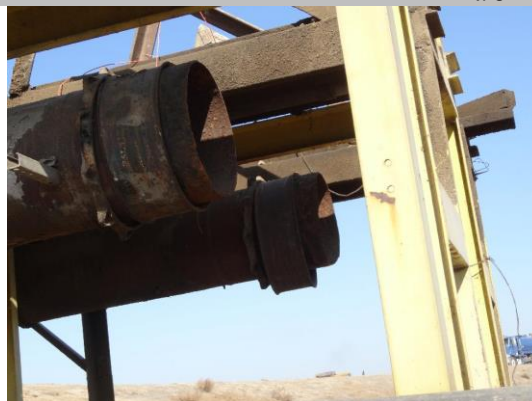
Photo 3 of 3 : UCIP\_SP\_2020\_22807\_38903.jpg

WS view: two 16-inch pipes. Pumps were removed. Pumphouse dismantled.

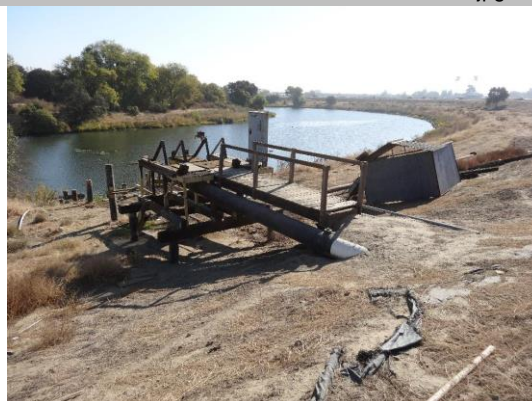
Photo 1 of 3 : UCIP\_SP\_2020\_22809\_38913.jpg

DS\_ID:19183  
FS\_ID:22809  
EP\_NO: 12679  
Repair Type: Non-Urgent  
Crossing Status: Found  
UCIP Comments: - All 3 pipes on landside looks new.- Pumps, pump house, and pipes removed from waterside.- Land development activities going on in this area.- Needs to confirm from LMA or DWR Inspector about the crossing.  
FIELD\_STRUCT\_DESC: 2 of 3: 16-inch steel irrigation discharge pipe through the levee, 5 feet below the crown. Electrical conduit through the levee. Slant pump in a pump house on the waterside (WS) slope. Siphon breaker on the landside (LS) slope. Service pole and concrete gate valve box at the landside (LS) toe. Installed by USACE in 1961. (Plans to replace rusted portions of two 16-inch irrigation pipes through the levee authorized under Permit No. 16124, 1993 - Reclamation District No. 2062). [Additional Reference(s): DWR Levee Log, 2007. USACE San Joaquin O&M Manual 9, April 1964, (HLM 1.65)].

WS view: pipes, walkway, and dismantled pumphouse (right).

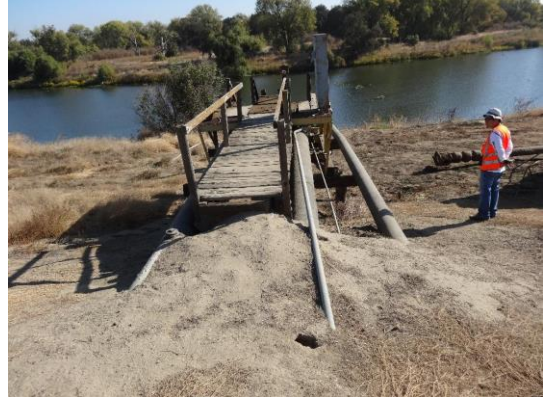
Photo 2 of 3 : UCIP\_SP\_2020\_22809\_38912.jpg

WS view: 16-inch pipes on both sides of walkway and 10-inch pipe (on right) away from walkway.

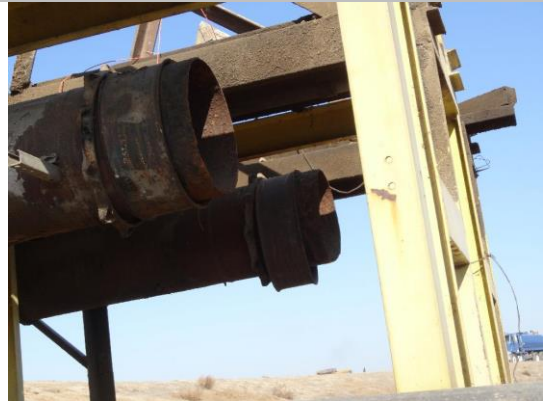
Photo 3 of 3 : UCIP\_SP\_2020\_22809\_38911.jpg

WS view: two 16-inch pipes under walkway; pumps were removed.

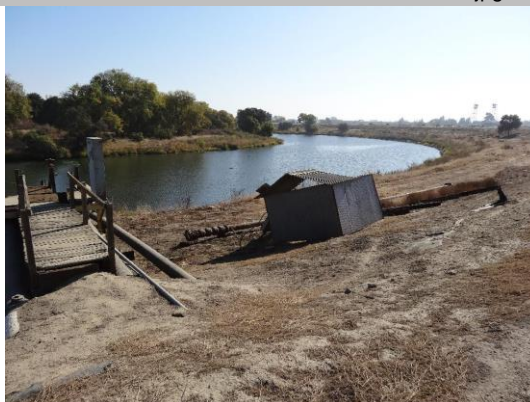
Photo 2 of 3 : UCIP\_SP\_2020\_22810\_38917.jpg

DS\_ID:19184  
FS\_ID:22810  
EP\_NO: 12679  
Repair Type: Non-Urgent  
Crossing Status: Found  
UCIP Comments: - All 3 pipes on landside looks new. No pump associated with 8-inch pipe.- Pumps, pump house, and pipes removed from waterside.- Land development activities going on in this area.- Needs to confirm from LMA or DWR Inspector about the crossing.  
FIELD\_STRUCT\_DESC: 3 of 3: 8-inch steel irrigation discharge pipe through the levee, 8 feet below the crown. Electrical conduit through the levee. Slant pump in a pump house on the waterside (WS) slope. Siphon breaker on the landside (LS) slope. Service pole and concrete gate valve box at the landside (LS) toe. (Plans to install a 75-horsepower pump on the bank with a 10-inch steel discharge pipe through the levee authorized under Permit No. 12679, 1979 - Reclamation District No. 2062). [Additional Reference(s): DWR Levee Log, 2007].  
FS Date: 10/22/2013

WS view: electric conduit and 10-inch pipe (right). Dismantled/removed pipe and pump house (far right).

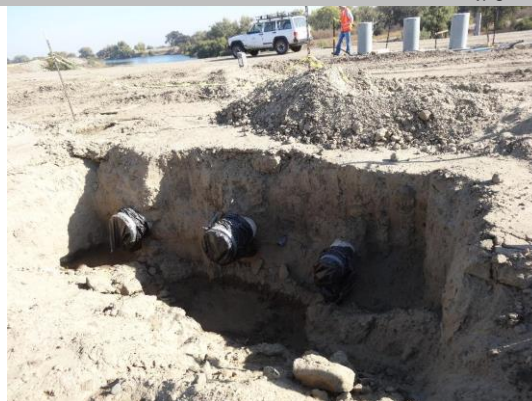
Photo 3 of 3 : UCIP\_SP\_2020\_22810\_38916.jpg

LS view: two 16-inch pipes (left) and one 10-inch pipe (right) in ditch. Concrete box removed.

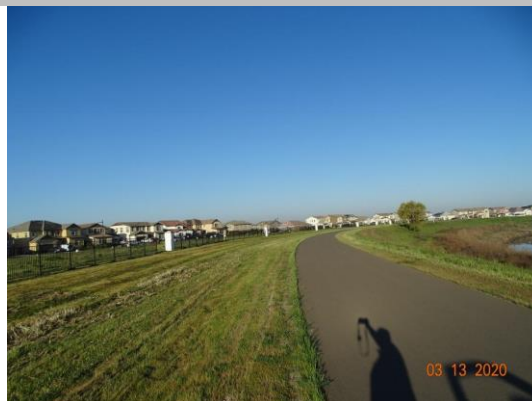
Photo 1 of 1 : SP\_2020\_RD2062\_309\_13\_20200318\_00012.jpg

Typical view of well maintained vegetation on landside slope. Spring 2020

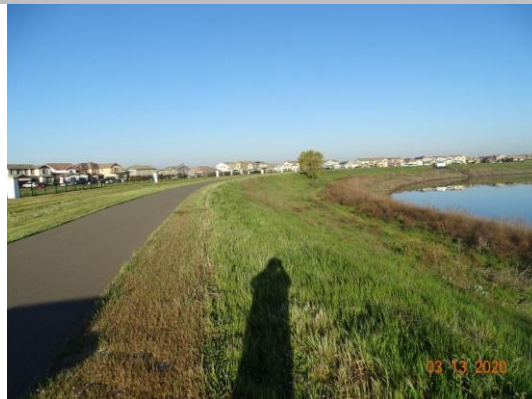
Photo 1 of 1 : SP\_2020\_RD2062\_309\_12\_20200318\_00013.jpg

Typical view of well maintained vegetation on waterside slope. Spring 2020

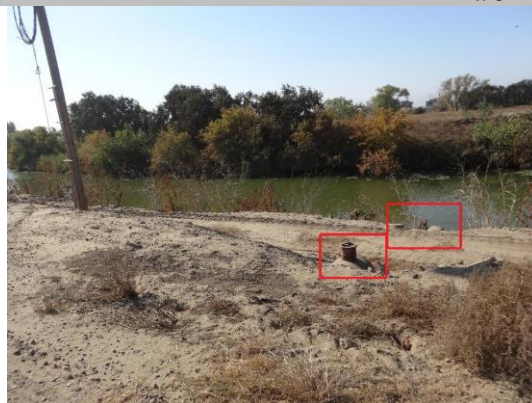
Photo 1 of 3 : UCIP\_SP\_2020\_23110\_39398.jpg

| DS_ID:24697<br>FS_ID:23110<br>EP_NO: N/A<br>Repair Type: Non-Urgent<br>Crossing Status: Found<br>UCIP Comments: Found on field with the help of USACE 2012 PI Report.Needs proper abandonment.<br>FIELD_STRUCT_DESC: *ABANDONED* 24-inch steel irrigation discharge pipe through the levee, at an unknown depth. Damaged siphon breaker on the waterside (WS) slope. Pump on a concrete sump in an irrigation ditch on the landside (LS). Service pole on the LS slope. Pump disconnected from the service pole.<br>FS Date: 10/23/2013 | | | | | |

WS view: power pole (left), siphon breaker (marked- left), and steel pipe (right) on levee slope.

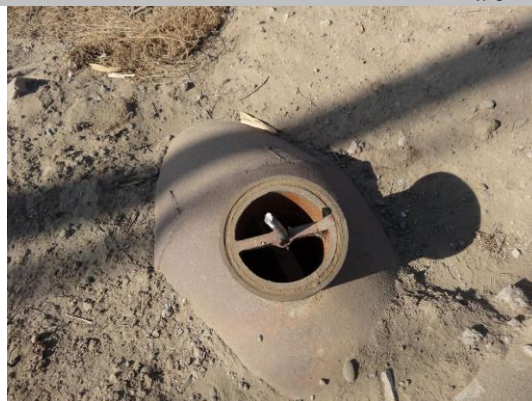
Photo 2 of 3 : UCIP\_SP\_2020\_23110\_39397.jpg

WS view: exposed steel pipe and damaged siphon breaker on levee slope.

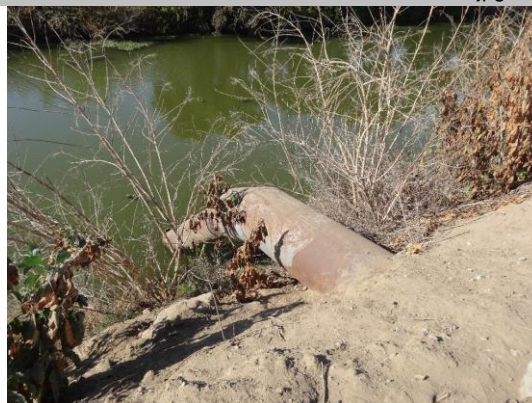
Photo 3 of 3 : UCIP\_SP\_2020\_23110\_39396.jpg

WS view: exposed steel pipe on channel bank and also immersed into channel water.

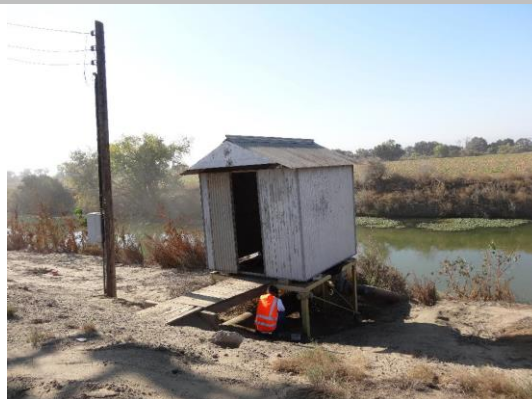
Photo 1 of 3 : UCIP\_SP\_2020\_23181\_39792.jpg

DS\_ID:19192  
FS\_ID:23181  
EP\_NO: 12427  
Repair Type: Non-Urgent  
Crossing Status: Found  
UCIP Comments: - no siphon breaker found- levee toe erosion under walkway on waterside.- erosion around concrete standpipe on landside- may be base of the standpipe was leaking.  
FIELD\_STRUCT\_DESC: 18-inch irrigation discharge pipe of an unknown material through the levee, 4.4 feet below the crown. Pump house on the waterside (WS) slope. Metal walkway from the pump house to the crown. Service pole on the WS. Flap gate, siphon breaker, and concrete distribution box on the landside (LS) slope. (Emergency plans to replace an existing 18-inch discharge pipe through the levee authorized under Permit No. 12427, 1978 - Reclamation District No. 2062). [Additional Reference(s): DWR Levee Log, 2007, 16-inch pipe referenced. USACE San Joaquin O&M Manual 9, April 1964, (HLM 0.76)].  
FS Date: 10/23/2013

WS view: pipe, walkway, service pole, and pumphouse on levee slope.

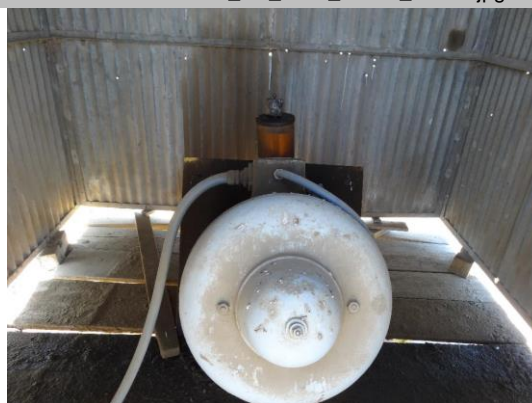
Photo 2 of 3 : UCIP\_SP\_2020\_23181\_39791.jpg

WS view: leaky slant pump in pumphouse on levee slope.

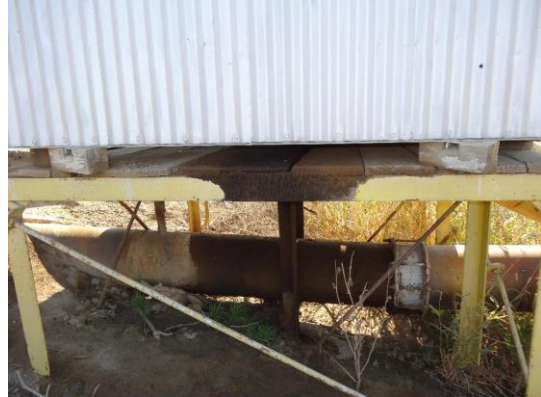
Photo 3 of 3 : UCIP\_SP\_2020\_23181\_39790.jpg

WS view: oil leakage from slant pump. Pipe under pump house.

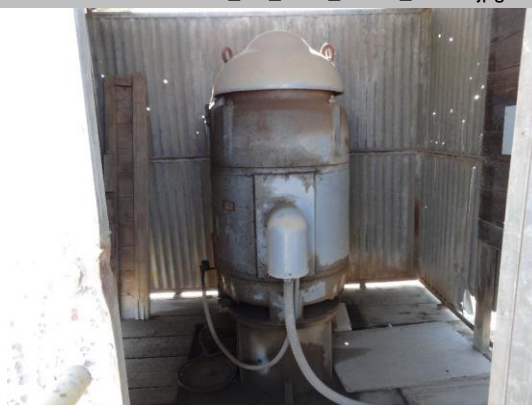
Photo 2 of 3 : UCIP\_SP\_2020\_51468\_39194.jpg

DS\_ID:19193  
FS\_ID:51468  
EP\_NO: N/A  
Repair Type: Non-Urgent  
Crossing Status: Found  
UCIP Comments: 04/05/2017: Pipe has been plugged as a flood fight measure and is likely to be replaced under a permit. MBK (Michael Moncrief) is working on the permit. Photo and update courtesy of Max Khashchuk as part of his 2017 Spring Inspection. (K. Fazel - UCIP)10/22/2013:- pumphouse on concrete sump in the channel.- erosion under walkway on waterside. (P. Amatya - DWR)  
FIELD\_STRUCT\_DESC: 20-inch steel irrigation discharge pipe through the levee, 8 feet below the crown. Pump house on the waterside (WS) slope. Metal walkway from the pump house to the crown. Flap gate, siphon breaker, and concrete distribution box on the landside (LS) slope. [Additional Reference(s): DWR Levee Log, 2007, 18-inch pipe referenced. USACE San Joaquin O&M Manual 9, April 1964, (HLM 1.40), 18-inch pipe referenced].

WS view: leaky pump and control box in pumphouse.

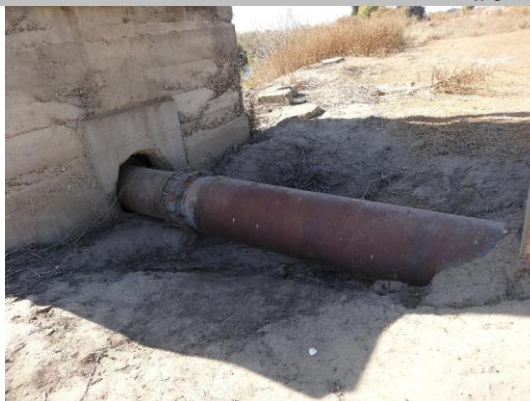
Photo 3 of 3 : UCIP\_SP\_2020\_51468\_39193.jpg

WS view: exposed steel pipe under walkway. Soil erosion under walkway. This may be due to leaky pipe joint.

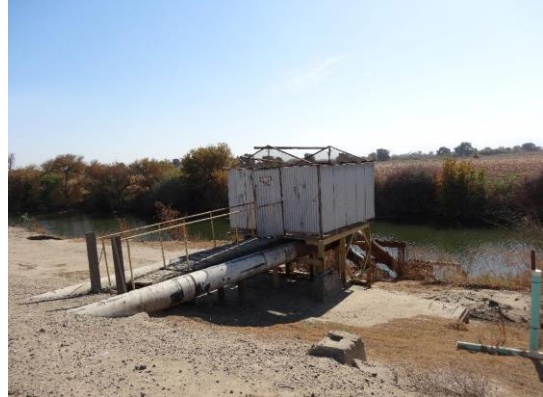
Photo 1 of 3 : UCIP\_SP\_2020\_53375\_39187.jpg

DS\_ID:19194  
FS\_ID:53375  
EP\_NO: 4305  
Repair Type: Urgent  
Crossing Status: Found  
UCIP Comments: 10/10/2018 Extremely overgrown vegetation did not allow visual inspection of WS levee erosion; however, there are indications based on vegetation growth patterns that the erosion is still present, so keeping crossing as Urgent (D. Sanoski - DWR UCIP).08/31/2016: Heavy sloughing and sink hole remains at the WS slope in alignment with pipe. Though sloughing is not affecting levee prism, it is still an indication of a pipe integrity problem. Oil leak at the pump but does not appear to impact the levee. (K. Fazel - UCIP)10/22/2013:- missing roof in pump house.- no protection for siphon breaker- huge erosion under pumphouse and levee slope on waterside. (P. Amatya - DWR)  
FIELD\_STRUCT\_DESC: 1 of 2: 18-inch steel irrigation discharge pipe through the levee, 4.8 feet below the crown. Pump house on the waterside (WS) slope. Siphon breaker on the landside (LS) shoulder. Service pole on the LS shoulder. Concrete distribution box at the LS toe. (Plans for installation of two irrigation pumps on the bank to replace an old centrifugal pumping plant at the same location authorized under Permit No. 4305, 1963 - Reclamation District No. 2062) [Additional Reference(s): DWR Levee Log, 2007. USACE San Joaquin O&M Manual 9, April 1964, (HLM 1.67)].

WS view: pipes, walkway, and pumphouse with missing roof (right).

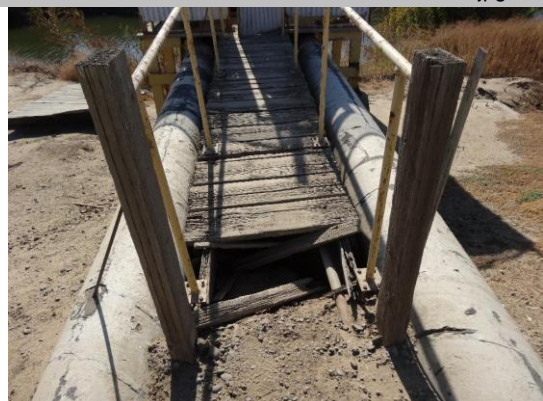
Photo 2 of 3 : UCIP\_SP\_2020\_53375\_39186.jpg

WS view: walkway to pumphouse. Walkway in poor condition.

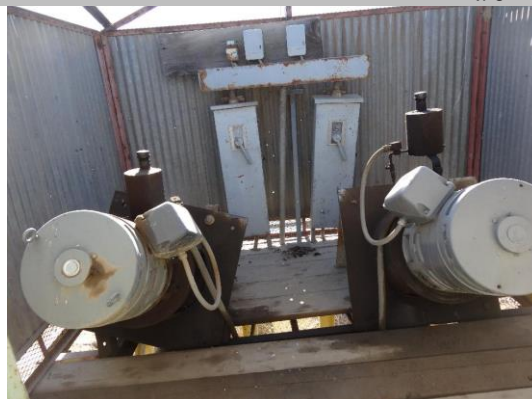
Photo 3 of 3 : UCIP\_SP\_2020\_53375\_39185.jpg

WS view: two leaky slant pumps in pumphouse with missing roof.

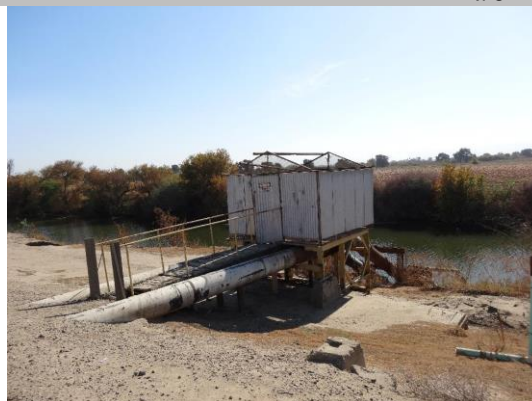
Photo 1 of 3 : UCIP\_SP\_2020\_53376\_39176.jpg

DS\_ID:19197  
FS\_ID:53376  
EP\_NO: 4305  
Repair Type: Urgent  
Crossing Status: Found  
UCIP Comments: 10/10/2018 Extremely overgrown vegetation did not allow visual inspection of WS levee erosion; however, there are indications based on vegetation growth patterns that the erosion is still present, so keeping crossing as Urgent (D. Sanoski - DWR UCIP).08/31/2016: Heavy sloughing and sink hole remains at the WS slope in alignment with pipes. Though sloughing is not affecting levee prism, it is still an indication of a pipe integrity problem. Oil leak at the pump but does not appear to impact levee. (K. Fazel - UCIP)10/22/2013:- missing roof in pump house.- no protection for siphon breaker- huge erosion under pumphouse and levee slope on waterside. (P. Amatya - DWR)  
FIELD\_STRUCT\_DESC: 2 of 2: 18-inch steel irrigation discharge pipe through the levee, 4.8 feet below the crown. Pump house on the waterside (WS) slope. Siphon breaker on the landside (LS) shoulder. Service pole on the LS shoulder. Concrete distribution box at the LS toe. (Plans for installation of two irrigation pumps on the bank to replace an old centrifugal pumping plant at the same location authorized under Permit No. 4305, 1963 - Reclamation District No. 2062) [Additional Reference(s): DWR Levee Log, 2007. USACE San Joaquin O&M Manual 9, April 1964, (HLM 1.67)].

WS view: pipes, walkway, and pumphouse with missing roof (right).

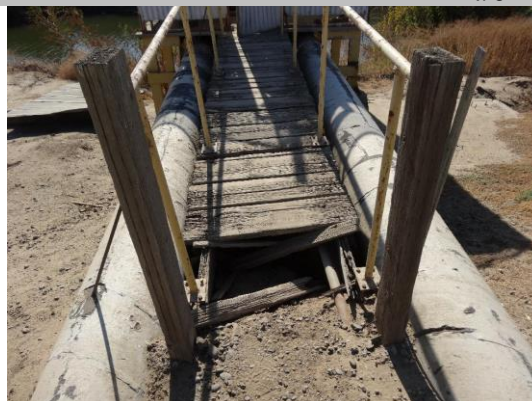
Photo 2 of 3 : UCIP\_SP\_2020\_53376\_39175.jpg

WS view: walkway in poor condition, to pumphouse.

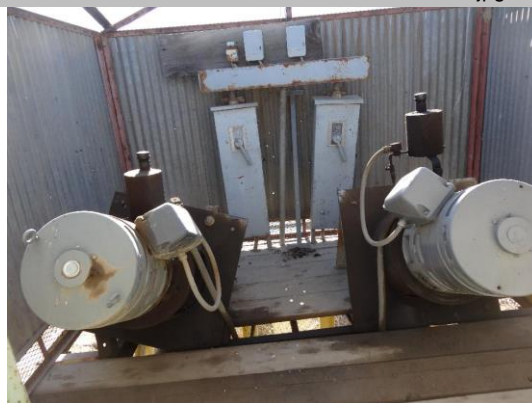
Photo 3 of 3 : UCIP\_SP\_2020\_53376\_39174.jpg

WS view: two leaky slant pumps in pumphouse with missing roof.

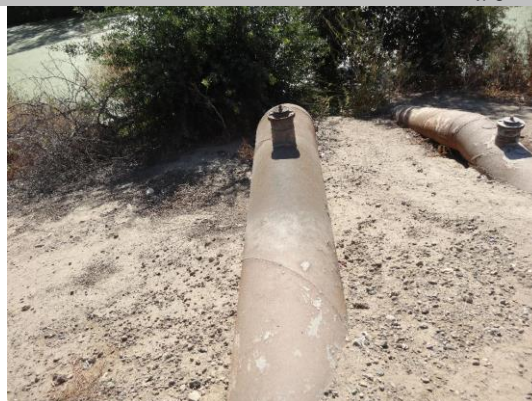
Photo 1 of 3 : UCIP\_SP\_2020\_23304\_40147.jpg

DS\_ID:19199  
FS\_ID:23304  
EP\_NO: 11524  
Repair Type: Non-Urgent  
Crossing Status: Found  
UCIP Comments: - waterside pipe immersed into channel water.- most of the pipe on landside exposed and siphon breaker on waterside not protected.  
FIELD\_STRUCT\_DESC: 1 of 3: 24-inch coated steel drainage discharge pipe through the levee, 2 feet below the crown. Siphon breaker on the waterside (WS) slope. Pump on a steel platform in a drainage ditch, 350 feet from the levee centerline off the landward berm. (Plans to install a drainage pump and 24-inch discharge line through the levee at existing main drainage pump authorized under Permit No. 11524, 1976 - Reclamation District No. 2062). [Additional Reference(s): DWR Levee Log, 2007. USACE San Joaquin O&M Manual 9, April 1964, (HLM 3.29)].  
FS Date: 10/22/2013

WS view: 24-inch steel pipe (left) with siphon breaker on levee slope. 18-inch pipe on right.

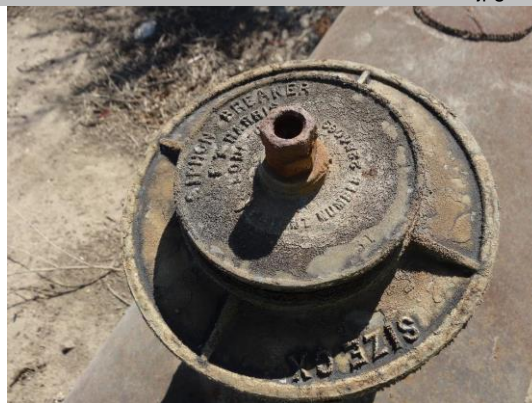
Photo 2 of 3 : UCIP\_SP\_2020\_23304\_40146.jpg

WS view: leaky siphon breaker on levee slope.

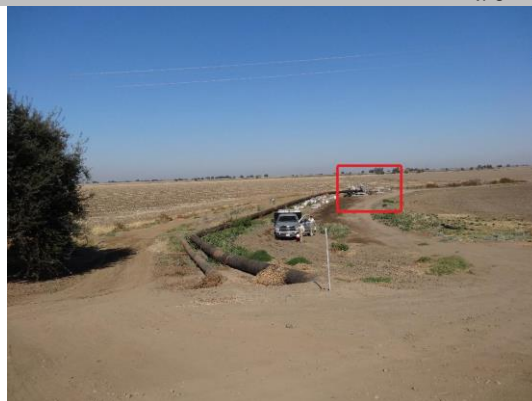
Photo 3 of 3 : UCIP\_SP\_2020\_23304\_40148.jpg

LS view: overview of pipes on levee berm and pump platform (marked - right) off the berm 350 ft from the levee.

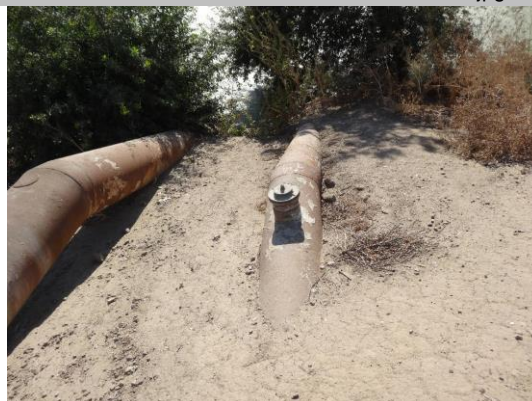
Photo 1 of 3 : UCIP\_SP\_2020\_23023\_39082.jpg

DS\_ID:19198  
FS\_ID:23023  
EP\_NO: 11524  
Repair Type: Non-Urgent  
Crossing Status: Found  
UCIP Comments: - 18-inch pipe bifurcated near the pump and two gate valves installed.- waterside pipe immersed into channel water.- most of the pipe on landside exposed and siphon breaker on waterside not protected.  
FIELD\_STRUCT\_DESC: 2 of 3: 18-inch coated steel drainage discharge pipe through the levee, 4 feet below the crown. Siphon breaker on the waterside (WS) slope. Pump on a steel platform in a drainage ditch, 350 feet from the levee centerline off the landward berm. (Plans to install a drainage pump and 24-inch discharge line through the levee at existing main drainage pump authorized under Permit No. 11524, 1976 - Reclamation District No. 2062). [Additional Reference(s): DWR Levee Log, 2007. USACE San Joaquin O&M Manual 9, April 1964, (HLM 3.29), 16-inch pipe referenced].  
FS Date: 10/22/2013

WS view: exposed 18-inch pipe with siphon breaker on levee slope. Exposed 24-inch pipe (left).

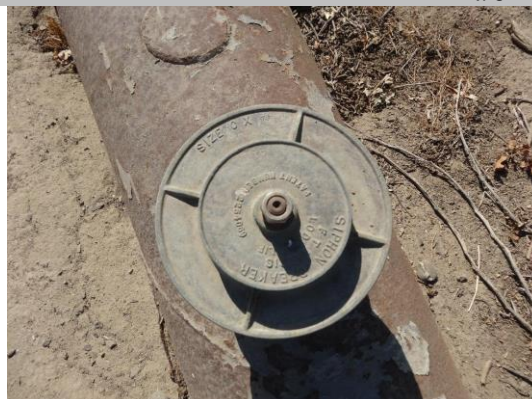
Photo 2 of 3 : UCIP\_SP\_2020\_23023\_39081.jpg

WS view: closer view of 18-inch pipe with siphon breaker on levee slope.

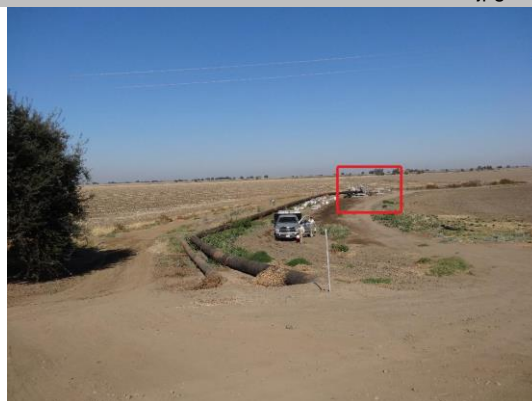
Photo 3 of 3 : UCIP\_SP\_2020\_23023\_39080.jpg

LS view: overview of exposed pipes and pump station (marked-right) 350 ft from levee center.

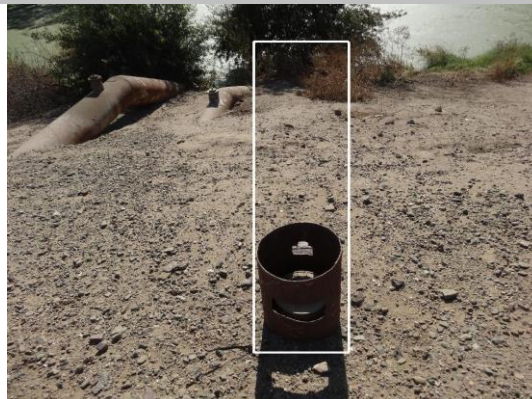
Photo 1 of 3 : UCIP\_SP\_2020\_23305\_40153.jpg

DS\_ID:19195  
FS\_ID:23305  
EP\_NO: 11524  
Repair Type: Non-Urgent  
Crossing Status: Found  
UCIP Comments: - no associated pump or any other appurtenances found on landside.- looks abandoned pipe. Needs proper abandonment.  
FIELD\_STRUCT\_DESC: 3 of 3: 24-inch coated steel drainage discharge pipe through the levee, 2 feet below the crown. Siphon breaker on the waterside (WS) slope. Pump on a steel platform in a drainage ditch, 350 feet from the levee centerline off the landward berm. (Plans to install a drainage pump and 24-inch discharge line through the levee at existing main drainage pump authorized under Permit No. 11524, 1976 - Reclamation District No. 2062). [Additional Reference(s): DWR Levee Log, 2007. USACE San Joaquin O&M Manual 9, April 1964, (HLM 3.29)].  
FS Date: 10/22/2013

WS view: siphon breaker in steel pipe riser on levee slope.

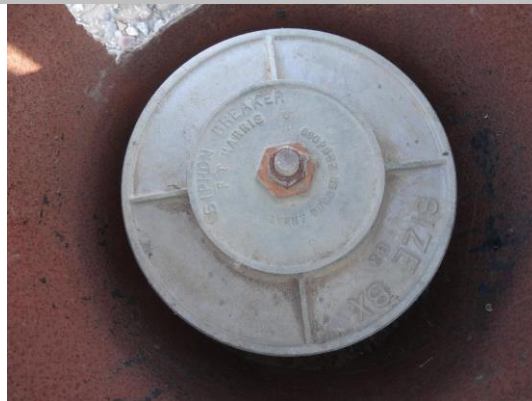
Photo 2 of 3 : UCIP\_SP\_2020\_23305\_40152.jpg

WS view: closer view of siphon breaker in steel pipe riser on levee slope.

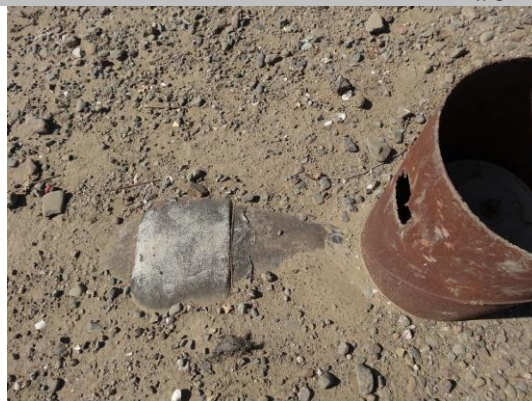
Photo 3 of 3 : UCIP\_SP\_2020\_23305\_40151.jpg

WS view: exposed pipe and steel pipe riser on levee slope.

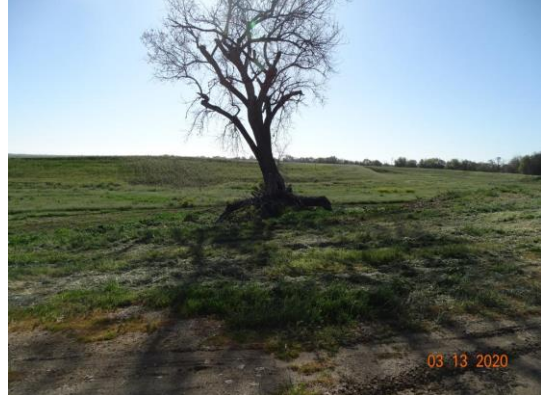
Photo 1 of 1 : SP\_2020\_RD2062\_310\_15\_20200318\_00026.jpg

View of fallen tree branches on landside slope. Spring 2020

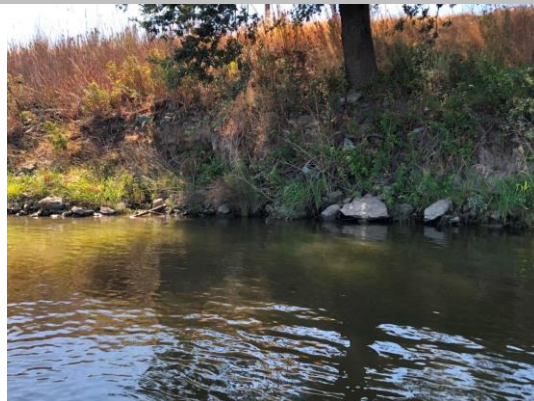
Photo 1 of 3 : SP\_2020\_RD2062\_311\_1\_20200228\_00001.jpg

Front view of the erosion site. Note the large tree above the erosion.

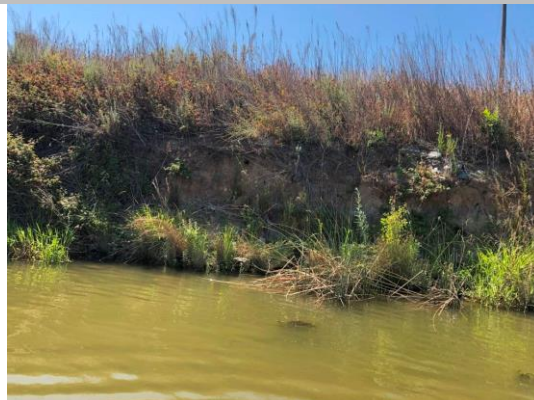
Photo 2 of 3 : SP\_2020\_RD2062\_311\_1\_20200228\_00002.jpg

Close-up view of the erosion.

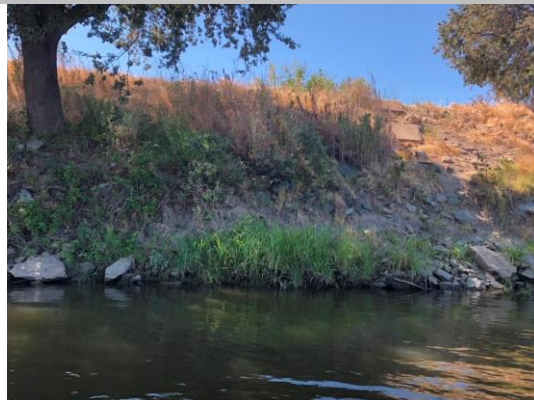
Photo 3 of 3 : SP\_2020\_RD2062\_311\_1\_20200228\_00003.jpg

Close-up view of the erosion.

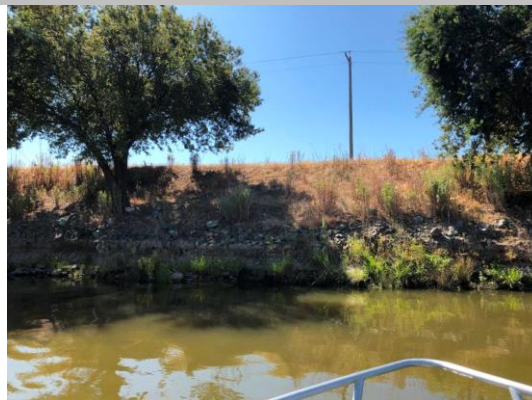
Photo 2 of 3 : SP\_2020\_RD2062\_311\_2\_20200228\_00005.jpg

Close-up view of the erosion. Note signs of animal activities at the site..

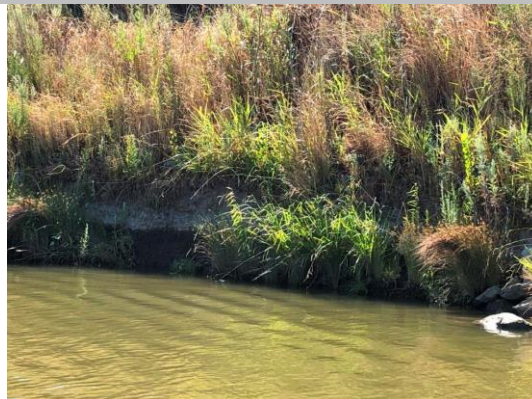
Photo 1 of 3 : SP\_2020\_RD2062\_311\_4\_20200228\_00010.jpg

View of the pocket erosion.

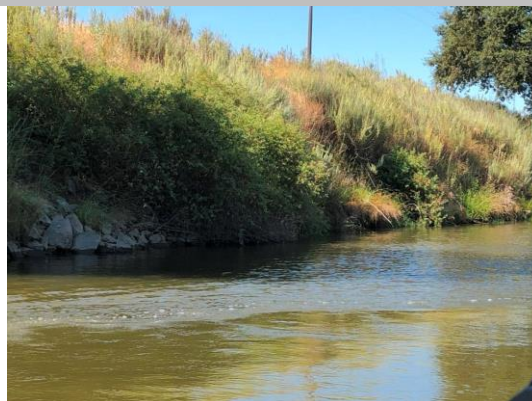
Photo 2 of 3 : SP\_2020\_RD2062\_311\_4\_20200228\_00011.jpg

Close-up view of the pocket erosion. Note the dense vegetation at the site.

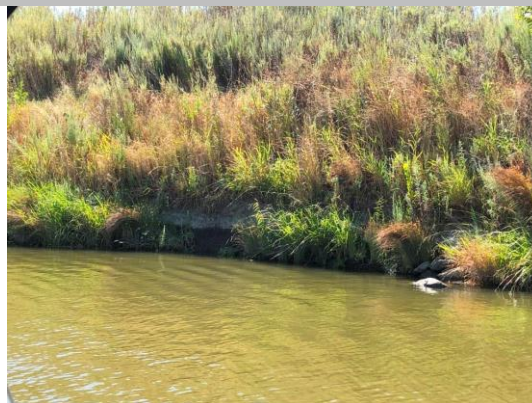
Photo 3 of 3 : SP\_2020\_RD2062\_311\_4\_20200228\_00012.jpg

Front view of the site with dense vegetation.

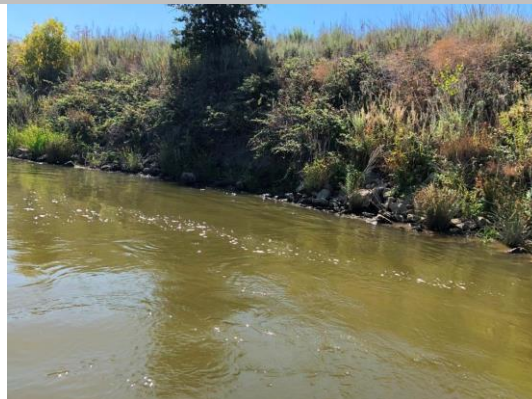
Photo 1 of 3 : SP\_2020\_RD2062\_311\_5\_20200228\_00013.jpg

Front view of the erosion.

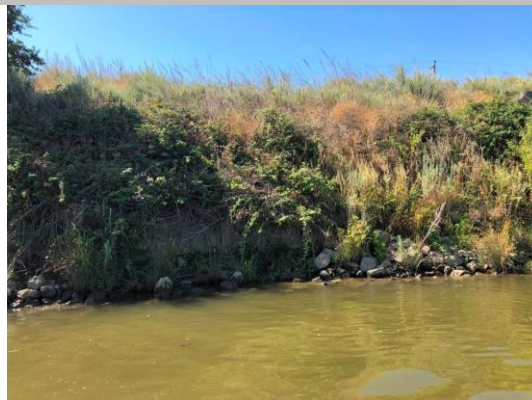
Photo 2 of 3 : SP\_2020\_RD2062\_311\_5\_20200228\_00014.jpg

Close-up view of the site. Note the dense vegetation at the site.

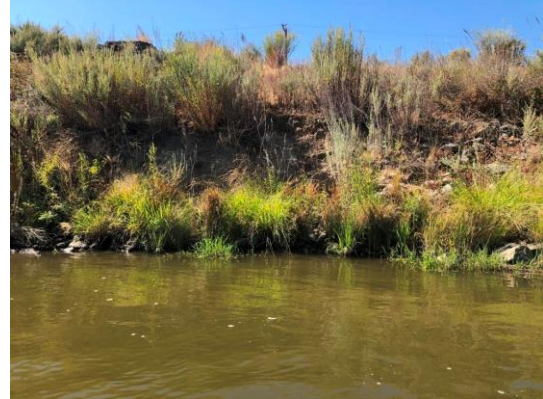
Photo 3 of 3 : SP\_2020\_RD2062\_311\_5\_20200228\_00015.jpg

Close-up view of the erosion.

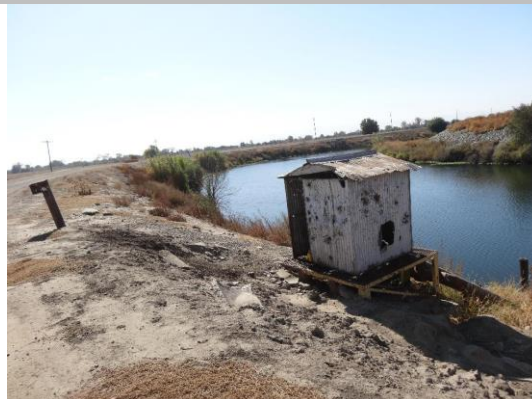
Photo 1 of 3 : UCIP\_SP\_2020\_53377\_40158.jpg

WS view: pump house on levee slope and soil erosion on levee slope.

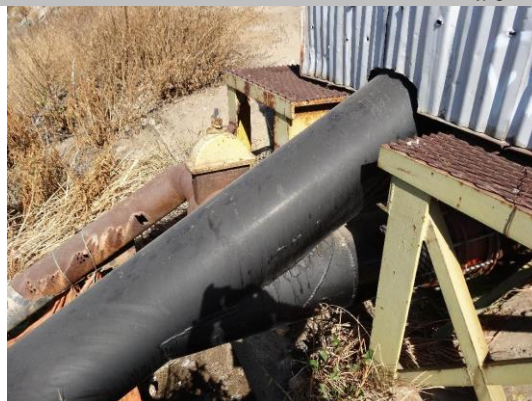
Photo 2 of 3 : UCIP\_SP\_2020\_53377\_40157.jpg

WS view: pump house on levee slope and holes-pits on corroded overflow pipe (left).

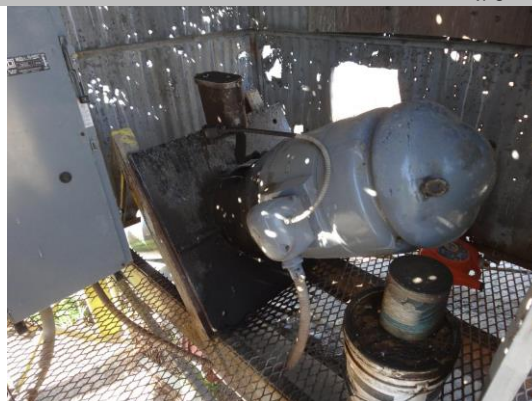
Photo 3 of 3 : UCIP\_SP\_2020\_53377\_40156.jpg

WS view: slant pump in pumphouse on levee slope.

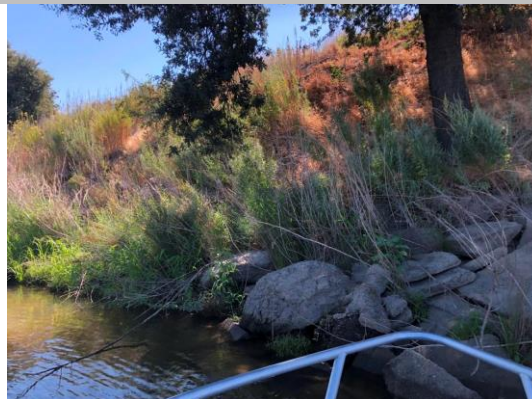
Photo 3 of 3 : SP\_2020\_RD2062\_311\_9\_20200228\_00024.jpg

Close-up view of the site. Note the existing broken concrete on levee slope and at the levee toe.

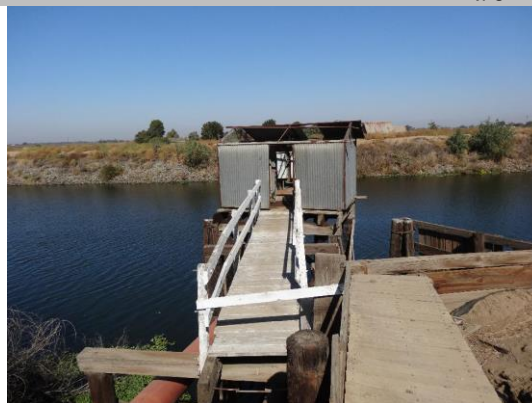
Photo 1 of 3 : UCIP\_SP\_2020\_23311\_40175.jpg

WS view: wooden walkway to pumphouse, pumphouse on wooden pile structure in the stream.

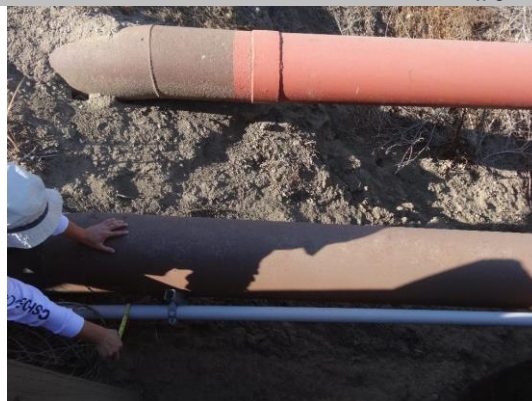
Photo 2 of 3 : UCIP\_SP\_2020\_23311\_40174.jpg

WS view: exposed steel pipes and an electric conduit on levee slope.

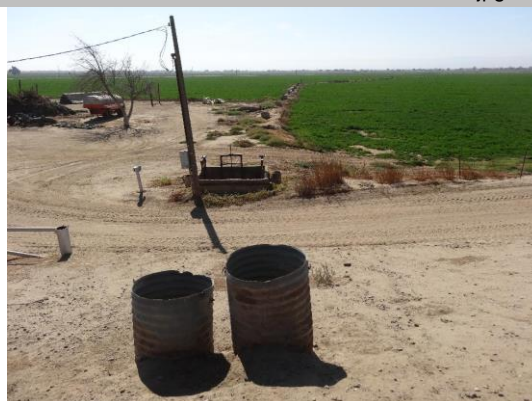
Photo 3 of 3 : UCIP\_SP\_2020\_23311\_40173.jpg

LS view: two CMP risers on levee slope, concrete distribution box, and service pole across the dirt road, off the levee toe.

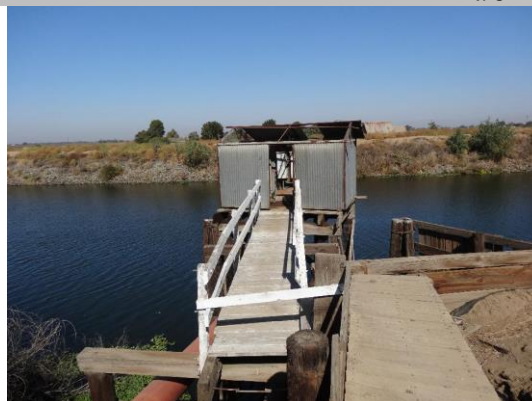
Photo 1 of 3 : UCIP\_SP\_2020\_23312\_40181.jpg

WS view: wooden walkway to pumphouse, pumphouse on wooden pile structure in the stream.

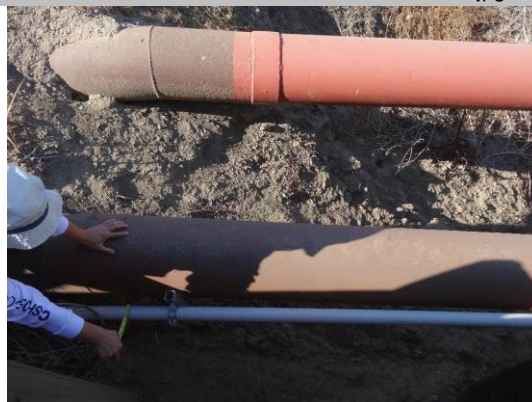
Photo 2 of 3 : UCIP\_SP\_2020\_23312\_40179.jpg

WS view: exposed steel pipes and a electric conduit on levee slope.

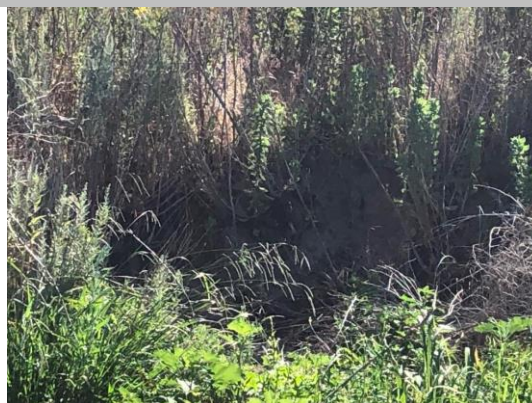
Photo 1 of 3 : SP\_2020\_RD2062\_311\_10\_20200228\_00025.jpg

Close-up view of the erosion located at the inside of a sharp river bend.

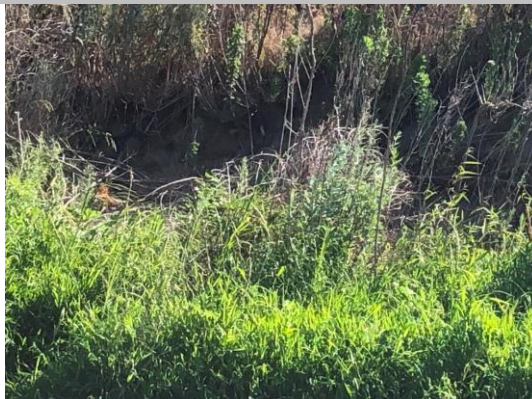
Photo 2 of 3 : SP\_2020\_RD2062\_311\_10\_20200228\_00026.jpg

Close-up view of the erosion.

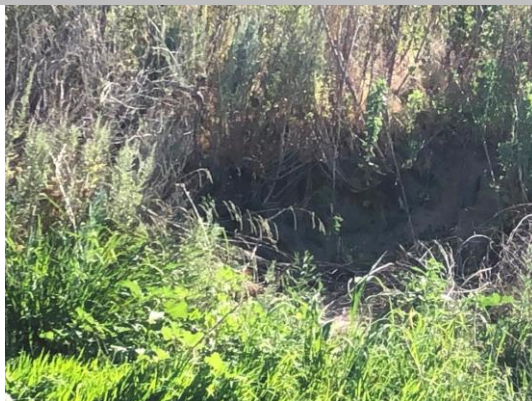
Photo 3 of 3 : SP\_2020\_RD2062\_311\_10\_20200228\_00027.jpg

Close-up view of the erosion. Note the sandy material of the river bank at the erosion site.

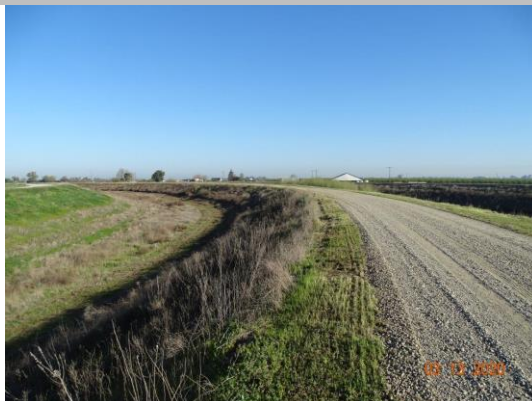
Photo 1 of 1 : SP\_2020\_RD2062\_311\_17\_20200318\_00051.jpg

Typical view of well maintained vegetation on landside slope. Spring 2020

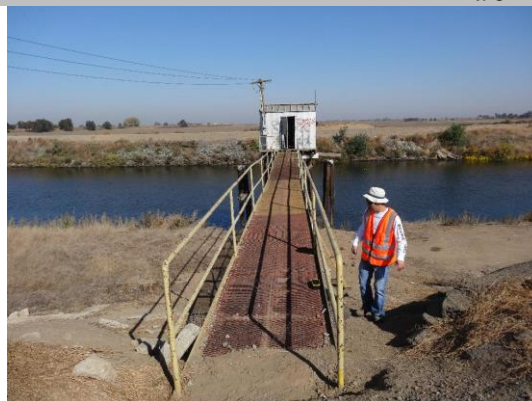
Photo 1 of 3 : UCIP\_SP\_2020\_23142\_39549.jpg

WS view: steel walkway to pump house in the stream.

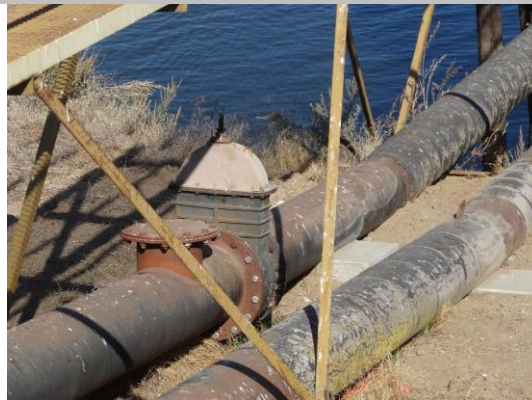
Photo 2 of 3 : UCIP\_SP\_2020\_23142\_39548.jpg

WS view: two 16-inch pipes under walkway. Gate valve without handle on one of the pipes.

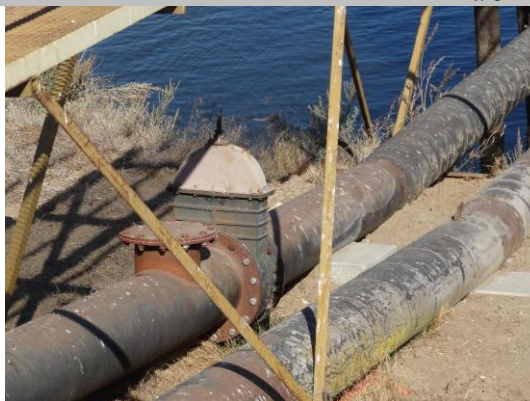
Photo 2 of 3 : UCIP\_SP\_2020\_23140\_39530.jpg

WS view: two 16-inch pipes under walkway. Gate valve without handle on one of the pipes.

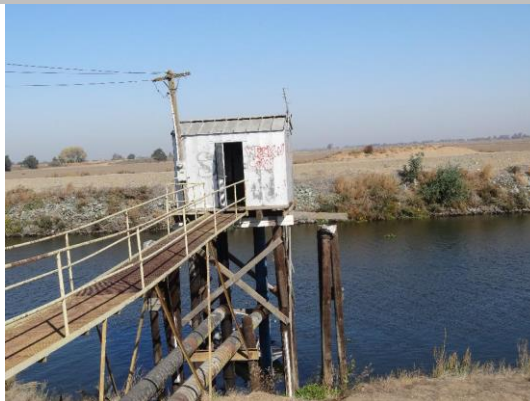
Photo 3 of 3 : UCIP\_SP\_2020\_23140\_39529.jpg

WS view: pump house on wooden pipe structure in the stream. Two steel pipes under the walkway.
