**Flood Control Project Maintenance
Levee Inspections
Unit Cover Sheet**

Reclamation District No. 2062 Stewart

Levee Inspection Report By Mile - Spring 2021

Waterway	Bank	Unit Miles	Inspection Start/End	Inspector
Unit No. 01 San Joaquin River	Left	2.64	04/07/2021 04/07/2021	Alberto De Leon

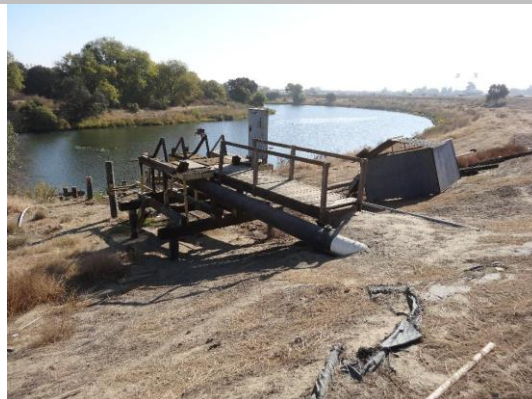
Photo 1 of 3 : UCIP_SP_2021_22807_38905.jpg

FS_ID:22807
DS_ID:19177
EP_NO: 12679
Repair Type: Non-Urgent
Crossing Status: Found
UCIP Comments: - All 3 pipes on landside looks new.- Pumps, pump house, and pipes removed from waterside.- Land development activities going on in this area.- Needs to confirm from LMA or DWR Inspector about the crossing.
FIELD_STRUCT_DESC: 1 of 3: 16-inch steel irrigation discharge pipe through the levee, 5 feet below the crown. Electrical conduit through the levee. Slant pump in a pump house on the waterside (WS) slope. Siphon breaker on the landside (LS) slope. Service pole and concrete gate valve box at the landside (LS) toe. Installed by USACE in 1961. (Plans to replace rusted portions of two 16-inch irrigation pipes through the levee authorized under Permit No. 16124, 1993 - Reclamation District No. 2062). [Additional Reference(s): DWR Levee Log, 2007. USACE San Joaquin O&M Manual 9, April 1964, (HLM 1.65)].

WS view: pipes, walkway, and dismantled pumphouse (right).

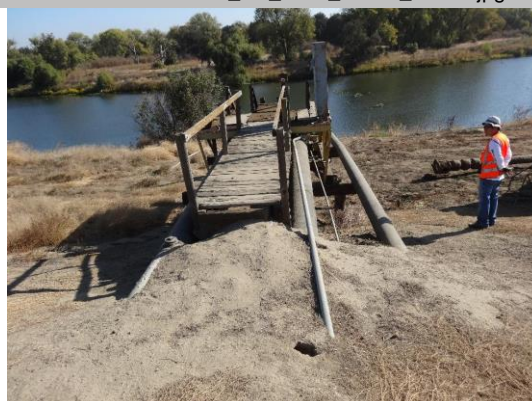
Photo 2 of 3 : UCIP_SP_2021_22807_38904.jpg

WS view: 16-inch pipes on both sides of walkway and 10-inch pipe (on right) away from walkway.

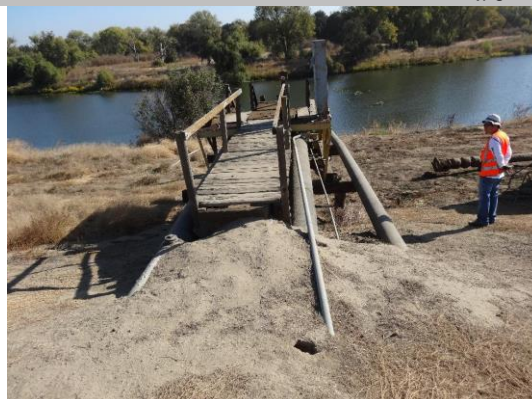
Photo 2 of 3 : UCIP_SP_2021_22809_38912.jpg

WS view: 16-inch pipes on both sides of walkway and 10-inch pipe (on right) away from walkway.

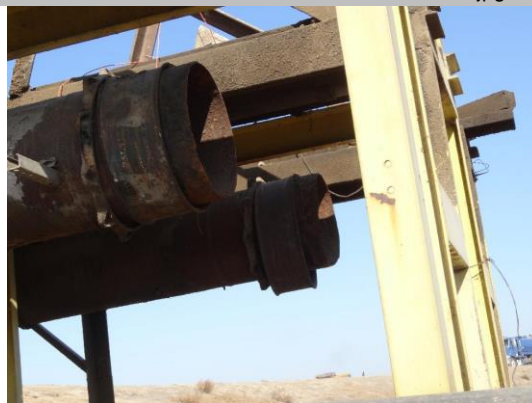
Photo 3 of 3 : UCIP_SP_2021_22809_38911.jpg

WS view: two 16-inch pipes under walkway; pumps were removed.

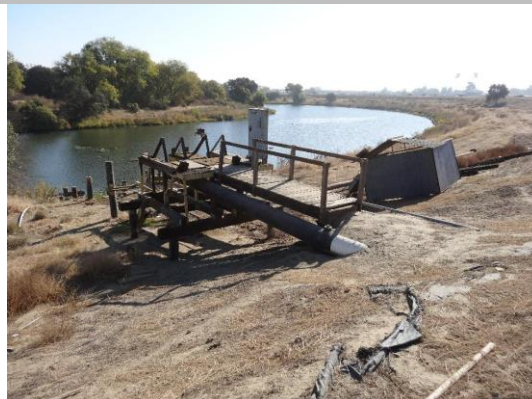
Photo 1 of 3 : UCIP_SP_2021_22810_38918.jpg

FS_ID:22810
DS_ID:19184
EP_NO: 12679
Repair Type: Non-Urgent
Crossing Status: Found
UCIP Comments: - All 3 pipes on landside looks new. No pump associated with 8-inch pipe.- Pumps, pump house, and pipes removed from waterside.- Land development activities going on in this area.- Needs to confirm from LMA or DWR Inspector about the crossing.
FIELD_STRUCT_DESC: 3 of 3: 8-inch steel irrigation discharge pipe through the levee, 8 feet below the crown. Electrical conduit through the levee. Slant pump in a pump house on the waterside (WS) slope. Siphon breaker on the landside (LS) slope. Service pole and concrete gate valve box at the landside (LS) toe. (Plans to install a 75-horsepower pump on the bank with a 10-inch steel discharge pipe through the levee authorized under Permit No. 12679, 1979 - Reclamation District No. 2062). [Additional Reference(s): DWR Levee Log, 2007].
FS Date: 10/22/2013

WS view: pipes, walkway, and dismantled pumphouse (right).

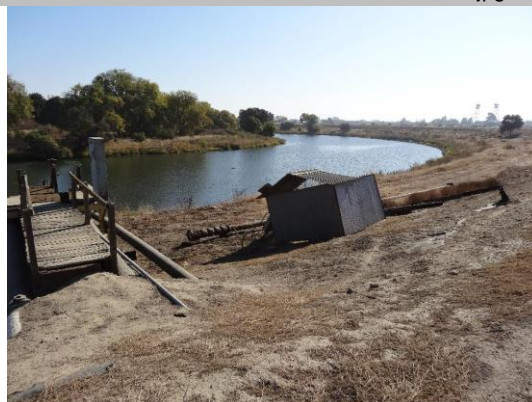
Photo 2 of 3 : UCIP_SP_2021_22810_38917.jpg

WS view: electric conduit and 10-inch pipe (right). Dismantled/removed pipe and pump house (far right).

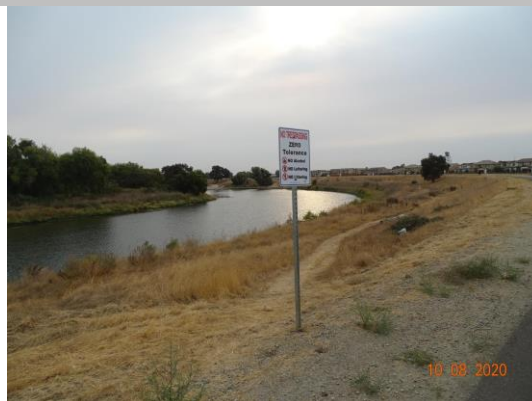
Photo 1 of 1 : SP_2021_RD2062_309_12_20210210_00002.jpg

LM Start	1.66	Rating **	A/W	Issue No.	12
LM End	1.66	Issue Type +	Ma	Location *	WS
Category	Earthen Levee			GPS Latitude/Longitude	
				Start	End
Item	Slope Stability			37.793207 °	37.793207 °
				-121.315214 °	-121.315214 °
DWR ID	DWR_RD2062_01_f_2020_12				
Comment Code					
S2 : Repair the levee slope damaged by foot traffic and prevent access where possible.					
Inspector Comment					
Pedestrian pathway on waterside slope needs to monitored for slope stability.

View of pedestrian pathway on waterside slope. Fall 2020

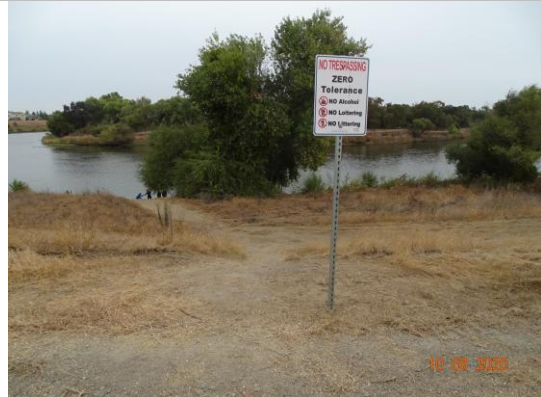
Photo 1 of 1 : SP_2021_RD2062_309_10_20210210_00001.jpg

LM Start	1.91	Rating **	A/W	Issue No.	10
LM End	1.91	Issue Type +	Ma	Location *	WS
Category	Earthen Levee			GPS Latitude/Longitude	
				Start	End
Item	Slope Stability			37.791977 °	37.791977 °
				-121.311383 °	-121.311383 °
DWR ID	DWR_RD2062_01_f_2020_10				
Comment Code					
S2 : Repair the levee slope damaged by foot traffic and prevent access where possible.					
Inspector Comment

View of pedestrian pathway on waterside slope. Fall 2020

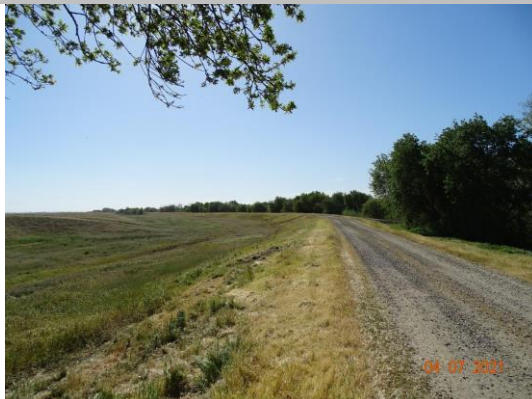
Photo 1 of 1 : SP_2021_RD2062_310_10_20210419_00026.jpg

View of well maintained vegetation along the landside slope and easement. Spring 2021

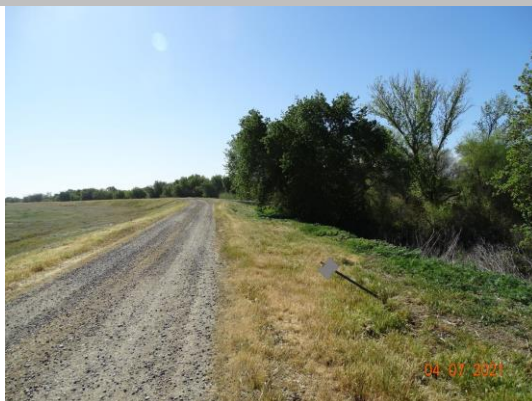
Photo 1 of 1 : SP_2021_RD2062_310_11_20210419_00027.jpg

View of well maintained vegetation along the waterside slope. Spring 2021

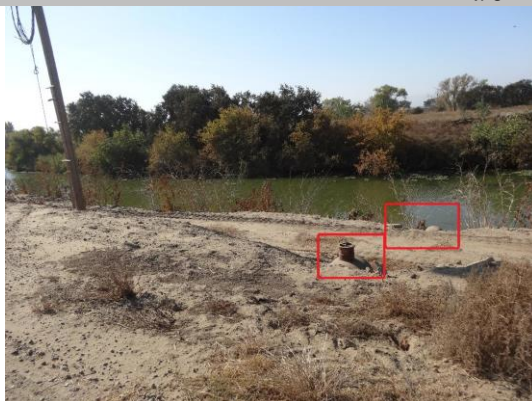
Photo 1 of 3 : UCIP_SP_2021_23110_39398.jpg

LM Start	0.56	Rating **	M	Issue No.	1	
LM End	0.56	Issue Type +	En	Location *		
Category	Supplemental			GPS Latitude/Longitude		
				Start		End
Item	DWR UCIP Field Study			37.784380 °		37.784380 °
				-121.338985 °		-121.338985 °
DWR ID	24697					
Comment Code						
Inspector Comment						
FS_ID:23110 DS_ID:24697 EP_NO: N/A Repair Type: Non-Urgent Crossing Status: Found UCIP Comments: Found on field with the help of USACE 2012 PI Report.Needs proper abandonment. FIELD_STRUCT_DESC: *ABANDONED* 24-inch steel irrigation discharge pipe through the levee, at an unknown depth. Damaged siphon breaker on the waterside (WS) slope. Pump on a concrete sump in an irrigation ditch on the landside (LS). Service pole on the LS slope. Pump disconnected from the service pole. FS Date: 10/23/2013

WS view: power pole (left), siphon breaker (marked- left), and steel pipe (right) on levee slope.

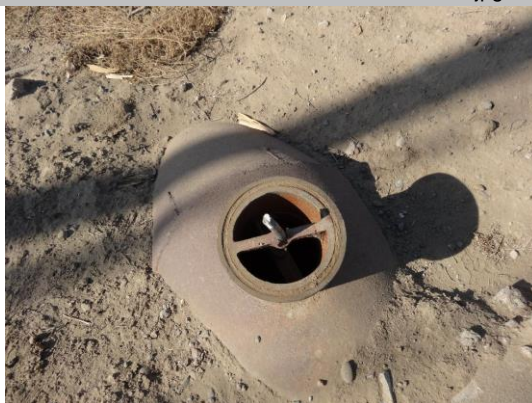
Photo 2 of 3 : UCIP_SP_2021_23110_39397.jpg

WS view: exposed steel pipe and damaged siphon breaker on levee slope.

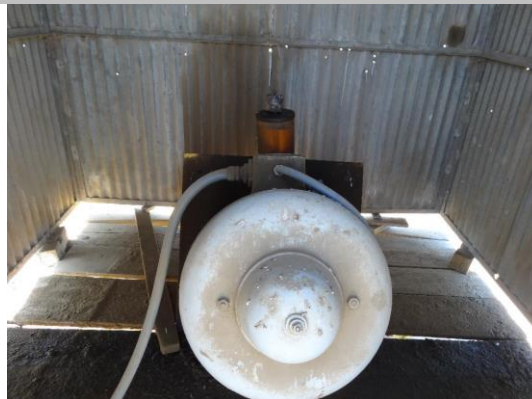
Photo 2 of 3 : UCIP_SP_2021_23181_39791.jpg

WS view: leaky slant pump in pumphouse on levee slope.

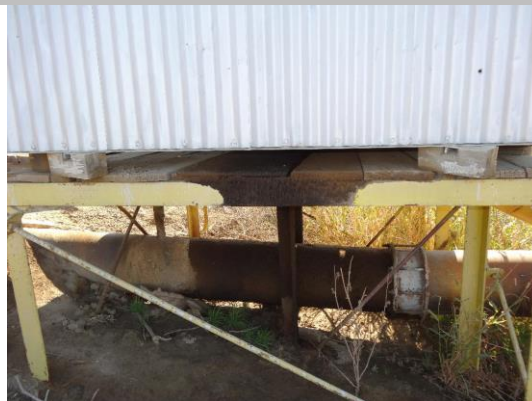
Photo 3 of 3 : UCIP_SP_2021_23181_39790.jpg

WS view: oil leakage from slant pump. Pipe under pump house.

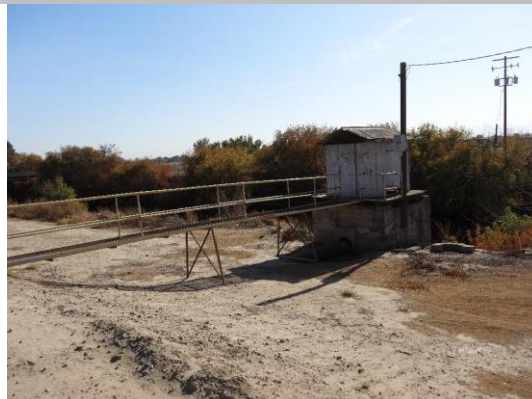
Photo 1 of 3 : UCIP_SP_2021_51468_39195.jpg

FS_ID:51468
DS_ID:19193
EP_NO: N/A
Repair Type: Non-Urgent
Crossing Status: Found
UCIP Comments: 04/05/2017: Pipe has been plugged as a flood fight measure and is likely to be replaced under a permit. MBK (Michael Moncrief) is working on the permit. Photo and update courtesy of Max Khashchuk as part of his 2017 Spring Inspection. (K. Fazel - UCIP)10/22/2013:- pumphouse on concrete sump in the channel.- erosion under walkway on waterside. (P. Amatya - DWR)
FIELD_STRUCT_DESC: 20-inch steel irrigation discharge pipe through the levee, 8 feet below the crown. Pump house on the waterside (WS) slope. Metal walkway from the pump house to the crown. Flap gate, siphon breaker, and concrete distribution box on the landside (LS) slope. [Additional Reference(s): DWR Levee Log, 2007, 18-inch pipe referenced. USACE San Joaquin O&M Manual 9, April 1964, (HLM 1.40), 18-inch pipe referenced].
FS Date: 4/6/2017

WS view: pipe, walkway, and pumphouse on levee berm. Service pole on waterside.

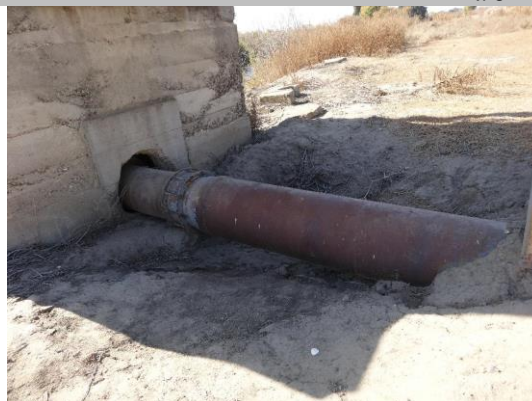
Photo 3 of 3 : UCIP_SP_2021_51468_39193.jpg

WS view: exposed steel pipe under walkway. Soil erosion under walkway. This may be due to leaky pipe joint.

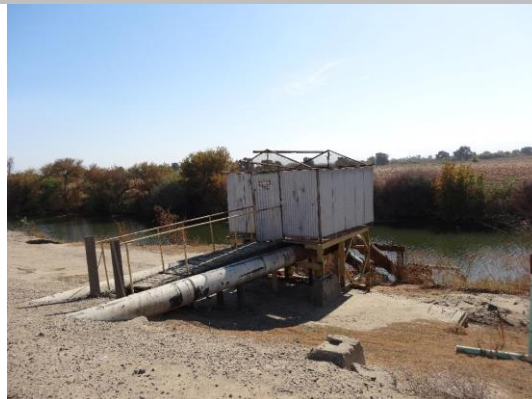
Photo 1 of 3 : UCIP_SP_2021_53375_39187.jpg

FS_ID:53375
DS_ID:19194
EP_NO: 4305
Repair Type: Urgent
Crossing Status: Found
UCIP Comments: 10/10/2018 Extremely overgrown vegetation did not allow visual inspection of WS levee erosion; however, there are indications based on vegetation growth patterns that the erosion is still present, so keeping crossing as Urgent (D. Sanoski - DWR UCIP).08/31/2016: Heavy sloughing and sink hole remains at the WS slope in alignment with pipe. Though sloughing is not affecting levee prism, it is still an indication of a pipe integrity problem. Oil leak at the pump but does not appear to impact the levee. (K. Fazel - UCIP)10/22/2013:- missing roof in pump house.- no protection for siphon breaker- huge erosion under pumphouse and levee slope on waterside. (P. Amatya - DWR)
FIELD_STRUCT_DESC: 1 of 2: 18-inch steel irrigation discharge pipe through the levee, 4.8 feet below the crown. Pump house on the waterside (WS) slope. Siphon breaker on the landside (LS) shoulder. Service pole on the LS shoulder. Concrete distribution box at the LS toe. (Plans for installation of two irrigation pumps on the bank to replace an old centrifugal pumping plant at the same location authorized under Permit No. 4305, 1963 - Reclamation District No. 2062) [Additional Reference(s): DWR Levee Log, 2007. USACE San Joaquin O&M Manual 9, April 1964, (HLM 1.67)].

WS view: pipes, walkway, and pumphouse with missing roof (right).

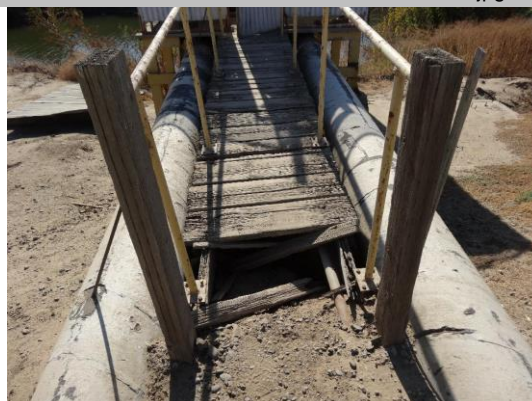
Photo 2 of 3 : UCIP_SP_2021_53375_39186.jpg

WS view: walkway to pumphouse. Walkway in poor condition.

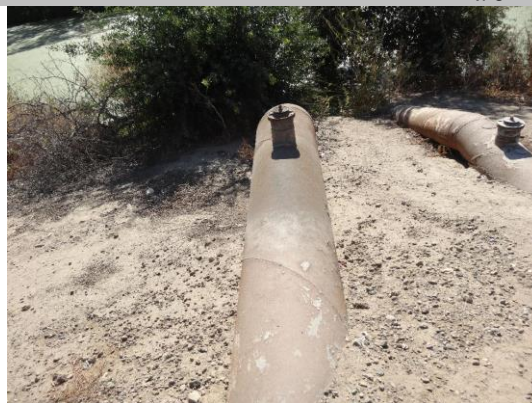
Photo 1 of 3 : UCIP_SP_2021_23304_40147.jpg

Comment Code						
Inspector Comment						
FS_ID:23304 DS_ID:19199 EP_NO: 11524 Repair Type: Non-Urgent Crossing Status: Found UCIP Comments: - waterside pipe immersed into channel water.- most of the pipe on landside exposed and siphon breaker on waterside not protected. FIELD_STRUCT_DESC: 1 of 3: 24-inch coated steel drainage discharge pipe through the levee, 2 feet below the crown. Siphon breaker on the waterside (WS) slope. Pump on a steel platform in a drainage ditch, 350 feet from the levee centerline off the landward berm. (Plans to install a drainage pump and 24-inch discharge line through the levee at existing main drainage pump authorized under Permit No. 11524, 1976 - Reclamation District No. 2062). [Additional Reference(s): DWR Levee Log, 2007. USACE San Joaquin O&M Manual 9, April 1964, (HLM 3.29)]. FS Date: 10/22/2013

WS view: 24-inch steel pipe (left) with siphon breaker on levee slope. 18-inch pipe on right.

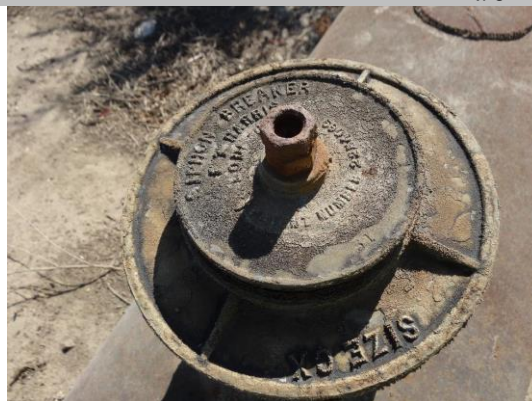
Photo 2 of 3 : UCIP_SP_2021_23304_40146.jpg

WS view: leaky siphon breaker on levee slope.

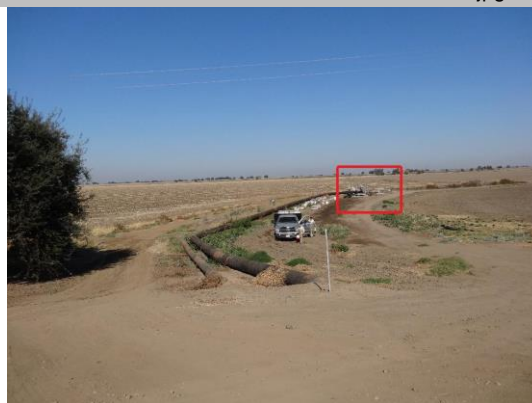
Photo 3 of 3 : UCIP_SP_2021_23304_40148.jpg

LS view: overview of pipes on levee berm and pump platform (marked - right) off the berm 350 ft from the levee.

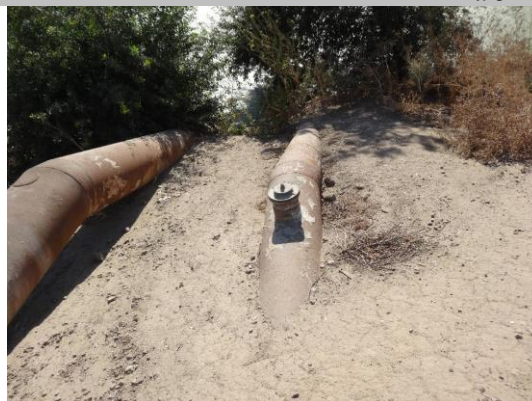
Photo 1 of 3 : UCIP_SP_2021_23023_39082.jpg

FS_ID:23023
DS_ID:19198
EP_NO: 11524
Repair Type: Non-Urgent
Crossing Status: Found
UCIP Comments: - 18-inch pipe bifurcated near the pump and two gate valves installed.- waterside pipe immersed into channel water.- most of the pipe on landside exposed and siphon breaker on waterside not protected.
FIELD_STRUCT_DESC: 2 of 3: 18-inch coated steel drainage discharge pipe through the levee, 4 feet below the crown. Siphon breaker on the waterside (WS) slope. Pump on a steel platform in a drainage ditch, 350 feet from the levee centerline off the landward berm. (Plans to install a drainage pump and 24-inch discharge line through the levee at existing main drainage pump authorized under Permit No. 11524, 1976 - Reclamation District No. 2062). [Additional Reference(s): DWR Levee Log, 2007. USACE San Joaquin O&M Manual 9, April 1964, (HLM 3.29), 16-inch pipe referenced].
FS Date: 10/22/2013

WS view: exposed 18-inch pipe with siphon breaker on levee slope.
Exposed 24-inch pipe (left).

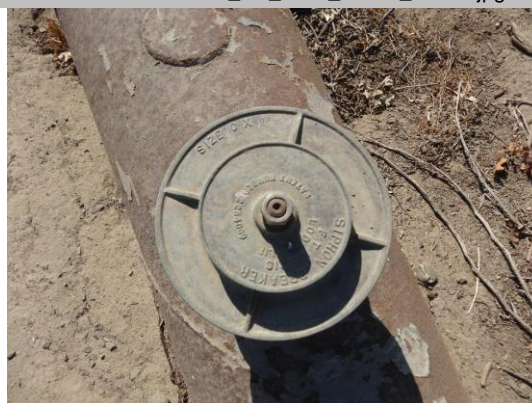
Photo 2 of 3 : UCIP_SP_2021_23023_39081.jpg

WS view: closer view of 18-inch pipe with siphon breaker on levee slope.

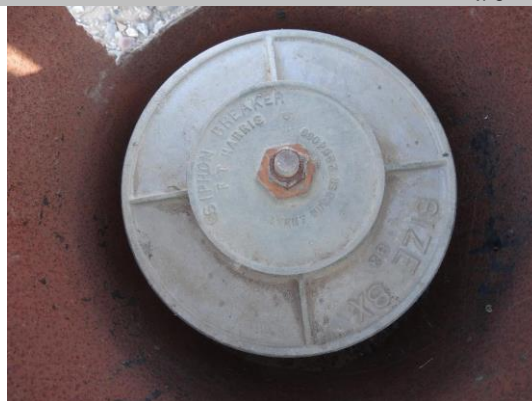
Photo 2 of 3 : UCIP_SP_2021_23305_40152.jpg

WS view: closer view of siphon breaker in steel pipe riser on levee slope.

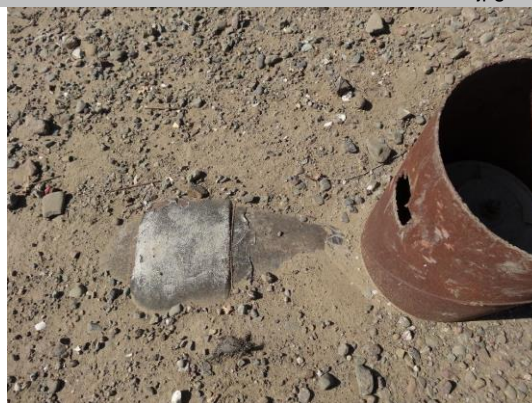
Photo 3 of 3 : UCIP_SP_2021_23305_40151.jpg

WS view: exposed pipe and steel pipe riser on levee slope.

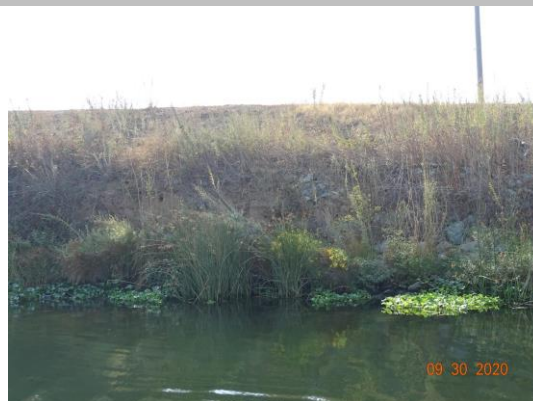
Photo 1 of 3 : SP_2021_RD2062_311_8_20210210_00016.jpg

9/30/2020: Close-up view of the scarp on the levee slope.

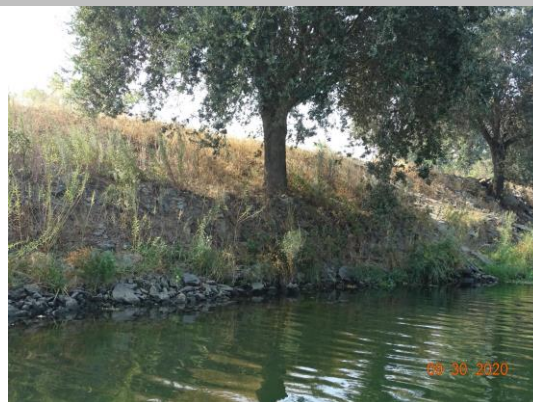
Photo 2 of 3 : SP_2021_RD2062_311_8_20210210_00017.jpg

9/30/2020: View of the eroded levee slope looking downstream.

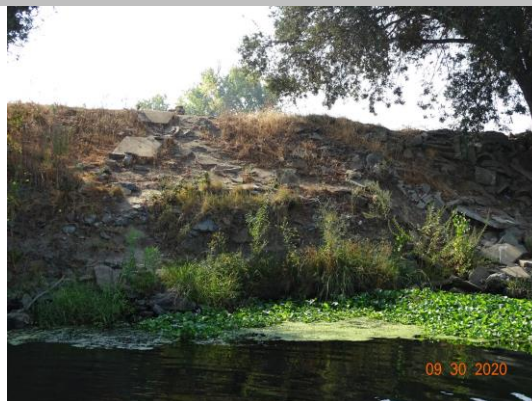
Photo 3 of 3 : SP_2021_RD2062_311_8_20210210_00018.jpg

9/30/2020: Crushed concrete on the eroded levee slope.

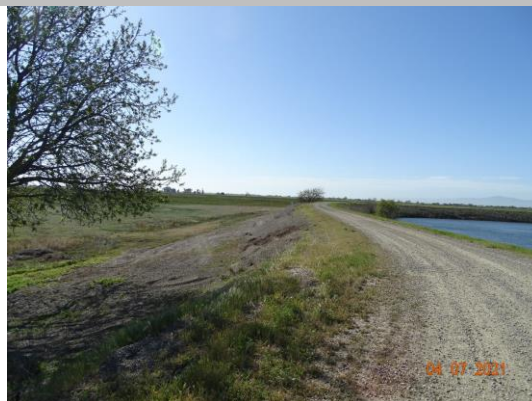
Photo 1 of 1 : SP_2021_RD2062_311_30_20210419_00042.jpg

Typical view of well maintained vegetation along the landside slope and easement. Spring 2021

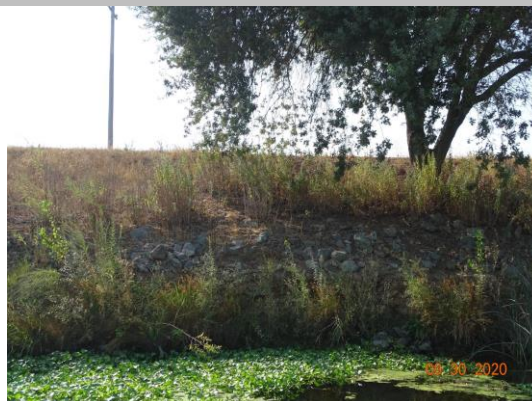
Photo 2 of 3 : SP_2021_RD2062_311_3_20210210_00005.jpg

9/30/2020: View of the erosion and some old riprap.

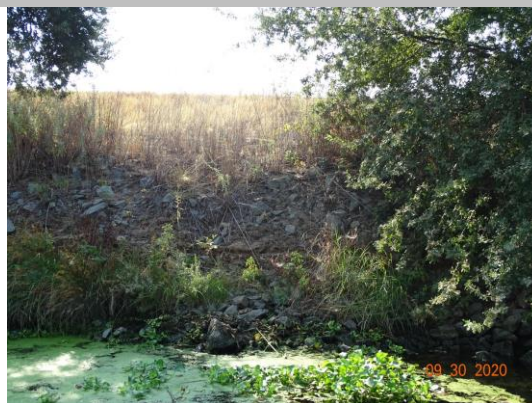
Photo 3 of 3 : SP_2021_RD2062_311_3_20210210_00006.jpg

9/30/2020: Another view of the erosion.

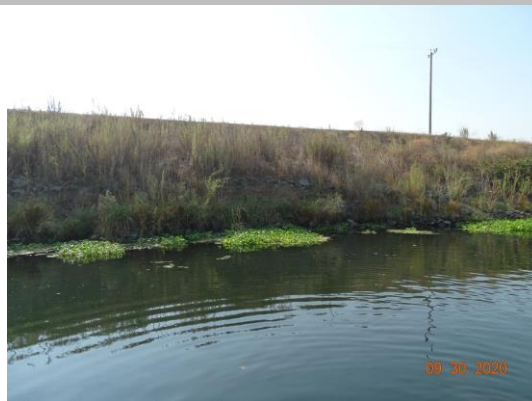
Photo 1 of 2 : SP_2021_RD2062_311_2_20210210_00002.jpg

9/30/2020: Overview of the erosion site.

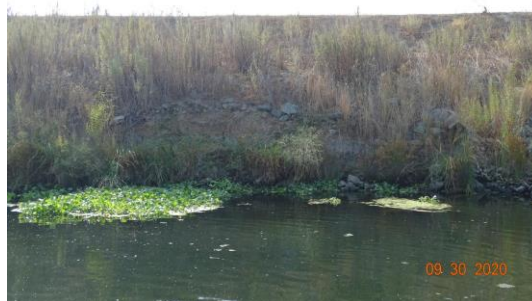
Photo 2 of 2 : SP_2021_RD2062_311_2_20210210_00003.jpg

9/30/2020: Close-up view of the erosion.

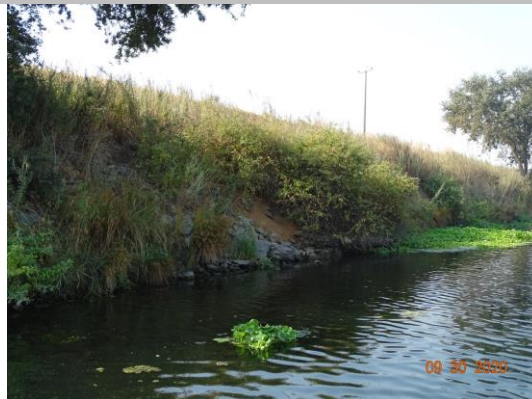
Photo 1 of 3 : SP_2021_RD2062_311_4_20210210_00007.jpg

9/30/2020: View of the eroding levee slope.

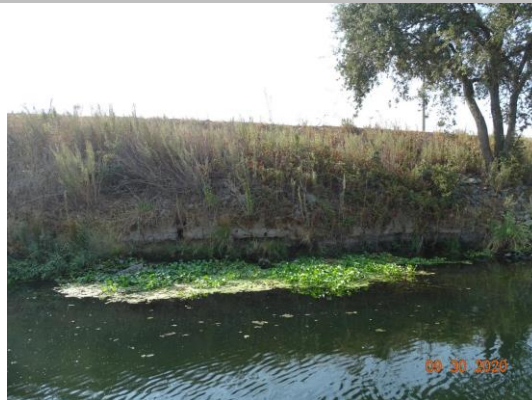
Photo 2 of 3 : SP_2021_RD2062_311_4_20210210_00008.jpg

9/30/2020: The erosion has cut into the levee prism.

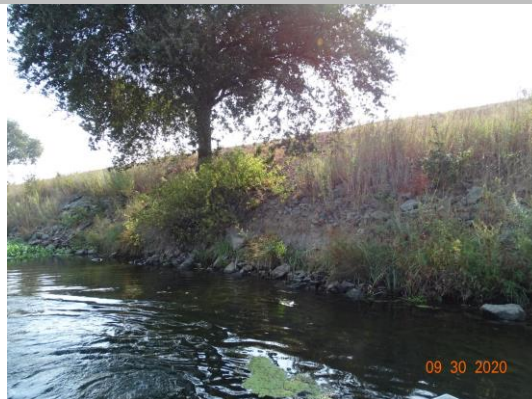
Photo 3 of 3 : SP_2021_RD2062_311_4_20210210_00009.jpg

9/30/2020: View of the erosion near the downstream end.

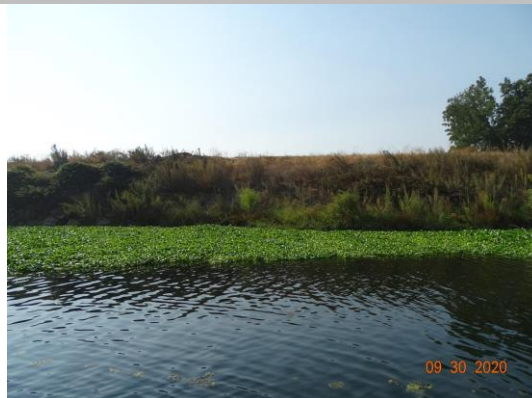
Photo 1 of 1 : SP_2021_RD2062_311_1_20210210_00001.jpg

9/30/2020: Front view of the erosion.

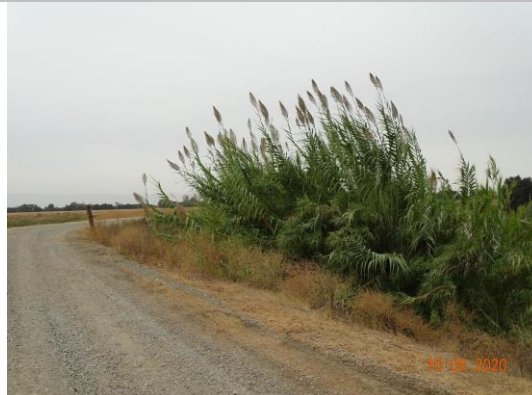
Photo 1 of 1 : SP_2021_RD2062_311_36_20210210_00025.jpg

Large Arundo plants blocking visibility on waterside slope. Fall 2020

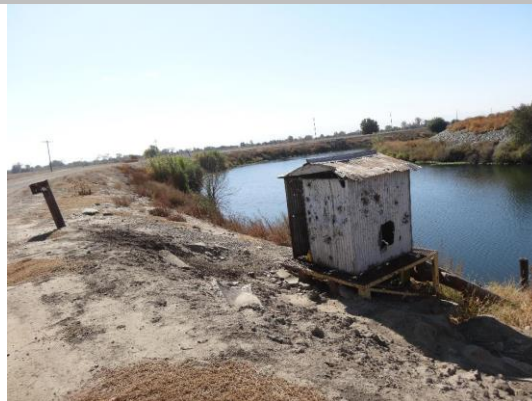
Photo 1 of 3 : UCIP_SP_2021_53377_40158.jpg

WS view: pump house on levee slope and soil erosion on levee slope.

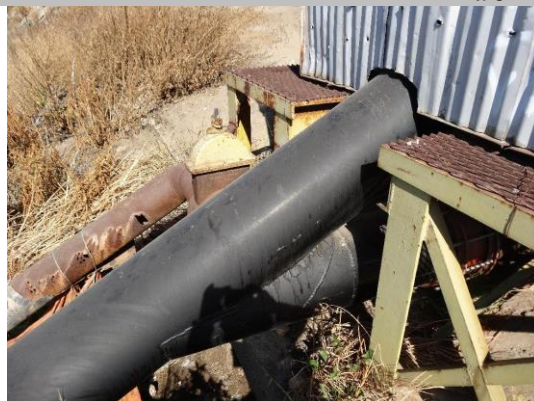
Photo 2 of 3 : UCIP_SP_2021_53377_40157.jpg

WS view: pump house on levee slope and holes-pits on corroded overflow pipe (left).

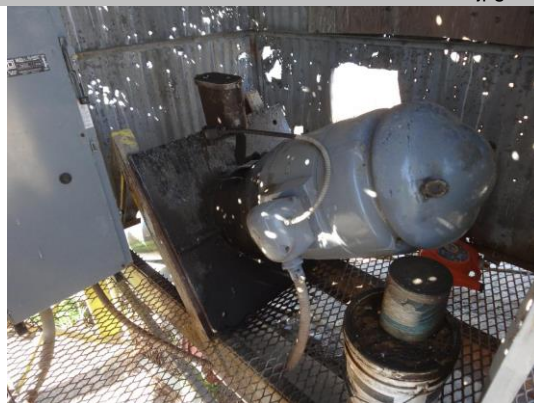
Photo 3 of 3 : UCIP_SP_2021_53377_40156.jpg

WS view: slant pump in pumphouse on levee slope.

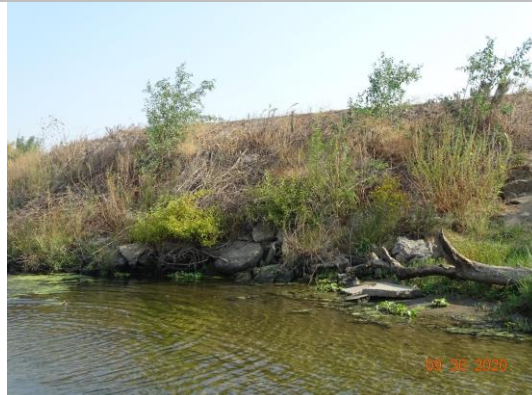
Photo 1 of 2 : SP_2021_RD2062_311_5_20210210_00010.jpg

9/30/2020: View of the eroded levee slope and displaced riprap.

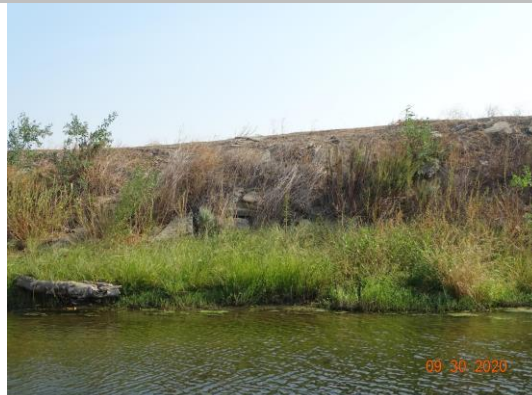
Photo 2 of 2 : SP_2021_RD2062_311_5_20210210_00011.jpg

9/30/2020: Another view of the eroded slope with displaced riprap.

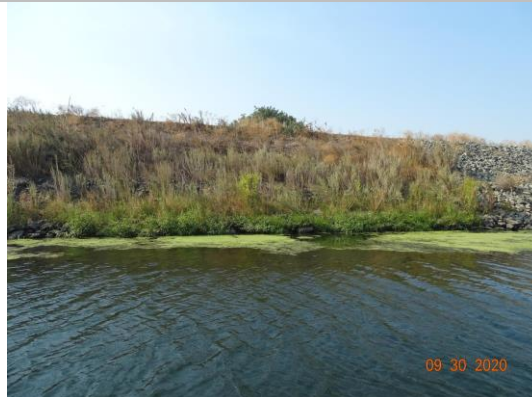
Photo 1 of 2 : SP_2021_RD2062_311_6_20210210_00012.jpg

9/30/2020: Front view of the erosion.

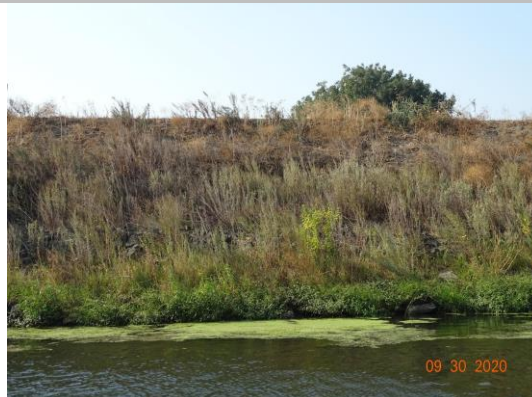
Photo 2 of 2 : SP_2021_RD2062_311_6_20210210_00013.jpg

9/30/2020: Close-up view of the erosion.

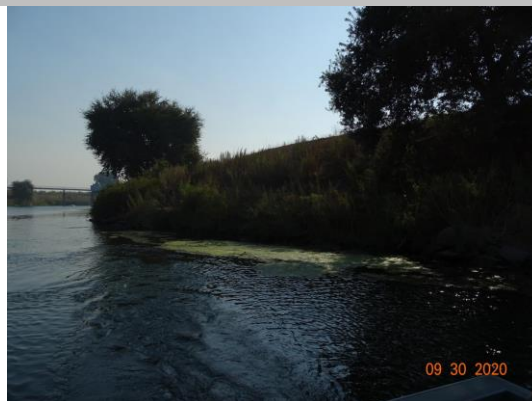
Photo 1 of 2 : SP_2021_RD2062_311_7_20210210_00014.jpg

9/30/2020: View of the erosion looking upstream.

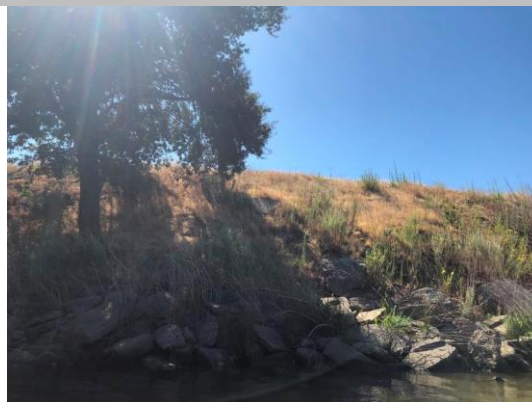
Photo 2 of 2 : SP_2021_RD2062_311_7_20210210_00015.jpg

8/14/2019: Close-up view of the site.

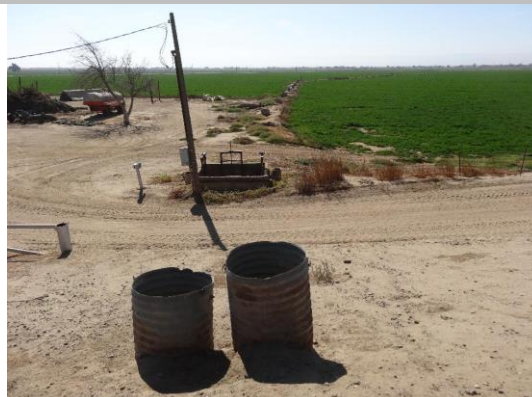
Photo 3 of 3 : UCIP_SP_2021_23311_40173.jpg

LS view: two CMP risers on levee slope, concrete distribution box, and service pole across the dirt road, off the levee toe.

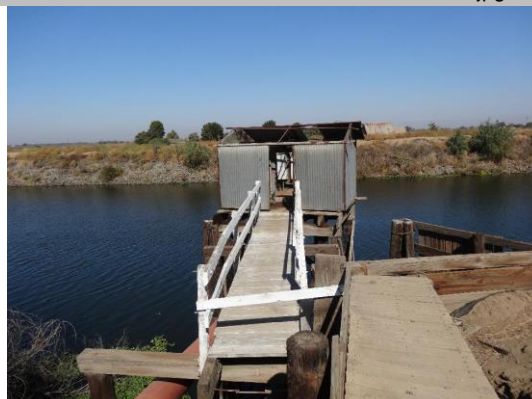
Photo 1 of 3 : UCIP_SP_2021_23312_40181.jpg

WS view: wooden walkway to pumphouse, pumphouse on wooden pile structure in the stream.

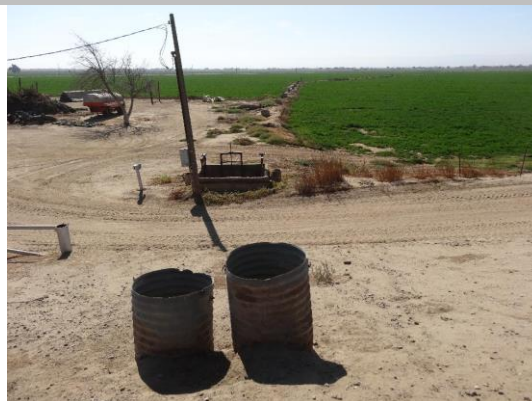
Photo 3 of 3 : UCIP_SP_2021_23312_40180.jpg

LS view: two CMP risers on levee slope, concrete distribution box, and service pole across the dirt road, off the levee toe.

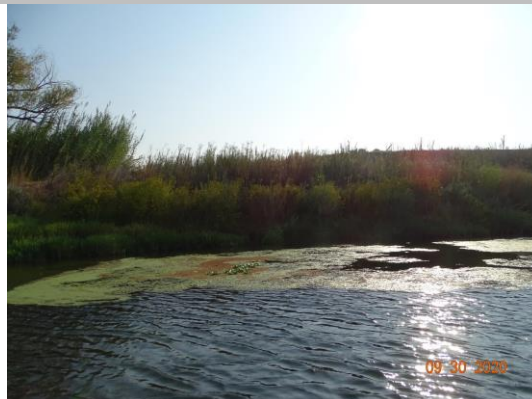
Photo 1 of 2 : SP_2021_RD2062_311_9_20210210_00019.jpg

9/30/2020: Front view of the erosion.

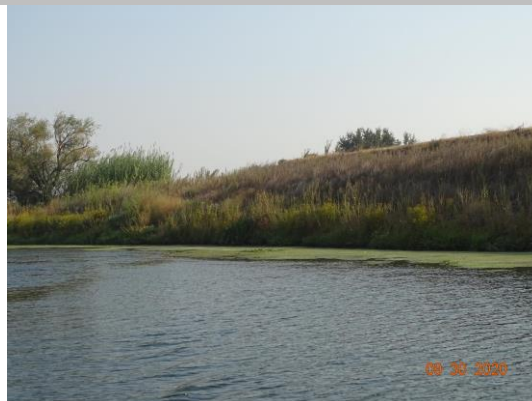
Photo 2 of 2 : SP_2021_RD2062_311_9_20210210_00020.jpg

9/30/2020: Another view of the erosion.

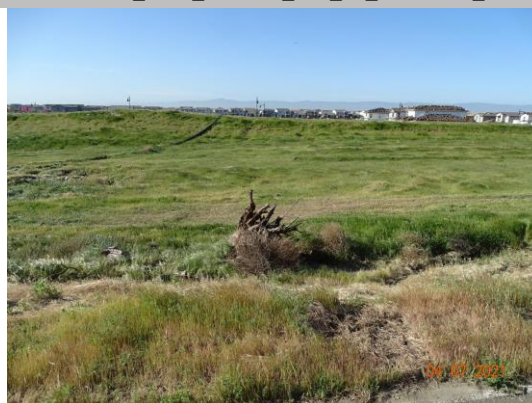
Photo 1 of 1 : SP_2021_RD2062_311_15_20210419_00041.jpg

View of tree limbs and stumps within the landside easement. Spring 2021

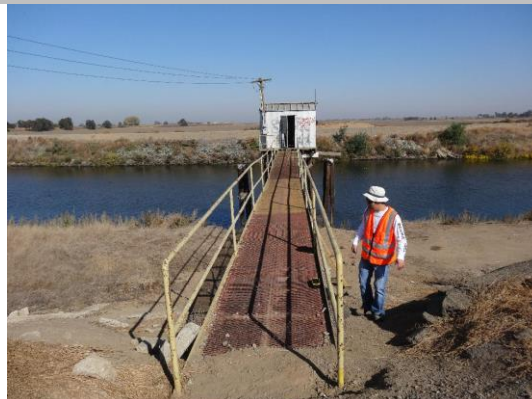
Photo 1 of 3 : UCIP_SP_2021_23142_39549.jpg

WS view: steel walkway to pump house in the stream.

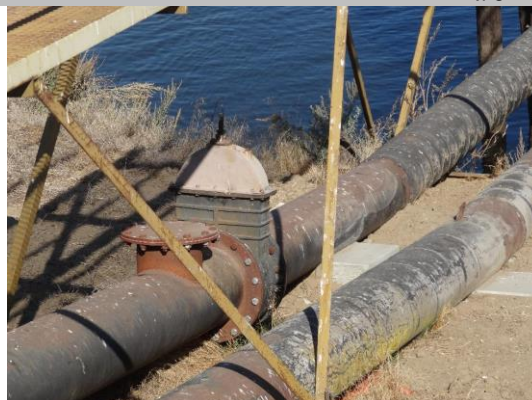
Photo 2 of 3 : UCIP_SP_2021_23142_39548.jpg

WS view: two 16-inch pipes under walkway. Gate valve without handle on one of the pipes.

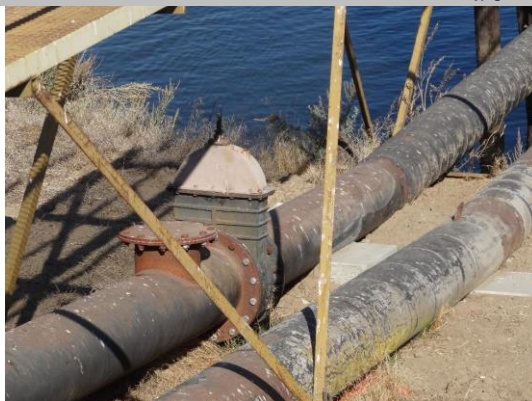
Photo 2 of 3 : UCIP_SP_2021_23140_39530.jpg

WS view: two 16-inch pipes under walkway. Gate valve without handle on one of the pipes.

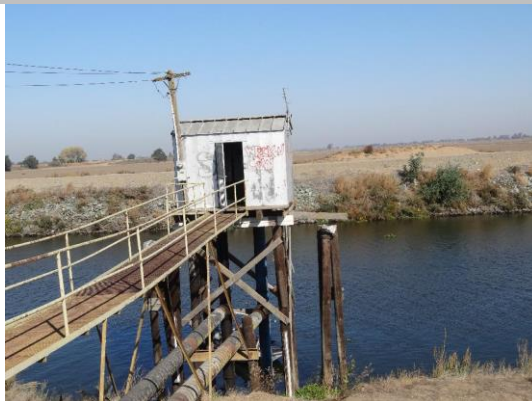
Photo 3 of 3 : UCIP_SP_2021_23140_39529.jpg

WS view: pump house on wooden pipe structure in the stream. Two steel pipes under the walkway.
