**Flood Control Project Maintenance
Levee Inspections
LMA District Cover Sheet**

Reclamation District No. 2062 Stewart

**Flood Control Project Maintenance
Levee Inspections**

Levee Inspection Report By Mile - Spring 2022

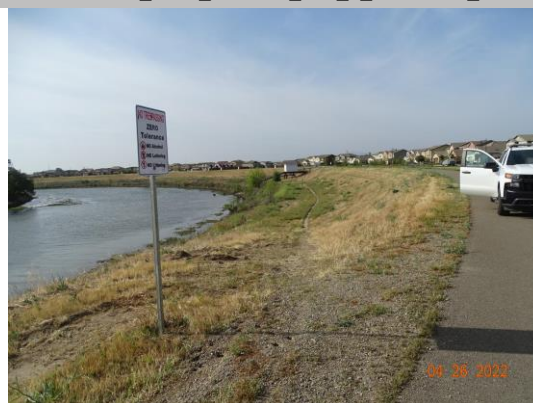
Photo 1 of 1 : SP_2022_RD2062_309_4_20220428_00011.jpg

View of pedestrian path on the waterside slope. Spring 2022

| E3 : Repair the levee slope damaged by foot traffic and prevent access where possible. | | | | | |

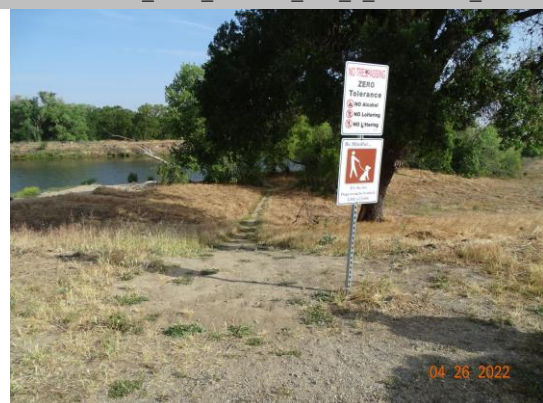
Photo 1 of 1 : SP_2022_RD2062_309_6_20220428_00010.jpg

View of pedestrian path on the waterside slope. Spring 2022

| E3 : Repair the levee slope damaged by foot traffic and prevent access where possible. | | | | | |

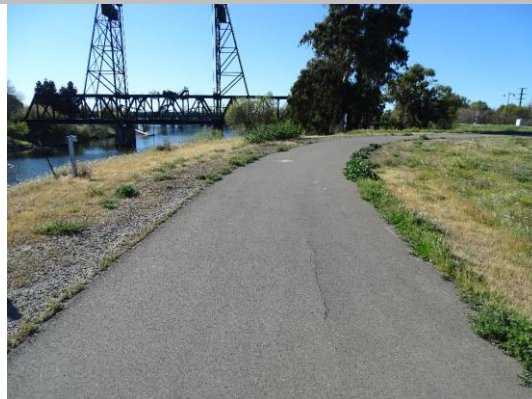
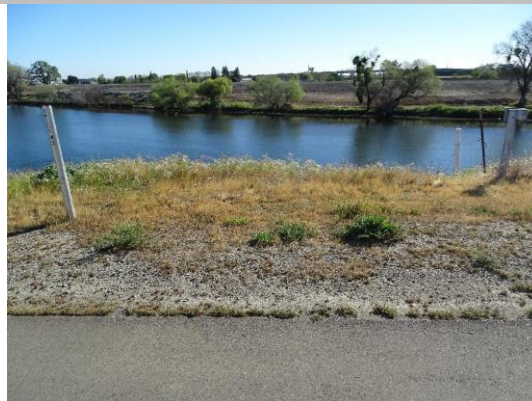
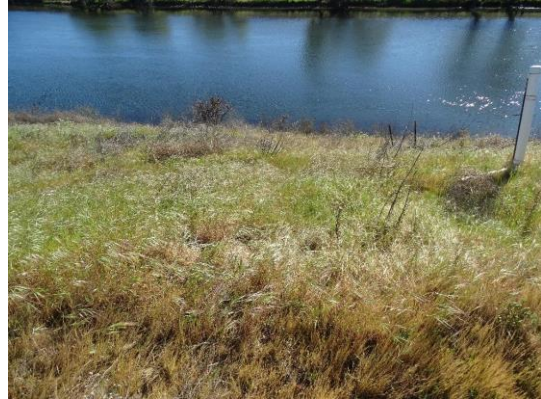
| FS_ID:72735 DS_ID:19178 EP_NO: N/A Repair Type: Non-Urgent Crossing Status: Not Found UCIP Comments: 03/22/2022 Record remains Non-Urgent. Crossing not found. Unauthorized encroachment recorded in Levee Log prior to 2011. (D.Sanoski - DWR UCIP) FIELD_STRUCT_DESC: Telephone conduit of an unknown size or material through the levee, 4 feet below the crown. [Additional Reference(s): DWR Levee Log, 2007]. FS Date: 3/22/2022 3:50:12 PM | | | | | | |

Top of Levee: view of crown.

Water-Side: view of shoulder.

Water-Side: view of slope.

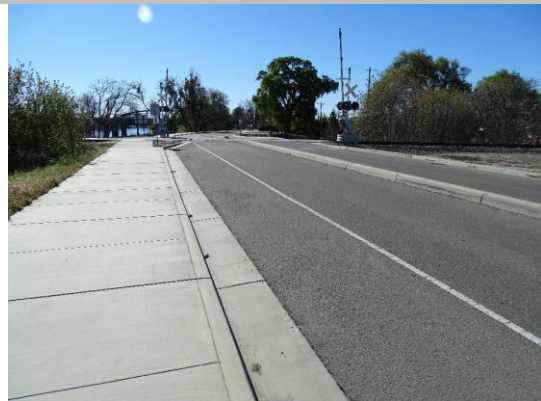
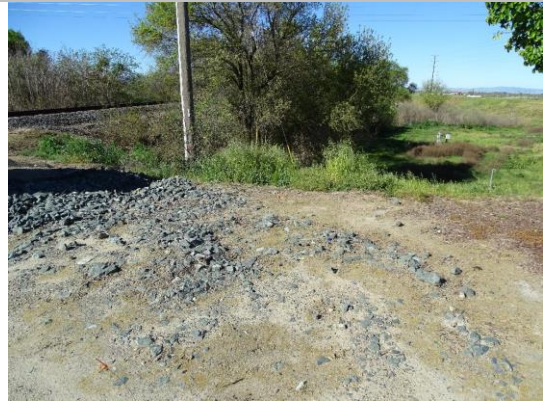
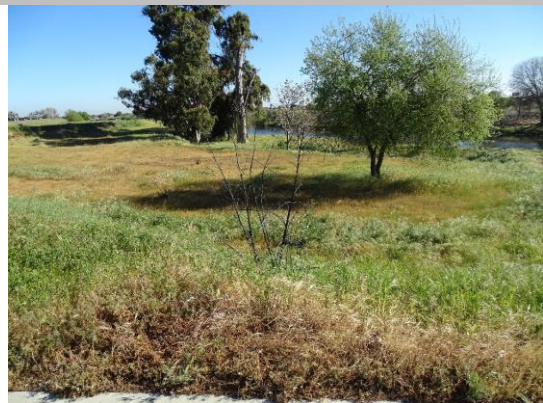
FS_ID:72736
DS_ID:19179
EP_NO: N/A
Repair Type: Non-Urgent
Crossing Status: Indicator Found
UCIP Comments: 03/22/2022 Record updated from No Action Needed to Non-Urgent. No inspection records were available to determine status of line through the levee. Unauthorized encroachment recorded in Levee Log prior to 2011. (D.Sanoski - DWR UCIP)
10/24/2013 Need to contact owner to determine status of crossing and install signs if appropriate. (P. Khoi - DWR UCIP)
FIELD_STRUCT_DESC: Natural gas pipeline of an unknown size or material through the levee, 2.5 feet below the crown. Gas line vent on the landside (LS) toe with small temporary Pacific Gas and Electric (PG&E) flags. (Pipeline owned by PG&E). [Additional Reference(s): DWR Levee Log, 2007].
FS Date: 3/22/2022 3:52:19 PM

Top of Levee: view of crown.

Land-Side: view of shoulder, slope, and gas vent.

Water-Side: view of slope.

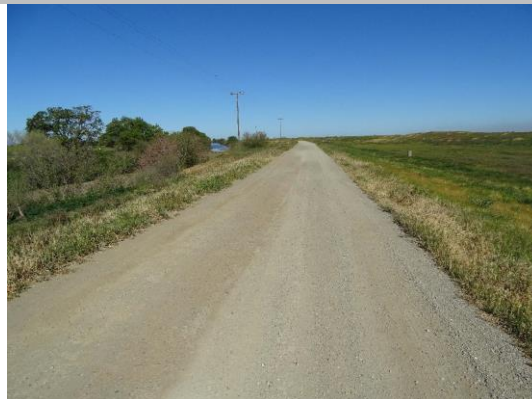
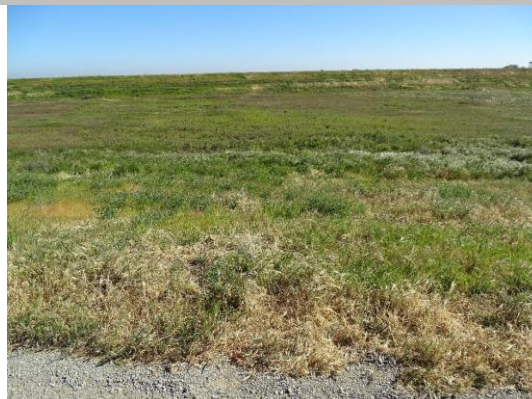
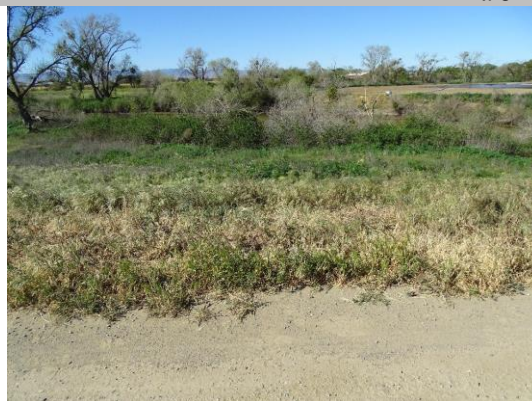
| FS_ID:72740 DS_ID:19191 EP_NO: N/A Repair Type: Non-Urgent Crossing Status: Not Found UCIP Comments: 03/22/2022 Record updated from No Action Needed to Non-Urgent. Geophysical results did not confirm presence of pipe through levee. Record will remain in UCIP's inspection records until future Levee Improvement Project can confirm no crossing was found through the levee. No permit has been identified authorizing pipe. (D.Sanoski - DWR UCIP) FIELD_STRUCT_DESC: *ABANDONED* 36-inch corrugated metal pipe of an unknown purpose under the levee, below ground elevation. Pipe plugged with concrete. [Additional Reference(s): DWR Levee Log, 2007. USACE San Joaquin O&M Manual 9, April 1964, (HLM 0.47)]. FS Date: 3/22/2022 4:01:39 PM | | | | | | |

Top of Levee: view of crown.

Land-Side: view of slope.

Water-Side: view of slope.

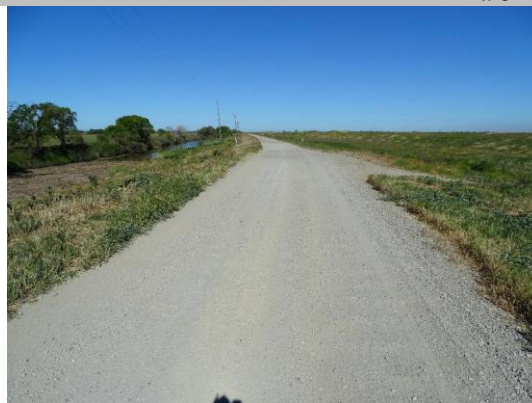
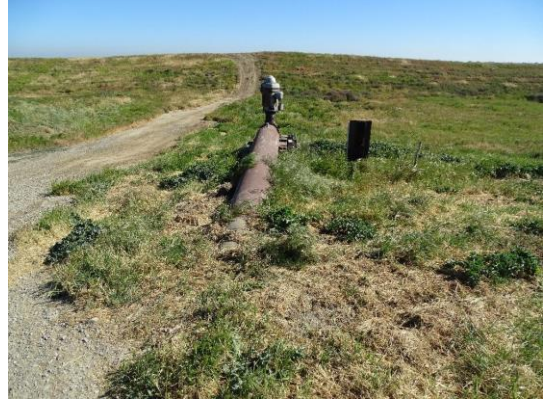
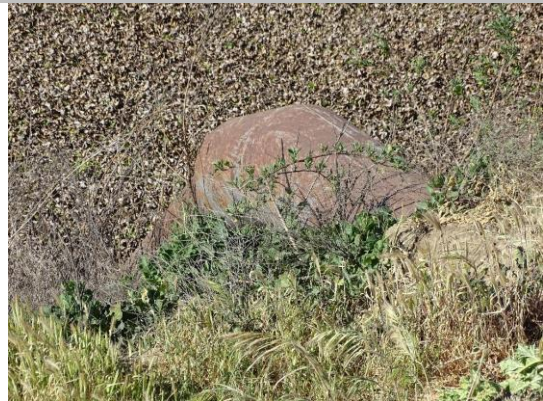
FS_ID:72742
DS_ID:24697
EP_NO: N/A
Repair Type: Non-Urgent
Crossing Status: Found
UCIP Comments: 03/22/2022 Record remains Non-Urgent. No permit has been found authorizing this pipe through the levee. Crossing appears abandoned. (D.Sanoski - DWR UCIP)
10/23/2013 Found on field with the help of USACE 2012 PI Report.

Needs proper abandonment. (P. Khoi - DWR UCIP)
FIELD_STRUCT_DESC: *ABANDONED* 24-inch steel irrigation discharge pipe through the levee, at an unknown depth. Damaged siphon breaker on the waterside (WS) slope. Pump on a concrete sump in an irrigation ditch on the landside (LS). Service pole on the LS slope. Pump disconnected from the service pole.
FS Date: 3/22/2022 4:03:35 PM

Top of Levee: view of crown.

Land-Side: view of slope and pipe to pump.

Water-Side: view of pipe out of slope.

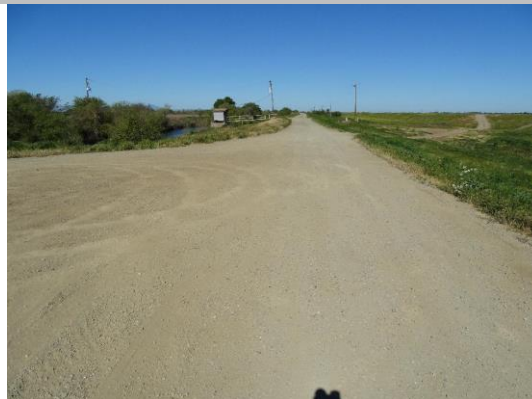
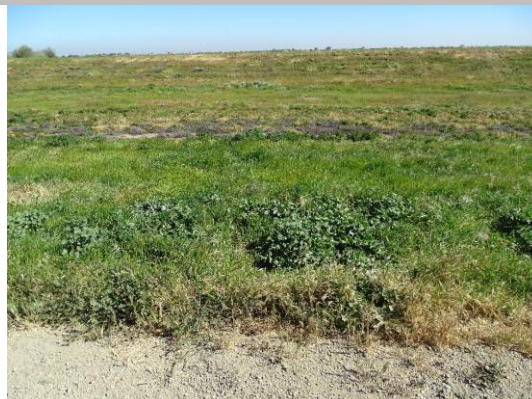
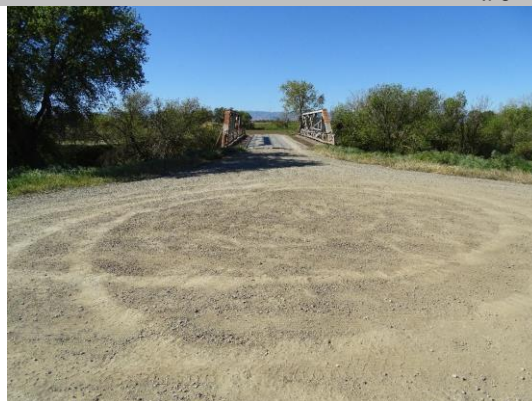
| FS_ID:72746 DS_ID:19196 EP_NO: N/A Repair Type: Non-Urgent Crossing Status: Not Found UCIP Comments: 03/22/2022 Record remains Non-Urgent. Geophysical results did not confirm presence of pipe through levee. Record will remain in UCIP's inspection records until future Levee Improvement Project can confirm no crossing was found through the levee. No permit has been identified authorizing pipe. (D.Sanoski - DWR UCIP) FIELD_STRUCT_DESC: *ABANDONED* 36-inch pipe of an unknown material or purpose through the levee, 8 feet below the crown. Pipe plugged with concrete. [Additional Reference(s): USACE San Joaquin O&M Manual 9, April 1964, (HLM 1.35)]. FS Date: 3/22/2022 4:13:14 PM | | | | | | |

Top of Levee: view of crown.

Land-Side: view of slope.

Water-Side: view of shoulder.

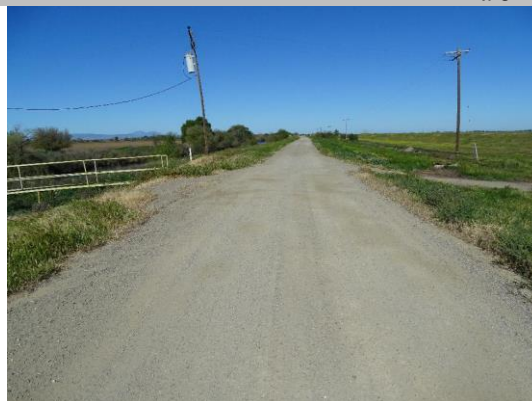
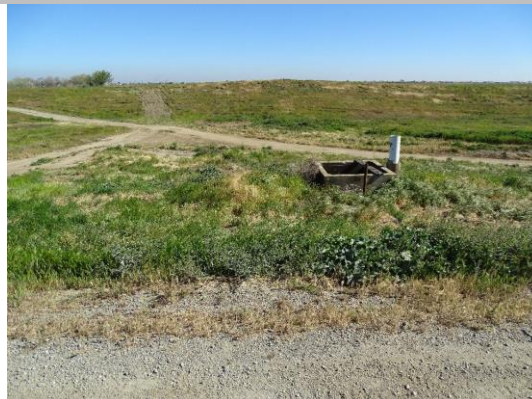
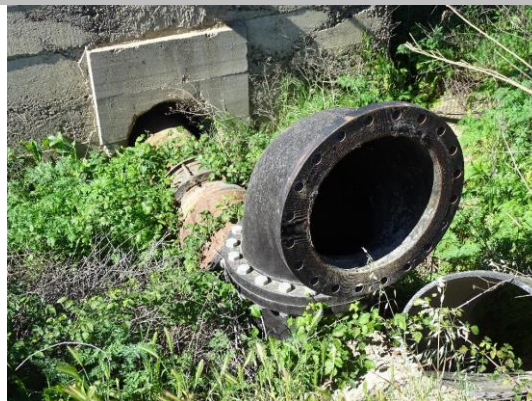
FS_ID:72747
DS_ID:19193
EP_NO: N/A
Repair Type: Non-Urgent
Crossing Status: Found
UCIP Comments: 03/22/2022 Record remains Non-Urgent. No permit has been identified authorizing pipe. Pipe capped with steel plate on WS and new attachment added to existing pipe out of pumphouse. (D.Sanoski - DWR UCIP)
04/05/2017 Pipe has been plugged as a flood fight measure and is likely to be replaced under a permit. MBK (Michael Moncrief) is working on the permit. Photo and update courtesy of Max Khashchuk as part of his 2017 Spring Inspection. (K. Fazel - UCIP)10/22/201 Pumphouse on concrete sump in the channel.- erosion under walkway on waterside. (P. Amatya - DWR)
FIELD_STRUCT_DESC: 20-inch steel irrigation discharge pipe through the levee, 8 feet below the crown. Pump house on the waterside (WS) slope. Metal walkway from the pump house to the crown. Flap gate, siphon breaker, and concrete distribution box on the landside (LS) slope. [Additional Reference(s): DWR Levee Log, 2007, 18-inch pipe referenced. USACE San Joaquin O&M Manual 9, April 1964, (HLM 1.40), 18-inch pipe referenced].

Top of Levee: view of crown.

Land-Side: view of slope to distribution box on toe.

Water-Side: view of new pipe alignment.

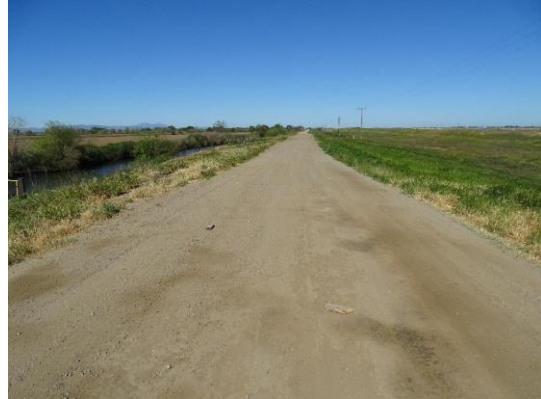
| FS_ID:72749 DS_ID:19197 EP_NO: 4305 Repair Type: Urgent Crossing Status: Found UCIP Comments: 03/22/2022 Record remains Urgent. DMP internal video inspection has found pipe integrity issues. LOF of crossing is between 5 and 6. Crossing will be monitored until funding becomes available to address the issues. Found holes in pipe on WS between water and pumphouse. (D.Sanoski - DWR UCIP) 10/10/2018 Extremely overgrown vegetation did not allow visual inspection of WS levee erosion; however, there are indications based on vegetation growth patterns that the erosion is still present, so keeping crossing as Urgent (D. Sanoski - DWR UCIP).08/31/2016: Heavy sloughing and sink hole remains at the WS slope in alignment with pipes. Though sloughing is not affecting levee prism, it is still an indication of a pipe integrity problem. Oil leak at the pump but does not appear to impact levee. (K. Fazel - UCIP)10/22/2013:- missing roof in pump house.- no protection for siphon breaker- huge erosion under pumphouse and levee slope on waterside. (P. Amatya - DWR) FIELD_STRUCT_DESC: 2 of 2: 18-inch steel irrigation discharge pipe through the levee, 4.8 feet below the crown. Pump house on the waterside (WS) slope. Siphon breaker on the landside (LS) shoulder. Service pole on the LS shoulder. Concrete distribution box at the LS toe. (Plans for installation of two irrigation pumps on the bank to replace an old centrifugal pumping plant at the same location authorized under Permit No. 4305, 1963 - Reclamation District No. 2062) [Additional Reference(s): DWR Levee Log, 2007. USACE San Joaquin O&M Manual 9, April 1964, (HLM 1.67)]. FS Date: 3/22/2022 4:28:01 PM | | | | | |

Top of Levee: view of crown.

Water-Side: view of pipe with corroded holes on far side.

Land-Side: view of pipe outlet in distribution box.

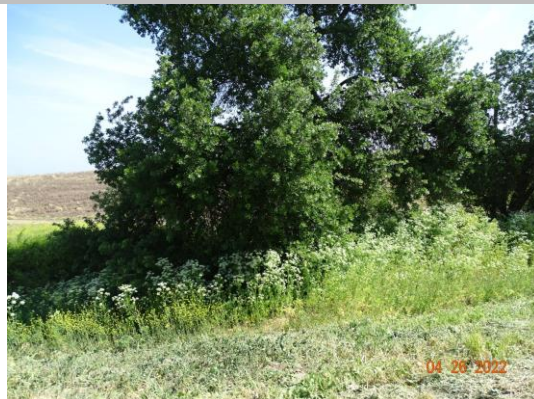
Photo 1 of 1 : SP_2022_RD2062_310_15_20220428_00017.jpg

View of untrimmed tree within the landside easement. Spring 2022

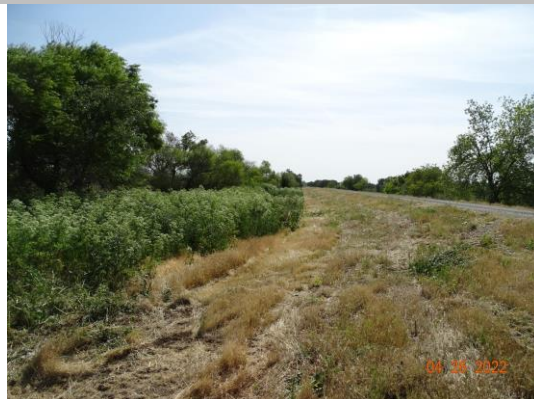
Photo 1 of 1 : SP_2022_RD2062_310_6_20220428_00016.jpg

View of landside vegetation completely blocking visibility of the easement. Spring 2022

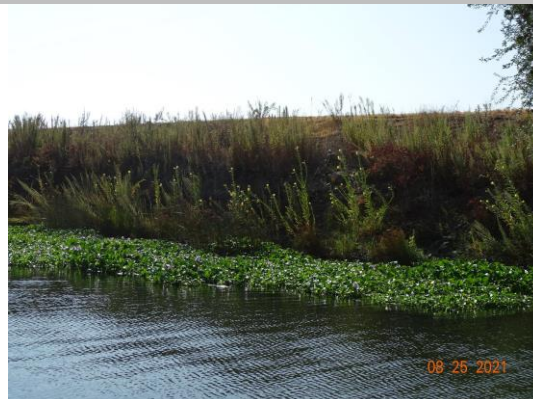
Photo 1 of 3 : SP_2022_RD2062_311_9_20220406_00016.jpg

08/25/2021: No significant changes were observed since the previous inspection

08/25/2021: Close-up view of the scarp on the levee slope.

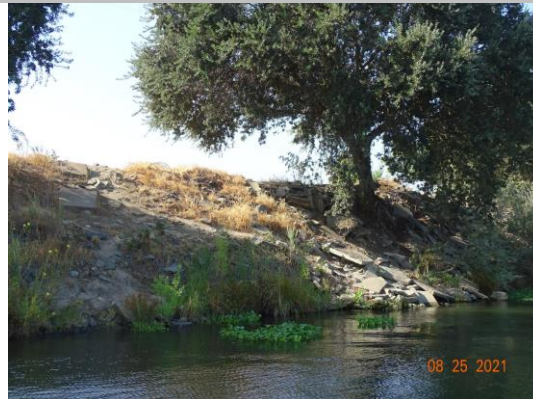
Photo 2 of 3 : SP_2022_RD2062_311_9_20220406_00017.jpg

08/25/2021: View of the eroded levee slope looking downstream.

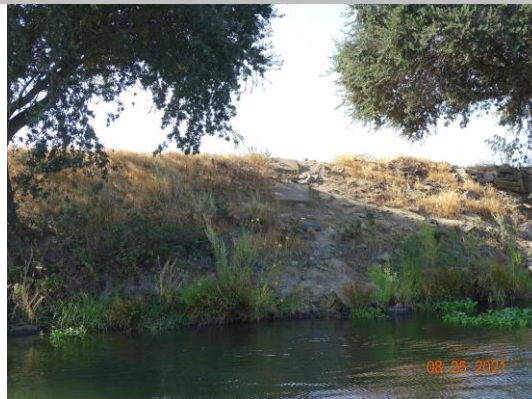
Photo 3 of 3 : SP_2022_RD2062_311_9_20220406_00018.jpg

08/25/2021: Crushed concrete on the eroded levee slope.

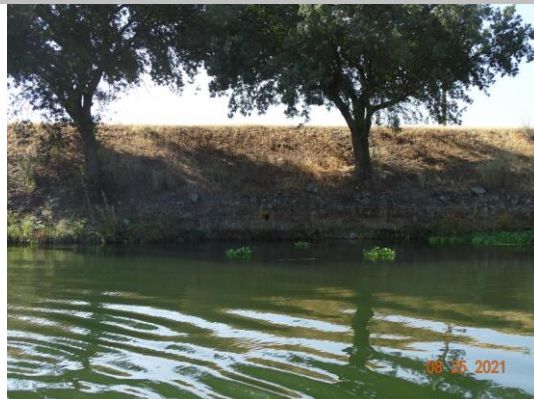
Photo 1 of 2 : SP_2022_RD2062_311_8_20220406_00014.jpg

09/13/2017: The erosion site has expanded significantly with the erosion length increased to approximately 90 ft from 40 ft. Signs of animal activities have been found at the site.

08/25/2021: View of the eroded levee toe and signs of animal activity.

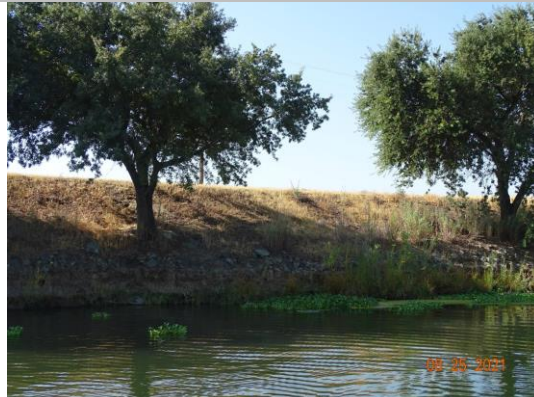
Photo 2 of 2 : SP_2022_RD2062_311_8_20220406_00015.jpg

08/25/2021: View of the erosion and some old riprap.

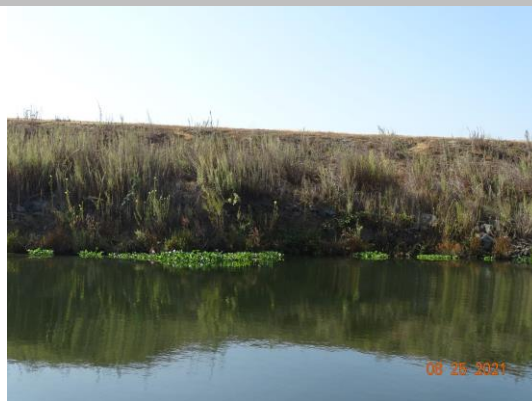
Photo 1 of 2 : SP_2022_RD2062_311_7_20220406_00012.jpg

| 08/25/2021: No significant changes were observed since the previous inspection. | | | | | |

08/25/2021: Overview of the erosion site.

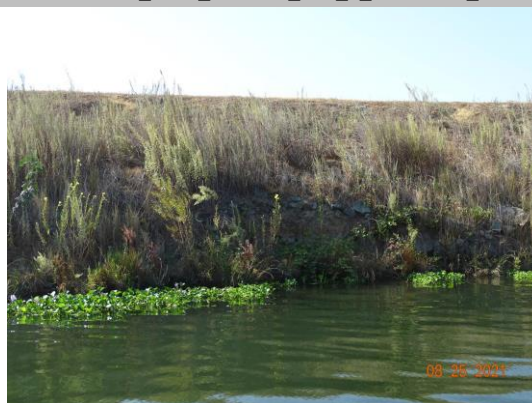
Photo 2 of 2 : SP_2022_RD2062_311_7_20220406_00013.jpg

08/25/2021: Close-up view of the erosion.

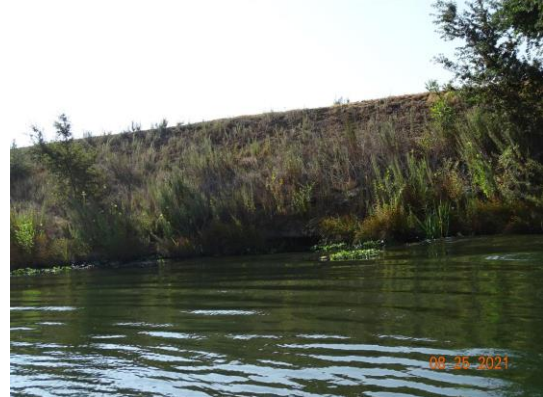
Photo 1 of 2 : SP_2022_RD2062_311_2_20220406_00003.jpg

Site ID: RD2062U03RM30.19
 08/25/2021: No significant changes were observed since the previous inspection.
 09/30/2020: From 2018 to present, no significant changes were observed during the annual survey.
 09/13/2017: The erosion has developed vertically. More vegetation at the site.
 07/25/2106: From 2014 to present, no significant changes were observed during the annual survey.
 08/13/2013: A new pocket erosion at the upper levee slope has been found directly above a large tree. The erosion might have been caused by internal pipe leakage or surface runoff. 08/07/2012: No significant change was observed.
 08/23/2011: Dense vegetation is visible along the water line.
 09/07/2010: Much of the upper slope was recently cleared of vegetation by spraying. 4- to 6-foot vertical scarp and pocket erosions are lined along a span of 475 feet. In some sections, the vertical scarp encroaches into the levee prism. There is a lack of berm along this reach, exposing the levee slope to high flow velocities during normal and flood events. 08/06/2010: Recommended as local maintenance issue, per CLRO. 03/09/2010: As discussed with Michael Moncrief of MBK Engineers, the site will be 'addressed' later this year. 09/29/2009: No major change observed since last visit; pocket erosion and a vertical scarp forming; this site was combined with Site RM30.13 and 30.02 with a combined total erosion length of 475 feet; recommended as annual assessment and monitoring of the site, per CLRO CES Evaluation 2008 Report; previously rated "M". 11/05/2008: Top of vertical scarp has rip rap that appears to be sliding; rodent holes; existing toe rip rap.

08/25/2021: View of the eroding levee slope.

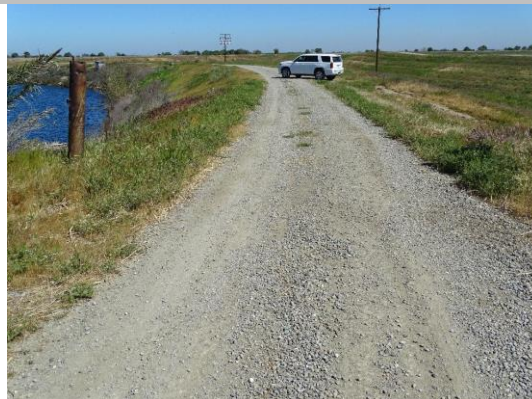
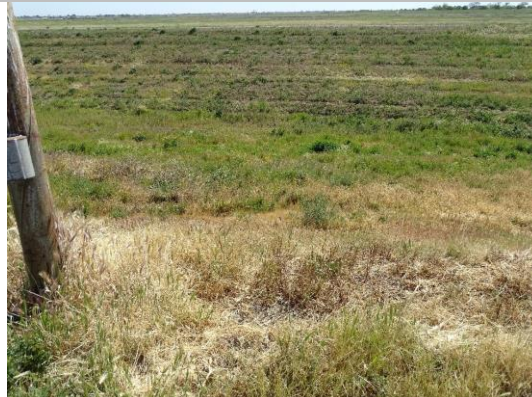
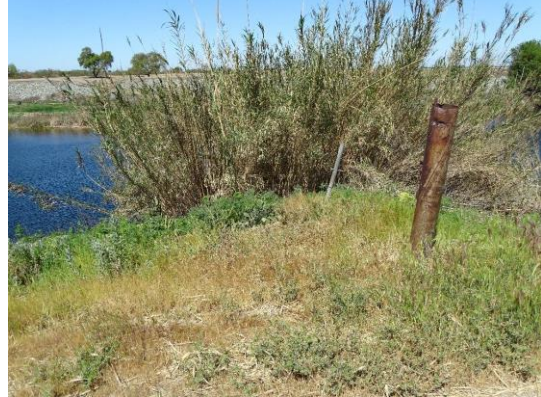
| FS_ID:72763 DS_ID:19204 EP_NO: N/A Repair Type: Non-Urgent Crossing Status: Not Found UCIP Comments: 03/22/2022 Record remains Non-Urgent. Crossing not found. No permit has been identified authorizing pipe. (D.Sanoski - DWR UCIP) FIELD_STRUCT_DESC: 12-inch irrigation discharge pipe of an unknown material through the levee, 7 feet below the crown. Pump house on the waterside (WS). [Additional Reference(s): USACE San Joaquin O&M Manual 9, April 1964, (HLM 0.32)]. FS Date: 3/22/2022 12:43:53 PM | | | | | | |

Top of Levee: view of crown.

Land-Side: view of slope.

Water-Side: view of slope.

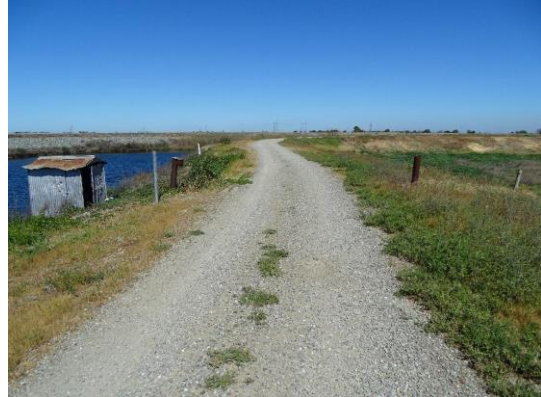
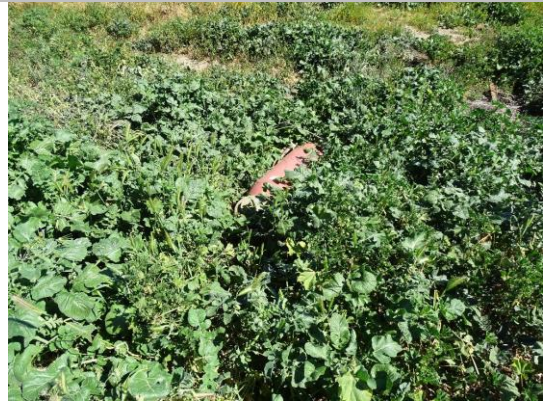
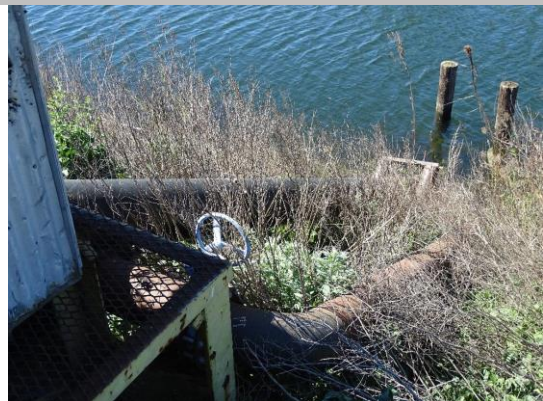
| FS_ID:72764 DS_ID:19200 EP_NO: 2029 Repair Type: Non-Urgent Crossing Status: Found UCIP Comments: 03/22/2022 Record updated from Urgent to Non-Urgent. Possible levee threat due to erosion on LS slope beneath pipe remains, but that is because it was too difficult to confirm due to the overgrown vegetation; but does appear to be imminent threat of failure. WS erosion beneath platform appears fixed. (D.Sanoski - DWR UCIP) 10/10/2018 Same as last inspection; erosion still present on LS slope, so keeping as Urgent (D. Sanoski - DWR UCIP).08/31/2016: Sloughing of LS slope beneath exposed section of pipe. Overflow pipe has been replaced on WS, though I could not locate a permit for that work. (K. Fazel - UCIP)10/22/2013:- pits and holes on overflow pipe on waterside.- underpinning at pump support.- slope erosion on both sides of the levee.- 2-inch electric conduit on waterside and power pole on landside. (P. Amatya - DWR) FIELD_STRUCT_DESC: 16-inch coated steel irrigation discharge pipe through the levee, 8 feet below the crown. Siphon breaker on the landside (LS) slope. Pump house on the waterside (WS) slope. Concrete distribution box on the LS. 2-inch electrical conduit on the WS. Service pole on the LS. Newly installed, as of 2016, overflow pipe with shutoff valve on the WS. (Plans for installation of an inclined irrigation pump on the bank authorized under Permit No. 2029, 1954 - Reclamation District No. 2062). [Additional Reference(s): DWR Levee Log, 2007. USACE San Joaquin O&M Manual 9, April 1964, (HLM 0.52)]. FS Date: 3/22/2022 12:45:54 PM | | | | | | |

Overview of Levee: view of crossing.

Land-Side: view of pipe and covered in vegetation.

Water-Side: view of slope and pipes.

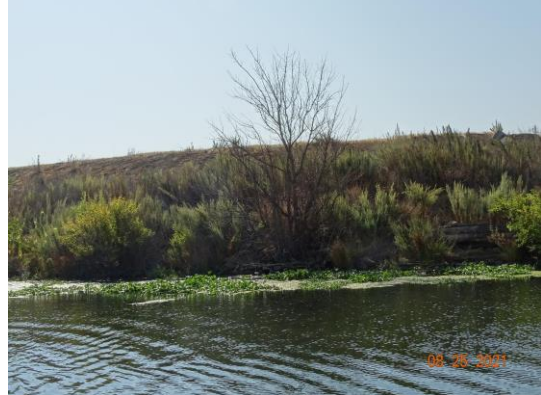
Photo 1 of 2 : SP_2022_RD2062_311_3_20220406_00005.jpg

Site ID: RD2062U03RM30.43
 08/25/2021: No significant changes were observed since the previous inspection.
 09/30/2020: From 2011 to present, no significant changes were observed during the annual survey.
 09/07/2010: Much of the placed rip rap revetment has slid. It is no longer adequately protecting the slope.
 08/06/2010: Recommended as local maintenance issue, per CLRO Report.
 03/09/2010: As discussed with Michael Moncrief of MBK, site will be 'addressed' this year.
 09/29/2009: No major change observed since last visit; a section of the rip rap has slipped, exposing a levee section that has eroded; recommended as local maintenance issue, per CLRO CES Evaluation 2008 Report; Site # is the same as RM30.43, LM0.63; previously rated "U".
 11/05/2008: Site is located inside of a bend; scarp looks to be into the levee prism; piles of concrete chunks placed on the slope, with some of them already starting to slide.

08/25/2021: View of the eroded levee slope and displaced riprap.

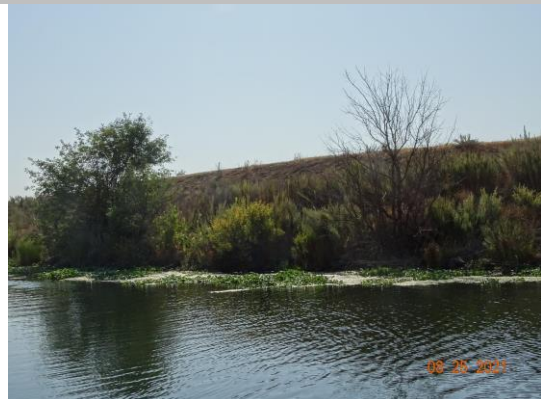
Photo 2 of 2 : SP_2022_RD2062_311_3_20220406_00006.jpg

08/25/2021: Another view of the eroded slope with displaced riprap.

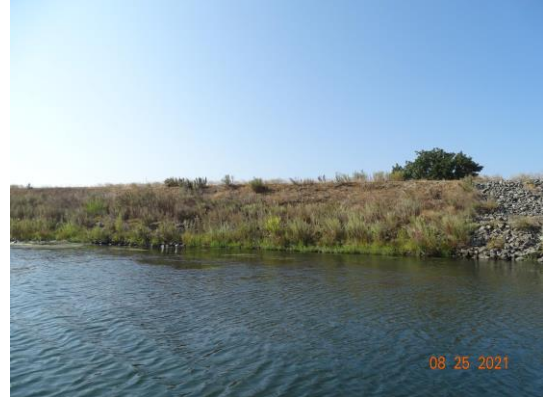
Photo 1 of 2 : SP_2022_RD2062_311_4_20220406_00007.jpg

08/25/2021: Front view of the erosion.

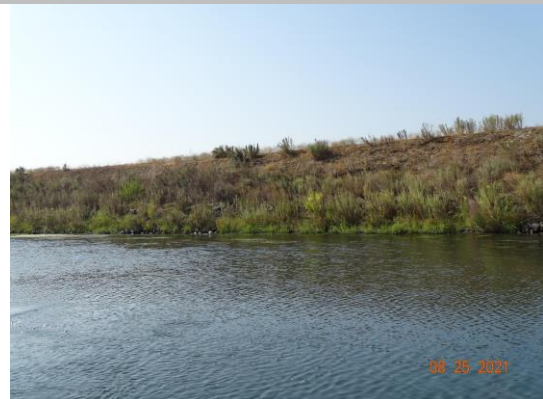
Photo 2 of 2 : SP_2022_RD2062_311_4_20220406_00008.jpg

08/25/2021: Close-up view of the erosion.

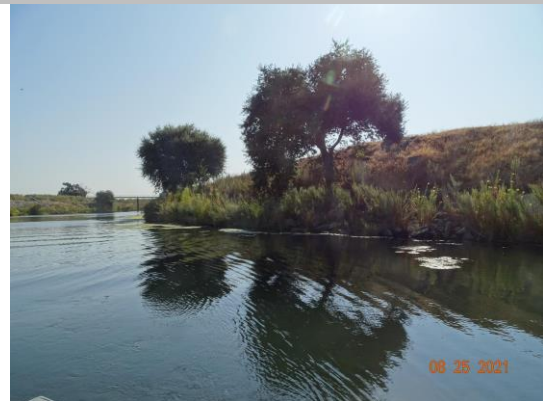
Photo 1 of 2 : SP_2022_RD2062_311_5_20220406_00009.jpg

| 08/25/2021: No significant changes were observed since the previous inspection. | | | | | |

08/25/2021: View of the erosion looking upstream.

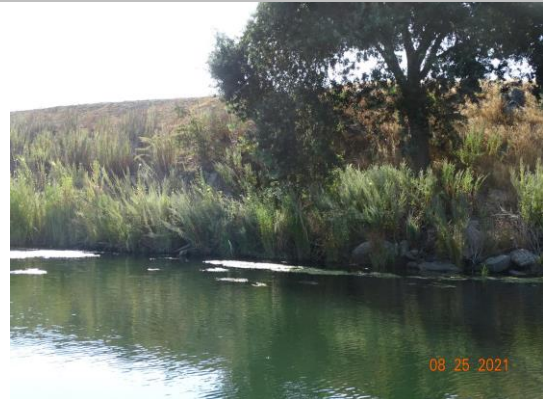
Photo 2 of 2 : SP_2022_RD2062_311_5_20220406_00010.jpg

08/25/2021: Close-up view of the site.

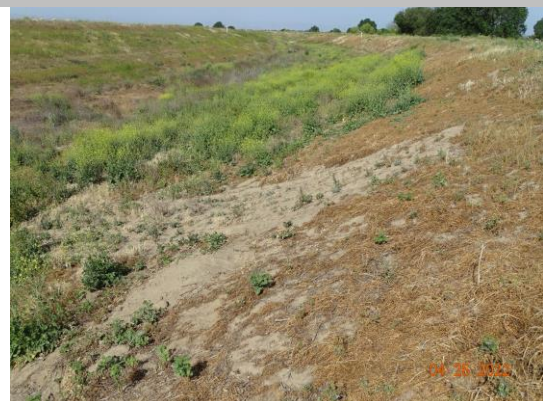
Photo 1 of 1 : SP_2022_RD2062_311_25_20220428_00042.jpg

View of large animal burrow along the landside slope. Spring 2022

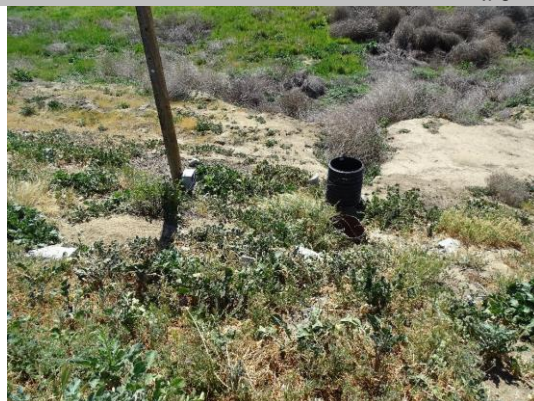
Photo 2 of 3 : UCIP_SP_2022_72765_109187.jpg

Land-Side: view of standpipes on slope.

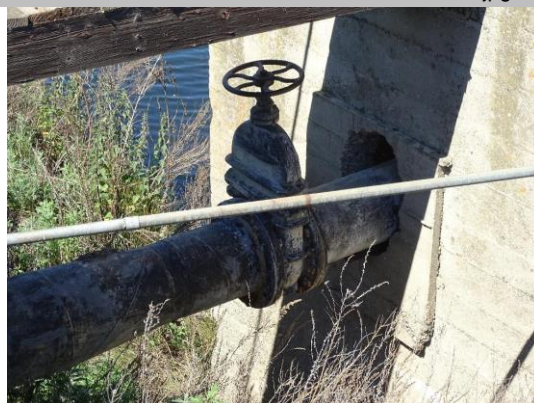
Photo 3 of 3 : UCIP_SP_2022_72765_109188.jpg

Water-Side: view of pipe and butterfly valve under walkway.

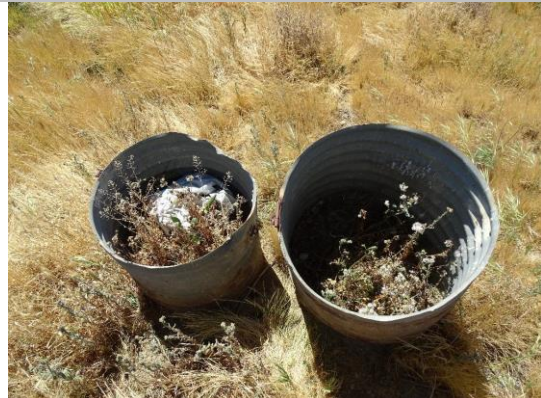
Photo 2 of 3 : UCIP_SP_2022_72770_109192.jpg

Land-Side: view of abandoned standpipes on slope.

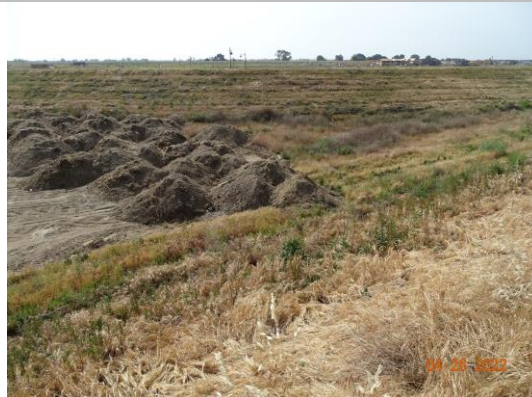
Photo 1 of 1 : SP_2022_RD2062_311_23_20220428_00041.jpg

View of landscape debris along the landside easement. Spring 2022

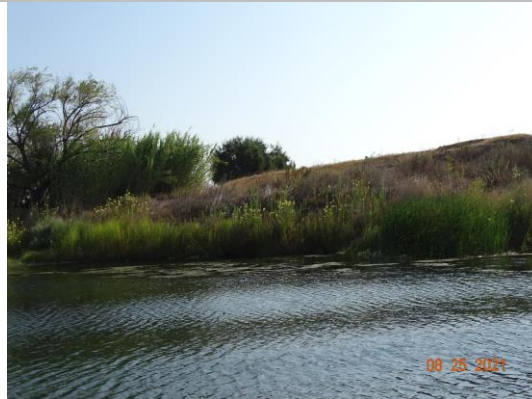
Photo 1 of 2 : SP_2022_RD2062_311_1_20220406_00001.jpg

08/25/2021: Front view of the erosion.

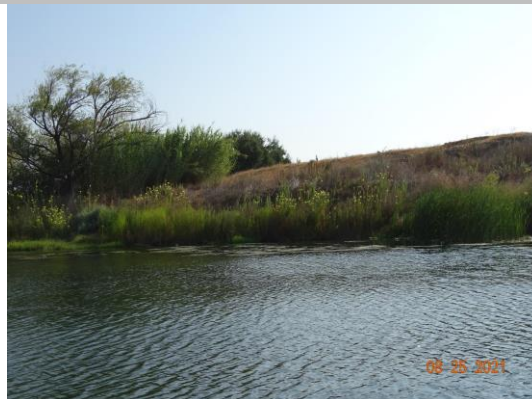
Photo 2 of 2 : SP_2022_RD2062_311_1_20220406_00002.jpg

08/25/2021: Another view of the erosion.

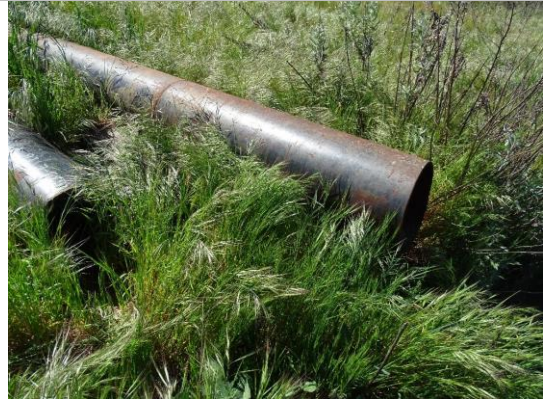
Photo 3 of 3 : UCIP_SP_2022_72768_109202.jpg

Water-Side: view of open-ended pipe on slope.

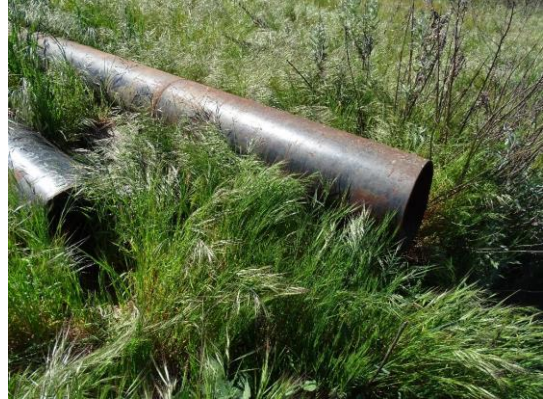
Photo 3 of 3 : UCIP_SP_2022_72769_109207.jpg

Water-Side: view of open-ended pipe on slope.
