**Flood Control Project Maintenance  
Levee Inspections  
LMA District Cover Sheet**

**Reclamation District No. 2062 Stewart**

**Levee Inspection Report By Mile - Spring 2023**

Waterway	Bank	Unit Miles	Inspection Start/End	Inspector
Unit No. 01 San Joaquin River	Left	2.64	05/09/2023 05/09/2023	Alberto De Leon

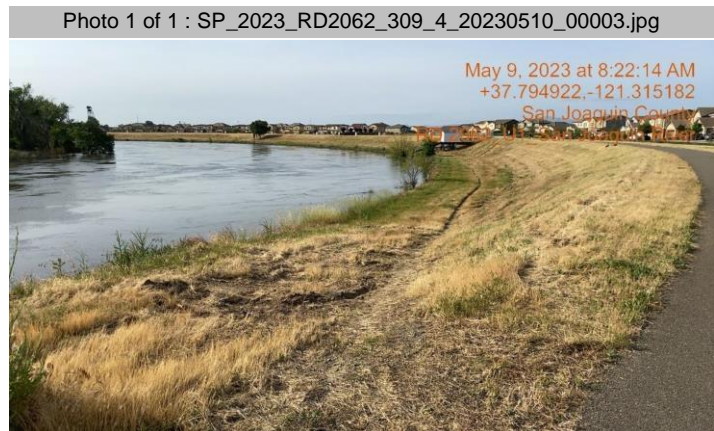
LM Start	1.54	Rating **	A/W	Issue No.	4
LM End	1.54	Issue Type +	Ma	Location *	WS
Category	Earthen Levee			GPS Latitude/Longitude	
				Start	End
Item	Erosion / Foot Traffic			37.794843°	37.794843°
				-121.315269°	-121.315269°
DWR ID	DWR_RD2062_01_s_2022_4				
Comment Code					
E3 : Repair the levee slope damaged by foot traffic and prevent access where possible.					
Inspector Comment					
There is a pedestrian pathway on the waterside slope that needs to be monitored.

View of pedestrian trail along the waterside slope. Spring 2023

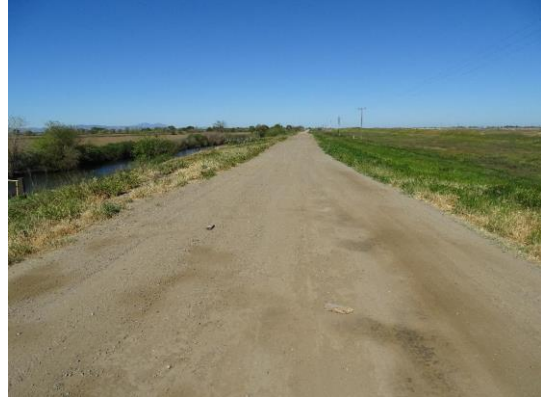
Photo 1 of 3 : UCIP\_SP\_2023\_72749\_109142.jpg

Comment Code						
Inspector Comment						
DS_ID:19197						
FS_ID:72749						
EP_NO: 4305						
Repair Type: Urgent						
EVAL Issue: 1, Pipe Integrity						
Crossing Status: Found						
UCIP Comments: 03/22/2022 Record remains Urgent. DMP internal video inspection has found pipe integrity issues. LOF of crossing is between 5 and 6. Crossing will be monitored until funding becomes available to address the issues. Found holes in pipe on WS between water and pumphouse. (D.Sanoski - DWR UCIP)						
10/10/2018 Extremely overgrown vegetation did not allow visual inspection of WS levee erosion; however, there are indications based on vegetation growth patterns that the erosion is still present, so keeping crossing as Urgent (D. Sanoski - DWR UCIP).08/31/2016: Heavy sloughing and sink hole remains at the WS slope in alignment with pipes. Though sloughing is not affecting levee prism, it is still an indication of a pipe integrity problem. Oil leak at the pump but does not appear to impact levee. (K. Fazel - UCIP)10/22/2013:- missing roof in pump house.- no protection for siphon breaker- huge erosion under pumphouse and levee slope on waterside. (P. Amatya - DWR)

FIELD_STRUCT_DESC: 2 of 2: 18-inch steel irrigation discharge pipe through the levee, 4.8 feet below the crown. Pump house on the waterside (WS) slope. Siphon breaker on the landside (LS) shoulder. Service pole on the LS shoulder. Concrete distribution box at the LS toe. (Plans for installation of two irrigation pumps on the bank to replace an old centrifugal pumping plant at the same location authorized under Permit No. 4305, 1963 - Reclamation District No. 2062) [Additional Reference(s): DWR Levee Log, 2007. USACE San Joaquin O&M Manual 9, April 1964, (HLM 1.67)].						
FS Date: 3/22/2022 4:28:01 PM

Top of Levee: view of crown.

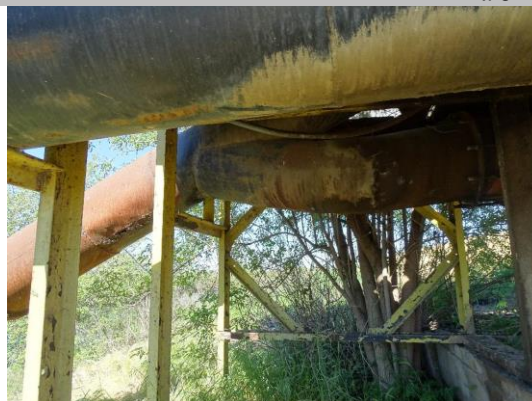
Photo 2 of 3 : UCIP\_SP\_2023\_72749\_109143.jpg

Water-Side: view of pipe with corroded holes on far side.

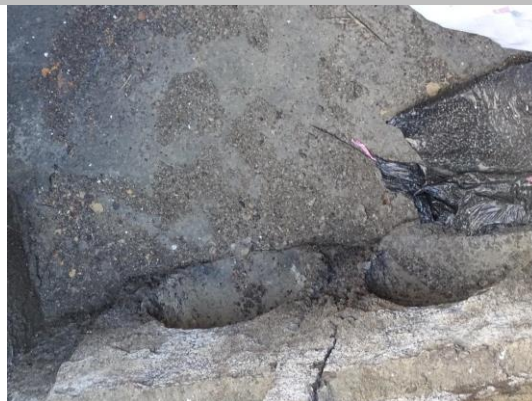
Photo 3 of 3 : UCIP\_SP\_2023\_72749\_109144.jpg

Land-Side: view of pipe outlet in distribution box.

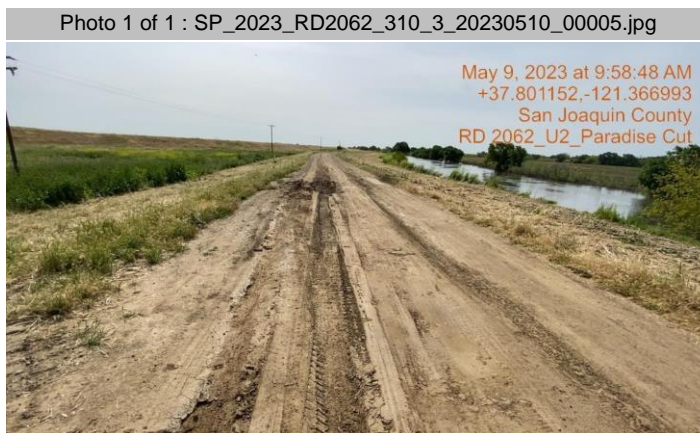
LM Start	2.17	Rating **	M	Issue No.	3
LM End	2.47	Issue Type +	Ma	Location *	CR
Category	Earthen Levee			GPS Latitude/Longitude	
				Start	End
Item	Crown Surface / Depressions / Rutting			37.798422°	37.801019°
				-121.362362°	-121.366819°
DWR ID	DWR_RD2062_02_s_2023_3				
Comment Code					
C2 : Repair depressions or ruts in the crown or slope.					
Inspector Comment

View of ruts along the crown of levee road. Spring 2023

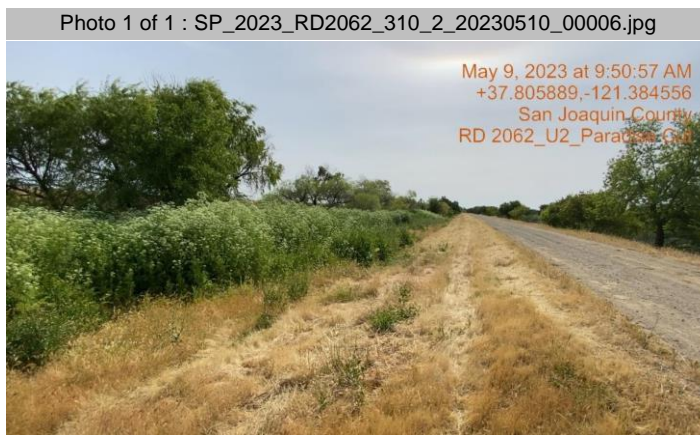
LM Start	3.25	Rating **	U	Issue No.	2
LM End	3.53	Issue Type +	Ma	Location *	LS
Category	Earthen Levee			GPS Latitude/Longitude	
				Start	End
Item	Vegetation			37.804806°	37.805890°
				-121.379852°	-121.384802°
DWR ID	DWR_RD2062_02_s_2023_2				
Comment Code					
V2 : Remove the wild growth and woody vegetation other than native grasses from the levee slopes.					
Inspector Comment

View of wild growth along the landside slope. Spring 2023

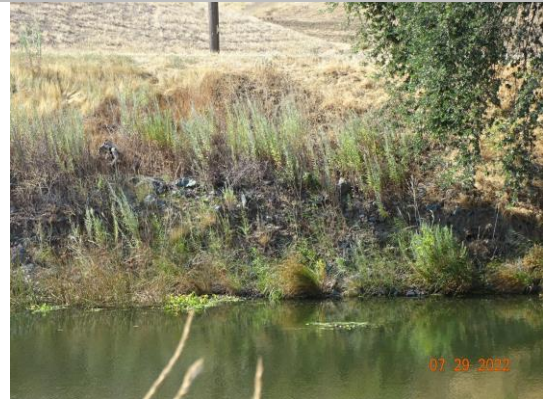
Photo 1 of 2 : SP\_2023\_RD2062\_311\_8\_20230306\_00013.jpg

07/29/2022: From 2021 to present, no significant changes were observed during the annual survey.

7/29/2022: View of the erosion from the opposite bank.

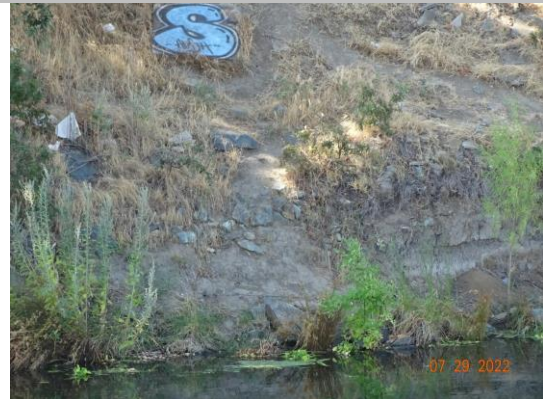
Photo 2 of 2 : SP\_2023\_RD2062\_311\_8\_20230306\_00014.jpg

7/29/2022: Another view of the erosion.

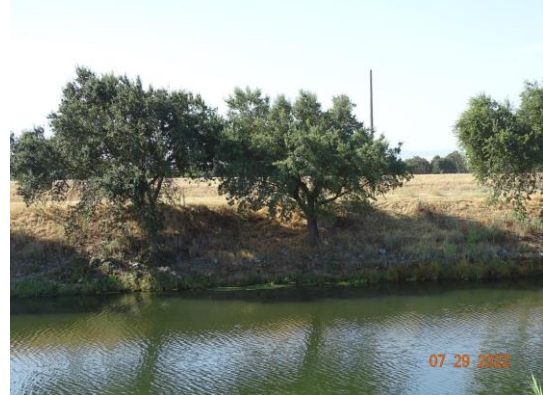
Photo 1 of 2 : SP\_2023\_RD2062\_311\_7\_20230306\_00011.jpg

07/29/2022: From 2021 to present, no significant changes were observed during the annual survey. There is a large animal burrow on the lower bank.

09/13/2017: The erosion site has expanded significantly with the erosion length increased to approximately 90 ft from 40 ft. Signs of animal activities have been found at the site.

7/29/2022: View of the erosion from the opposite bank.

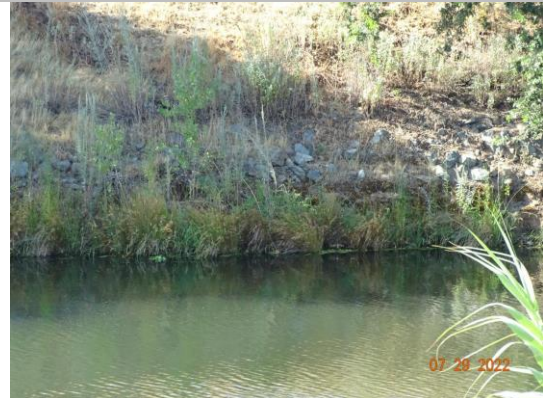
Photo 2 of 2 : SP\_2023\_RD2062\_311\_7\_20230306\_00012.jpg

7/29/2022: Close-up view of the erosion.

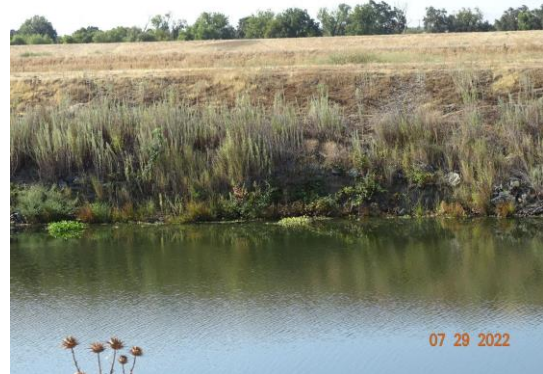
Photo 1 of 1 : SP\_2023\_RD2062\_311\_6\_20230306\_00010.jpg

LM Start	0.17	Rating **	M	Issue No.	6
LM End	0.18	Issue Type +	Ma	Location *	WS
Category	Supplemental			GPS Latitude/Longitude	
				Start	End
Item	DWR Erosion Survey			37.810268 °	37.810268 °
				-121.387495 °	-121.387495 °
DWR ID	RD2062U03RM30.1				
Comment Code					
Inspector Comment					
Site ID: RD2062U03RM30.1					
07/29/2022: From 2012 to present, no significant changes were observed during the annual survey.					
08/23/2011: The protection at the levee toe has been washed away.

7/29/2022: View of the erosion from the opposite bank.

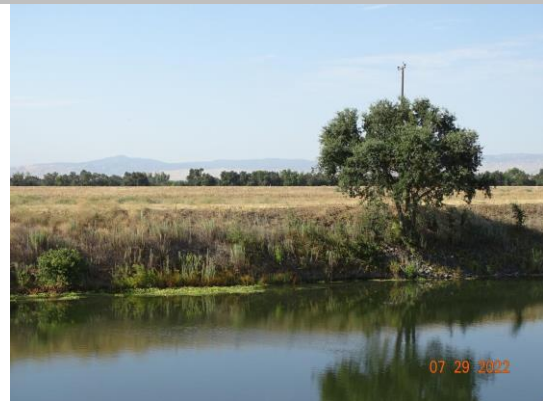
Photo 1 of 2 : SP\_2023\_RD2062\_311\_2\_20230306\_00003.jpg

Comment Code					
Inspector Comment					
Site ID: RD2062U03RM30.19					
07/29/2022: From 2018 to present, no significant changes were observed during the annual survey.					
09/13/2017: The erosion has developed vertically. More vegetation at the site.					
08/13/2013: A new pocket erosion at the upper levee slope has been found directly above a large tree. The erosion might have been caused by internal pipe leakage or surface runoff.					
09/07/2010: Much of the upper slope was recently cleared of vegetation by spraying. 4- to 6-foot vertical scarp and pocket erosions are lined along a span of 475 feet. In some sections, the vertical scarp encroaches into the levee prism. There is a lack of berm along this reach, exposing the levee slope to high flow velocities during normal and flood events.					
11/05/2008: Top of vertical scarp has rip rap that appears to be sliding, rodent holes and existing toe rip rap.

7/29/2022: View of the erosion from the opposite bank.

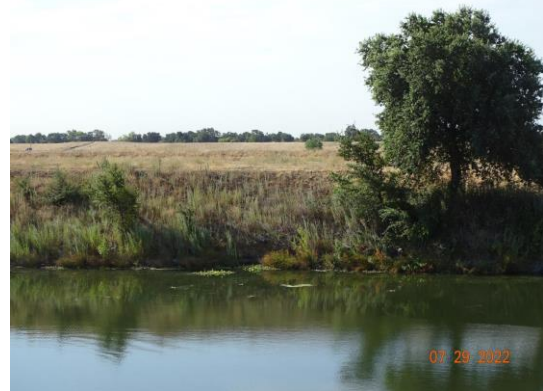
Photo 2 of 2 : SP\_2023\_RD2062\_311\_2\_20230306\_00004.jpg

7/29/2022: Another view of the erosion.

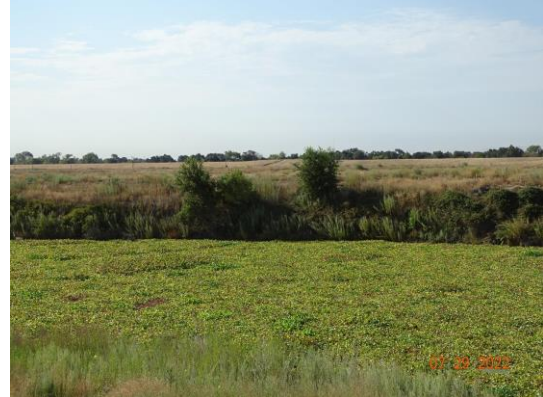
Photo 1 of 2 : SP\_2023\_RD2062\_311\_5\_20230306\_00008.jpg

07/29/2022: From 2012 to present, no significant changes were observed during the annual survey.

08/23/2011: The site is right at the downstream of a river bend.

7/29/2022: View of the erosion from the opposite bank.

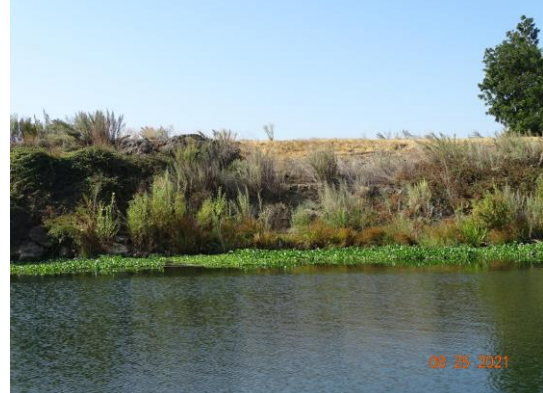
Photo 2 of 2 : SP\_2023\_RD2062\_311\_5\_20230306\_00009.jpg

8/25/2021: Front view of the erosion.

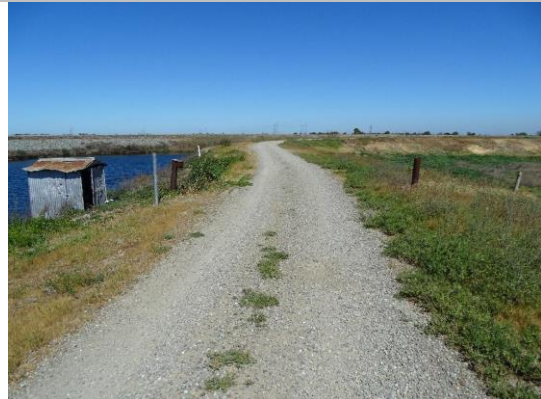
Photo 1 of 3 : UCIP\_SP\_2023\_72764\_109181.jpg

Comment Code						
Inspector Comment						
DS_ID:19200 FS_ID:72764 EP_NO: 2029 Repair Type: Non-Urgent EVAL Issue: 6, Levee Damage or Threat for Levee Damage Crossing Status: Found UCIP Comments: 03/22/2022 Record updated from Urgent to Non-Urgent. Possible levee threat due to erosion on LS slope beneath pipe remains, but that is because it was too difficult to confirm due to the overgrown vegetation. WS erosion beneath platform appears fixed. (D.Sanoski - DWR UCIP) 10/10/2018 Same as last inspection; erosion still present on LS slope, so keeping as Urgent (D. Sanoski - DWR UCIP).08/31/2016: Sloughing of LS slope beneath exposed section of pipe. Overflow pipe has been replaced on WS, though I could not locate a permit for that work. (K. Fazel - UCIP)10/22/2013:- pits and holes on overflow pipe on waterside.- underpinning at pump support.- slope erosion on both sides of the levee.- 2-inch electric conduit on waterside and power pole on landside. (P. Amatya - DWR) FIELD_STRUCT_DESC: 16-inch coated steel irrigation discharge pipe through the levee, 8 feet below the crown. Siphon breaker on the landside (LS) slope. Pump house on the waterside (WS) slope. Concrete distribution box on the LS. 2-inch electrical conduit on the WS. Service pole on the LS. Newly installed, as of 2016, overflow pipe with shutoff valve on the WS. (Plans for installation of an inclined irrigation pump on the bank authorized under Permit No. 2029, 1954 - Reclamation District No. 2062). [Additional Reference(s): DWR Levee Log, 2007. USACE San Joaquin O&M Manual 9, April 1964, (HLM 0.52)]. FS Date: 3/22/2022 12:45:54 PM

Overview of Levee: view of crossing.

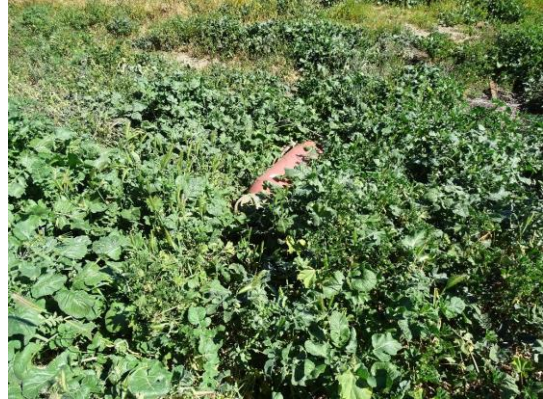
Photo 2 of 3 : UCIP\_SP\_2023\_72764\_109182.jpg

Land-Side: view of pipe and covered in vegetation.

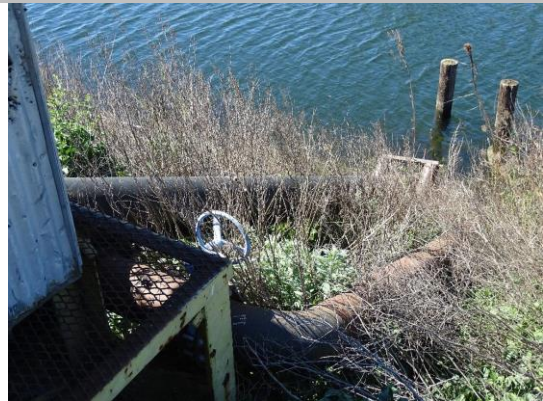
Photo 3 of 3 : UCIP\_SP\_2023\_72764\_109183.jpg

Water-Side: view of slope and pipes.

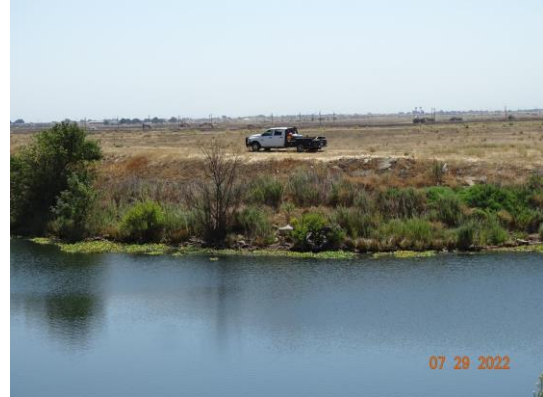
Photo 1 of 1 : SP\_2023\_RD2062\_311\_3\_20230306\_00005.jpg

Comment Code					
Inspector Comment					
Site ID: RD2062U03RM30.43 07/29/2022: From 2011 to present, no significant changes were observed during the annual survey. 09/07/2010: Much of the placed rip rap revetment has slid. It is no longer adequately protecting the slope. 08/06/2010: Recommended as local maintenance issue, per CLRO Report. 03/09/2010: As discussed with Michael Moncrief of MBK, site will be 'addressed' this year. 09/29/2009: No major change observed since last visit; a section of the rip rap has slipped, exposing a levee section that has eroded; recommended as local maintenance issue, per CLRO CES Evaluation 2008 Report; Site # is the same as RM30.43,LM0.63; previously rated "U". 11/05/2008: Site is located inside of a bend; scarp looks to be into the levee prism; piles of concrete chunks placed on the slope, with some of them already starting to slide.

7/29/2022: View of the erosion from the opposite bank.

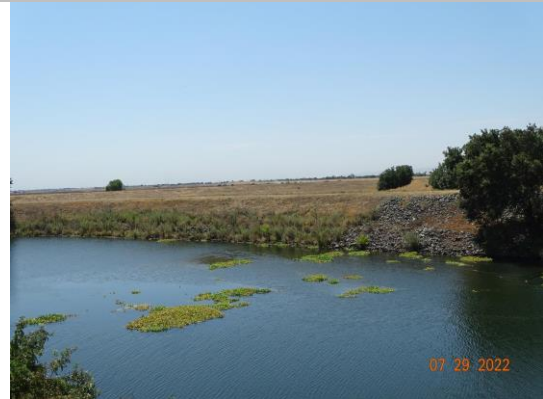
Photo 1 of 2 : SP\_2023\_RD2062\_311\_4\_20230306\_00006.jpg

Comment Code					
Inspector Comment					
Site ID: RD2062U03RM31.12					
07/29/2022: From 2011 to present, no significant changes were observed during the annual survey. The site is immediately upstream of a repaired site.					
09/07/2010: Much of the seasonal grass along the slope was cleared. Site consists of an existing scalloped erosion approximately 30 feet long by 5 feet wide at its widest opening. The lateral crack is extended outwards along the middle slope. There is a 1 to 2 feet of differential settlement that could further develop into a shallow slide.					
08/06/2010: Recommended as local maintenance issue, per CLRO.					
03/09/2010: As discussed with Michael Moncrief of MBK Engineers, site will be 'addressed' this year.					
09/28/2009: No major change observed; section of rip rap has slipped, creating a terraced effect; dense vegetation growth; recommended as a local maintenance issue, per CLRO CES Evaluation 2008 Report; Site # is the same as RM31.12, LM1.25; previously rated "U".

7/29/2022: View of the erosion from the opposite bank.

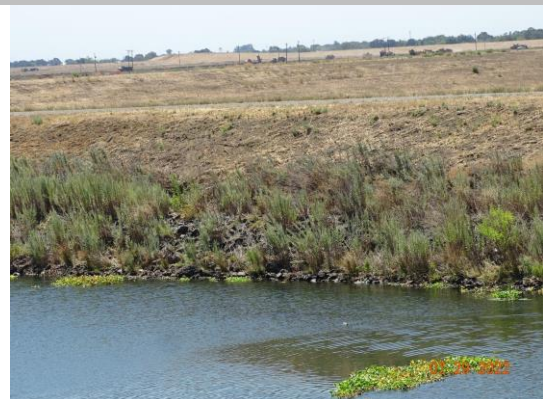
Photo 2 of 2 : SP\_2023\_RD2062\_311\_4\_20230306\_00007.jpg

7/29/2022: Close-up view of the erosion.

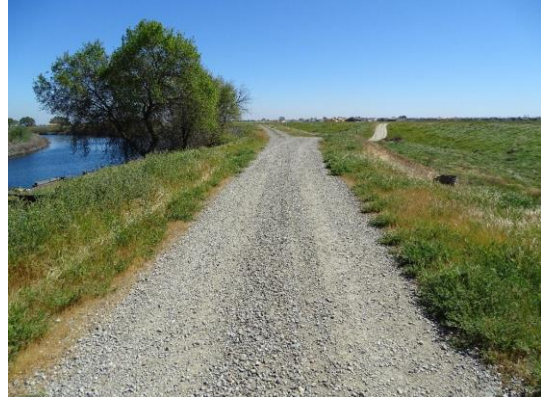
Photo 1 of 3 : UCIP\_SP\_2023\_72770\_109191.jpg

Comment Code						
Inspector Comment						
DS_ID:19202 FS_ID:72770 EP_NO: 2505 Repair Type: Non-Urgent EVAL Issue: 11, Maintenance Compliance Issue Crossing Status: Found UCIP Comments: 03/22/2022 Record remains Non-Urgent. Maintenance compliance issue with risers filled with soil. (D.Sanoski - DWR UCIP) 10/22/2013 Pumphouse roof missing, siphon breaker buried by dirt in CMP riser, and 2.25 inch electric conduit and power pole on landside. (P. Khoi - DWR UCIP) FIELD_STRUCT_DESC: 2 of 2: 16-inch irrigation discharge pipe of an unknown material through the levee, 6.5 feet below the crown. Pump in a pump house on a pile structure in the stream. Timber walkway to the pump. Siphon breaker in a corrugated metal pipe (CMP) riser on the landside (LS) slope. Concrete distribution box at the LS toe. Timber bulkhead and slab on the waterside (WS) slope. Installed by USACE in 1963. (Plans for the installation of two irrigation pumps on the bank to replace an existing pumping plant at this location authorized under Permit No. 2505, 1959 - Reclamation District No. 2062). [Additional Reference(s): DWR Levee Log, 2007. USACE San Joaquin O&M Manual 9, April 1964, (HLM 2.81)]. FS Date: 3/22/2022 12:57:00 PM

Top of Levee: view of crown.

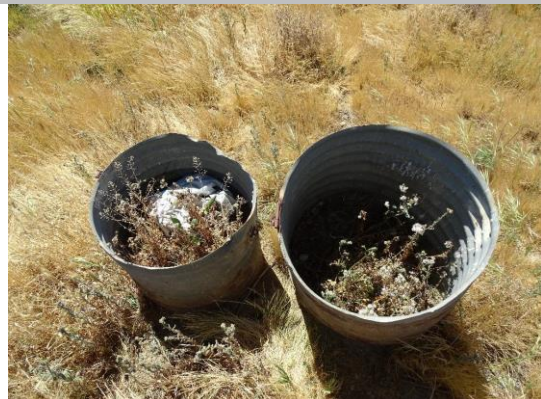
Photo 2 of 3 : UCIP\_SP\_2023\_72770\_109192.jpg

Land-Side: view of abandoned standpipes on slope.

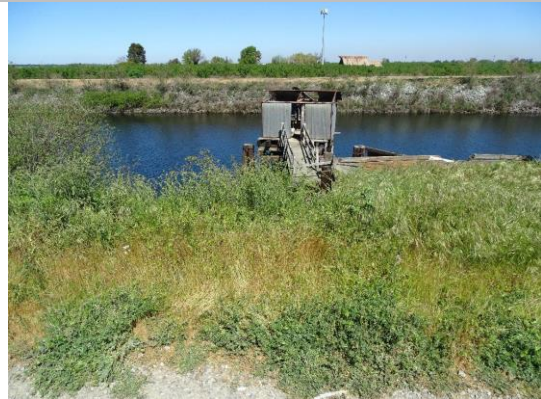
Photo 3 of 3 : UCIP\_SP\_2023\_72770\_109194.jpg

Water-Side: view of slope.

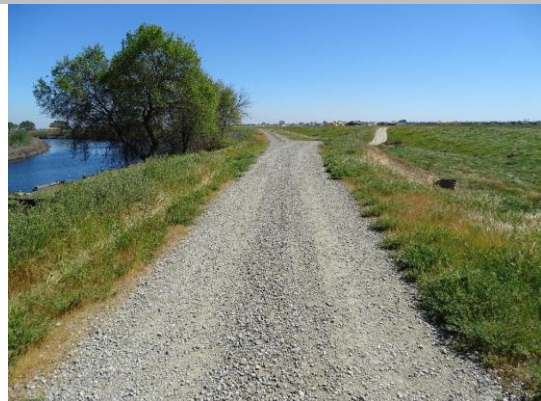
Photo 1 of 3 : UCIP\_SP\_2023\_72771\_109195.jpg

DS\_ID:19205  
 FS\_ID:72771  
 EP\_NO: 2505  
 Repair Type: Non-Urgent  
 EVAL Issue: 11, Maintenance Compliance Issue  
 Crossing Status: Found  
 UCIP Comments: 03/22/2022 Record remains Non-Urgent.  
 Maintenance compliance issue with risers filled with soil. (D.Sanoski - DWR UCIP)  
 10/22/2013 Pumphouse roof missing, siphon breaker buried by dirt in CMP riser, and 2.25 inch electric conduit and power pole on landside. (P. Khoi - DWR UCIP)  
 FIELD\_STRUCT\_DESC: 1 of 2: 14-inch irrigation discharge pipe of an unknown material through the levee, 6.5 feet below the crown. Pump in a pump house on a pile structure in the stream. Timber walkway to the pump. Siphon breaker in a corrugated metal pipe (CMP) riser on the landside (LS) slope. Concrete distribution box at the LS toe. Timber bulkhead and slab on the waterside (WS) slope. Installed by USACE in 1963. (Plans for the installation of two irrigation pumps on the bank to replace an existing pumping plant at this location authorized under Permit No. 2505, 1959 - Reclamation District No. 2062). [Additional Reference(s): DWR Levee Log, 2007. USACE San Joaquin O&M Manual 9, April 1964, (HLM 2.81)].

Top of Levee: view of crown.

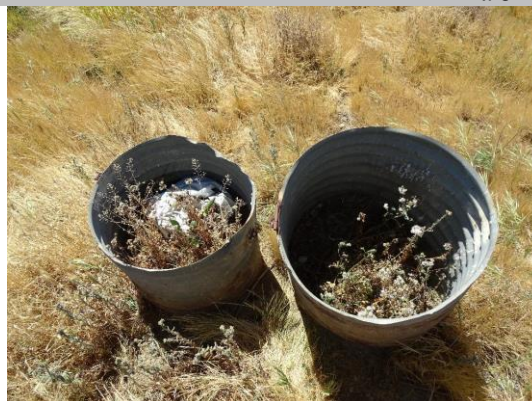
Photo 2 of 3 : UCIP\_SP\_2023\_72771\_109196.jpg

Land-Side: view of soil-filled risers on slope.

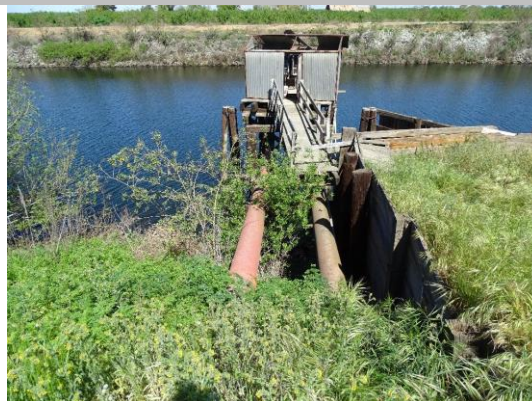
Photo 3 of 3 : UCIP\_SP\_2023\_72771\_109197.jpg

Water-Side: view of pipes to pumphouse.

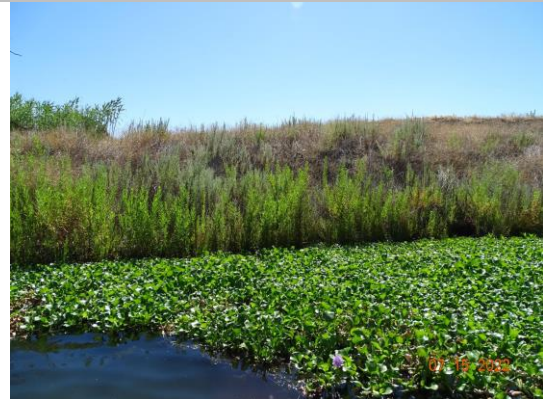
Photo 1 of 2 : SP\_2023\_RD2062\_311\_1\_20230306\_00001.jpg

LM Start	4.00	Rating **	A/W	Issue No.	1
LM End	4.01	Issue Type +	Ma	Location *	WS
Category	Supplemental			GPS Latitude/Longitude	
				Start	End
Item	DWR Erosion Survey			37.820750°	37.820750°
				-121.340159°	-121.340159°
DWR ID	RD2062U03RM33.92				
Comment Code					
Inspector Comment					
Site ID: RD2062U03RM33.92 This site is not rated due to the relatively wide berm. 07/15/2022: The sloughing on the mid and upper slope was visible, as well as some undermining on the lower bank. 08/25/2021: From 2018 to present, no significant changes were observed during the annual survey. 09/13/2017: The erosion site is immediately downstream of a sharp river bend.

7/15/2022: Front view of the erosion.

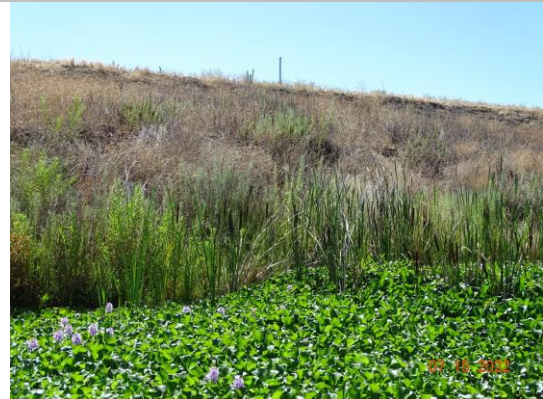
Photo 2 of 2 : SP\_2023\_RD2062\_311\_1\_20230306\_00002.jpg

7/15/2022: Another view of the erosion.

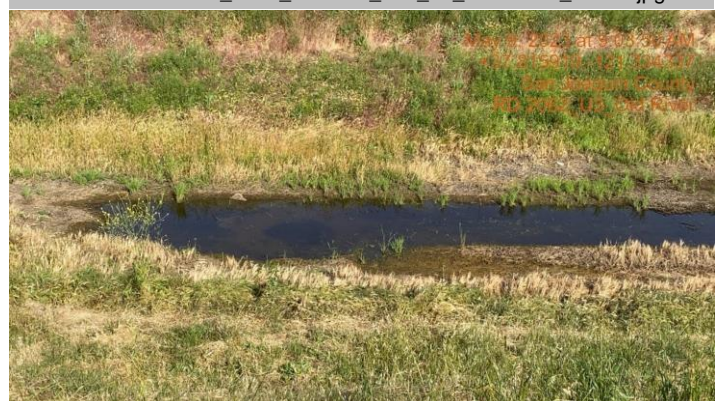
Photo 1 of 1 : SP\_2023\_RD2062\_311\_13\_20230510\_00026.jpg

View of seepage area and boil in the landside easement. Spring 2023

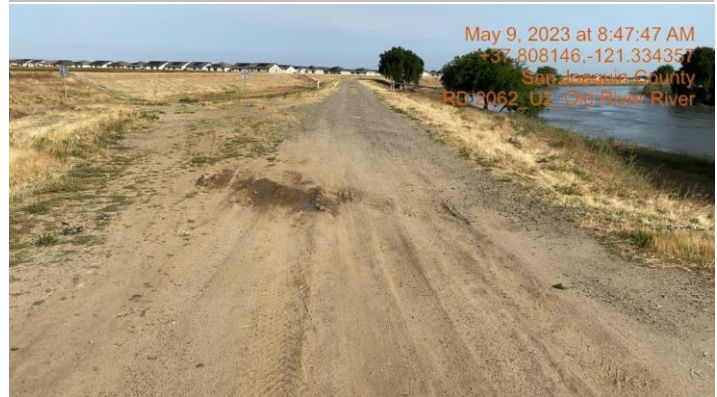
Photo 1 of 1 : SP\_2023\_RD2062\_311\_12\_20230510\_00025.jpg

LM Start	5.18	Rating **	M	Issue No.	12
LM End	5.18	Issue Type +	Ma	Location *	CR
Category	Earthen Levee			GPS Latitude/Longitude	
				Start	End
Item	Crown Surface / Depressions / Rutting			37.808179°	37.808179°
				-121.334451°	-121.334451°
DWR ID	DWR_RD2062_03_s_2023_12				
Comment Code					
C2 : Repair depressions or ruts in the crown or slope.					
Inspector Comment

View of ruts in the crown of levee surface road. Spring 2023
