Flood Control Project Maintenance  
Levee Inspections  
LMA District Cover Sheet

Reclamation District No. 2062 Stewart

**Levee Inspection Report By Mile - Spring 2024**

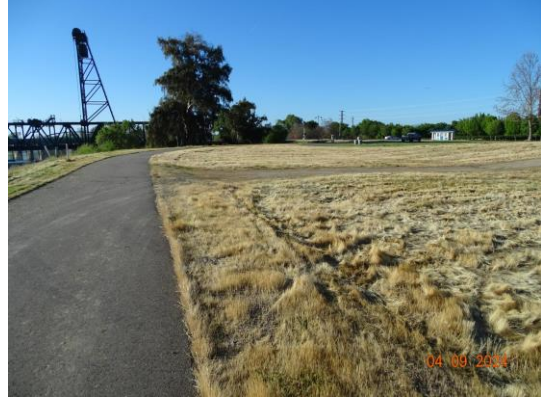
Photo 1 of 1 : SP\_2024\_RD2062\_309\_1\_20240410\_00002.jpg

LM Start	0.00	Rating **	A	Issue No.	1
LM End	2.55	Issue Type +	Ma	Location *	LS
Category	Earthen Levee			GPS Latitude/Longitude	
				Start	End
Item	Vegetation			37.807490°	37.788316°
				-121.328105°	-121.308961°
DWR ID	DWR_RD2062_01_s_2024_1				
Comment Code					
V1 : Control annual grass and weeds on the levee slopes and easements.					
Inspector Comment

Typical view of well maintained vegetation along the landside slope.  
Spring 2024

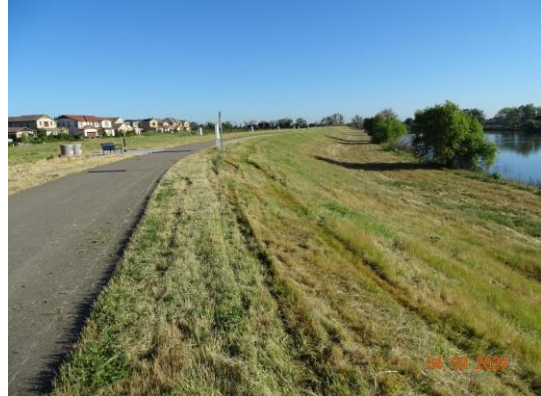
Photo 1 of 1 : SP\_2024\_RD2062\_309\_3\_20240410\_00003.jpg

LM Start	0.00	Rating **	A	Issue No.	3
LM End	2.55	Issue Type +	Ma	Location *	WS
Category	Earthen Levee			GPS Latitude/Longitude	
				Start	End
Item	Vegetation			37.807488°	37.788314°
				-121.328104°	-121.308959°
DWR ID	DWR_RD2062_01_s_2024_3				
Comment Code					
V1 : Control annual grass and weeds on the levee slopes and easements.					
Inspector Comment

Typical view of well maintained vegetation along the waterside slope.  
Spring 2024

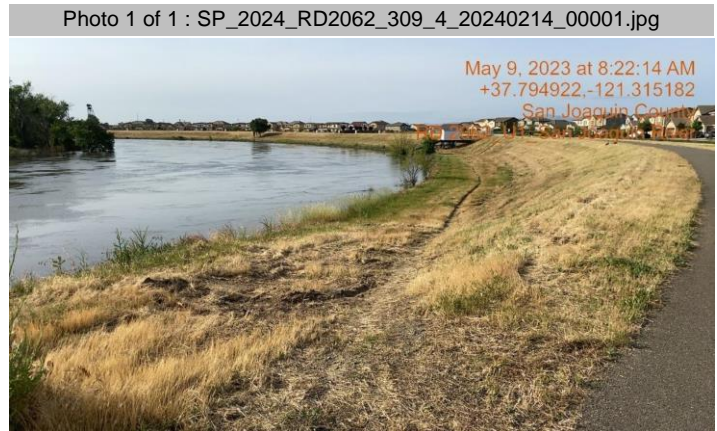
LM Start	1.54	Rating **	A/W	Issue No.	4
LM End	1.54	Issue Type +	Ma	Location *	WS
Category	Earthen Levee			GPS Latitude/Longitude	
				Start	End
Item	Erosion / Foot Traffic			37.794843°	37.794843°
				-121.315269°	-121.315269°
DWR ID	DWR_RD2062_01_s_2022_4				
Comment Code					
E3 : Repair the levee slope damaged by foot traffic and prevent access where possible.					
Inspector Comment					
There is a pedestrian pathway on the waterside slope that needs to be monitored.

View of pedestrian trail along the waterside slope. Spring 2023

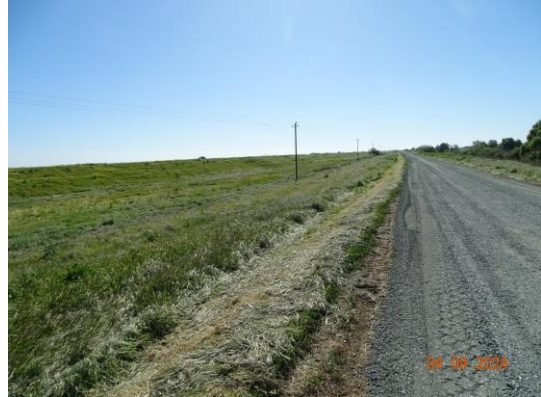
Photo 1 of 1 : SP\_2024\_RD2062\_310\_2\_20240410\_00005.jpg

LM Start	0.03	Rating **	M	Issue No.	2
LM End	3.94	Issue Type +	Ma	Location *	LS
Category	Earthen Levee			GPS Latitude/Longitude	
				Start	End
Item	Vegetation			37.778138°	37.809069°
				-121.333361°	-121.390435°
DWR ID	DWR_RD2062_02_s_2024_2				
Comment Code					
V1 : Control annual grass and weeds on the levee slopes and easements.					
Inspector Comment

Typical view of vegetation along the landside slope. Spring 2024

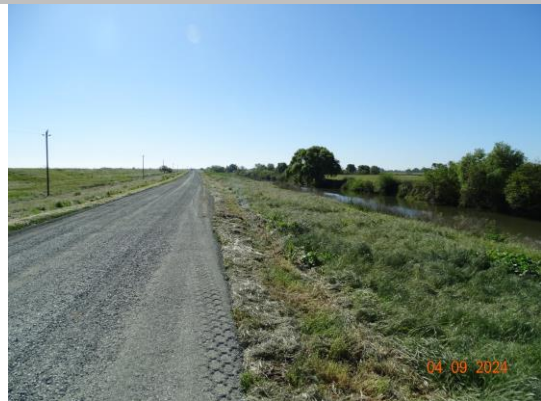
Photo 1 of 1 : SP\_2024\_RD2062\_310\_3\_20240410\_00006.jpg

LM Start	0.03	Rating **	M	Issue No.	3
LM End	3.94	Issue Type +	Ma	Location *	WS
Category	Earthen Levee			GPS Latitude/Longitude	
				Start	End
Item	Vegetation			37.778138°	37.809060°
				-121.333365°	-121.390427°
DWR ID	DWR_RD2062_02_s_2024_3				
Comment Code					
V1 : Control annual grass and weeds on the levee slopes and easements.					
Inspector Comment

Typical view of vegetation along the waterside slope. Spring 2024

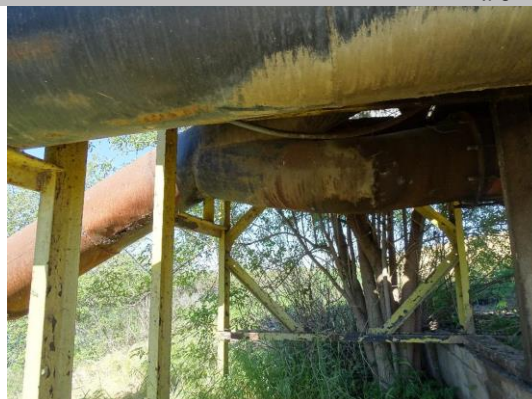
Photo 2 of 3 : UCIP\_SP\_2024\_72749\_109143.jpg

Water-Side: view of pipe with corroded holes on far side.

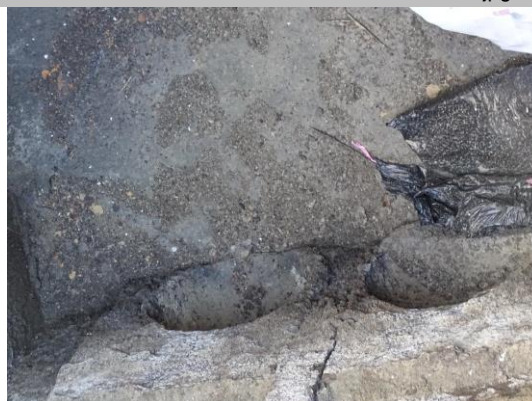
Photo 3 of 3 : UCIP\_SP\_2024\_72749\_109144.jpg

Land-Side: view of pipe outlet in distribution box.

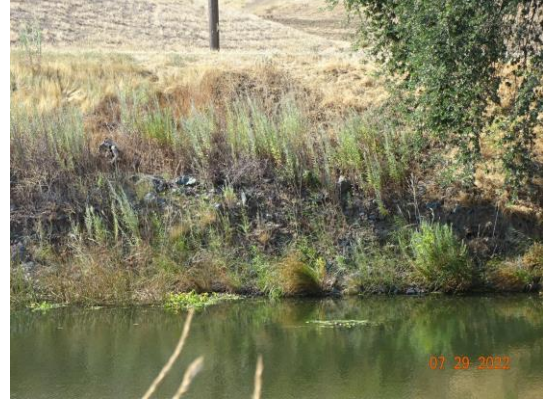
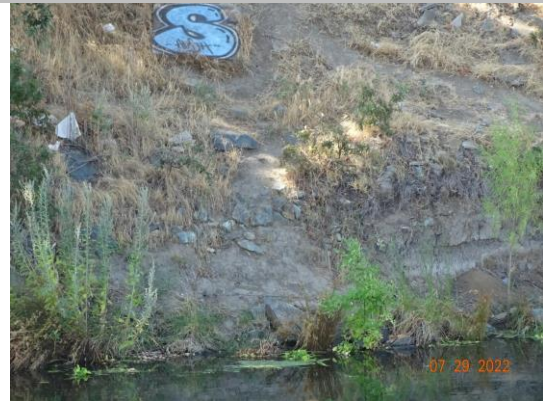
LM Start	-0.03	Rating **	M	Issue No.	7
LM End	0.07	Issue Type +	Ma	Location *	WS
Category	Supplemental			GPS Latitude/Longitude	
				Start	End
Item	DWR Erosion Survey			37.809514°	37.809514°
				-121.390125°	-121.390125°
DWR ID	RD2062U03RM29.94

8/30/2023: From 2020 to present, no significant changes were observed during the annual survey.

09/30/2020: Nearly vertical scarp visible along the levee slope. Noticed rodent holes in some areas and crushed concrete pieces.

09/13/2017: The erosion site has expanded significantly along the river bank.

06/25/2015: The erosion is below a large oak tree. Vegetation is visible around the erosion site.

7/29/2022: View of the erosion from the opposite bank.

7/29/2022: Another view of the erosion.

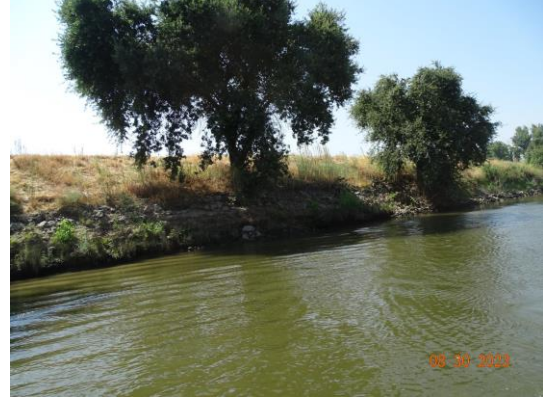
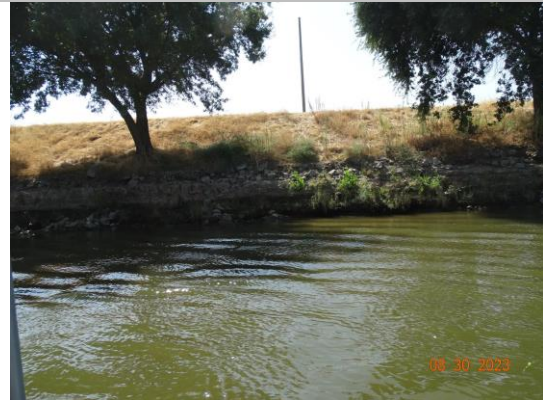
8/30/2023: From 2020 to present, no significant changes were observed during the annual survey. There is a large animal burrow on the lower bank.

09/13/2017: The erosion site has expanded significantly with the erosion length increased to approximately 90 ft from 40 ft. Signs of animal activities have been found at the site.

8/30/2023: View of the erosion looking downstream.

8/30/2023: Close-up view of the erosion.

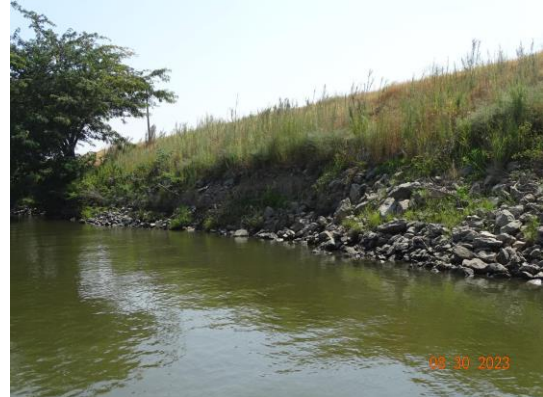
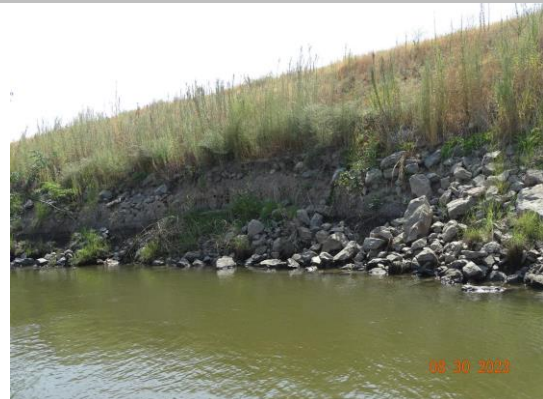
LM Start	0.16	Rating **	M	Issue No.	5
LM End	0.19	Issue Type +	Ma	Location *	WS
Category	Supplemental			GPS Latitude/Longitude	
				Start	End
Item	DWR Erosion Survey			37.810268°	37.810268°
				-121.387495°	-121.387495°
DWR ID	RD2062U03RM30.1				
Comment Code					
Inspector Comment					
Site ID: RD2062U03RM30.1					
8/30/2023: During the annual survey the erosion length has been revised to 150 ft.					
07/29/2022: From 2012 to present, no significant changes were observed during the annual survey.					
08/23/2011: The protection at the levee toe has been washed away.

8/30/2023: View of the erosion looking upstream.

8/30/2023: Close-up view of erosion.

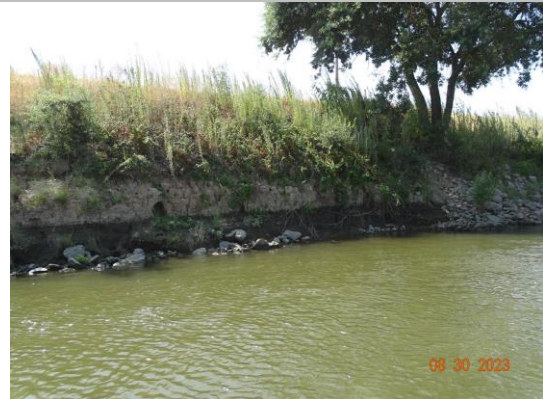
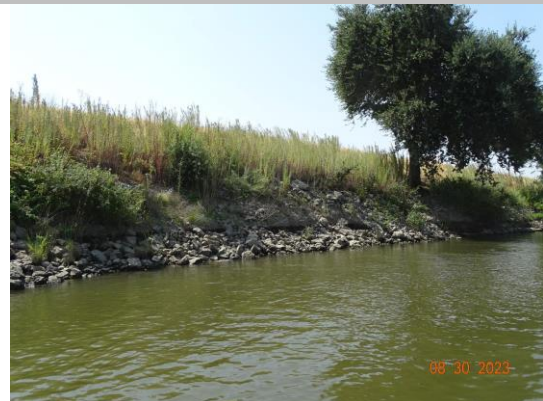
08/13/2013: A new pocket erosion at the upper levee slope has been found directly above a large tree. The erosion might have been caused by internal pipe leakage or surface runoff.

8/30/2023: Close-up view of erosion looking downstream.

8/30/2023: Another view of the erosion.

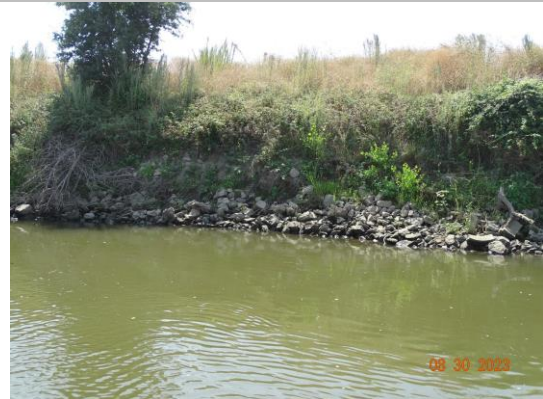
Photo 1 of 1 : SP\_2024\_RD2062\_311\_4\_20240214\_00005.jpg

LM Start	0.35	Rating **	M	Issue No.	4
LM End	0.36	Issue Type +	Ma	Location *	WS
Category	Supplemental			GPS Latitude/Longitude	
				Start	End
Item	DWR Erosion Survey			37.811101°	37.811101°
				-121.384402°	-121.384402°
DWR ID	RD2062U03RM30.27				
Comment Code					
Inspector Comment					
Site ID: RD2062U03RM30.27					
8/30/2023: From 2011 to present, no significant changes were observed during the annual survey.					
08/23/2011: The site is right at the downstream of a river bend.

8/30/2023: View of the erosion.

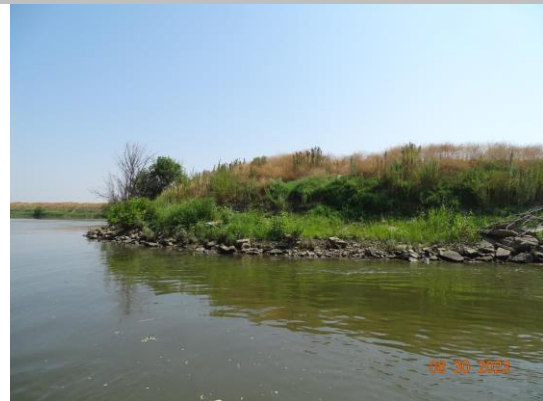
Photo 1 of 1 : SP\_2024\_RD2062\_311\_2\_20240214\_00003.jpg

LM Start	0.55	Rating **	M	Issue No.	2
LM End	0.56	Issue Type +	Ma	Location *	WS
Category	Supplemental			GPS Latitude/Longitude	
				Start	End
Item	DWR Erosion Survey			37.813070°	37.813070°
				-121.383100°	-121.383100°
DWR ID	RD2062U03RM30.43

Comment Code					
Inspector Comment					
Site ID: RD2062U03RM30.43					
8/30/2023: From 2010 to present, no significant changes were observed during the annual survey.					
09/07/2010: Much of the placed rip rap revetment has slid. It is no longer adequately protecting the slope.					
08/06/2010: Recommended as local maintenance issue, per CLRO Report.					
03/09/2010: As discussed with Michael Moncrief of MBK, site will be 'addressed' this year.					
09/29/2009: No major change observed since last visit; a section of the rip rap has slipped, exposing a levee section that has eroded; recommended as local maintenance issue, per CLRO CES Evaluation 2008 Report; Site # is the same as RM30.43,LM0.63; previously rated "U".					
11/05/2008: Site is located inside of a bend; scarp looks to be into the levee prism; piles of concrete chunks placed on the slope, with some of them already starting to slide.

8/30/2023: View of the erosion.

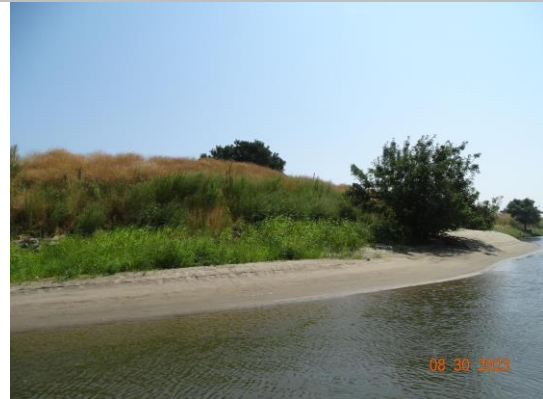
Photo 1 of 1 : SP\_2024\_RD2062\_311\_3\_20240214\_00004.jpg

Comment Code					
Inspector Comment					
Site ID: RD2062U03RM31.12 8/30/2023: From 2010 to present, no significant changes were observed during the annual survey. The site is immediately upstream of a repaired site. 09/07/2010: Much of the seasonal grass along the slope was cleared. Site consists of an existing scalloped erosion approximately 30 feet long by 5 feet wide at its widest opening. The lateral crack is extended outwards along the middle slope. There is a 1 to 2 feet of differential settlement that could further develop into a shallow slide. 08/06/2010: Recommended as local maintenance issue, per CLRO. 03/09/2010: As discussed with Michael Moncrief of MBK Engineers, site will be 'addressed' this year. 09/28/2009: No major change observed; section of rip rap has slipped, creating a terraced effect; dense vegetation growth; recommended as a local maintenance issue, per CLRO CES Evaluation 2008 Report; Site # is the same as RM31.12, LM1.25; previously rated "U". 09/14/2006: 1-2' into prism.

8/30/2023: View of the erosion.

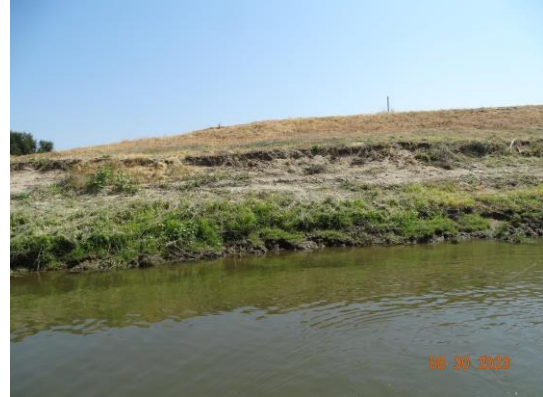
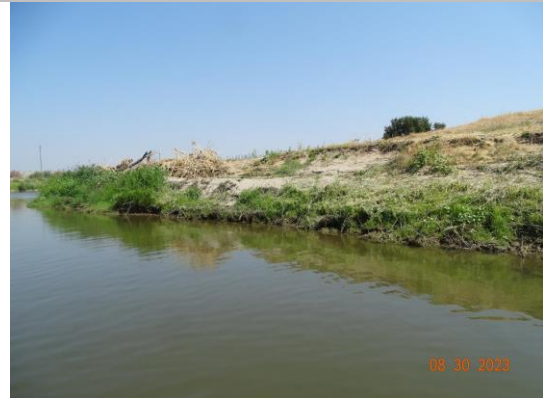
Issue has been transferred to Levee Mile Report and will continued to monitored. Site ID: RD2062U03RM33.92  
 This site is not rated due to the relatively wide berm.  
 07/15/2022: The sloughing on the mid and upper slope was visible, as well as some undermining on the lower bank.  
 08/25/2021: From 2018 to present, no significant changes were observed during the annual survey.  
 09/13/2017: The erosion site is immediately downstream of a sharp river bend

View of bank erosion. 8/30/2023

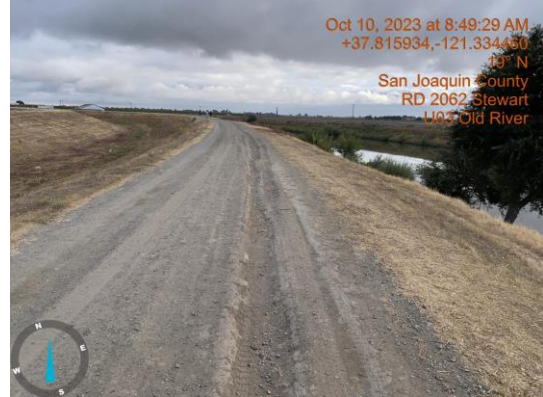
Photo 1 of 1 : SP\_2024\_RD2062\_311\_14\_20240214\_00017.jpg

LM Start	4.56	Rating **	M	Issue No.	14
LM End	4.60	Issue Type +	Ma	Location *	CR
Category	Earthen Levee			GPS Latitude/Longitude	
				Start	End
Item	Crown Surface / Depressions / Rutting			37.816427°	37.815897°
				-121.334039°	-121.334364°
DWR ID	DWR_RD2062_03_f _ 2023_14				
Comment Code					
C2 : Repair depressions or ruts in the crown or slope.					
Inspector Comment

View of ruts in the crown of levee surface road. Fall 2023

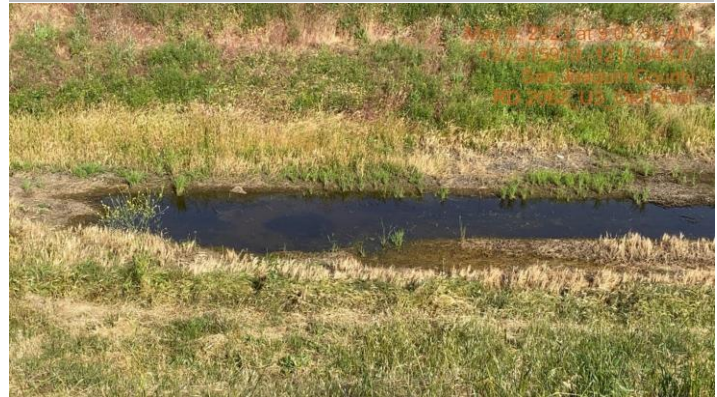
Photo 1 of 1 : SP\_2024\_RD2062\_311\_13\_20240214\_00016.jpg

LM Start	4.60	Rating **	A/W	Issue No.	13
LM End	4.60	Issue Type +	Ob	Location *	LS
Category	Earthen Levee			GPS Latitude/Longitude	
				Start	End
Item	Seepage / Sandboils			37.815962°	37.815962°
				-121.334347°	-121.334347°
DWR ID	DWR_RD2062_03_s_2023_13				
Comment Code					
SS : Seepage / Sandboils					
Inspector Comment

View of seepage area and boil in the landside easement. Spring 2023

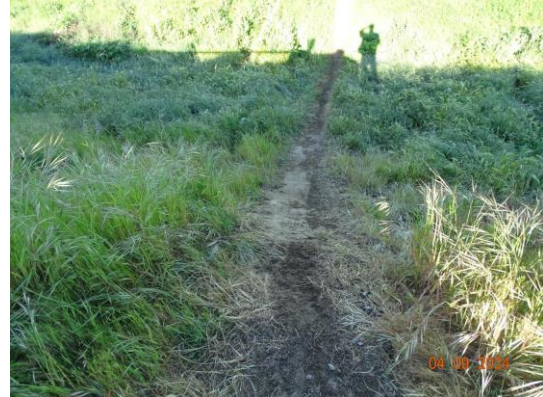
Photo 1 of 1 : SP\_2024\_RD2062\_311\_18\_20240410\_00020.jpg

LM Start	4.74	Rating **	M	Issue No.	18
LM End	4.74	Issue Type +	Ma	Location *	LS
Category	Earthen Levee			GPS Latitude/Longitude	
				Start	End
Item	Erosion / Vehicle Traffic			37.814250°	37.814250°
				-121.335728°	-121.335728°
DWR ID	DWR_RD2062_03_s_2024_18				
Comment Code					
E6 : Repair the levee slope damaged by vehicle traffic and prevent access where possible.					
Inspector Comment

View of erosion rills caused by motorcycles along the landside slope and easement. Spring 2024
