**Flood Control Project Maintenance  
Levee Inspections**

**Maintenance Issue Types Only, Levee Inspection Report By Mile - Spring 2015**

**Reclamation District No. 2062 Stewart**

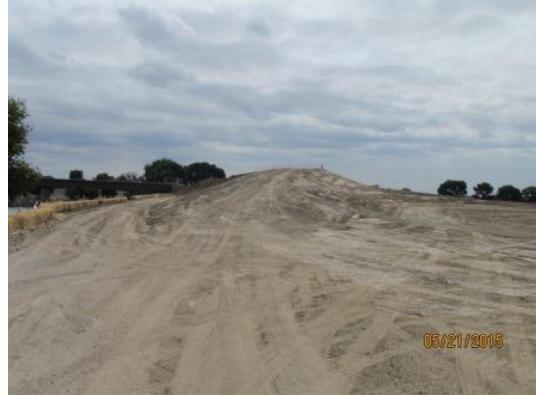
Photo 1 of 1 : SP\_2015\_RD2062\_309\_6\_20150526\_00003.jpg

LM Start	<b>0.72</b>	Rating **	A/W	Issue No.	<b>6</b>
LM End	<b>0.72</b>	Issue Type +	Ma	Location *	WS
Category	Earthen Levee		GPS Latitude/Longitude		
			Start	End	
Item	Crown Surface / Depressions / Rutting		37.805138 °	37.805138 °	
			-121.316420 °	-121.316420 °	
DWR ID	DWR_RD2062_01_s_2015_6				
Action/Comments					
Add appropriate gravel or road base. Grade and compact. Inspector Comments: New levee patrol road is being installed. Make sure all-weather access is available before next flood season.

View of the new patrol road installation in process.

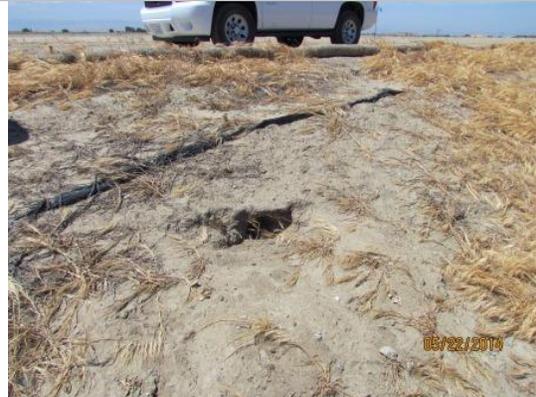
Photo 1 of 1 : SP\_2015\_RD2062\_309\_12\_20150317\_00001.jpg

LM Start	<b>1.82</b>	Rating **	A/W	Issue No.	<b>12</b>
LM End	<b>1.82</b>	Issue Type +	Ma	Location *	WS
Category	Earthen Levee		GPS Latitude/Longitude		
			Start	End	
Item	Animal Control		37.791798 °	37.791798 °	
			-121.312904 °	-121.312904 °	
DWR ID	DWR_RD2062_01_s_2012_12				
Action/Comments					
No rodents visible, but rodent burrows visible; need to backfill and compact or grout burrows.

View of a rodent hole on the waterside levee slope.

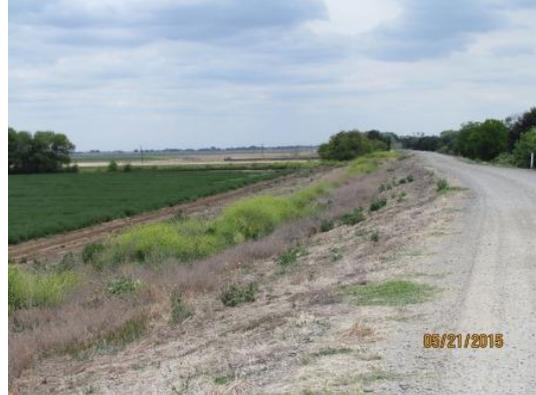
Photo 1 of 1 : SP\_2015\_RD2062\_310\_11\_20150526\_00012.jpg

LM Start	<b>2.52</b>	Rating **	M	Issue No.	<b>11</b>
LM End	<b>3.73</b>	Issue Type +	Ma	Location *	LS
Category	Earthen Levee		GPS Latitude/Longitude		
			Start	End	
Item	Vegetation		37.801429 °	37.806755 °	
			-121.367499 °	-121.388268 °	
DWR ID	DWR_RD2062_02_s_2015_11				
Action/Comments					
Control annual grass and weeds on the levee slopes and easements.

View of the vegetation on the landside levee slope.

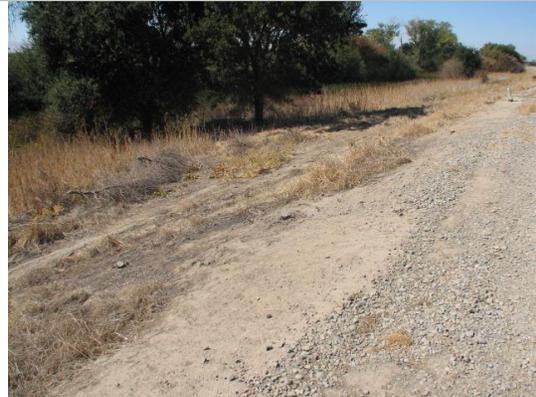
Photo 1 of 1 : SP\_2015\_RD2062\_310\_3\_20150317\_00001.jpg

LM Start	<b>2.84</b>	Rating **	N	Issue No.	<b>3</b>
LM End	<b>2.84</b>	Issue Type +	Ma	Location *	WS
Category	Earthen Levee		GPS Latitude/Longitude		
			Start	End	
Item	Trim / Thin Trees		37.803827 °	37.803827 °	
			-121.372424 °	-121.372424 °	
DWR ID	DWR_RD2062_02_s_2012_3				
Action/Comments					
Tree stumps. Inspector Comments: Three small tree stumps.

Three small stumps on levee slope.

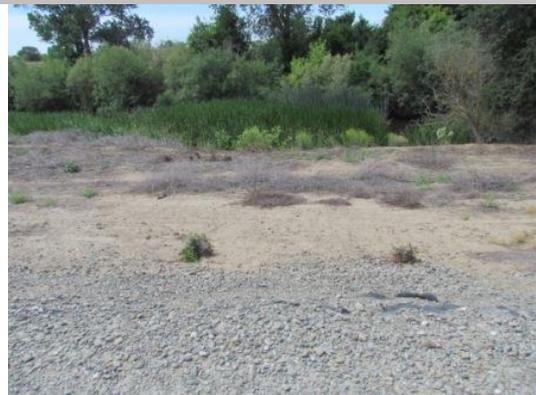
Photo 1 of 1 : SP\_2015\_RD2062\_310\_13\_20150317\_00003.jpg

LM Start	<b>2.88</b>	Rating **	N	Issue No.	<b>13</b>
LM End	<b>2.88</b>	Issue Type +	Ma	Location *	WS
Category	Earthen Levee		GPS Latitude/Longitude		
			Start	End	
Item	Trim / Thin Trees		37.804060 °	37.804060 °	
			-121.373245 °	-121.373245 °	
DWR ID	DWR_RD2062_02_s_2012_13				
Action/Comments					
Tree stumps. Inspector Comments: Four small oak stumps on levee slope.

View of tree stumps on waterside slope. 05/17/2012

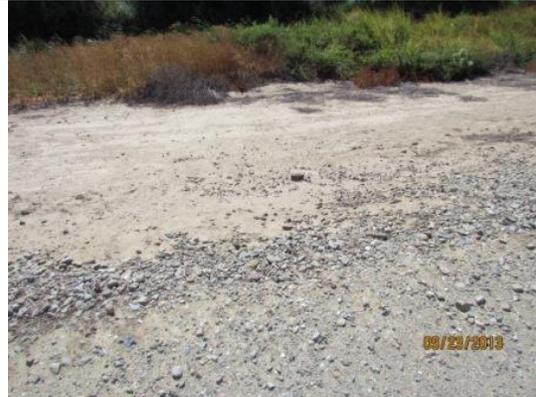
Photo 1 of 1 : SP\_2015\_RD2062\_310\_14\_20150317\_00004.jpg

LM Start	<b>2.98</b>	Rating **	N	Issue No.	<b>14</b>
LM End	<b>2.98</b>	Issue Type +	Ma	Location *	WS
Category	Earthen Levee		GPS Latitude/Longitude		
			Start	End	
Item	Trim / Thin Trees		37.804452 °	37.804452 °	
			-121.374903 °	-121.374903 °	
DWR ID	DWR_RD2062_02_s_2012_14				
Action/Comments					
Tree stumps.

View of the tree stump in the middle of the photo.

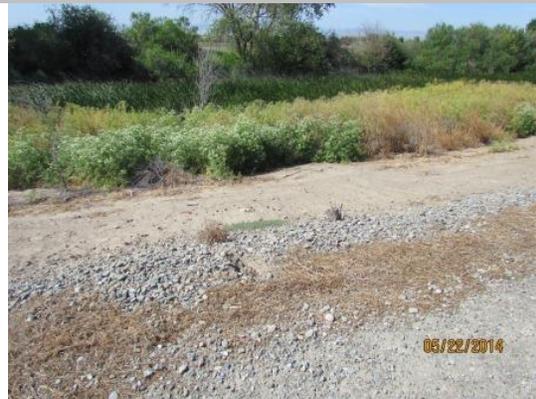
Photo 1 of 1 : SP\_2015\_RD2062\_310\_15\_20150317\_00005.jpg

LM Start	<b>3.01</b>	Rating **	N	Issue No.	<b>15</b>
LM End	<b>3.01</b>	Issue Type +	Ma	Location *	WS
Category	Earthen Levee		GPS Latitude/Longitude		
			Start	End	
Item	Trim / Thin Trees		37.804481 °	37.804481 °	
			-121.375510 °	-121.375510 °	
DWR ID	DWR_RD2062_02_s_2012_15				
Action/Comments					
Tree stumps.

View of the tree stumps on the waterside levee slope.

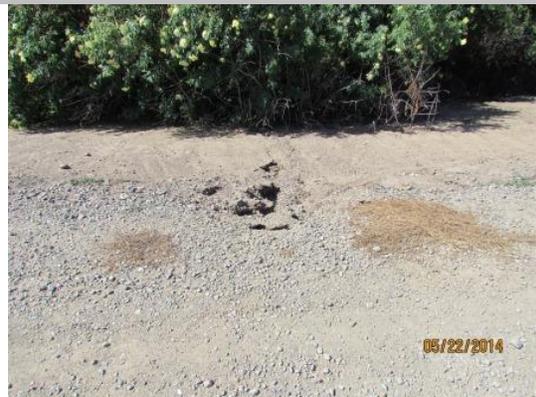
Photo 1 of 1 : SP\_2015\_RD2062\_310\_8\_20150317\_00002.jpg

LM Start	<b>3.64</b>	Rating **	M	Issue No.	<b>8</b>
LM End	<b>3.64</b>	Issue Type +	Ma	Location *	WS
Category	Earthen Levee		GPS Latitude/Longitude		
			Start	End	
Item	Erosion / Bank Caving		37.806347 °	37.806347 °	
			-121.386692 °	-121.386692 °	
DWR ID	DWR_RD2062_02_s_2014_8				
Action/Comments					
Schedule repair of erosion site prior to the next inspection.

View of the erosion from surface runoff on the waterside levee slope.

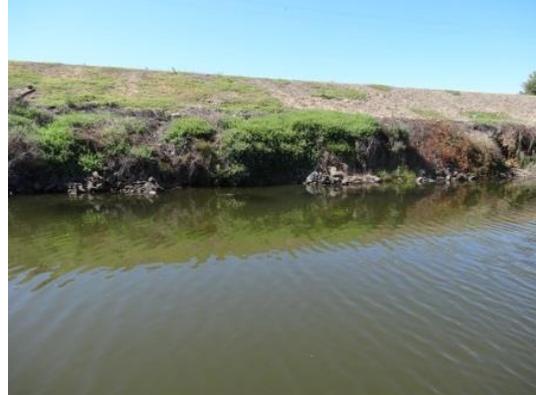
Photo 1 of 1 : SP\_2015\_RD2062\_311\_1\_20150317\_00001.jpg

LM Start	<b>0.02</b>	Rating **	U	Issue No.	<b>1</b>
LM End	<b>0.02</b>	Issue Type +	Ma	Location *	WS
Category	Supplemental			GPS Latitude/Longitude	
				Start	End
Item	DWR Erosion Survey			37.809673 °	37.809673 °
				-121.390321 °	-121.390321 °
DWR ID	DWR_RD2062_03_s_2015_1				
Action/Comments					
Inspector Comments: 07/02/2014: No significant change observed. 08/13/2013: No significant change observed. 08/07/2012: The site has been visited by boat survey. No significant change observed 08/23/2011: Site is at the upstream of a drainage ditch. [2014 Site ID:RD2062U03RM29.93]

Front view of the erosion.

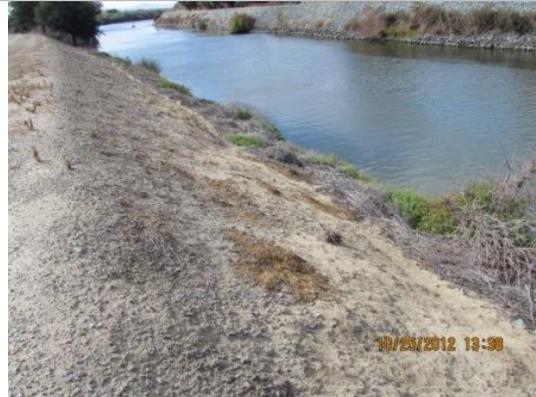
Photo 1 of 1 : SP\_2015\_RD2062\_311\_3\_20150317\_00003.jpg

LM Start	<b>0.08</b>	Rating **	N	Issue No.	<b>3</b>
LM End	<b>0.08</b>	Issue Type +	Ma	Location *	WS
Category	Earthen Levee			GPS Latitude/Longitude	
				Start	End
Item	Trim / Thin Trees			37.809727 °	37.809727 °
				-121.389100 °	-121.389100 °
DWR ID	DWR_RD2062_03_f_2012_3				
Action/Comments					
Tree stumps.

View of tree stumps on waterside slope.

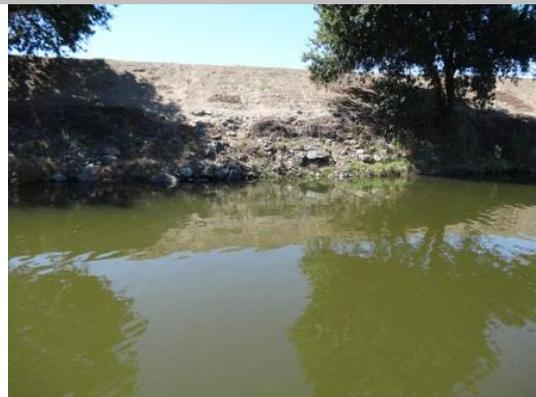
Photo 1 of 1 : SP\_2015\_RD2062\_311\_2\_20150317\_00002.jpg

LM Start	<b>0.10</b>	Rating **	U	Issue No.	<b>2</b>
LM End	<b>0.10</b>	Issue Type +	Ma	Location *	WS
Category	Supplemental			GPS Latitude/Longitude	
				Start	End
Item	DWR Erosion Survey			37.810052 °	37.810052 °
				-121.388847 °	-121.388847 °
DWR ID	DWR_RD2062_03_s_2015_2				
Action/Comments					
Inspector Comments: 07/02/2014: No significant change observed. 08/13/2013: No significant change observed. 08/07/2012: The site has been visited by boat survey. No significant change observed 08/23/2011: Hard to view the erosion because of the dense vegetation and trees on site. The site is under the bush, close to the tree. [2014 Site ID:RD2062U03RM30.02]

Front view of the site.

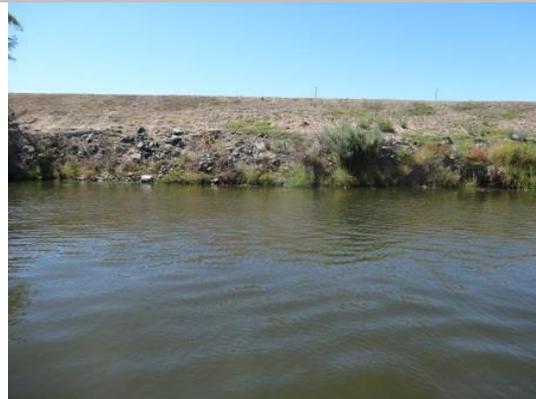
Photo 1 of 1 : SP\_2015\_RD2062\_311\_4\_20150317\_00004.jpg

LM Start	<b>0.18</b>	Rating **	M	Issue No.	<b>4</b>
LM End	<b>0.18</b>	Issue Type +	Ma	Location *	WS
Category	Supplemental			GPS Latitude/Longitude	
				Start	End
Item	DWR Erosion Survey			37.810468 °	37.810468 °
				-121.387492 °	-121.387492 °
DWR ID	DWR_RD2062_03_s_2015_4				
Action/Comments					
Inspector Comments: 07/02/2014: No significant change observed. 08/13/2013: No significant change observed. 08/07/2012: The site has been visited by boat survey. No significant change observed 08/23/2011: The protection at the levee toe has been washed away. [2014 Site ID:RD2062U03RM30.1]

Direct view of the site.

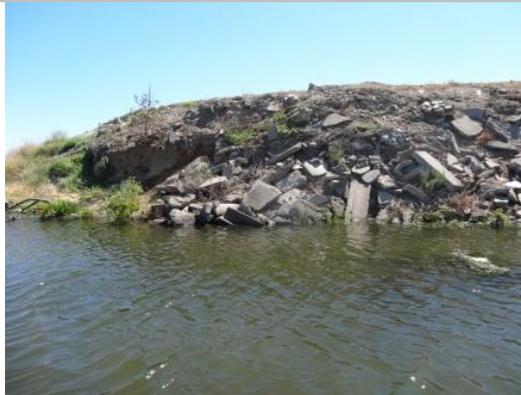
Photo 1 of 1 : SP\_2015\_RD2062\_311\_9\_20150317\_00008.jpg

LM Start	<b>0.55</b>	Rating **	M	Issue No.	<b>9</b>
LM End	<b>0.55</b>	Issue Type +	Ma	Location *	WS
Category	Supplemental			GPS Latitude/Longitude	
				Start	End

Item	DWR Erosion Survey			37.813070 °	37.813070 °
				-121.383100 °	-121.383100 °
DWR ID	DWR_RD2062_03_s_2015_9				
Action/Comments					
<p>Inspector Comments: 07/02/2014: No significant change observed.                  08/13/2013: No significant change observed.                  08/07/2012: The site has been visited by boat survey. No significant change observed.                  08/23/2011: No significant change observed on site.                  09/07/2010: No significant change observed on site. Much of the placed rip rap revetment has slid. It is no longer adequately protecting the slope.                  08/06/2010: Recommended as local maintenance issue, per CLRO Report.                  03/09/2010: As discussed with Michael Moncrief of MBK, site will be 'addressed' this year.                  09/29/2009: No major change observed since last visit; a section of the rip rap has slipped, exposing a levee section that has eroded; recommended as local maintenance issue, per CLRO CES Evaluation 2008 Report; Site # is the same as RM30.43,LM0.63; previously rated "U".                  11/05/2008: Site is located inside of a bend; scarp looks to be into the levee prism; piles of concrete chunks placed on the slope, with some of them already starting to slide. [2014 Site ID:RD2062U03RM30.43]</p>

Front view of the site. Rip rap no longer adequately protecting levee slope.

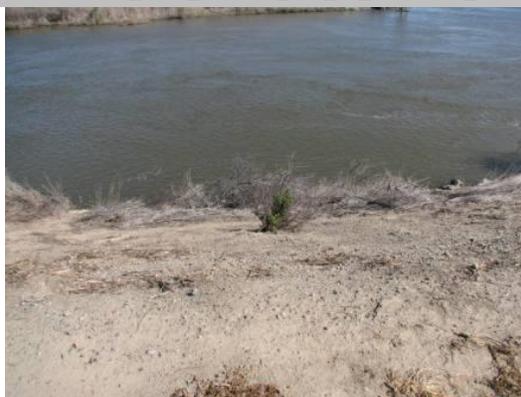
Photo 1 of 1 : SP\_2015\_RD2062\_311\_10\_20150317\_00009.jpg

LM Start	<b>0.61</b>	Rating **	N	Issue No.	<b>10</b>
LM End	<b>0.61</b>	Issue Type +	Ma	Location *	WS
Category	Earthen Levee			GPS Latitude/Longitude	
				Start	End
Item	Trim / Thin Trees			37.813570 °	37.813570 °
				-121.382094 °	-121.382094 °
DWR ID	DWR_RD2062_03_s_2012_10				
Action/Comments					
<p>Tree stumps.                  Inspector Comments: Stump in slope.</p>

05/11/2011 Stump in slope, new growth in center of photo is at the location of the stump.

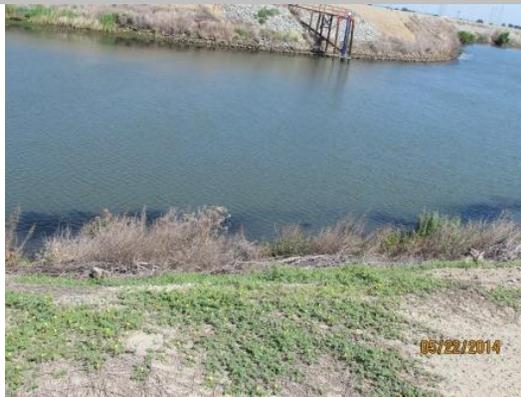
Photo 1 of 1 : SP\_2015\_RD2062\_311\_12\_20150317\_00012.jpg

LM Start	<b>0.64</b>	Rating **	N	Issue No.	<b>12</b>
LM End	<b>0.64</b>	Issue Type +	Ma	Location *	WS
Category	Earthen Levee		GPS Latitude/Longitude		
			Start	End	
Item	Trim / Thin Trees		37.813894 °	37.813894 °	
			-121.381680 °	-121.381680 °	
DWR ID	DWR_RD2062_03_s_2012_12				
Action/Comments					
Tree stumps. Inspector Comments: 2 stumps on waterside slope.

View of the tree stumps on the waterside levee slope.

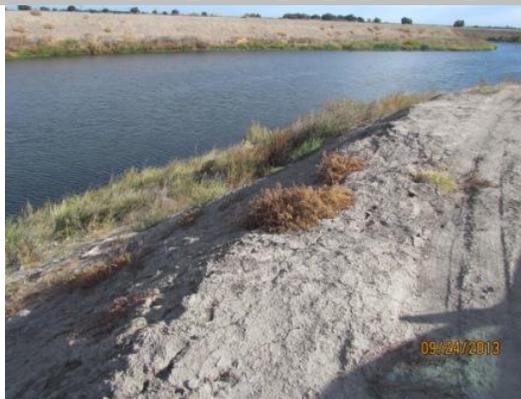
Photo 1 of 2 : SP\_2015\_RD2062\_311\_11\_20150317\_00010.jpg

LM Start	<b>0.81</b>	Rating **	A/W	Issue No.	<b>11</b>
LM End	<b>0.81</b>	Issue Type +	Ma	Location *	WS
Category	Earthen Levee		GPS Latitude/Longitude		
			Start	End	
Item	Erosion / Bank Caving		37.816315 °	37.816315 °	
			-121.381587 °	-121.381587 °	
DWR ID	DWR_RD2062_03_s_2012_11				
Action/Comments					
Schedule repair of erosion site prior to the next inspection. Inspector Comments: Cracking developing along the waterside levee hinge.

View of cracking at waterside levee hinge.

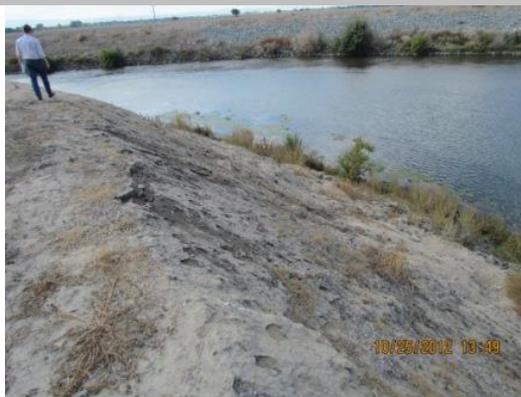
Photo 2 of 2 : SP\_2015\_RD2062\_311\_11\_20150317\_00011.jpg

LM Start	<b>0.81</b>	Rating **	A/W	Issue No.	<b>11 (cont)</b>
LM End	<b>0.81</b>	Issue Type +	Ma	Location *	WS

View of slope erosion from foot traffic.

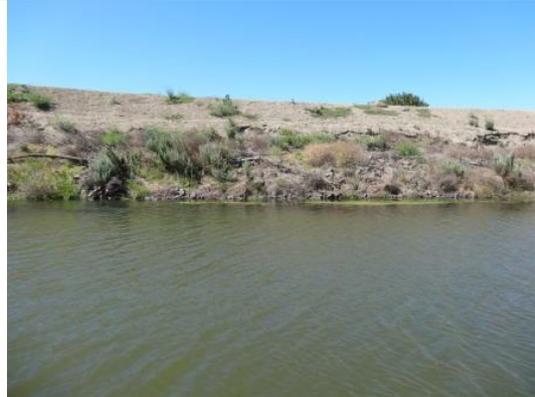
Photo 1 of 1 : SP\_2015\_RD2062\_311\_13\_20150317\_00013.jpg

LM Start	<b>1.18</b>	Rating **	U	Issue No.	<b>13</b>
LM End	<b>1.18</b>	Issue Type +	Ma	Location *	WS
Category	Supplemental			GPS Latitude/Longitude	
				Start	End
Item	DWR Erosion Survey			37.819290 °	37.819290 °
				-121.378880 °	-121.378880 °
DWR ID	DWR_RD2062_03_s_2015_13				
Action/Comments					
Inspector Comments: 07/02/2014: No significant change observed. 08/13/2013: No significant change observed. 08/07/2012: The site has been visited by boat survey. No significant change observed 08/23/2011: No significant change observed on site. 09/07/2010: No significant change observed on site. Much of the

Front view of the site.

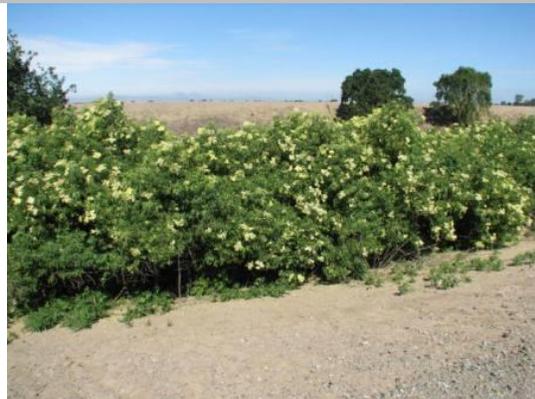
Photo 1 of 1 : SP\_2015\_RD2062\_311\_18\_20150317\_00015.jpg

LM Start	<b>1.35</b>	Rating **	A/W	Issue No.	<b>18</b>
LM End	<b>1.35</b>	Issue Type +	Ma	Location *	WS
Category	Earthen Levee			GPS Latitude/Longitude	
				Start	End
Item	Vegetation			37.820885 °	37.820885 °
				-121.376986 °	-121.376986 °
DWR ID	DWR_RD2062_03_s_2012_18				
Action/Comments					
Elderberries are blocking visibility and flood fight capability. Inspector Comments: Elderberry bush blocks visibility.

05/11/2011 Elderberry bush on water side slope.

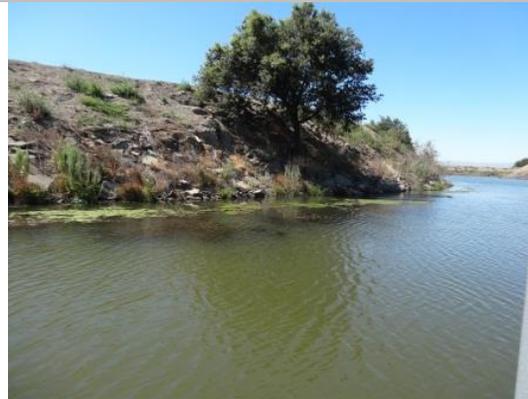
Photo 1 of 1 : SP\_2015\_RD2062\_311\_20\_20150317\_00017.jpg

LM Start	<b>1.39</b>	Rating **	U	Issue No.	<b>20</b>
LM End	<b>1.39</b>	Issue Type +	Ma	Location *	WS
Category	Supplemental			GPS Latitude/Longitude	
				Start	End

Item	DWR Erosion Survey			37.821380 °	37.821380 °
				-121.376900 °	-121.376900 °
DWR ID	DWR_RD2062_03_s_2015_20				
Action/Comments					
<p>Inspector Comments: 07/02/2014: No significant change observed.                      08/13/2013: No significant change observed.                      08/07/2012: The site has been visited by boat survey. No significant change observed                      08/23/2011: No significant change observed on site.                      09/07/2010: No significant change observed on site. There is a small-to medium sized Oak tree on the mid-slope just above rip rap. Some of the rip rap has collapsed, creating a pocket erosion just above the existing toe rip rap and upstream of the Oak tree.                      08/06/2010: Recommended as local maintenance issue, per CLRO.                      03/09/2010: As discussed with Michael Moncrief of MBK Engineer, site will be 'addressed' in 2010.                      09/29/2009: No major change since last visit; sliding of the rip rap at the base of the lone tree; there is noticeable man-made trail and foot traffic extending from the crown to the toe; much of the broken concrete used as temporary rip rap has slid, exposing portion of the bare levee slope; recommended as local maintenance issue, per CLRO CES Evaluation 2008 Report; Site # is the same as RM31.3, LM1.45; previously rated "M".                      11/05/2008: Portion of rip rap collapsing.                      09/14/2006: Portion of rip rap along the slope has collapsed; exposed levee section is starting to erode, exposing roots from the nearby tree.                      [2014 Site ID:RD2062U03RM31.28]</p>

Front view of the site.

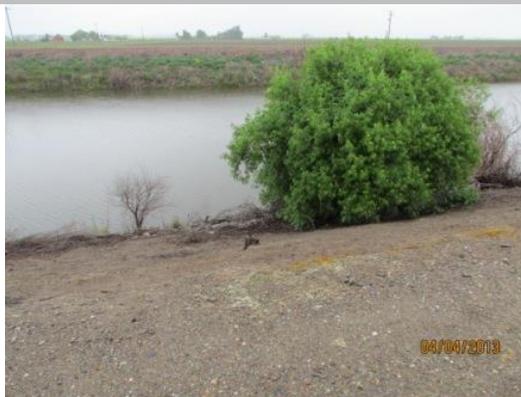
Photo 1 of 1 : SP\_2015\_RD2062\_311\_15\_20150317\_00014.jpg

LM Start	<b>1.66</b>	Rating **	N	Issue No.	<b>15</b>
LM End	<b>1.66</b>	Issue Type +	Ma	Location *	WS
Category	Earthen Levee		GPS Latitude/Longitude		
			Start	End	
Item	Trim / Thin Trees		37.820890 °	37.820890 °	
			-121.372227 °	-121.372227 °	
DWR ID	DWR_RD2062_03_s_2012_15				
Action/Comments					
Tree stumps.

View of the tree stump on the waterside levee slope.

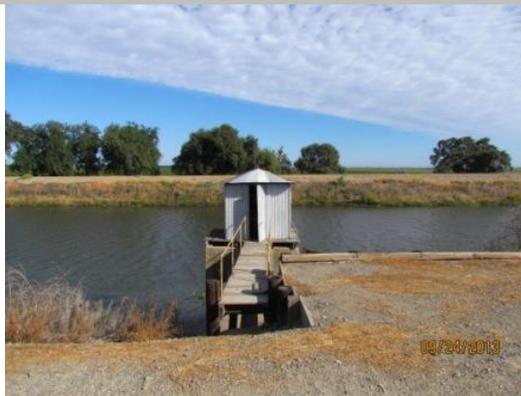
Photo 1 of 1 : SP\_2015\_RD2062\_311\_19\_20150317\_00016.jpg

LM Start	<b>2.12</b>	Rating **	A/W	Issue No.	<b>19</b>
LM End	<b>2.12</b>	Issue Type +	Ma	Location *	WS
Category	Earthen Levee		GPS Latitude/Longitude		
			Start	End	
Item	Encroachments		37.818645 °	37.818645 °	
			-121.364894 °	-121.364894 °	
DWR ID	DWR_RD2062_03_s_2012_19				
Action/Comments					
Pipe Inspector Comments: Irrigation intake.

View of the pump house on the waterside levee slope.

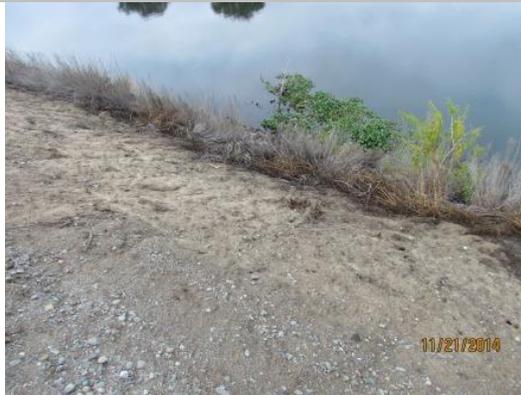
Photo 1 of 1 : SP\_2015\_RD2062\_311\_26\_20150317\_00019.jpg

LM Start	<b>3.10</b>	Rating **	N	Issue No.	<b>26</b>
LM End	<b>3.10</b>	Issue Type +	Ma	Location *	WS
Category	Earthen Levee		GPS Latitude/Longitude		
			Start	End	
Item	Trim / Thin Trees		37.818532 °	37.818532 °	
			-121.349510 °	-121.349510 °	
DWR ID	DWR_RD2062_03_s_2012_26				
Action/Comments					
Tree stumps.

View of the tree stump on the waterside levee slope.

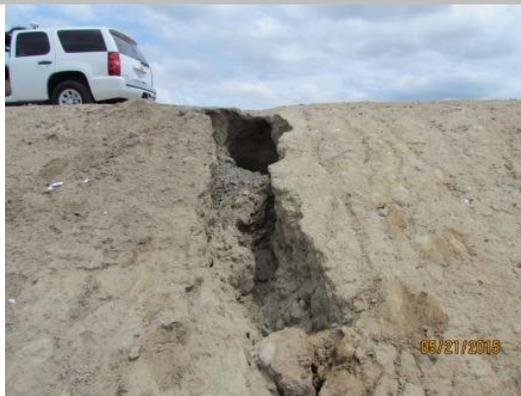
Photo 1 of 1 : SP\_2015\_RD2062\_311\_32\_20150526\_00026.jpg

LM Start	<b>3.44</b>	Rating **	U	Issue No.	<b>32</b>
LM End	<b>3.44</b>	Issue Type +	Ma	Location *	LS
Category	Earthen Levee		GPS Latitude/Longitude		
			Start	End	
Item	Erosion / Bank Caving		37.818694 °	37.818694 °	
			-121.345124 °	-121.345124 °	
DWR ID	DWR_RD2062_03_s_2015_32				
Action/Comments					
Schedule repair of erosion site prior to the next inspection.

View of the erosion of the landside levee slope.

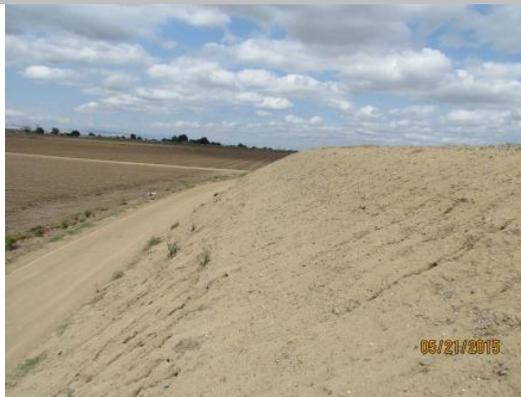
Photo 1 of 1 : SP\_2015\_RD2062\_311\_31\_20150526\_00025.jpg

LM Start	<b>3.61</b>	Rating **	M	Issue No.	<b>31</b>
LM End	<b>3.66</b>	Issue Type +	Ma	Location *	LS
Category	Earthen Levee		GPS Latitude/Longitude		
			Start	End	
Item	Erosion / Bank Caving		37.816982 °	37.816541 °	
			-121.342939 °	-121.342191 °	
DWR ID	DWR_RD2062_03_s_2015_31				
Action/Comments					
Schedule repair of erosion site prior to the next inspection. Inspector Comments: About a 3 ft vertical cut at the levee to into the levee prism.

View of the eroded landside levee toe.

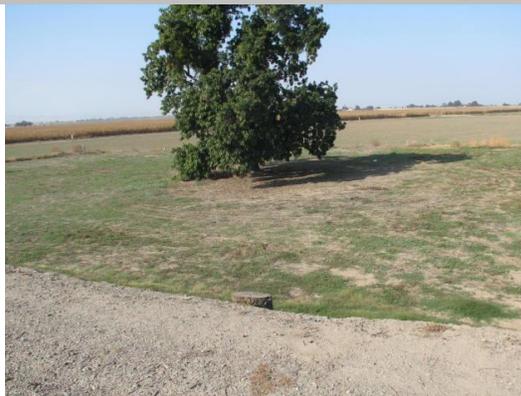
Photo 1 of 1 : SP\_2015\_RD2062\_311\_7\_20150317\_00006.jpg

LM Start	<b>4.75</b>	Rating **	N	Issue No.	<b>7</b>
LM End	<b>4.75</b>	Issue Type +	Ma	Location *	LS
Category	Earthen Levee		GPS Latitude/Longitude		
			Start	End	
Item	Trim / Thin Trees		37.813986 °	37.813986 °	
			-121.335821 °	-121.335821 °	
DWR ID	DWR_RD2062_03_s_2012_7				
Action/Comments					
Tree stumps. Inspector Comments: 14" stump on landside slope.

10/21/2011 Photo taken the next day. Stump can be seen in the lower center of the photo.

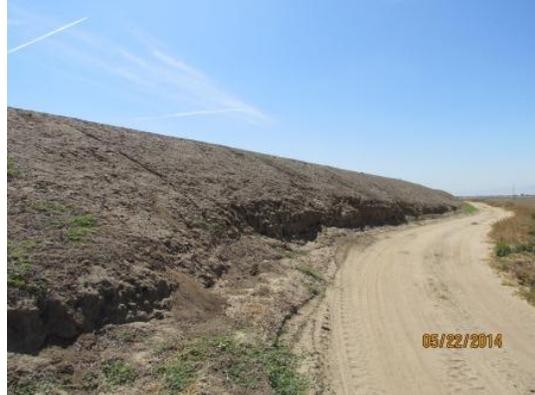
Photo 1 of 1 : SP\_2015\_RD2062\_311\_35\_20150317\_00020.jpg

LM Start	<b>4.88</b>	Rating **	M	Issue No.	<b>35</b>
LM End	<b>4.88</b>	Issue Type +	Ma	Location *	LS
Category	Earthen Levee		GPS Latitude/Longitude		
			Start	End	
Item	Erosion / Bank Caving		37.812225 °	37.812225 °	
			-121.336112 °	-121.336112 °	
DWR ID	DWR_RD2062_03_f_2014_35				
Action/Comments					
Note and monitor erosion site. Inspector Comments: 2 to 3 feet vertical cut possibly caused by previous floods.

View of a 2-3 feet vertical cut at the landside levee toe.
