**Flood Control Project Maintenance
Levee Inspections**

Fall 2011 Levee Maintenance Deficiency Summary Report

San Joaquin River Basin

Reclamation District No. 2063 Crows Landing

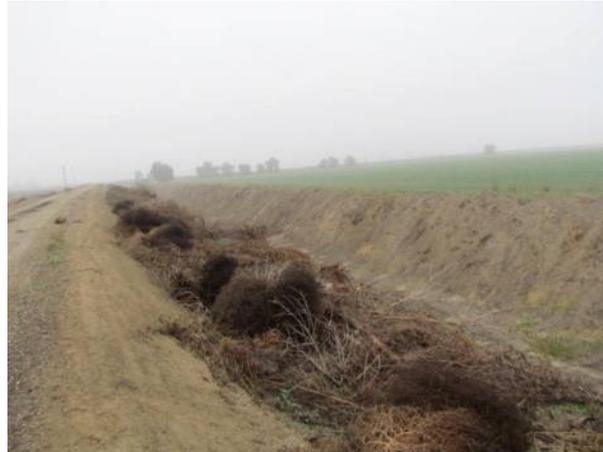
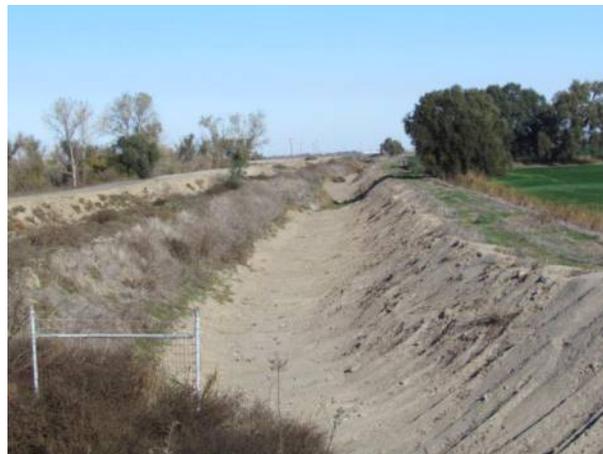
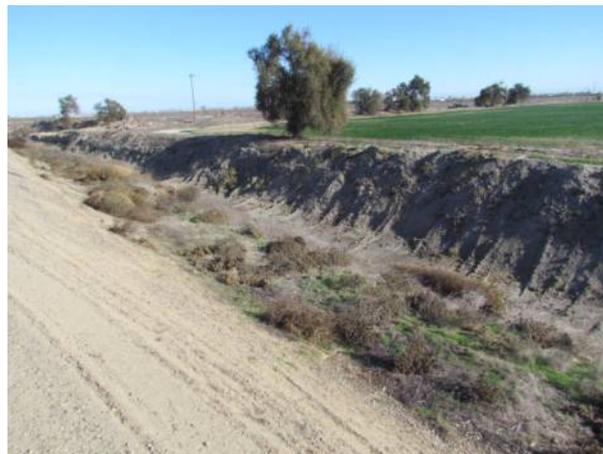
Levee Mile Report Line	4
Start Levee Mile	0.03
End Levee Mile	0.49
Location	Land Side
Category	Earthen Levee
Item	Encroachments
Looking north at ditch on landside berm and toe.	
richard_f_20111130_476.jpg

Levee Mile Report Line	4
Start Levee Mile	0.03
End Levee Mile	0.49
Location	Land Side
Category	Earthen Levee
Item	Encroachments
Looking south at canal-ditch at landside berm and toe.	
richard_f_20111205_484.jpg

Levee Mile Report Line	4
Start Levee Mile	0.03
End Levee Mile	0.49
Location	Land Side
Category	Earthen Levee
Item	Encroachments
Looking northeast at canal-ditch on landside berm.	
richard_f_20111205_485.jpg

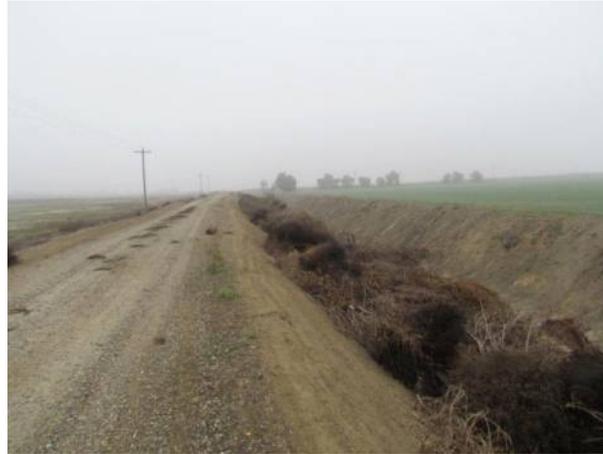
Levee Mile Report Line	5
Start Levee Mile	0.14
End Levee Mile	0.22
Location	Land Side
Category	Earthen Levee
Item	Encroachments

Looking north at prunings stacked on landside toe and berm.

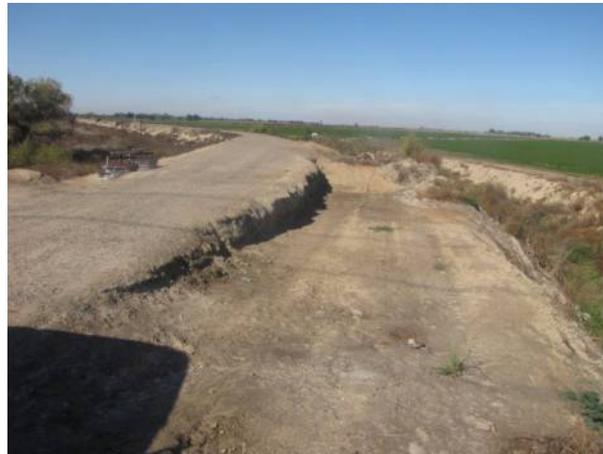
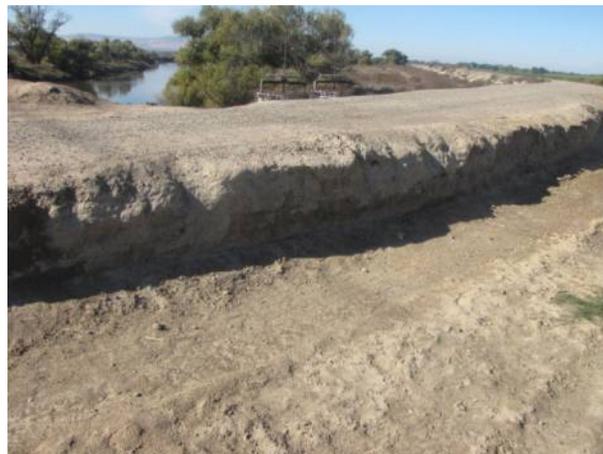
Levee Mile Report Line	6
Start Levee Mile	1.35
End Levee Mile	1.35
Location	Land Side
Category	Earthen Levee
Item	Encroachments

6	1.35	1.35	Earthen Levee	Encroachments	LS	CO	Ramp Inspector Comments: Ramp does not meet CVFPB standards. Ramp has 18-20" vertical cut at landside shoulder.	37.464308 ° -121.032603 °	37.464308 ° -121.032603 °	6 Y
7	1.47	1.50	Earthen Levee	Vegetation	LS	M	Remove the wild growth other than native grasses from the levee slopes.	37.462723 ° -121.032020 °	37.462303 ° -121.031928 °	8
8	1.54	1.54	Earthen Levee	Slope Stability	LS	M	Repair the levee slope damaged by vehicle traffic and prevent access where possible.	37.461762 ° -121.031822 °	37.461762 ° -121.031822 °	10 Y
9	1.57	1.57	Earthen Levee	Animal Control	LS	M	Exterminate rodents and backfill and compact or grout burrows.	37.461322 ° -121.031785 °	37.461322 ° -121.031785 °	4
10	1.69	1.69	Earthen Levee	Animal Control	LS	M	No rodents visible, but rodent burrows visible; need to backfill and compact or grout burrows.	37.459813 ° -121.032372 °	37.459813 ° -121.032372 °	11 Y

Looking north at ramp and equipment working pad on landside slope with a 18-20" vertical cut at shoulder.

Looking west at 18-20" vertical cut for ramp on landside shoulder and slope

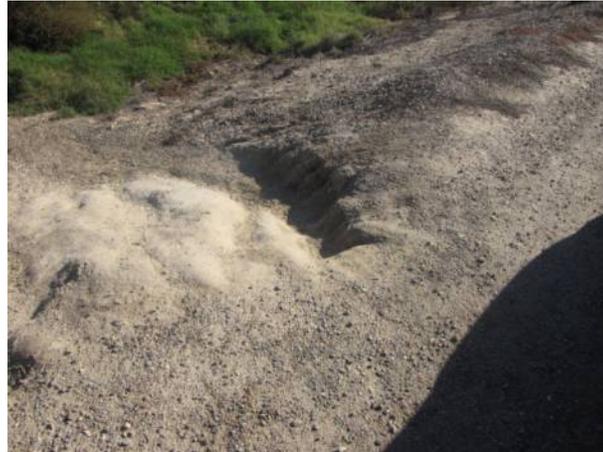
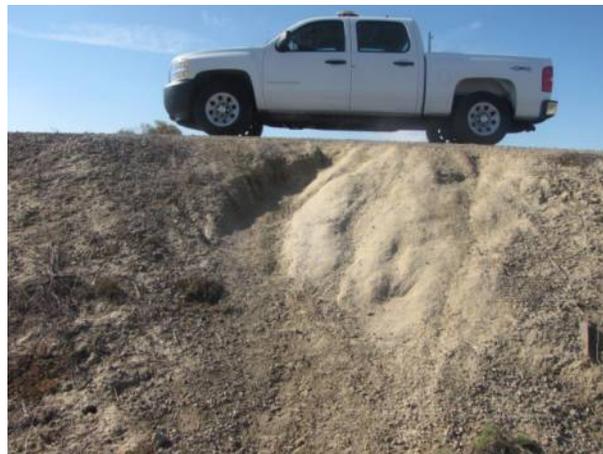
Levee Mile Report Line	8
Start Levee Mile	1.54
End Levee Mile	1.54
Location	Land Side
Category	Earthen Levee
Item	Slope Stability
Looking east at landside slope damage (six to eight inch erosion) by vehicle	
richard_f_20110922_557.jpg

Levee Mile Report Line	8
Start Levee Mile	1.54
End Levee Mile	1.54
Location	Land Side
Category	Earthen Levee
Item	Slope Stability
Looking west at landside slope damage cause by vehicle traffic.	
richard_f_20110922_558.jpg

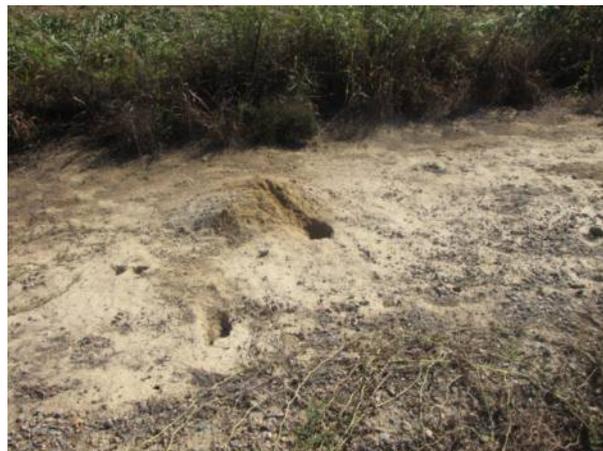
Levee Mile Report Line	10
Start Levee Mile	1.69
End Levee Mile	1.69
Location	Land Side
Category	Earthen Levee
Item	Animal Control
Looking east at squirrel holes on landside slope.	
richard_f_20110922_559.jpg

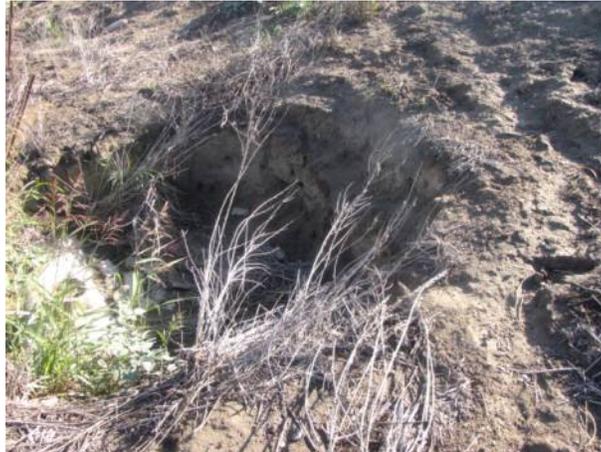
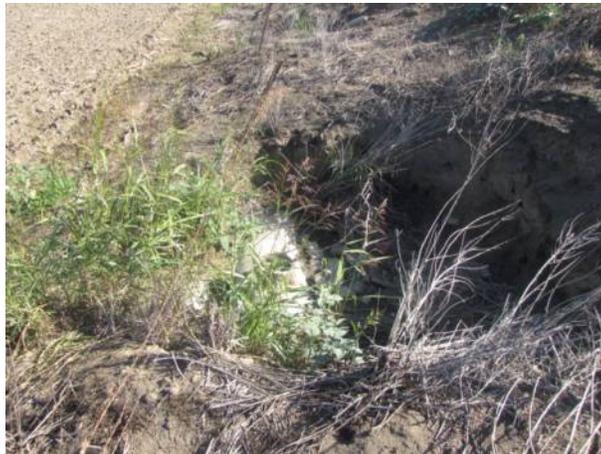
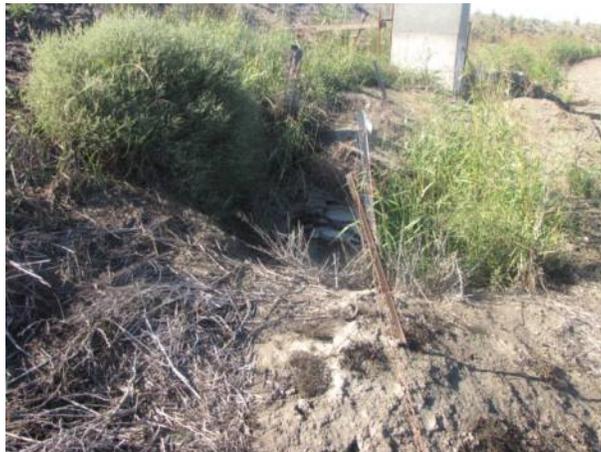
11	2.31	2.47	Earthen Levee	Erosion / Bank Caving	LS	U	Schedule repair of erosion site prior to the next inspection. Inspector Comments: Erosion is occurring around a 10-12 inch concrete irrigation pipe at landside toe.	37.451927 ° -121.030555 °	37.450290 ° -121.028592 °	12 Y
12	2.32	2.52	Earthen Levee	Vegetation	LS	M	Remove the wild growth other than native grasses from the levee slopes.	37.451895 ° -121.030492 °	37.449892 ° -121.028072 °	1
13	2.56	2.56	Earthen Levee	Vegetation	LS	M	Remove the wild growth other than native grasses from the levee slopes.	37.449432 ° -121.027472 °	37.449432 ° -121.027472 °	13
14	2.72	2.72	Supplemental	DWR Erosion Survey	WS	C	Inspector Comments: 08/18/2011: No sign of new erosion activities observed on site. 10/20/2010: Site has been repaired by the district. Site was previously rated "M".08/06/2010: Recommended as local maintenance issue, per CLRO.2009: Note this site has not been reported to be repaired.08/07/2007: sinkhole that is approximately 7'x7'x2'; rated "M". [2011 Site ID:RD2063U01RM105.5]	37.447450 ° -121.026090 °	37.447450 ° -121.026090 °	35

Levee Mile Report Line	11
Start Levee Mile	2.31
End Levee Mile	2.47
Location	Land Side
Category	Earthen Levee
Item	Erosion / Bank Caving
Looking west at slope caving around concrete irrigation pipe on landside toe.	
richard_f_20110922_560.jpg

Levee Mile Report Line	11
Start Levee Mile	2.31
End Levee Mile	2.47
Location	Land Side
Category	Earthen Levee
Item	Erosion / Bank Caving
Looking south at additional caving around concrete pipe.	
richard_f_20110922_561.jpg

Levee Mile Report Line	11
Start Levee Mile	2.31
End Levee Mile	2.47
Location	Land Side
Category	Earthen Levee
Item	Erosion / Bank Caving
Looking north at site #1 caving around pipe on landside slope.	
richard_f_20110922_562.jpg

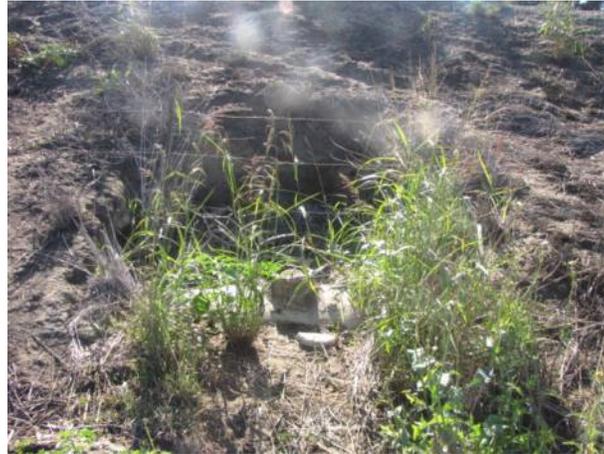
Levee Mile Report Line	11
Start Levee Mile	2.31
End Levee Mile	2.47
Location	Land Side
Category	Earthen Levee
Item	Erosion / Bank Caving

Looking west at caving around concrete pipe at site #3.

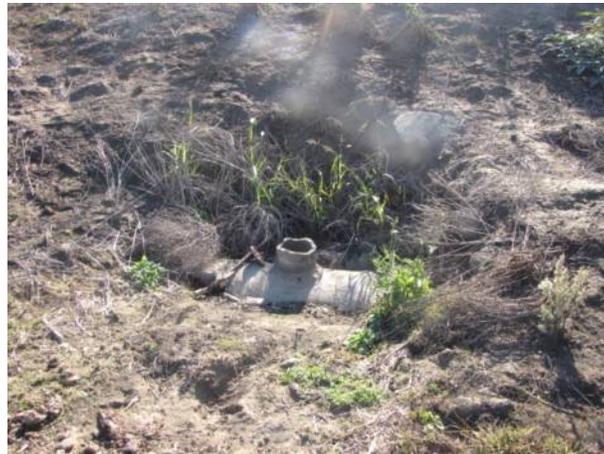
Levee Mile Report Line	11
Start Levee Mile	2.31
End Levee Mile	2.47
Location	Land Side
Category	Earthen Levee
Item	Erosion / Bank Caving

Looking west at concrete irrigation pipe that runs along landside toe.

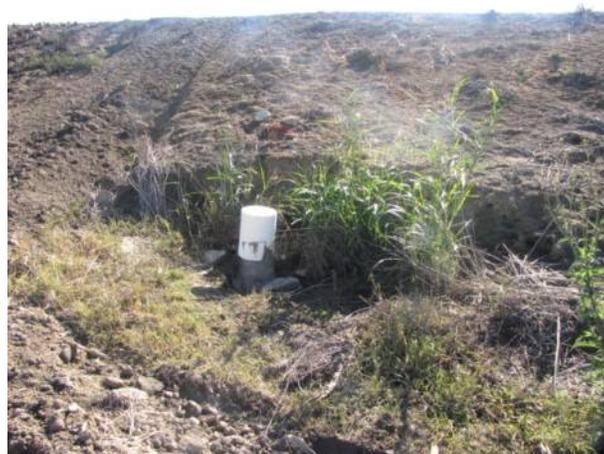
Levee Mile Report Line	11
Start Levee Mile	2.31
End Levee Mile	2.47
Location	Land Side
Category	Earthen Levee
Item	Erosion / Bank Caving

Looking southwest at site # 4 of slope caving around concrete irrigation pipe at landside toe.

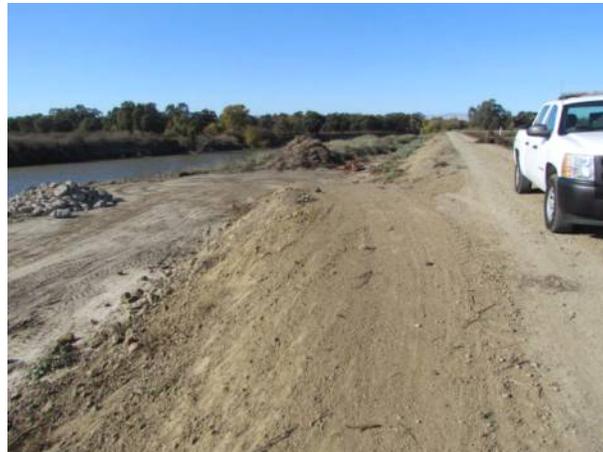
19	3.16	3.16	Earthen Levee	Encroachments	WS	CO	Ramp Inspector Comments: Unauthorized ramp installed to access erosion site. Ramp should be removed or the district should apply for a permit to maintain ramp.	37.442510 ° -121.023772 °	37.442510 ° -121.023772 °	26 Y
20	3.17	3.17	Earthen Levee	Encroachments	WS	U	Material Inspector Comments: LMA has a stockpile of concrete for erosion repair. Revetment is not according to Title 23 standards. Rebar should be removed from concrete. .	37.442478 ° -121.023593 °	37.442478 ° -121.023593 °	19 Y
21	3.30	3.30	Earthen Levee	Encroachments	WS	M	Material Inspector Comments: Concrete rubble should be free of rebar before using on river bank.	37.441723 ° -121.021552 °	37.441723 ° -121.021552 °	28 Y
22	3.82	3.82	Earthen Levee	Animal Control	LS	M	No rodents visible, but rodent burrows visible; need to backfill and compact or grout burrows.	37.435732 ° -121.016090 °	37.435732 ° -121.016090 °	29 Y

Levee Mile Report Line	19
Start Levee Mile	3.16
End Levee Mile	3.16
Location	Water Side
Category	Earthen Levee
Item	Encroachments
Looking south at unauthorized ramp on waterside slope.	
richard_f_20111205_490.jpg

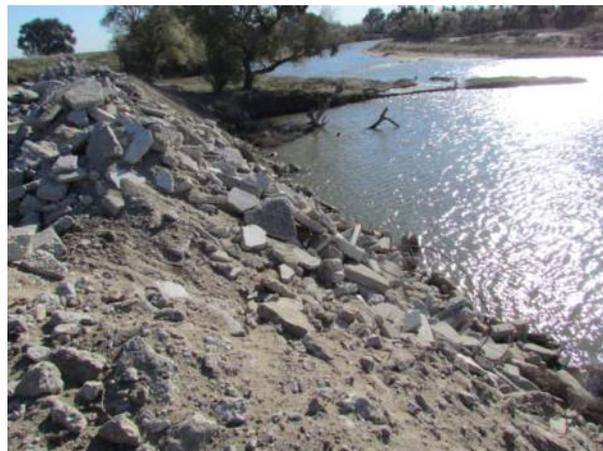
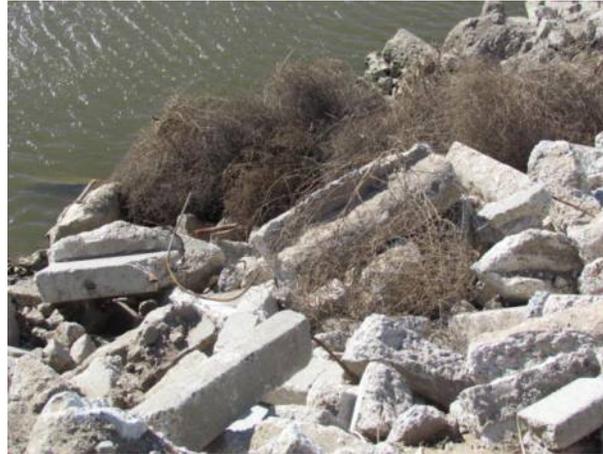
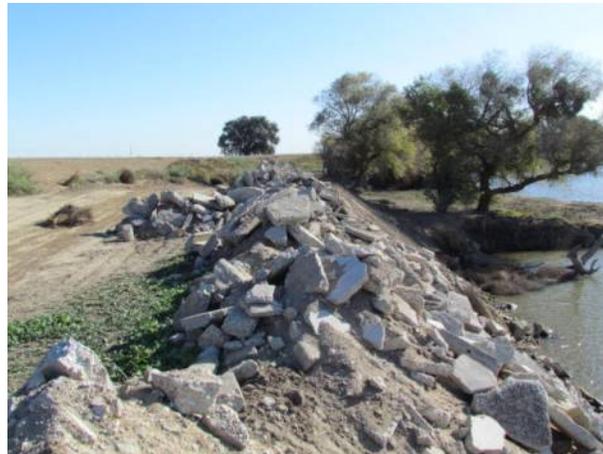
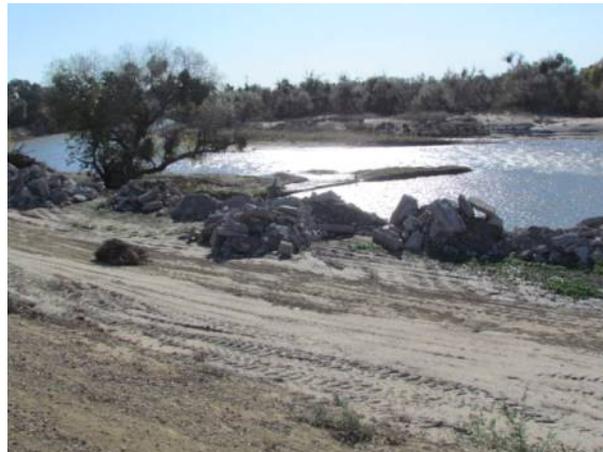
Levee Mile Report Line	20
Start Levee Mile	3.17
End Levee Mile	3.17
Location	Water Side
Category	Earthen Levee
Item	Encroachments
Looking north at concrete rip rap (with rebar) place on waterside berm slope.	
richard_f_20111205_486.jpg

Levee Mile Report Line	20
Start Levee Mile	3.17
End Levee Mile	3.17
Location	Water Side
Category	Earthen Levee
Item	Encroachments
Looking southeast at concrete rip rap with rebar place on waterside berm slope.	
richard_f_20111205_487.jpg

Levee Mile Report Line	20
Start Levee Mile	3.17
End Levee Mile	3.17
Location	Water Side
Category	Earthen Levee
Item	Encroachments
Looking south at concrete rip rap on stock pile and place on waterside berm.	
richard_f_20111205_488.jpg

Levee Mile Report Line	20
Start Levee Mile	3.17
End Levee Mile	3.17
Location	Water Side
Category	Earthen Levee
Item	Encroachments
Looking southeast at concrete rip rap stock pile on waterside berm.	
richard_f_20111205_489.jpg

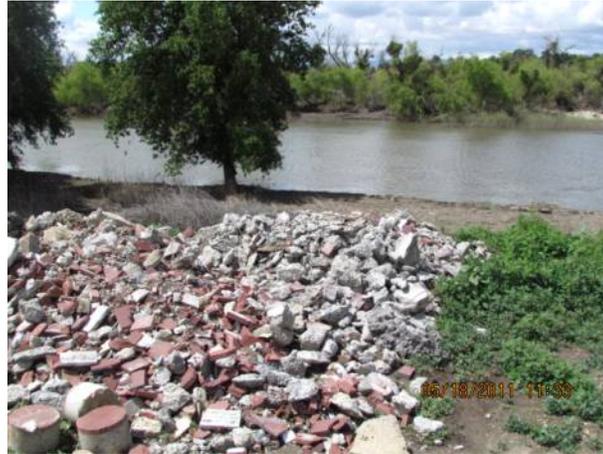
Levee Mile Report Line	21
Start Levee Mile	3.30
End Levee Mile	3.30
Location	Water Side
Category	Earthen Levee
Item	Encroachments
Looking at concrete rubble on waterside shoulder with rebar.	
richard_f_20110922_566.jpg

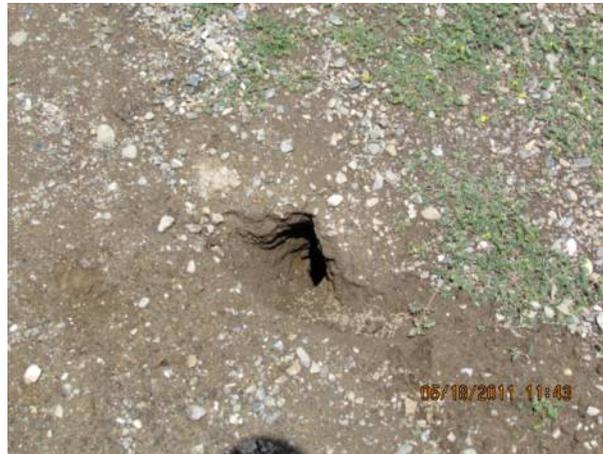
Levee Mile Report Line	22
Start Levee Mile	3.82
End Levee Mile	3.82
Location	Land Side
Category	Earthen Levee
Item	Animal Control
Looking at typical view of a squirrel hole on landside shoulder.	
richard_f_20110922_567.jpg

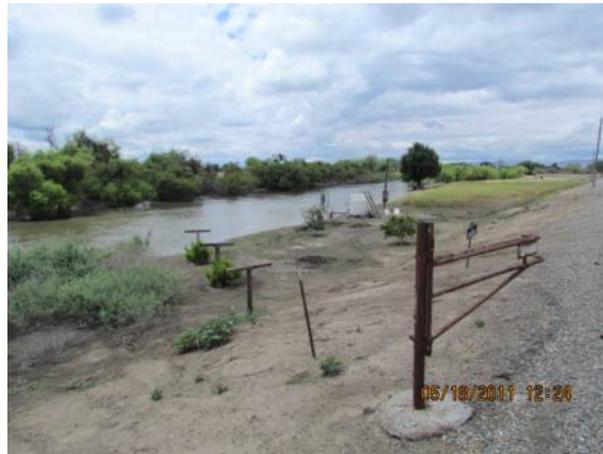
Levee Mile Report Line	25
Start Levee Mile	4.68
End Levee Mile	4.68
Location	Water Side
Category	Earthen Levee
Item	Encroachments
Looking south at grapevines and fruit trees on waterside berm.	
richard_f_20110922_568.jpg

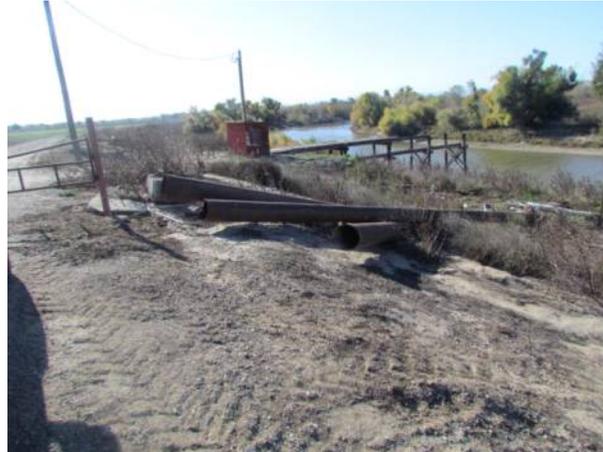
LMIR No.	Levee Mile		Category	Item	Location *	Rating **	Action/Comment	GPS Latitude/Longitude		Issue No. Photo
	Start	End						Start	End	
27	5.12	5.12	Earthen Levee	Encroachments	WS	M	Garbage Inspector Comments: Old pipes on waterside slope should be removed.	37.427375 ° -120.999343 °	37.427375 ° -120.999343 °	21 Y
28	5.13	5.13	Earthen Levee	Encroachments	LS	M	Pipe Inspector Comments: Landowner modified pipe structure and cut into landside slope without permission from CVFPB. See field investigation report for more detail.	37.427210 ° -120.999288 °	37.477210 ° -120.992880 °	50 Y
29	5.48	5.48	Earthen Levee	Slope Stability	LS	W	Repair the levee slope damaged by vehicle traffic and prevent access where possible.	37.422827 ° -121.001788 °	37.422827 ° -121.001788 °	32
30	6.05	6.63	Earthen Levee	Vegetation	WS	M	Remove the wild growth other than native grasses from the levee slopes.	37.416235 ° -120.997563 °	37.411285 ° -120.998188 °	22

Levee Mile Report Line	27
Start Levee Mile	5.12
End Levee Mile	5.12
Location	Water Side
Category	Earthen Levee
Item	Encroachments
Looking north at abandoned pipes on waterside slope.	
richard_f_20111205_491.jpg

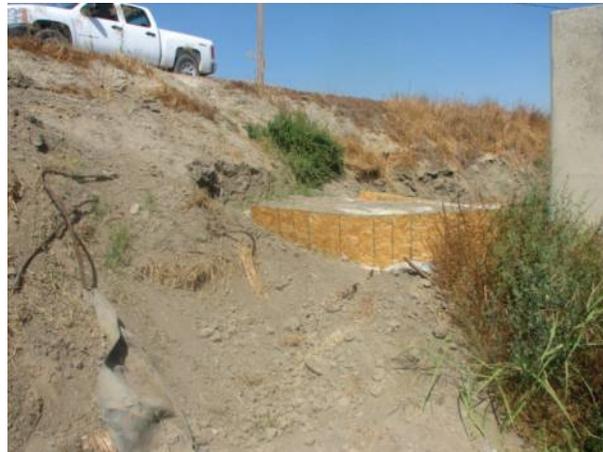
Levee Mile Report Line	28
Start Levee Mile	5.13
End Levee Mile	5.13
Location	Land Side
Category	Earthen Levee
Item	Encroachments
View of cut into landside slope	
richard_f_20110922_569.jpg

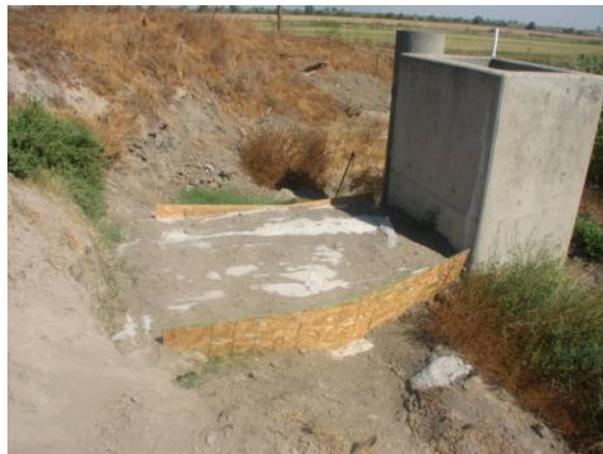
Levee Mile Report Line	28
Start Levee Mile	5.13
End Levee Mile	5.13
Location	Land Side
Category	Earthen Levee
Item	Encroachments
View of concrete stand pipe and encased pipe on landside toe.	
richard_f_20110922_570.jpg
