**Flood Control Project Maintenance
Levee Inspections**

Fall 2014 Levee Maintenance Deficiency Summary Report

Reclamation District No. 2063 Crows Landing

Levee Inspection Report By Mile - Fall 2014

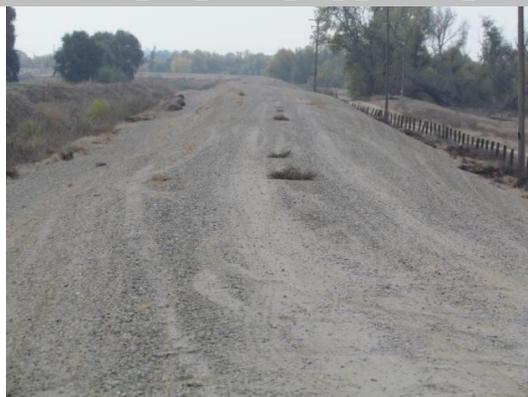
Photo 1 of 1 : FA_2014_RD2063_112_3_20141103_00001.jpg

LM Start	0.02	Rating **	A/W	Issue No.	3
LM End	0.51	Issue Type +	Ma	Location *	WS
Category	Earthen Levee		GPS Latitude/Longitude		
			Start	End	
Item	Vegetation		37.478550 °	37.471548 °	
			-121.044603 °	-121.044553 °	
DWR ID	DWR_RD2063_01_s_2012_3				
Action/Comments					
Remove the wild growth other than native grasses from the levee slopes.

Looking south at typical view of waterside and landside slopes.

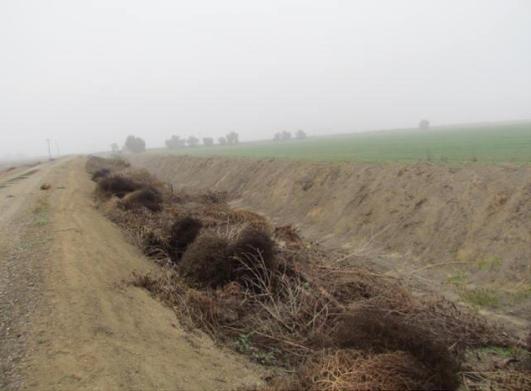
Photo 1 of 3 : FA_2014_RD2063_112_18_20141103_00011.jpg

LM Start	0.03	Rating **	U	Issue No.	18
LM End	1.32	Issue Type +	En	Location *	LS
Category	Earthen Levee		GPS Latitude/Longitude		
			Start	End	
Item	Encroachments		37.478470 °	37.464660 °	
			-121.044598 °	-121.032946 °	
DWR ID	DWR_RD2063_01_s_2012_18				
Action/Comments					
Ditch Inspector Comments: Ditch on landside has encroached into the berm and toe of the levee.

Looking north at ditch on landside berm and toe.

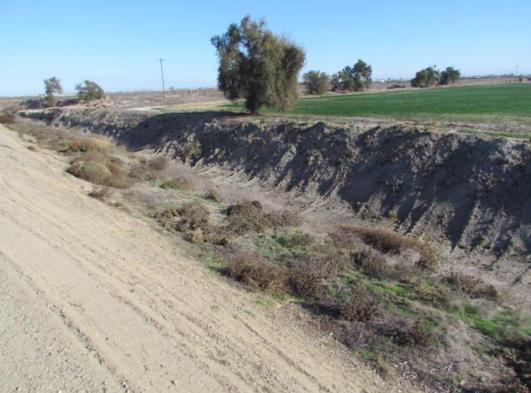
Photo 2 of 3 : FA_2014_RD2063_112_18_20141103_00012.jpg

Looking northeast at canal-ditch on landside berm.

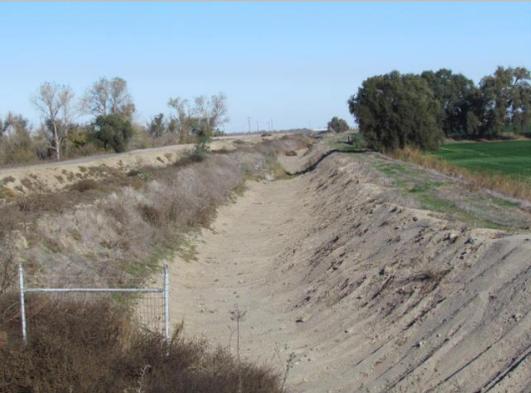
Photo 3 of 3 : FA_2014_RD2063_112_18_20141103_00013.jpg

Looking south at canal-ditch at landside berm and toe.

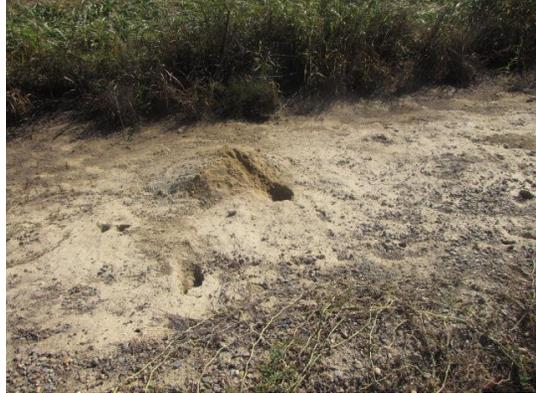
Photo 1 of 1 : FA_2014_RD2063_112_11_20141103_00004.jpg

LM Start	1.69	Rating **	A/W	Issue No.	11
LM End	1.69	Issue Type +	Ma	Location *	LS
Category	Earthen Levee		GPS Latitude/Longitude		
			Start	End	
Item	Animal Control		37.459813 °	37.459813 °	
			-121.032372 °	-121.032372 °	
DWR ID	DWR_RD2063_01_s_2012_11				
Action/Comments					
No rodents visible, but rodent burrows visible; need to backfill and compact or grout burrows.

Looking east at squirrel holes on landside slope.

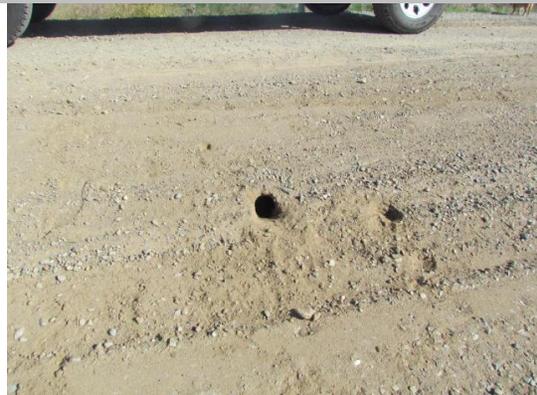
Photo 1 of 1 : FA_2014_RD2063_112_53_20141120_00049.jpg

LM Start	3.55	Rating **	M	Issue No.	53
LM End	3.55	Issue Type +	Ma	Location *	WS
Category	Earthen Levee		GPS Latitude/Longitude		
			Start	End	
Item	Animal Control		37.438697 °	37.438697 °	
			-121.019232 °	-121.019232 °	
DWR ID	DWR_RD2063_01_f_2014_53				
Action/Comments					
Exterminate rodents and backfill and compact or grout burrows. Inspector Comments: Typical view of rodent holes on landward slope.

Looking north at typical view of rodent holes on waterward slope.

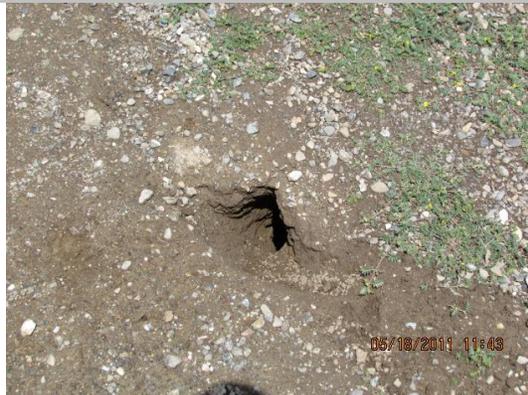
Photo 1 of 1 : FA_2014_RD2063_112_29_20141103_00014.jpg

LM Start	3.77	Rating **	A/W	Issue No.	29
LM End	3.82	Issue Type +	Ma	Location *	LS
Category	Earthen Levee		GPS Latitude/Longitude		
			Start	End	
Item	Animal Control		37.436197 °	37.435732 °	
			-121.016937 °	-121.016090 °	
DWR ID	DWR_RD2063_01_s_2012_29				
Action/Comments					
No rodents visible, but rodent burrows visible; need to backfill and compact or grout burrows.

Looking at typical view of a squirrel hole on landside shoulder.

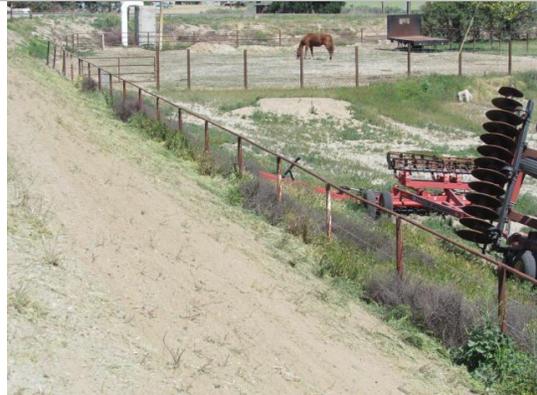
Photo 1 of 1 : FA_2014_RD2063_112_55_20141103_00025.jpg

LM Start	4.21	Rating **	M	Issue No.	55
LM End	4.29	Issue Type +	En	Location *	LS
Category	Earthen Levee			GPS Latitude/Longitude	
				Start	End
Item	Encroachments			37.431316 °	37.430509 °
				-121.012154 °	-121.011304 °
DWR ID	DWR_RD2063_01_s_2014_55				
Action/Comments					
Fence

Looking northeast at fence along landward toe.

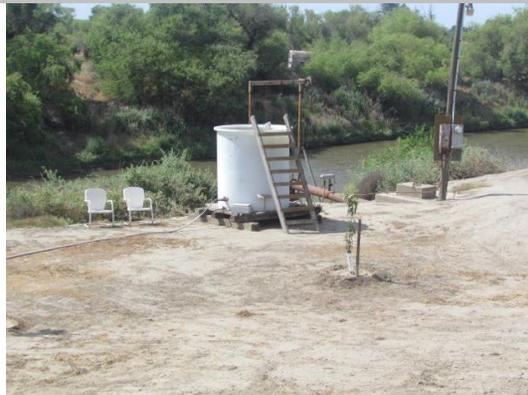
Photo 1 of 2 : FA_2014_RD2063_112_31_20141103_00018.jpg

LM Start	4.68	Rating **	M	Issue No.	31
LM End	4.68	Issue Type +	En	Location *	WS
Category	Earthen Levee		GPS Latitude/Longitude		
			Start	End	
Item	Encroachments		37.429638 °	37.429638 °	
			-121.005348 °	-121.005348 °	
DWR ID	DWR_RD2063_01_s_2012_31				
Action/Comments					
Crops Inspector Comments: Landowner planted grape vines and fruit trees and water tank on waterside berm without a permit from the CVFPB.

Looking west at water tank on waterward berm.

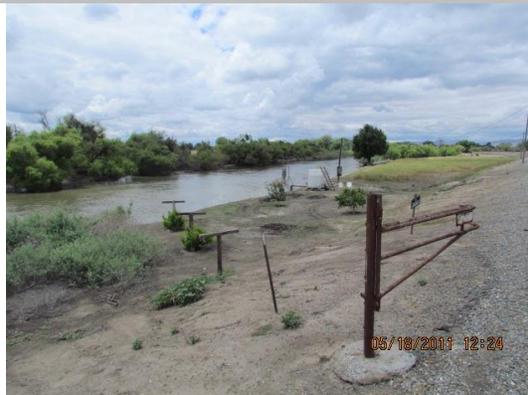
Photo 2 of 2 : FA_2014_RD2063_112_31_20141103_00019.jpg

Looking south at grapevines and fruit trees on waterside berm.

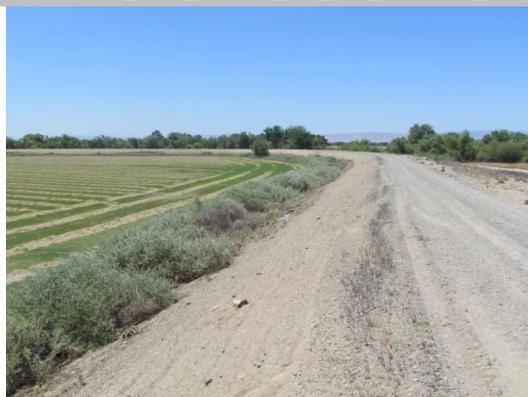
Photo 1 of 1 : FA_2014_RD2063_112_120_20141103_00030.jpg

LM Start	6.15	Rating **	A/W	Issue No.	120
LM End	6.36	Issue Type +	Ma	Location *	LS
Category	Earthen Levee		GPS Latitude/Longitude		
			Start	End	
Item	Vegetation		37.415488 °	37.413473 °	
			-120.998988 °	-121.001680 °	
DWR ID	DWR_RD2063_01_s_2012_120				
Action/Comments					
Remove the wild growth other than native grasses from the levee slopes.

Looking south at dense vegetation on landside toe.

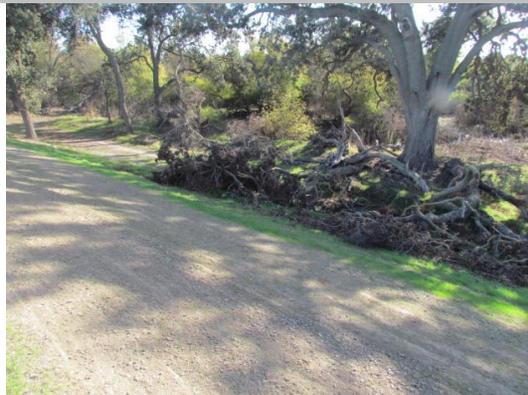
Photo 1 of 1 : FA_2014_RD2063_112_6_20141120_00051.jpg

LM Start	7.48	Rating **	M	Issue No.	6
LM End	7.48	Issue Type +	Ma	Location *	WS
Category	Earthen Levee		GPS Latitude/Longitude		
			Start	End	
Item	Encroachments		37.404377 °	37.404377 °	
			-120.988852 °	-120.988852 °	
DWR ID	DWR_RD2063_01_f_2014_6				
Action/Comments					
Tree or limb Inspector Comments: Fallen tree limbs at waterward toe.

Looking southwest at fallen tree limbs at waterward toe.

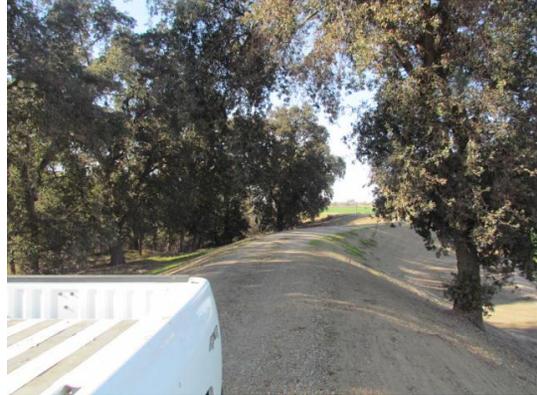
Photo 1 of 1 : FA_2014_RD2063_112_7_20141120_00052.jpg

LM Start	7.69	Rating **	M	Issue No.	7
LM End	7.69	Issue Type +	Ma	Location *	LS
Category	Earthen Levee		GPS Latitude/Longitude		
			Start	End	
Item	Trim / Thin Trees		37.403516 °	37.403516 °	
			-120.985718 °	-120.985718 °	
DWR ID	DWR_RD2063_01_s_2012_7				
Action/Comments					
Trim trees over roadway to at least 12 feet above ground level.

Looking north at overhanging tree on landward slope.

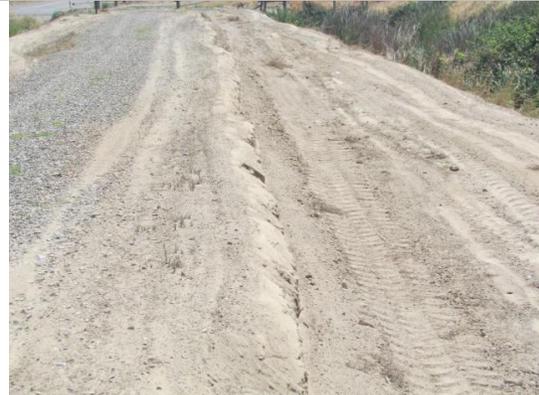
Photo 1 of 1 : FA_2014_RD2063_112_42_20141103_00024.jpg

LM Start	10.56	Rating **	M	Issue No.	42
LM End	10.61	Issue Type +	Ma	Location *	WS
Category	Earthen Levee			GPS Latitude/Longitude	
				Start	End
Item	Erosion / Bank Caving			37.390503 °	37.390483 °
				-120.942368 °	-120.941480 °
DWR ID	DWR_RD2063_01_s_2013_42				
Action/Comments					
Schedule repair of erosion site prior to the next inspection. Inspector Comments: Repair erosion on waterward shoulder. Erosion cause by farm equipment.

Looking north at erosion on waterward shoulder.
