**Flood Control Project Maintenance  
Levee Inspections**

**Fall 2015 Levee Maintenance Deficiency Summary Report  
Overall LMA & Unit Ratings, including DWR Erosion Survey**

**San Joaquin River Basin**

**Reclamation District No. 2063 Crows Landing**

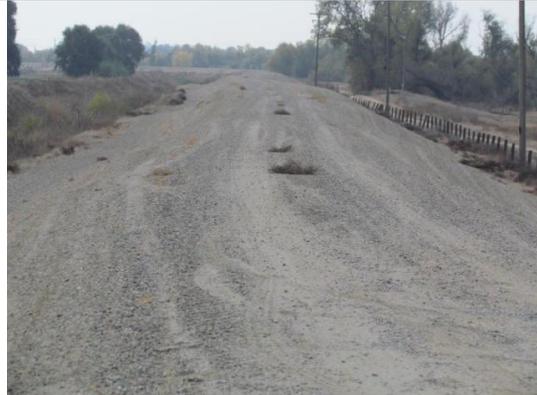
Photo 1 of 2 : FA\_2015\_RD2063\_112\_3\_20150914\_00001.jpg

Looking south at typical view of waterside and landside slopes.

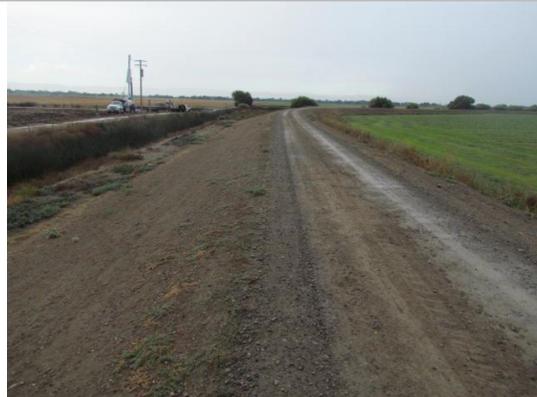
Photo 2 of 2 : FA\_2015\_RD2063\_112\_3\_20151005\_00032.jpg

Looking at typical view of levee slopes.

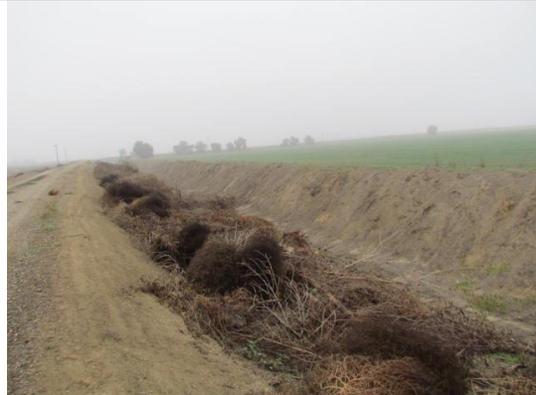
Photo 1 of 3 : FA\_2015\_RD2063\_112\_18\_20150914\_00005.jpg

Looking north at ditch on landside berm and toe.

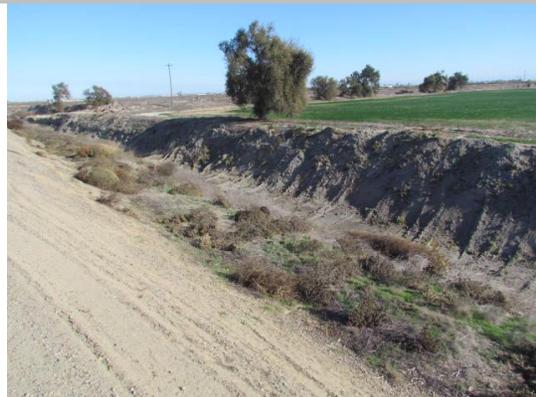
Photo 2 of 3 : FA\_2015\_RD2063\_112\_18\_20150914\_00006.jpg

Looking northeast at canal-ditch on landside berm.

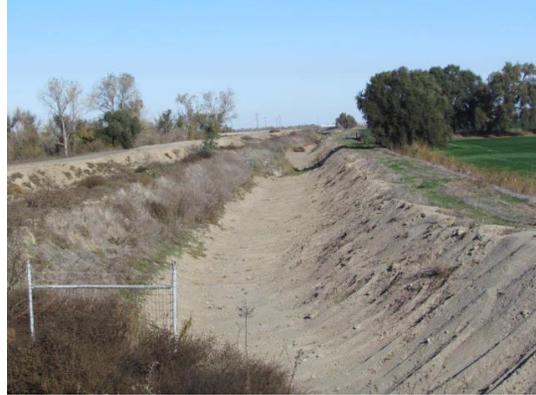
Photo 3 of 3 : FA\_2015\_RD2063\_112\_18\_20150914\_00007.jpg

Looking south at canal-ditch at landside berm and toe.

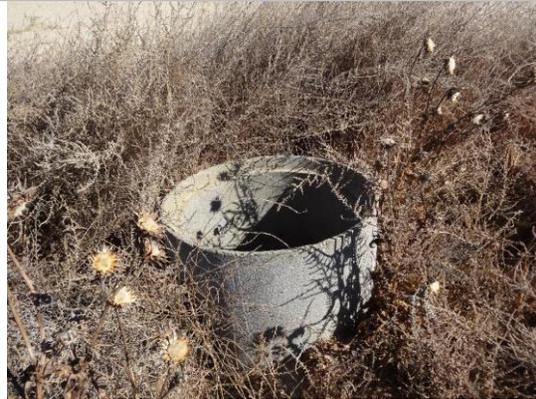
Photo 1 of 3 : UCIP\_FA\_2015\_2128.jpg

Item	DWR UCIP Field Study			37.464839 °	37.464839 °
				-121.033270 °	-121.033270 °
DWR ID					
Action/Comments					
Inspector Comments: FS_ID:41588 DS_ID:22075 EP_NO: N/A FS_HLM: 1.296 Repair Type: Urgent Crossing Status: Found UCIP Comments: - Pipe has visible holes throughout both LS and WS along with pipe deformation. - looks abandoned. Needs proper abandonment.- alfalfa valve on concrete pipe riser on waterside toe.- no slide gate found on waterside. No pump and pile structure found in river. FIELD_STRUCT_DESC: 24-inch CM pipe through the levee, 10.0 feet below the crown. Pipe supported on two timber pile bents across drain ditch on the landward side. Two concrete standpipes on berm. Installed by USCE 1961. O&M Manual SJR 006, Sept. 1961. FS Date: 11/05/2013

WS view: concrete riser with alfalfa valve on levee berm.

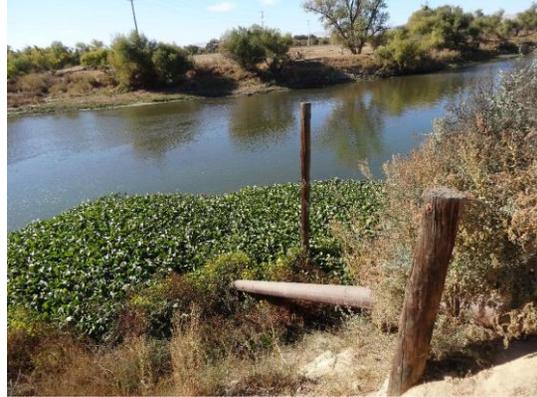
Photo 2 of 3 : UCIP\_FA\_2015\_2130.jpg

WS view: steel pipe immersed into the river. No pump found.

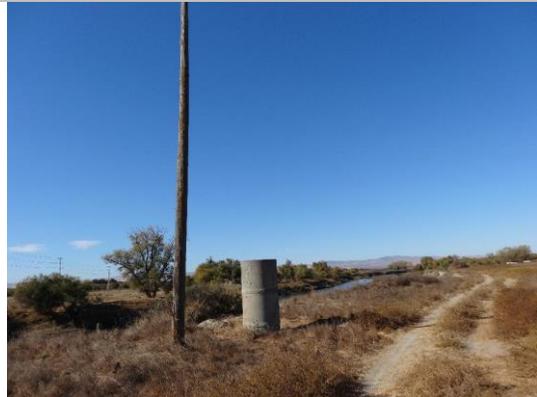
Photo 3 of 3 : UCIP\_FA\_2015\_2131.jpg

WS view: abandoned concrete standpipe and abandoned power pole.

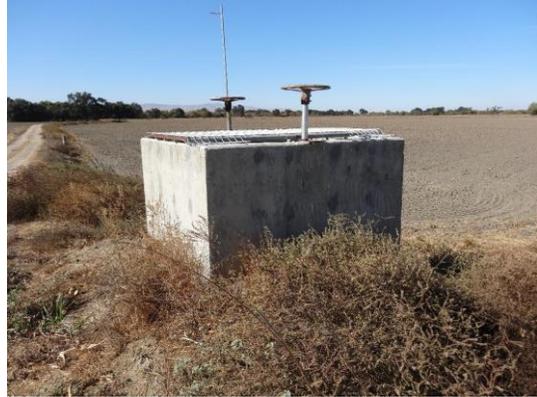
Photo 1 of 3 : UCIP\_FA\_2015\_2132.jpg

LM Start	<b>2.09</b>	Rating **	M	Issue No.	<b>984</b>
LM End	<b>2.09</b>	Issue Type +	En	Location *	LS
Category	Supplemental			GPS Latitude/Longitude	
				Start	End
Item	DWR UCIP Field Study			37.454125 °	37.454125 °
				-121.032240 °	-121.032240 °
DWR ID					
Action/Comments					
Inspector Comments: FS_ID:24404 DS_ID:22078 EP_NO: N/A FS_HLM: 2.125 Repair Type: Non-Urgent Crossing Status: Found UCIP Comments: Concrete distribution box with alfalfa valve not found at the waterward toe. Two steel standpipes and dismantled concrete standpipe on waterside levee toe. Concrete distribution box 50 ft off the levee center. FIELD_STRUCT_DESC: 30-inch CM pipe through the levee 16.5 feet below the crown. Slide gate in concrete distribution box 50 ft off the levee. Underground irrigation system. Installed by USCE 1961. O&M Manual SJR 006, Sept. 1961. FS Date: 11/05/2013

WS view: concrete distribution box with slide gate off the levee toe.

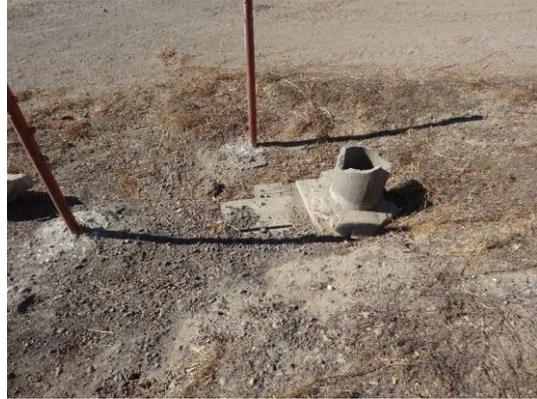
Photo 2 of 3 : UCIP\_FA\_2015\_2133.jpg

WS view: a dismantled concrete pipe on levee toe.

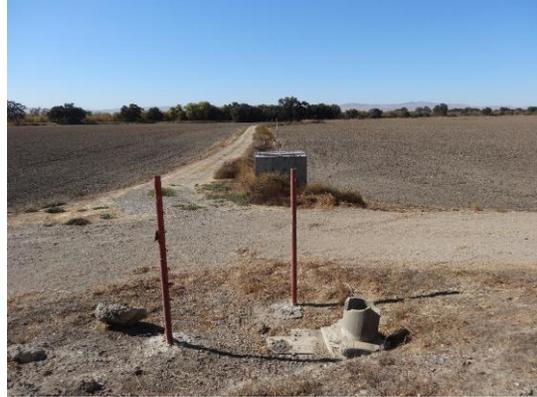
Photo 3 of 3 : UCIP\_FA\_2015\_2134.jpg

WS view: concrete box (top), and a dismantled concrete pipe on levee toe.

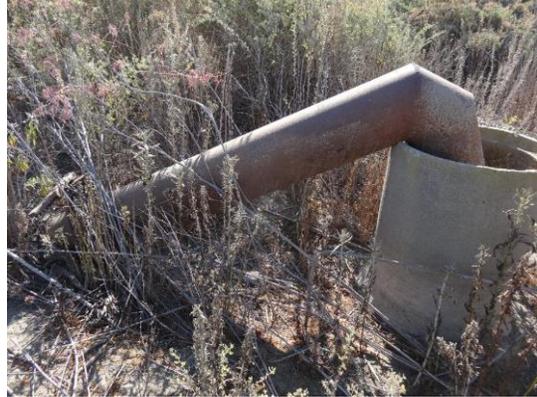
Photo 1 of 3 : UCIP\_FA\_2015\_2135.jpg

Item	DWR UCIP Field Study			37.450330 °	37.450330 °
				-121.028674 °	-121.028674 °
DWR ID					
Action/Comments					
Inspector Comments: FS_ID:24427 DS_ID:22085 EP_NO: N/A FS_HLM: 2.4681 Repair Type: Non-Urgent Crossing Status: Found UCIP Comments: Abandoned steel pipe and service pole on waterside. Pump not found on river bank. CMP riser on waterside slope. Slide gate not found in CMP riser. Steel pipe riser on waterside berm. Damaged PVC standpipe on waterside slope. FIELD_STRUCT_DESC: Abandoned 24-inch CM pipe through the levee 10.0 feet below the crown. 20-inch standpipe 3.0 feet from the landward toe. 12-inch pipe across the berm and into CMP riser on the waterward slope. Installed by USCE 1961. O&M Manual SJR 006, Sept. 1961. FS Date: 11/05/2013

WS view: steel pipe and concrete riser on levee berm.

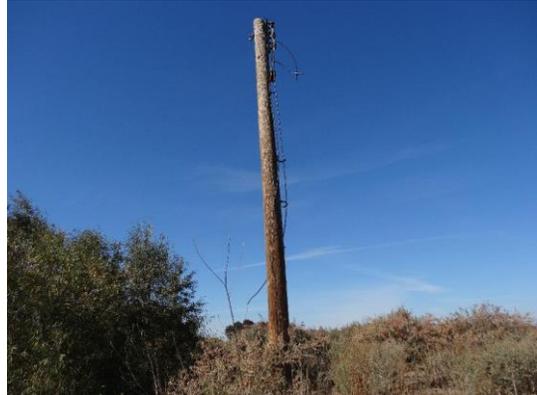
Photo 2 of 3 : UCIP\_FA\_2015\_2136.jpg

WS view: abandoned power pole on levee berm.

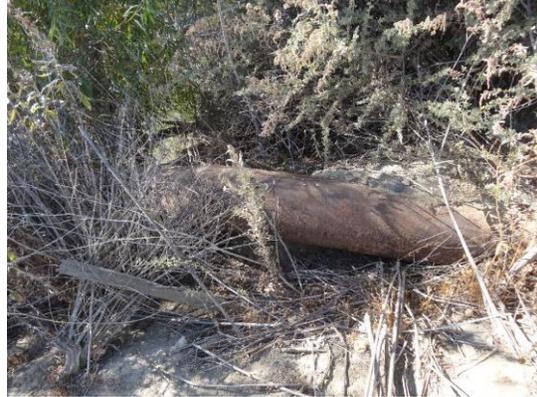
Photo 3 of 3 : UCIP\_FA\_2015\_2694.jpg

WS view: abandoned steel pipe on river bank. No pump found on river bank.

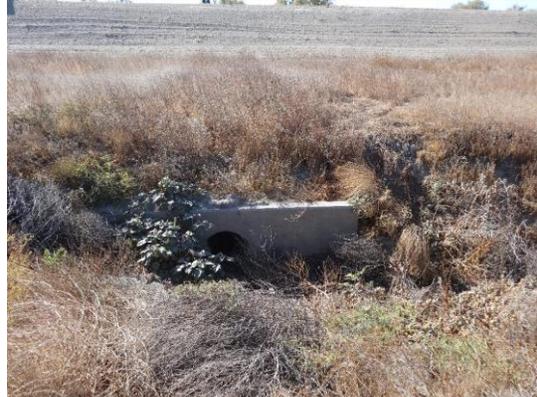
Photo 1 of 3 : UCIP\_FA\_2015\_2695.jpg

LS view: concrete headwall with CMP 70 ft off the levee center.

**Action/Comments**  
 Inspector Comments: FS\_ID:24435  
 DS\_ID:22086  
 EP\_NO: N/A  
 FS\_HLM: 2.6599  
 Repair Type: Non-Urgent  
 Crossing Status: Found  
 UCIP Comments: Both pipe ends 70 ft off the levee center. Clearing and cleaning of inlet/outlet pipe needed.  
 FIELD\_STRUCT\_DESC: 24-inch CM pipe through the levee 12.0 feet below the crown. Flap gate on the waterward end. Concrete headwall on both ends. Installed by USCE 1961. O&M Manual SJR 006, Sept. 1961.  
 FS Date: 11/05/2013

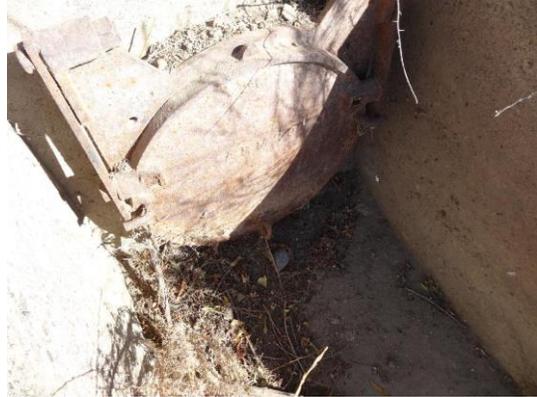
Photo 2 of 3 : UCIP\_FA\_2015\_2696.jpg

WS view: U shaped headwall outlet structure and pipe with flap gate.

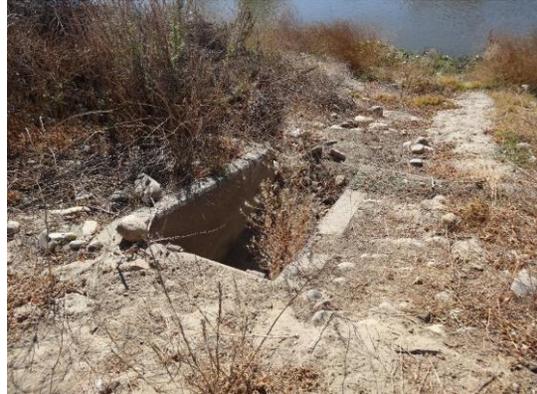
Photo 3 of 3 : UCIP\_FA\_2015\_2697.jpg

WS view: U shaped headwall outlet structure 70 ft off the levee center.

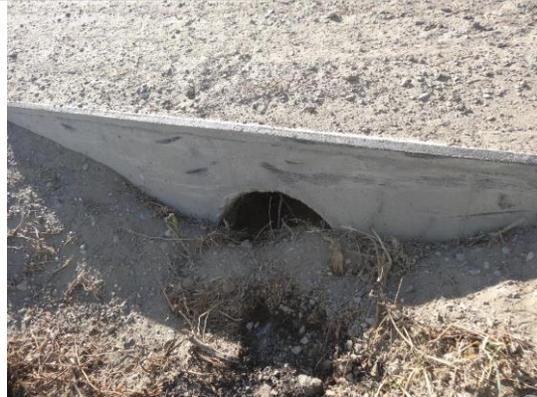
Photo 1 of 3 : UCIP\_FA\_2015\_2698.jpg

LM Start	<b>2.93</b>	Rating **	M	Issue No.	<b>988</b>
LM End	<b>2.93</b>	Issue Type +	En	Location *	LS
Category	Supplemental			GPS Latitude/Longitude	
				Start	End
Item	DWR UCIP Field Study			37.443871 °	37.443871 °
				-121.025775 °	-121.025775 °
DWR ID					
Action/Comments					
Inspector Comments: FS_ID:24443 DS_ID:22088 EP_NO: N/A FS_HLM: 2.9777 Repair Type: Non-Urgent Crossing Status: Found UCIP Comments: - clear and clean debris FIELD_STRUCT_DESC: Abandoned 24-inch CM pipe through the levee 9.5 feet below the crown. Flap gate on the waterward end. Pipe open on landward end. Concrete headwall on both ends. O&M Manual SJR 006, Sept. 1961 FS Date: 11/05/2013

WS view: pipe, flap concrete headwall with soil debris blocking the inlet.

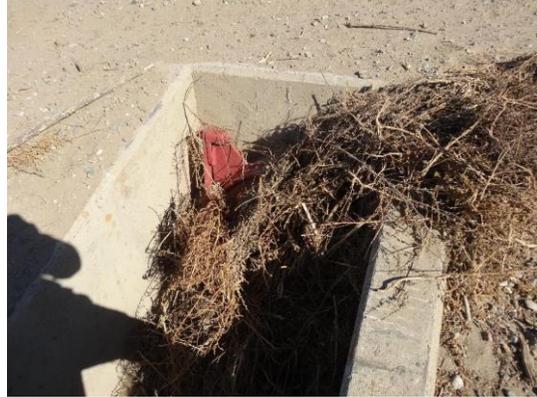
Photo 2 of 3 : UCIP\_FA\_2015\_2699.jpg

WS view: pipe, flap gate, and concrete headwall with debris blocking the outlet.

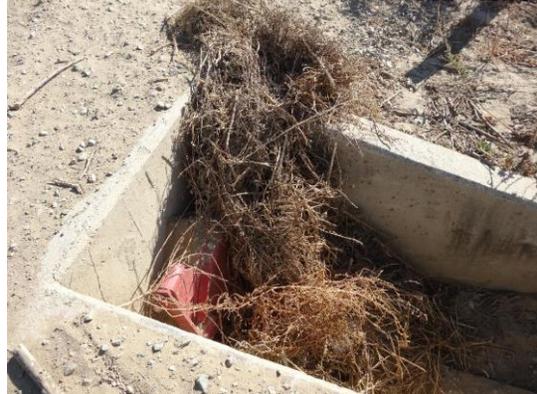
Photo 3 of 3 : UCIP\_FA\_2015\_2700.jpg

WS view: U typed concrete headwall on levee slope.

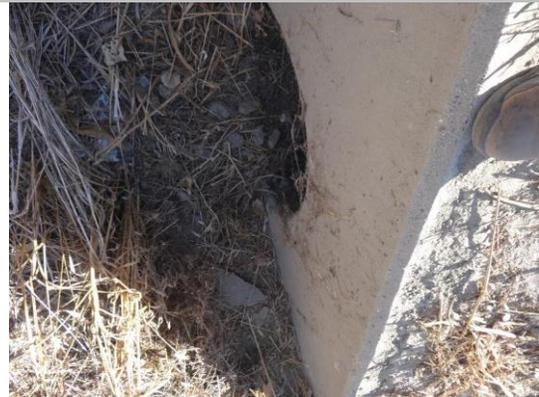
Photo 1 of 3 : UCIP\_FA\_2015\_2701.jpg

LM Start	<b>3.29</b>	Rating **	M	Issue No.	<b>989</b>
LM End	<b>3.29</b>	Issue Type +	En	Location *	WS
Category	Supplemental			GPS Latitude/Longitude	
				Start	End
Item	DWR UCIP Field Study			37.441213 °	37.441213 °
				-121.021130 °	-121.021130 °
DWR ID					
Action/Comments					
Inspector Comments: FS_ID:24469 DS_ID:22089 EP_NO: N/A FS_HLM: 3.3402 Repair Type: Non-Urgent Crossing Status: Found UCIP Comments: - cleaning required in inlet pipe.- new flap gate FIELD_STRUCT_DESC: 24-inch CM pipe through the levee 12.5 feet below the crown. Flap gate on the waterward end. Concrete headwall on both ends. O&M Manual SJR 006, Sept. 1961. FS Date: 11/05/2013

LS view: CM pipe and concrete headwall on levee slope. Debris blocking inlet pipe.

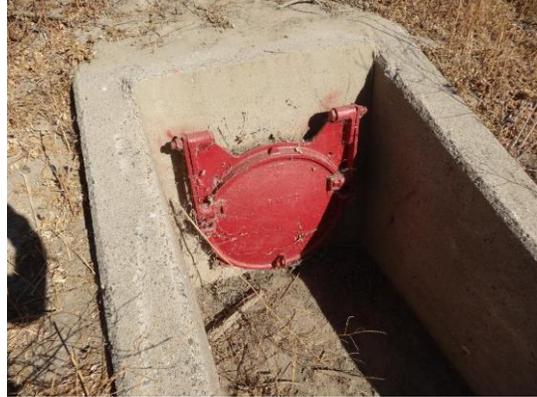
Photo 2 of 3 : UCIP\_FA\_2015\_2702.jpg

WS view: new flap gate, and U typed concrete headwall.

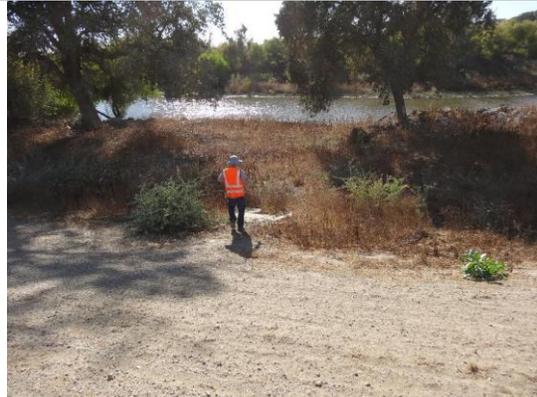
Photo 3 of 3 : UCIP\_FA\_2015\_2703.jpg

WS view: U typed concrete headwall on levee toe

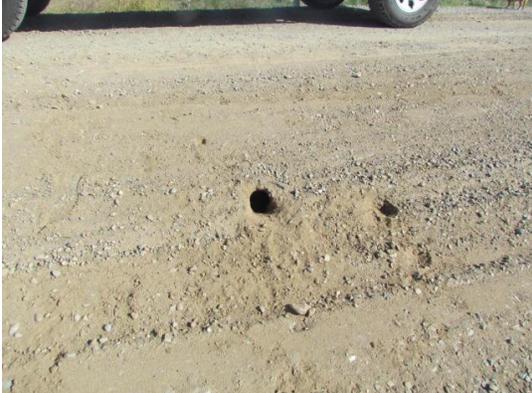
Photo 1 of 1 : FA\_2015\_RD2063\_112\_53\_20150914\_00013.jpg

Looking north at typical view of rodent holes on waterward slope.

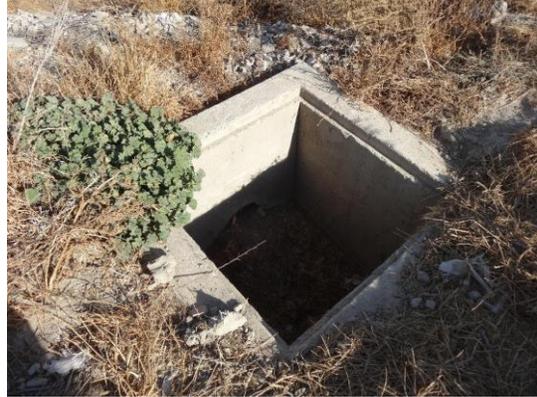
Photo 1 of 3 : UCIP\_FA\_2015\_2704.jpg

**Action/Comments**  
 Inspector Comments: FS\_ID:24485  
 DS\_ID:22093  
 EP\_NO: N/A  
 FS\_HLM: 3.6979  
 Repair Type: Non-Urgent  
 Crossing Status: Found  
 UCIP Comments: - new flap gate on waterside.- cleaning and clearing of inlet box needed.  
 FIELD\_STRUCT\_DESC: 24-inch CM pipe through the levee 12.0 feet below the crown. Flap gate and concrete saddle on the waterward end. Concrete drop inlet box on landward side. Installed by USCE 1961. O&M Manual SJR 006, Sept. 1961.  
 FS Date: 11/05/2013

LS view: concrete drop inlet box on levee toe.

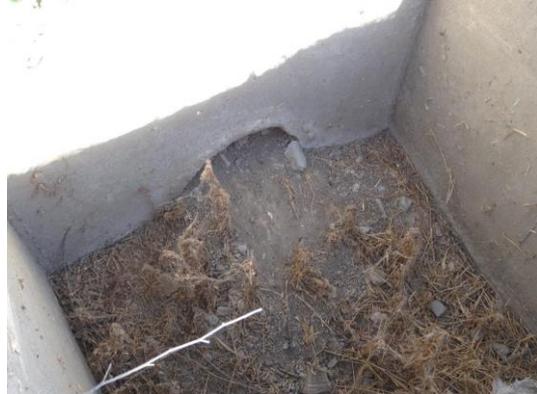
Photo 2 of 3 : UCIP\_FA\_2015\_2705.jpg

LS view: inside view of inlet box on levee toe. Debris blocking inlet pipe.

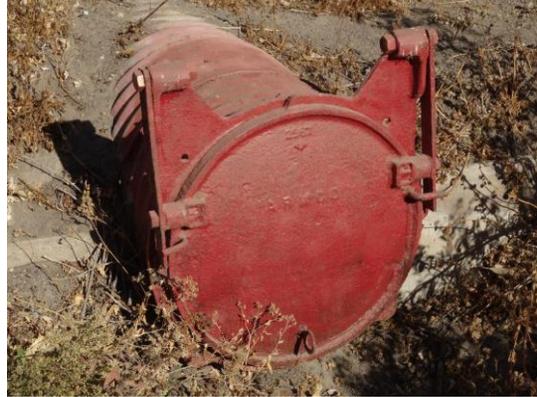
Photo 3 of 3 : UCIP\_FA\_2015\_2706.jpg

WS view: pipe, flap gate, and concrete saddle on levee slope

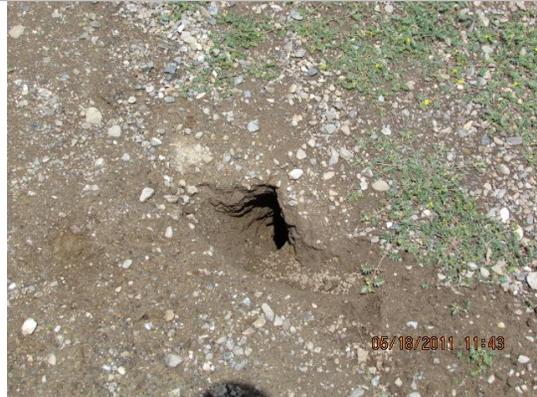
Photo 1 of 1 : FA\_2015\_RD2063\_112\_29\_20150914\_00008.jpg

Looking at typical view of a squirrel hole on landside shoulder.

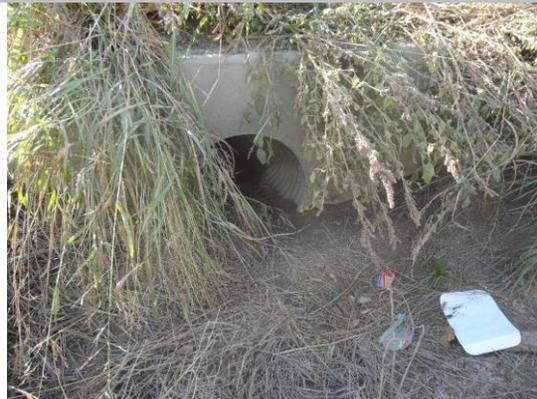
Photo 2 of 3 : UCIP\_FA\_2015\_1341.jpg

**Action/Comments**  
 Inspector Comments: FS\_ID:24583  
 DS\_ID:22096  
 EP\_NO: N/A  
 FS\_HLM: 4.0838  
 Repair Type: Non-Urgent  
 Crossing Status: Found  
 UCIP Comments: - new flap gate on waterside.- cleaning of outlet and inlet pipes required.  
 FIELD\_STRUCT\_DESC: 24-inch CM pipe through the levee 12.0 feet below the crown. Flap gate on the waterwad end. Concrete headwall on both ends. Installed by USCE 1961. O&M Manual SJR 006, Sept. 1961  
 FS Date: 11/05/2013

LS view: CM pipe and concrete headwall on levee toe.

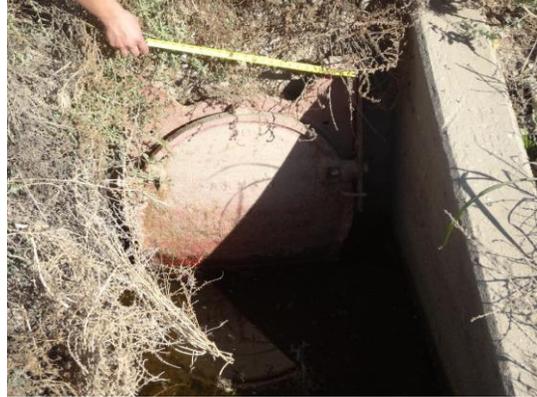
Photo 3 of 3 : UCIP\_FA\_2015\_1357.jpg

WS view: pipe, flap gate, and concrete headwall on drainage ditch.

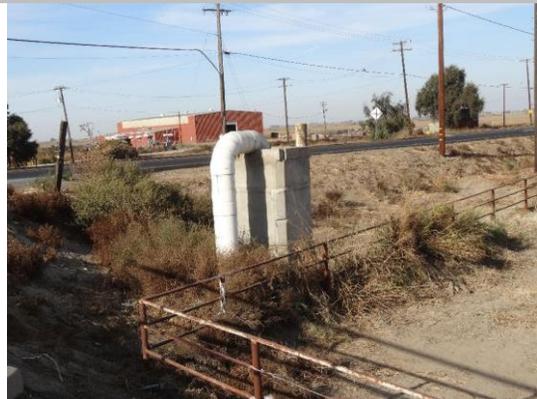
Photo 1 of 3 : UCIP\_FA\_2015\_1358.jpg

LS view: discharge pipe and concrete distribution box on levee toe.

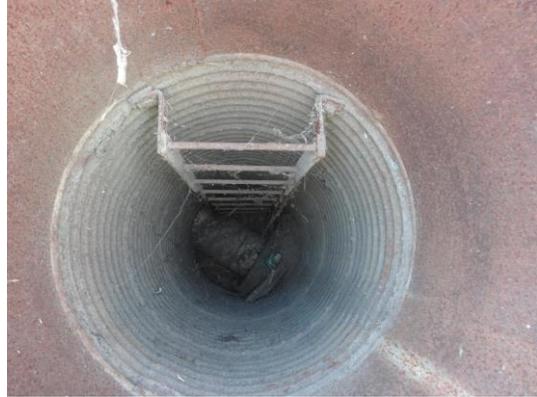
Photo 2 of 3 : UCIP\_FA\_2015\_1359.jpg

WS view: inside view of CMP riser on levee slope. Steel pipe and 24" CMP visible inside the riser.

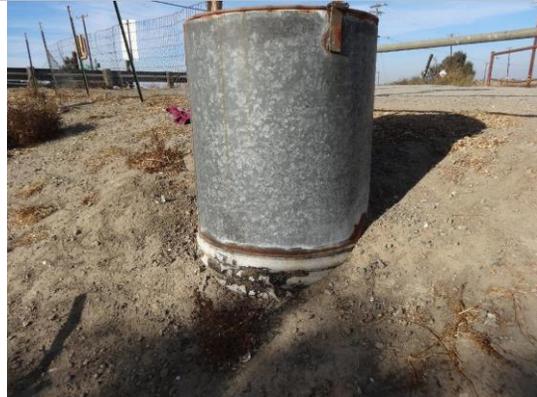
Photo 3 of 3 : UCIP\_FA\_2015\_1360.jpg

WS view: CMP riser on levee slope. Steel riser on top of CMP.

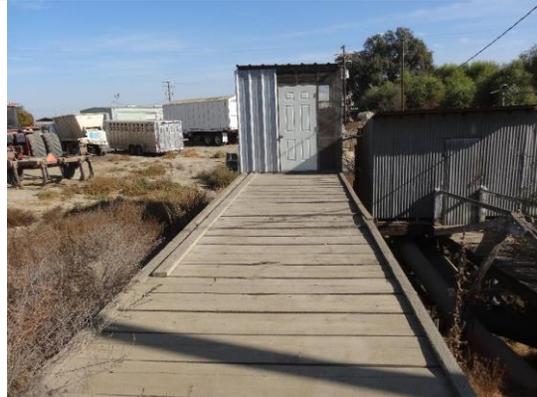
Photo 1 of 3 : UCIP\_FA\_2015\_2594.jpg

LS view: walkway to pump and pump house on levee slope.

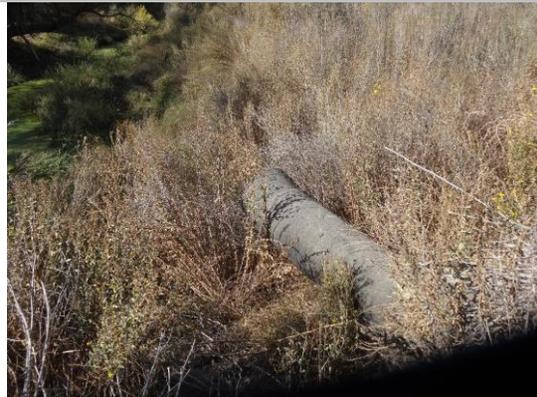
Photo 2 of 3 : UCIP\_FA\_2015\_2595.jpg

WS view: discharge pipe end on levee toe. No flap gate.

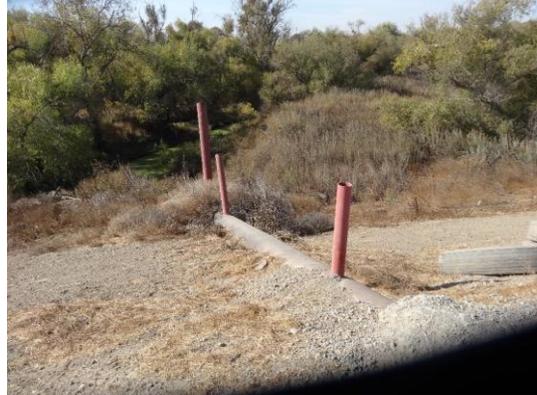
Photo 3 of 3 : UCIP\_FA\_2015\_2596.jpg

WS view: air vents (top- red) on exposed steel pipe.

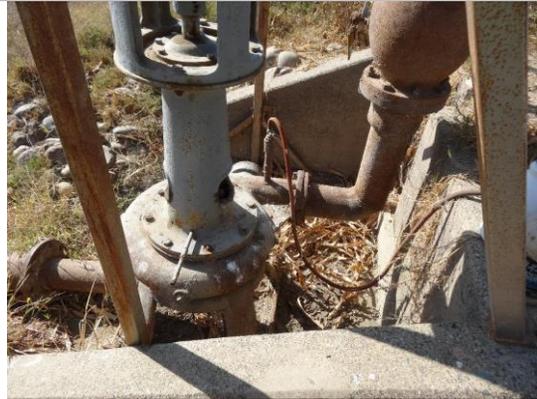
Photo 1 of 3 : UCIP\_FA\_2015\_2597.jpg

WS view: U type headwall and pump on river bank.

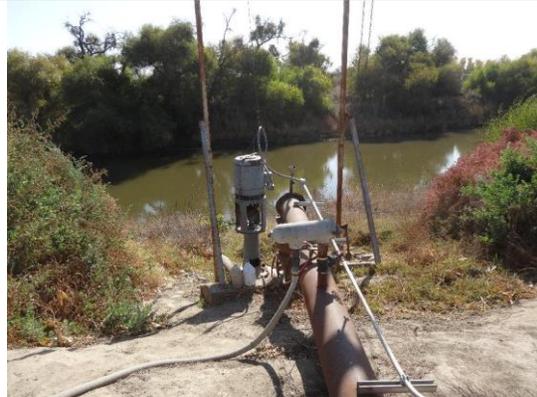
Photo 2 of 3 : UCIP\_FA\_2015\_2598.jpg

WS view: pump, pipe and other appurtenances on levee toe.

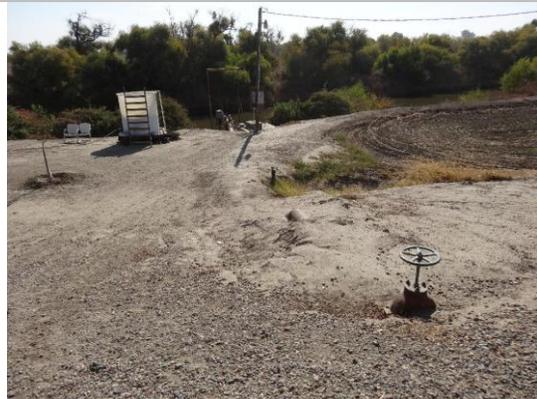
Photo 3 of 3 : UCIP\_FA\_2015\_2599.jpg

WS view: overview of waterside- gate valve and power pole on levee slope.

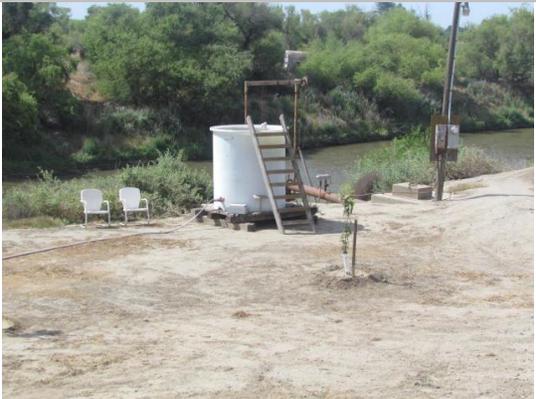
Photo 1 of 2 : FA\_2015\_RD2063\_112\_31\_20150914\_00009.jpg

Looking west at water tank on waterward berm.

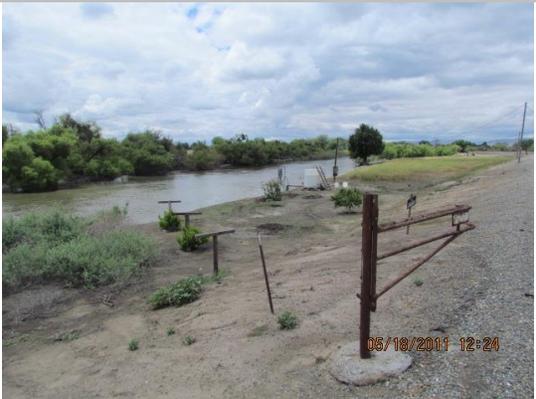
Photo 2 of 2 : FA\_2015\_RD2063\_112\_31\_20150914\_00010.jpg

Looking south at grapevines and fruit trees on waterside berm.

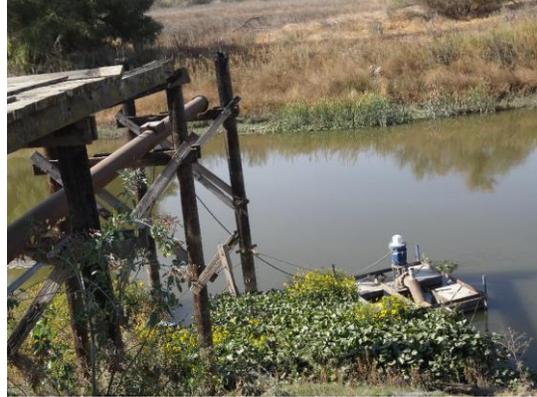
Photo 1 of 3 : UCIP\_FA\_2015\_2604.jpg

WS view: abandoned walkway, pipe (left) and pump on floating structure in the river.

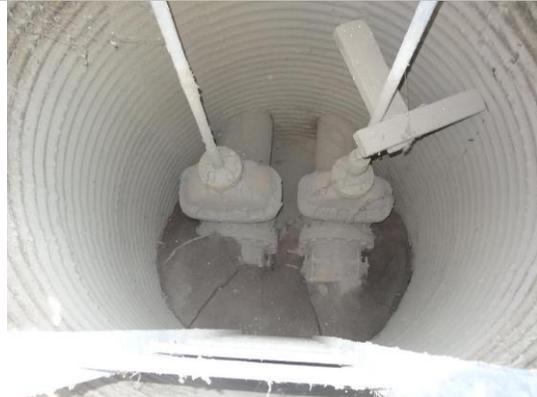
Photo 2 of 3 : UCIP\_FA\_2015\_2630.jpg

WS view: two gate valves inside CMP riser on levee slope.

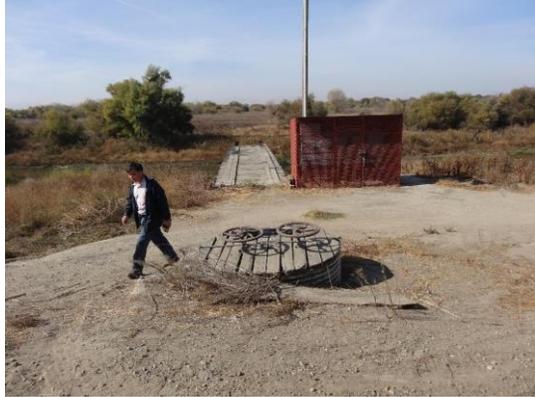
Photo 3 of 3 : UCIP\_FA\_2015\_2631.jpg

WS view: CMP riser, abandoned walkway, power pole on levee slope.

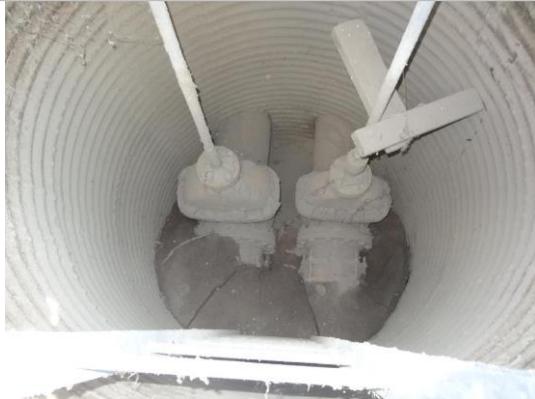
Photo 1 of 3 : UCIP\_FA\_2015\_1527.jpg

WS view: two gate valves inside CMP riser on levee slope.

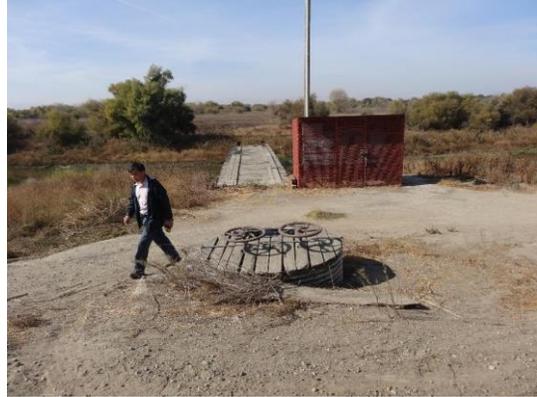
Photo 2 of 3 : UCIP\_FA\_2015\_1528.jpg

WS view: CMP riser, abandoned walkway, power pole on levee slope.

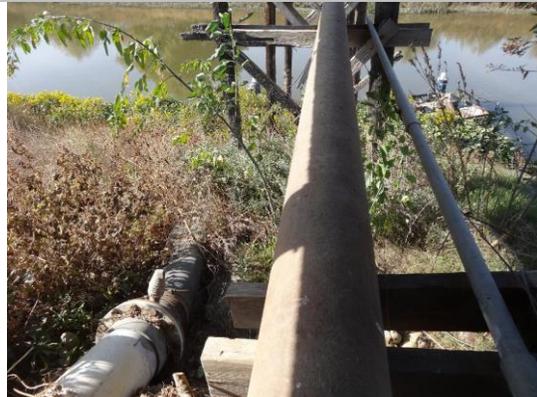
Photo 3 of 3 : UCIP\_FA\_2015\_1642.jpg

WS view: abandoned steel pipe (right), rubber pipe attached to steel pipe to pump on floating structure in the river.

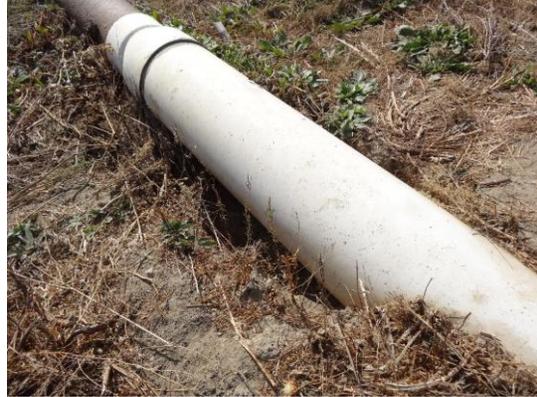
Photo 1 of 3 : UCIP\_FA\_2015\_2873.jpg

WS view: exposed pipe on levee slope. Erosion under the pipe.

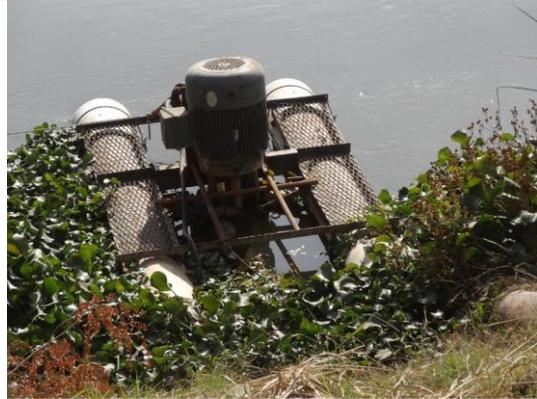
Photo 2 of 3 : UCIP\_FA\_2015\_2874.jpg

WS view: pump on floating structure in the stream.

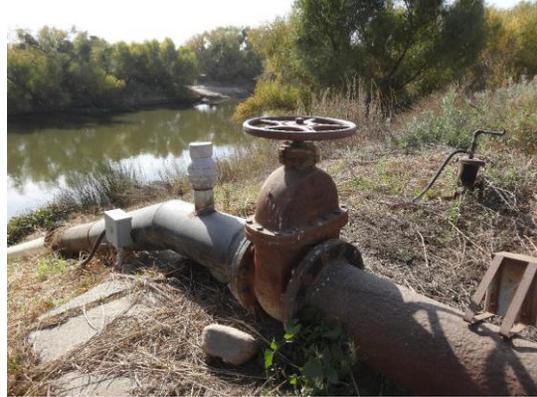
Photo 3 of 3 : UCIP\_FA\_2015\_2875.jpg

WS view: steel pipe, gate valve, air vent on levee berm.

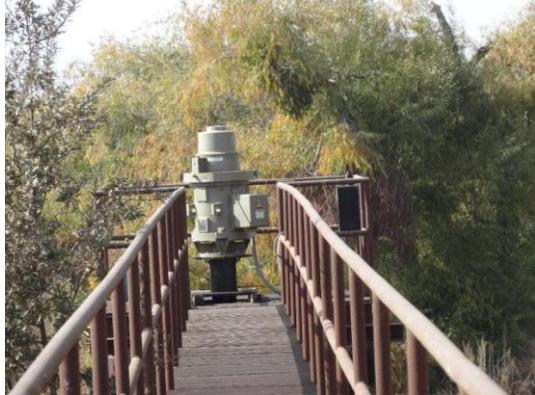
Photo 1 of 3 : UCIP\_FA\_2015\_2876.jpg

WS view: walkway to pump and pump on pile structure in the stream.

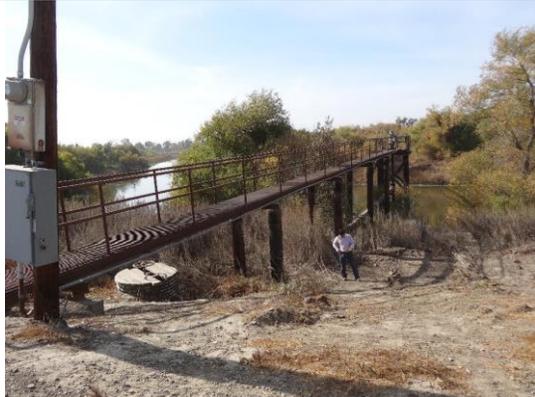
Photo 2 of 3 : UCIP\_FA\_2015\_2877.jpg

WS view: power pole, walkway to pump, CMP riser, and pipe on waterside slope.

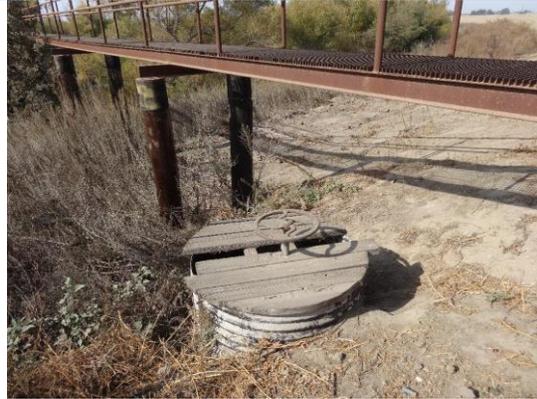
Photo 3 of 3 : UCIP\_FA\_2015\_2878.jpg

WS view: gate valve in CMP riser. Soil erosion around CMP riser.

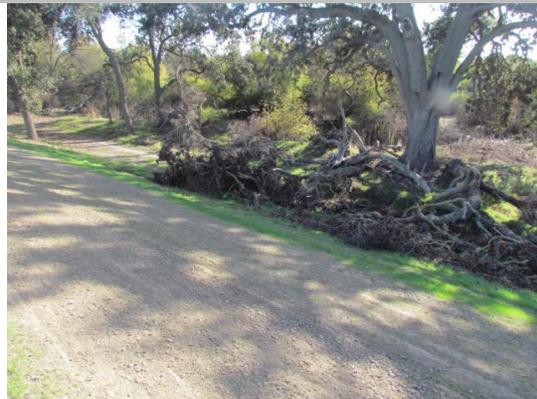
Photo 1 of 1 : FA\_2015\_RD2063\_112\_6\_20150914\_00002.jpg

Looking southwest at fallen tree limbs at waterward toe.

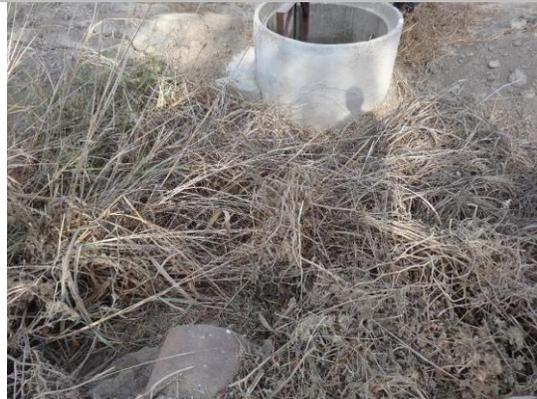
Photo 1 of 3 : UCIP\_FA\_2015\_2632.jpg

LS view: open-ended steel pipe on levee slope (bottom).

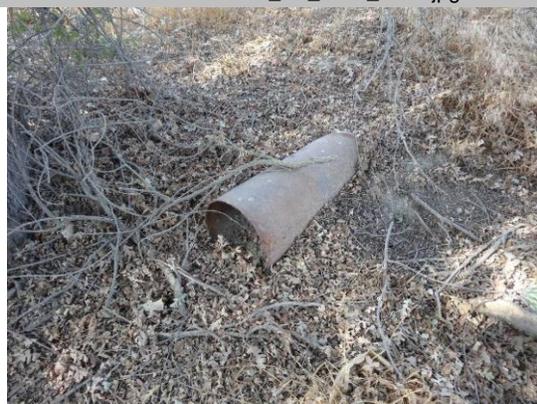
Photo 2 of 3 : UCIP\_FA\_2015\_2633.jpg

WS view: steel pipe with open-end on waterside slope.

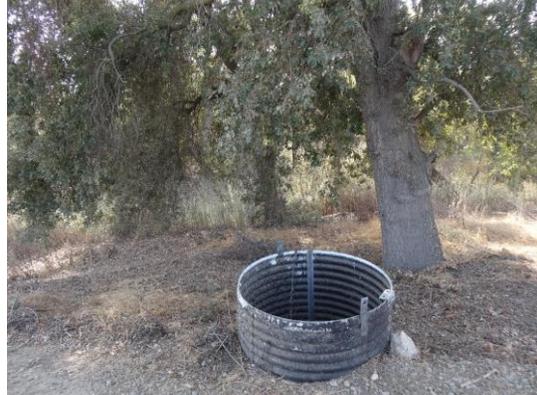
Photo 3 of 3 : UCIP\_FA\_2015\_2634.jpg

WS view: CMP riser with slide gate. Missing slide gate handwheel.

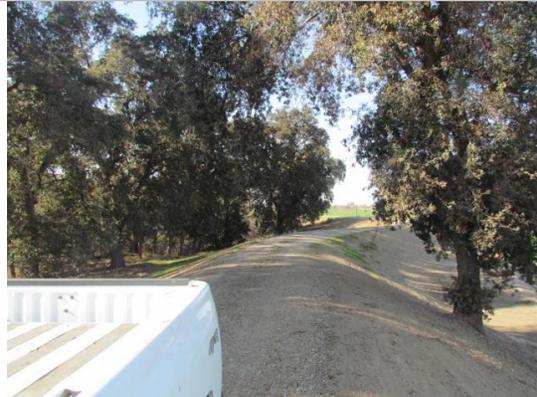
Photo 1 of 1 : FA\_2015\_RD2063\_112\_7\_20150914\_00003.jpg

Looking north at overhanging tree on landward slope.

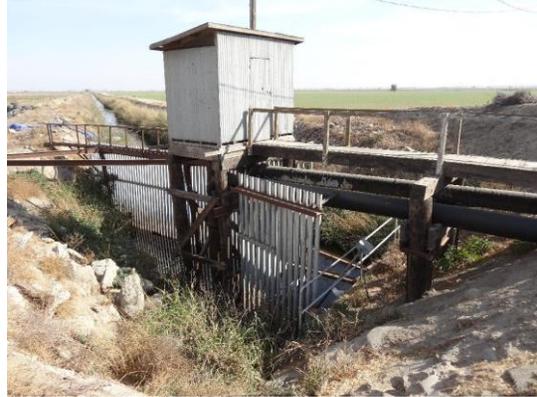
Photo 1 of 3 : UCIP\_FA\_2015\_2711.jpg

LS view: pipes under walkway to pump house.

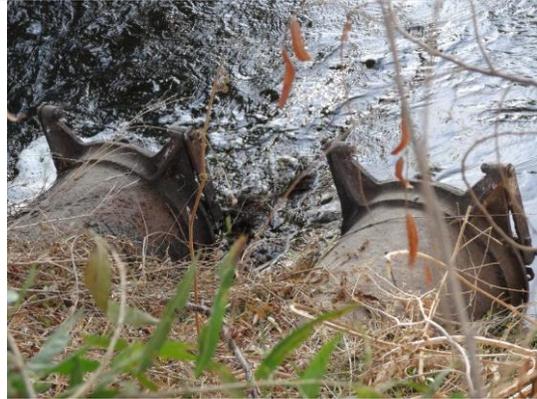
Photo 2 of 3 : UCIP\_FA\_2015\_2712.jpg

WS view: two flap gates on outfall pipe ends.

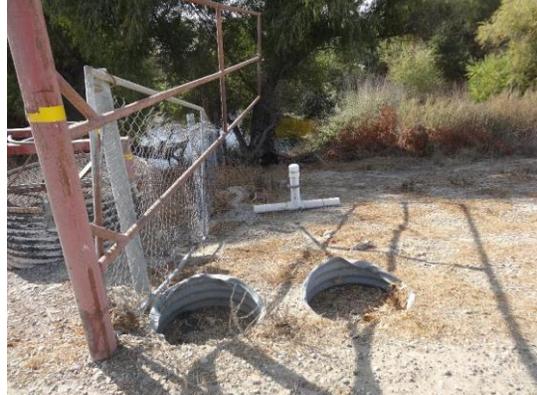
Photo 3 of 3 : UCIP\_FA\_2015\_2713.jpg

WS view: two siphon breakers in CMP risers on levee slope.

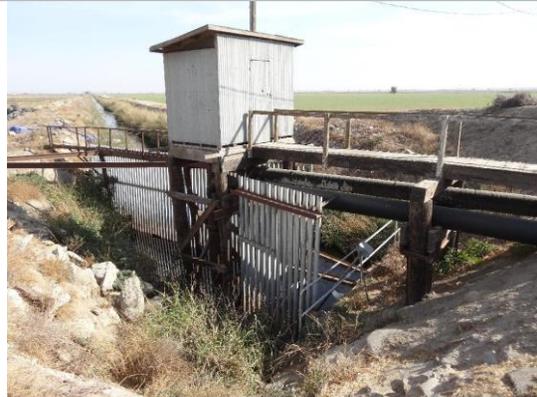
Photo 1 of 3 : UCIP\_FA\_2015\_2714.jpg

LS view: pipes under walkway to pump house.

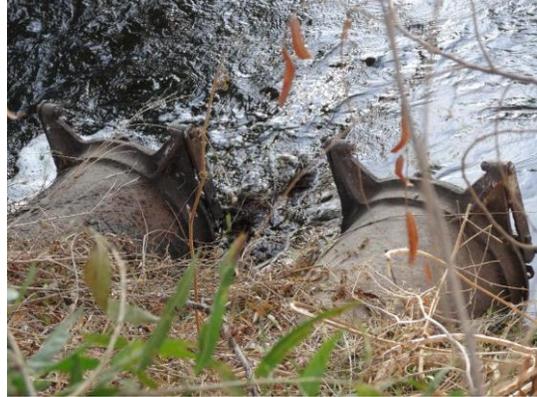
Photo 2 of 3 : UCIP\_FA\_2015\_2715.jpg

WS view: two flap gates on outfall pipe ends.

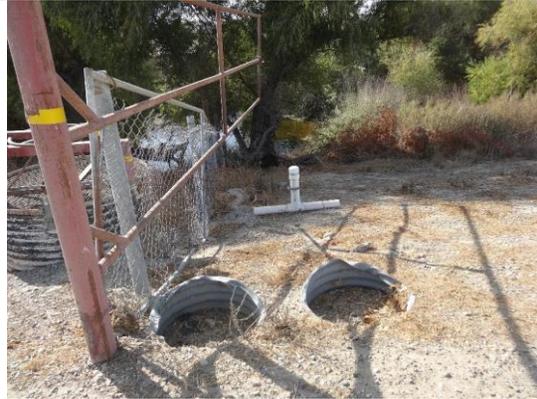
Photo 3 of 3 : UCIP\_FA\_2015\_2716.jpg

WS view: two siphon breakers in CMP risers on levee slope.

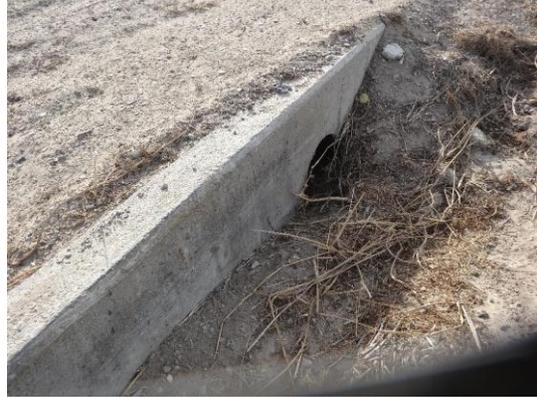
Photo 1 of 2 : UCIP\_FA\_2015\_2707.jpg

LS view: concrete headwall and partially blocked inlet opening.

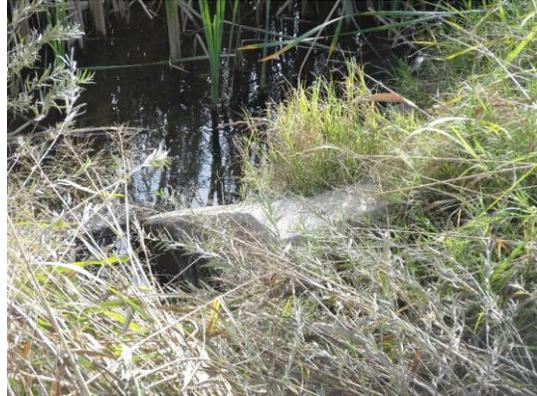
Photo 2 of 2 : UCIP\_FA\_2015\_2708.jpg

WS view: concrete U type headwall on channel bank. Not accessible.

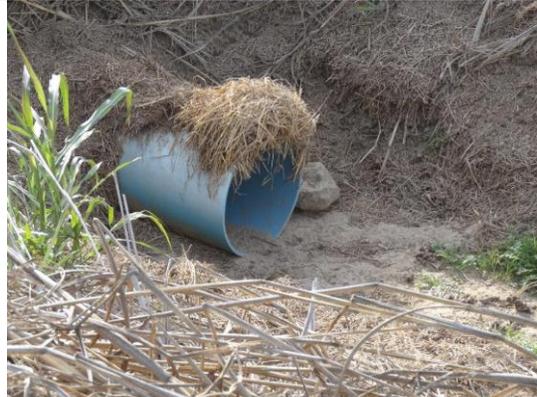
Photo 1 of 2 : UCIP\_FA\_2015\_2709.jpg

LS view: PVC pipe with open end on levee toe.

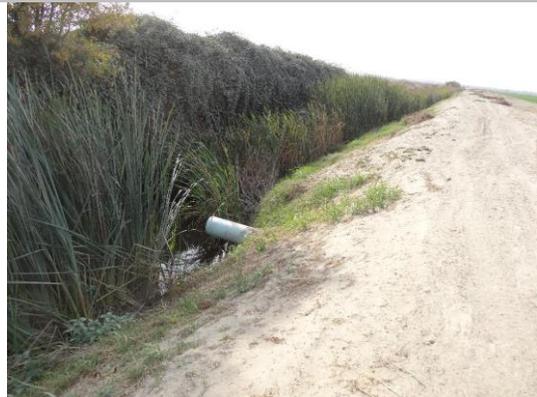
Photo 2 of 2 : UCIP\_FA\_2015\_2710.jpg

WS view: PVC pipe with open end on levee slope.

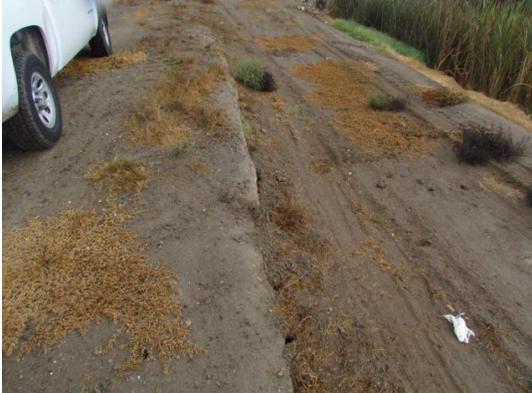
Photo 1 of 2 : FA\_2015\_RD2063\_112\_42\_20151005\_00030.jpg

Looking at erosion on waterward levee shoulder. (Fall 2015)

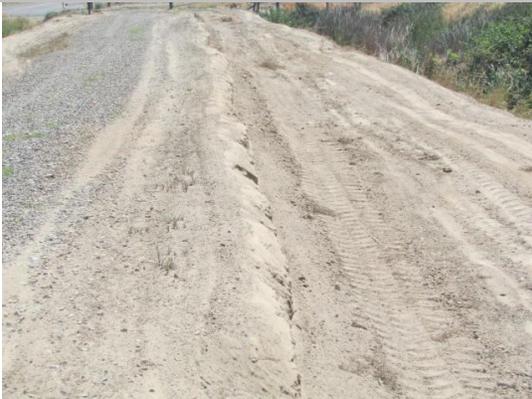
Photo 2 of 2 : FA\_2015\_RD2063\_112\_42\_20150914\_00012.jpg

Looking north at erosion on waterward shoulder. (Spring 2015)
