**Flood Control Project Maintenance  
Levee Inspections  
LMA District Cover Sheet  
Spring 2015 Levee Inspection Results**

**Reclamation District No. 2063 Crows Landing**

**Spring 2015 Levee Inspection Results**

Waterway	Bank	Unit Miles	Inspection Start/End	Inspector
Unit No. 01 San Joaquin River	Right	10.44	05/12/2015 05/12/2015	Richard Willoughby

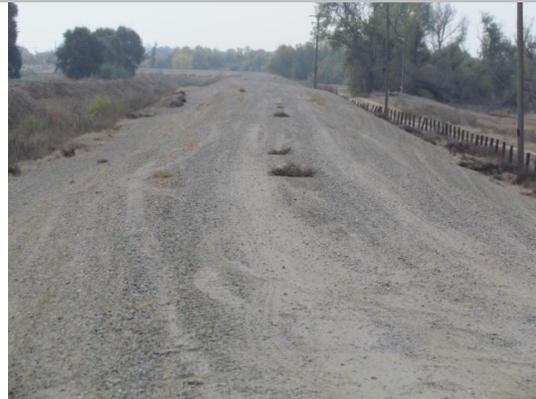
Photo 1 of 1 : SP\_2015\_RD2063\_112\_3\_20150309\_00001.jpg

LM Start	<b>0.01</b>	Rating **	A/W	Issue No.	<b>3</b>
LM End	<b>0.50</b>	Issue Type +	Ma	Location *	WS
Category	Earthen Levee			GPS Latitude/Longitude	
				Start	End
Item	Vegetation			37.478550 °	37.471548 °
				-121.044603 °	-121.044553 °
DWR ID	DWR_RD2063_01_s_2012_3				
Action/Comments					
Remove the wild growth other than native grasses from the levee slopes.

Looking south at typical view of waterside and landside slopes.

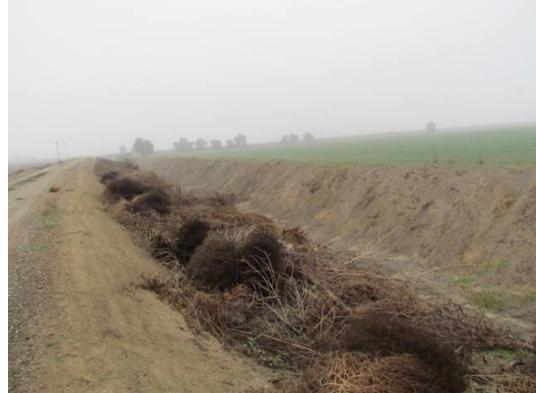
Photo 1 of 3 : SP\_2015\_RD2063\_112\_18\_20150309\_00005.jpg

LM Start	<b>0.02</b>	Rating **	U	Issue No.	<b>18</b>
LM End	<b>1.30</b>	Issue Type +	En	Location *	LS
Category	Earthen Levee		GPS Latitude/Longitude		
			Start	End	
Item	Encroachments		37.478470 °	37.464660 °	
			-121.044598 °	-121.032946 °	
DWR ID	DWR_RD2063_01_s_2012_18				
Action/Comments					
Ditch Inspector Comments: Ditch on landside has encroached into the berm and toe of the levee.

Looking north at ditch on landside berm and toe.

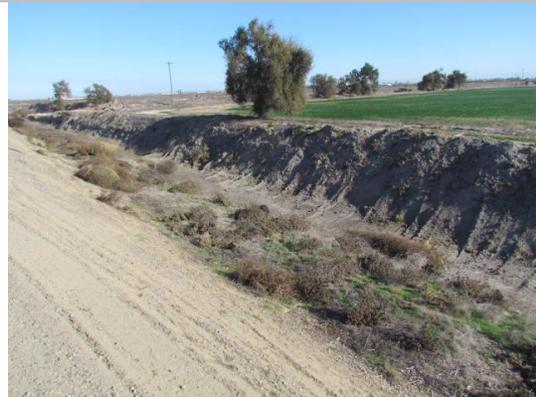
Photo 2 of 3 : SP\_2015\_RD2063\_112\_18\_20150309\_00006.jpg

Looking northeast at canal-ditch on landside berm.

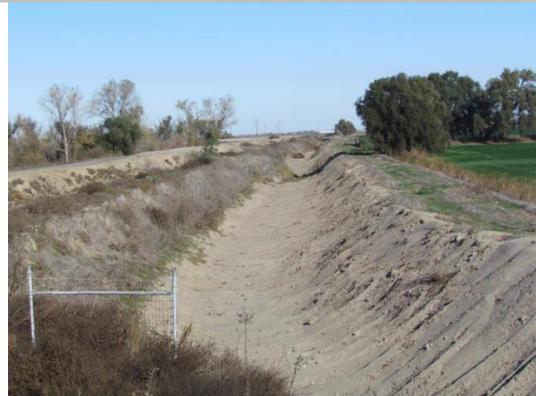
Photo 3 of 3 : SP\_2015\_RD2063\_112\_18\_20150309\_00007.jpg

Looking south at canal-ditch at landside berm and toe.

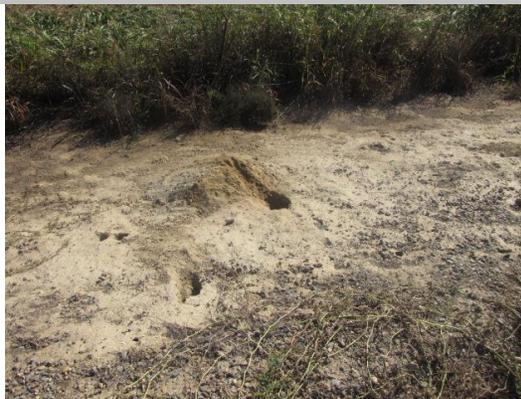
Photo 1 of 1 : SP\_2015\_RD2063\_112\_11\_20150309\_00004.jpg

LM Start	<b>1.65</b>	Rating **	A/W	Issue No.	<b>11</b>
LM End	<b>1.65</b>	Issue Type +	Ma	Location *	LS
Category	Earthen Levee			GPS Latitude/Longitude	
				Start	End
Item	Animal Control			37.459813 °	37.459813 °
				-121.032372 °	-121.032372 °
DWR ID	DWR_RD2063_01_s_2012_11				
Action/Comments					
No rodents visible, but rodent burrows visible; need to backfill and compact or grout burrows.

Looking east at squirrel holes on landside slope.

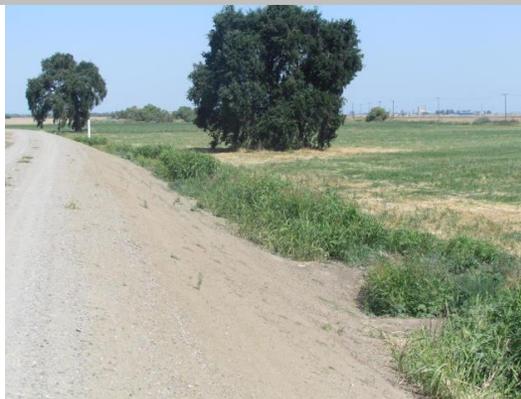
Photo 1 of 1 : SP\_2015\_RD2063\_112\_38\_20150514\_00030.jpg

LM Start	<b>3.35</b>	Rating **	M	Issue No.	<b>38</b>
LM End	<b>3.64</b>	Issue Type +	Ma	Location *	LS
Category	Earthen Levee			GPS Latitude/Longitude	
				Start	End
Item	Vegetation			37.440438 °	37.436906 °
				-121.020487 °	-121.017835 °
DWR ID	DWR_RD2063_01_f_2012_38				
Action/Comments					
Remove the wild growth other than native grasses from the levee slopes. Inspector Comments: Control Johnson grass at landward toe.

Looking south at vegetation at landward toe.

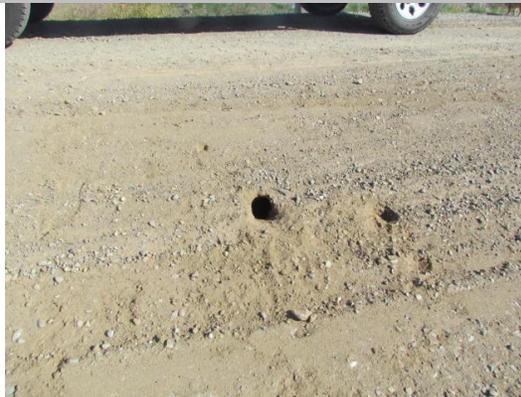
Photo 1 of 1 : SP\_2015\_RD2063\_112\_53\_20150309\_00012.jpg

LM Start	<b>3.49</b>	Rating **	M	Issue No.	<b>53</b>
LM End	<b>3.49</b>	Issue Type +	Ma	Location *	WS
Category	Earthen Levee			GPS Latitude/Longitude	
				Start	End
Item	Animal Control			37.438697 °	37.438697 °
				-121.019232 °	-121.019232 °
DWR ID	DWR_RD2063_01_f_2014_53				
Action/Comments					
Exterminate rodents and backfill and compact or grout burrows.

Looking north at typical view of rodent holes on waterward slope.

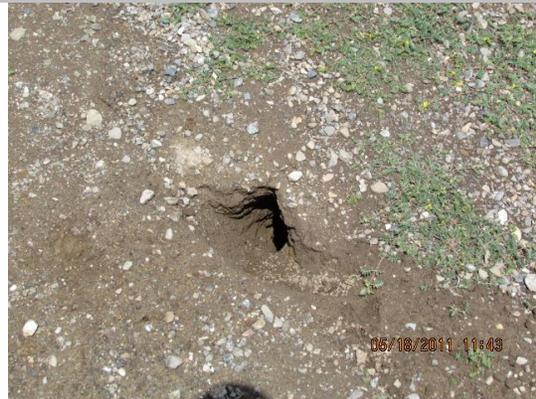
Photo 1 of 1 : SP\_2015\_RD2063\_112\_29\_20150309\_00008.jpg

LM Start	<b>3.71</b>	Rating **	A/W	Issue No.	<b>29</b>
LM End	<b>3.76</b>	Issue Type +	Ma	Location *	LS
Category	Earthen Levee			GPS Latitude/Longitude	
				Start	End
Item	Animal Control			37.436197 °	37.435732 °
				-121.016937 °	-121.016090 °
DWR ID	DWR_RD2063_01_s_2012_29				
Action/Comments					
No rodents visible, but rodent burrows visible; need to backfill and compact or grout burrows.

Looking at typical view of a squirrel hole on landside shoulder.

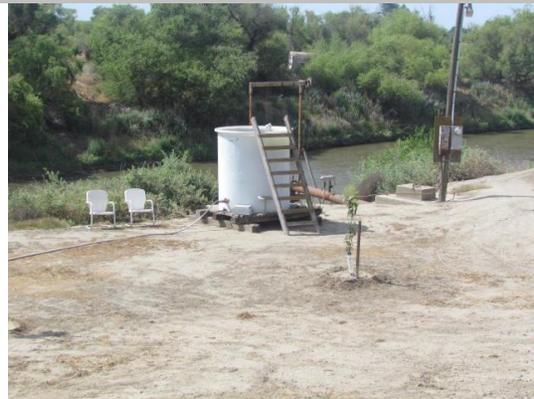
Photo 1 of 2 : SP\_2015\_RD2063\_112\_31\_20150309\_00009.jpg

LM Start	<b>4.60</b>	Rating **	M	Issue No.	<b>31</b>
LM End	<b>4.60</b>	Issue Type +	En	Location *	WS
Category	Earthen Levee			GPS Latitude/Longitude	
				Start	End
Item	Encroachments			37.429638 °	37.429638 °
				-121.005348 °	-121.005348 °
DWR ID	DWR_RD2063_01_s_2012_31				
Action/Comments					
Crops Inspector Comments: Landowner planted grape vines and fruit trees and water tank on waterside berm without a permit from the CVFPB.

Looking west at water tank on waterward berm.

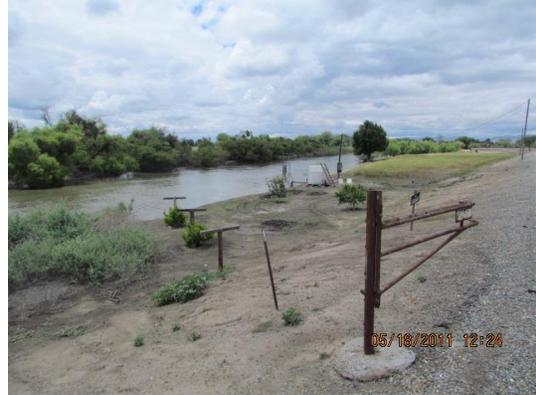
Photo 2 of 2 : SP\_2015\_RD2063\_112\_31\_20150309\_00010.jpg

LM Start	<b>4.60</b>	Rating **	M	Issue No.	<b>31 (cont)</b>
LM End	<b>4.60</b>	Issue Type +	En	Location *	WS
Category	Earthen Levee			GPS Latitude/Longitude	
				Start	End
Item	Encroachments			37.429638 °	37.429638 °
				-121.005348 °	-121.005348 °
DWR ID	DWR_RD2063_01_s_2012_31				
Action/Comments					
Crops Inspector Comments: Landowner planted grape vines and fruit trees and water tank on waterside berm without a permit from the CVFPB.

Looking south at grapevines and fruit trees on waterside berm.

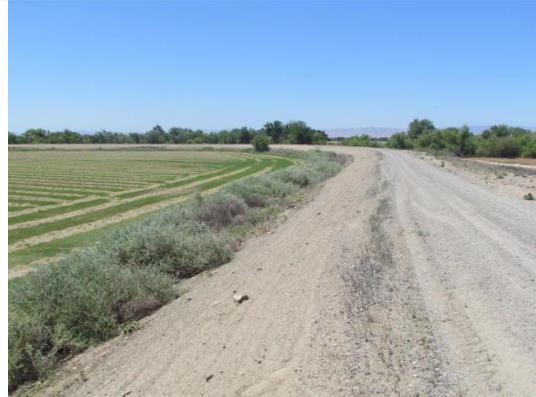
Photo 1 of 1 : SP\_2015\_RD2063\_112\_120\_20150309\_00014.jpg

LM Start	<b>6.04</b>	Rating **	A/W	Issue No.	<b>120</b>
LM End	<b>6.26</b>	Issue Type +	Ma	Location *	LS
Category	Earthen Levee		GPS Latitude/Longitude		
			Start	End	
Item	Vegetation		37.415488 °	37.413473 °	
			-120.998988 °	-121.001680 °	
DWR ID	DWR_RD2063_01_s_2012_120				
Action/Comments					
Remove the wild growth other than native grasses from the levee slopes.

Looking south at dense vegetation on landside toe.

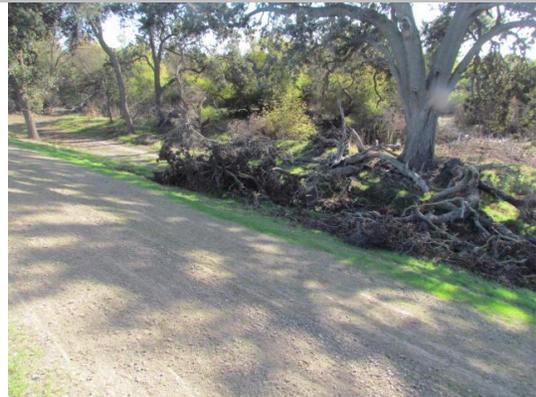
Photo 1 of 1 : SP\_2015\_RD2063\_112\_6\_20150309\_00002.jpg

LM Start	<b>7.35</b>	Rating **	M	Issue No.	<b>6</b>
LM End	<b>7.35</b>	Issue Type +	Ma	Location *	WS
Category	Earthen Levee			GPS Latitude/Longitude	
				Start	End
Item	Encroachments			37.404377 °	37.404377 °
				-120.988852 °	-120.988852 °
DWR ID	DWR_RD2063_01_f_2014_6				
Action/Comments					
Tree or limb Inspector Comments: Fallen tree limbs at waterward toe.

Looking southwest at fallen tree limbs at waterward toe.
