Flood Control Project Maintenance
2008 Structure Summary Report
Overall Unit and Item Ratings

Reclamation District No. 2063 Pumping Plant (Nelson Drain)

Unit Cover Sheet
2008 Pumping Plant Inspection Results

Date of Inspection	11/21/2008
DWR Inspector	David Pesavento
Pumping Plant Rating	A

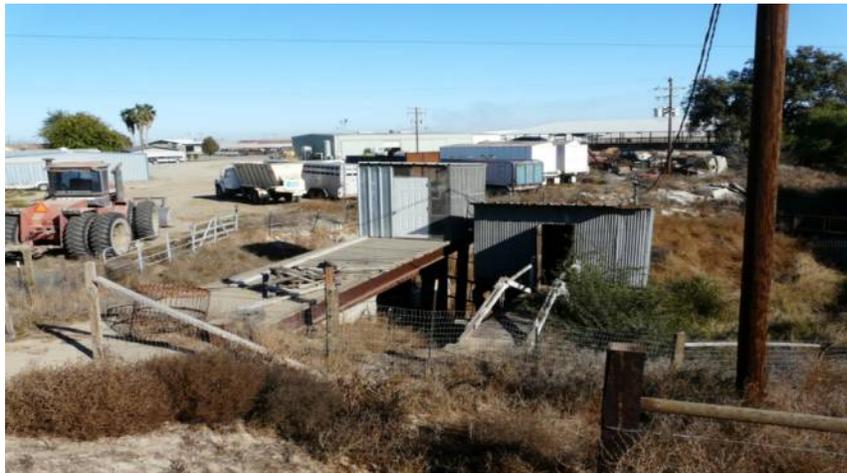
Report Line	3
Location	
Category	Pump Stations
Item	Plant Building
View of pump plant from crown of levee

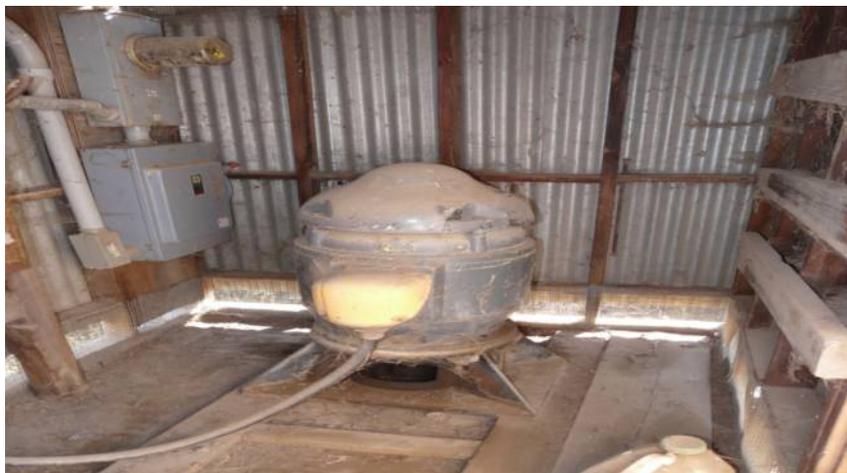
Report Line	7
Location	
Category	Pump Stations
Item	Pumps
Photo of one of the smaller pumps

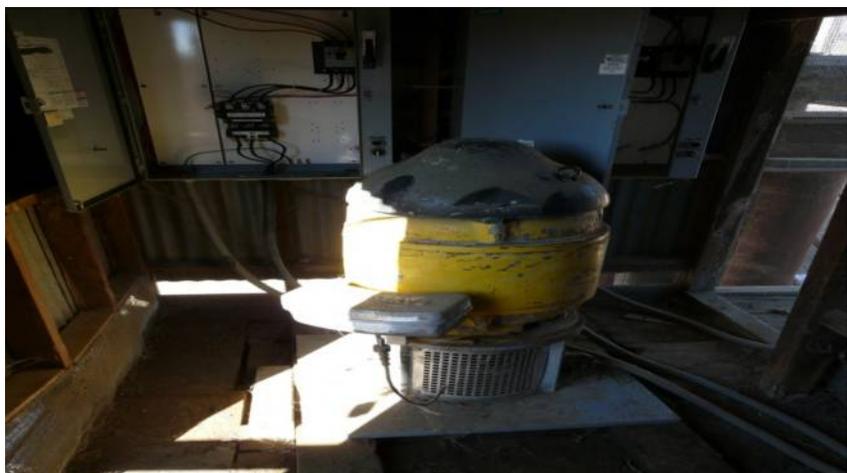
Report Line	7
Location	
Category	Pump Stations
Item	Pumps
Photo of one of the smaller pumps

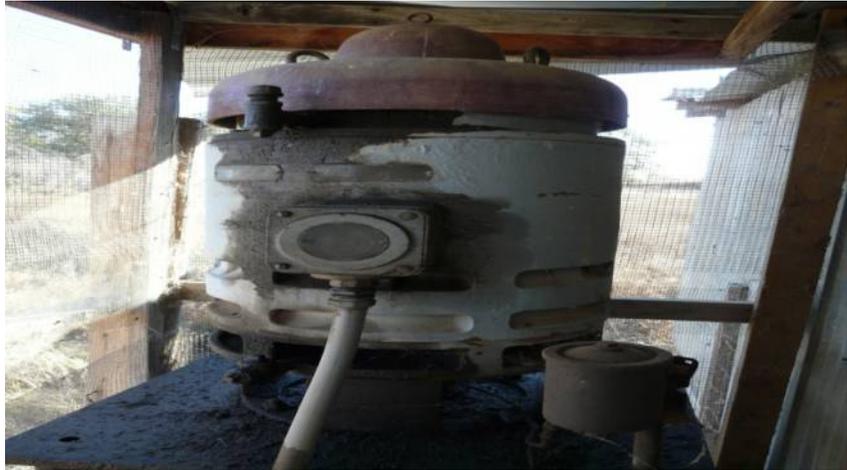
Report Line	7
Location	
Category	Pump Stations
Item	Pumps

Photo of one of the smaller pumps

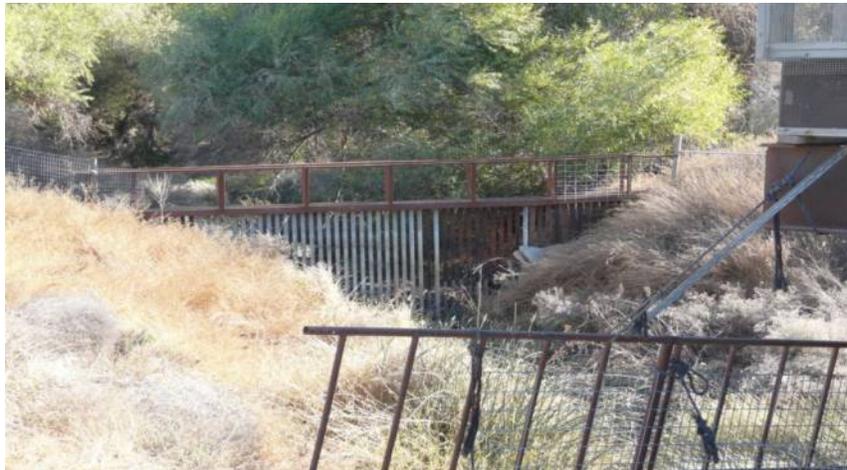
Report Line	12
Location	
Category	Pump Stations
Item	Trash Racks

View of trash rack looking upstream from pumps. Screen appears adequate to prevent debris from clogging pipe intakes and is manually cleared from catwalk above screen.

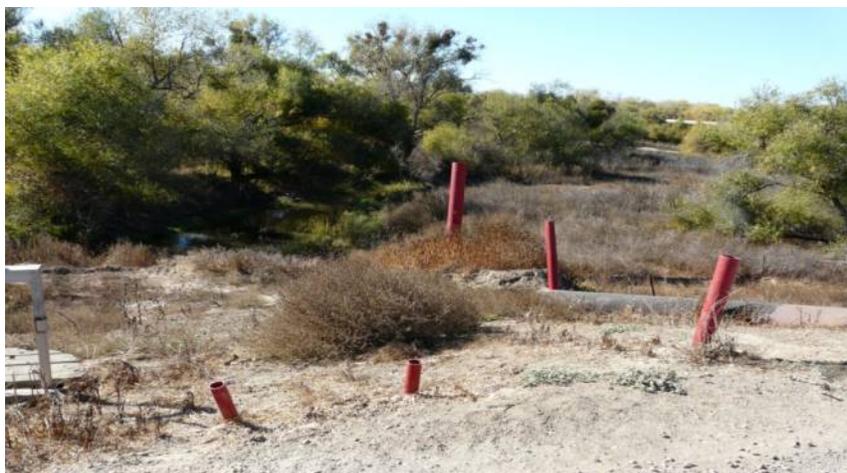
Report Line	18
Location	
Category	Pump Stations
Item	Flap Gates

View of several of the risers on siphon breakers toward crown of levee. One siphon breaker's riser has been broken off of the pipe, but should function acceptably.

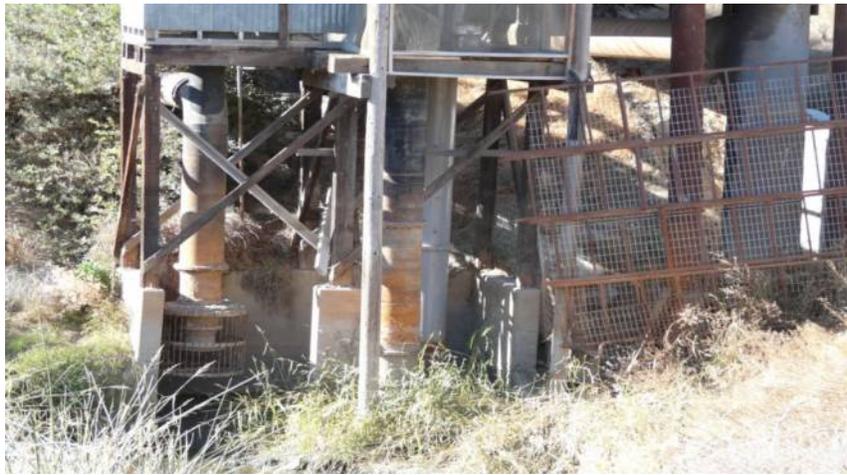
Report Line	21
Location	
Category	Pump Stations
Item	Intake and Discharge Pipes
<p>Pump intakes appear in acceptable condition and able to perform in a flood.</p>

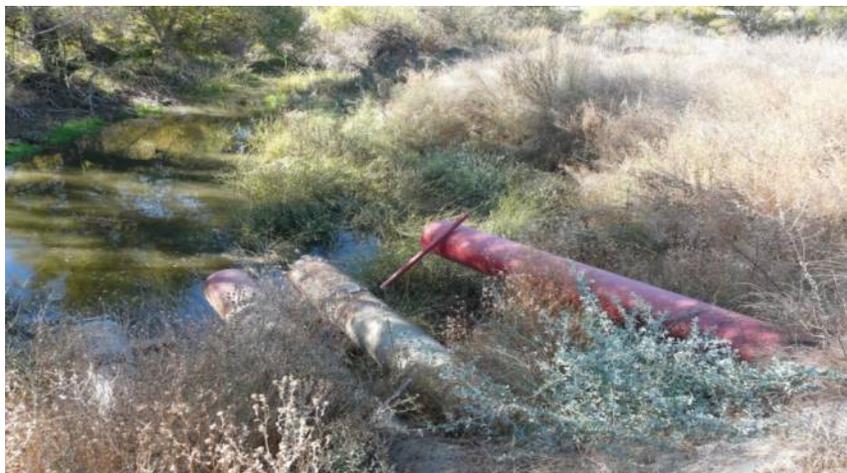
Report Line	21
Location	
Category	Pump Stations
Item	Intake and Discharge Pipes
<p>View of discharge pipes into San Joaquin River. No flap gates are present but siphon breakers are present at crown of levee.</p>

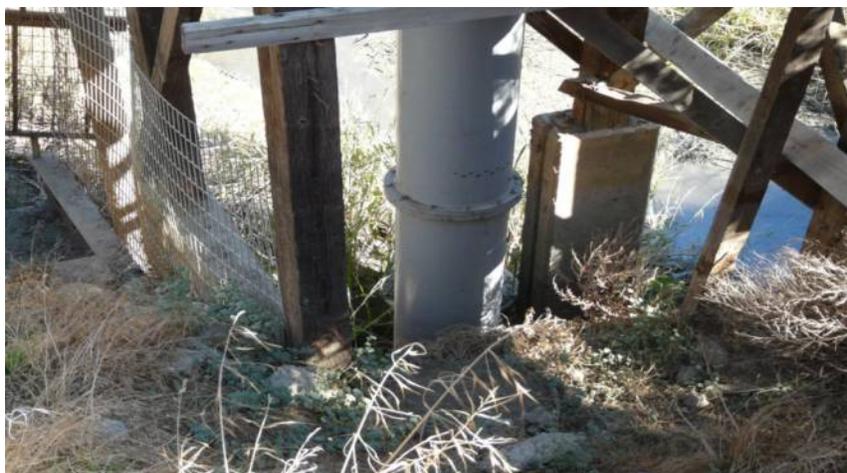
Report Line	21
Location	
Category	Pump Stations
Item	Intake and Discharge Pipes
<p>View of one of the intake pipes from levee. Minor vegetation present but should not adversely affect operation of station.</p>

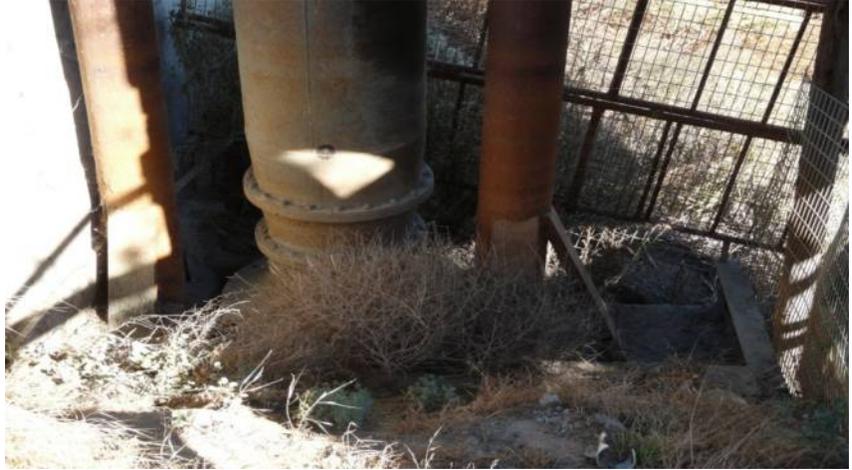
Report Line	21
Location	
Category	Pump Stations
Item	Intake and Discharge Pipes

View of another one of the intake pipes from levee. Minor vegetation present but should not adversely affect operation of station. Note additional debris screen around this intake.
