**Flood Control Project Maintenance**  
**2015 Structure Summary Report**  
**Overall Unit and Item Ratings**

**Reclamation District No. 2063 Crows Landing**

**Lateral No. 6 Pumping Plant**

**Flood Control Project Maintenance****Unit Cover Sheet****2015 Pumping Plant Inspection Results****Reclamation District No. 2063 Crows Landing**

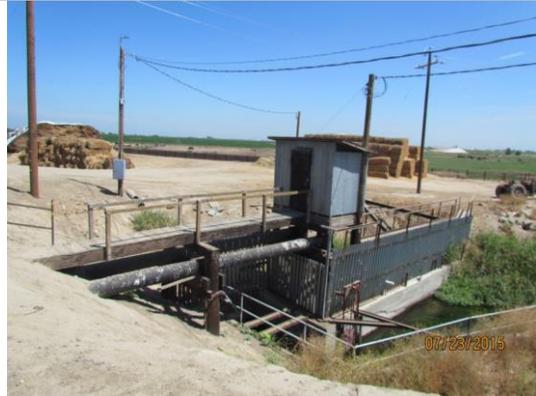
Photo 1 of 1 : ST\_2015\_RD2063\_53\_4\_20150811\_00015.jpg

LM Start	<b>0.00</b>	Rating **	A	Issue No.	<b>4</b>
LM End	<b>0.00</b>	Issue Type +	Ma	Location *	
Category	Pump Stations		GPS Latitude/Longitude		
			Start	End	
Item	Plant Building		37.397931 °	37.397931 °	
			-120.972176 °	-120.972176 °	
DWR ID	DWR_RD2063_53_t_2012_4				
Action/Comments					
Inspector Comments: The plant building appeared to be in a good structural condition.

View of the pumping plant.

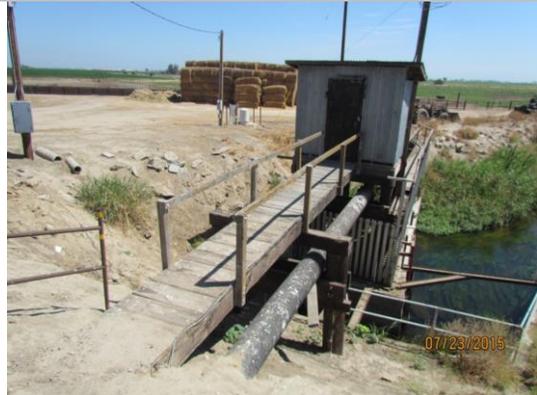
Photo 1 of 1 : ST\_2015\_RD2063\_53\_6\_20150811\_00016.jpg

LM Start	<b>0.00</b>	Rating **	A	Issue No.	<b>6</b>
LM End	<b>0.00</b>	Issue Type +	Ma	Location *	
Category	Pump Stations		GPS Latitude/Longitude		
			Start	End	
Item	Safety		37.397931 °	37.397931 °	
			-120.972176 °	-120.972176 °	
DWR ID	DWR_RD2063_53_t_2012_6				
Action/Comments					
Inspector Comments: There was not any significant safety hazard present outside of the pumping plant during inspection and the handrails prevented falling hazards around the pumping plant.

View of the handrails.

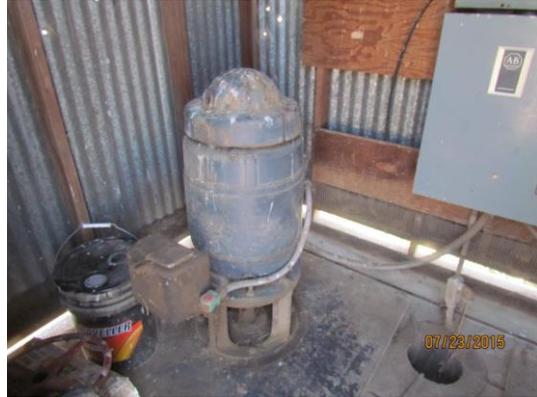
Photo 1 of 2 : ST\_2015\_RD2063\_53\_7\_20150811\_00017.jpg

LM Start	<b>0.00</b>	Rating **	A	Issue No.	<b>7</b>
LM End	<b>0.00</b>	Issue Type +	Ma	Location *	
Category	Pump Stations		GPS Latitude/Longitude		
			Start	End	
Item	Pumps		37.397931 °	37.397931 °	
			-120.972176 °	-120.972176 °	
DWR ID	DWR_RD2063_53_t_2013_7				
Action/Comments					
Inspector Comments: Pumps appeared to be in a good working condition.

View of one of the pumps inside the plant.

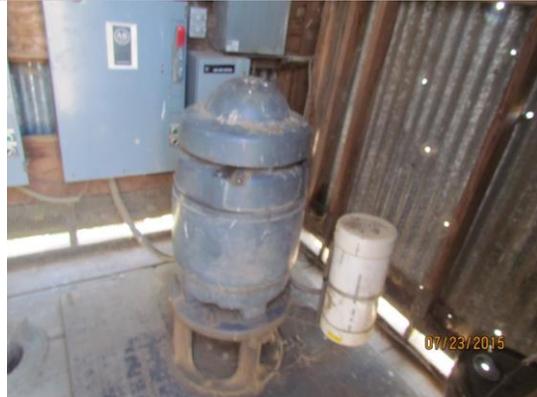
Photo 2 of 2 : ST\_2015\_RD2063\_53\_7\_20150811\_00018.jpg

View of another pump at the plant.

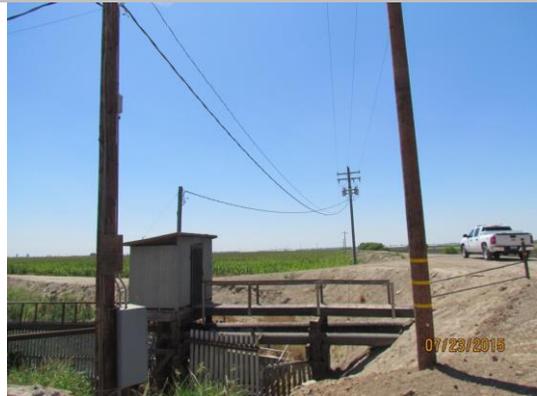
Photo 1 of 1 : ST\_2015\_RD2063\_53\_9\_20150811\_00019.jpg

LM Start	<b>0.00</b>	Rating **	A	Issue No.	<b>9</b>
LM End	<b>0.00</b>	Issue Type +	Ma	Location *	
Category	Pump Stations		GPS Latitude/Longitude		
			Start	End	
Item	Power		37.397931 °	37.397931 °	
			-120.972176 °	-120.972176 °	
DWR ID	DWR_RD2063_53_t_2013_9				
Action/Comments					
Inspector Comments: The power source appeared to be safe and adequate.

View of the power sources for the pumping plant.

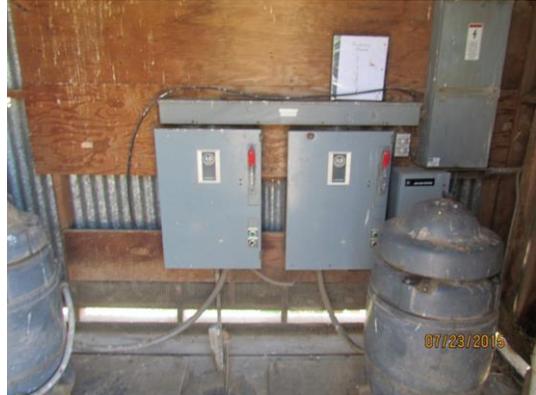
Photo 1 of 2 : ST\_2015\_RD2063\_53\_10\_20150811\_00020.jpg

LM Start	<b>0.00</b>	Rating **	A	Issue No.	<b>10</b>
LM End	<b>0.00</b>	Issue Type +	Ma	Location *	
Category	Pump Stations		GPS Latitude/Longitude		
			Start	End	
Item	Pump Control Systems		37.397931 °	37.397931 °	
			-120.972176 °	-120.972176 °	
DWR ID	DWR_RD2063_53_t_2012_10				
Action/Comments					
Inspector Comments: Pump control systems were operational and in good condition.

View of the power control systems inside the plant.

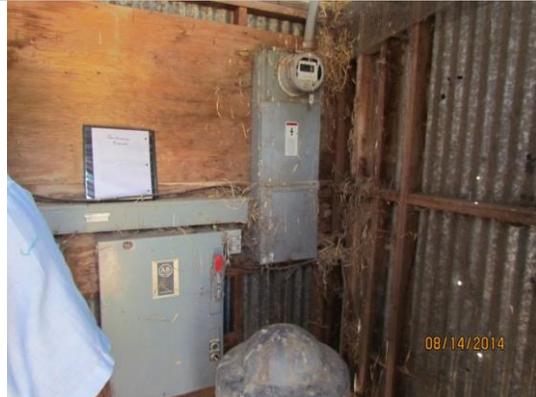
Photo 2 of 2 : ST\_2015\_RD2063\_53\_10\_20150710\_00008.jpg

View of the power meter.

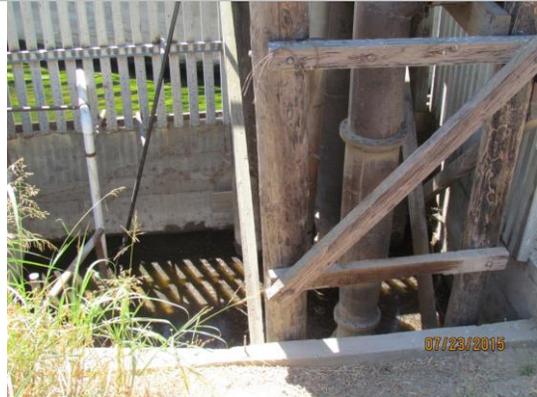
Photo 1 of 1 : ST\_2015\_RD2063\_53\_12\_20150811\_00021.jpg

LM Start	<b>0.00</b>	Rating **	A	Issue No.	<b>12</b>
LM End	<b>0.00</b>	Issue Type +	Ma	Location *	
Category	Pump Stations		GPS Latitude/Longitude		
			Start	End	
Item	Sumps/Wet Well		37.397931 °	37.397931 °	
			-120.972176 °	-120.972176 °	
DWR ID	DWR_RD2063_53_t_2012_12				
Action/Comments					
Inspector Comments: The sump well was free of debris.

View of sump well.

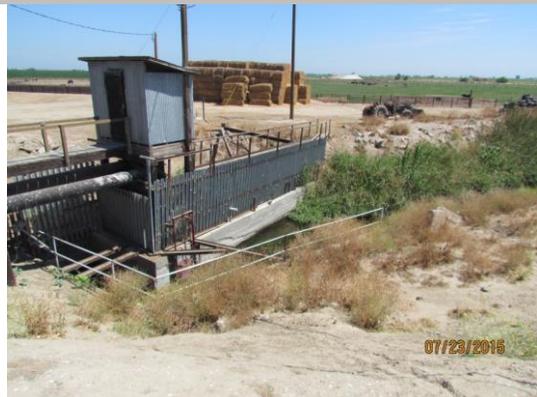
Photo 1 of 1 : ST\_2015\_RD2063\_53\_13\_20150811\_00022.jpg

LM Start	<b>0.00</b>	Rating **	A	Issue No.	<b>13</b>
LM End	<b>0.00</b>	Issue Type +	Ma	Location *	
Category	Pump Stations		GPS Latitude/Longitude		
			Start	End	
Item	Trash Racks		37.397931 °	37.397931 °	
			-120.972176 °	-120.972176 °	
DWR ID	DWR_RD2063_53_t_2012_13				
Action/Comments					
Inspector Comments: The trash racks appears to be in good working condition.

View of the trash rack.

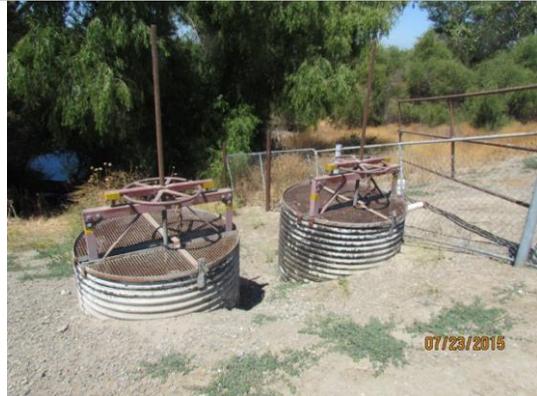
Photo 1 of 1 : ST\_2015\_RD2063\_53\_17\_20150811\_00024.jpg

LM Start	<b>0.00</b>	Rating **	A	Issue No.	<b>17</b>
LM End	<b>0.00</b>	Issue Type +	Ma	Location *	
Category	Pump Stations		GPS Latitude/Longitude		
			Start	End	
Item	Manual Gate Operators		37.397931 °	37.397931 °	
			-120.972176 °	-120.972176 °	
DWR ID	DWR_RD2063_53_t_2012_17				
Action/Comments					
Inspector Comments: The manual gate operator appeared to be in working condition.

View of the manual gates.

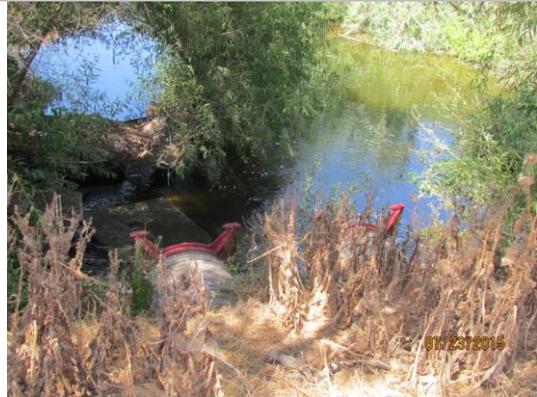
Photo 1 of 1 : ST\_2015\_RD2063\_53\_16\_20150811\_00023.jpg

LM Start	<b>0.00</b>	Rating **	A	Issue No.	<b>16</b>
LM End	<b>0.00</b>	Issue Type +	Ma	Location *	
Category	Pump Stations		GPS Latitude/Longitude		
			Start	End	
Item	Flap Gates		37.397931 °	37.397931 °	
			-120.972176 °	-120.972176 °	
DWR ID	DWR_RD2063_53_t_2013_16				
Action/Comments					
Inspector Comments: Flap gates appeared to be in a good working condition.

View of the flap gates.

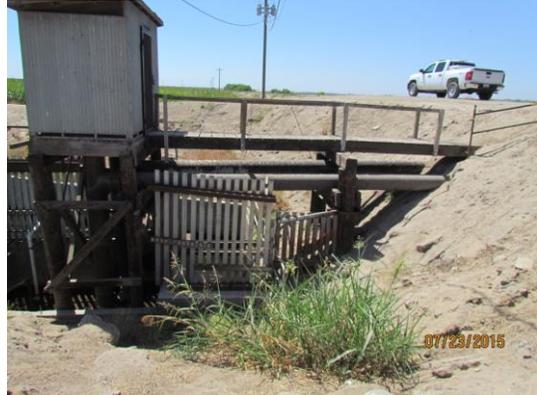
Photo 1 of 1 : ST\_2015\_RD2063\_53\_20\_20150811\_00025.jpg

LM Start	<b>0.00</b>	Rating **	A	Issue No.	<b>20</b>
LM End	<b>0.00</b>	Issue Type +	Ma	Location *	
Category	Pump Stations		GPS Latitude/Longitude		
			Start	End	
Item	Intake and Discharge Pipes		37.397931 °	37.397931 °	
			-120.972176 °	-120.972176 °	
DWR ID	DWR_RD2063_53_t_2013_20				
Action/Comments					
Inspector Comments: The intake and discharge pipes appeared to be in good condition.

View of the intake pipes.
