**Flood Control Project Maintenance
Levee Inspections**
LMA District Cover Sheet
Spring 2014 Levee Inspection Results

Reclamation District No. 2064 River Junction

Levee Inspection Report By Mile - Spring 2014

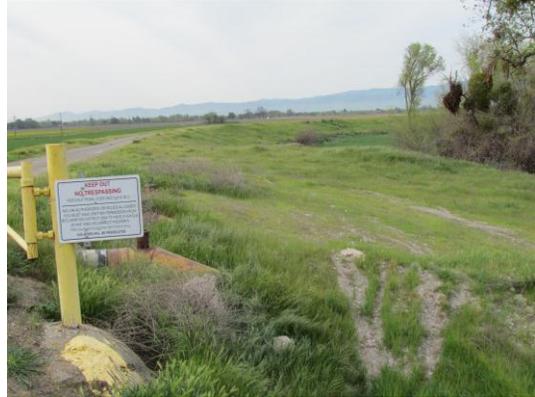
Photo 1 of 1 : phillips_s_20140603_06037.jpg

LM Start	0.00	Rating **	U	Issue No.	11
LM End	0.00	Issue Type +	Ma	Location *	WS
Category	Earthen Levee		GPS Latitude/Longitude		
			Start	End	
Item	Vegetation		37.709804 °	37.709804 °	
			-121.267564 °	-121.267564 °	
DWR ID	DWR_RD2064_01_s_2013_11				
Action/Comments					
Remove the wild growth other than native grasses from the levee slopes.

Looking downstream from waterside levee slope weed covering the levee section. Photo taken 03-25-2014.

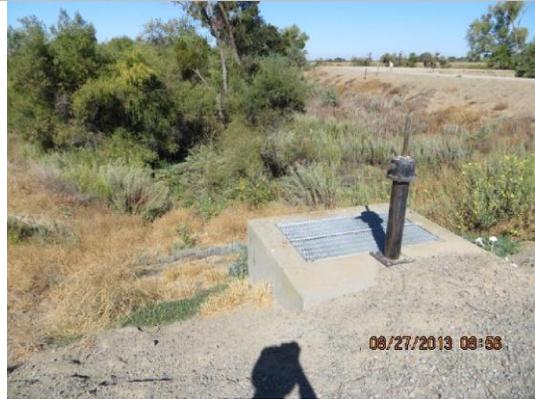
Photo 1 of 1 : UCIP_1714.jpg

LM Start	0.07	Rating **	M	Issue No.	7
LM End	0.07	Issue Type +	En	Location *	WS
Category	Supplemental		GPS Latitude/Longitude		
			Start	End	
Item	DWR UCIP Field Study		37.709803 °	37.709803 °	
			-121.267558 °	-121.267558 °	
DWR ID	DWR_RD2064_01_s_2014_7				
Action/Comments					
Inspector Comments: FS_ID:18708 EP_NO: N/A Repair Type: Crossing Status: UCIP Comments: Debris blocking closure of flapgate on WS toe. FIELD_STRUCT_DESC: 36-inch square reinforced concrete storm drain box culvert through the levee 21.0 feet below the crown. Concrete "U" shaped headwalls on both ends. Slide gate in 6'X7' concrete riser unit on the waterward slope. Flap gate on the waterward end. Flashboard slots on the landside headwall. Originally included in the 1968 O&M manual. FS Date: 8/27/2013

Slide gate in concrete riser on WS shoulder.

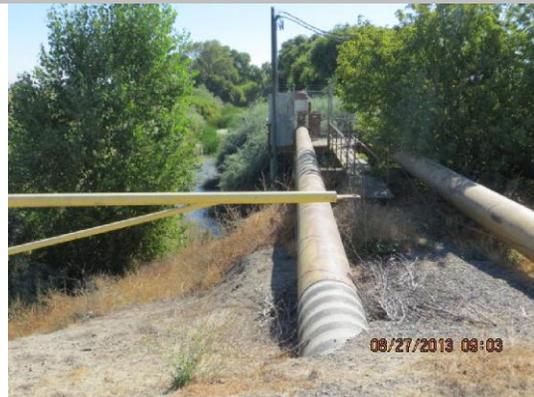
Photo 1 of 1 : UCIP_1717.jpg

LM Start	0.08	Rating **	M	Issue No.	8
LM End	0.08	Issue Type +	En	Location *	LS
Category	Supplemental		GPS Latitude/Longitude		
			Start	End	
Item	DWR UCIP Field Study		37.709725 °	37.709725 °	
			-121.267534 °	-121.267534 °	
DWR ID	DWR_RD2064_01_s_2014_8				
Action/Comments					
Inspector Comments: FS_ID:18718 EP_NO: 13907 Repair Type: Crossing Status: UCIP Comments: This pipe has less than 1-foot of cover. FIELD_STRUCT_DESC: 1 of 3: 24-inch stormdrain discharge pipe through the levee 2.0 feet below the crown (Permit No. 13907, 1985). Two 100-horsepower and one 75-horsepower pumps on landward toe of levee. Siphon breaker on WS shoulder. FS Date: 8/27/2013

Steel storm drain pipe with pump on pier in background.

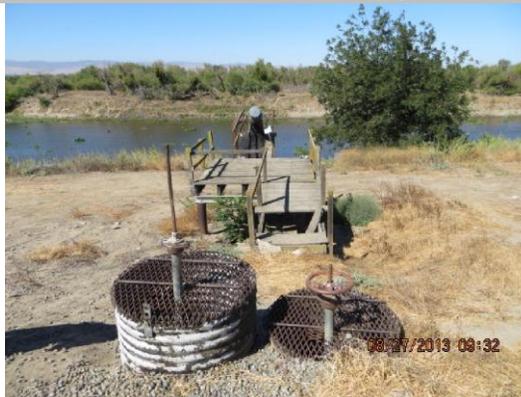
Photo 1 of 1 : UCIP_1733.jpg

LM Start	1.28	Rating **	M	Issue No.	14
LM End	1.28	Issue Type +	En	Location *	WS
Category	Supplemental		GPS Latitude/Longitude		
			Start	End	
Item	DWR UCIP Field Study		37.695529 °	37.695529 °	
			-121.270005 °	-121.270005 °	
DWR ID	DWR_RD2064_01_s_2014_14				
Action/Comments					
Inspector Comments: FS_ID:18746 EP_NO: N/A Repair Type: Crossing Status: UCIP Comments: FIELD_STRUCT_DESC: 12-inch steel concrete encased irrigation pipe through the levee 13.0 feet below the crown, slant pump on the WS toe. Slide gate in 36-inch CMP riser on the WS shoulder. 6'X6' concrete distribution box and filter plant on LS toe. 2-inch galvanized iron electrical conduit at same location. Originally included in the 1968 O&M manual. FS Date: 8/27/2013

Slide gate in CMP riser on WS shoulder.

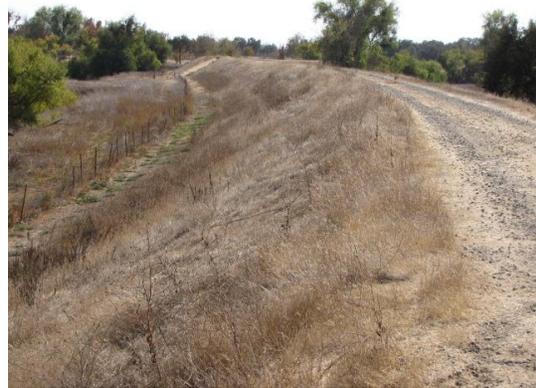
Photo 1 of 1 : phillips_s_20140306_789.JPG

LM Start	1.34	Rating **	U	Issue No.	31
LM End	3.54	Issue Type +	Ma	Location *	LS
Category	Earthen Levee		GPS Latitude/Longitude		
			Start	End	
Item	Vegetation		37.694665 °	37.676964 °	
			-121.269783 °	-121.264281 °	
DWR ID	DWR_RD2064_01_f_2013_31				
Action/Comments					
Control annual grass and weeds on the levee slopes and easements. Inspector Comments: Unwanted vegetation on the landward slope needs to be removed.

RD 2064 Landside slope levee mile 1.31 looking downstream. Photo taken 10-25-2013. No new photo taken 03-25-2014.

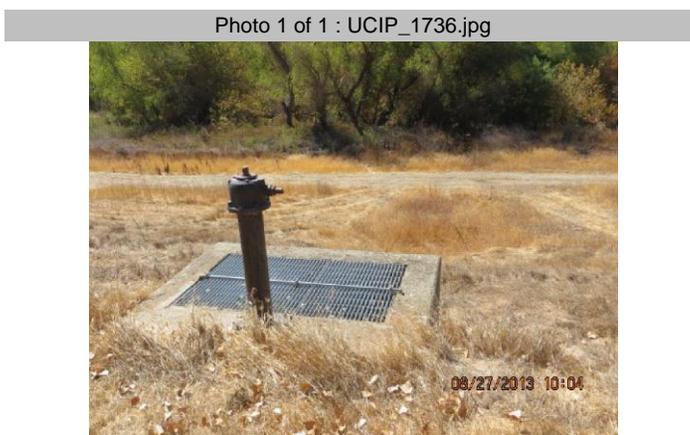
LM Start	2.00	Rating **	M	Issue No.	16
LM End	2.00	Issue Type +	En	Location *	WS
Category	Supplemental		GPS Latitude/Longitude		
			Start	End	
Item	DWR UCIP Field Study		37.689899 °	37.689899 °	
			-121.264802 °	-121.264802 °	
DWR ID	DWR_RD2064_01_s_2014_16				
Action/Comments					
Inspector Comments: FS_ID:18763 EP_NO: N/A Repair Type: Crossing Status: UCIP Comments: Culvert filled nearly to the top with soil. FIELD_STRUCT_DESC: 30-inch square reinforced concrete stormdrain box culvert through the levee 14.7-feet below the crown. Slide gate in concrete riser unit on the waterward slope. Concrete "U" shaped headwalls on both ends. Flap gate on the waterward end. Originally included in the 1968 O&M manual. FS Date: 8/27/2013

Slide gate in Concrete riser on WS shoulder.

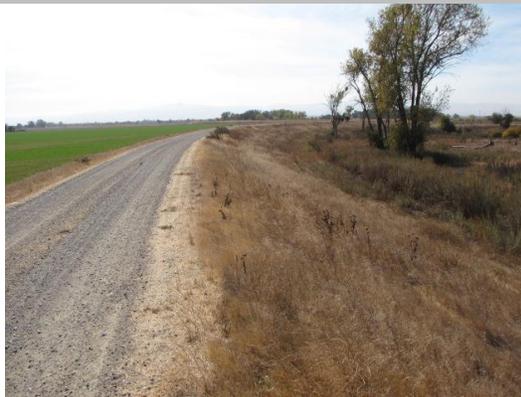
Photo 1 of 1 : phillips_s_20140604_06038.jpg

LM Start	2.48	Rating **	U	Issue No.	37
LM End	5.67	Issue Type +	Ma	Location *	WS
Category	Earthen Levee		GPS Latitude/Longitude		
			Start	End	
Item	Vegetation		37.687738 °	37.667578 °	
			-121.256947 °	-121.241159 °	
DWR ID	DWR_RD2064_01_s_2014_37				
Action/Comments					
Control annual grass and weeds on the levee slopes and easements.

Levee mile 2.48 waterside looking downstream. No new photo taken 03-25-2014.

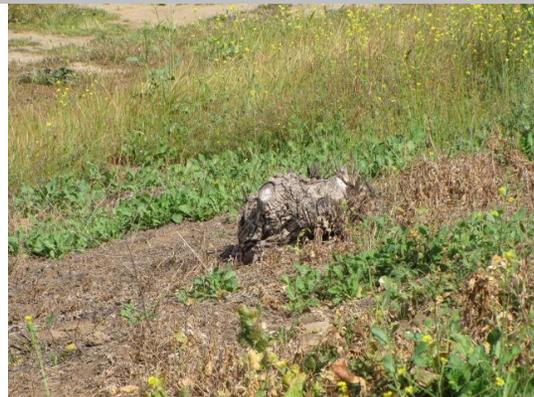
Photo 1 of 1 : phillips_s_20140306_775.jpg

LM Start	3.55	Rating **	N	Issue No.	2
LM End	3.55	Issue Type +	Ma	Location *	LS
Category	Earthen Levee		GPS Latitude/Longitude		
			Start	End	
Item	Trim / Thin Trees		37.676801 °	37.676801 °	
			-121.264203 °	-121.264203 °	
DWR ID	DWR_RD2064_01_s_2012_2				
Action/Comments					
Tree stumps.

View of a tree stump.

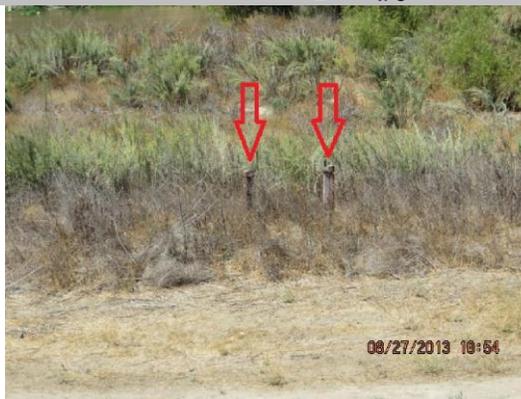
Photo 1 of 1 : UCIP_3063.jpg

LM Start	3.55	Rating **	M	Issue No.	17
LM End	3.55	Issue Type +	En	Location *	LS
Category	Supplemental		GPS Latitude/Longitude		
			Start	End	
Item	DWR UCIP Field Study		37.676750 °	37.676750 °	
			-121.264193 °	-121.264193 °	
DWR ID	DWR_RD2064_01_s_2014_17				
Action/Comments					
Inspector Comments: FS_ID:22731 EP_NO: N/A Repair Type: Crossing Status: UCIP Comments: Neet to verify status of pipeline. FIELD_STRUCT_DESC: Underground gas line crossing; depth through the levee and size unknown. Found possible sign posts on WS toe. FS Date: 8/27/2013

Possible sign posts on WS toe.

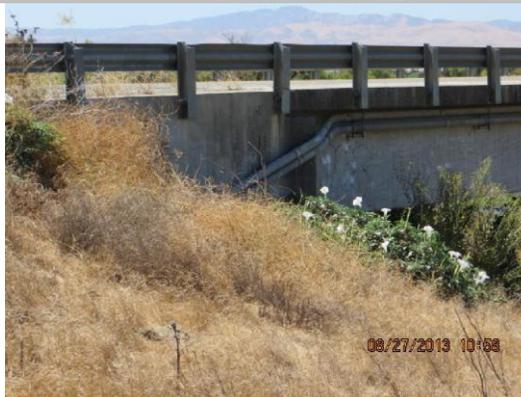
Photo 1 of 1 : UCIP_3220.jpg

LM Start	3.59	Rating **	M	Issue No.	19
LM End	3.59	Issue Type +	En	Location *	LS
Category	Supplemental			GPS Latitude/Longitude	
				Start	End
Item	DWR UCIP Field Study			37.676276 °	37.676276 °
				-121.264104 °	-121.264104 °
DWR ID	DWR_RD2064_01_s_2014_19				
Action/Comments					
Inspector Comments: FS_ID:22790 EP_NO: N/A Repair Type: Crossing Status: UCIP Comments: Unable to identify purpose or permit for this crossing. FIELD_STRUCT_DESC: 2 of 2: 4-inch galvanized iron conduit through the levee at unknown depth below the crown. Visible on downstream side of the bridge. 3.5-foot by 6-foot steel vault on crown. FS Date: 8/27/2013

Lower conduit visible on DS side of bridge at WS slope.

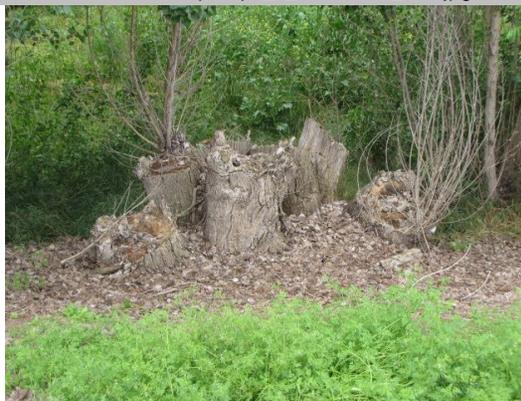
Photo 1 of 1 : phillips_s_20140306_776.jpg

LM Start	3.66	Rating **	N	Issue No.	3
LM End	3.66	Issue Type +	Ma	Location *	LS
Category	Earthen Levee			GPS Latitude/Longitude	
				Start	End
Item	Trim / Thin Trees			37.675379 °	37.675379 °
				-121.263555 °	-121.263555 °
DWR ID	DWR_RD2064_01_s_2012_3				
Action/Comments					
Tree stumps.

View of tree stumps.

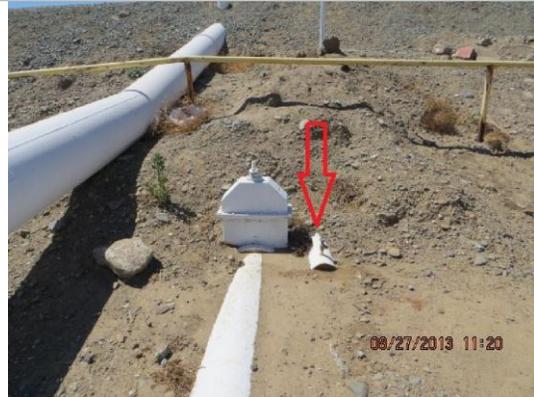
Photo 1 of 1 : UCIP_3064.jpg

LM Start	3.67	Rating **	M	Issue No.	20
LM End	3.67	Issue Type +	En	Location *	LS
Category	Supplemental			GPS Latitude/Longitude	
				Start	End
Item	DWR UCIP Field Study			37.675266 °	37.675266 °
				-121.263421 °	-121.263421 °
DWR ID	DWR_RD2064_01_s_2014_20				
Action/Comments					
Inspector Comments: FS_ID:22732 EP_NO: N/A Repair Type: Crossing Status: UCIP Comments: Need to determine if pipe was actually removed from levee. FIELD_STRUCT_DESC: 12-inch steel stormdrain pipe through the levee at unknown depth below the crown. Steel plate welded over LS end at LS toe. Permit No. 6450, states it was removed in 1973, but it remains visible on the LS toe. Originally included in the 1968 O&M manual. FS Date: 8/27/2013

Pipe with welded steel plate over LS end at LS toe.

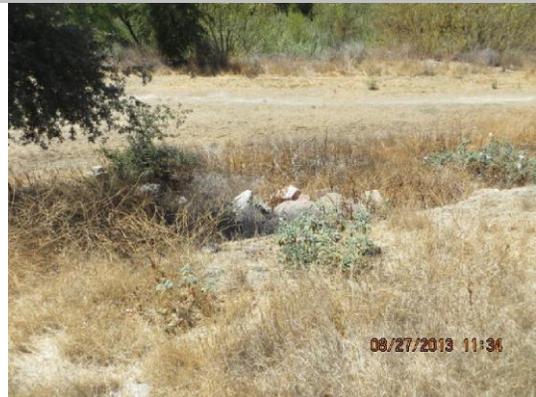
Photo 1 of 1 : UCIP_1751.jpg

LM Start	3.70	Rating **	M	Issue No.	23
LM End	3.70	Issue Type +	En	Location *	LS
Category	Supplemental			GPS Latitude/Longitude	
				Start	End
Item	DWR UCIP Field Study			37.675005 °	37.675005 °
				-121.263103 °	-121.263103 °
DWR ID	DWR_RD2064_01_s_2014_23				
Action/Comments					
Inspector Comments: FS_ID:19046 EP_NO: 13609 Repair Type: Crossing Status: UCIP Comments: Pipes should be abandoned properly. FIELD_STRUCT_DESC: 2 of 2: *Removed* 24-inch steel pipe through levee 12.67 feet below crown (Permit No. 13609, 1983). Approx. 75 feet upstream of first 24-inch pipe. According to notes in permit, Concrete rubble was placed over pipe on WS slope. FS Date: 8/27/2013

Concrete rubble on WS slope possible indicator of abandoned pipe location.

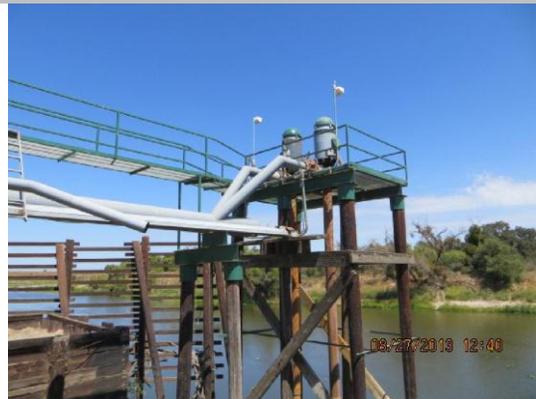
Photo 1 of 1 : UCIP_1754.jpg

LM Start	4.84	Rating **	M	Issue No.	24
LM End	4.84	Issue Type +	En	Location *	LS
Category	Supplemental		GPS Latitude/Longitude		
			Start	End	
Item	DWR UCIP Field Study		37.670160 °	37.670160 °	
			-121.246972 °	-121.246972 °	
DWR ID	DWR_RD2064_01_s_2014_24				
Action/Comments					
Inspector Comments: FS_ID:19064 EP_NO: 3359 Repair Type: Crossing Status: UCIP Comments: Pipe not found. Need to determine disposition of pipe as all other appurtances remain. FIELD_STRUCT_DESC: 2 of 2: 18-inch pipe through levee 3.5 feet below the crown (Permit No. 3359, 1961). Pump mounted on pipe structure in the river; protective fender in the stream, wooden walkway to the pump structure. Siphon breaker on the landward side. Originally included in the 1968 O&M manual. FS Date: 8/27/2013

Pump platform and fender visible on WS toe.

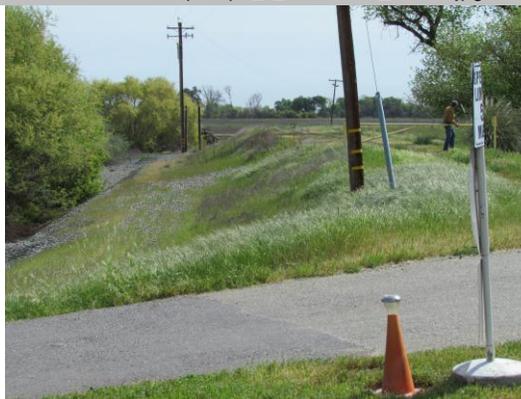
Photo 1 of 1 : phillips_s_20140604_06039.jpg

LM Start	0.00	Rating **	M	Issue No.	230
LM End	0.00	Issue Type +	Ma	Location *	LS
Category	Earthen Levee			GPS Latitude/Longitude	
				Start	End
Item	Vegetation			37.667068 °	37.667068 °
				-121.240900 °	-121.240900 °
DWR ID	DWR_RD2064_02_s_2014_230				
Action/Comments					
Control annual grass and weeds on the levee slopes and easements.

Looking downstream from landside shoulder downstream at Unit 2, RD 2064. Photo taken 03-25-2014.

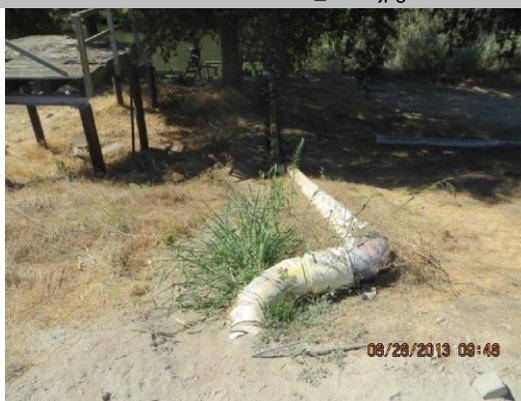
Photo 1 of 1 : UCIP_2840.jpg

LM Start	0.34	Rating **	M	Issue No.	1
LM End	0.34	Issue Type +	En	Location *	LS
Category	Supplemental			GPS Latitude/Longitude	
				Start	End
Item	DWR UCIP Field Study			37.664752 °	37.664752 °
				-121.236512 °	-121.236512 °
DWR ID	DWR_RD2064_02_s_2014_1				
Action/Comments					
Inspector Comments: FS_ID:22092 EP_NO: N/A Repair Type: Crossing Status: UCIP Comments: No permit identified for large PVC irrigation pipe with inadequate cover. FIELD_STRUCT_DESC: 8-inch PVC irrigation pipe through the levee 0.5-feet below the crown. Portable pump on the WS berm and a filter plant on the LS toe. Vent at filter plant on LS toe. FS Date: 8/27/2013

Pipe visible on WS shoulder/slope.

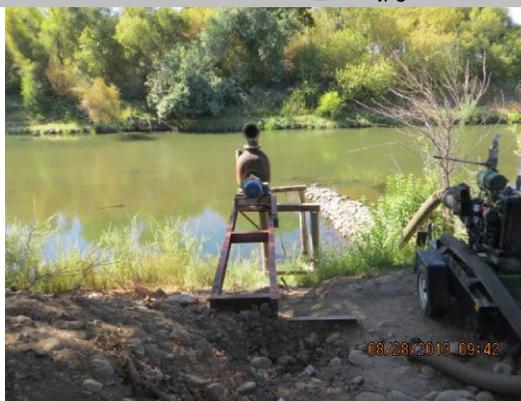
Photo 1 of 1 : UCIP_1766.jpg

LM Start	0.34	Rating **	M	Issue No.	3
LM End	0.34	Issue Type +	En	Location *	CR
Category	Supplemental			GPS Latitude/Longitude	
				Start	End
Item	DWR UCIP Field Study			37.664740 °	37.664740 °
				-121.236474 °	-121.236474 °
DWR ID	DWR_RD2064_02_s_2014_3				
Action/Comments					
Inspector Comments: FS_ID:19073 EP_NO: 4462 Repair Type: Crossing Status: UCIP Comments: Pipe failing on LS toe do to excessive rust. Pump missing from deteriorating wooden platform on LS slope. Pipe crossing being repaired at site. FIELD_STRUCT_DESC: 16-inch steel irrigation pipe through the levee 3.5-feet below the crown. Slant pump on the WS bank. Siphon breaker on the landward shoulder. Timber walkway from the levee slope to the pump motor (Permit No. 4462, 1964). Originally included in the 1968 O&M manual. 2-inch electrical conduit at same location. FS Date: 8/28/2013

New pump being installed on WS to.

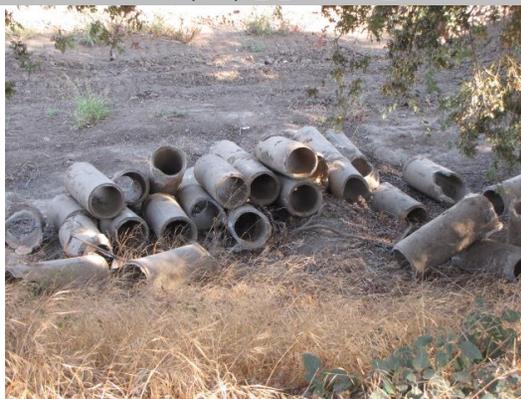
Photo 1 of 1 : phillips_s_20140306_031.JPG

LM Start	0.44	Rating **	U	Issue No.	13
LM End	0.44	Issue Type +	En	Location *	LS
Category	Earthen Levee		GPS Latitude/Longitude		
			Start	End	
Item	Encroachments		37.663920 °	37.663920 °	
			-121.234854 °	-121.234854 °	
DWR ID	DWR_RD2064_02_f_2013_13				
Action/Comments					
Pipe Inspector Comments: Concrete pipe on landside toe.

Unauthorized encroachment on landside within 10-foot of toe. Photo taken 10-30-2013. No new photo was taken, issue not removed 03-25-2014.

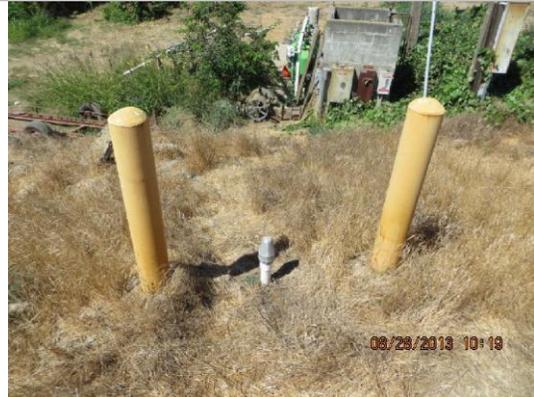
Photo 1 of 1 : UCIP_2847.jpg

LM Start	2.01	Rating **	M	Issue No.	4
LM End	2.01	Issue Type +	En	Location *	LS
Category	Supplemental			GPS Latitude/Longitude	
				Start	End
Item	DWR UCIP Field Study			37.676454 °	37.676454 °
				-121.223204 °	-121.223204 °
DWR ID	DWR_RD2064_02_s_2014_4				
Action/Comments					
Inspector Comments: FS_ID:22095 EP_NO: N/A Repair Type: Crossing Status: UCIP Comments: No permit identified for this crossing. FIELD_STRUCT_DESC: 6-inch steel irrigation pipe through the levee at unknown depth below the crown. Pump on wooden pier at WS . Vent between 2 steel bollards on LS shoulder. Filter plant on LS toe. 1.5-inch galvanized iron electrical conduit at same location. FS Date: 8/27/2013

Vent on LS shoulder.

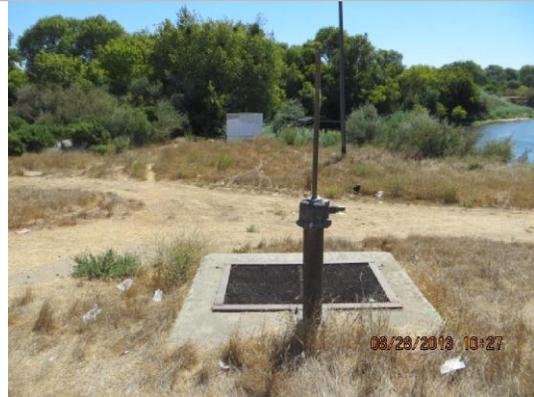
Photo 1 of 1 : UCIP_1770.jpg

LM Start	2.58	Rating **	M	Issue No.	5
LM End	2.58	Issue Type +	En	Location *	WS
Category	Supplemental			GPS Latitude/Longitude	
				Start	End
Item	DWR UCIP Field Study			37.684148 °	37.684148 °
				-121.223599 °	-121.223599 °
DWR ID	DWR_RD2064_02_s_2014_5				
Action/Comments					
Inspector Comments: FS_ID:19086 EP_NO: N/A Repair Type: Crossing Status: UCIP Comments: Leak next to roadway may indicate pipe has reached life capacity-good candidate for video inspection. FIELD_STRUCT_DESC: 30-inch reinforced concrete box culvert through the levee 14.5-feet below the crown. Pipe reduced to 24-inch through the berm to pump house. Slide gate in 6'X7' concrete riser unit on the waterward slope. Slant pump mounted on WS berm next to 5'X9' concrete riser. 1.5-inch electrical conduit at same location. Originally included in the 1968 O&M manual. FS Date: 8/28/2013

Gate valve on WS shoulder. Pump next to concrete riser in background.

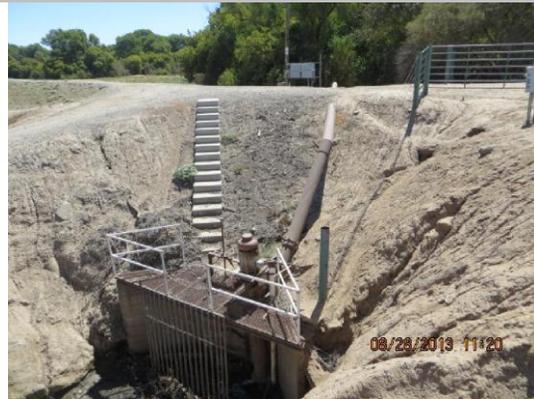
Photo 1 of 1 : UCIP_2855.jpg

LM Start	4.32	Rating **	M	Issue No.	224
LM End	4.32	Issue Type +	En	Location *	LS
Category	Supplemental			GPS Latitude/Longitude	
				Start	End
Item	DWR UCIP Field Study			37.695745 °	37.695745 °
				-121.205865 °	-121.205865 °
DWR ID	DWR_RD2064_02_s_2014_224				
Action/Comments					
Inspector Comments: FS_ID:22107 EP_NO: N/A Repair Type: Crossing Status: UCIP Comments: Pipe does not have adequate cover at crown. FIELD_STRUCT_DESC: 12-inch steel discharge pipe through the levee 0.5-feet below the crown. Pump on concrete headwall at LS toe. Pipe discharges into 6'X7' concrete box on WS shoulder. FS Date: 8/28/2013

Pump for pipe on concrete headwall at LS toe.

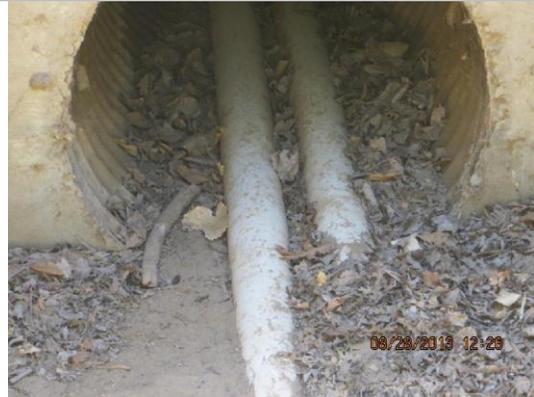
Photo 1 of 1 : UCIP_2860.jpg

LM Start	5.01	Rating **	M	Issue No.	225
LM End	5.01	Issue Type +	En	Location *	LS
Category	Supplemental			GPS Latitude/Longitude	
				Start	End
Item	DWR UCIP Field Study			37.696146 °	37.696146 °
				-121.194093 °	-121.194093 °
DWR ID	DWR_RD2064_02_s_2014_225				
Action/Comments					
Inspector Comments: FS_ID:22109 EP_NO: N/A Repair Type: Crossing Status: UCIP Comments: No permit identified for this crossing. FIELD_STRUCT_DESC: 2 of 2: 4-inch PVC discharge pipe through the 30-inch stormdrain pipe 11-feet below the crown. No permit. FS Date: 8/28/2013

PVC conduit at left on LS toe.

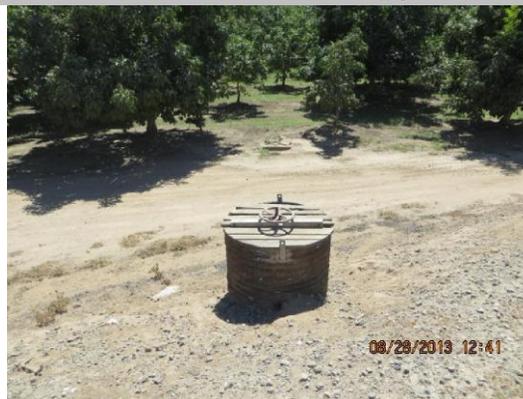
Photo 1 of 1 : UCIP_1798.jpg

Slide gate in CMP riser on WS slope

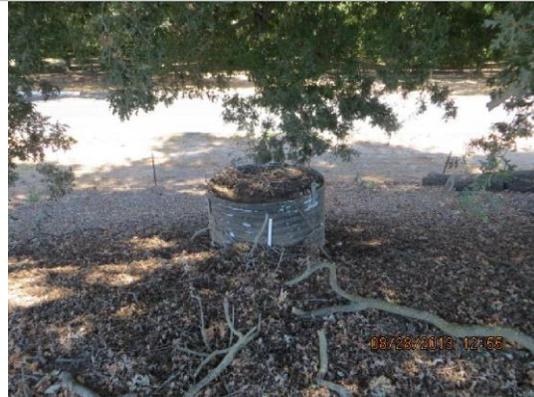
Photo 1 of 1 : UCIP_1799.jpg

CMP riser for slide gate filled with soil.
