**Flood Control Project Maintenance  
Levee Inspections**

## Maintenance Issue Types Only, Levee Inspection Report By Mile - Fall 2014

### Reclamation District No. 2064 River Junction

Waterway	Bank	Unit Miles	Inspection Start/End	Inspector
Unit No. 01 San Joaquin River	Right	5.56	10/28/2014 10/28/2014	Herman Phillips

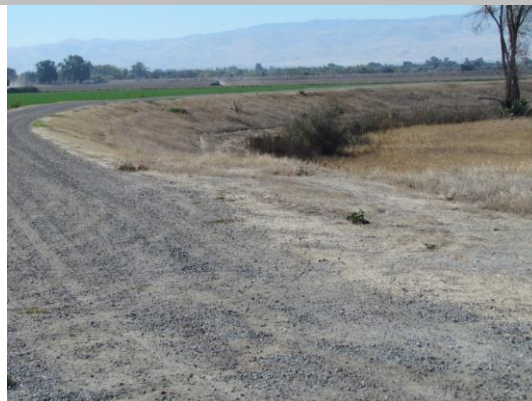
Photo 1 of 1 : FA\_2014\_RD2064\_313\_2\_20141104\_00001.jpg

LM Start	0.09	Rating **	A	Issue No.	2
LM End	5.70	Issue Type +	Ma	Location *	WS
Category	Earthen Levee			GPS Latitude/Longitude	
				Start	End
Item	Vegetation			37.709528 °	37.667195 °
				-121.267532 °	-121.241052 °
DWR ID	DWR_RD2064_01_f_2014_2				
Action/Comments					
Control annual grass and weeds on the levee slopes and easements. Inspector Comments: RD 2064 has mowed the slopes and sprayed for wild weeds.

Looking downstream from waterside slope levee mile 0.09.

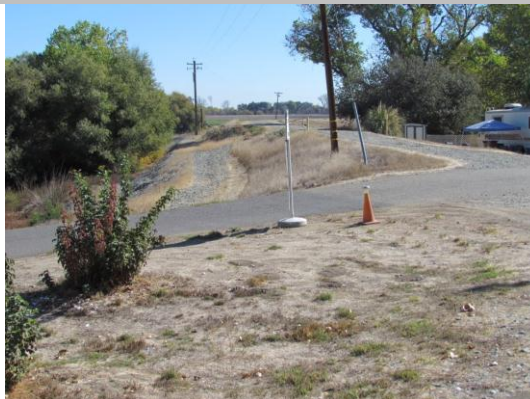
Photo 1 of 1 : FA\_2014\_RD2064\_314\_2\_20141104\_00015.jpg

LM Start	0.00	Rating **	M	Issue No.	2
LM End	6.20	Issue Type +	Ma	Location *	WS
Category	Earthen Levee			GPS Latitude/Longitude	
				Start	End
Item	Vegetation			37.667068 °	37.704049 °
				-121.240899 °	-121.181042 °
DWR ID	DWR_RD2064_02_s_2012_2				
Action/Comments					
Control annual grass and weeds on the levee slopes and easements.

Looking downstream from levee mile 0.00 at the landside slope.
