**Flood Control Project Maintenance  
Levee Inspections**

## Maintenance Issue Types Only, Levee Inspection Report By Mile - Fall 2015

### Reclamation District No. 2064 River Junction

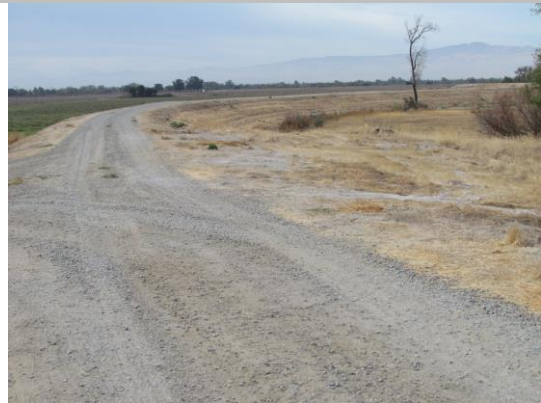
Photo 1 of 1 : FA\_2015\_RD2064\_313\_22\_20151001\_00009.jpg

LM Start	0.07	Rating **	A	Issue No.	22
LM End	1.49	Issue Type +	Ma	Location *	WS
Category	Earthen Levee			GPS Latitude/Longitude	
				Start	End
Item	Vegetation			37.709545 °	37.691882 °
				-121.267527 °	-121.269553 °
DWR ID	DWR_RD2064_01_f_2015_22				
Action/Comments					
Control annual grass and weeds on the levee slopes and easements. Inspector Comments: No unwanted weeds at this location.

Looking downstream from levee mile 0.07 district has mowed the slope to levee mile 1.49.

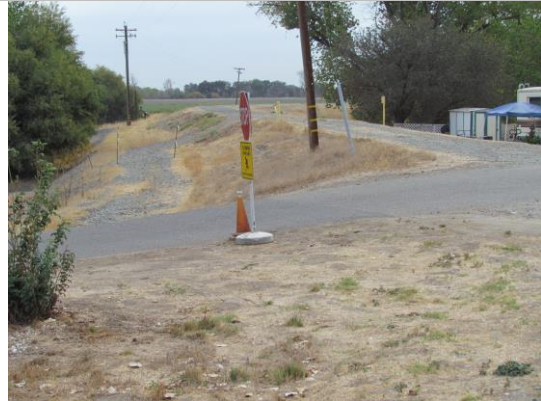
Photo 1 of 1 : FA\_2015\_RD2064\_314\_17\_20151006\_00013.jpg

LM Start	0.05	Rating **	M	Issue No.	17
LM End	2.00	Issue Type +	Ma	Location *	WS
Category	Earthen Levee			GPS Latitude/Longitude	
				Start	End
Item	Vegetation			37.666865 °	37.676955 °
				-121.240122 °	-121.223248 °
DWR ID	DWR_RD2064_02_f_2015_17				
Action/Comments					
Control annual grass and weeds on the levee slopes and easements.

RD 2064 Looking downstream from levee mile 0.05 landside slope.
