**Flood Control Project Maintenance
Levee Inspections**

Maintenance Issue Types Only, Levee Inspection Report By Mile - Fall 2016

Reclamation District No. 2064 River Junction

Waterway	Bank	Unit Miles	Inspection Start/End	Inspector
Unit No. 01 San Joaquin River	Right	5.56	09/19/2016 09/19/2016	Herman Phillips

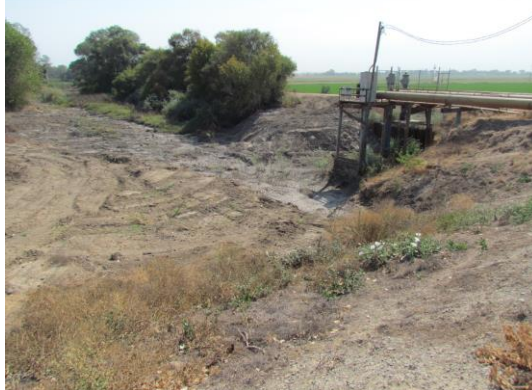
Photo 1 of 1 : FA_2016_RD2064_313_19_20161102_00036.jpg

LM Start	0.04	Rating **	A	Issue No.	19
LM End	5.55	Issue Type +	Ma	Location *	LS
Category	Earthen Levee			GPS Latitude/Longitude	
				Start	End
Item	Vegetation			37.709986 °	37.667210 °
				-121.267545 °	-121.241020 °
DWR ID	DWR_RD2064_01_f_2016_19				
Comment Code					
V1 : Control annual grass and weeds on the levee slopes and easements.					
Inspector Comment

RD 2064 Looking downstream from levee mile 0.04 Unit 1 landside.
