**Flood Control Project Maintenance
Levee Inspections**

Maintenance Issue Types Only, Levee Inspection Report By Mile - Fall 2017

Reclamation District No. 2064 River Junction

Waterway	Bank	Unit Miles	Inspection Start/End	Inspector
Unit No. 01 San Joaquin River	Right	5.56	10/12/2017 10/12/2017	Keith Millard

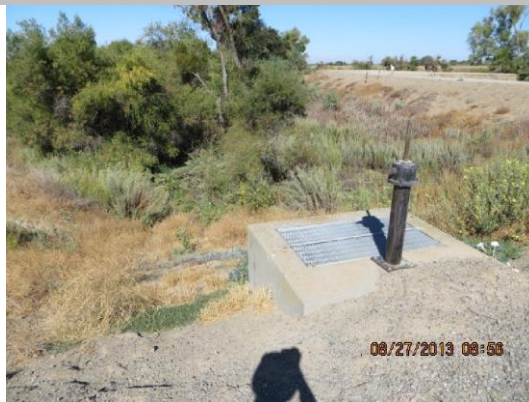
Photo 1 of 3 : UCIP_FA_2017_43603_31258.jpg

LM Start	0.06	Rating **	A/W	Issue No.	31
LM End	0.06	Issue Type +	Ma	Location *	
Category	Supplemental		GPS Latitude/Longitude		
			Start	End	
Item	DWR UCIP LMA Responsibility		37.709804 °	37.709804 °	
			-121.267559 °	-121.267559 °	
DWR ID					
Comment Code					
Inspector Comment					
FS_ID:43603 DS_ID:20511 EP_NO: N/A Repair Type: No Action Needed Crossing Status: Found UCIP Comments: Debris removed from flap gate on waterside tow FIELD_STRUCT_DESC: 36-inch by 36-inch reinforced concrete box drainage culvert through the levee, 21 feet below the crown. Concrete U-shaped headwalls on both ends. Slide gate in a 6-foot by 7-foot concrete riser on the waterside (WS) slope. Flap gate on the WS end. Flashboard slots on the landside (LS) headwall. [Additional Reference(s): DWR Levee Log, 2005. USACE San Joaquin O&M Manual 3, December 1968, (HLM 0.07)]. FS Date: 3/2/2015

Slide gate in concrete riser on WS shoulder.

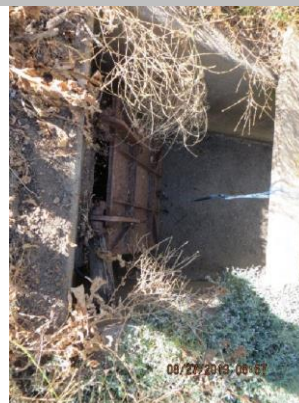
Photo 2 of 3 : UCIP_FA_2017_43603_31257.jpg

Comment Code						
Inspector Comment						
FS_ID:43603						
DS_ID:20511						
EP_NO: N/A						
Repair Type: No Action Needed						
Crossing Status: Found						
UCIP Comments: Debri removed from flap gate on waterside tow						
FIELD_STRUCT_DESC: 36-inch by 36-inch reinforced concrete box						
drainage culvert through the levee, 21 feet below the crown. Concrete U-						
shaped headwalls on both ends. Slide gate in a 6-foot by 7-foot						
concrete riser on the waterside (WS) slope. Flap gate on the WS end.						
Flashboard slots on the landside (LS) headwall. [Additional						
Reference(s): DWR Levee Log, 2005. USACE San Joaquin O&M						
Manual 3, December 1968, (HLM 0.07)].						
FS Date: 3/2/2015

Flap gate and U shaped headwall on WS toe. Debris blocking closure of gate.

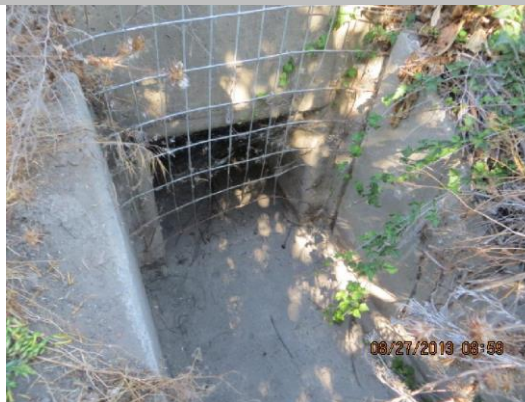
Photo 3 of 3 : UCIP_FA_2017_43603_31256.jpg

Concrete headwall at inlet on LS toe.

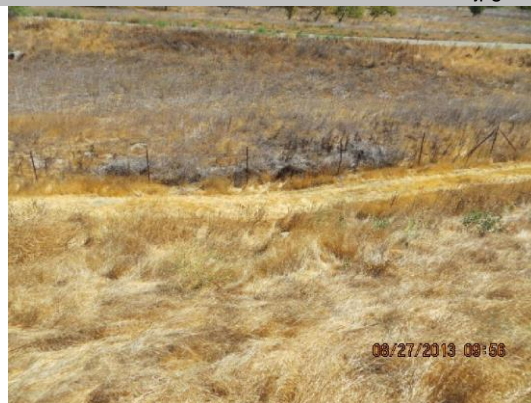
Photo 1 of 3 : UCIP_FA_2017_18748_31380.jpg

LM Start	1.65	Rating **	A/W	Issue No.	37
LM End	1.65	Issue Type +	Ma	Location *	
Category	Supplemental			GPS Latitude/Longitude	
				Start	End
Item	DWR UCIP LMA Responsibility			37.690072 °	37.690072 °
				-121.269823 °	-121.269823 °
DWR ID					
Comment Code					
Inspector Comment					
FS_ID:18748 DS_ID:20514 EP_NO: N/A Repair Type: No Action Needed Crossing Status: Found UCIP Comments: FIELD_STRUCT_DESC: 30-inch by 30-inch reinforced concrete box drainage culvert through the levee, 15 feet below the crown. Slide gate in a concrete riser on the waterside (WS) shoulder. Concrete U-shaped headwalls on both ends. Flap gate on the WS end. [Additional Reference(s): DWR Levee Log, 2005. USACE San Joaquin O&M Manual 3, December 1968, (HLM 1.65)]. FS Date: 8/27/2013

Concrete headwall on LS toe.

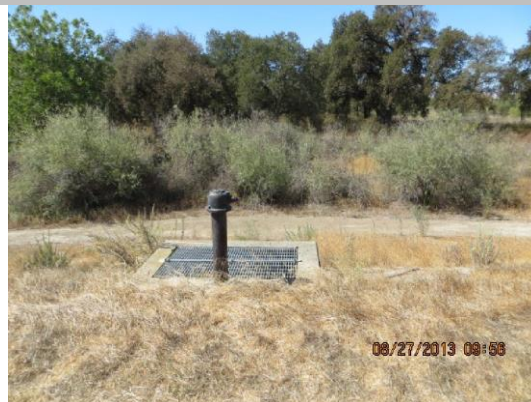
Photo 2 of 3 : UCIP_FA_2017_18748_31379.jpg

Slide gate in concrete vault on WS shoulder.

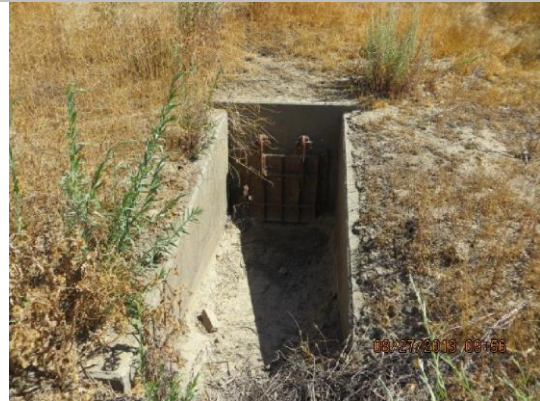
Photo 3 of 3 : UCIP_FA_2017_18748_31378.jpg

Flap gate on WS toe.

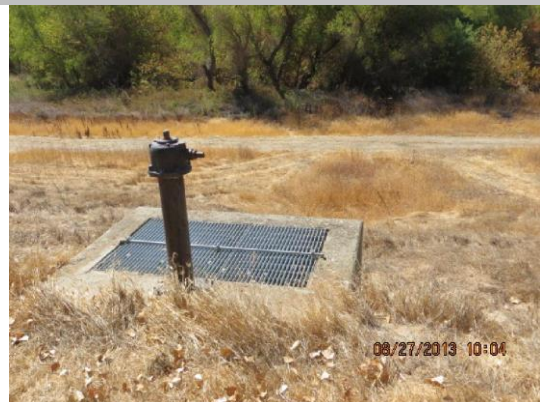
Photo 1 of 3 : UCIP_FA_2017_18763_31402.jpg

LM Start	1.94	Rating **	M	Issue No.	38
LM End	1.94	Issue Type +	Ma	Location *	
Category	Supplemental			GPS Latitude/Longitude	
				Start	End
Item	DWR UCIP LMA Responsibility			37.689900 °	37.689900 °
				-121.264802 °	-121.264802 °
DWR ID					
Comment Code					
Inspector Comment					
FS_ID:18763 DS_ID:20515 EP_NO: N/A Repair Type: Non-Urgent Crossing Status: Found UCIP Comments: Culvert filled nearly to the top with soil. FIELD_STRUCT_DESC: 30-inch by 30-inch reinforced concrete box drainage culvert through the levee, 14.7 feet below the crown. Slide gate in a concrete riser on the waterside (WS) slope. Concrete U-shaped headwalls on both ends. Flap gate on the WS end. [Additional Reference(s): DWR Levee Log, 2005. USACE San Joaquin O&M Manual 3, December 1968, (HLM 1.93)]. FS Date: 8/27/2013

Slide gate in Concrete riser on WS shoulder.

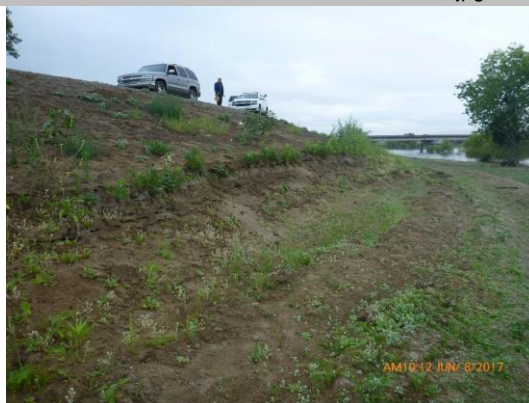
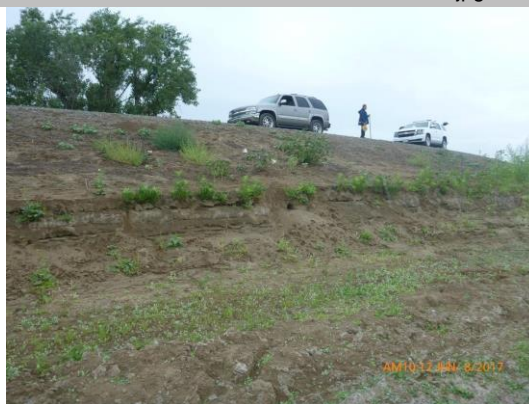
Notes: minor erosion on ws, not within levee prism, no action required

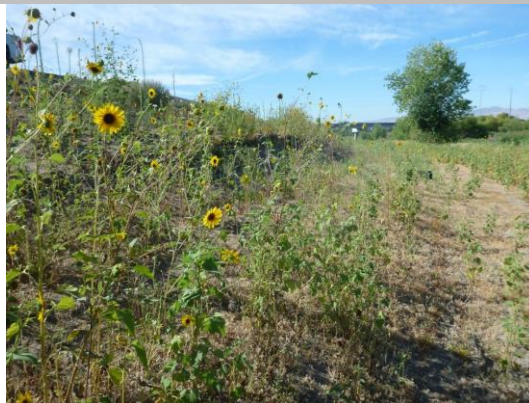
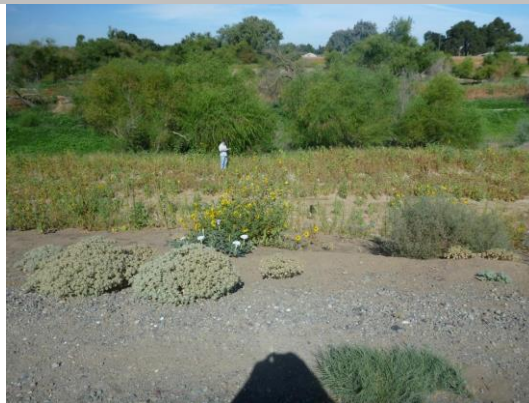
LM Start	3.26	Rating **	A/W	Issue No.	22 (cont)
LM End	3.39	Issue Type +	Ma	Location *	
Category	Supplemental			GPS Latitude/Longitude	
				Start	End
Item	2017 Storm Damage			37.679100°	37.677800°
				-121.262600°	-121.264400°
DWR ID	DWR_RD2064_01_f_2017_22				
Comment Code					
Inspector Comment					
Levee Evaluation Comments					
Description:Erosion from high water flows caused erosion scarps from 12" to 30" in height. The area of damage is approximately 400 feet in length.					
Site ID No:582					
Site Designation:LMA-488					
Repair Type: Erosion					
Rating:Serious					
Field Date:8/14/2017					
Notes:

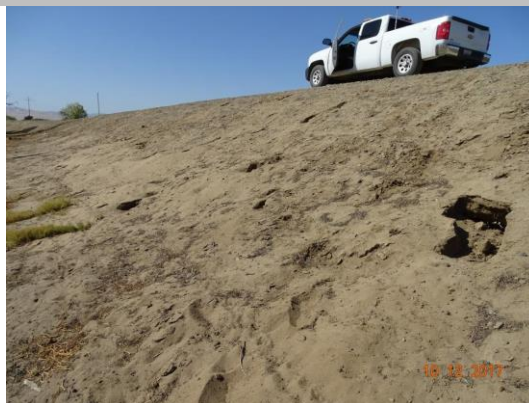
Photo 1 of 1 : FA_2017_RD2064_313_10_20171020_00075.jpg

LM Start	3.31	Rating **	M	Issue No.	10
LM End	3.45	Issue Type +	Ma	Location *	LS
Category	Earthen Levee			GPS Latitude/Longitude	
				Start	End
Item	Animal Control			37.678708 °	37.676786 °
				-121.263415 °	-121.264207 °
DWR ID	DWR_RD2064_01_f_2017_10				
Comment Code					
A1 : Exterminate rodents and backfill and compact or grout burrows.					
Inspector Comment					
Bait traps in place, but increased measures may be needed.

Rodent activity on landside at LM 3.34.

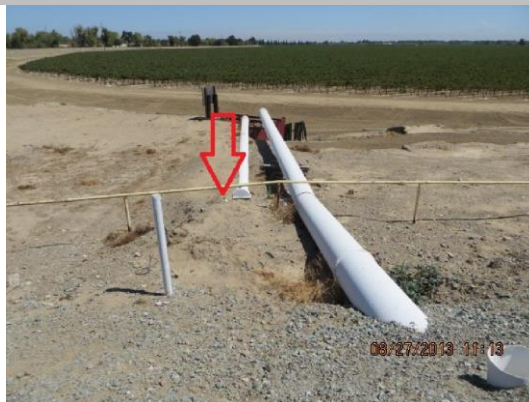
Photo 1 of 2 : UCIP_FA_2017_22732_38465.jpg

LM Start	3.57	Rating **	M	Issue No.	43	
LM End	3.57	Issue Type +	Ma	Location *		
Category	Supplemental			GPS Latitude/Longitude		
				Start		End
Item	DWR UCIP LMA Responsibility			37.675266 °	37.675266 °	
				-121.263421 °	-121.263421 °	
DWR ID						
Comment Code						
Inspector Comment						
FS_ID:22732						
DS_ID:20525						
EP_NO: N/A						
Repair Type: Non-Urgent						
Crossing Status: Found						
UCIP Comments: Need to determine if pipe was actually removed from levee.						
FIELD_STRUCT_DESC: 12-inch steel drainage pipe through the levee, at an unknown depth. Steel plate welded over the landside (LS) end at the LS toe. (Permit No. 6450, 1969 - Reclamation District No. 2064, states it was removed in 1973, but it remains visible on the LS toe).						
[Additional Reference(s): USACE San Joaquin O&M Manual 3, December 1968, (HLM 3.55)].						
FS Date: 8/27/2013

Pipe visible on LS toe.

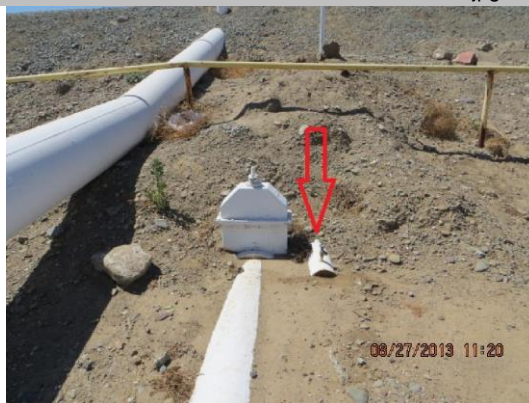
Photo 2 of 2 : UCIP_FA_2017_22732_38464.jpg

Pipe with welded steel plate over LS end at LS toe.

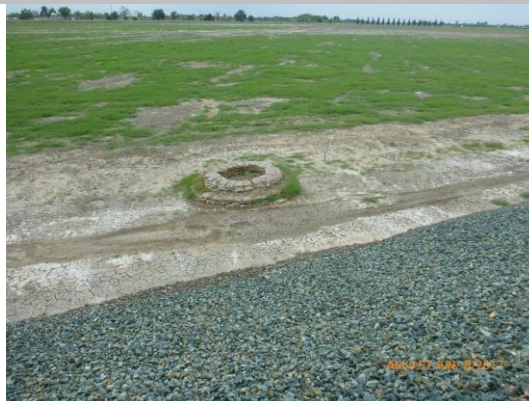
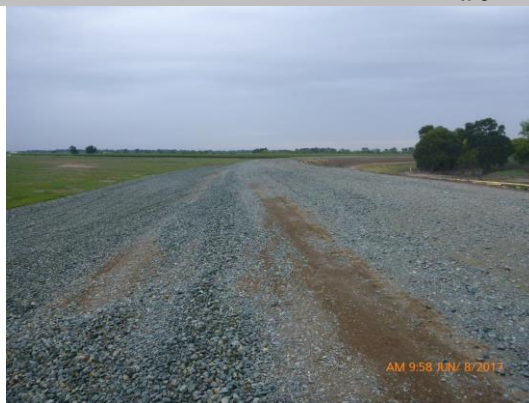
Notes: large stability berm present, built 3/17. historic seepage in area, boils present but running clean. 10/12/17: Rock berm mitigated the boils and instability. Site is now acceptable.

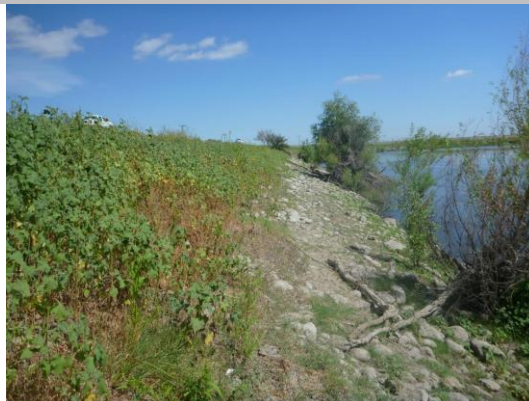
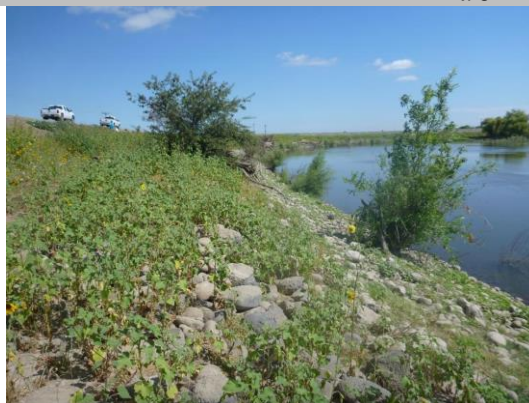
LM Start	4.82	Rating **	A/W	Issue No.	26 (cont)
LM End	4.85	Issue Type +	Ma	Location *	
Category	Supplemental			GPS Latitude/Longitude	
				Start	End
Item	2017 Storm Damage			37.671730 °	37.672140 °
				-121.246820 °	-121.246800 °
DWR ID	DWR_RD2064_01_f_2017_26				
Comment Code					
Inspector Comment					
Levee Evaluation Comments					
Description:Erosion from high water flows caused erosion scarps from 12" to 24" in height. The area of damage is approximately 600 feet in length.					
Site ID No:583					
Site Designation:LMA-489					
Repair Type: Erosion					
Rating:Area of Concern					
Field Date:8/14/2017					
Notes: Minor toe erosion

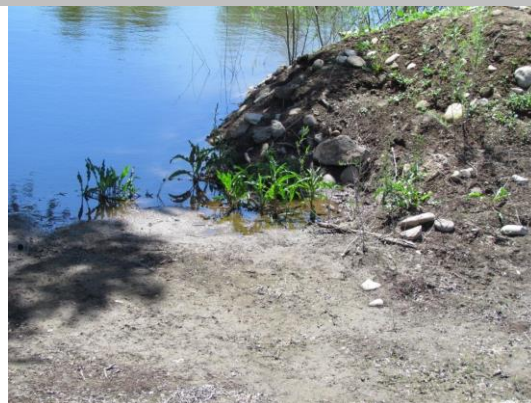
Photo 1 of 1 : FA_2017_RD2064_314_19_20171002_00002.jpg

LM Start	0.33	Rating **	M	Issue No.	19
LM End	0.33	Issue Type +	Ma	Location *	WS
Category	Earthen Levee			GPS Latitude/Longitude	
				Start	End
Item	Erosion / Bank Caving			37.664740 °	37.664740 °
				-121.236474 °	-121.236474 °
DWR ID	DWR_RD2064_02_s_2017_19				
Comment Code					
E1 : Note and monitor erosion site.					
Inspector Comment					
This levee berm was damaged by the farmer who leases the property at this location a pump was replaced and structure was removed from the channel. Mr. Mathew Of MOCO FARMS. 10/12/2017: Erosion on waterside bank is at least 15 feet from waterside toe.

Waterside berm at levee mile 0.33.

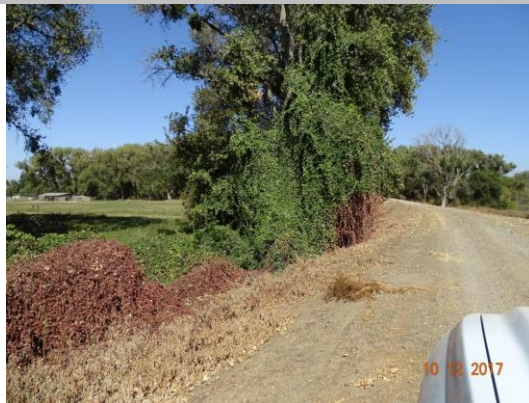
Photo 1 of 1 : FA_2017_RD2064_314_21_20171020_00068.jpg

LM Start	2.70	Rating **	M	Issue No.	21
LM End	2.76	Issue Type +	Ma	Location *	LS
Category	Earthen Levee			GPS Latitude/Longitude	
				Start	End
Item	Trim / Thin Trees			37.684271 °	37.684943 °
				-121.220939 °	-121.220247 °
DWR ID	DWR_RD2064_02_f_2017_21				
Comment Code					
T2 : Thin trees to allow visibility of the ground and room to flood fight.					
Inspector Comment					
Trim trees and remove vines to allow visibility and access to landside slope and toe.

Trim trees and remove vines to allow visibility and access to landside slope and toe.

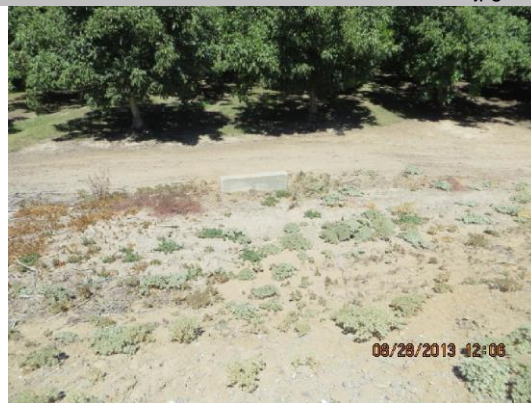
Photo 1 of 3 : UCIP_FA_2017_19117_32069.jpg

Headwall on LS toe.

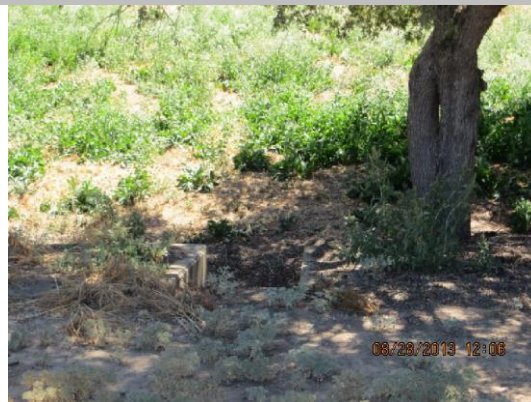
Photo 2 of 3 : UCIP_FA_2017_19117_32068.jpg

Headwall on WS toe.

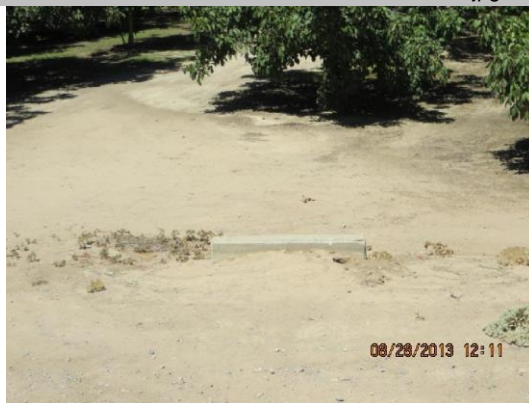
Photo 2 of 3 : UCIP_FA_2017_22793_38841.jpg

Concrete headwall on LS toe.

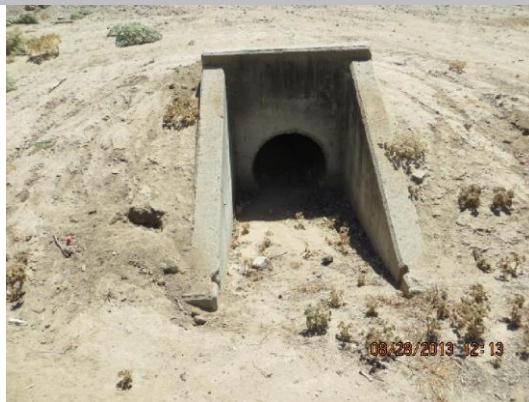
Photo 3 of 3 : UCIP_FA_2017_22793_38844.jpg

Concrete headwall on LS toe.

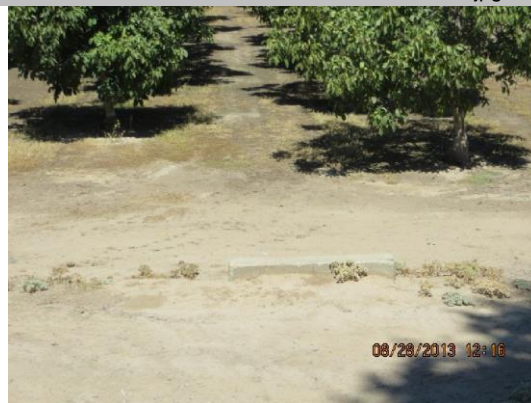
Photo 1 of 3 : UCIP_FA_2017_19120_32079.jpg

Concrete headwall on LS toe.

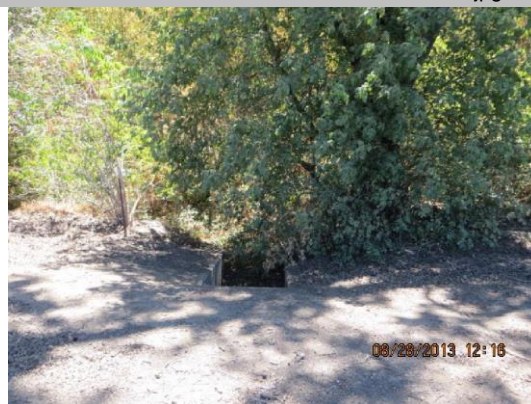
Photo 2 of 3 : UCIP_FA_2017_19120_32078.jpg

Concrete headwall on WS toe.

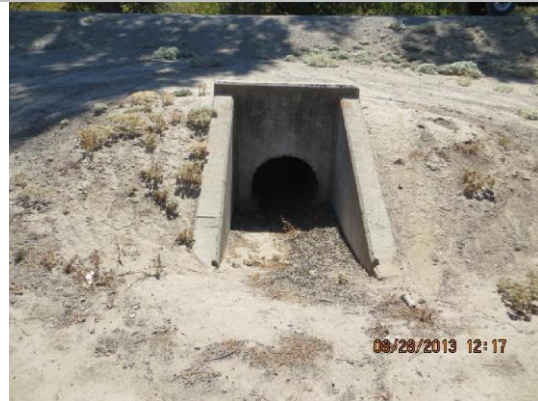
Photo 3 of 3 : UCIP_FA_2017_19120_32077.jpg

Concrete headwall on LS toe.

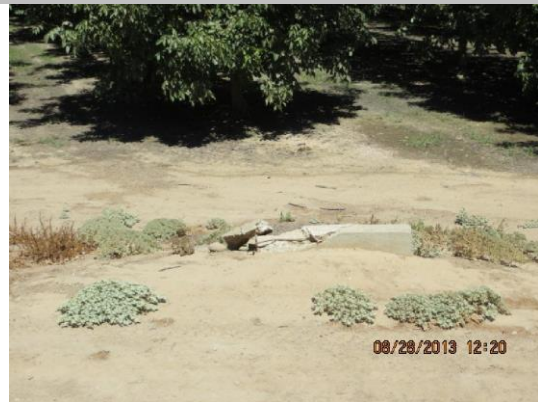
Photo 1 of 3 : UCIP_FA_2017_19122_32083.jpg

Concrete headwall on LS toe.

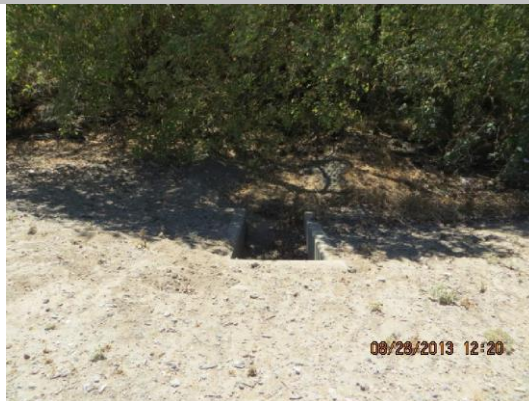
Photo 2 of 3 : UCIP_FA_2017_19122_32082.jpg

Concrete headwall on WS toe.

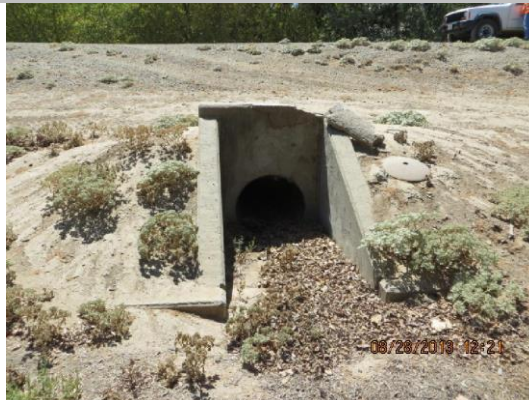
Photo 3 of 3 : UCIP_FA_2017_19122_32081.jpg

Concrete headwall on LS toe.

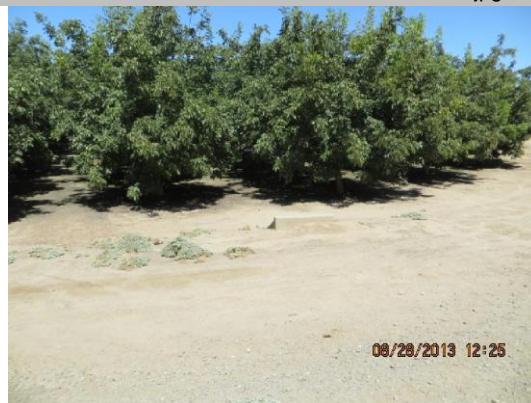
Photo 1 of 3 : UCIP_FA_2017_19143_32122.jpg

Concrete headwall on LS toe.

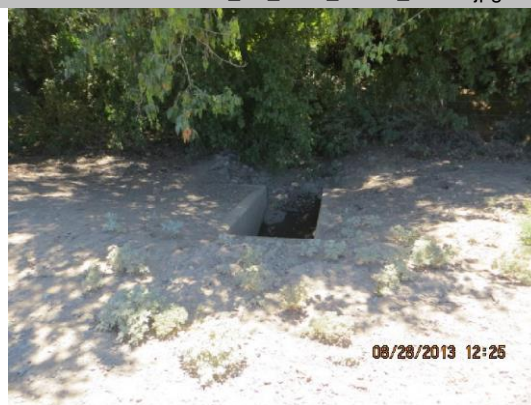
Photo 2 of 3 : UCIP_FA_2017_19143_32121.jpg

Concrete headwall on WS toe.

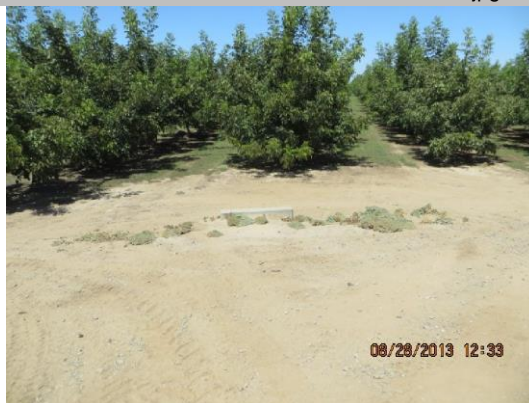
Photo 2 of 3 : UCIP_FA_2017_22794_38850.jpg

Concrete headwall on LS toe.

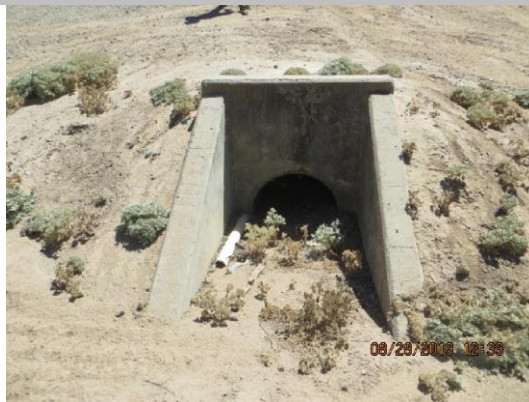
Photo 3 of 3 : UCIP_FA_2017_22794_38853.jpg

Concrete headwall on LS toe.
