**Flood Control Project Maintenance
Levee Inspections**

Maintenance Issue Types Only, Levee Inspection Report By Mile - Fall 2018

Reclamation District No. 2064 River Junction

Waterway	Bank	Unit Miles	Inspection Start/End	Inspector
Unit No. 01 San Joaquin River	Right	5.56	10/05/2018 10/05/2018	Luz Dial

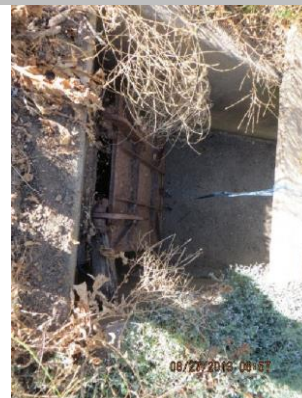
Photo 2 of 3 : UCIP_FA_2018_43603_31257.jpg

Flap gate and U shaped headwall on WS toe. Debris blocking closure of gate.

Comment Code						
Inspector Comment						
FS_ID:43603						
DS_ID:20511						
EP_NO: N/A						
Repair Type: No Action Needed						
Crossing Status: Found						
UCIP Comments: Debris removed from flap gate on waterside tow						
FIELD_STRUCT_DESC: 36-inch by 36-inch reinforced concrete box						
drainage culvert through the levee, 21 feet below the crown. Concrete U-						
shaped headwalls on both ends. Slide gate in a 6-foot by 7-foot						
concrete riser on the waterside (WS) slope. Flap gate on the WS end.						
Flashboard slots on the landside (LS) headwall. [Additional						
Reference(s): DWR Levee Log, 2005. USACE San Joaquin O&M						
Manual 3, December 1968, (HLM 0.07)].						
FS Date: 3/2/2015

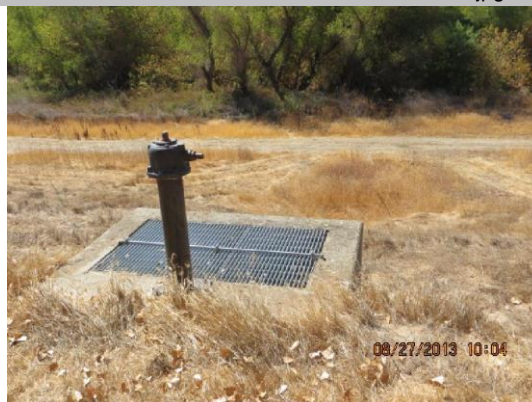
Photo 1 of 3 : UCIP_FA_2018_18763_31402.jpg

LM Start	1.94	Rating **	M	Issue No.	42
LM End	1.94	Issue Type +	Ma	Location *	
Category	Supplemental			GPS Latitude/Longitude	
				Start	End
Item	DWR UCIP LMA Responsibility			37.689900 °	37.689900 °
				-121.264802 °	-121.264802 °
DWR ID	20515				
Comment Code					
Inspector Comment					
FS_ID:18763 DS_ID:20515 EP_NO: N/A Repair Type: Non-Urgent Crossing Status: Found UCIP Comments: Culvert filled nearly to the top with soil. FIELD_STRUCT_DESC: 30-inch by 30-inch reinforced concrete box drainage culvert through the levee, 14.7 feet below the crown. Slide gate in a concrete riser on the waterside (WS) slope. Concrete U-shaped headwalls on both ends. Flap gate on the WS end. [Additional Reference(s): DWR Levee Log, 2005. USACE San Joaquin O&M Manual 3, December 1968, (HLM 1.93)]. FS Date: 8/27/2013

Slide gate in Concrete riser on WS shoulder.

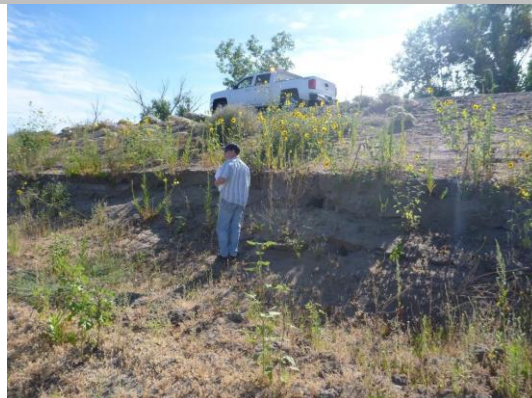
Photo 1 of 3 : FA_2018_RD2064_313_22_20180910_00002.jpg

LM Start	3.26	Rating **	A/W	Issue No.	22
LM End	3.39	Issue Type +	Ma	Location *	
Category	Supplemental			GPS Latitude/Longitude	
				Start	End
Item	2017 Storm Damage			37.679100°	37.677800°
				-121.262600°	-121.264400°
DWR ID	DWR_RD2064_01_f_2017_22				
Comment Code					
Inspector Comment					
Levee Evaluation Comments					
Description:Erosion from high water flows caused erosion scarps from 12" to 30" in height. The area of damage is approximately 400 feet in length.					
Site ID No:582					
Site Designation:LMA-488					
Repair Type: Erosion					
Rating:Serious					
Field Date:8/14/2017					
Notes:

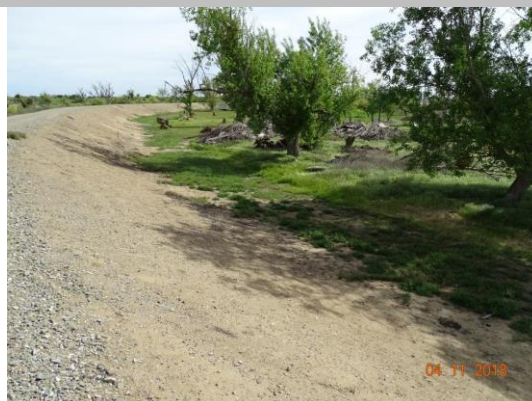
Photo 2 of 2 : FA_2018_RD2064_313_10_20180910_00001.jpg

View of former landside rodent area and slash pile in distance. Rodent control program has largely mitigated the problem, but should continue.
Fall 2017

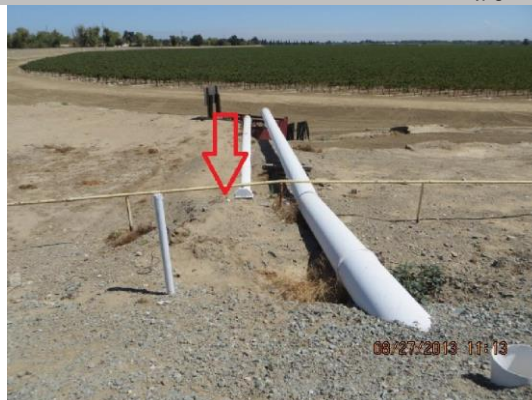
Photo 1 of 2 : UCIP_FA_2018_22732_38465.jpg

LM Start	3.57	Rating **	M	Issue No.	47	
LM End	3.57	Issue Type +	Ma	Location *		
Category	Supplemental			GPS Latitude/Longitude		
				Start		End
Item	DWR UCIP LMA Responsibility			37.675266 °		37.675266 °
				-121.263421 °		-121.263421 °
DWR ID	20525					
Comment Code						
Inspector Comment						
FS_ID:22732 DS_ID:20525 EP_NO: N/A Repair Type: Non-Urgent Crossing Status: Found UCIP Comments: Need to determine if pipe was actually removed from levee. FIELD_STRUCT_DESC: 12-inch steel drainage pipe through the levee, at an unknown depth. Steel plate welded over the landside (LS) end at the LS toe. (Permit No. 6450, 1969 - Reclamation District No. 2064, states it was removed in 1973, but it remains visible on the LS toe). [Additional Reference(s): USACE San Joaquin O&M Manual 3, December 1968, (HLM 3.55)]. FS Date: 8/27/2013

Pipe visible on LS toe.

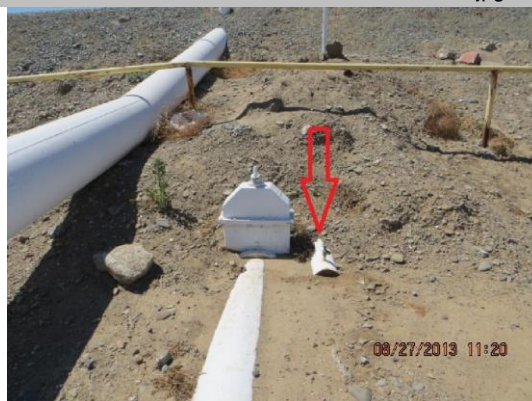
Photo 2 of 2 : UCIP_FA_2018_22732_38464.jpg

Pipe with welded steel plate over LS end at LS toe.

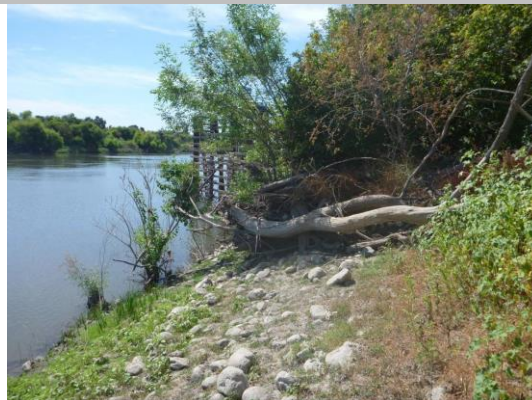
Photo 1 of 3 : FA_2018_RD2064_313_26_20180910_00008.jpg

LM Start	4.82	Rating **	A/W	Issue No.	26
LM End	4.85	Issue Type +	Ma	Location *	
Category	Supplemental			GPS Latitude/Longitude	
				Start	End
Item	2017 Storm Damage			37.671730 °	37.672140 °
				-121.246820 °	-121.246800 °
DWR ID	DWR_RD2064_01_f_2017_26				
Comment Code					
Inspector Comment					
Levee Evaluation Comments					
Description:Erosion from high water flows caused erosion scarps from 12" to 24" in height. The area of damage is approximately 600 feet in length.					
Site ID No:583					
Site Designation:LMA-489					
Repair Type: Erosion					
Rating:Area of Concern					
Field Date:8/14/2017					
Notes: Minor toe erosion

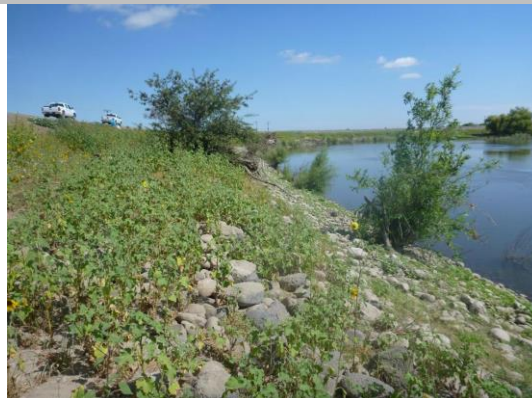
Photo 3 of 3 : FA_2018_RD2064_313_26_20180910_00010.jpg

LM Start	4.82	Rating **	A/W	Issue No.	26 (cont)
LM End	4.85	Issue Type +	Ma	Location *	
Category	Supplemental			GPS Latitude/Longitude	
				Start	End
Item	2017 Storm Damage			37.671730 °	37.672140 °
				-121.246820 °	-121.246800 °
DWR ID	DWR_RD2064_01_f_2017_26				
Comment Code					
Inspector Comment					
Levee Evaluation Comments					
Description:Erosion from high water flows caused erosion scarps from 12" to 24" in height. The area of damage is approximately 600 feet in length.					
Site ID No:583					
Site Designation:LMA-489					
Repair Type: Erosion					
Rating:Area of Concern					
Field Date:8/14/2017					
Notes: Minor toe erosion

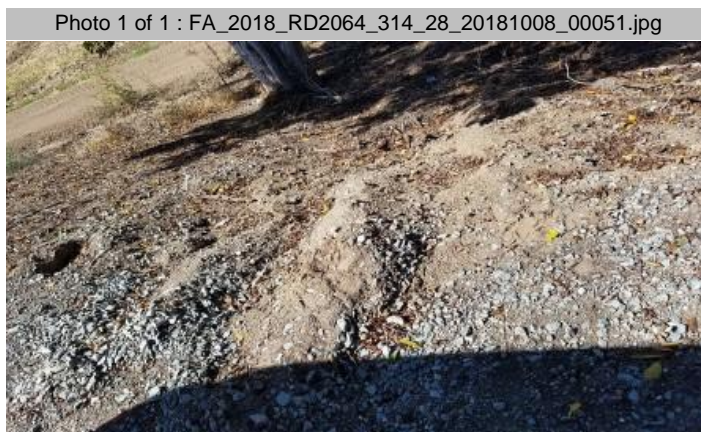
LM Start	1.05	Rating **	M	Issue No.	28
LM End	1.07	Issue Type +	Ma	Location *	LS
Category	Earthen Levee			GPS Latitude/Longitude	
				Start	End
Item	Slope Stability			37.668788 °	37.669144 °
				-121.229731 °	-121.229501 °
DWR ID	DWR_RD2064_02_f_2018_28				
Comment Code					
S3 : Repair the levee slope damaged by vehicle traffic and prevent access where possible.					
Inspector Comment					
Slope damage caused by vehicular traffic needs to be repaired.

View of slope damage from vehicular traffic. Fall 2018

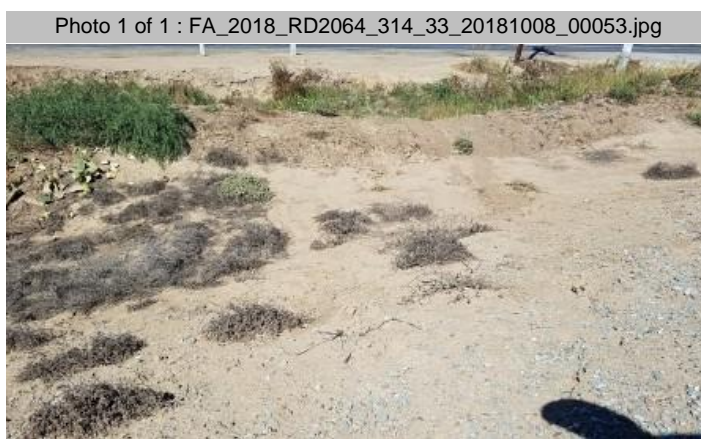
LM Start	2.51	Rating **	A/W	Issue No.	33
LM End	2.51	Issue Type +	Ma	Location *	LS
Category	Earthen Levee			GPS Latitude/Longitude	
				Start	End
Item	Slope Stability			37.683919 °	37.683919 °
				-121.223832 °	-121.223832 °
DWR ID	DWR_RD2064_02_f_2018_33				
Comment Code					
S3 : Repair the levee slope damaged by vehicle traffic and prevent access where possible.					
Inspector Comment					
Monitor vehicle traffic onto levee slope.

View of slope damage near ditch caused by vehicular traffic. Fall 2018
