**Flood Control Project Maintenance  
Levee Inspections**

**Maintenance Issue Types Only, Levee Inspection Report By Mile - Fall 2019**

**Reclamation District No. 2064 River Junction**

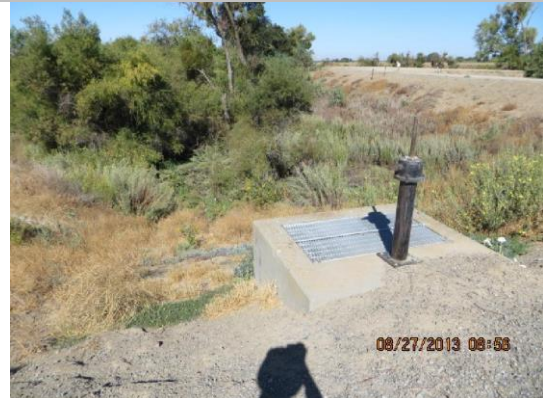
Photo 1 of 3 : UCIP\_FA\_2019\_43603\_31258.jpg

LM Start	0.06	Rating **	A/W	Issue No.	45
LM End	0.06	Issue Type +	Ma	Location *	
Category	Supplemental			GPS Latitude/Longitude	
				Start	End
Item	DRAFT DWR UCIP LMA Responsibility			37.709804 °	37.709804 °
				-121.267559 °	-121.267559 °
DWR ID	20511

Comment Code					
Inspector Comment					
DS_ID:20511					
FS_ID:43603					
EP_NO: N/A					
Repair Type: No Action Needed					
Crossing Status: Found					
UCIP Comments: Debris removed from flap gate on waterside tow					
FIELD_STRUCT_DESC: 36-inch by 36-inch reinforced concrete box					
drainage culvert through the levee, 21 feet below the crown. Concrete U-					
shaped headwalls on both ends. Slide gate in a 6-foot by 7-foot					
concrete riser on the waterside (WS) slope. Flap gate on the WS end.					
Flashboard slots on the landside (LS) headwall. [Additional					
Reference(s): DWR Levee Log, 2005. USACE San Joaquin O&M					
Manual 3, December 1968, (HLM 0.07)].					
FS Date: 3/2/2015

Slide gate in concrete riser on WS shoulder.

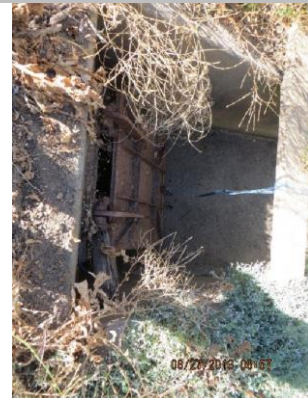
Photo 2 of 3 : UCIP\_FA\_2019\_43603\_31257.jpg

Flap gate and U shaped headwall on WS toe. Debris blocking closure of gate.

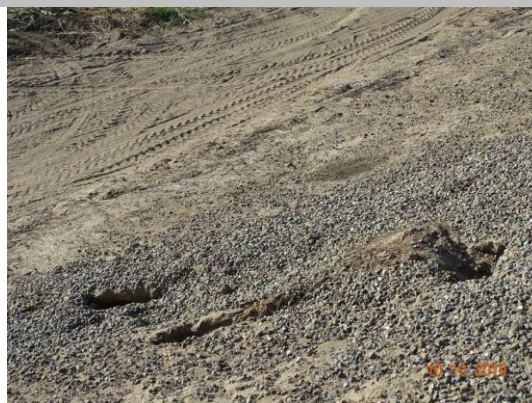
Photo 1 of 1 : FA\_2019\_RD2064\_313\_27\_20191111\_00054.jpg

View of large rodent burrows on landside slope. Fall 2019

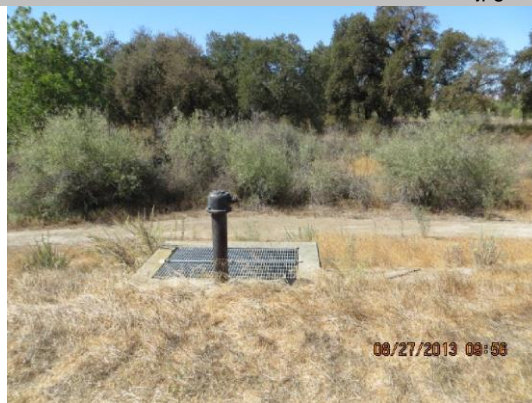
Photo 2 of 3 : UCIP\_FA\_2019\_18748\_31379.jpg

Slide gate in concrete vault on WS shoulder.

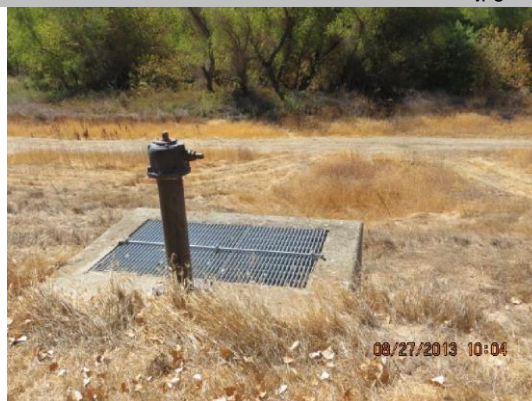
Photo 1 of 3 : UCIP\_FA\_2019\_18763\_31402.jpg

LM Start	1.94	Rating **	M	Issue No.	52	
LM End	1.94	Issue Type +	Ma	Location *		
Category	Supplemental			GPS Latitude/Longitude		
				Start		End
Item	DRAFT DWR UCIP LMA Responsibility			37.689900 °		37.689900 °
				-121.264802 °		-121.264802 °
DWR ID	20515					
Comment Code						
Inspector Comment						
DS_ID:20515 FS_ID:18763 EP_NO: N/A Repair Type: Non-Urgent Crossing Status: Found UCIP Comments: Culvert filled nearly to the top with soil. FIELD_STRUCT_DESC: 30-inch by 30-inch reinforced concrete box drainage culvert through the levee, 14.7 feet below the crown. Slide gate in a concrete riser on the waterside (WS) slope. Concrete U-shaped headwalls on both ends. Flap gate on the WS end. [Additional Reference(s): DWR Levee Log, 2005. USACE San Joaquin O&M Manual 3, December 1968, (HLM 1.93)]. FS Date: 8/27/2013

Slide gate in Concrete riser on WS shoulder.

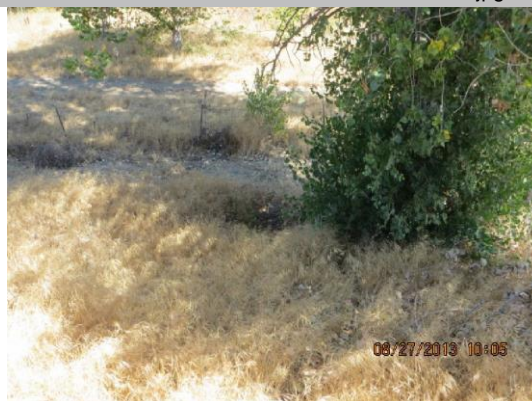
Photo 2 of 3 : UCIP\_FA\_2019\_18763\_31401.jpg

Concrete U-shaped headwall on LS toe.

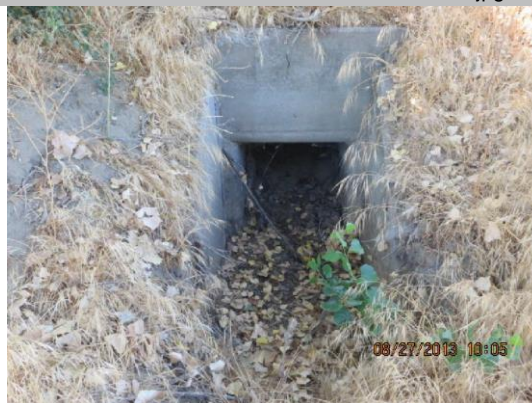
Photo 3 of 3 : UCIP\_FA\_2019\_18763\_31400.jpg

Concrete U-shaped headwall on LS toe.

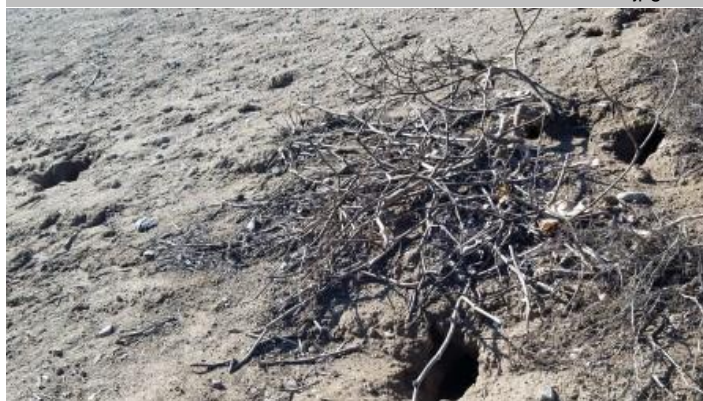
Photo 1 of 1 : FA\_2019\_RD2064\_313\_31\_20190830\_00012.jpg

View of animal holes on levee slope. Fall 2018

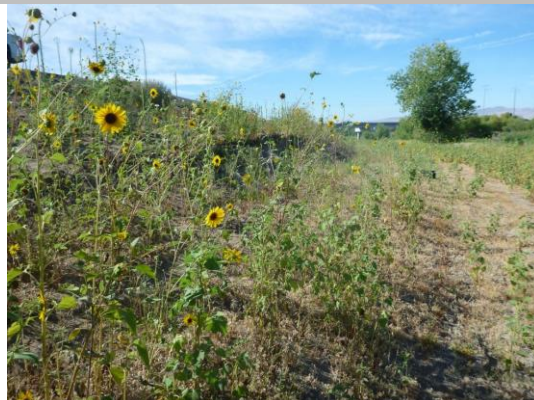
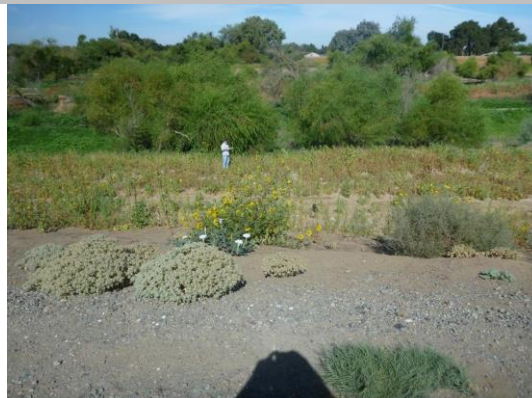
LM Start	3.26	Rating **	A/W	Issue No.	44
LM End	3.39	Issue Type +	Ma	Location *	
Category	Supplemental			GPS Latitude/Longitude	
				Start	End
Item	2017 Storm Damage			37.679100°	37.677800°
				-121.262600°	-121.264400°
DWR ID	LMA-488				
Comment Code					
Inspector Comment					
Levee Evaluation Comments					
Description:Erosion from high water flows caused erosion scarps from 12" to 30" in height. The area of damage is approximately 400 feet in length.					
Site ID No:582					
Site Designation:LMA-488					
Repair Type: Erosion					
Rating:Serious					
Field Date:8/14/2017					
Notes:

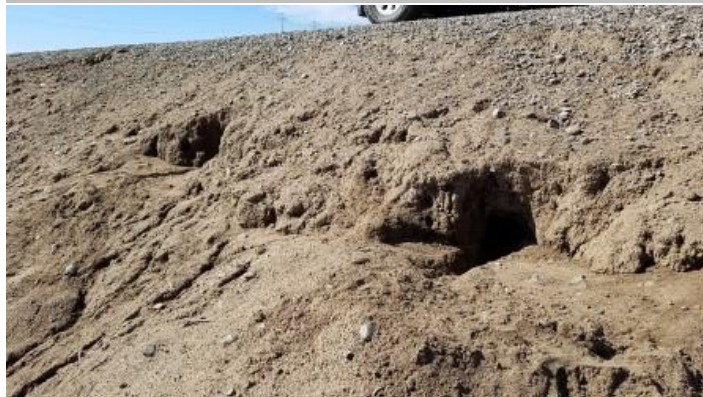
Photo 1 of 1 : FA\_2019\_RD2064\_313\_10\_20190830\_00001.jpg

LM Start	3.31	Rating **	M	Issue No.	10
LM End	3.45	Issue Type +	Ma	Location *	LS
Category	Earthen Levee			GPS Latitude/Longitude	
				Start	End
Item	Animal Control			37.678708 °	37.676786 °
				-121.263415 °	-121.264207 °
DWR ID	DWR_RD2064_01_f_2017_10				
Comment Code					
A3 : No rodents visible, but rodent burrows visible; need to backfill and compact or grout burrows.					
Inspector Comment

View of animal holes on levee slope. Fall 2018

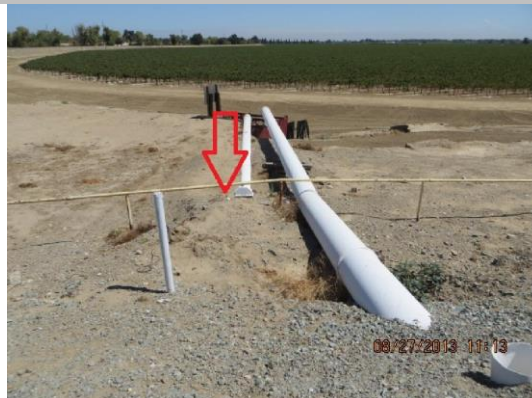
Photo 1 of 2 : UCIP\_FA\_2019\_22732\_38465.jpg

LM Start	3.57	Rating **	M	Issue No.	57	
LM End	3.57	Issue Type +	Ma	Location *		
Category	Supplemental			GPS Latitude/Longitude		
				Start	End	
Item	DRAFT DWR UCIP LMA Responsibility			37.675266 °	37.675266 °	
				-121.263421 °	-121.263421 °	
DWR ID	20525					
Comment Code						
Inspector Comment						
DS_ID:20525 FS_ID:22732 EP_NO: N/A Repair Type: Non-Urgent Crossing Status: Found UCIP Comments: Need to determine if pipe was actually removed from levee. FIELD_STRUCT_DESC: 12-inch steel drainage pipe through the levee, at an unknown depth. Steel plate welded over the landside (LS) end at the LS toe. (Permit No. 6450, 1969 - Reclamation District No. 2064, states it was removed in 1973, but it remains visible on the LS toe). [Additional Reference(s): USACE San Joaquin O&M Manual 3, December 1968, (HLM 3.55)]. FS Date: 8/27/2013

Pipe visible on LS toe.

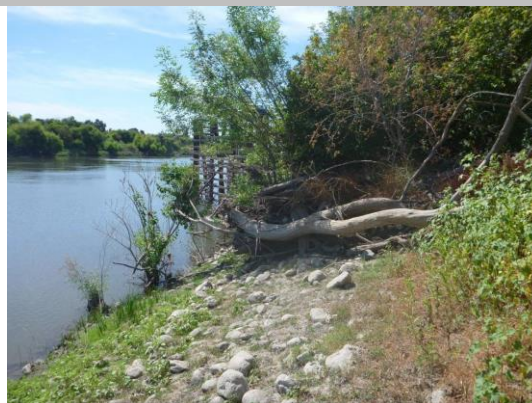
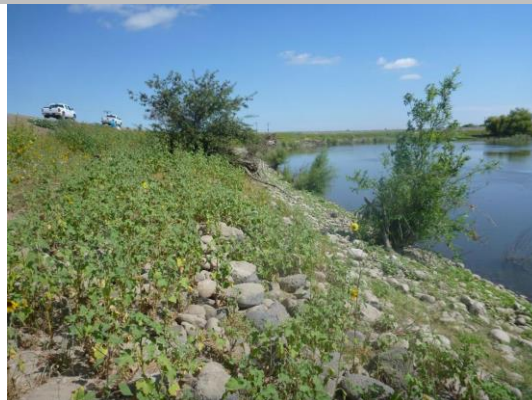
LM Start	4.82	Rating **	A/W	Issue No.	26
LM End	4.85	Issue Type +	Ma	Location *	
Category	Supplemental			GPS Latitude/Longitude	
				Start	End
Item	2017 Storm Damage			37.671730 °	37.672140 °
				-121.246820 °	-121.246800 °
DWR ID	LMA-489				
Comment Code					
Inspector Comment					
Levee Evaluation Comments					
Description:Erosion from high water flows caused erosion scarps from 12" to 24" in height. The area of damage is approximately 600 feet in length.					
Site ID No:583					
Site Designation:LMA-489					
Repair Type: Erosion					
Rating:Area of Concern					
Field Date:8/14/2017					
Notes: Minor toe erosion

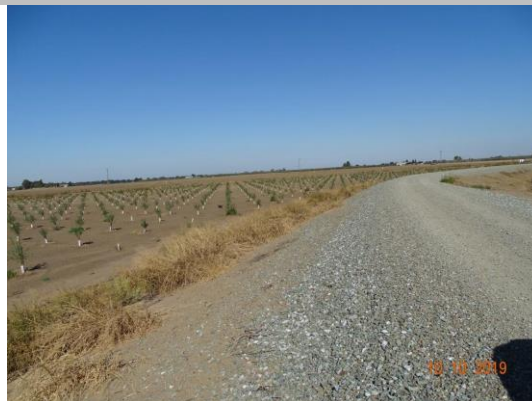
Photo 1 of 1 : FA\_2019\_RD2064\_314\_32\_20191111\_00055.jpg

View of vegetation on landside slope. Fall 2019

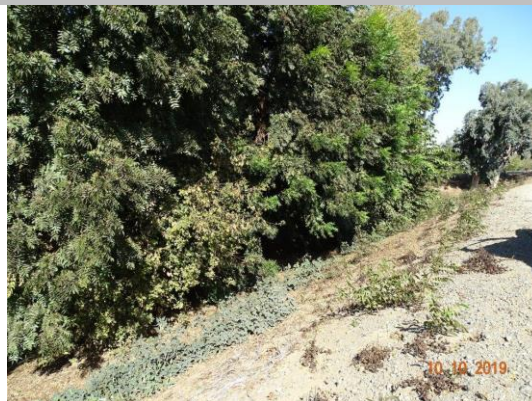
Photo 1 of 1 : FA\_2019\_RD2064\_314\_42\_20191111\_00056.jpg

View of trees on landside slope. Fall 2019
