**Flood Control Project Maintenance
Levee Inspections**

Maintenance Issue Types Only, Levee Inspection Report By Mile - Fall 2020

Reclamation District No. 2064 River Junction

Waterway	Bank	Unit Miles	Inspection Start/End	Inspector
Unit No. 01 San Joaquin River	Right	5.56	10/19/2020 10/19/2020	Alberto De Leon

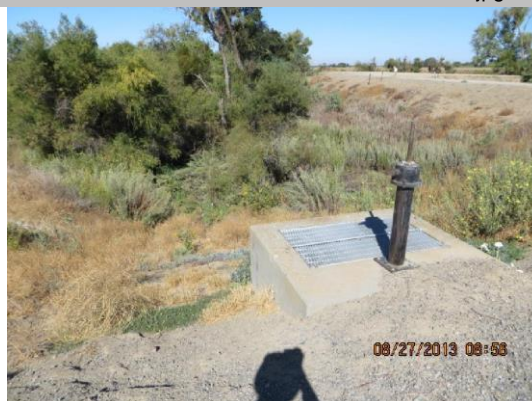
Photo 1 of 3 : UCIP_FA_2020_43603_31258.jpg

LM Start	0.06	Rating **	A/W	Issue No.	52
LM End	0.06	Issue Type +	Ma	Location *	
Category	Supplemental			GPS Latitude/Longitude	
				Start	End
Item	DWR UCIP LMA Responsibility			37.709804 °	37.709804 °
				-121.267559 °	-121.267559 °
DWR ID	20511				
Comment Code					
Inspector Comment					
DS_ID:20511 FS_ID:43603 EP_NO: N/A Repair Type: No Action Needed EVAL Issue: Crossing Status: Found UCIP Comments: Debris removed from flap gate on waterside tow FIELD_STRUCT_DESC: 36-inch by 36-inch reinforced concrete box drainage culvert through the levee, 21 feet below the crown. Concrete U-shaped headwalls on both ends. Slide gate in a 6-foot by 7-foot concrete riser on the waterside (WS) slope. Flap gate on the WS end. Flashboard slots on the landside (LS) headwall. [Additional Reference(s): DWR Levee Log, 2005. USACE San Joaquin O&M Manual 3, December 1968, (HLM 0.07)]. FS Date: 3/2/2015

Slide gate in concrete riser on WS shoulder.

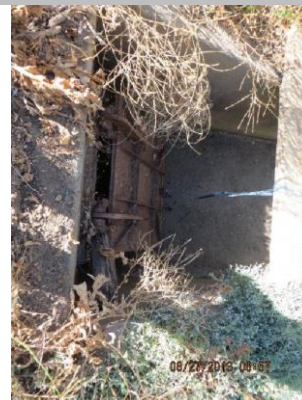
Photo 2 of 3 : UCIP_FA_2020_43603_31257.jpg

Flap gate and U shaped headwall on WS toe. Debris blocking closure of gate.

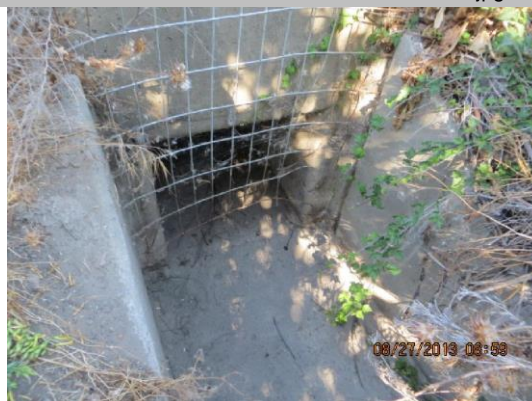
Photo 3 of 3 : UCIP_FA_2020_43603_31256.jpg

Concrete headwall at inlet on LS toe.

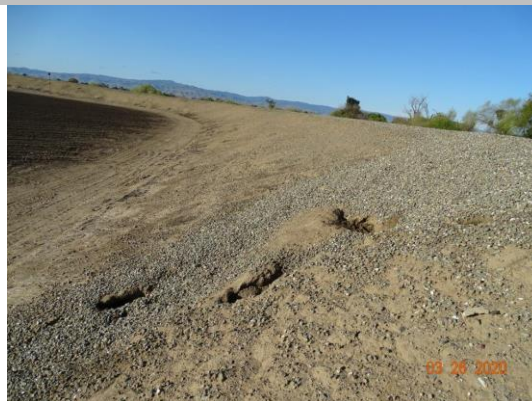
Photo 1 of 2 : FA_2020_RD2064_313_27_20200901_00007.jpg

LM Start	0.83	Rating **	M	Issue No.	27	
LM End	0.83	Issue Type +	Ma	Location *	LS	
Category	Earthen Levee			GPS Latitude/Longitude		
				Start		End
Item	Animal Control			37.700318 °		37.700318 °
				-121.272995 °		-121.272995 °
DWR ID	DWR_RD2064_01_f_2019_27					
Comment Code						
A3 : No rodents visible, but rodent burrows visible; need to backfill and compact or grout burrows.						
Inspector Comment

View of large rodent burrows on landside slope. Spring 2020

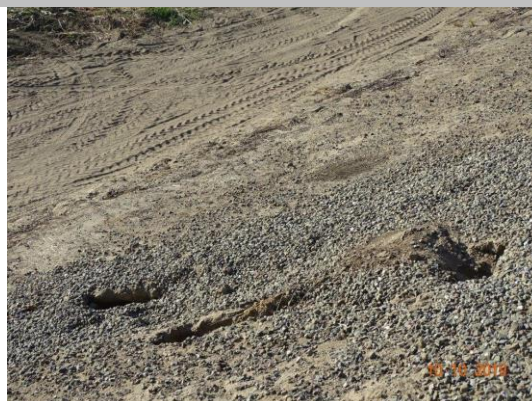
Photo 2 of 2 : FA_2020_RD2064_313_27_20200901_00008.jpg

View of large rodent burrows on landside slope. Fall 2019

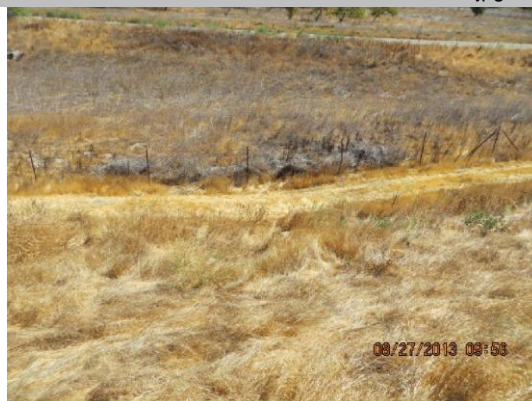
Photo 1 of 3 : UCIP_FA_2020_18748_31380.jpg

LM Start	1.65	Rating **	A/W	Issue No.	58
LM End	1.65	Issue Type +	Ma	Location *	
Category	Supplemental			GPS Latitude/Longitude	
				Start	End
Item	DWR UCIP LMA Responsibility			37.690072 °	37.690072 °
				-121.269823 °	-121.269823 °
DWR ID	20514				
Comment Code					
Inspector Comment					
DS_ID:20514 FS_ID:18748 EP_NO: N/A Repair Type: No Action Needed EVAL Issue: Crossing Status: Found UCIP Comments: FIELD_STRUCT_DESC: 30-inch by 30-inch reinforced concrete box drainage culvert through the levee, 15 feet below the crown. Slide gate in a concrete riser on the waterside (WS) shoulder. Concrete U-shaped headwalls on both ends. Flap gate on the WS end. [Additional Reference(s): DWR Levee Log, 2005. USACE San Joaquin O&M Manual 3, December 1968, (HLM 1.65)]. FS Date: 8/27/2013

Concrete headwall on LS toe.

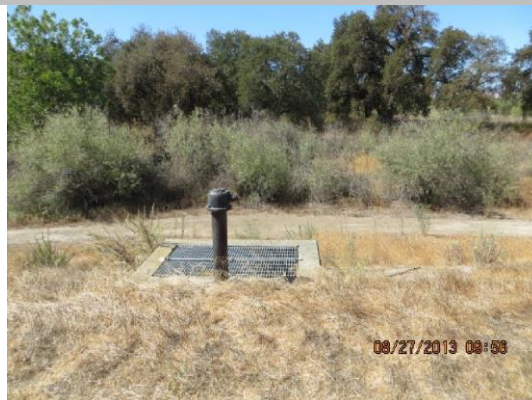
Photo 2 of 3 : UCIP_FA_2020_18748_31379.jpg

Slide gate in concrete vault on WS shoulder.

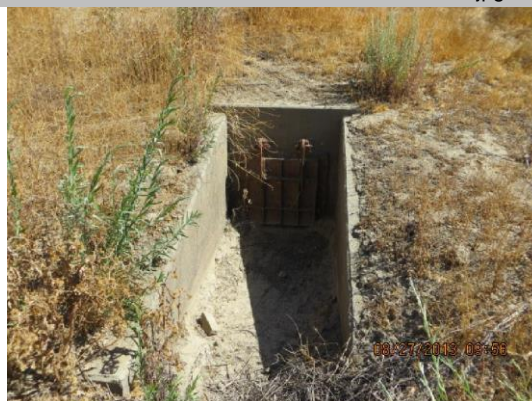
Photo 3 of 3 : UCIP_FA_2020_18748_31378.jpg

Flap gate on WS toe.

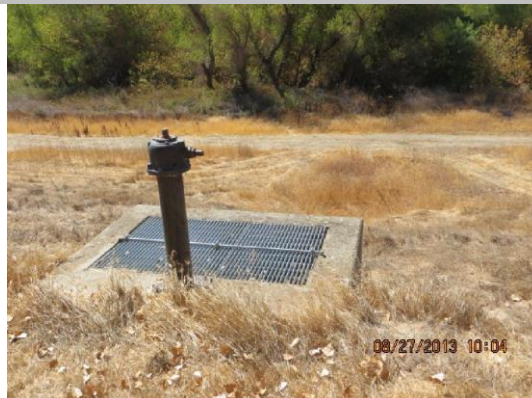
Photo 1 of 3 : UCIP_FA_2020_18763_31402.jpg

LM Start	1.94	Rating **	M	Issue No.	59	
LM End	1.94	Issue Type +	Ma	Location *		
Category	Supplemental			GPS Latitude/Longitude		
				Start		End
Item	DWR UCIP LMA Responsibility			37.689900 °		37.689900 °
				-121.264802 °		-121.264802 °
DWR ID	20515					
Comment Code						
Inspector Comment						
DS_ID:20515 FS_ID:18763 EP_NO: N/A Repair Type: Non-Urgent EVAL Issue: Crossing Status: Found UCIP Comments: Culvert filled nearly to the top with soil. FIELD_STRUCT_DESC: 30-inch by 30-inch reinforced concrete box drainage culvert through the levee, 14.7 feet below the crown. Slide gate in a concrete riser on the waterside (WS) slope. Concrete U-shaped headwalls on both ends. Flap gate on the WS end. [Additional Reference(s): DWR Levee Log, 2005. USACE San Joaquin O&M Manual 3, December 1968, (HLM 1.93)]. FS Date: 8/27/2013

Slide gate in Concrete riser on WS shoulder.

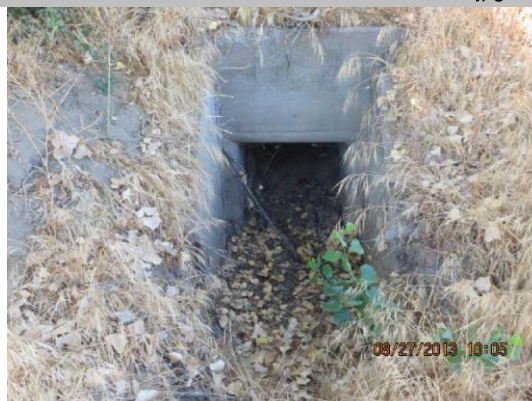
Photo 3 of 3 : UCIP_FA_2020_18763_31400.jpg

Concrete U-shaped headwall on LS toe.

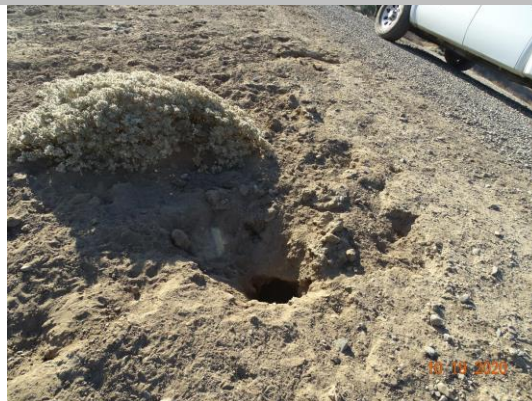
Photo 1 of 1 : FA_2020_RD2064_313_31_20201019_00056.jpg

LM Start	2.02	Rating **	M	Issue No.	32
LM End	2.02	Issue Type +	Ma	Location *	LS
Category	Earthen Levee			GPS Latitude/Longitude	
				Start	End
Item	Animal Control			37.689603 °	37.689603 °
				-121.263398 °	-121.263398 °
DWR ID	DWR_RD2064_01_s_2020_32				
Comment Code					
A3 : No rodents visible, but rodent burrows visible; need to backfill and compact or grout burrows.					
Inspector Comment

View of large animal burrow on landside slope. Fall 2020

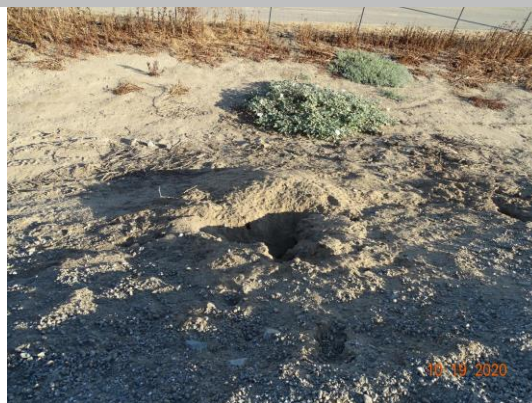
Photo 1 of 1 : FA_2020_RD2064_313_37_20201019_00057.jpg

View of large rodent hole on landside slope. Fall 2020

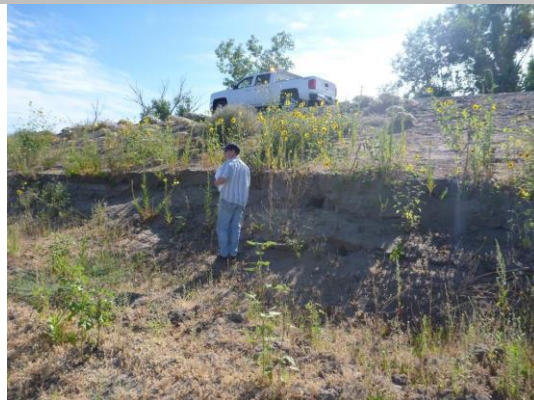
Photo 1 of 3 : FA_2020_RD2064_313_44_20200901_00011.jpg

LM Start	3.26	Rating **	A/W	Issue No.	44
LM End	3.39	Issue Type +	Ma	Location *	WS
Category	Supplemental			GPS Latitude/Longitude	
				Start	End
Item	2017 Storm Damage			37.679100 °	37.677800 °
				-121.262600 °	-121.264400 °
DWR ID	LMA-488				
Comment Code					
Inspector Comment					
Planned For PL 84-99 Repair in 2020.					
Levee Evaluation Comments					
Description:Erosion from high water flows caused erosion scarps from 12" to 30" in height. The area of damage is approximately 400 feet in length.					
Site ID No:582					
Site Designation:LMA-488					
Repair Type: Erosion					
Rating:Serious					
Field Date:8/14/2017					
Notes:

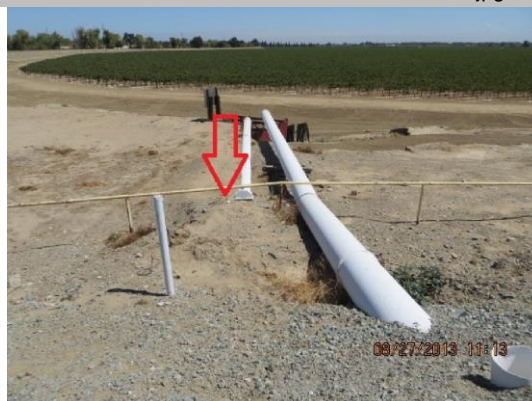
Photo 1 of 2 : UCIP_FA_2020_22732_38465.jpg

LM Start	3.57	Rating **	M	Issue No.	64	
LM End	3.57	Issue Type +	Ma	Location *		
Category	Supplemental			GPS Latitude/Longitude		
				Start		End
Item	DWR UCIP LMA Responsibility			37.675266 °	37.675266 °	
				-121.263421 °	-121.263421 °	
DWR ID	20525					
Comment Code						
Inspector Comment						
DS_ID:20525 FS_ID:22732 EP_NO: N/A Repair Type: Non-Urgent EVAL Issue: Crossing Status: Found UCIP Comments: Need to determine if pipe was actually removed from levee. FIELD_STRUCT_DESC: 12-inch steel drainage pipe through the levee, at an unknown depth. Steel plate welded over the landside (LS) end at the LS toe. (Permit No. 6450, 1969 - Reclamation District No. 2064, states it was removed in 1973, but it remains visible on the LS toe). [Additional Reference(s): USACE San Joaquin O&M Manual 3, December 1968, (HLM 3.55)]. FS Date: 8/27/2013

Pipe visible on LS toe.

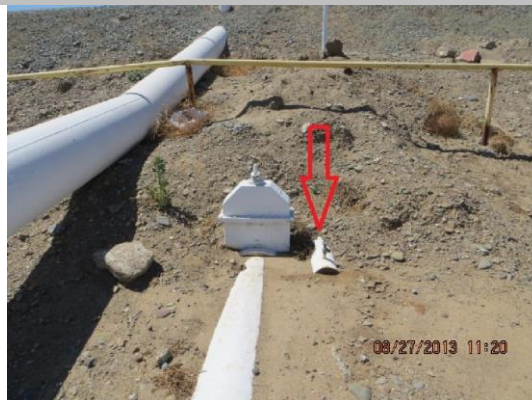
Photo 2 of 2 : UCIP_FA_2020_22732_38464.jpg

Pipe with welded steel plate over LS end at LS toe.

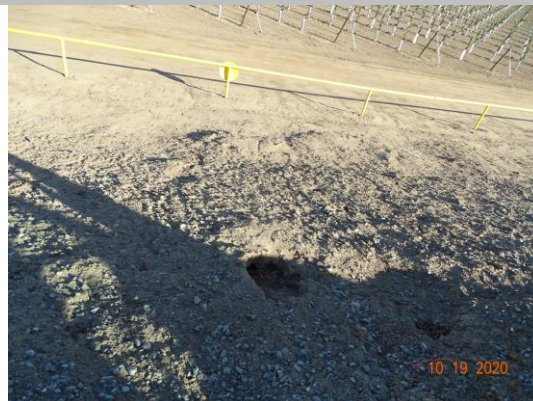
Photo 1 of 1 : FA_2020_RD2064_313_49_20201019_00059.jpg

View of large animal burrow on landside slope. Fall 2020

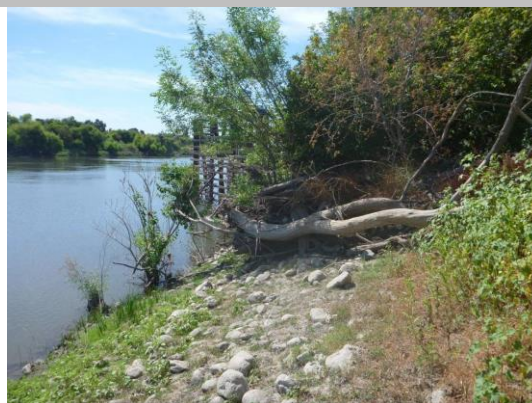
Photo 1 of 3 : FA_2020_RD2064_313_26_20200901_00004.jpg

LM Start	4.82	Rating **	A/W	Issue No.	26
LM End	4.85	Issue Type +	Ma	Location *	WS
Category	Supplemental			GPS Latitude/Longitude	
				Start	End
Item	2017 Storm Damage			37.671730 °	37.672140 °
				-121.246820 °	-121.246800 °
DWR ID	LMA-489				
Comment Code					
Inspector Comment					
Planned For PL 84-99 Repair in 2020.					
Levee Evaluation Comments					
Description:Erosion from high water flows caused erosion scarps from 12" to 24" in height. The area of damage is approximately 600 feet in length.					
Site ID No:583					
Site Designation:LMA-489					
Repair Type: Erosion					
Rating:Area of Concern					
Field Date:8/14/2017					
Notes: Minor toe erosion

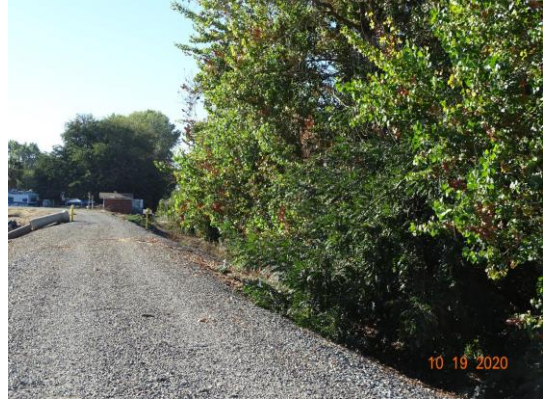
Photo 1 of 1 : FA_2020_RD2064_313_51_20201019_00061.jpg

View of untrimmed tree on waterside slope. Fall 2020

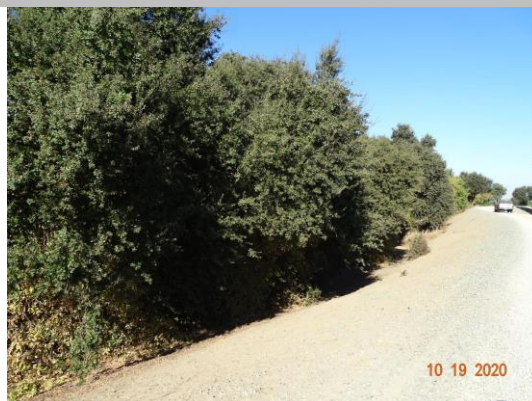
Photo 1 of 1 : FA_2020_RD2064_314_21_20201019_00056.jpg

View of vegetation along the fence line on landside easement. Fall 2020

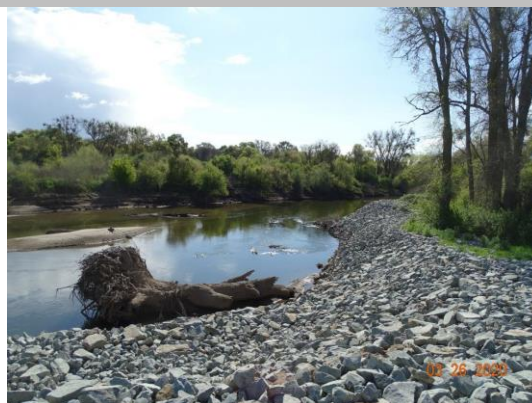
Photo 1 of 1 : FA_2020_RD2064_314_23_20200901_00001.jpg

LM Start	2.40	Rating **	A/W	Issue No.	23
LM End	2.40	Issue Type +	Ma	Location *	WS
Category	Earthen Levee			GPS Latitude/Longitude	
				Start	End
Item	Erosion / Bank Caving			37.682375 °	37.682375 °
				-121.223848 °	-121.223848 °
DWR ID	DWR_RD2064_02_s_2020_23				
Comment Code					
E2 : Schedule repair of erosion site prior to the next inspection.					
Inspector Comment					
Erosion repaired December 2019. Continue to monitor.

View of waterside erosion repair looking downstream. Spring 2020
