**Flood Control Project Maintenance
Levee Inspections**

Maintenance Issue Types Only, Levee Inspection Report By Mile - Fall 2021

Reclamation District No. 2064 River Junction

Waterway	Bank	Unit Miles	Inspection Start/End	Inspector
Unit No. 01 San Joaquin River	Right	5.56	10/28/2021 10/28/2021	Alberto De Leon

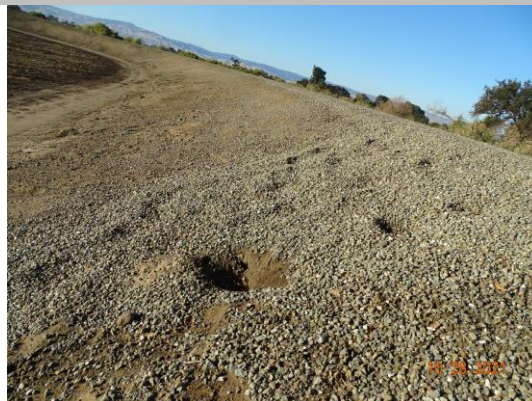
Photo 1 of 1 : FA_2021_RD2064_313_27_20211028_00058.jpg

LM Start	0.83	Rating **	M	Issue No.	27
LM End	0.83	Issue Type +	Ma	Location *	LS
Category	Earthen Levee			GPS Latitude/Longitude	
				Start	End
Item	Animal Control			37.700318 °	37.700318 °
				-121.272995 °	-121.272995 °
DWR ID	DWR_RD2064_01_f_2019_27				
Comment Code					
A3 : No rodents visible, but rodent burrows visible; need to backfill and compact or grout burrows.					
Inspector Comment

View of animal burrow on landside slope. Fall 2021

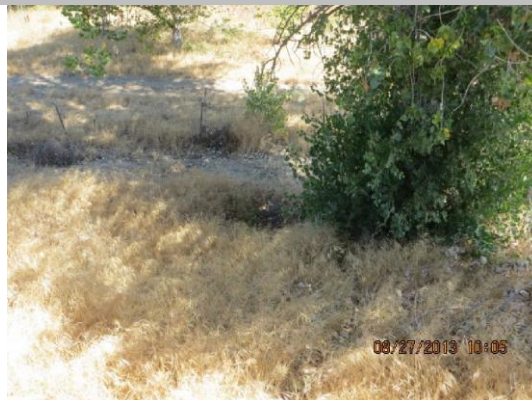
Photo 2 of 3 : UCIP_FA_2021_18763_31401.jpg

Concrete U-shaped headwall on LS toe.

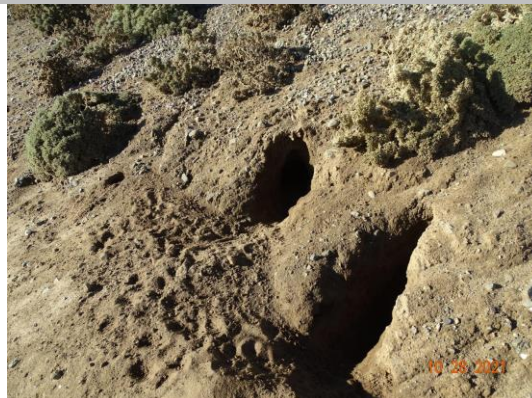
Photo 1 of 1 : FA_2021_RD2064_313_29_20211028_00060.jpg

LM Start	3.43	Rating **	U	Issue No.	29
LM End	3.47	Issue Type +	Ma	Location *	LS
Category	Earthen Levee			GPS Latitude/Longitude	
				Start	End
Item	Animal Control			37.677069 °	37.676621 °
				-121.264247 °	-121.264181 °
DWR ID	DWR_RD2064_01_f_2020_29				
Comment Code					
A3 : No rodents visible, but rodent burrows visible; need to backfill and compact or grout burrows.					
Inspector Comment

View of multiple rodent holes on landside slope. Fall 2021

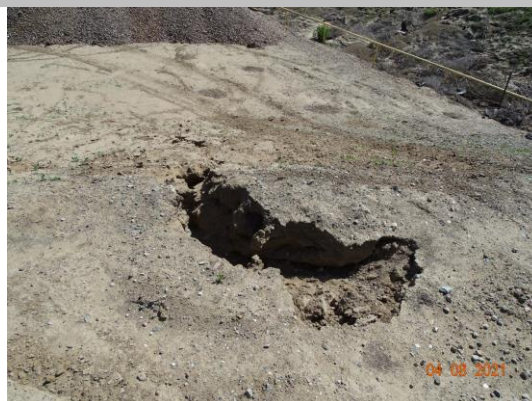
Photo 1 of 1 : FA_2021_RD2064_313_43_20210913_00010.jpg

LM Start	3.48	Rating **	M	Issue No.	43
LM End	3.48	Issue Type +	Ma	Location *	LS
Category	Earthen Levee			GPS Latitude/Longitude	
				Start	End
Item	Slope Stability			37.676475 °	37.676475 °
				-121.264163 °	-121.264163 °
DWR ID	DWR_RD2064_01_s_2021_43				
Comment Code					
S1 : Repair slope instability.					
Inspector Comment					
Soil separation on landside slope. Separation likely caused by surface runoff from adjacent highway near the north side gate at S Airport Way. Spring 2021

View of soil separation on landside slope, caused by surface runoff from adjacent highway. Spring 2021

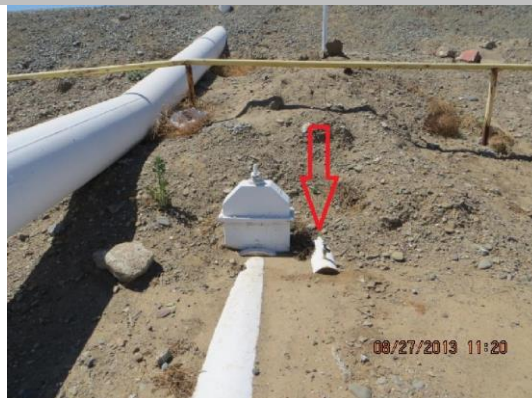
Photo 2 of 2 : UCIP_FA_2021_22732_38464.jpg

Pipe with welded steel plate over LS end at LS toe.

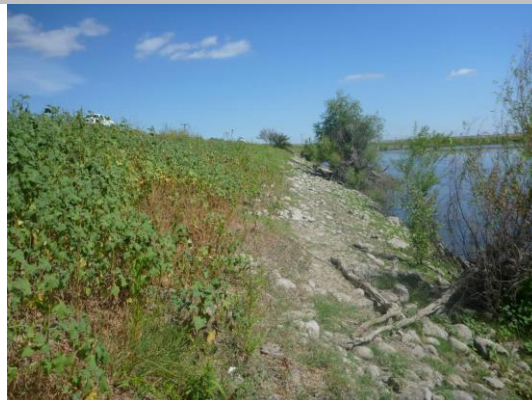
Photo 1 of 2 : FA_2021_RD2064_313_26_20210913_00004.jpg

LM Start	4.82	Rating **	A/W	Issue No.	26
LM End	4.85	Issue Type +	Ma	Location *	WS
Category	Earthen Levee			GPS Latitude/Longitude	
				Start	End
Item	Erosion / Bank Caving			37.671664 °	37.672099 °
				-121.246843 °	-121.246813 °
DWR ID	DWR_RD2064_01_f_2021_26				
Comment Code					
E1 : Note and monitor erosion site.					
Inspector Comment					
This was a 2017 Storm Damage site. During the 2017 event the upper third of the waterside slope was armored with revetment. Erosion scarps on the waterside toe should continue to be monitored.

View of waterside toe looking upstream.

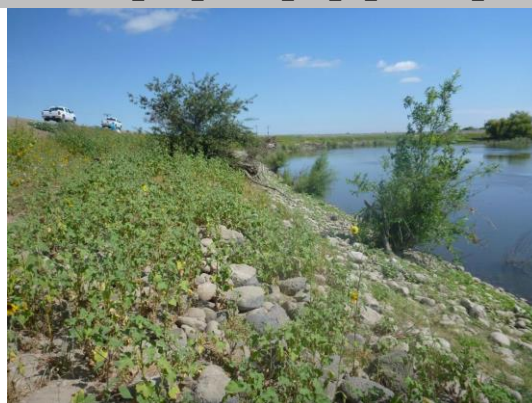
Photo 2 of 2 : FA_2021_RD2064_313_26_20210913_00005.jpg

View of waterside toe looking upstream.

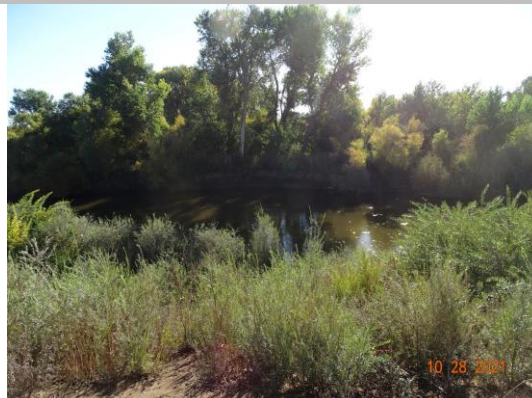
Photo 1 of 2 : FA_2021_RD2064_314_33_20211028_00057.jpg

LM Start	1.55	Rating **	A/W	Issue No.	33
LM End	1.57	Issue Type +	Ma	Location *	WS
Category	Earthen Levee			GPS Latitude/Longitude	
				Start	End
Item	Erosion / Bank Caving			37.670791 °	37.671053 °
				-121.222220 °	-121.221903 °
DWR ID	DWR_RD2064_02_f_2020_33				
Comment Code					
E1 : Note and monitor erosion site.					
Inspector Comment					
Waterside berm has slowly been eroding. Berm ranges from 10-50 ft from waterside toe. RD plans to monitor. Spring 2021

View of waterside berm, approximately 10-40 ft from waterside toe. Fall 2021

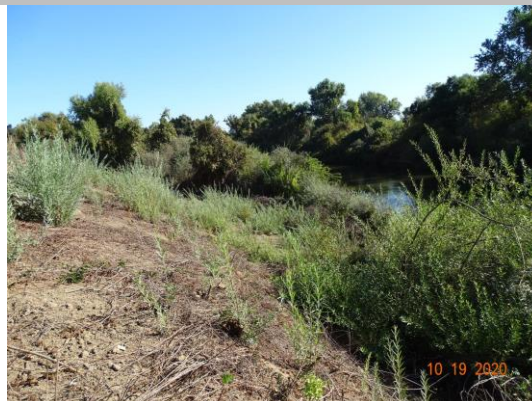
Photo 2 of 2 : FA_2021_RD2064_314_33_20210913_00010.jpg

View of waterside berm, approximately 10-40 ft from waterside toe. Fall 2020

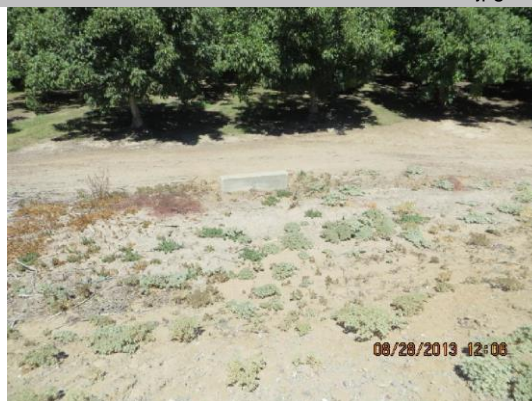
Photo 1 of 3 : UCIP_FA_2021_19117_32069.jpg

LM Start	4.41	Rating **	A/W	Issue No.	50
LM End	4.41	Issue Type +	Ma	Location *	
Category	Supplemental			GPS Latitude/Longitude	
				Start	End
Item	DWR UCIP LMA Responsibility			37.696386 °	37.696386 °
				-121.202963 °	-121.202963 °
DWR ID	20549				
Comment Code					
Inspector Comment					
DS_ID:20549 FS_ID:19117 EP_NO: N/A Repair Type: No Action Needed EVAL Issue: Crossing Status: Found UCIP Comments: FIELD_STRUCT_DESC: 30-inch drainage pipe of an unknown material through the levee, 10.5 feet below the crown. Concrete U-shaped headwalls on both ends. Flap gate on the waterside (WS) end. Two corrugated metal cutoff walls. [Additional Reference(s): DWR Levee Log, 2005. USACE San Joaquin O&M Manual 3, December 1968, (HLM 4.37)]. FS Date: 8/28/2013

Headwall on LS toe.

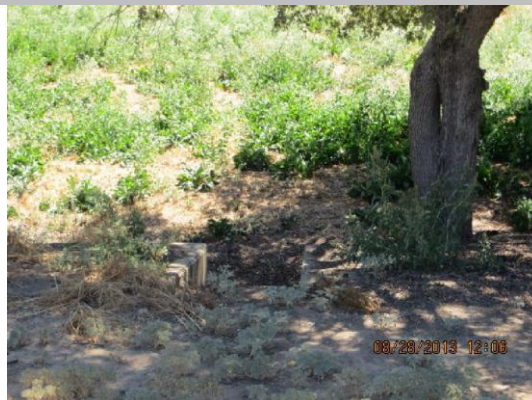
Photo 2 of 3 : UCIP_FA_2021_19117_32068.jpg

Headwall on WS toe.

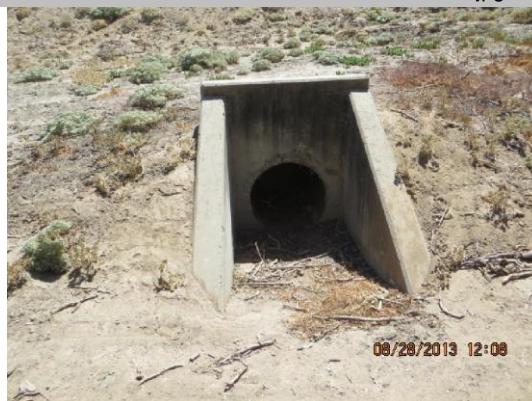
Photo 3 of 3 : UCIP_FA_2021_19117_32067.jpg

Headwall on LS toe.

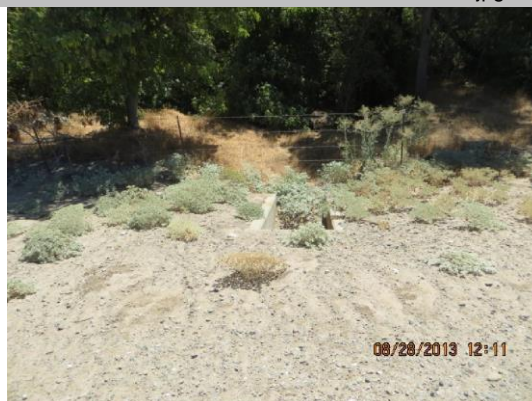
Photo 1 of 3 : UCIP_FA_2021_22793_38842.jpg

DS_ID:20550
 FS_ID:22793
 EP_NO: N/A
 Repair Type: No Action Needed
 EVAL Issue:
 Crossing Status: Found
 UCIP Comments:
 FIELD_STRUCT_DESC: 30-inch corrugated metal drainage pipe through the levee, 8 feet below the crown. Concrete U-shaped headwalls on both ends, and a flap gate on the waterside (WS) end. Grouted spillway on the WS. [Additional Reference(s): DWR Levee Log, 2005. USACE San Joaquin O&M Manual 3, December 1968, (HLM 4.47)].
 FS Date: 8/28/2013

Concrete headwall on WS toe.

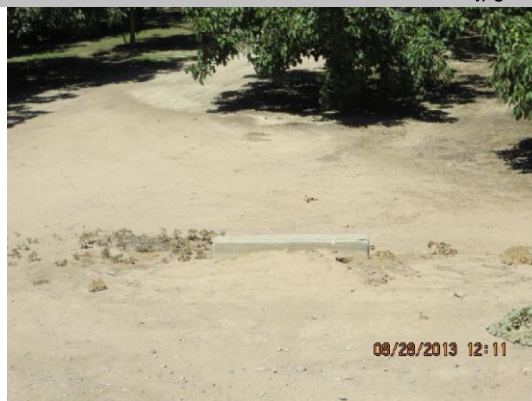
Photo 2 of 3 : UCIP_FA_2021_22793_38841.jpg

Concrete headwall on LS toe.

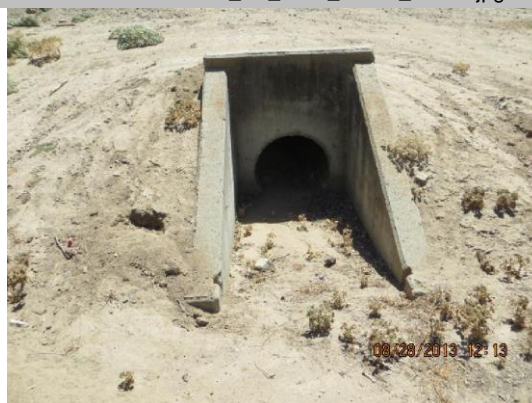
Photo 3 of 3 : UCIP_FA_2021_22793_38844.jpg

Concrete headwall on LS toe.

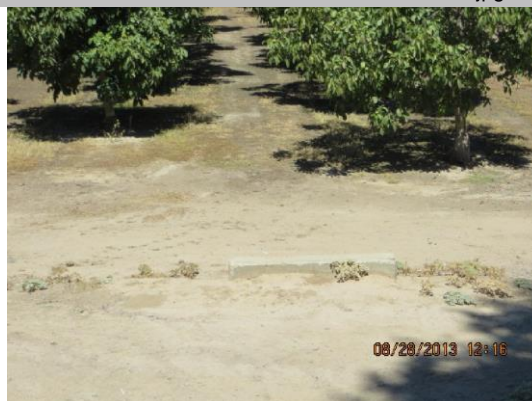
Photo 1 of 3 : UCIP_FA_2021_19120_32079.jpg

LM Start	4.64	Rating **	A/W	Issue No.	52
LM End	4.64	Issue Type +	Ma	Location *	
Category	Supplemental			GPS Latitude/Longitude	
				Start	End
Item	DWR UCIP LMA Responsibility			37.697101 °	37.697101 °
				-121.199048 °	-121.199048 °
DWR ID	20551				
Comment Code					
Inspector Comment					
DS_ID:20551 FS_ID:19120 EP_NO: N/A Repair Type: No Action Needed EVAL Issue: Crossing Status: Found UCIP Comments: FIELD_STRUCT_DESC: 30-inch corrugated metal drainage pipe through the levee, 10 feet below the crown. Concrete U-shaped headwalls on both ends. Flap gate on the waterside (WS) end. Two corrugated metal cutoff walls. Grouted spillway on the WS. Spillway damaged due to uprooted tree. [Additional Reference(s): DWR Levee Log, 2005. USACE San Joaquin O&M Manual 3, December 1968, (HLM 4.59)]. FS Date: 8/28/2013

Concrete headwall on LS toe.

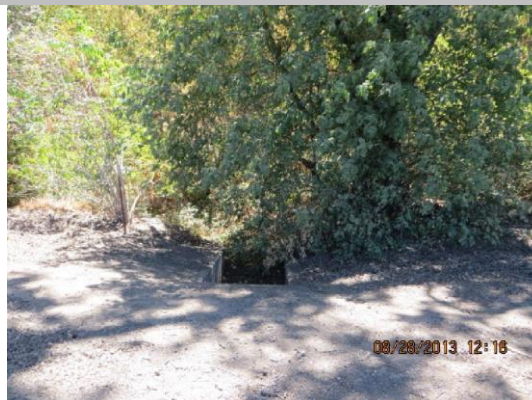
Photo 2 of 3 : UCIP_FA_2021_19120_32078.jpg

Concrete headwall on WS toe.

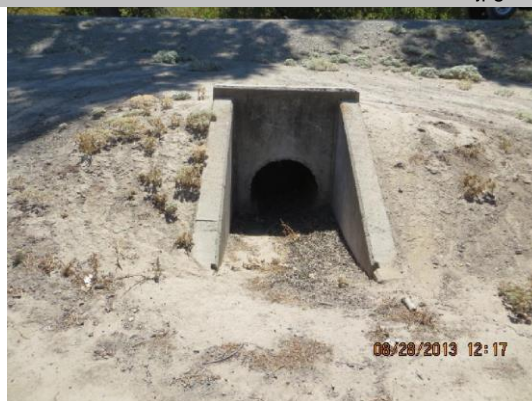
Photo 3 of 3 : UCIP_FA_2021_19120_32077.jpg

Concrete headwall on LS toe.

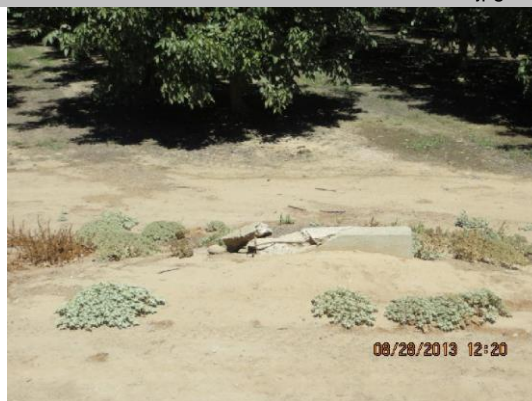
Photo 1 of 3 : UCIP_FA_2021_19122_32083.jpg

DS_ID:20552
 FS_ID:19122
 EP_NO: N/A
 Repair Type: No Action Needed
 EVAL Issue:
 Crossing Status: Found
 UCIP Comments:
 FIELD_STRUCT_DESC: 30-inch corrugated metal drainage pipe through the levee, 8.5 feet below the crown. Concrete U-shaped headwalls on both ends. Flap gate on the waterside (WS) end. Two corrugated metal cutoff walls. Grouted spillway on the WS. [Additional Reference(s): DWR Levee Log, 2005. USACE San Joaquin O&M Manual 3, December 1968, (HLM 4.73)].
 FS Date: 8/28/2013

Concrete headwall on LS toe.

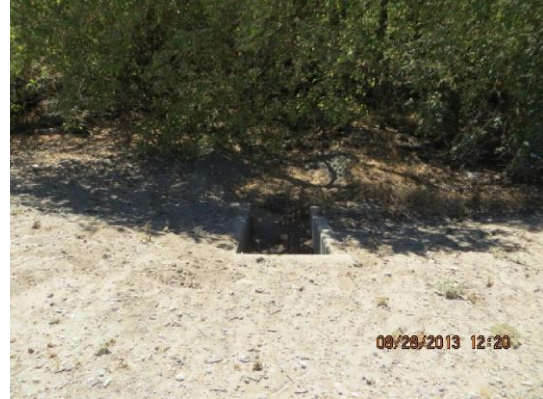
Photo 2 of 3 : UCIP_FA_2021_19122_32082.jpg

Concrete headwall on WS toe.

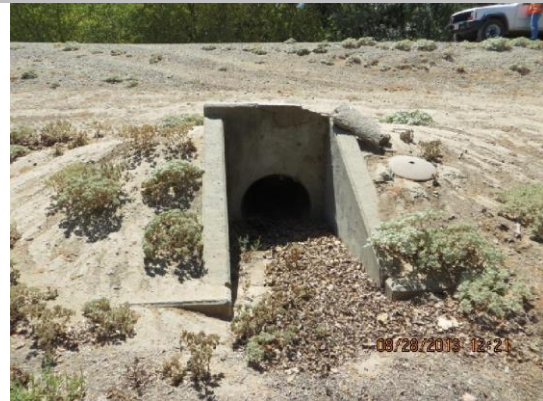
Photo 3 of 3 : UCIP_FA_2021_19122_32081.jpg

Concrete headwall on LS toe.

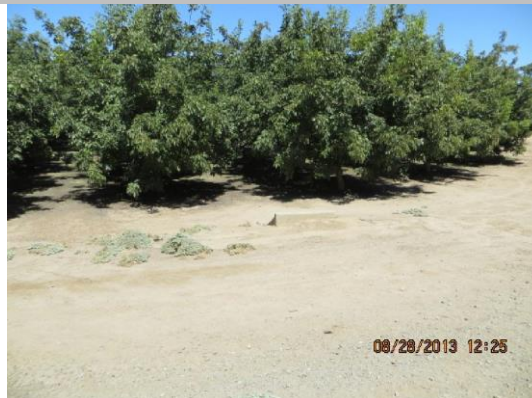
Photo 1 of 3 : UCIP_FA_2021_19143_32122.jpg

LM Start	4.92	Rating **	A/W	Issue No.	56
LM End	4.92	Issue Type +	Ma	Location *	
Category	Supplemental			GPS Latitude/Longitude	
				Start	End
Item	DWR UCIP LMA Responsibility			37.696146 °	37.696146 °
				-121.194093 °	-121.194093 °
DWR ID	20553				
Comment Code					
Inspector Comment					
DS_ID:20553 FS_ID:19143 EP_NO: N/A Repair Type: No Action Needed EVAL Issue: Crossing Status: Found UCIP Comments: FIELD_STRUCT_DESC: 30-inch corrugated metal drainage pipe through the levee, 8 feet below the crown. Concrete U-shaped headwalls on both ends. Flap gate on the waterside (WS) end. Two corrugated metal cutoff walls. Grouted spillway on the WS. [Additional Reference(s): DWR Levee Log, 2005. USACE San Joaquin O&M Manual 3, December 1968, (HLM 4.88)]. FS Date: 8/28/2013

Concrete headwall on LS toe.

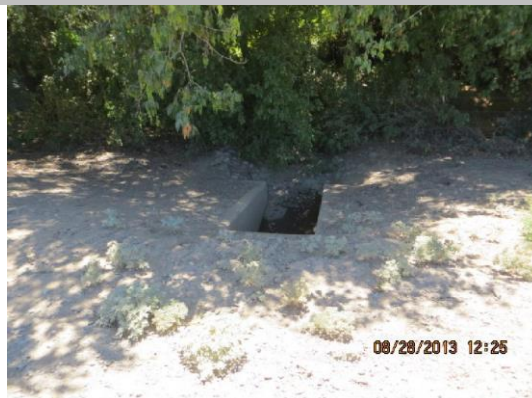
Photo 2 of 3 : UCIP_FA_2021_19143_32121.jpg

Concrete headwall on WS toe.

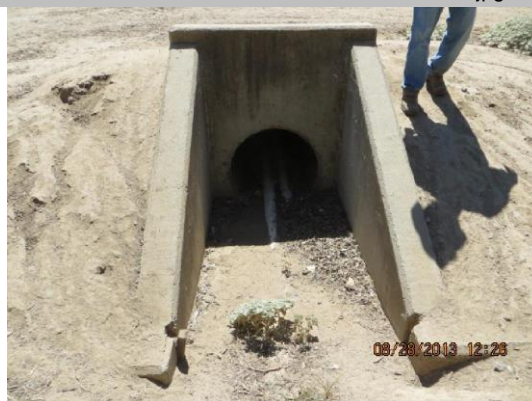
Photo 3 of 3 : UCIP_FA_2021_19143_32120.jpg

Concrete headwall on LS toe.

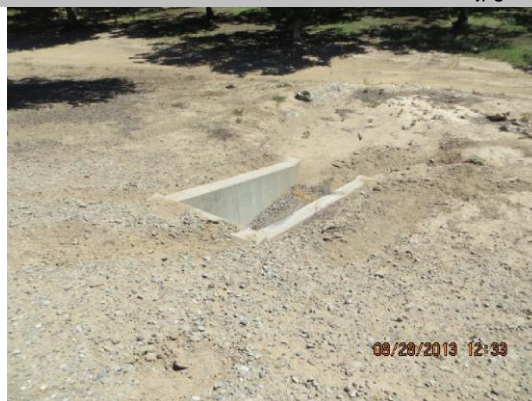
Photo 1 of 3 : UCIP_FA_2021_22794_38851.jpg

DS_ID:20554
 FS_ID:22794
 EP_NO: N/A
 Repair Type: No Action Needed
 EVAL Issue:
 Crossing Status: Found
 UCIP Comments:
 FIELD_STRUCT_DESC: 30-inch corrugated metal drainage pipe through the levee, 8 feet below the crown. Concrete U-shaped headwalls on both ends. Flap gate on the waterside (WS) end. Two corrugated metal cutoff walls. Grouted spillway on the WS. [Additional Reference(s): DWR Levee Log, 2005. USACE San Joaquin O&M Manual 3, December 1968, (HLM 5.05)].
 FS Date: 8/28/2013

Concrete U shaped headwall on WS toe.

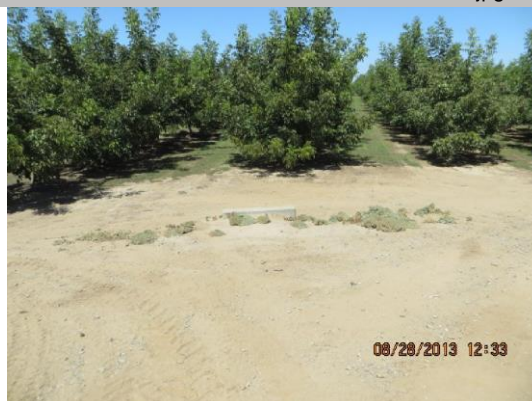
Photo 2 of 3 : UCIP_FA_2021_22794_38850.jpg

Concrete headwall on LS toe.

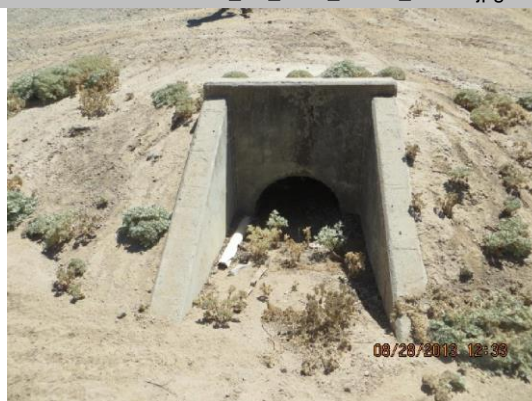
Photo 3 of 3 : UCIP_FA_2021_22794_38853.jpg

Concrete headwall on LS toe.
