**Flood Control Project Maintenance
Levee Inspections**

Maintenance Issue Types Only, Levee Inspection Report By Mile - Fall 2022

Reclamation District No. 2064 River Junction

Waterway	Bank	Unit Miles	Inspection Start/End	Inspector
Unit No. 01 San Joaquin River	Right	5.56	10/18/2022 10/18/2022	Alberto De Leon

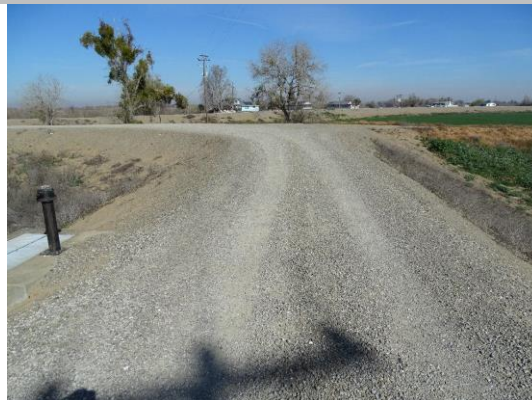
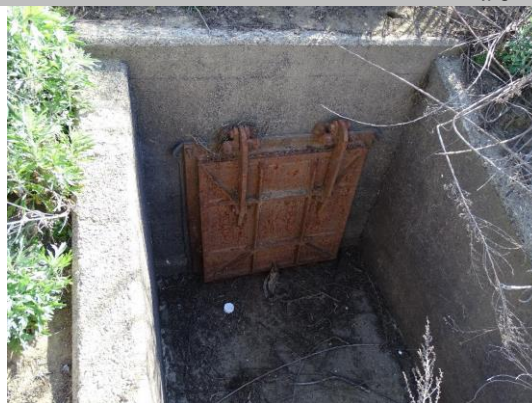
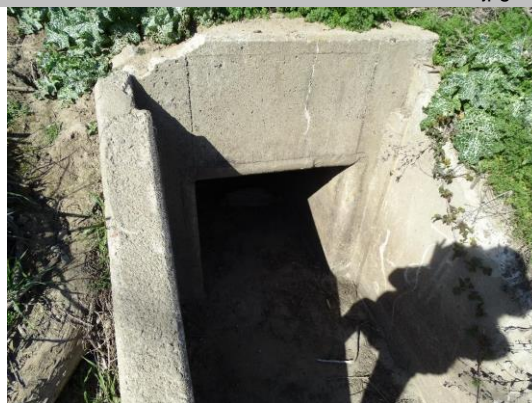
LM Start	0.06	Rating **	M	Issue No.	44	
LM End	0.06	Issue Type +	Ma	Location *		
Category	Supplemental			GPS Latitude/Longitude		
				Start		End
Item	DWR UCIP LMA Responsibility			37.709804 °		37.709804 °
				-121.267559 °		-121.267559 °
DWR ID	20511

Comment Code						
Inspector Comment						
DS_ID:20511 FS_ID:72428 EP_NO: N/A Repair Type: Non-Urgent EVAL Issue: Crossing Status: Found UCIP Comments: 03/01/2022 Record updated from No Action Needed to Non-Urgent. No permit has been identified authorizing pipe. Debris has been cleared. (D.Sanoski - DWR UCIP) 03/02/2015 Debris removed from flap gate on waterside tow (G.Armstrong - DWR UCIP) FIELD_STRUCT_DESC: 36-inch by 36-inch reinforced concrete box drainage culvert through the levee, 21 feet below the crown. Concrete U-shaped headwalls on both ends. Slide gate in a 6-foot by 7-foot concrete riser on the waterside (WS) slope. Flap gate on the WS end. Flashboard slots on the landside (LS) headwall. [Additional Reference(s): DWR Levee Log, 2005. USACE San Joaquin O&M Manual 3, December 1968, (HLM 0.07)]. FS Date: 3/1/2022 11:31:10 AM

Top of Levee: view of crown.

Water-Side: view of headwall and flap gate.

Land-Side: view of headwall and inlet.

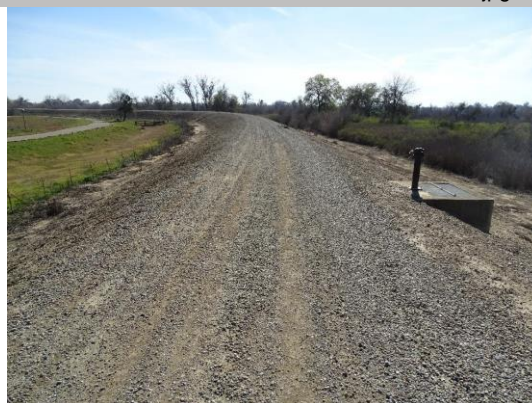
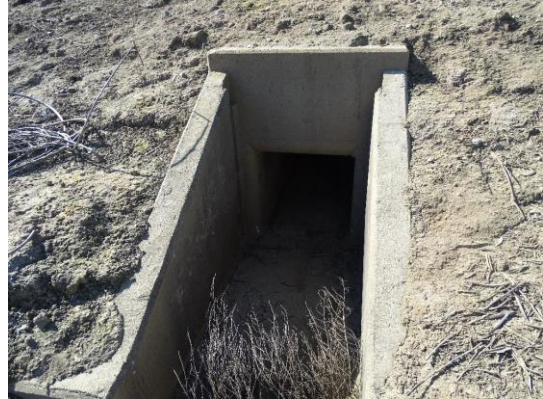
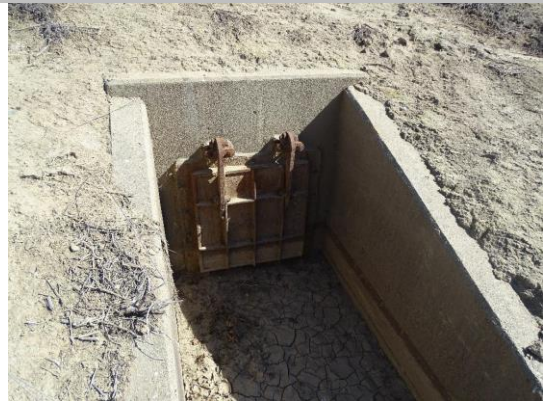
LM Start	1.65	Rating **	M	Issue No.	45
LM End	1.65	Issue Type +	Ma	Location *	
Category	Supplemental			GPS Latitude/Longitude	
				Start	End
Item	DWR UCIP LMA Responsibility			37.690072 °	37.690072 °
				-121.269823 °	-121.269823 °
DWR ID	20514

DS_ID:20514
 FS_ID:72439
 EP_NO: N/A
 Repair Type: Non-Urgent
 EVAL Issue:
 Crossing Status: Found
 UCIP Comments: 03/01/2022 Record remains No Action Needed. DMP internal video inspection has not found pipe integrity issues. LOF of crossing is less or equal to 4. Recommend next video inspection in 5 years. System Feature. (D.Sanoski - DWR UCIP)
 FIELD_STRUCT_DESC: 30-inch by 30-inch reinforced concrete box drainage culvert through the levee, 15 feet below the crown. Slide gate in a concrete riser on the waterside (WS) shoulder. Concrete U-shaped headwalls on both ends. Flap gate on the WS end. [Additional Reference(s): DWR Levee Log, 2005. USACE San Joaquin O&M Manual 3, December 1968, (HLM 1.65)].
 FS Date: 3/1/2022 12:30:04 PM

Top of Levee: view of crown.

Land-Side: view of headwall and inlet on toe.

Water-Side: view of headwall and flap gate on toe.

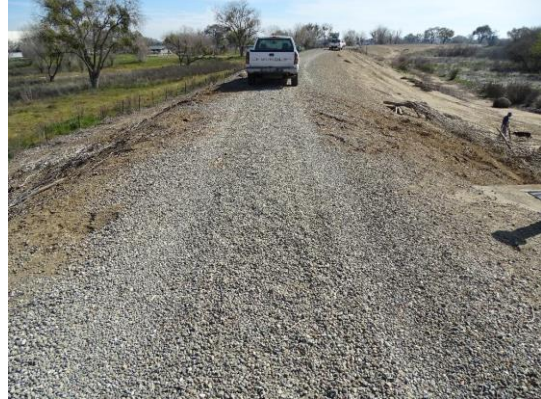
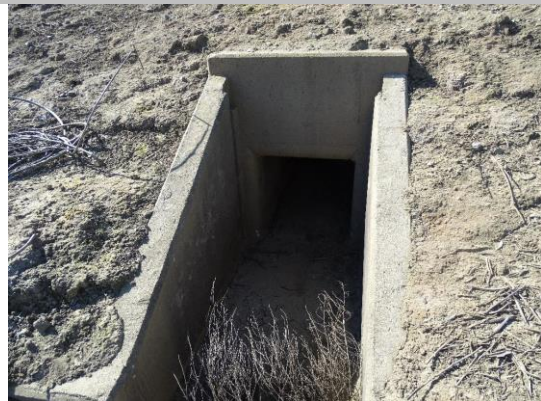
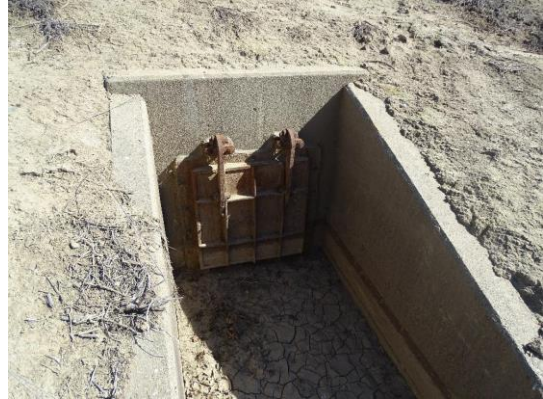
LM Start	1.94	Rating **	M	Issue No.	46
LM End	1.94	Issue Type +	Ma	Location *	
Category	Supplemental			GPS Latitude/Longitude	
				Start	End
Item	DWR UCIP LMA Responsibility			37.689900 °	37.689900 °
				-121.264802 °	-121.264802 °
DWR ID	20515

Comment Code					
Inspector Comment					
DS_ID:20515 FS_ID:72438 EP_NO: N/A Repair Type: Non-Urgent EVAL Issue: Crossing Status: Found UCIP Comments: 03/01/2022 Record remains No Action Needed. DMP internal video inspection has not found pipe integrity issues. LOF of crossing is less or equal to 4. Recommend next video inspection in 5 years. (D.Sanoski - DWR UCIP) 08/27/2013 Culvert filled nearly to the top with soil. (W.Wylie - DWR UCIP) FIELD_STRUCT_DESC: 30-inch by 30-inch reinforced concrete box drainage culvert through the levee, 14.7 feet below the crown. Slide gate in a concrete riser on the waterside (WS) slope. Concrete U-shaped headwalls on both ends. Flap gate on the WS end. [Additional Reference(s): DWR Levee Log, 2005. USACE San Joaquin O&M Manual 3, December 1968, (HLM 1.93)]. FS Date: 3/1/2022 12:25:21 PM

Levee crown: view of crown and crossing.

Land-Side: view of headwall and inlet.

Water-Side: view of headwall and flap gate.

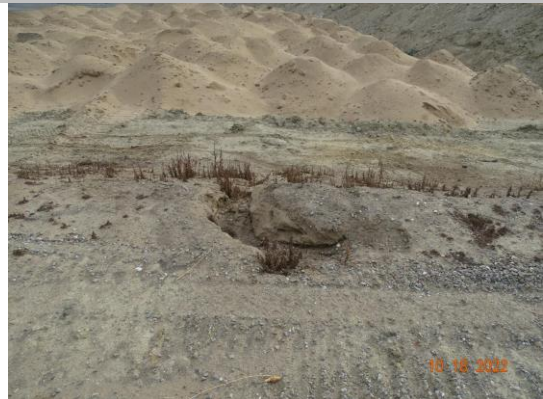
Photo 1 of 1 : FA_2022_RD2064_313_43_20221024_00036.jpg

LM Start	3.48	Rating **	M	Issue No.	43
LM End	3.48	Issue Type +	Ma	Location *	LS
Category	Earthen Levee			GPS Latitude/Longitude	
				Start	End
Item	Erosion / Bank Caving			37.676475 °	37.676475 °
				-121.264163 °	-121.264163 °
DWR ID	DWR_RD2064_01_s_2021_43				
Comment Code					
E2 : Schedule repair of erosion site prior to the next inspection.					
Inspector Comment					
Soil separation on landside slope. Separation likely caused by surface runoff from adjacent highway near the north side gate at S Airport Way. Spring 2021

View of soil separation on landside slope, caused by surface runoff from adjacent highway. Fall 2022

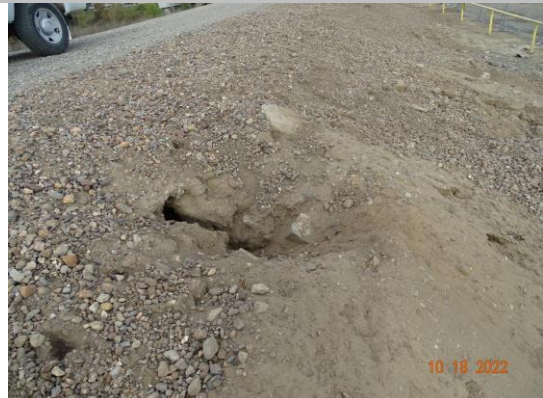
Photo 1 of 1 : FA_2022_RD2064_313_15_20221024_00037.jpg

LM Start	3.56	Rating **	U	Issue No.	15
LM End	3.56	Issue Type +	Ma	Location *	LS
Category	Earthen Levee			GPS Latitude/Longitude	
				Start	End
Item	Animal Control			37.675416 °	37.675416 °
				-121.263579 °	-121.263579 °
DWR ID	DWR_RD2064_01_f_2022_15				
Comment Code					
A3 : No rodents visible, but rodent burrows visible; need to backfill and compact or grout burrows.					
Inspector Comment

View of large animal burrow along the landside slope. Fall 2022

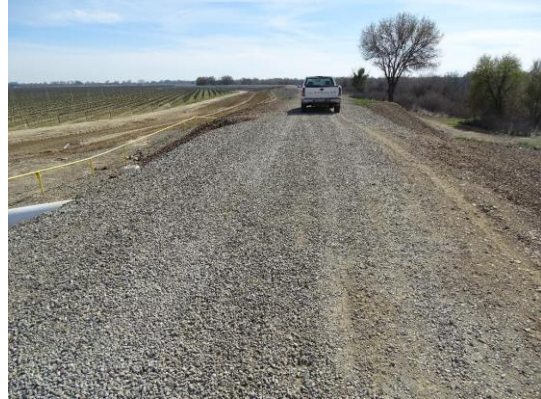
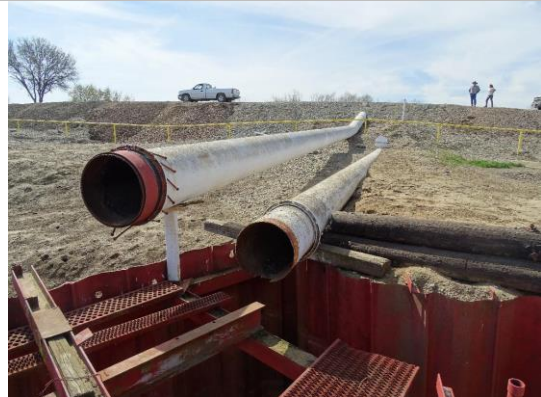
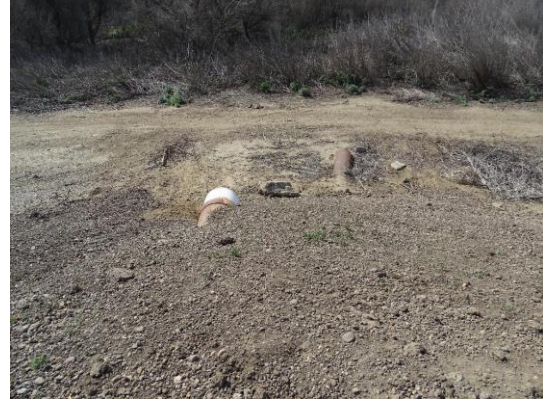
LM Start	3.57	Rating **	M	Issue No.	47	
LM End	3.57	Issue Type +	Ma	Location *		
Category	Supplemental			GPS Latitude/Longitude		
				Start		End
Item	DWR UCIP LMA Responsibility			37.675266 °		37.675266 °
				-121.263421 °		-121.263421 °
DWR ID	20525

Comment Code						
Inspector Comment						
DS_ID:20525						
FS_ID:72448						
EP_NO: N/A						
Repair Type: Non-Urgent						
EVAL Issue:						
Crossing Status: Found						
UCIP Comments: 08/01/2022 Work authorization WA2022058 issued for pipe removal. (O.Yakimov- DWR UCIP)						
03/01/2022 Record remains Non-Urgent. No permit has been identified authorizing pipe. Crossing appears abandoned. LMA Rep says they are working with CVFPB to remove these crossings. (D.Sanoski - DWR UCIP)						
08/27/2013 Need to determine if pipe was actually removed from levee. (W.Wylie - DWR UCIP)						
FIELD_STRUCT_DESC: 12-inch steel drainage pipe through the levee, at an unknown depth. Steel plate welded over the landside (LS) end at the LS toe. (Permit No. 6450, 1969 - Reclamation District No. 2064, states it was removed in 1973, but it remains visible on the LS toe). (Pipe removal authorized under Permit No. WA2022058, 2022 - JB Wilson, Reclamation District 2064). [Additional Reference(s): USACE San Joaquin O&M Manual 3, December 1968, (HLM 3.55)].

Top of Levee: view of crown.

Land-Side: view of pipe on slope.

Water-Side: view of slope.

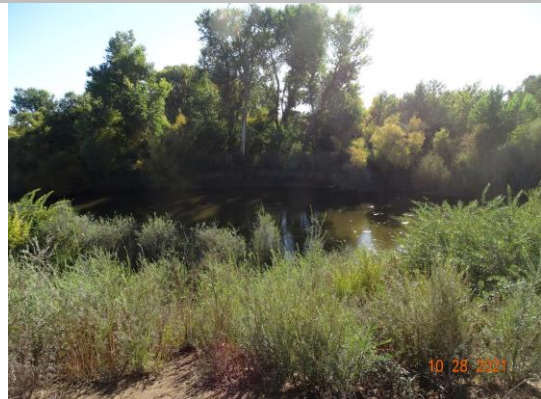
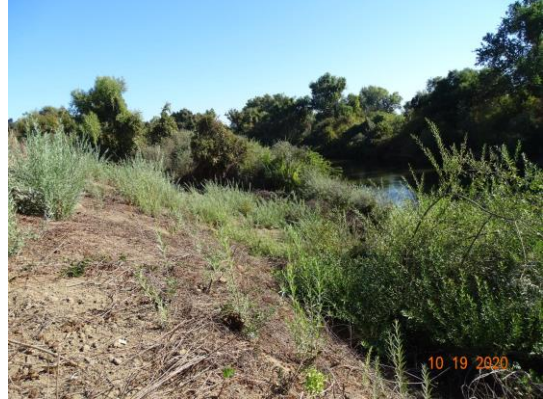
LM Start	1.55	Rating **	A/W	Issue No.	33
LM End	1.57	Issue Type +	Ma	Location *	WS
Category	Earthen Levee			GPS Latitude/Longitude	
				Start	End
Item	Erosion / Bank Caving			37.670791 °	37.671053 °
				-121.222220 °	-121.221903 °
DWR ID	DWR_RD2064_02_f_2020_33				
Comment Code					
E1 : Note and monitor erosion site.					
Inspector Comment					
Waterside berm has slowly been eroding. Berm ranges from 10-50 ft from waterside toe. RD plans to monitor. Spring 2021

View of waterside berm, approximately 10-40 ft from waterside toe. Fall 2021

View of waterside berm, approximately 10-40 ft from waterside toe. Fall 2020

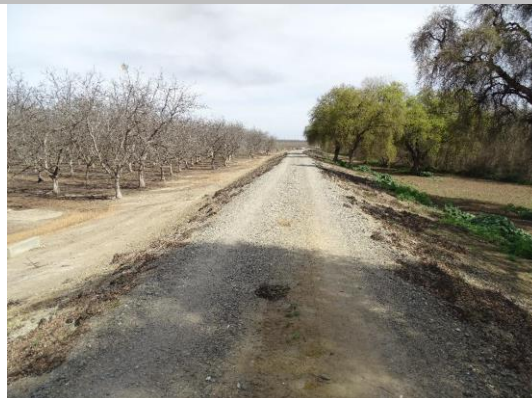
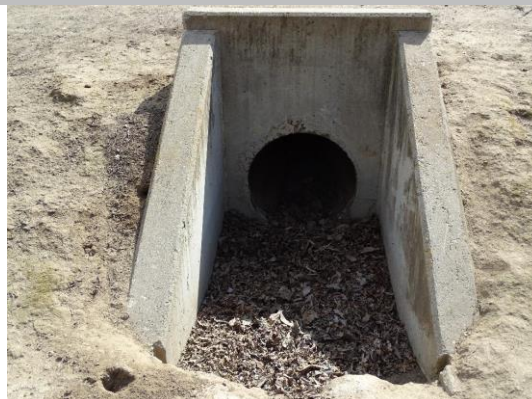
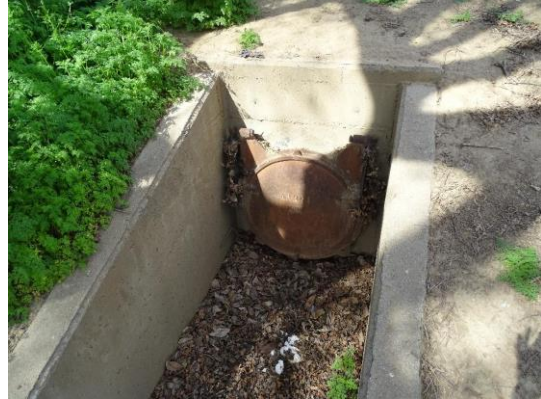
LM Start	4.41	Rating **	M	Issue No.	45	
LM End	4.41	Issue Type +	Ma	Location *		
Category	Supplemental			GPS Latitude/Longitude		
				Start	End	
Item	DWR UCIP LMA Responsibility			37.696386 °	37.696386 °	
				-121.202963 °	-121.202963 °	
DWR ID	20549

Comment Code						
Inspector Comment						
DS_ID:20549 FS_ID:72478 EP_NO: N/A Repair Type: Non-Urgent EVAL Issue: Crossing Status: Found UCIP Comments: 03/03/2022 Record updated from No Action Needed to Non-Urgent. No permit has been identified authorizing pipe. (D.Sanoski - DWR UCIP) FIELD_STRUCT_DESC: 30-inch drainage pipe of an unknown material through the levee, 10.5 feet below the crown. Concrete U-shaped headwalls on both ends. Flap gate on the waterside (WS) end. Two corrugated metal cutoff walls. [Additional Reference(s): DWR Levee Log, 2005. USACE San Joaquin O&M Manual 3, December 1968, (HLM 4.37)]. FS Date: 3/3/2022 3:51:31 PM

Top of Levee: view of crown.

Land-Side: view of headwall and inlet.

Water-Side: view of headwall and flap gate.

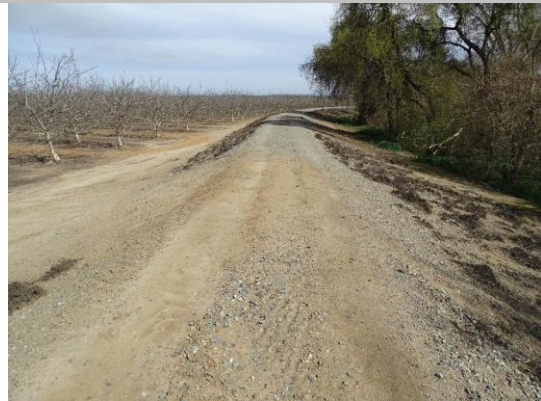
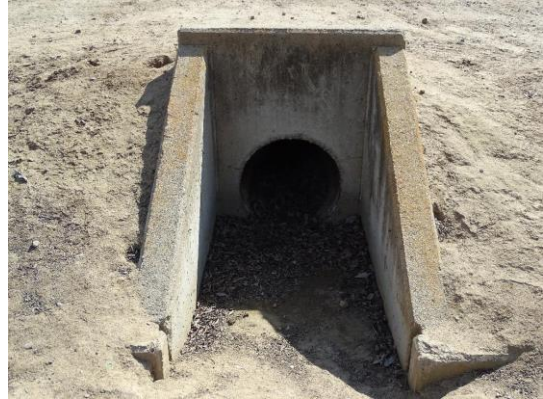
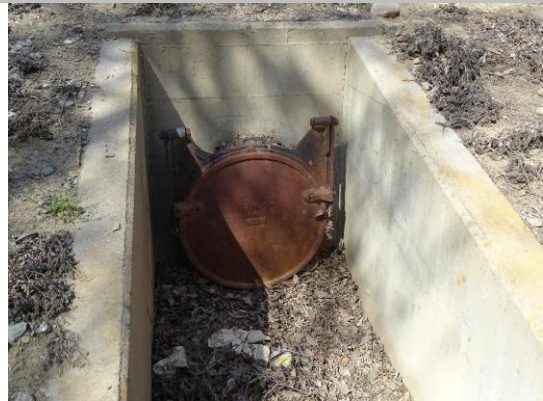
LM Start	4.51	Rating **	M	Issue No.	46
LM End	4.51	Issue Type +	Ma	Location *	
Category	Supplemental			GPS Latitude/Longitude	
				Start	End
Item	DWR UCIP LMA Responsibility			37.696892 °	37.696892 °
				-121.201228 °	-121.201228 °
DWR ID	20550

DS_ID:20550
FS_ID:72479
EP_NO: N/A
Repair Type: Non-Urgent
EVAL Issue:
Crossing Status: Found
UCIP Comments: 03/03/2022 Record updated from No Action Needed to Non-Urgent. No permit has been identified authorizing pipe. (D.Sanoski - DWR UCIP)

Top of Levee: view of crown.

Land-Side: view of headwall and inlet.

Water-Side: view of headwall and flap gate.

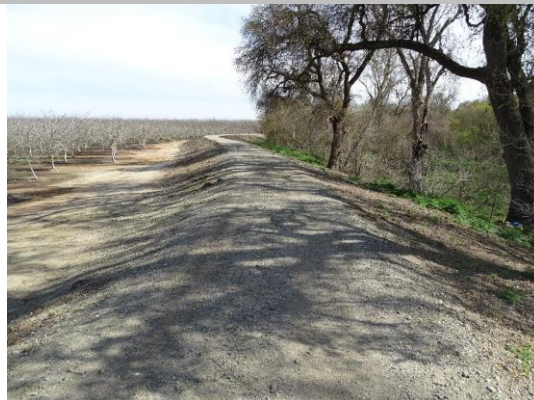
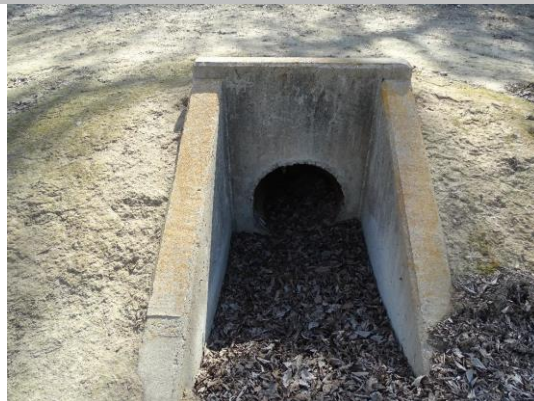
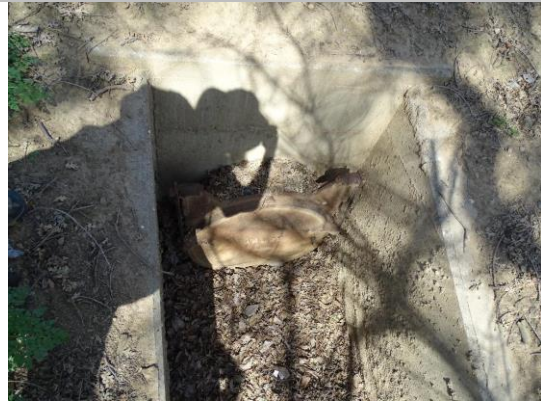
Comment Code					
Inspector Comment					
DS_ID:20551 FS_ID:72480 EP_NO: N/A Repair Type: Non-Urgent EVAL Issue: Crossing Status: Found UCIP Comments: 03/03/2022 Record updated from No Action Needed to Non-Urgent. No permit has been identified authorizing pipe. (D.Sanoski - DWR UCIP)					
FIELD_STRUCT_DESC: 30-inch corrugated metal drainage pipe through the levee, 10 feet below the crown. Concrete U-shaped headwalls on both ends. Flap gate on the waterside (WS) end. Two corrugated metal cutoff walls. Grouted spillway on the WS. Spillway damaged due to uprooted tree. [Additional Reference(s): DWR Levee Log, 2005. USACE San Joaquin O&M Manual 3, December 1968, (HLM 4.59)]. FS Date: 3/3/2022 4:11:22 PM

Top of Levee: view of crown.

Land-Side: view of headwall and inlet.

Water-Side: view of headwall and flap gate.

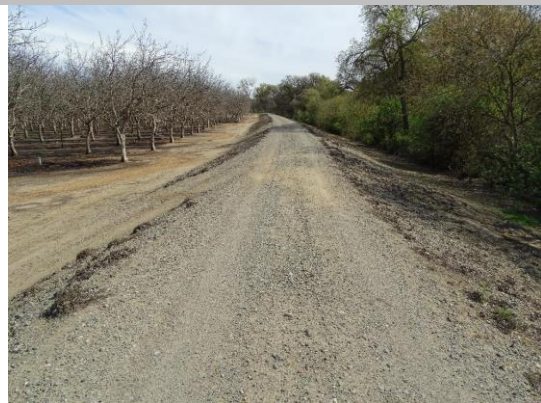
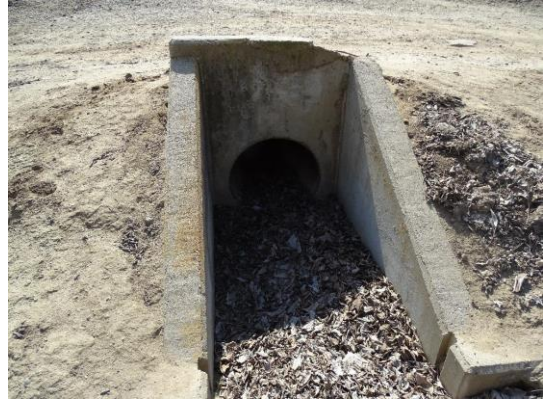
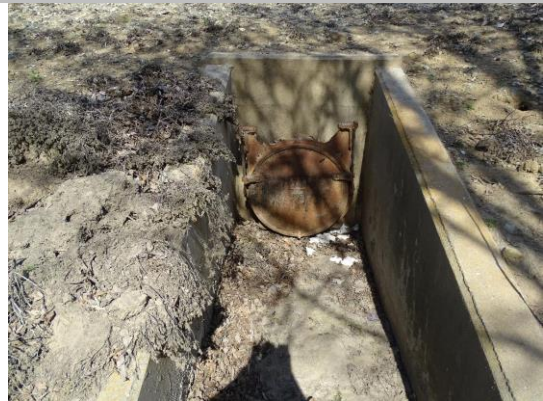
LM Start	4.78	Rating **	M	Issue No.	48
LM End	4.78	Issue Type +	Ma	Location *	
Category	Supplemental			GPS Latitude/Longitude	
				Start	End
Item	DWR UCIP LMA Responsibility			37.696888 °	37.696888 °
				-121.196511 °	-121.196511 °
DWR ID	20552

DS_ID:20552
 FS_ID:72481
 EP_NO: N/A
 Repair Type: Non-Urgent
 EVAL Issue:
 Crossing Status: Found
 UCIP Comments: 03/03/2022 Record updated from No Action Needed to Non-Urgent. No permit has been identified authorizing pipe. (D.Sanoski - DWR UCIP)
 FIELD_STRUCT_DESC: 30-inch corrugated metal drainage pipe through the levee, 8.5 feet below the crown. Concrete U-shaped headwalls on both ends. Flap gate on the waterside (WS) end. Two corrugated metal cutoff walls. Grouted spillway on the WS. [Additional Reference(s): DWR Levee Log, 2005. USACE San Joaquin O&M Manual 3, December 1968, (HLM 4.73)].
 FS Date: 3/3/2022 4:14:09 PM

Top of Levee: view of crown.

Land-Side: view of headwall and inlet.

Water-Side: view of headwall and flap gate.

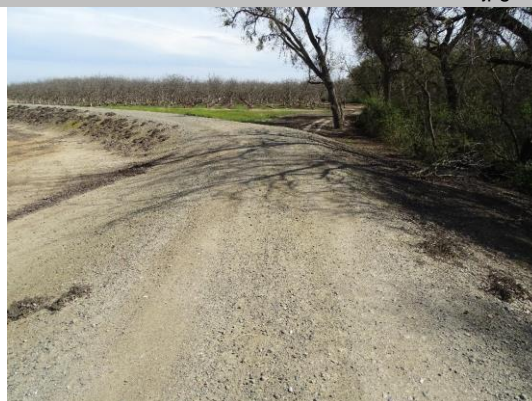
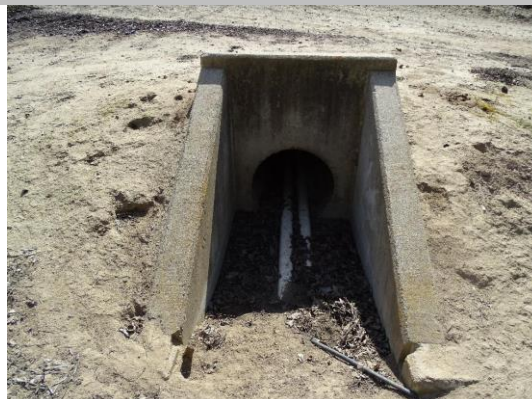
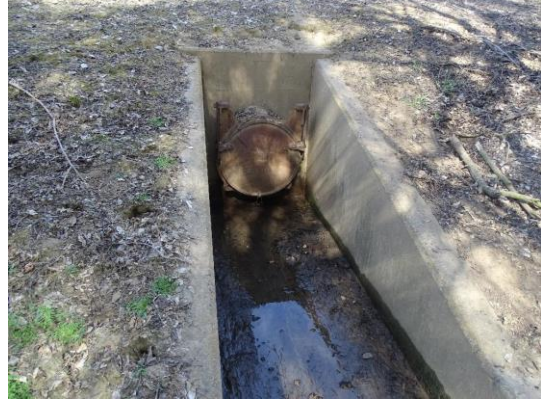
Comment Code						
Inspector Comment						
DS_ID:20553 FS_ID:72484 EP_NO: N/A Repair Type: Non-Urgent EVAL Issue: Crossing Status: Found UCIP Comments: 03/03/2022 Record updated from No Action Needed to Non-Urgent. No permit has been identified authorizing pipe. (D.Sanoski - DWR UCIP) FIELD_STRUCT_DESC: 30-inch corrugated metal drainage pipe through the levee, 8 feet below the crown. Concrete U-shaped headwalls on both ends. Flap gate on the waterside (WS) end. Two corrugated metal cutoff walls. Grouted spillway on the WS. [Additional Reference(s): DWR Levee Log, 2005. USACE San Joaquin O&M Manual 3, December 1968, (HLM 4.88)]. FS Date: 3/3/2022 4:21:52 PM

Top of Levee: view of crown.

Land-Side: view of headwall and pipe inlet.

Water-Side: view of headwall and flap gate.

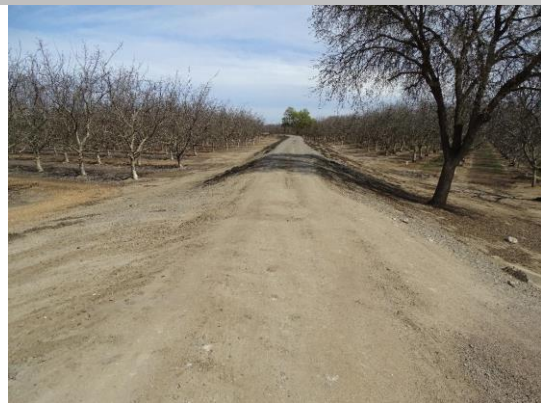
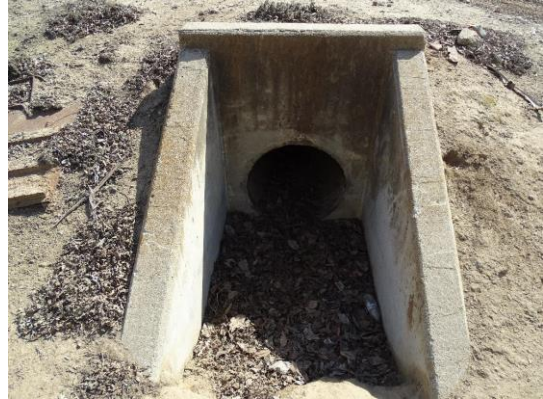
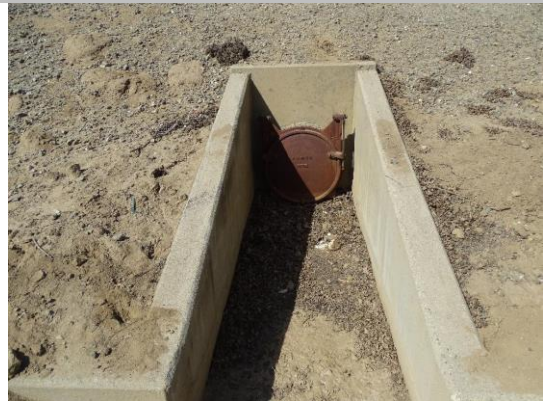
LM Start	5.10	Rating **	M	Issue No.	50
LM End	5.10	Issue Type +	Ma	Location *	
Category	Supplemental			GPS Latitude/Longitude	
				Start	End
Item	DWR UCIP LMA Responsibility			37.697483 °	37.697483 °
				-121.191332 °	-121.191332 °
DWR ID	20554

Top of Levee: view of crown.

Comment Code					
Inspector Comment					
DS_ID:20554 FS_ID:72485 EP_NO: N/A Repair Type: Non-Urgent EVAL Issue: Crossing Status: Found UCIP Comments: 03/03/2022 Record updated from No Action Needed to Non-Urgent. No permit has been identified authorizing pipe. (D.Sanoski - DWR UCIP) FIELD_STRUCT_DESC: 30-inch corrugated metal drainage pipe through the levee, 8 feet below the crown. Concrete U-shaped headwalls on both ends. Flap gate on the waterside (WS) end. Two corrugated metal cutoff walls. Grouted spillway on the WS. [Additional Reference(s): DWR Levee Log, 2005. USACE San Joaquin O&M Manual 3, December 1968, (HLM 5.05)]. FS Date: 3/3/2022 4:23:51 PM

Land-Side: view of headwall and inlet.

Water-Side: view of headwall and flap gate.
