**Flood Control Project Maintenance  
Levee Inspections**

## Maintenance Issue Types Only, Levee Inspection Report By Mile - Fall 2023

### Reclamation District No. 2064 River Junction

Waterway	Bank	Unit Miles	Inspection Start/End	Inspector
Unit No. 01 San Joaquin River	Right	5.56	10/16/2023 10/16/2023	Alberto De Leon

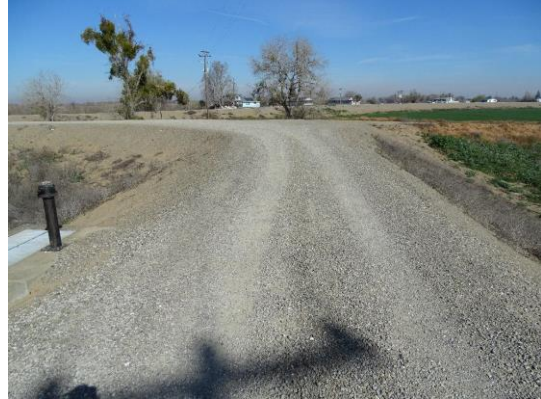
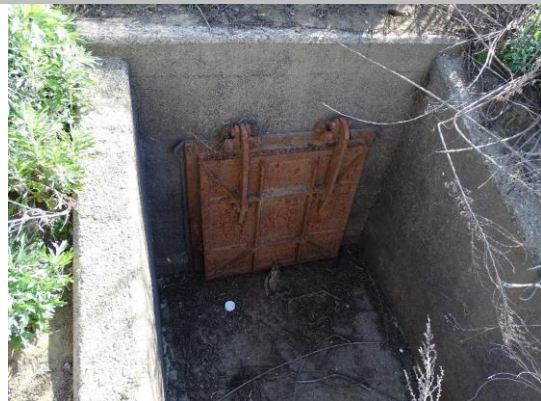
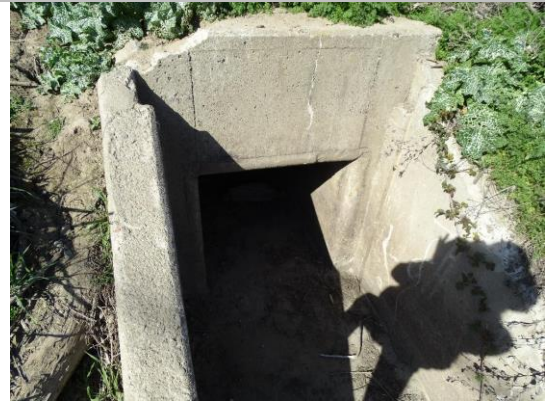
LM Start	0.06	Rating **	M	Issue No.	44
LM End	0.06	Issue Type +	Ma	Location *	
Category	Supplemental			GPS Latitude/Longitude	
				Start	End
Item	DWR UCIP LMA Responsibility			37.709804°	37.709804°
				-121.267559°	-121.267559°
DWR ID	20511

Comment Code					
Inspector Comment					
DS_ID:20511 FS_ID:72428 EP_NO: N/A Repair Type: Non-Urgent EVAL Issue: Crossing Status: Found UCIP Comments: 03/01/2022 Record updated from No Action Needed to Non-Urgent. No permit has been identified authorizing pipe. Debris has been cleared. (D.Sanoski - DWR UCIP) 03/02/2015 Debris removed from flap gate on waterside tow (G.Armstrong - DWR UCIP) FIELD_STRUCT_DESC: 36-inch by 36-inch reinforced concrete box drainage culvert through the levee, 21 feet below the crown. Concrete U-shaped headwalls on both ends. Slide gate in a 6-foot by 7-foot concrete riser on the waterside (WS) slope. Flap gate on the WS end. Flashboard slots on the landside (LS) headwall. [Additional Reference(s): DWR Levee Log, 2005. USACE San Joaquin O&M Manual 3, December 1968, (HLM 0.07)]. FS Date: 3/1/2022 11:31:10 AM

Top of Levee: view of crown.

Water-Side: view of headwall and flap gate.

Land-Side: view of headwall and inlet.

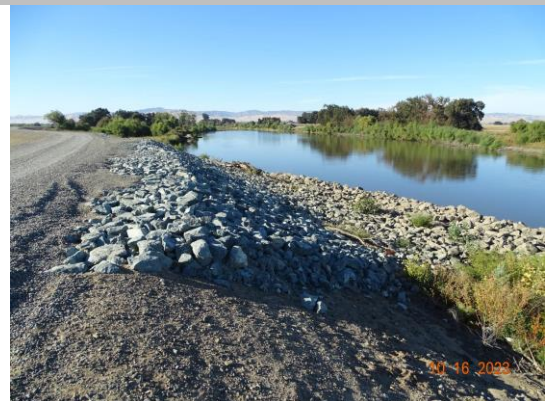
Photo 1 of 1 : FA\_2023\_RD2064\_313\_9\_20231016\_00037.jpg

LM Start	0.41	Rating **	A/W	Issue No.	9
LM End	0.48	Issue Type +	Ma	Location *	WS
Category	Earthen Levee			GPS Latitude/Longitude	
				Start	End
Item	Riprap Revetments			37.705975°	37.705041°
				-121.271092°	-121.271279°
DWR ID	DWR_RD2064_01_s_2023_9				
Comment Code					
RR : Riprap Revetments					
Inspector Comment					
Emergency erosion repair project has been completed in January 2023.

View of a completed (Jan. 2023) waterside erosion repair. Fall 2023

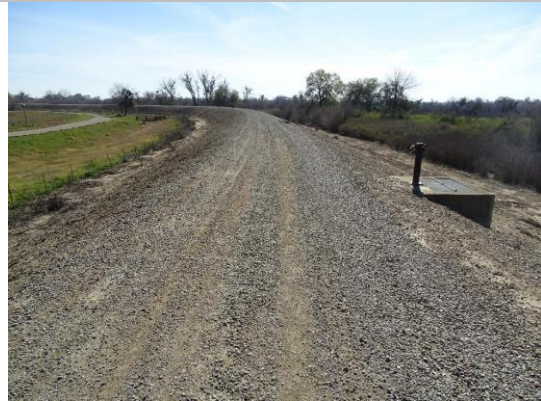
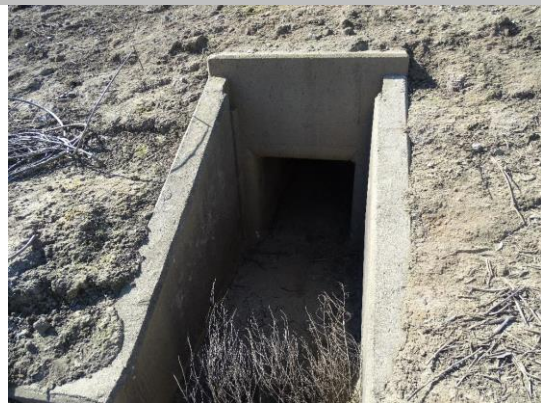
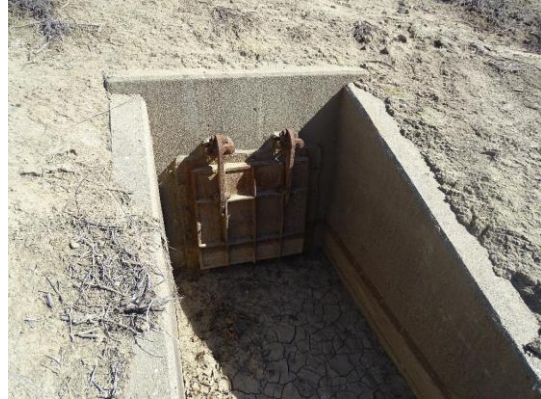
LM Start	1.65	Rating **	A/W	Issue No.	45	
LM End	1.65	Issue Type +	Ma	Location *		
Category	Supplemental			GPS Latitude/Longitude		
				Start	End	
Item	DWR UCIP LMA Responsibility			37.690072°	37.690072°	
				-121.269823°	-121.269823°	
DWR ID	20514

Comment Code						
Inspector Comment						
DS_ID:20514 FS_ID:72439 EP_NO: N/A Repair Type: No Action Needed EVAL Issue: Crossing Status: Found UCIP Comments: 03/01/2022 Record remains No Action Needed. DMP internal video inspection has not found pipe integrity issues. LOF of crossing is less or equal to 4. Recommend next video inspection in 5 years. System Feature. (D.Sanoski - DWR UCIP) FIELD_STRUCT_DESC: 30-inch by 30-inch reinforced concrete box drainage culvert through the levee, 15 feet below the crown. Slide gate in a concrete riser on the waterside (WS) shoulder. Concrete U-shaped headwalls on both ends. Flap gate on the WS end. [Additional Reference(s): DWR Levee Log, 2005. USACE San Joaquin O&M Manual 3, December 1968, (HLM 1.65)]. FS Date: 3/1/2022 12:30:04 PM

Top of Levee: view of crown.

Land-Side: view of headwall and inlet on toe.

Water-Side: view of headwall and flap gate on toe.

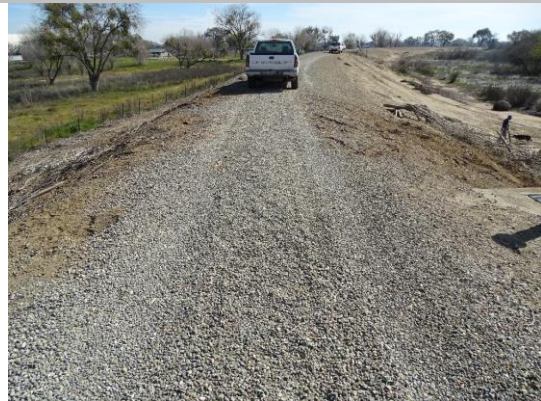
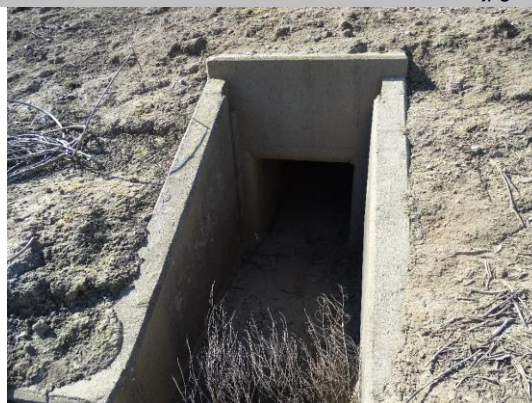
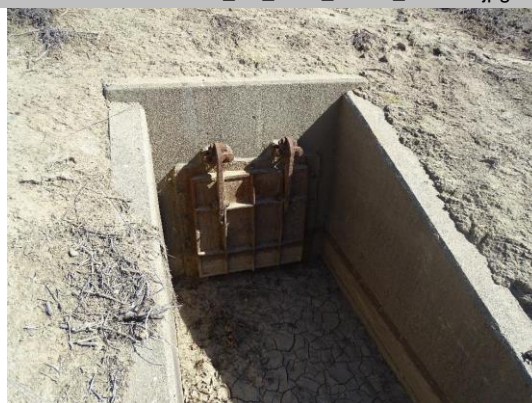
LM Start	<b>1.94</b>	Rating **	A/W	Issue No.	<b>46</b>
LM End	<b>1.94</b>	Issue Type +	Ma	Location *	
Category	Supplemental		GPS Latitude/Longitude		
			Start	End	
Item	DWR UCIP LMA Responsibility		37.689900°	37.689900°	
			-121.264802°	-121.264802°	
DWR ID	20515

DS\_ID:20515  
 FS\_ID:72438  
 EP\_NO: N/A  
 Repair Type: No Action Needed  
 EVAL Issue:  
 Crossing Status: Found  
 UCIP Comments: 03/01/2022 Record remains No Action Needed. DMP internal video inspection has not found pipe integrity issues. LOF of crossing is less or equal to 4. Recommend next video inspection in 5 years. (D.Sanoski - DWR UCIP)  
 08/27/2013 Culvert filled nearly to the top with soil. (W.Wylie - DWR UCIP)  
 FIELD\_STRUCT\_DESC: 30-inch by 30-inch reinforced concrete box drainage culvert through the levee, 14.7 feet below the crown. Slide gate in a concrete riser on the waterside (WS) slope. Concrete U-shaped headwalls on both ends. Flap gate on the WS end. [Additional Reference(s): DWR Levee Log, 2005. USACE San Joaquin O&M Manual 3, December 1968, (HLM 1.93)].  
 FS Date: 3/1/2022 12:25:21 PM

Levee crown: view of crown and crossing.

Land-Side: view of headwall and inlet.

Water-Side: view of headwall and flap gate.

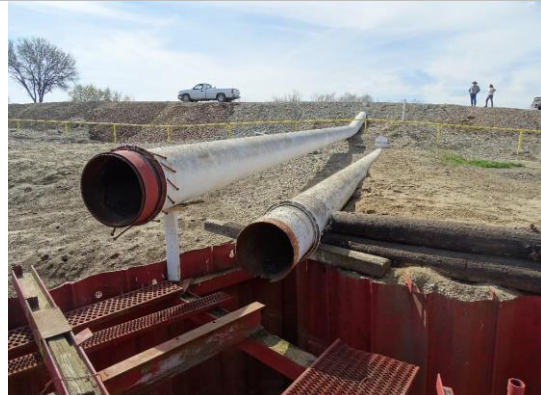
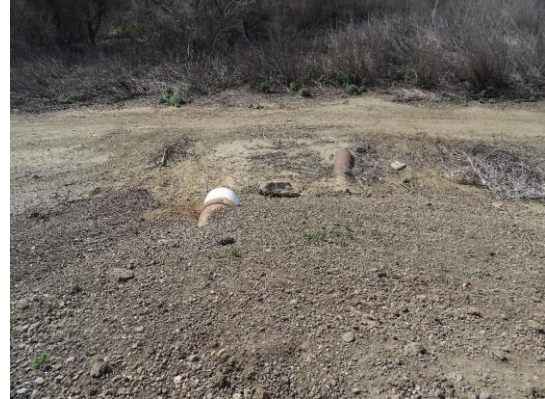
LM Start	3.57	Rating **	M	Issue No.	47
LM End	3.57	Issue Type +	Ma	Location *	
Category	Supplemental			GPS Latitude/Longitude	
				Start	End
Item	DWR UCIP LMA Responsibility			37.675266°	37.675266°
				-121.263421°	-121.263421°
DWR ID	20525

Comment Code					
Inspector Comment					
DS_ID:20525 FS_ID:72448 EP_NO: N/A Repair Type: Non-Urgent EVAL Issue: Crossing Status: Found UCIP Comments: 08/01/2022 Work authorization WA2022058 issued for pipe removal. (O.Yakimov- DWR UCIP) 03/01/2022 Record remains Non-Urgent. No permit has been identified authorizing pipe. Crossing appears abandoned. LMA Rep says they are working with CVFPB to remove these crossings. (D.Sanoski - DWR UCIP) 08/27/2013 Need to determine if pipe was actually removed from levee. (W.Wylie - DWR UCIP) FIELD_STRUCT_DESC: 12-inch steel drainage pipe through the levee, at an unknown depth. Steel plate welded over the landside (LS) end at the LS toe. (Permit No. 6450, 1969 - Reclamation District No. 2064, states it was removed in 1973, but it remains visible on the LS toe). (Pipe removal authorized under Permit No. WA2022058, 2022 - JB Wilson, Reclamation District 2064). [Additional Reference(s): USACE San Joaquin O&M Manual 3, December 1968, (HLM 3.55)]. FS Date: 3/1/2022 12:51:49 PM

Top of Levee: view of crown.

Land-Side: view of pipe on slope.

Water-Side: view of slope.

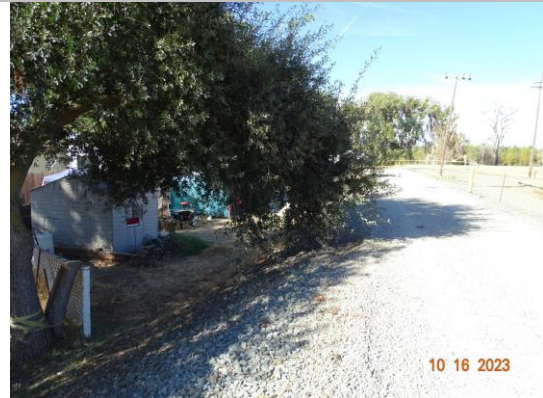
Photo 1 of 1 : FA\_2023\_RD2064\_314\_32\_20231016\_00028.jpg

LM Start	0.05	Rating **	M	Issue No.	32
LM End	0.05	Issue Type +	Ma	Location *	WS
Category	Earthen Levee			GPS Latitude/Longitude	
				Start	End
Item	Trim / Thin Trees			37.666872°	37.666872°
				-121.240207°	-121.240207°
DWR ID	DWR_RD2064_02_f_2022_32				
Comment Code					
T1 : Trim and thin trees to at least five feet above ground level to allow visibility of the ground and room to flood fight.					
Inspector Comment

View of untrimmed tree along the waterside slope. Fall 2023

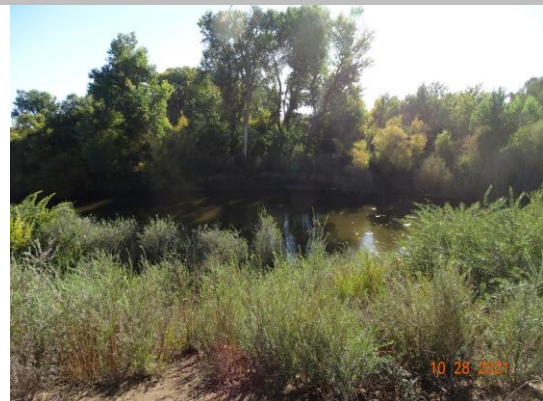
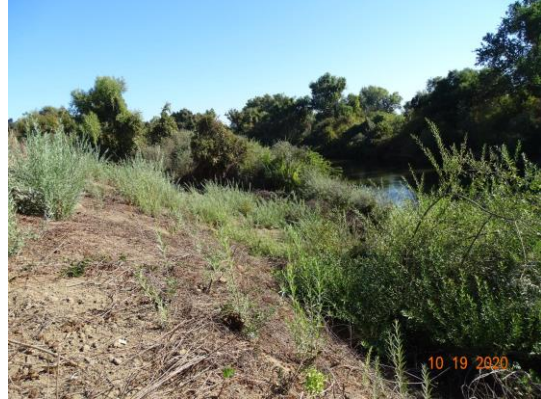
View of waterside berm, approximately 10-40 ft from waterside toe. Fall 2021

View of waterside berm, approximately 10-40 ft from waterside toe. Fall 2020

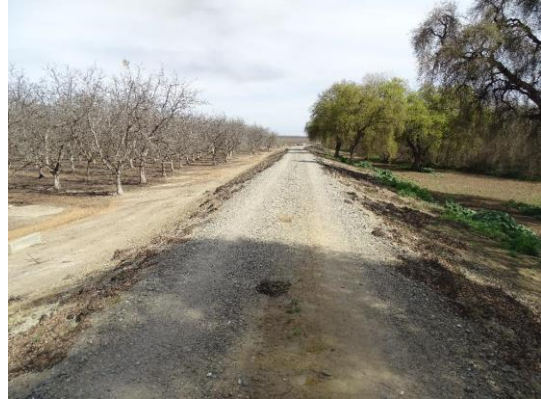
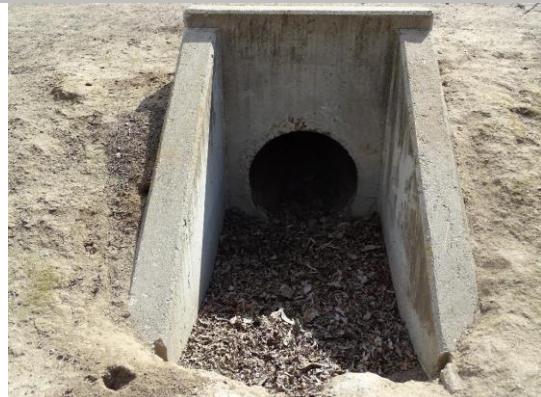
Comment Code						
Inspector Comment						
DS_ID:20549 FS_ID:72478 EP_NO: N/A Repair Type: Non-Urgent EVAL Issue: Crossing Status: Found UCIP Comments: 03/03/2022 Record updated from No Action Needed to Non-Urgent. No permit has been identified authorizing pipe. (D.Sanoski - DWR UCIP)  FIELD_STRUCT_DESC: 30-inch drainage pipe of an unknown material through the levee, 10.5 feet below the crown. Concrete U-shaped headwalls on both ends. Flap gate on the waterside (WS) end. Two corrugated metal cutoff walls. [Additional Reference(s): DWR Levee Log, 2005. USACE San Joaquin O&M Manual 3, December 1968, (HLM 4.37)]. FS Date: 3/3/2022 3:51:31 PM

Top of Levee: view of crown.

Land-Side: view of headwall and inlet.

Water-Side: view of headwall and flap gate.

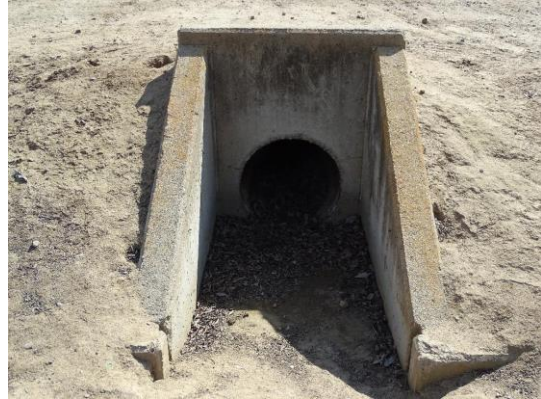
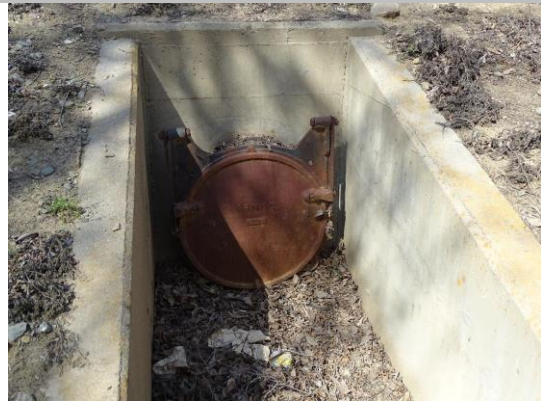
LM Start	<b>4.51</b>	Rating **	M	Issue No.	<b>46</b>
LM End	<b>4.51</b>	Issue Type +	Ma	Location *	
Category	Supplemental			GPS Latitude/Longitude	
				Start	End
Item	DWR UCIP LMA Responsibility			37.696892°	37.696892°
				-121.201228°	-121.201228°
DWR ID	20550

DS\_ID:20550  
FS\_ID:72479  
EP\_NO: N/A  
Repair Type: Non-Urgent  
EVAL Issue:  
Crossing Status: Found  
UCIP Comments: 03/03/2022 Record updated from No Action Needed to Non-Urgent. No permit has been identified authorizing pipe. (D.Sanoski - DWR UCIP)

Top of Levee: view of crown.

Land-Side: view of headwall and inlet.

Water-Side: view of headwall and flap gate.

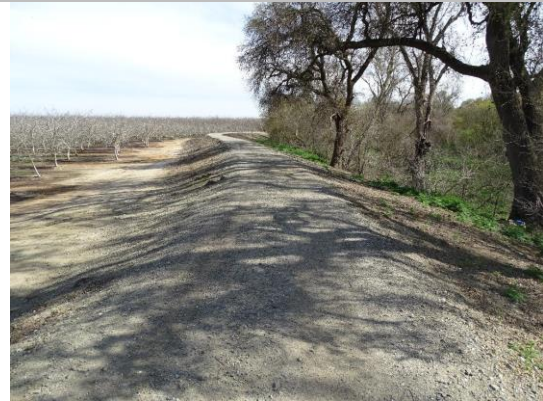
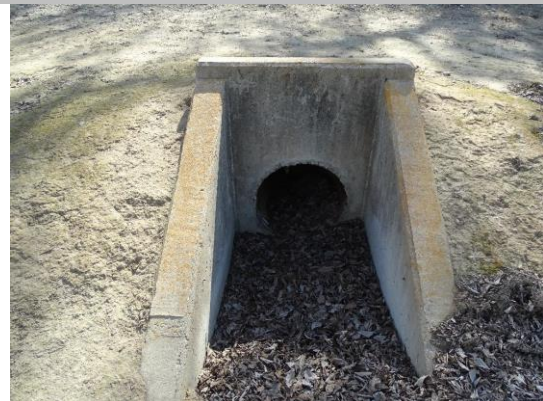
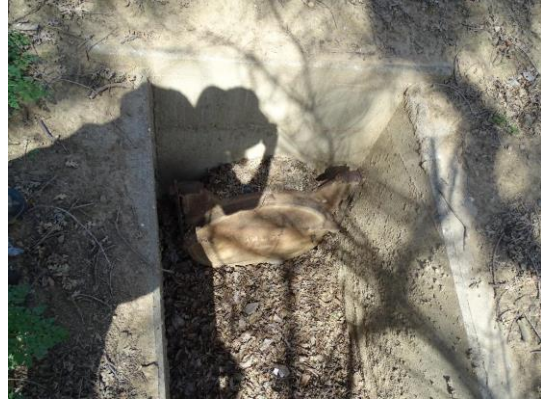
Comment Code					
Inspector Comment					
DS_ID:20551 FS_ID:72480 EP_NO: N/A Repair Type: Non-Urgent EVAL Issue: Crossing Status: Found UCIP Comments: 03/03/2022 Record updated from No Action Needed to Non-Urgent. No permit has been identified authorizing pipe. (D.Sanoski - DWR UCIP)  FIELD_STRUCT_DESC: 30-inch corrugated metal drainage pipe through the levee, 10 feet below the crown. Concrete U-shaped headwalls on both ends. Flap gate on the waterside (WS) end. Two corrugated metal cutoff walls. Grouted spillway on the WS. Spillway damaged due to uprooted tree. [Additional Reference(s): DWR Levee Log, 2005. USACE San Joaquin O&M Manual 3, December 1968, (HLM 4.59)]. FS Date: 3/3/2022 4:11:22 PM

Top of Levee: view of crown.

Land-Side: view of headwall and inlet.

Water-Side: view of headwall and flap gate.

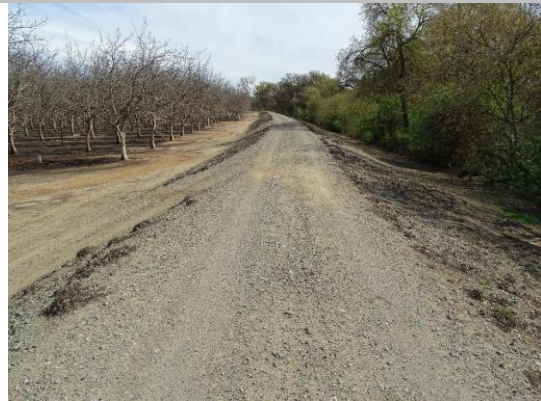
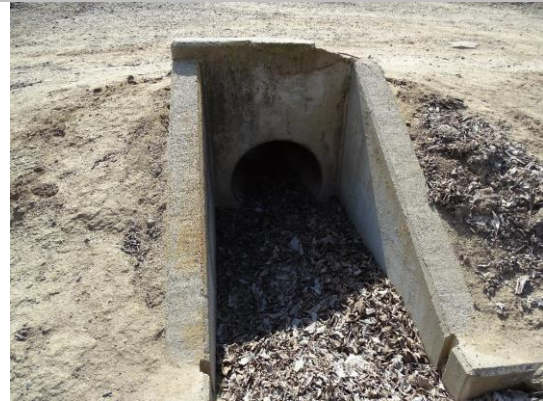
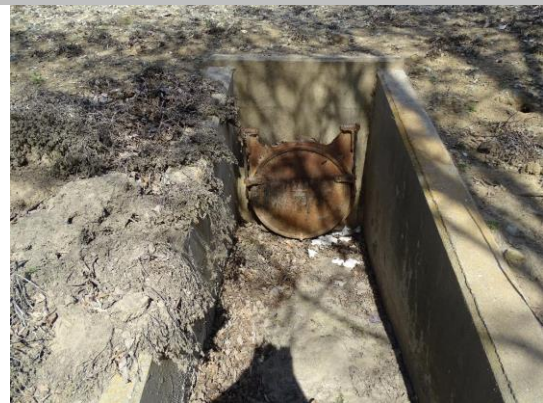
LM Start	<b>4.78</b>	Rating **	M	Issue No.	<b>48</b>
LM End	<b>4.78</b>	Issue Type +	Ma	Location *	
Category	Supplemental			GPS Latitude/Longitude	
				Start	End
Item	DWR UCIP LMA Responsibility			37.696888°	37.696888°
				-121.196511°	-121.196511°
DWR ID	20552

DS\_ID:20552  
 FS\_ID:72481  
 EP\_NO: N/A  
 Repair Type: Non-Urgent  
 EVAL Issue:  
 Crossing Status: Found  
 UCIP Comments: 03/03/2022 Record updated from No Action Needed to Non-Urgent. No permit has been identified authorizing pipe.  
 (D.Sanoski - DWR UCIP)

Top of Levee: view of crown.

Land-Side: view of headwall and inlet.

Water-Side: view of headwall and flap gate.
