**Flood Control Project Maintenance
Levee Inspections**

Maintenance Issue Types Only, Levee Inspection Report By Mile - Fall 2024

Reclamation District No. 2064 River Junction

Waterway	Bank	Unit Miles	Inspection Start/End	Inspector
Unit No. 01 San Joaquin River	Right	5.56	10/28/2024 10/28/2024	Alberto De Leon

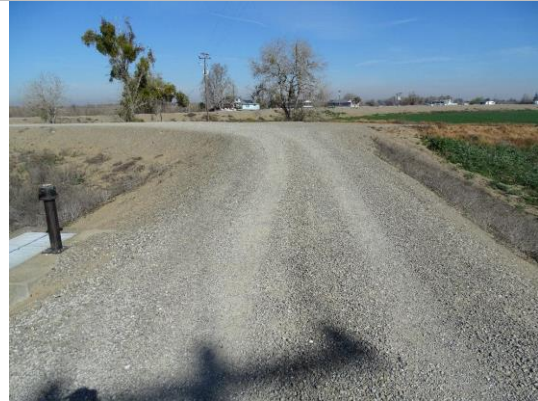
Photo 1 of 3 : UCIP_FA_2024_82220_108212.jpg

Comment Code					
Inspector Comment					
DS_ID:20511 FS_ID:82220 EP_NO: N/A Repair Type: No Action Needed EVAL Issue: Crossing Status: Found UCIP Comments: 02/05/2024 Record updated from Non-Urgent to No Action Needed. Pipe is a system feature. (J. Taylor - DWR UCIP) 03/01/2022 Record updated from No Action Needed to Non-Urgent. No permit has been identified authorizing pipe. Debris has been cleared. (D.Sanoski - DWR UCIP) 03/02/2015 Debris removed from flap gate on waterside tow (G.Armstrong - DWR UCIP) FIELD_STRUCT_DESC: 36-inch by 36-inch reinforced concrete box drainage culvert through the levee, 21 feet below the crown. Concrete U-shaped headwalls on both ends. Slide gate in a 6-foot by 7-foot concrete riser on the waterside (WS) slope. Flap gate on the WS end. Flashboard slots on the landside (LS) headwall. [Additional Reference(s): DWR Levee Log, 2005 (HLM 0.07). USACE San Joaquin O&M Manual, Unit 3, December 1968, Revised 29 December 2016, (HLM 0.03), listed as 36-inch square culvert]. FS Date: 3/1/2022 11:31:10 AM

Top of Levee: view of crown.

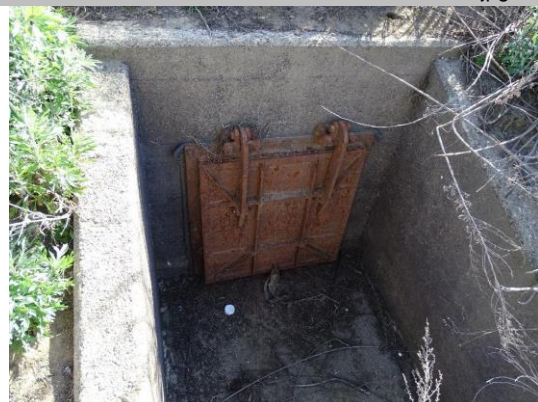
Photo 2 of 3 : UCIP_FA_2024_82220_108213.jpg

Water-Side: view of headwall and flap gate.

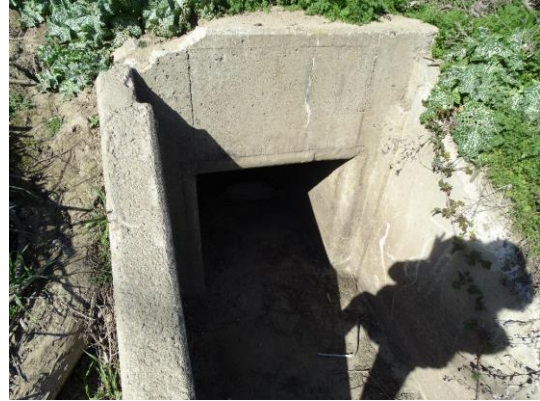
Photo 3 of 3 : UCIP_FA_2024_82220_108214.jpg

Land-Side: view of headwall and inlet.

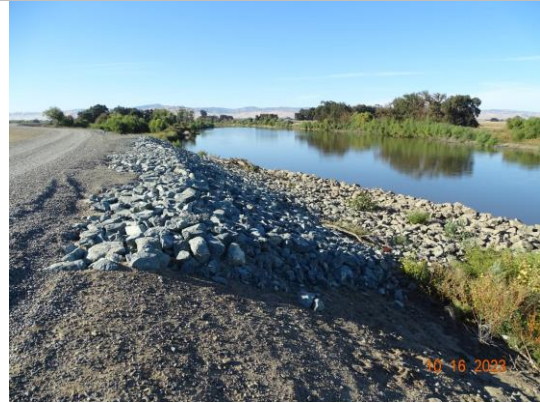
Photo 1 of 1 : FA_2024_RD2064_313_9_20240910_00001.jpg

LM Start	0.41	Rating **	A/W	Issue No.	9
LM End	0.48	Issue Type +	Ma	Location *	WS
Category	Earthen Levee			GPS Latitude/Longitude	
				Start	End
Item	Riprap Revetments			37.705975°	37.705041°
				-121.271092°	-121.271279°
DWR ID	DWR_RD2064_01_s_2023_9				
Comment Code					
RR : Riprap Revetments					
Inspector Comment					
Emergency erosion repair project has been completed in January 2023.

View of a completed (Jan. 2023) waterside erosion repair. Fall 2023

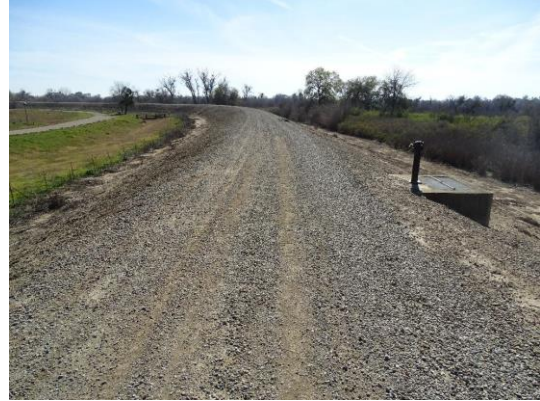
Photo 1 of 3 : UCIP_FA_2024_82221_108257.jpg

Comment Code					
Inspector Comment					
DS_ID:20514 FS_ID:82221 EP_NO: N/A Repair Type: No Action Needed EVAL Issue: Crossing Status: Found UCIP Comments: 03/01/2022 Record remains No Action Needed. DMP internal video inspection has not found pipe integrity issues. LOF of crossing is less or equal to 4. Recommend next video inspection in 5 years. System Feature. (D.Sanoski - DWR UCIP) FIELD_STRUCT_DESC: 30-inch by 30-inch reinforced concrete box drainage culvert through the levee, 15 feet below the crown. Slide gate in a concrete riser on the waterside (WS) shoulder. Concrete U-shaped headwalls on both ends. Flap gate on the WS end. [Additional Reference(s): DWR Levee Log, 2005 (HLM 1.70). USACE San Joaquin O&M Manual, Unit 3, December 1968, Revised 29 December 2016, (HLM 1.70), listed as 30-inch square culvert]. FS Date: 3/1/2022 12:30:04 PM

Top of Levee: view of crown.

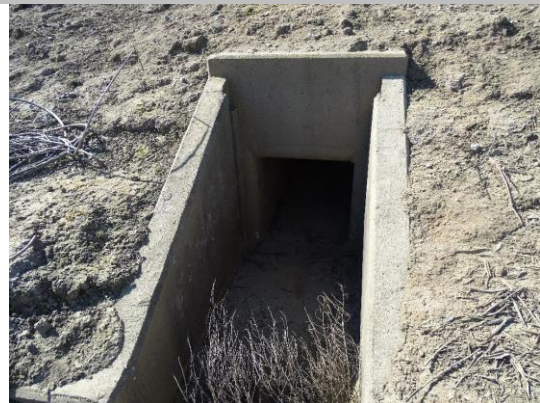
Photo 2 of 3 : UCIP_FA_2024_82221_108258.jpg

Land-Side: view of headwall and inlet on toe.

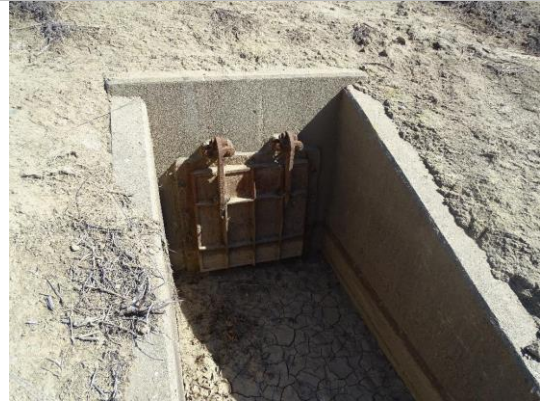
Photo 3 of 3 : UCIP_FA_2024_82221_108259.jpg

Water-Side: view of headwall and flap gate on toe.

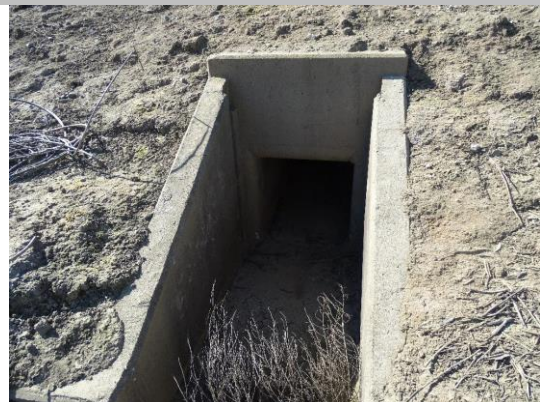
Photo 2 of 3 : UCIP_FA_2024_82223_108253.jpg

Land-Side: view of headwall and inlet.

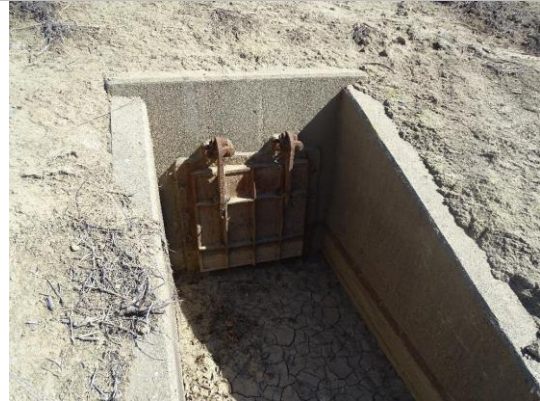
Photo 3 of 3 : UCIP_FA_2024_82223_108254.jpg

Water-Side: view of headwall and flap gate.

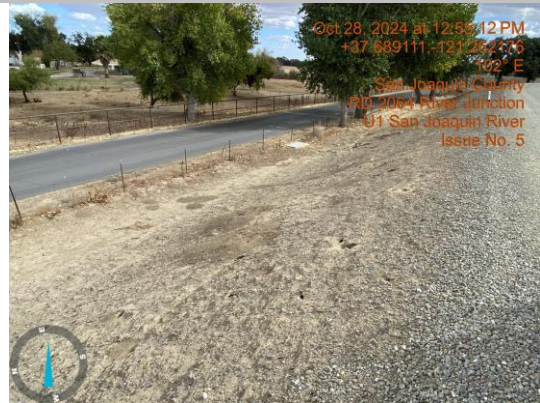
Photo 1 of 1 : FA_2024_RD2064_313_5_20241029_00032.jpg

LM Start	2.10	Rating **	M	Issue No.	5
LM End	2.10	Issue Type +	Ma	Location *	LS
Category	Earthen Levee			GPS Latitude/Longitude	
				Start	End
Item	Animal Control			37.689065°	37.689065°
				-121.262059°	-121.262059°
DWR ID	DWR_RD2064_01_f_2024_5				
Comment Code					
A3 : No rodents visible, but rodent burrows visible; need to backfill and compact or grout burrows.					
Inspector Comment

View of multiple animal burrows on the landside slope. Fall 2024

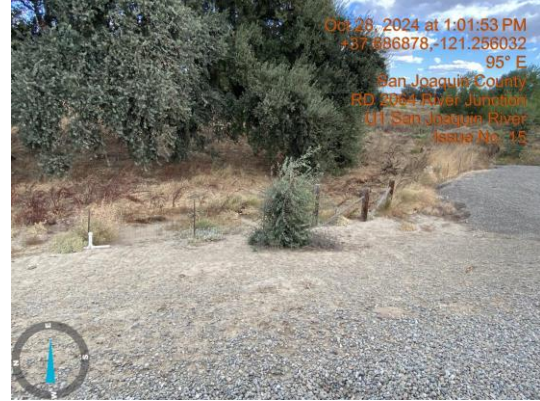
Photo 1 of 1 : FA_2024_RD2064_313_15_20241029_00033.jpg

LM Start	2.49	Rating **	M	Issue No.	15
LM End	2.49	Issue Type +	Ma	Location *	LS
Category	Earthen Levee			GPS Latitude/Longitude	
				Start	End
Item	Vegetation			37.686830°	37.686830°
				-121.256106°	-121.256106°
DWR ID	DWR_RD2064_01_f_2024_15				
Comment Code					
V2 : Remove the wild growth and woody vegetation other than native grasses from the levee slopes.					
Inspector Comment					
There is a tree sapling on the landside easement.

View of tree sapling on the landside slope. Fall 2024

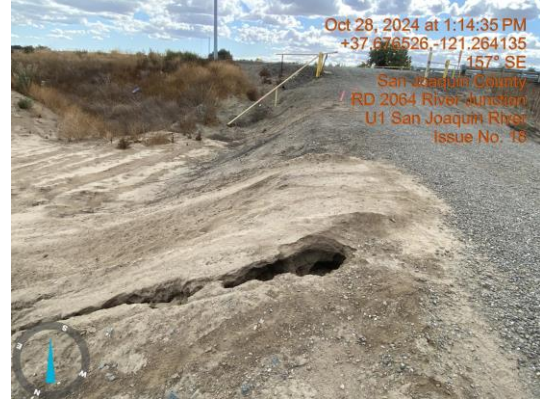
Photo 1 of 1 : FA_2024_RD2064_313_18_20241029_00034.jpg

LM Start	3.47	Rating **	U	Issue No.	18
LM End	3.47	Issue Type +	Ma	Location *	LS
Category	Earthen Levee			GPS Latitude/Longitude	
				Start	End
Item	Erosion / Bank Caving			37.676530°	37.676530°
				-121.264192°	-121.264192°
DWR ID	DWR_RD2064_01_f_2024_18				
Comment Code					
E2 : Schedule repair of erosion site prior to the next inspection.					
Inspector Comment					
There is erosion on the landside slope caused by surface runoff. Erosion is approximately 18 inches deep, 12 inches wide, and 20 feet long.

View of erosion on the landside slope. Fall 2024

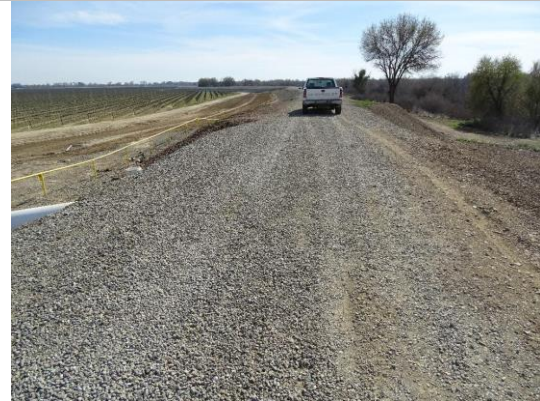
Photo 1 of 3 : UCIP_FA_2024_72448_108284.jpg

Comment Code						
Inspector Comment						
DS_ID:20525 FS_ID:72448 EP_NO: N/A Repair Type: Non-Urgent EVAL Issue: Crossing Status: Found UCIP Comments: 08/01/2022 Work authorization WA2022058 issued for pipe removal. (O.Yakimov- DWR UCIP) 03/01/2022 Record remains Non-Urgent. No permit has been identified authorizing pipe. Crossing appears abandoned. LMA Rep says they are working with CVFPB to remove these crossings. (D.Sanoski - DWR UCIP) 08/27/2013 Need to determine if pipe was actually removed from levee. (W.Wylie - DWR UCIP) FIELD_STRUCT_DESC: 12-inch steel drainage pipe through the levee, at an unknown depth. Steel plate welded over the landside (LS) end at the LS toe. (12-inch pipe authorized under Permit No. 6450, 1969 - Reclamation District No. 2064, states it was removed in 1973, but it remains visible on the LS toe). (Pipe removal authorized under Permit No. WA2022058, 2022 - JB Wilson, Reclamation District 2064). [Additional Reference(s): USACE San Joaquin O&M Manual, Unit 3, December 1968, Revised 29 December 2016, (HLM 3.55), listed as 12-inch pipe]. FS Date: 3/1/2022 12:51:49 PM

Top of Levee: view of crown.

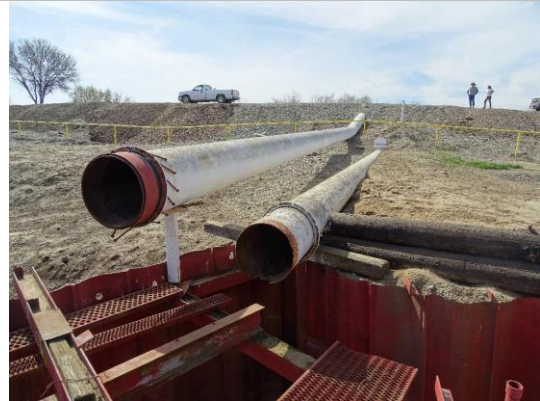
Photo 2 of 3 : UCIP_FA_2024_72448_108285.jpg

Land-Side: view of pipe on slope.

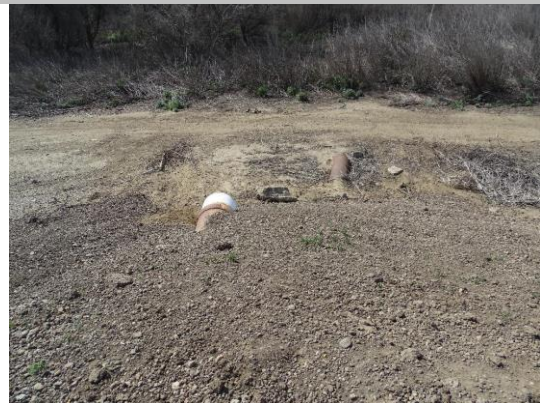
Photo 3 of 3 : UCIP_FA_2024_72448_108286.jpg

Water-Side: view of slope.

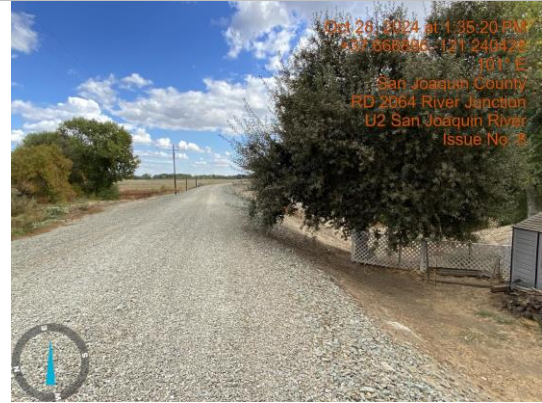
Photo 1 of 1 : FA_2024_RD2064_314_8_20241029_00028.jpg

View of untrimmed tree on the waterside slope. Fall 2024

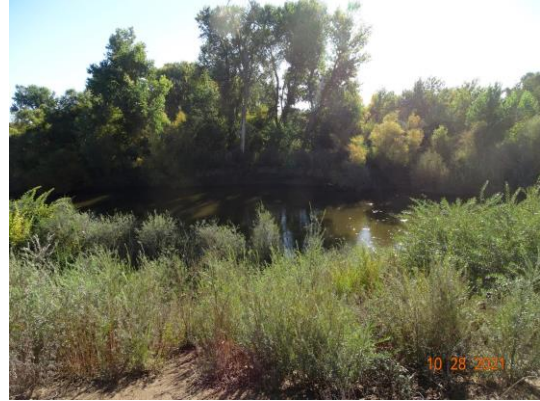
Photo 1 of 2 : FA_2024_RD2064_314_33_20240910_00005.jpg

View of waterside berm, approximately 10-40 ft from waterside toe. Fall 2021

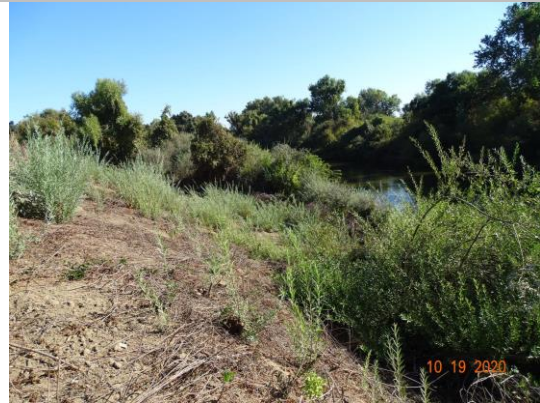
Photo 2 of 2 : FA_2024_RD2064_314_33_20240910_00006.jpg

View of waterside berm, approximately 10-40 ft from waterside toe. Fall 2020

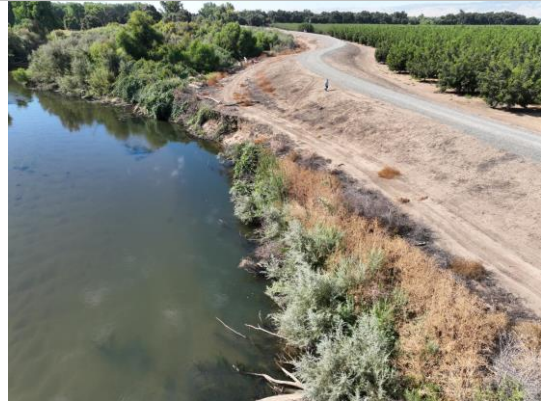
Photo 1 of 2 : SJR2024_RD2064U02RM2.22_1.jpg

8/12/2024: Aerial view of erosion.

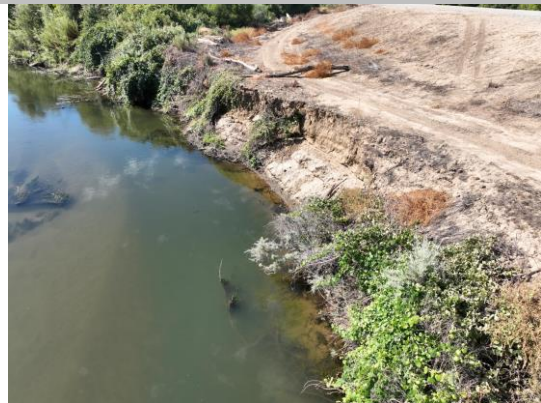
Photo 2 of 2 : SJR2024_RD2064U02RM2.22_6.jpg

8/12/2024: Aerial view of erosion.

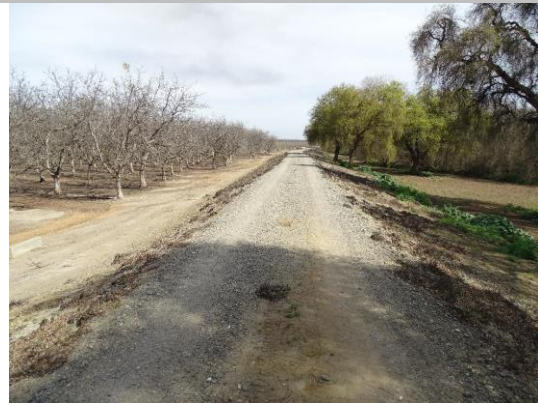
Photo 1 of 3 : UCIP_FA_2024_82257_108401.jpg

Comment Code						
Inspector Comment						
DS_ID:20549 FS_ID:82257 EP_NO: N/A Repair Type: No Action Needed EVAL Issue: Crossing Status: Found UCIP Comments: 02/12/2024 Record updated from Non-Urgent to No Action Needed. Pipe is a system feature. (J. Taylor - DWR UCIP) 03/03/2022 Record updated from No Action Needed to Non-Urgent. No permit has been identified authorizing pipe. (D.Sanoski - DWR UCIP) FIELD_STRUCT_DESC: 30-inch drainage pipe of an unknown material through the levee, 10.5 feet below the crown. Concrete U-shaped headwalls on both ends. Flap gate on the waterside (WS) end. Two corrugated metal cutoff walls. [Additional Reference(s): DWR Levee Log, 2005 (HLM 4.49). USACE San Joaquin O&M Manual, Unit 3, December 1968, Revised 29 December 2016, (HLM 4.37), listed as 30-inch pipe]. FS Date: 3/3/2022 3:51:31 PM

Top of Levee: view of crown.

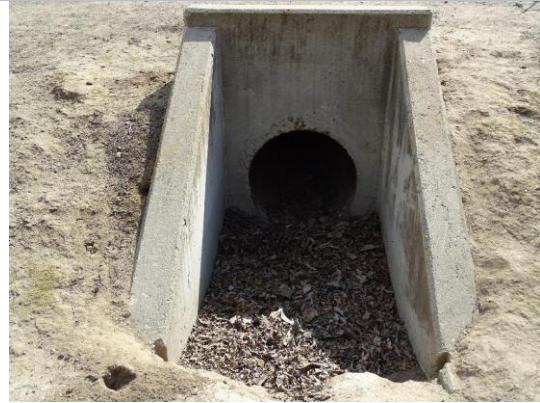
Photo 2 of 3 : UCIP_FA_2024_82257_108402.jpg

Land-Side: view of headwall and inlet.

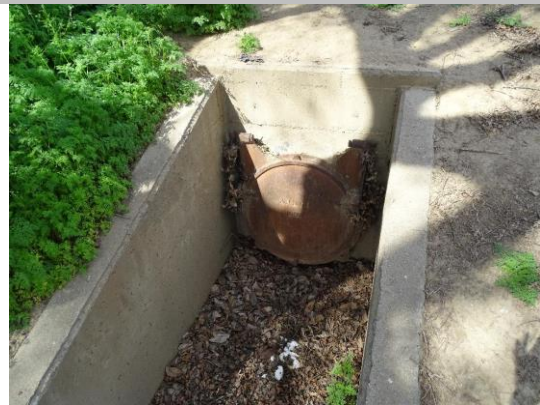
Photo 3 of 3 : UCIP_FA_2024_82257_108403.jpg

Water-Side: view of headwall and flap gate.

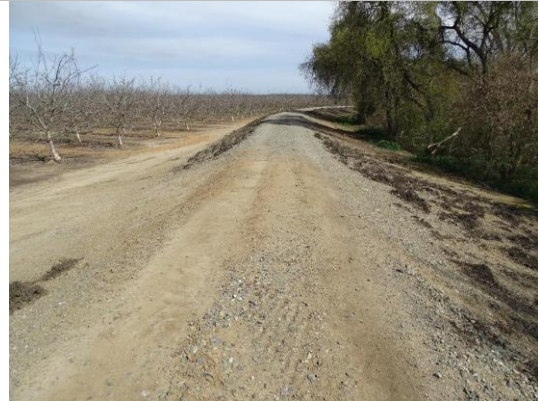
Photo 1 of 3 : UCIP_FA_2024_82258_108405.jpg

Comment Code					
Inspector Comment					
DS_ID:20550 FS_ID:82258 EP_NO: N/A Repair Type: No Action Needed EVAL Issue: Crossing Status: Found UCIP Comments: 02/12/2022 Record updated from Non-Urgent to No Action Needed. Pipe is a system feature. (J. Taylor - DWR UCIP) 03/03/2022 Record updated from No Action Needed to Non-Urgent. No permit has been identified authorizing pipe. (D.Sanoski - DWR UCIP) FIELD_STRUCT_DESC: 30-inch corrugated metal drainage pipe through the levee, 8 feet below the crown. Concrete U-shaped headwalls on both ends, and a flap gate on the waterside (WS) end. Grouted spillway on the WS. [Additional Reference(s): DWR Levee Log, 2005 (HLM 4.60). USACE San Joaquin O&M Manual, Unit 3, December 1968, Revised 29 December 2016, (HLM 4.47), listed as 30-inch pipe]. FS Date: 3/3/2022 3:53:51 PM

Top of Levee: view of crown.

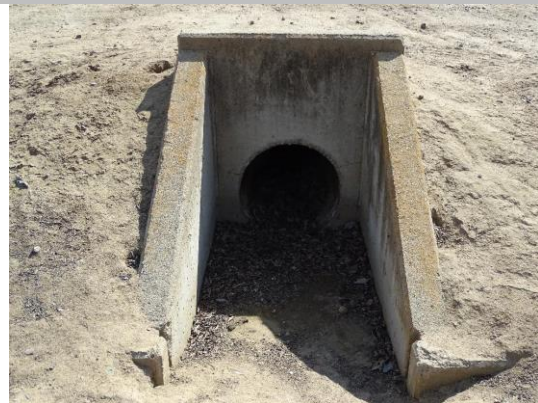
Photo 2 of 3 : UCIP_FA_2024_82258_108406.jpg

Land-Side: view of headwall and inlet.

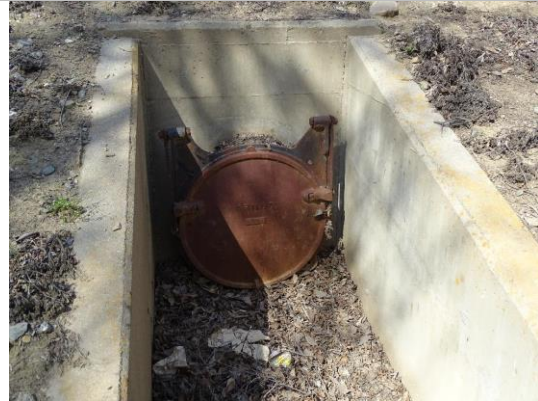
Photo 3 of 3 : UCIP_FA_2024_82258_108407.jpg

Water-Side: view of headwall and flap gate.

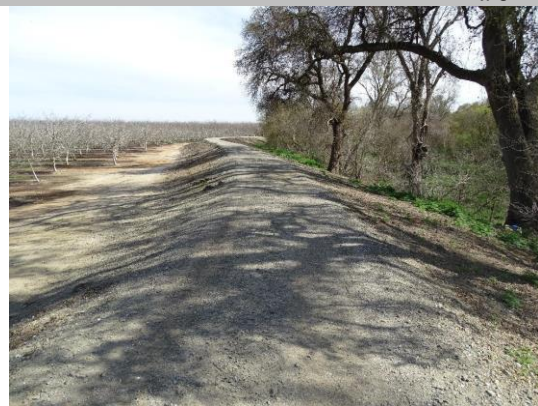
Photo 1 of 3 : UCIP_FA_2024_82259_108410.jpg

DS_ID:20551
FS_ID:82259
EP_NO: N/A
Repair Type: No Action Needed
EVAL Issue:
Crossing Status: Found
UCIP Comments: 02/12/2022 Record updated from Non-Urgent to No Action Needed. Pipe is a system feature. (J. Taylor - DWR UCIP)
03/03/2022 Record updated from No Action Needed to Non-Urgent. No permit has been identified authorizing pipe. (D.Sanoski - DWR UCIP)
FIELD_STRUCT_DESC: 30-inch corrugated metal drainage pipe through the levee, 10 feet below the crown. Concrete U-shaped headwalls on both ends. Flap gate on the waterside (WS) end. Two corrugated metal cutoff walls. Grouted spillway on the WS. Spillway damaged due to uprooted tree. [Additional Reference(s): DWR Levee Log, 2005 (HLM 4.72). USACE San Joaquin O&M Manual, Unit 3, December 1968, Revised 29 December 2016, (HLM 4.59), listed as 30-inch pipe].
FS Date: 3/3/2022 4:11:22 PM

Top of Levee: view of crown.

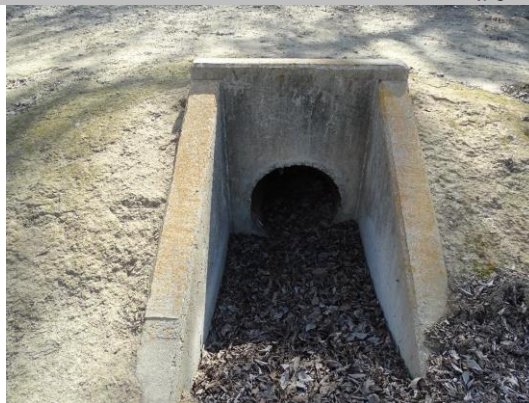
Photo 2 of 3 : UCIP_FA_2024_82259_108411.jpg

Land-Side: view of headwall and inlet.

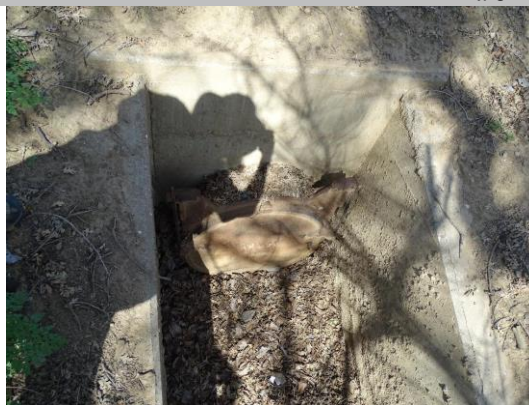
Photo 3 of 3 : UCIP_FA_2024_82259_108412.jpg

Water-Side: view of headwall and flap gate.

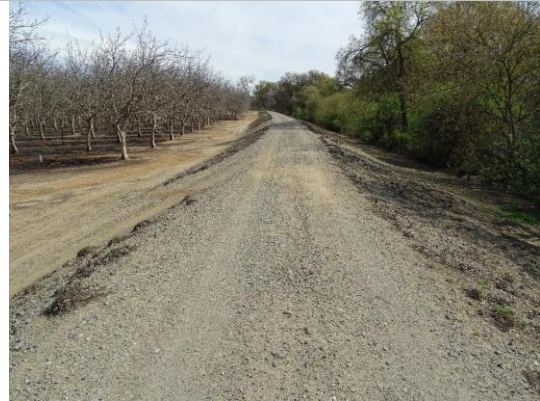
Photo 1 of 3 : UCIP_FA_2024_82261_108415.jpg

Comment Code						
Inspector Comment						
DS_ID:20552 FS_ID:82261 EP_NO: N/A Repair Type: No Action Needed EVAL Issue: Crossing Status: Found UCIP Comments: 02/12/2022 Record updated from Non-Urgent to No Action Needed. Pipe is a system feature. (J. Taylor - DWR UCIP) 03/03/2022 Record updated from No Action Needed to Non-Urgent. No permit has been identified authorizing pipe. (D.Sanoski - DWR UCIP) FIELD_STRUCT_DESC: 30-inch corrugated metal drainage pipe through the levee, 8.5 feet below the crown. Concrete U-shaped headwalls on both ends. Flap gate on the waterside (WS) end. Two corrugated metal cutoff walls. Grouted spillway on the WS. [Additional Reference(s): DWR Levee Log, 2005 (HLM 4.87). USACE San Joaquin O&M Manual, Unit 3, December 1968, Revised 29 December 2016, (HLM 4.73), listed as 30-inch pipe]. FS Date: 3/3/2022 4:14:09 PM

Top of Levee: view of crown.

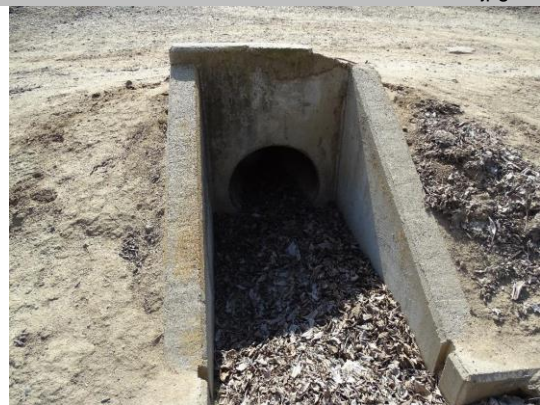
Photo 2 of 3 : UCIP_FA_2024_82261_108416.jpg

Land-Side: view of headwall and inlet.

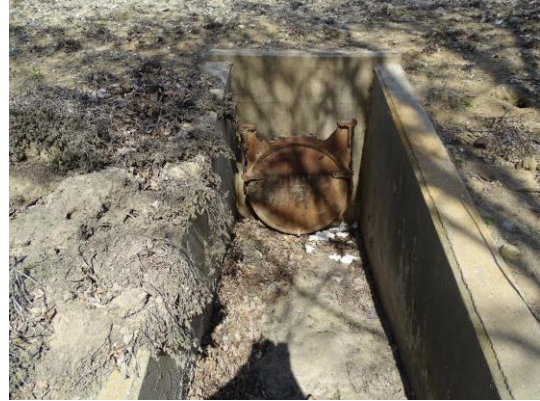
Photo 3 of 3 : UCIP_FA_2024_82261_108417.jpg

Water-Side: view of headwall and flap gate.

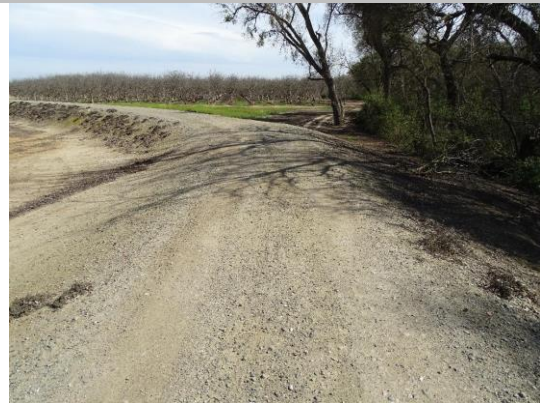
Photo 1 of 3 : UCIP_FA_2024_82263_108430.jpg

DS_ID:20553
FS_ID:82263
EP_NO: N/A
Repair Type: No Action Needed
EVAL Issue:
Crossing Status: Found
UCIP Comments: 02/12/2022 Record updated from Non-Urgent to No Action Needed. Pipe is a system feature. (J. Taylor - DWR UCIP)
03/03/2022 Record updated from No Action Needed to Non-Urgent. No permit has been identified authorizing pipe. (D.Sanoski - DWR UCIP)
FIELD_STRUCT_DESC: 30-inch corrugated metal drainage pipe through the levee, 8 feet below the crown. Concrete U-shaped headwalls on both ends. Flap gate on the waterside (WS) end. Two corrugated metal cutoff walls. Grouted spillway on the WS. [Additional Reference(s): DWR Levee Log, 2005 (HLM 5.01). USACE San Joaquin O&M Manual, Unit 3, December 1968, Revised 29 December 2016, (HLM 4.88), listed as 30-inch pipe].
FS Date: 3/3/2022 4:21:52 PM

Top of Levee: view of crown.

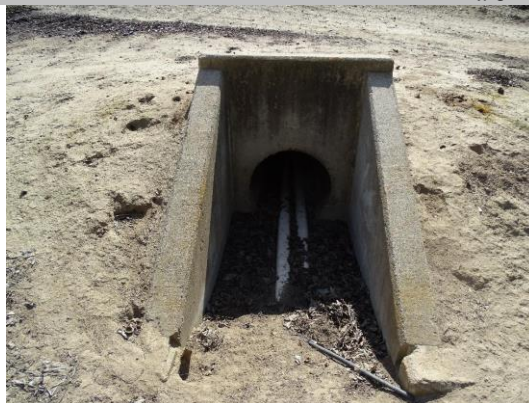
Photo 2 of 3 : UCIP_FA_2024_82263_108431.jpg

Land-Side: view of headwall and pipe inlet.

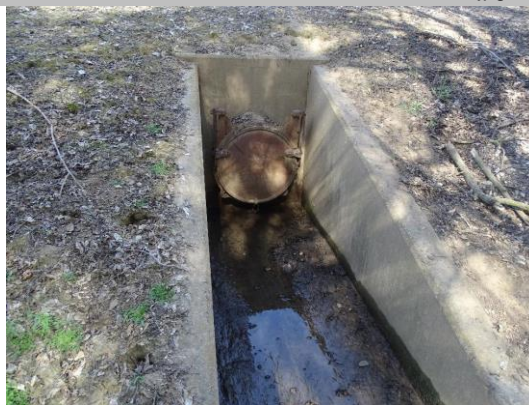
Photo 3 of 3 : UCIP_FA_2024_82263_108432.jpg

Water-Side: view of headwall and flap gate.

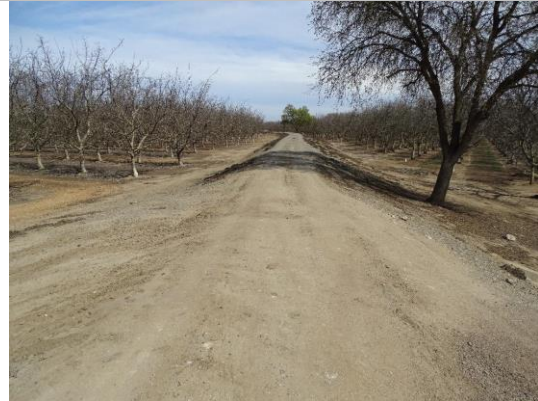
Photo 1 of 3 : UCIP_FA_2024_82264_108435.jpg

Comment Code						
Inspector Comment						
DS_ID:20554 FS_ID:82264 EP_NO: N/A Repair Type: No Action Needed EVAL Issue: Crossing Status: Found UCIP Comments: 02/12/2022 Record updated from Non-Urgent to No Action Needed. Pipe is a system feature. (J. Taylor - DWR UCIP) 03/03/2022 Record updated from No Action Needed to Non-Urgent. No permit has been identified authorizing pipe. (D.Sanoski - DWR UCIP) FIELD_STRUCT_DESC: 30-inch corrugated metal drainage pipe through the levee, 8 feet below the crown. Concrete U-shaped headwalls on both ends. Flap gate on the waterside (WS) end. Two corrugated metal cutoff walls. Grouted spillway on the WS. [Additional Reference(s): DWR Levee Log, 2005 (HLM 5.19). USACE San Joaquin O&M Manual, Unit 3, December 1968, Revised 29 December 2016, (HLM 5.05), listed as 30-inch pipe]. FS Date: 3/3/2022 4:23:51 PM

Top of Levee: view of crown.

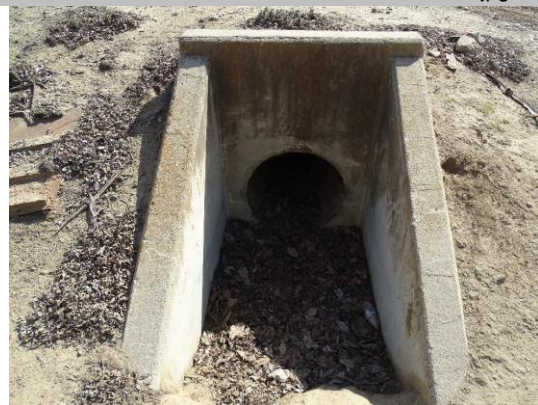
Photo 2 of 3 : UCIP_FA_2024_82264_108436.jpg

Land-Side: view of headwall and inlet.

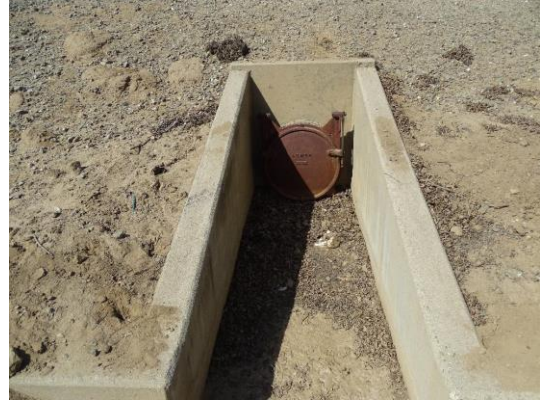
Photo 3 of 3 : UCIP_FA_2024_82264_108437.jpg

Water-Side: view of headwall and flap gate.
