**Flood Control Project Maintenance
Levee Inspections**

Fall 2011 Levee Maintenance Deficiency Summary Report

Reclamation District No. 2068 Yolano

Levee Inspection Report By Mile - Fall 2011

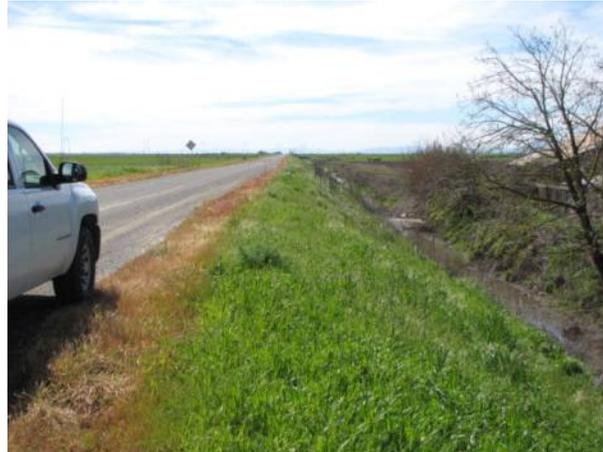
| Levee Mile Report Line | 2 |

| LMIR No. | Levee Mile | | Category | Item | * Location | ** Rating | Action/Comment | GPS Latitude/Longitude | | Issue No. Photo |
|---|---|---|---|---|---|---|---|---|---|---|
| 2 | 0.50 | 0.50 | Earthen Levee | Vegetation | LS | M | Remove the wild growth other than native grasses from the levee slopes. | 38.401323 ° -121.693755 ° | 38.401323 ° -121.693755 ° | 12 Y |

| Looking downstream from levee mile 0.50 Unit #1 RD 2068 landside slope. Photo taken 3-30-2011 | |

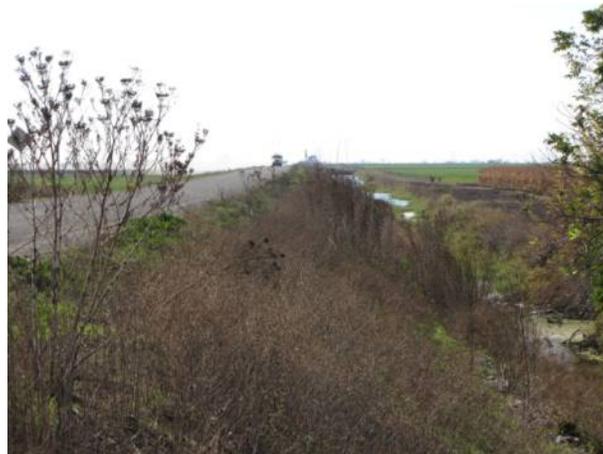
| Levee Mile Report Line | 2 |

| RD 2068 Unit 1 landward looking downstream from levee mile 0.50. Photo taken 10-19-2011. | |

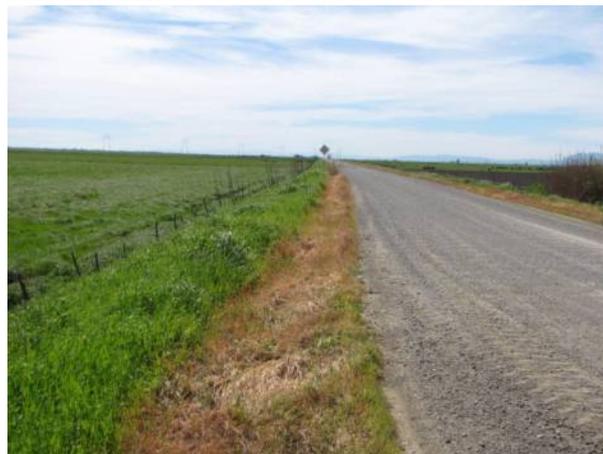
| Levee Mile Report Line | 3 |

| LMIR No. | Levee Mile | | Category | Item | * Location | ** Rating | Action/Comment | GPS Latitude/Longitude | | Issue No. Photo |
|---|---|---|---|---|---|---|---|---|---|---|
| 3 | 0.50 | 0.50 | Earthen Levee | Vegetation | WS | M | Remove the wild growth other than native grasses from the levee slopes. | 38.401323 ° -121.693755 ° | 38.401323 ° -121.693755 ° | 14 Y |

| Looking downstream from levee mile 0.50 Unit #1 RD 2068 waterside slope. Photo taken 3-30-2011. | |

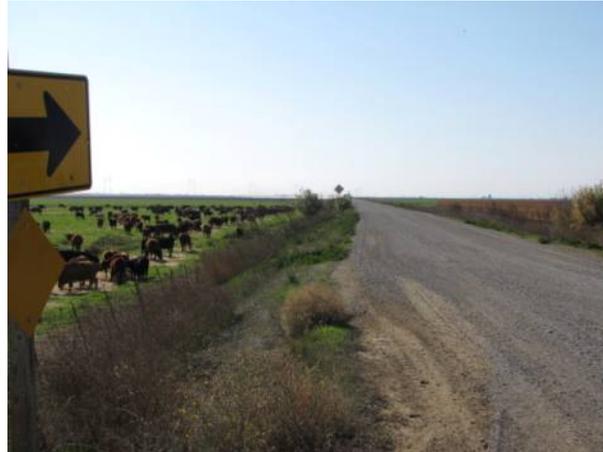
| Levee Mile Report Line | 3 |

| RD 2068 Unit 1 looking downstream levee mile 0.51 waterward. Photo taken 10-19-2011. | |

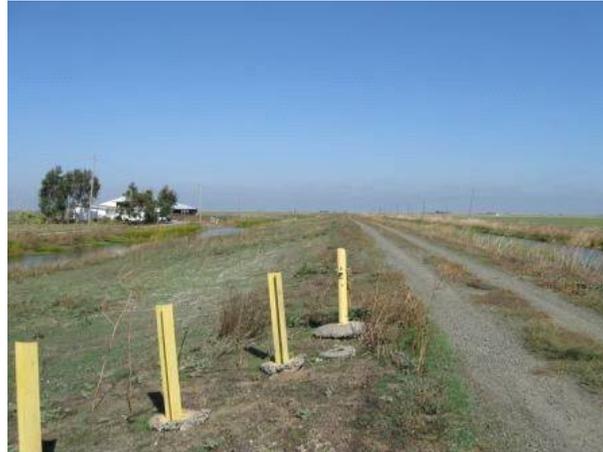
| Levee Mile Report Line | 1 |

| LMIR No. | Levee Mile | | Category | Item | * Location | ** Rating | Action/Comment | GPS Latitude/Longitude | | Issue No. Photo |
|---|---|---|---|---|---|---|---|---|---|---|
| 1 | 0.00 | 0.00 | Earthen Levee | Vegetation | LS | A | Remove the wild growth other than native grasses from the levee slopes. | 38.358206 ° -121.740377 ° | 38.358206 ° -121.740377 ° | 3 Y |

RD 2068 Unit 2 looking downstream from levee mile 0.00 landward. Photo taken 10-19-2011.

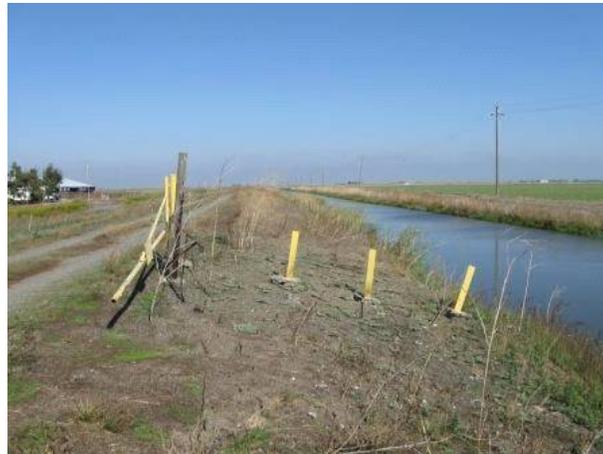
| Levee Mile Report Line | 2 |

| LMIR No. | Levee Mile | | Category | Item | * Location | ** Rating | Action/Comment | GPS Latitude/Longitude | | Issue No. Photo |
|---|---|---|---|---|---|---|---|---|---|---|
| 2 | 0.00 | 0.00 | Earthen Levee | Vegetation | WS | A | Remove the wild growth other than native grasses from the levee slopes. | 38.358206 ° -121.740377 ° | 38.358206 ° -121.740377 ° | 4 Y |

RD 2068 Levee mile 0.00 looking downstream. Photo taken 10-19-2011.
