**Flood Control Project Maintenance
Levee Inspections**

Fall 2013 Levee Maintenance Deficiency Summary Report

Sacramento River Basin

Reclamation District No. 2068 Yolano

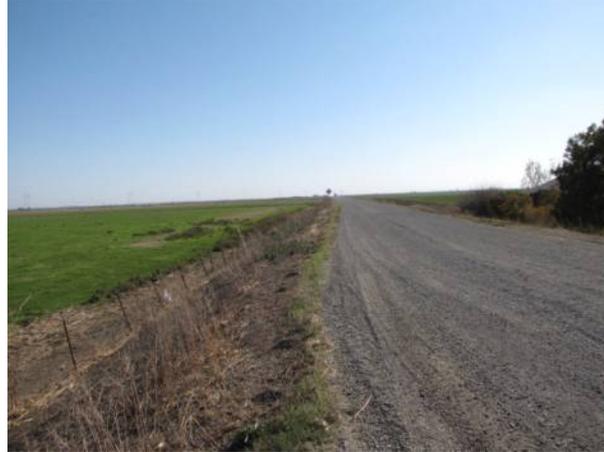
Levee Mile Report Line	6
Start Levee Mile	0.51
End Levee Mile	0.51
Location	Water Side
Category	Earthen Levee
Item	Vegetation
<p>Standing on the water side of the levee slope looking downstream from levee mile 0.51. District has removed the vegetation from levee slopes. Photo taken 10-09-2013.</p>	
<p>phillips_f_20131011_621.JPG</p>

DWR ID: DWR_RD2068_01_f_2013_160		
6	0.51	0.51	Earthen Levee	Vegetation	WS	A Ma	V2 : Remove the wild growth other than native grasses from the levee slopes. Inspector Comments: The District has removed the growth from both levee slopes. 10-10-13	38.401240 ° -121.693732 °	38.401240 ° -121.693732 °	12 Y
								DWR ID: DWR_RD2068_01_s_2013_12		
7	0.53	1.54	Earthen Levee	Encroachments	WS	M En	FE : Fence	38.400897 ° -121.693767 °	38.386340 ° -121.693803 °	2
								DWR ID: DWR_RD2068_01_s_2012_2		
8	2.00	2.00	Supplemental	DWR UCIP Field Study	WS	M En	Inspector Comments: FS_ID:17545 EP_NO: 12389 Repair Type: Non-Urgent Crossing Status: Not Found UCIP Comments: Need to determine disposition of pipe with PG&E. FIELD_STRUCT_DESC: 6-inch gas line through the levee 4 feet below the crown (Permit No. 12389, 1978). FS Date: 8/8/2013	38.379660 ° -121.693870 °	38.379660 ° -121.693870 °	161
								DWR ID: DWR_RD2068_01_f_2013_161

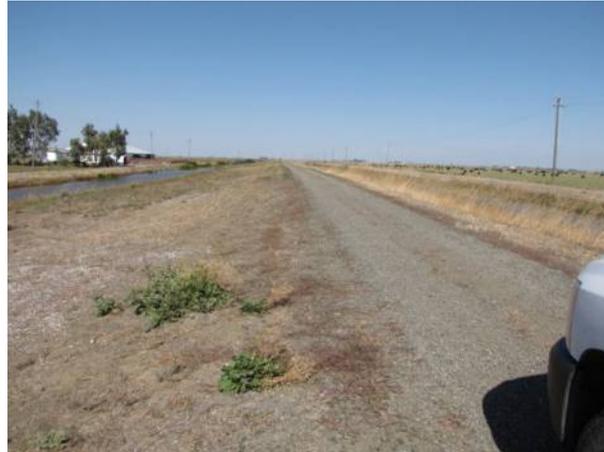
Levee Mile Report Line	1
Start Levee Mile	0.00
End Levee Mile	0.27
Location	Land Side
Category	Earthen Levee
Item	Vegetation
RD 2068 Looking downstream from gate at levee mile 0.00 landside slope. Photo taken 10-09-2013.	
phillips_f_20131011_619.JPG

LMR No.	Levee Mile		Category	Item	Location	Rating	Action/Comment	GPS Latitude/Longitude		Issue No. Photo
	Start	End						Start	End	
1	0.00	0.27	Earthen Levee	Vegetation	LS	A	V2 : Remove the wild growth other than native grasses from the levee slopes.	38.358235 ° -121.740392 °	38.362138 ° -121.740339 °	1 Y
DWR ID: DWR_RD2068_02_s_2013_1										
2	0.00	0.31	Earthen Levee	Vegetation	WS	C	V2 : Remove the wild growth other than native grasses from the levee slopes.	38.358235 ° -121.740392 °	38.362686 ° -121.740335 °	3 Y
DWR ID: DWR_RD2068_02_s_2013_3										
3	0.00	0.00	Supplemental	DWR UCIP Field Study	WS	M	Inspector Comments: FS_ID:17505 EP_NO: 13490 Repair Type: Non-Urgent Crossing Status: Not Found UCIP Comments: Appears abandoned. Need to verify pipe status with PG&E. FIELD_STRUCT_DESC: 4-inch steel gas pipeline through the levee 3.5 feet below the crown (Permit No. 13490, 1982). FS Date: 8/8/2013	38.358250 ° -121.740377 °	38.358250 ° -121.740377 °	61

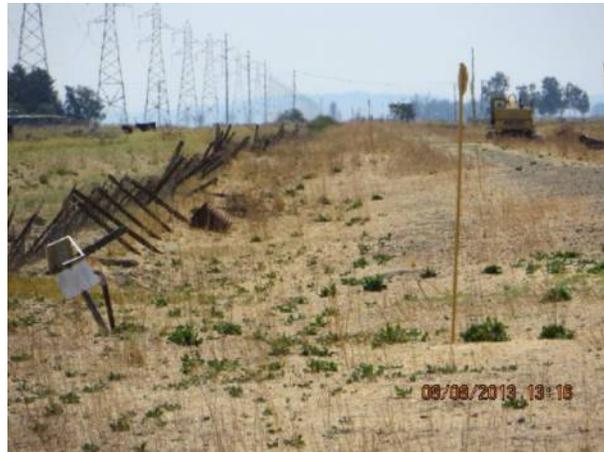
Levee Mile Report Line	9
Start Levee Mile	0.90
End Levee Mile	0.90
Location	Land Side
Category	Supplemental
Item	DWR UCIP Field Study
Gasline markers next to old rail road grade, looking south.	
UCIP_9944.jpg

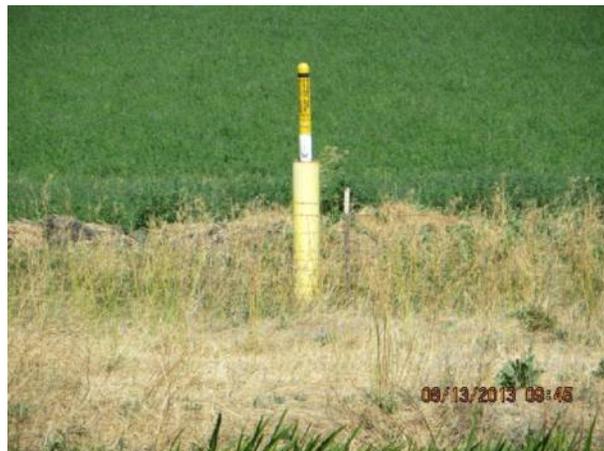
Levee Mile Report Line	13
Start Levee Mile	1.07
End Levee Mile	1.07
Location	Land Side
Category	Supplemental
Item	DWR UCIP Field Study
Sign marker off LS toe.	
UCIP_9938.jpg

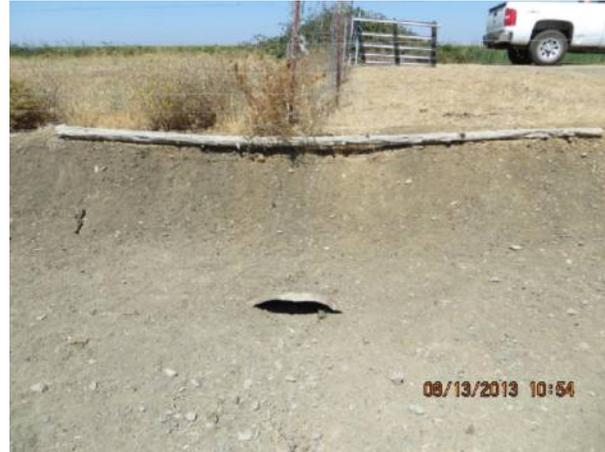
Levee Mile Report Line	15
Start Levee Mile	3.16
End Levee Mile	3.16
Location	Land Side
Category	Supplemental
Item	DWR UCIP Field Study
Pipe burried but visible at toe of east side of levee.	
UCIP_9948.jpg
