**Flood Control Project Maintenance
Levee Inspections**
LMA District Cover Sheet
Spring 2011 Levee Inspection Results

Reclamation District No. 2068 Yolano

Levee Inspection Report By Mile - Spring 2011

Waterway			Bank	Unit Miles	Inspection Start/End	Inspector
Unit No. 02 Back Levee			Left	3.23	03/30/2011 03/30/2011	Herman Phillips

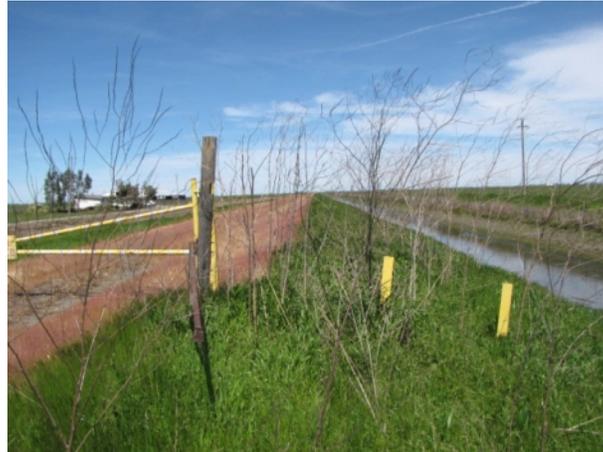
Levee Mile Report Line	1
Start Levee Mile	0.00
End Levee Mile	0.00
Location	Water Side
Category	Earthen Levee
Item	Vegetation
Looking downstream from levee mile 0.00 waterside of RD 2068. Photo taken 3-30-2011.	
phillips_s_20110330_226.jpg

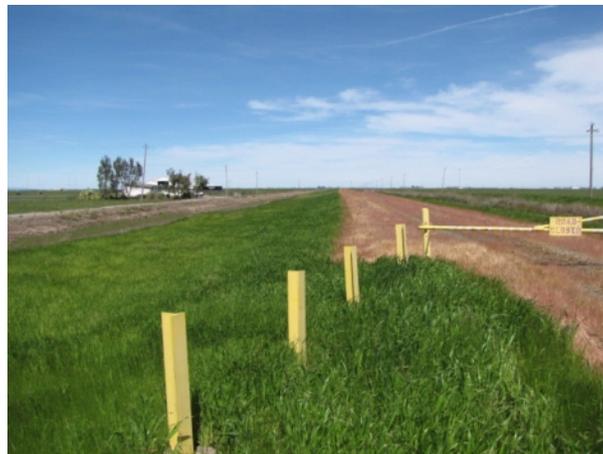
Levee Mile Report Line	2
Start Levee Mile	0.00
End Levee Mile	0.00
Location	Land Side
Category	Earthen Levee
Item	Vegetation
Landside looking downstream from levee mile 0.00 Unit # 2 RD 2068. Photo taken 3-30-2011.	
phillips_s_20110330_225.jpg
