**Flood Control Project Maintenance
Levee Inspections**
LMA District Cover Sheet
Spring 2016 Levee Inspection Results

Reclamation District No. 2068 Yolano

Levee Inspection Report By Mile - Spring 2016

Waterway	Bank	Unit Miles	Inspection Start/End	Inspector
Unit No. 01 Yolo Bypass	Right	5.48	04/06/2016 04/06/2016	Herman Phillips

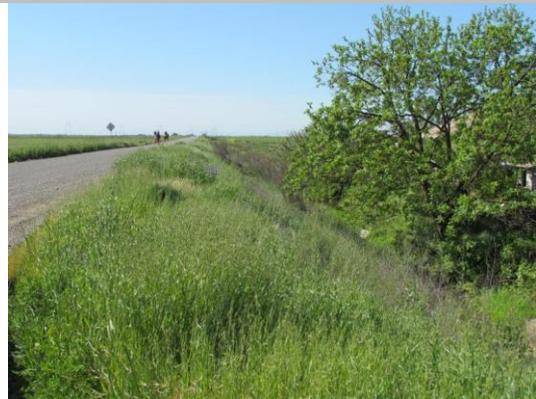
Photo 1 of 1 : SP_2016_RD2068_193_9_20160408_00001.jpg

LM Start	0.52	Rating **	M	Issue No.	9
LM End	5.48	Issue Type +	Ma	Location *	LS
Category	Earthen Levee			GPS Latitude/Longitude	
				Start	End
Item	Vegetation			38.401050 °	38.329078 °
				-121.693805 °	-121.694058 °
DWR ID	DWR_RD2068_01_s_2016_9				
Comment Code					
V1 : Control annual grass and weeds on the levee slopes and easements.					
Inspector Comment					
The RD will have this vegetation removed from the levee slope.

Looking downstream from levee mile 0.52 landside levee slope.

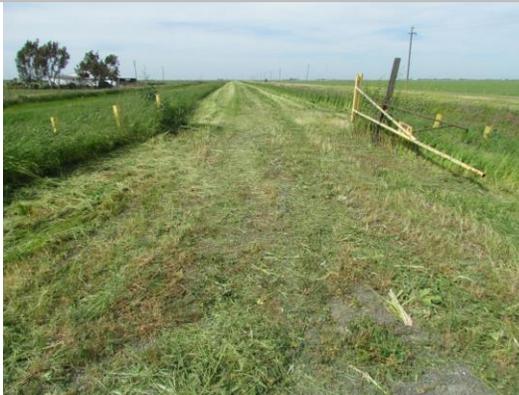
Photo 1 of 1 : SP_2016_RD2068_194_11_20160408_00007.jpg

LM Start	0.03	Rating **	M	Issue No.	11
LM End	0.84	Issue Type +	Ma	Location *	LS
Category	Earthen Levee		GPS Latitude/Longitude		
			Start	End	
Item	Vegetation		38.358546 °	38.370343 °	
			-121.740381 °	-121.740170 °	
DWR ID	DWR_RD2068_02_s_2016_11				
Comment Code					
V1 : Control annual grass and weeds on the levee slopes and easements.					
Inspector Comment					
RD 2068 In process of mowing the levee section during this inspection.

Looking downstream from levee mile 0.03 unit 2 RD 2068.

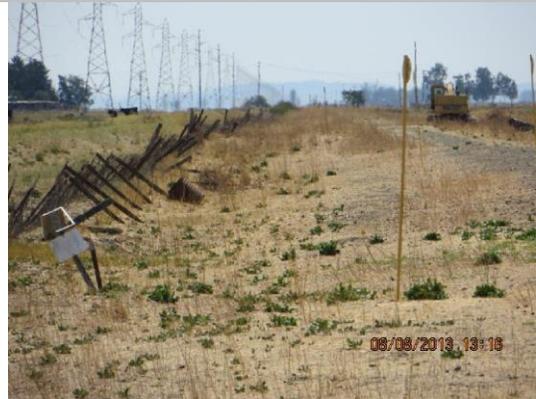
Photo 1 of 2 : UCIP_SP_2016_17531_29641.jpg

LM Start	0.91	Rating **	M	Issue No.	16
LM End	0.91	Issue Type +	En	Location *	WS
Category	Supplemental			GPS Latitude/Longitude	
				Start	End
Item	DWR UCIP Field Study			38.371273 °	38.371273 °
				-121.740138 °	-121.740138 °
DWR ID					
Comment Code					
Inspector Comment					
FS_ID:17531 DS_ID:19355 EP_NO: 8151 Repair Type: Non-Urgent Crossing Status: Indicator Found UCIP Comments: Appears abandoned. Need to verify with pipeline owner. FIELD_STRUCT_DESC: 8-inch steel gas pipe through the levee 3 feet below the crown (Permit No. 8151, 1972). Gasline markers visible on east toe of levee at intersection of levee and Delhi road. FS Date: 8/8/2013

Gasline markers next to old rail road grade, looking south.

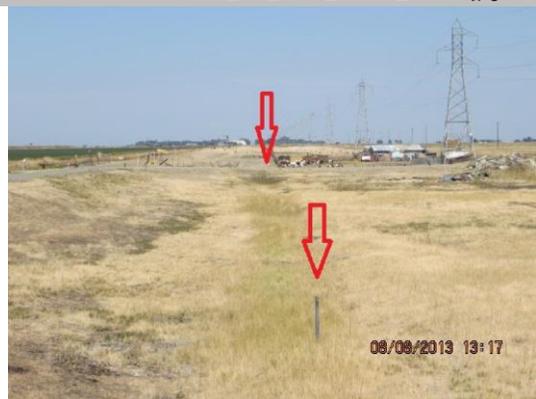
Photo 2 of 2 : UCIP_SP_2016_17531_29640.jpg

Gasline markers on east side of levee toe looking North.
