**Flood Control Project Maintenance
Levee Inspections**

Maintenance Issue Types Only, Levee Inspection Report By Mile - Spring 2016

Reclamation District No. 2068 Yolano

Waterway	Bank	Unit Miles	Inspection Start/End	Inspector
Unit No. 01 Yolo Bypass	Right	5.48	04/06/2016 04/06/2016	Herman Phillips

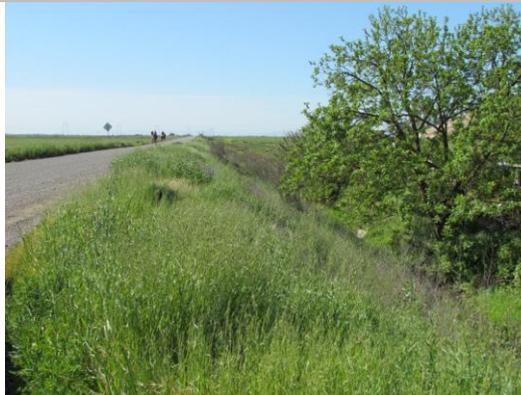
Photo 1 of 1 : SP_2016_RD2068_193_9_20160408_00001.jpg

LM Start	0.52	Rating **	M	Issue No.	9
LM End	5.48	Issue Type +	Ma	Location *	LS
Category	Earthen Levee		GPS Latitude/Longitude		
			Start	End	
Item	Vegetation		38.401050 °	38.329078 °	
			-121.693805 °	-121.694058 °	
DWR ID	DWR_RD2068_01_s_2016_9				
Comment Code					
V1 : Control annual grass and weeds on the levee slopes and easements.					
Inspector Comment					
The RD will have this vegetation removed from the levee slope.

Looking downstream from levee mile 0.52 landside levee slope.

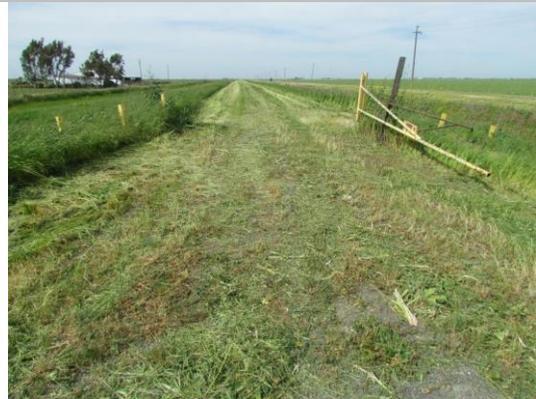
Photo 1 of 1 : SP_2016_RD2068_194_11_20160408_00007.jpg

LM Start	0.03	Rating **	M	Issue No.	11
LM End	0.84	Issue Type +	Ma	Location *	LS
Category	Earthen Levee		GPS Latitude/Longitude		
			Start	End	
Item	Vegetation		38.358546 °	38.370343 °	
			-121.740381 °	-121.740170 °	
DWR ID	DWR_RD2068_02_s_2016_11				
Comment Code					
V1 : Control annual grass and weeds on the levee slopes and easements.					
Inspector Comment					
RD 2068 In process of mowing the levee section during this inspection.

Looking downstream from levee mile 0.03 unit 2 RD 2068.
