**Flood Control Project Maintenance
Levee Inspections
LMA District Cover Sheet
Spring 2010 Levee Inspection Results**

Reclamation District No. 2068 Yolano

Spring 2010 Levee Inspection Results

Levee Inspection Report By Mile - Spring 2010

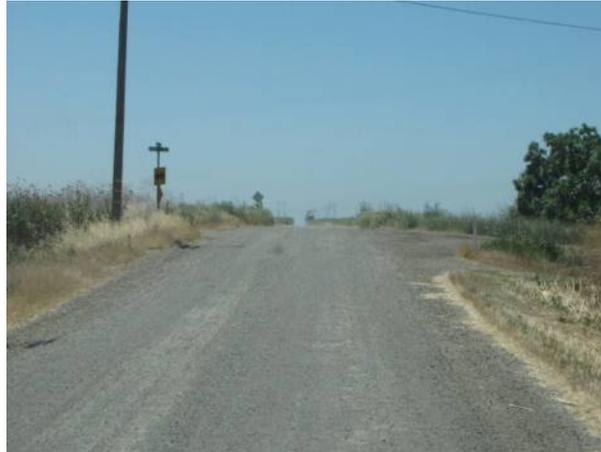
Levee Mile Report Line	1
Start Levee Mile	0.07
End Levee Mile	0.07
Location	Land Side
Category	
Item	Vegetation
Unit 1 RD 2068 LEEVE MILE 0.07 Looking downstream stream.	
phillips_s_20100707_154.jpg

LMIR No	Levee Mile		Category	Item	Location *	Rating **	Action/Comment	GPS Latitude/Longitude		Issue No. Photo
	Start	End						Start	End	
1	0.07	0.07		Vegetation	LS	M	Control annual grass and weeds on the levee slopes and easements.	38.522630 ° -121.631460 °	38.522630 ° -121.631460 °	15 Y
2	0.49	2.51		Encroachmens	LS	PO	Agricultural Ditch	38.401308 ° -121.693788 °	38.372530 ° -121.693775 °	1
3	0.53	1.54		Encroachmens	WS	PO	Fences	38.400897 ° -121.693767 °	38.386340 ° -121.693803 °	2
4	1.52	2.65		Encroachmens	LS	PO	Agricultural Ditch	38.515262 ° -121.655535 °	38.517428 ° -121.676112 °	16
5	1.64	2.49		Vegetation	WS	M	Control annual grass and weeds on the levee slopes and easements.	38.384917 ° -121.693730 °	38.372527 ° -121.693792 °	3
6	2.01	2.47		Encroachmens	WS	PO	Fences	38.379570 ° -121.693787 °	38.372822 ° -121.693782 °	4
7	2.52	5.50		Vegetation	CR	M	Control annual grass and weeds on the levee slopes and easements.	38.372188 ° -121.693917 °	38.329177 ° -121.694043 °	5

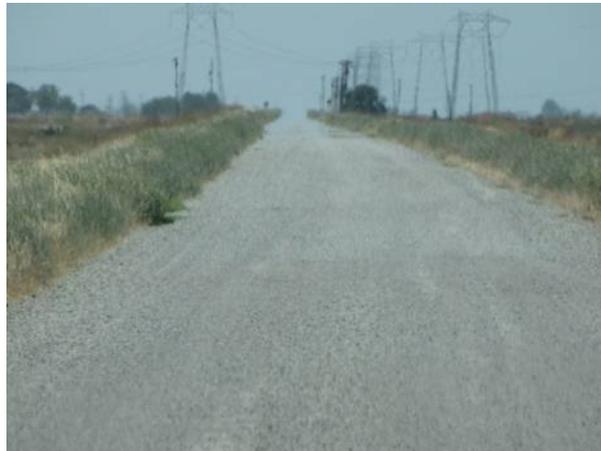
Levee Mile Report Line	1
Start Levee Mile	0.07
End Levee Mile	0.07
Location	Land Side
Category	
Item	Vegetation
Looking downstream of waterside levee slope.	
phillips_s_20100707_155.jpg

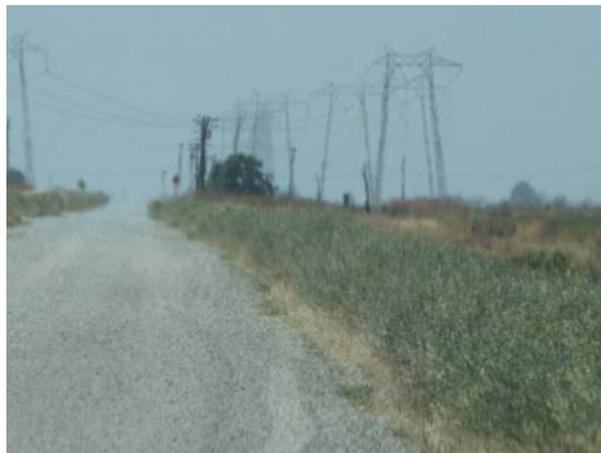
Levee Mile Report Line	1
Start Levee Mile	0.07
End Levee Mile	0.07
Location	Land Side
Category	
Item	Vegetation
Looking downstream on land side.	
phillips_s_20100707_156.jpg

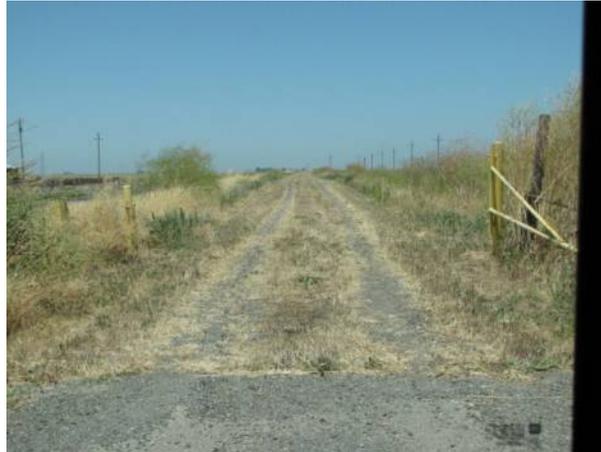
Levee Mile Report Line	1
Start Levee Mile	0.00
End Levee Mile	0.87
Location	Crown
Category	
Item	Vegetation
<p>Levee mile 0.00 this view shows the growth on levee section, District has mowed the center and slopes. This growth is common throughout this section of levee.</p>	
<p>phillips_s_20100707_153.jpg</p>

LMIR No	Levee Mile		Category	Item	Location *	Rating **	Action/Comment	GPS Latitude/Longitude		Issue No. Photo
	Start	End						Start	End	
1	0.00	0.87		Vegetation	CR	M	Control annual grass and weeds on the levee slopes and easements.	38.358190 ° -121.740450 °	38.370783 ° -121.740152 °	3 Y
