**Flood Control Project Maintenance
Levee Inspections**
LMA District Cover Sheet
Spring 2012 Levee Inspection Results

Reclamation District No. 2068 Yolano

Levee Inspection Report By Mile - Spring 2012

Waterway		Bank	Unit Miles	Inspection Start/End	Inspector
Unit No. 01 Yolo Bypass		Right	5.50	05/08/2012 05/08/2012	Herman Phillips

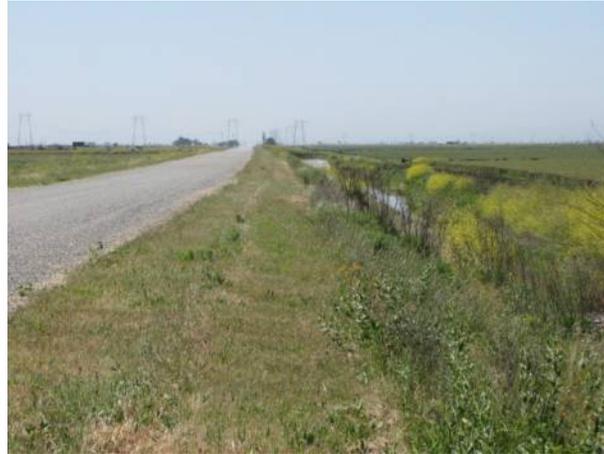
LMR No.	Levee Mile		Category	Item	Location	Rating	Action/Comment	GPS Latitude/Longitude		Issue No. Photo
	Start	End						Start	End	
1			Earthen Levee	Emergency Supplies & Equipment	LS	A Ma				5
								DWR ID: DWR_RD2068_01_s_2012_5		
2			Earthen Levee	Flood Preparedness & Training	LS	A Ma				6
								DWR ID: DWR_RD2068_01_s_2012_6		
3			Earthen Levee	Operations & Maintenance Manuals	LS	A Ma				18
								DWR ID: DWR_RD2068_01_s_2012_18		
4	0.49	2.51	Earthen Levee	Encroachments	LS	M En	AD : Agricultural Ditch Inspector Comments: The Reclamation District has a Drainage ditch along the toe of the landward slope. Levee mile 0.49-2.50. This drainage ditch has always been at this location.	38.401308 ° -121.693788 °	38.372530 ° -121.693775 °	1
								DWR ID: DWR_RD2068_01_s_2012_1		
5	0.50	0.50	Earthen Levee	Vegetation	LS	M Ma	V2 : Remove the wild growth other than native grasses from the levee slopes.	38.401323 ° -121.693755 °	38.401323 ° -121.693755 °	12 Y

Levee Mile Report Line	5
Start Levee Mile	0.50
End Levee Mile	0.50
Location	Land Side
Category	Earthen Levee
Item	Vegetation
Looking downstream from levee mile 0.50 landside. Photo taken 5-8-2012.	
phillips_s_20120508_412.jpg

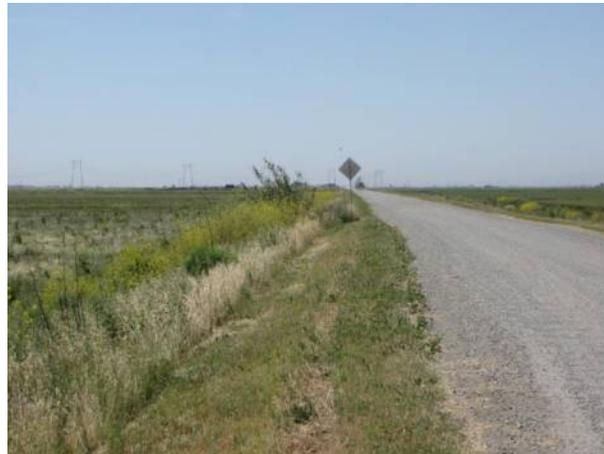
DWR ID: DWR_RD2068_01_s_2012_12		
6	0.50	0.50	Earthen Levee	Vegetation	WS	M Ma	V2 : Remove the wild growth other than native grasses from the levee slopes.	38.401323 ° -121.693755 °	38.401323 ° -121.693755 °	14 Y
								DWR ID: DWR_RD2068_01_s_2012_14		
7	0.51	1.19	Earthen Levee	Vegetation	WS	M Ma	V1 : Control annual grass and weeds on the levee slopes and easements.	38.401175 ° -121.693753 °	38.391325 ° -121.693830 °	7
								DWR ID: DWR_RD2068_01_s_2012_7		
8	0.51	1.12	Earthen Levee	Vegetation	LS	M Ma	V1 : Control annual grass and weeds on the levee slopes and easements.	38.401175 ° -121.693752 °	38.392348 ° -121.693755 °	3
								DWR ID: DWR_RD2068_01_s_2012_3		
9	0.53	1.54	Earthen Levee	Encroachments	WS	M En	FE : Fences	38.400897 ° -121.693767 °	38.386340 ° -121.693803 °	2
								DWR ID: DWR_RD2068_01_s_2012_2		
10	1.66	1.94	Earthen Levee	Vegetation	LS	M Ma	V1 : Control annual grass and weeds on the levee slopes and easements.	38.384570 ° -121.693852 °	38.380484 ° -121.693894 °	10

Levee Mile Report Line	6
Start Levee Mile	0.50
End Levee Mile	0.50
Location	Water Side
Category	Earthen Levee
Item	Vegetation
Looking downstream from levee mile 0.50 waterside. Photo taken 5-8-2012.	
phillips_s_20120508_413.jpg

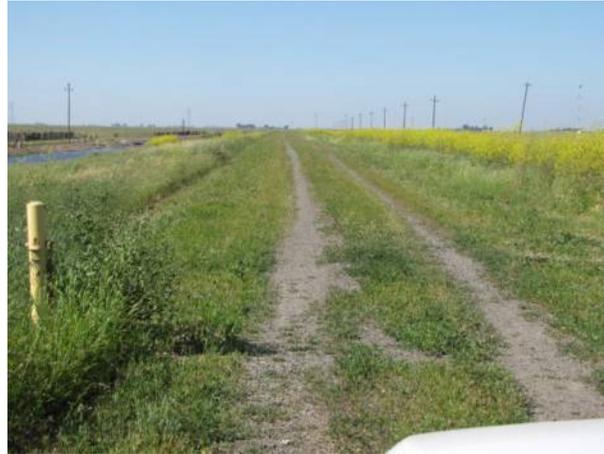
LMIR No.	Levee Mile		Category	Item	* Location	+ Rating	Action/Comment	GPS Latitude/Longitude		Issue No. Photo
	Start	End						Start	End	
1	0.00	0.00	Earthen Levee	Vegetation	LS	M Ma	V1 : Control annual grass and weeds on the levee slopes and easements.	38.358257 ° -121.740403 °	38.358257 ° 121.740403 °	1 Y
DWR ID: DWR_RD2068_02_s_2012_1										
2	0.00	0.90	Earthen Levee	Vegetation	WS	M Ma	V1 : Control annual grass and weeds on the levee slopes and easements.	38.358257 ° -121.740403 °	38.371257 ° -121.740139 °	6
DWR ID: DWR_RD2068_02_s_2012_6										
3	0.00	3.23	Earthen Levee	Crown Surface / Depressions / Rutting	CR	M Ma	C1 : Keep the crown roadway free of vegetation.	35.358257 ° -121.740403 °	38.398783 ° -121.715642 °	3
DWR ID: DWR_RD2068_02_s_2012_3

Levee Mile Report Line	1
Start Levee Mile	0.00
End Levee Mile	0.00
Location	Land Side
Category	Earthen Levee
Item	Vegetation
RD 2068 Standing at levee mile 0.00 looking downstream. Photo taken 5-9-2012	
phillips_s_20120511_414.jpg
