**Flood Control Project Maintenance
Levee Inspections**

Fall 2011 Levee Maintenance Deficiency Summary Report

Reclamation District No. 2075 McMullin

Levee Inspection Report By Mile - Fall 2011

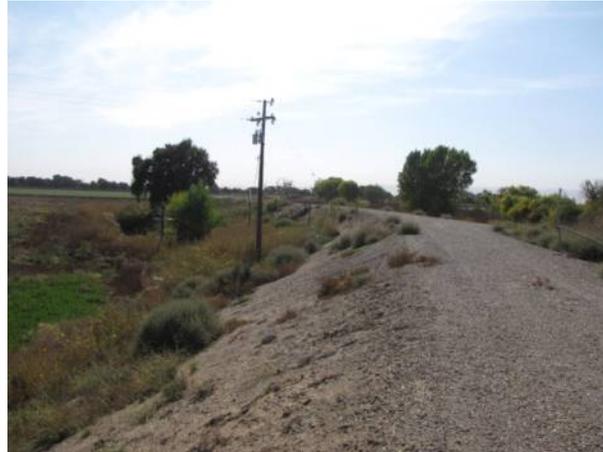
Levee Mile Report Line	1
Start Levee Mile	0.05
End Levee Mile	0.05
Location	Land Side
Category	Earthen Levee
Item	Vegetation
RD 2075 Looking downstream from levee mile 0.00 landside slope. Photo taken 11-02-2011.	
phillips_f_20111207_101.jpg

Waterway				Bank	Unit Miles	Inspection Start/End	Inspector			
Unit No. 01 San Joaquin River				Right	7.52	11/02/2011 11/02/2011	Herman Phillips			
LMIR No.	Levee Mile		Category	Item	Location	Rating	Action/Comment	GPS Latitude/Longitude		Issue No. Photo
	Start	End						Start	End	
1	0.05	0.05	Earthen Levee	Vegetation	LS	M	Remove the wild growth other than native grasses from the levee slopes.	37.748816 ° -121.289640 °	37.748816 ° 121.289640 °	183 Y
2	0.05	0.05	Earthen Levee	Vegetation	WS	M	Remove the wild growth other than native grasses from the levee slopes.	37.748816 ° -121.289640 °	37.748816 ° -121.289640 °	184 Y
3	0.12	0.25	Earthen Levee	Vegetation	WS	M	Remove the wild growth other than native grasses from the levee slopes.	37.748177 ° -121.289740 °	37.746334 ° -121.289547 °	179
4	0.12	0.16	Earthen Levee	Vegetation	LS	M	Remove the wild growth other than native grasses from the levee slopes.	37.748189 ° -121.289727 °	37.747503 ° -121.289412 °	180

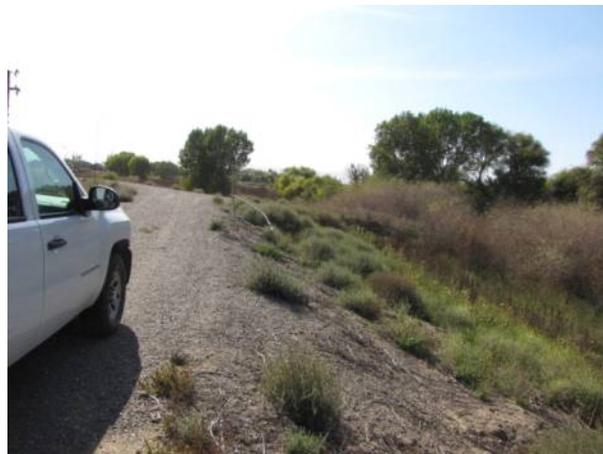
Levee Mile Report Line	2
Start Levee Mile	0.05
End Levee Mile	0.05
Location	Water Side
Category	Earthen Levee
Item	Vegetation
RD 2075 Looking downstream from levee mile 0.05 waterside. Photo taken 11-02-2011.	
phillips_f_20111207_102.jpg

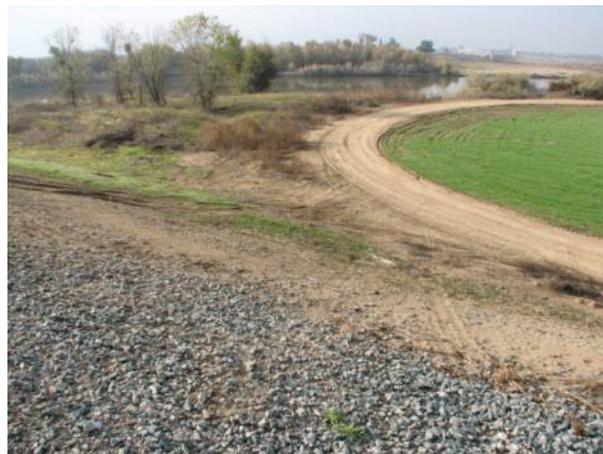
12	2.32	2.32	Earthen Levee	Trim / Thin Trees	WS	M	Trim trees to at least five feet above ground level.	37.731507 ° -121.293760 °	37.731507 ° -121.293760 °	7
13	2.73	2.73	Earthen Levee	Crown Surface / Depressions / Rutting	WS	M	Inspector Comments: This item was identified with an Unacceptable rating in the USACE PI report (MCMU_2009_a_0096). Reinspection on 12/2/10 revealed that repairs were made as indicated in the 11/8/10 letter from KSN, however new depressions present.	37.725810 ° -121.294645 °	37.725810 ° -121.294645 °	18 Y

Levee Mile Report Line	13
Start Levee Mile	2.73
End Levee Mile	2.73
Location	Water Side
Category	Earthen Levee
Item	Crown Surface / Depressions / Rutting
Photo taken from crown looking down waterside slope during 12/2/2010 reinspection. Repairs were made to depressions on levee slope as indicated in KSN letter. Since then, vehicular traffic has created new ruts in repaired area approximately 1 to 6 inches in depth.	
phillips_f_20111010_749.jpg

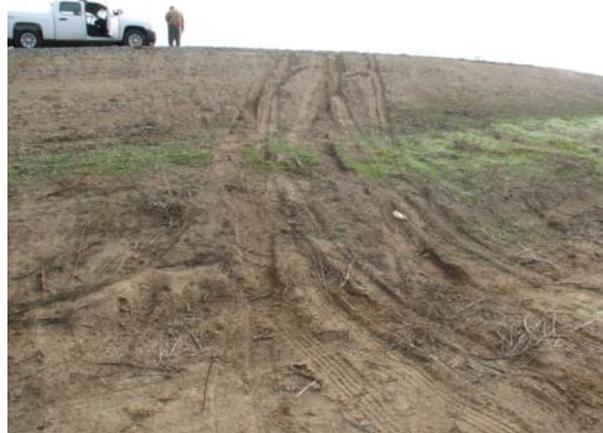
Levee Mile Report Line	13
Start Levee Mile	2.73
End Levee Mile	2.73
Location	Water Side
Category	Earthen Levee
Item	Crown Surface / Depressions / Rutting
<p>Photo taken during 12/2/10 reinspection from the waterside. Depressions from vehicle traffic made in previously repaired area.</p>	
<p>phillips_f_20111010_750.jpg</p>

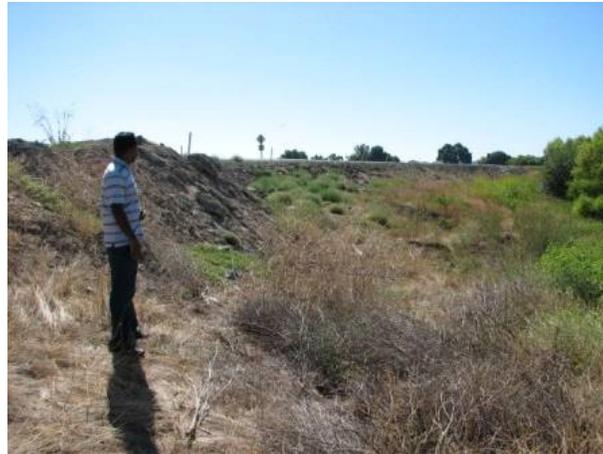
LMIR No.	Levee Mile		Category	Item	Location *	Rating **	Action/Comment	GPS Latitude/Longitude		Issue No. Photo
	Start	End						Start	End	
14	5.34	5.35	Supplemental	DWR Erosion Survey	WS	U	Inspector Comments: 08/18/2011: No significant changes observed on site. Some new material added to the water side levee slope, but the added material is loose and seems not helping the levee protection. 10/05/2010: No significant changes observed on site. Levee slope has minimal vegetation and lacks rip rap protection. Sandy material found on the lower and middle slope is an undesirable material to have on a levee.08/05/2010: Recommended for annual assessment and monitoring during flood events, per CLRO.08/20/2009: No major change since last visit; site is located in an oxbow; slope surface consists of very sandy material; there is a tree on site leaning and with exposed tree roots; site is recommended as a local maintenance issue, per CLRO CES Evaluation 2008 Report; Eddy Cordoza from the district is aware of the site and is looking for recommendation; site is previously rated "U".08/17/2007: Site is close to an irrigation pump inlet. [2011 Site ID:RD2075U01RM64.34]	37.727933 ° -121.274491 °	37.727933 ° -121.274491 °	2 Y

Levee Mile Report Line	14
Start Levee Mile	5.34
End Levee Mile	5.35
Location	Water Side
Category	Supplemental
Item	DWR Erosion Survey
<p>Looking upstream of the site towards the levee crown.</p>	
<p>SJR2011_RD2075U01RM64.34_1.jpg</p>

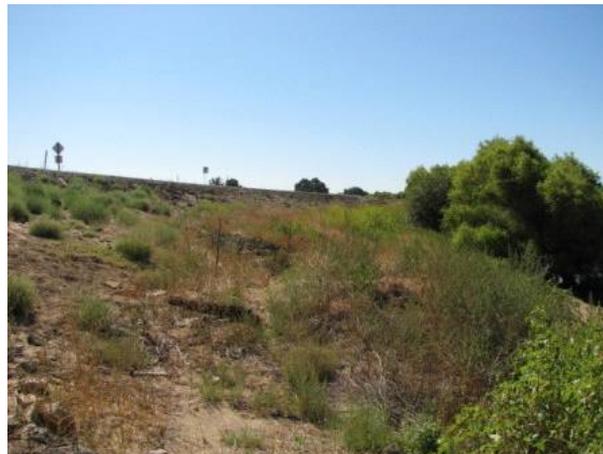
Levee Mile Report Line	14
Start Levee Mile	5.34
End Levee Mile	5.35
Location	Water Side
Category	Supplemental
Item	DWR Erosion Survey
<p>Looking up to the levee crown at the added material.</p>	
<p>SJR2011_RD2075U01RM64.34_2.jpg</p>

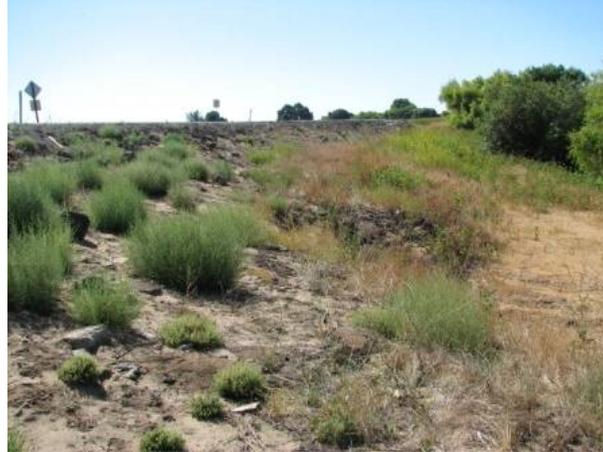
Levee Mile Report Line	14
Start Levee Mile	5.34
End Levee Mile	5.35
Location	Water Side
Category	Supplemental
Item	DWR Erosion Survey
Looking upstream of the erosion site	
SJR2011_RD2075U01RM64.34_3.jpg

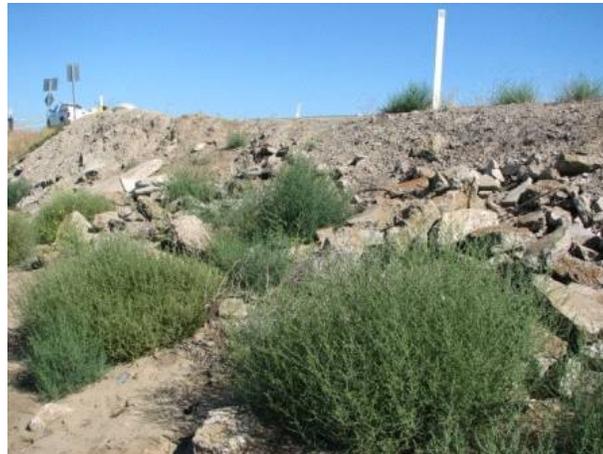
Levee Mile Report Line	14
Start Levee Mile	5.34
End Levee Mile	5.35
Location	Water Side
Category	Supplemental
Item	DWR Erosion Survey
Looking downstream from the added material to the levee	
SJR2011_RD2075U01RM64.34_4.jpg
