**Flood Control Project Maintenance
Levee Inspections**
LMA District Cover Sheet
Spring 2014 Levee Inspection Results

Reclamation District No. 2075 McMullin

Levee Inspection Report By Mile - Spring 2014

Waterway		Bank	Unit Miles	Inspection Start/End	Inspector
Unit No. 01 San Joaquin River		Right	7.52	03/25/2014 03/25/2014	Herman Phillips

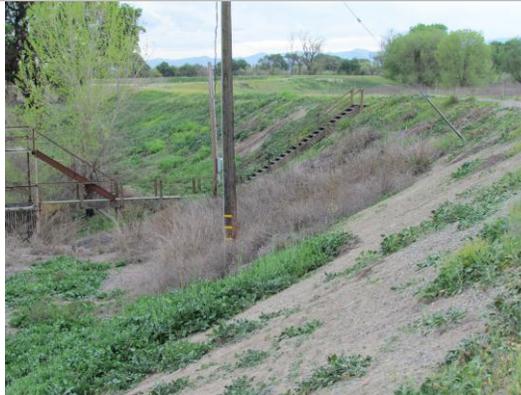
Photo 1 of 1 : phillips_s_20140603_06036.jpg

LM Start	0.00	Rating **	M	Issue No.	221
LM End	0.00	Issue Type +	Ma	Location *	LS
Category	Earthen Levee		GPS Latitude/Longitude		
			Start	End	
Item	Vegetation		37.749405 °	37.749405 °	
			-121.288930 °	-121.288930 °	
DWR ID	DWR_RD2075_01_s_2014_221				
Action/Comments					
Control annual grass and weeds on the levee slopes and easements. Inspector Comments: Looking downstream at the landside slope there are weeds presently growing on the slope. The District said that the weeds were sprayed 3-24.2014. just one day prior to this inspection 3-25-2014. Photos were taken 3-25-2014.

RD 2075 looking downstream from levee mile 0.00 landside. Photo taken 03-25-2014.

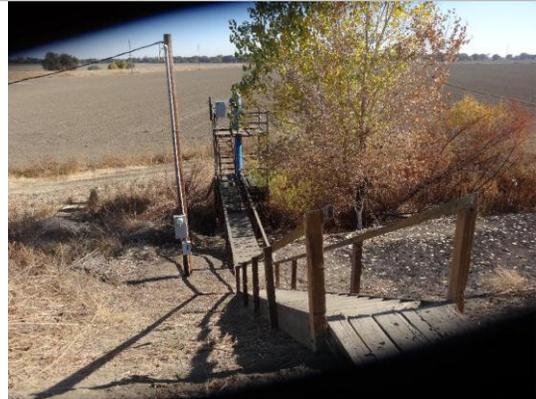
Photo 1 of 1 : UCIP_4188.jpg

LM Start	0.12	Rating **	M	Issue No.	211
LM End	0.12	Issue Type +	En	Location *	WS
Category	Supplemental			GPS Latitude/Longitude	
				Start	End
Item	DWR UCIP Field Study			37.748199 °	37.748199 °
				-121.289717 °	-121.289717 °
DWR ID	DWR_RD2075_01_s_2014_211				
Action/Comments					
Inspector Comments: FS_ID:24663 EP_NO: 4736 Repair Type: Crossing Status: UCIP Comments: - pipe not visible on waterside.no access to concrete riser on waterside.blocked siphon breaker. FIELD_STRUCT_DESC: 14-inch steel pipe through the levee, 4.0 feet below the crown. Pump mounted on pile structure in drainage ditch on the landside. Siphon breaker in concrete riser unit on the waterward slope. Concrete distribution box at the toe of waterward slope. (App. No. 4736 - E. E. Brown). O&M Manual SJR 003, Dec. 1968. FS Date: 11/13/2013

LS view: walkway, pump, service pole, and intake structure.

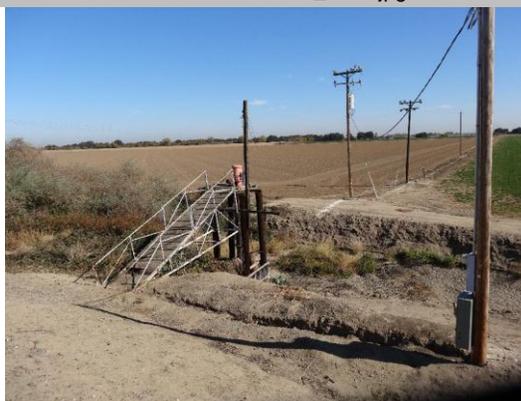
Photo 1 of 1 : UCIP_4196.jpg

LM Start	2.35	Rating **	M	Issue No.	212
LM End	2.35	Issue Type +	En	Location *	WS
Category	Supplemental			GPS Latitude/Longitude	
				Start	End
Item	DWR UCIP Field Study			37.731314 °	37.731314 °
				-121.293712 °	-121.293712 °
DWR ID	DWR_RD2075_01_s_2014_212				
Action/Comments					
Inspector Comments: FS_ID:24666 EP_NO: N/A Repair Type: Crossing Status: UCIP Comments: - service pole on landside looks abandoned. Walkway in dilapidated condition. FIELD_STRUCT_DESC: 16-inch pipe through the levee, 4.5 feet below the crown. Pump mounted on pile structure in drain ditch on the landward side. Siphon breaker in CM riser unit on the waterward slope. O&M Manual SJR 003, Dec. 1968. FS Date: 11/13/2013

LS view: walkway, pump, pile structure, and service pole.

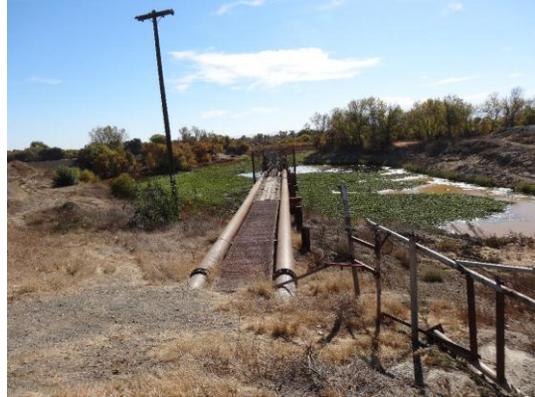
Photo 1 of 1 : UCIP_4551.jpg

LM Start	5.26	Rating **	M	Issue No.	213
LM End	5.26	Issue Type +	En	Location *	WS
Category	Supplemental			GPS Latitude/Longitude	
				Start	End
Item	DWR UCIP Field Study			37.728848 °	37.728848 °
				-121.275195 °	-121.275195 °
DWR ID	DWR_RD2075_01_s_2014_213				
Action/Comments					
Inspector Comments: FS_ID:25184 EP_NO: N/A Repair Type: Crossing Status: UCIP Comments: Flap gate lid displaced. FIELD_STRUCT_DESC: 2 of 2: Two 16-inch pipes through the levee, 8.0 feet below the crown. Pump mounted on pile structure in the river. Walkway to the pumps. Siphon breakers and concrete distribution box on the landward slope. Electric conduit through the levee. O&M Manual SJR 003, Dec. 1968. FS Date: 11/13/2013

WS view: two pipes, walkway to pump and pile structure in the stream.

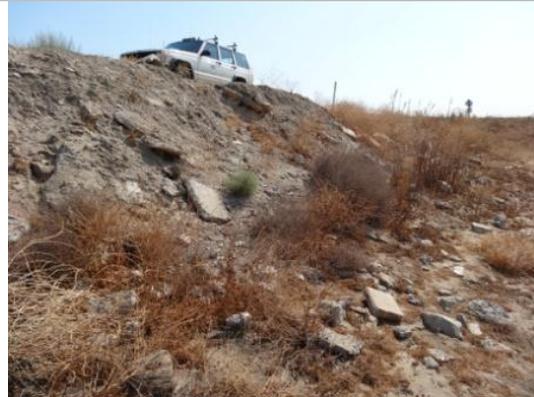
Photo 1 of 1 : phillips_s_20140306_673.jpg

LM Start	5.34	Rating **	M	Issue No.	1
LM End	5.35	Issue Type +	Ma	Location *	WS
Category	Supplemental		GPS Latitude/Longitude		
			Start	End	
Item	DWR Erosion Survey		37.727933 °	37.727933 °	
			-121.274491 °	-121.274491 °	
DWR ID	DWR_RD2075_01_s_2014_1				
Action/Comments					
<p>Inspector Comments: 09/10/2013: No significant change observed. 09/13/2012: No significant change observed. 08/18/2011: No significant change observed. Some new material added to the water side levee slope, but the added material is loose and seems not helping the levee protection. 10/05/2010: No significant changes observed. Levee slope has minimal vegetation and lacks rip rap protection. Sandy material found on the lower and middle slope is an undesirable material to have on a levee. 08/05/2010: Recommended for annual assessment and monitoring during flood events, per CLRO. 08/20/2009: No major change since last visit; site is located in an oxbow; slope surface consists of very sandy material; there is a tree on site leaning and with exposed tree roots; site is recommended as a local maintenance issue, per CLRO CES Evaluation 2008 Report; Eddy Cordoza from the district is aware of the site and is looking for recommendation; site is previously rated "U". 08/17/2007: Site is close to an irrigation pump inlet. [2013 Site ID:RD2075U01RM64.34]</p>

Looking up to the levee crown at the added material.

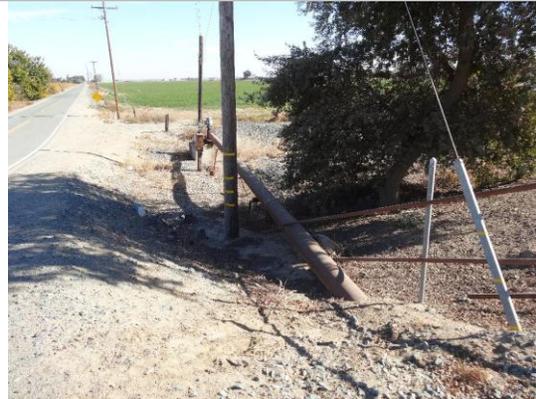
Photo 1 of 1 : UCIP_4198.jpg

LM Start	5.63	Rating **	M	Issue No.	214
LM End	5.63	Issue Type +	En	Location *	WS
Category	Supplemental			GPS Latitude/Longitude	
				Start	End
Item	DWR UCIP Field Study			37.724877 °	37.724877 °
				-121.271025 °	-121.271025 °
DWR ID	DWR_RD2075_01_s_2014_214				
Action/Comments					
Inspector Comments: FS_ID:24723 EP_NO: 3492 Repair Type: Crossing Status: UCIP Comments: Huge erosion on waterside levee slope due to siphon breaker leakage. It is not 16-inch but 12-inch steel pipe. Pump not mounted on pile structure but mounted on concrete sump. Siphon breaker not in concrete riser but on steel pipe. Pipe is not 8 ft. below the crown but 4 ft below the crown. Looks original pipe was replaced with new crossing. Needs more information from LMA or DWR Inspector. FIELD_STRUCT_DESC: 12-inch pipe through the levee, 4.0 feet below the crown. Pump mounted on concrete sump in drain ditch on the landside. Siphon breaker on the waterside slope. (App. No. 3492&A - RD2075) O&M Manual SJR 003, Dec. 1968. FS Date: 11/13/2013

LS view: pipe, pump and concrete sump in the drain ditch.

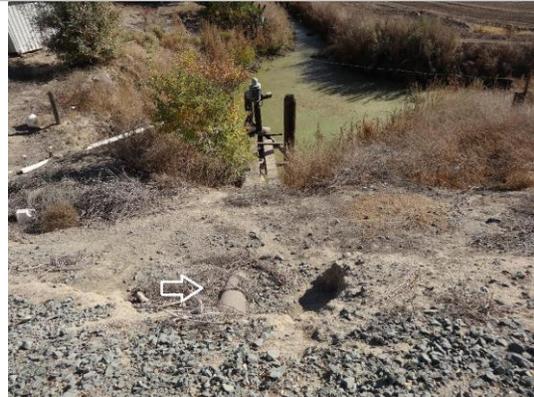
Photo 1 of 1 : UCIP_4557.jpg

LM Start	6.92	Rating **	M	Issue No.	215
LM End	6.92	Issue Type +	En	Location *	WS
Category	Supplemental			GPS Latitude/Longitude	
				Start	End
Item	DWR UCIP Field Study			37.714162 °	37.714162 °
				-121.259227 °	-121.259227 °
DWR ID	DWR_RD2075_01_s_2014_215				
Action/Comments					
Inspector Comments: FS_ID:25185 EP_NO: 4051 Repair Type: Crossing Status: UCIP Comments: - exposed deformed pipe on landside slope.soil erosion also occurred around the deformed pipe.a temporary 12-inch PVC pipe also found on both sides of the levee. FIELD_STRUCT_DESC: 12-inch pipe through the levee, 5.5 feet below the crown. Pump mounted over concrete sump at the landside levee toe. Siphon breaker in CM riser unit on the waterward shoulder. 12-inch PVC pipe 1.0 foot below the crown Installed for emergency use during 1986 floods. (App. No. 4051). O&M Manual SJR 003, Dec. 1968. FS Date: 11/13/2013

LS view: deformed pipe and soil erosion around it (marked bottom). Pipe and pump on pile structure in drain ditch.

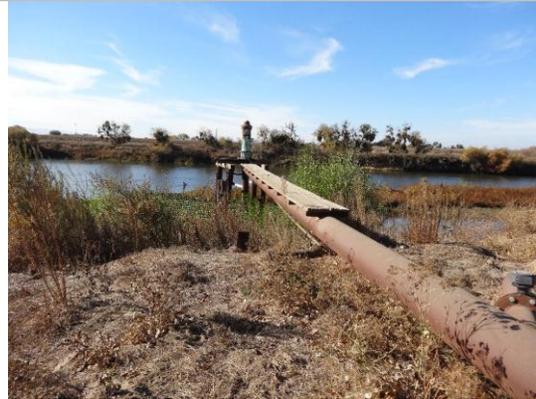
Photo 1 of 1 : UCIP_4202.jpg

LM Start	7.51	Rating **	M	Issue No.	216
LM End	7.51	Issue Type +	En	Location *	LS
Category	Supplemental			GPS Latitude/Longitude	
				Start	End
Item	DWR UCIP Field Study			37.710420 °	37.710420 °
				-121.268220 °	-121.268220 °
DWR ID	DWR_RD2075_01_s_2014_216				
Action/Comments					
Inspector Comments: FS_ID:24738 EP_NO: 2150 Repair Type: Crossing Status: UCIP Comments: Most of the pipe exposed on waterside leads investigation regarding levee subsidence along pipe alienment on landside slope. FIELD_STRUCT_DESC: 12-inch pipe through the levee, 4.5 feet below the crown. Pump mounted on pile structure in the river. Concrete distribution box at the landward toe. Electric conduit through the levee. (App. No. 2150 - Cardoza) O&M Manual SJR 003, Dec. 1968. FS Date: 11/13/2013

WS view: pipe, walkway, and pump on pile structure in the river.
