**Flood Control Project Maintenance
Levee Inspections**

Maintenance Issue Types Only, Levee Inspection Report By Mile - Fall 2014

Reclamation District No. 2075 McMullin

Waterway	Bank	Unit Miles	Inspection Start/End	Inspector
Unit No. 01 San Joaquin River	Right	7.45	10/29/2014 10/29/2014	Herman Phillips

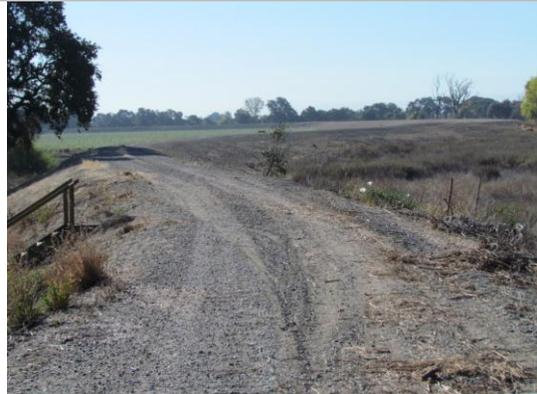
Photo 1 of 1 : FA_2014_RD2075_315_2_20141104_00001.jpg

LM Start	0.11	Rating **	A	Issue No.	2
LM End	2.32	Issue Type +	Ma	Location *	WS
Category	Earthen Levee		GPS Latitude/Longitude		
			Start	End	
Item	Vegetation		37.748402 °	37.731575 °	
			-121.289762 °	-121.293763 °	
DWR ID	DWR_RD2075_01_f_2014_2				
Action/Comments					
Control annual grass and weeds on the levee slopes and easements. Inspector Comments: District has done a great job removing unwanted grasses from the levee slopes.

Looking downstream from levee mile 0.11 both landside and waterside levee slopes has been maintained.

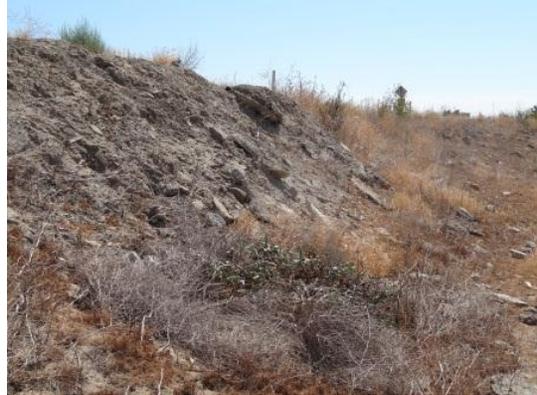
Photo 1 of 1 : SJR2014_RD2075U01RM64.34_1.jpg

LM Start	5.34	Rating **	M	Issue No.	12
LM End	5.35	Issue Type +	Ma	Location *	WS
Category	Supplemental		GPS Latitude/Longitude		
			Start	End	
Item	DWR Erosion Survey		37.727933 °	37.727933 °	
			-121.274491 °	-121.274491 °	
DWR ID					
Action/Comments					
Inspector Comments: 09/10/2013: No significant change observed. 09/13/2012: No significant change observed. 08/18/2011: No significant change observed. Some new material added to the water side levee slope, but the added material is loose and seems not helping the levee protection. 10/05/2010: No significant change observed. Levee slope has minimal vegetation and lacks rip rap protection. Sandy material found on the lower and middle slope is an undesirable material to have on a levee. 08/05/2010: Recommended for annual assessment and monitoring during flood events, per CLRO. 08/20/2009: No major change since last visit; site is located in an oxbow; slope surface consists of very sandy material; there is a tree on site leaning and with exposed tree roots; site is recommended as a local maintenance issue, per CLRO CES Evaluation 2008 Report; Eddy Cordoza from the district is aware of the site and is looking for recommendation; site is previously rated "U". 08/17/2007: Site is close to an irrigation pump inlet. [2014 Site ID:RD2075U01RM64.34]

Looking downstream of the erosion site.
