**Flood Control Project Maintenance  
Levee Inspections**

## Maintenance Issue Types Only, Levee Inspection Report By Mile - Spring 2015

### Reclamation District No. 2075 McMullin

Waterway	Bank	Unit Miles	Inspection Start/End	Inspector
Unit No. 01 San Joaquin River	Right	7.45	04/07/2015 04/07/2015	Herman Phillips

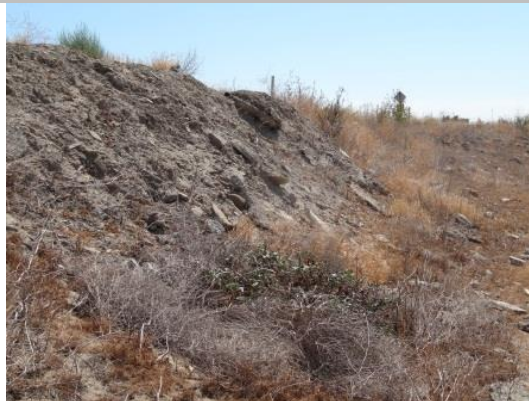
Photo 1 of 1 : SP\_2015\_RD2075\_315\_12\_20150312\_00001.jpg

LM Start	5.28	Rating **	M	Issue No.	12
LM End	5.28	Issue Type +	Ma	Location *	WS
Category	Supplemental			GPS Latitude/Longitude	
				Start	End
Item	DWR Erosion Survey			37.727933 °	37.727933 °
				-121.274491 °	-121.274491 °
DWR ID	DWR RD2075 01 s 2015 12

Action/Comments					
<p>Inspector Comments: 09/10/2013: No significant change observed.  09/13/2012: No significant change observed.  08/18/2011: No significant change observed. Some new material added to the water side levee slope, but the added material is loose and seems not helping the levee protection.  10/05/2010: No significant change observed. Levee slope has minimal vegetation and lacks rip rap protection. Sandy material found on the lower and middle slope is an undesirable material to have on a levee.  08/05/2010: Recommended for annual assessment and monitoring during flood events, per CLRO.  08/20/2009: No major change since last visit; site is located in an oxbow; slope surface consists of very sandy material; there is a tree on site leaning and with exposed tree roots; site is recommended as a local maintenance issue, per CLRO CES Evaluation 2008 Report; Eddy Cordoza from the district is aware of the site and is looking for recommendation; site is previously rated "U".  08/17/2007: Site is close to an irrigation pump inlet. [2014 Site ID:RD2075U01RM64.34]</p>

Looking downstream of the erosion site.
