**Flood Control Project Maintenance
Levee Inspections**

Maintenance Issue Types Only, Levee Inspection Report By Mile - Spring 2016

Reclamation District No. 2075 McMullin

Waterway	Bank	Unit Miles	Inspection Start/End	Inspector
Unit No. 01 San Joaquin River	Right	7.45	03/23/2016 03/23/2016	Herman Phillips

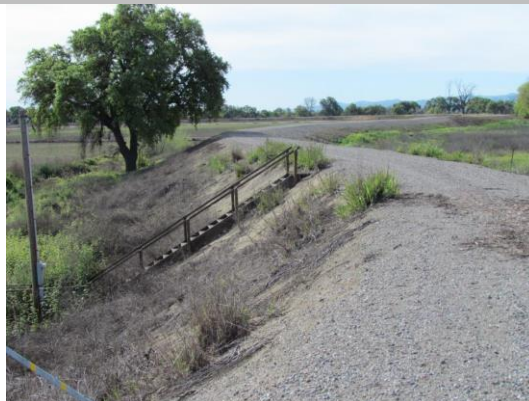
Photo 1 of 1 : SP_2016_RD2075_315_18_20160404_00031.jpg

LM Start	0.10	Rating **	A	Issue No.	18
LM End	5.21	Issue Type +	Ma	Location *	LS
Category	Earthen Levee			GPS Latitude/Longitude	
				Start	End
Item	Vegetation			37.748492 °	37.728805 °
				-121.289720 °	-121.275083 °
DWR ID	DWR_RD2075_01_s_2016_18				
Comment Code					
V1 : Control annual grass and weeds on the levee slopes and easements.					
Inspector Comment					
The RD has sprayed the levee section both landside and waterside slopes.

Looking downstream from levee mile 0.10 landside slope RD 2075.

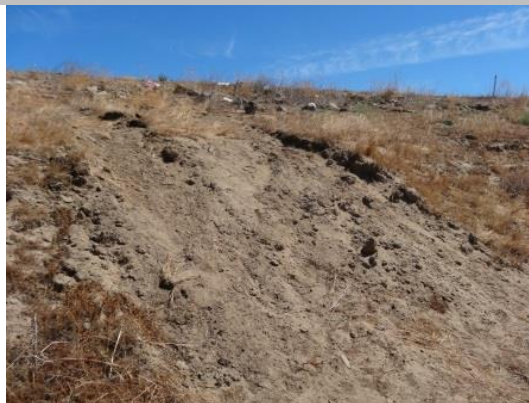
Photo 1 of 3 : SP_2016_RD2075_315_1_20160223_00001.jpg

LM Start	5.28	Rating **	M	Issue No.	1
LM End	5.29	Issue Type +	Ma	Location *	WS
Category	Supplemental			GPS Latitude/Longitude	
				Start	End
Item	DWR Erosion Survey			37.727933 °	37.727933 °
				-121.274491 °	-121.274491 °
DWR ID	DWR_RD2075_01_s _ 2016_1

Comment Code					
Inspector Comment					
08/28/2015: No significant change observed. Loose material is visible at the upper levee slope. The loose soil may have been caused by runoff.					
08/18/2014: No significant change observed.					
09/10/2013: No significant change observed.					
09/13/2012: No significant change observed.					
08/18/2011: No significant change observed. Some new material added to the water side levee slope, but the added material is loose and seems not helping the levee protection.					
10/05/2010: No significant change observed. Levee slope has minimal vegetation and lacks rip rap protection. Sandy material found on the lower and middle slope is an undesirable material to have on a levee.					
08/05/2010: Recommended for annual assessment and monitoring during flood events, per CLRO.					
08/20/2009: No major change since last visit; site is located in an oxbow; slope surface consists of very sandy material; there is a tree on site leaning and with exposed tree roots; site is recommended as a local maintenance issue, per CLRO CES Evaluation 2008 Report; Eddy Cordoza from the district is aware of the site and is looking for recommendation; site is previously rated "U".

08/17/2007: Site is close to an irrigation pump inlet. [2015 Site ID:RD2075U01RM64.34]

Direct view of the levee slope. Note the loose soil possibly caused by runoff.

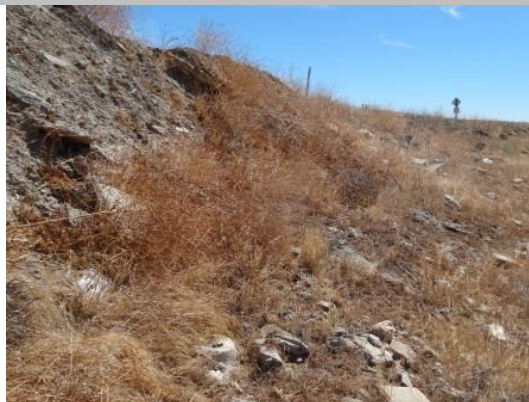
Photo 2 of 3 : SP_2016_RD2075_315_1_20160223_00002.jpg

Looking downstream at the erosion site.

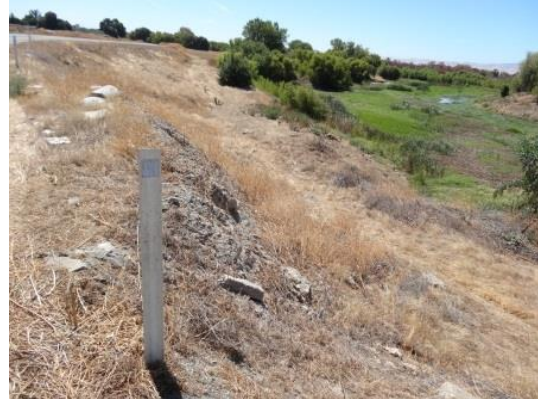
Photo 3 of 3 : SP_2016_RD2075_315_1_20160223_00003.jpg

Looking upstream at the site.
