**Flood Control Project Maintenance
Levee Inspections**

Maintenance Issue Types Only, Levee Inspection Report By Mile - Spring 2017

Reclamation District No. 2075 McMullin

Waterway	Bank	Unit Miles	Inspection Start/End	Inspector
Unit No. 01 San Joaquin River	Right	7.45	04/20/2017 04/20/2017	Herman Phillips

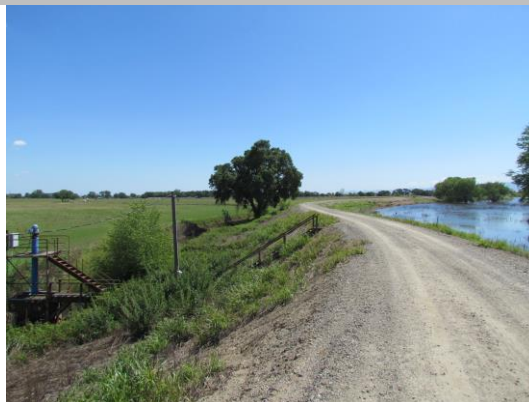
Photo 1 of 1 : SP_2017_RD2075_315_12_20170510_00029.jpg

LM Start	0.10	Rating **	U	Issue No.	12
LM End	1.04	Issue Type +	Ma	Location *	LS
Category	Earthen Levee			GPS Latitude/Longitude	
				Start	End
Item	Vegetation			37.748393 °	37.739322 °
				-121.289778 °	-121.281450 °
DWR ID	DWR_RD2075_01_f_2016_12				
Comment Code					
V1 : Control annual grass and weeds on the levee slopes and easements.					
Inspector Comment					
Weeds taller than 3.0 feet on the landside slope and shoulder need to be removed.

Looking upstream from levee mile 0.10 landside slope unwanted tall weeds present on the levee slope and toe.

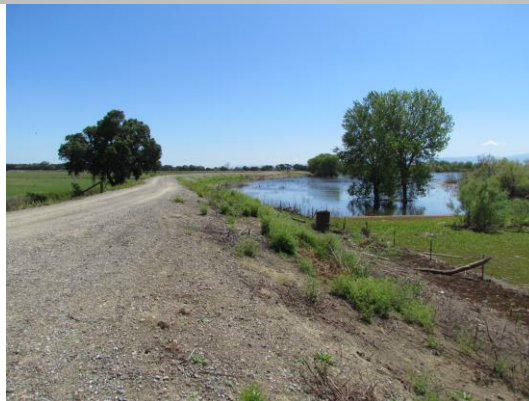
Photo 1 of 1 : SP_2017_RD2075_315_23_20170518_00030.jpg

LM Start	0.10	Rating **	M	Issue No.	23
LM End	0.48	Issue Type +	Ma	Location *	WS
Category	Earthen Levee			GPS Latitude/Longitude	
				Start	End
Item	Vegetation			37.748393 °	37.743153 °
				-121.289762 °	-121.289140 °
DWR ID	DWR_RD2075_01_s_2017_23				
Comment Code					
V1 : Control annual grass and weeds on the levee slopes and easements.					
Inspector Comment					
Spray and mow the weeds on the waterside slope.

RD 2075 Waterside slope looking upstream from levee mile 0.10.

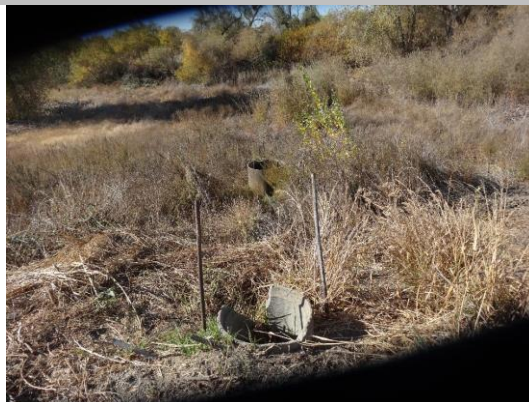
Photo 1 of 3 : UCIP_SP_2017_24663_44022.jpg

LM Start	0.12	Rating **	M	Issue No.	24
LM End	0.12	Issue Type +	Ma	Location *	WS
Category	Supplemental			GPS Latitude/Longitude	
				Start	End
Item	DWR UCIP LMA Responsibility			37.748200 °	37.748200 °
				-121.289717 °	-121.289717 °
DWR ID					
Comment Code					
Inspector Comment					
FS_ID:24663 DS_ID:24735 EP_NO: 4736 Repair Type: Non-Urgent Crossing Status: Found UCIP Comments: - pipe not visible on waterside.- no access to concrete riser on waterside.- blocked siphon breaker. FIELD_STRUCT_DESC: 14-inch steel pipe through the levee, 4.0 feet below the crown. Pump mounted on pile structure in drainage ditch on the landside. Siphon breaker in concrete riser unit on the waterward slope. Concrete distribution box at the toe of waterward slope. (App. No. 4736 - E. E. Brown). O&M Manual SJR 003, Dec. 1968. FS Date: 11/13/2013

WS view: concrete standpipe (top) and concrete pipe riser (bottom) on levee slope.

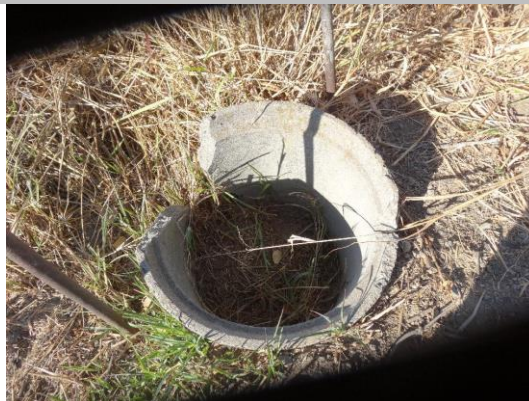
Photo 2 of 3 : UCIP_SP_2017_24663_44021.jpg

WS view: concrete pipe riser with siphon breaker on levee slope.

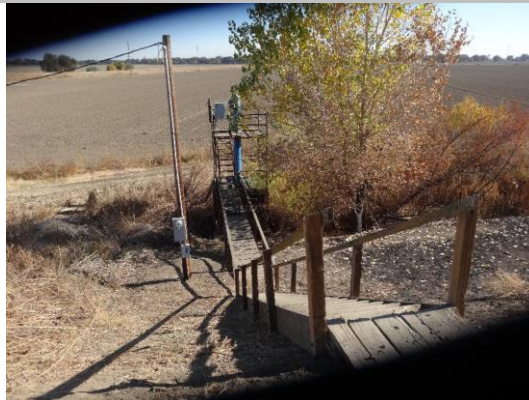
Photo 3 of 3 : UCIP_SP_2017_24663_44020.jpg

LS view: walkway, pump, service pole, and intake structure.

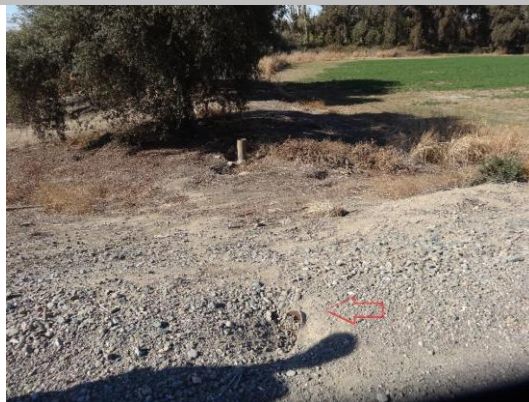
Photo 1 of 3 : UCIP_SP_2017_24666_45600.jpg

LM Start	2.32	Rating **	M	Issue No.	25
LM End	2.32	Issue Type +	Ma	Location *	LS
Category	Supplemental			GPS Latitude/Longitude	
				Start	End
Item	DWR UCIP LMA Responsibility			37.731314 °	37.731314 °
				-121.293713 °	-121.293713 °
DWR ID					
Comment Code					
Inspector Comment					
FS_ID:24666					
DS_ID:24737					
EP_NO: N/A					
Repair Type: Non-Urgent					
Crossing Status: Found					
UCIP Comments: - service pole on landside.- looks abandoned.					
Walkway in dilapidated condition.					
FIELD_STRUCT_DESC: 16-inch pipe through the levee, 4.5 feet below the crown. Pump mounted on pile structure in drain ditch on the landward side. Siphon breaker in CM riser unit on the waterward slope.					
O&M Manual SJR 003, Dec. 1968.					
FS Date: 11/13/2013

WS view: concrete standpipe (top) and steel pipe riser (bottom marked) on levee slope.

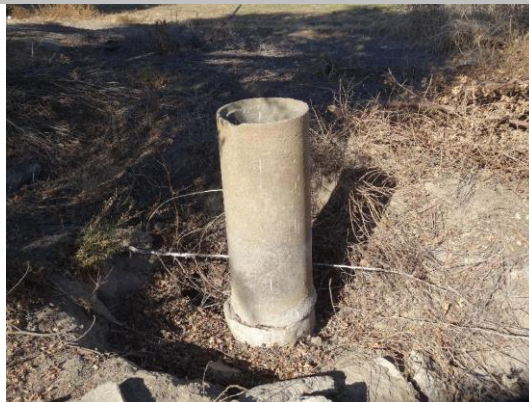
Photo 3 of 3 : UCIP_SP_2017_24666_44029.jpg

WS view: concrete standpipe on levee toe.

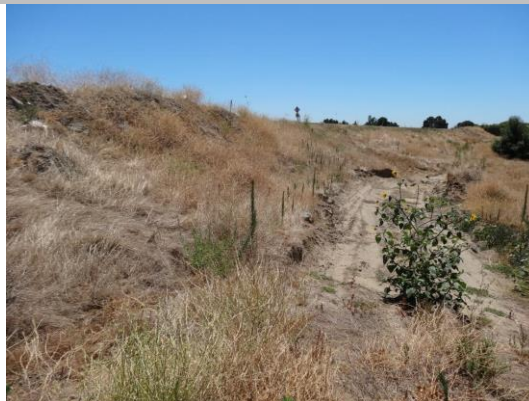
Photo 1 of 3 : SP_2017_RD2075_315_1_20170404_00001.jpg

07/12/2016: No significant change observed.
 08/28/2015: No significant change observed. Loose material is visible at the upper levee slope. The loose soil may have been caused by runoff.
 08/18/2014: No significant change observed.
 09/10/2013: No significant change observed.
 09/13/2012: No significant change observed.
 08/18/2011: No significant change observed. Some new material added to the water side levee slope, but the added material is loose and seems not helping the levee protection.
 10/05/2010: No significant change observed. Levee slope has minimal vegetation and lacks rip rap protection. Sandy material found on the lower and middle slope is an undesirable material to have on a levee.
 08/05/2010: Recommended for annual assessment and monitoring during flood events, per CLRO.
 08/20/2009: No major change since last visit; site is located in an oxbow; slope surface consists of very sandy material; there is a tree on site leaning and with exposed tree roots; site is recommended as a local maintenance issue, per CLRO CES Evaluation 2008 Report; Eddy Cordoza from the district is aware of the site and is looking for recommendation; site is previously rated "U".

08/17/2007: Site is close to an irrigation pump inlet. [2016 Site ID:RD2075U01RM64.34]

Upstream view of the erosion site.

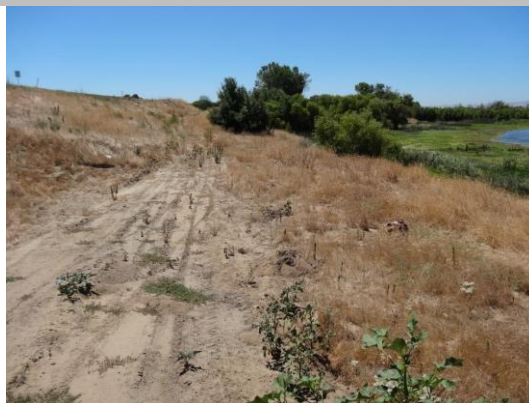
Photo 2 of 3 : SP_2017_RD2075_315_1_20170404_00002.jpg

Looking upstream at the site.

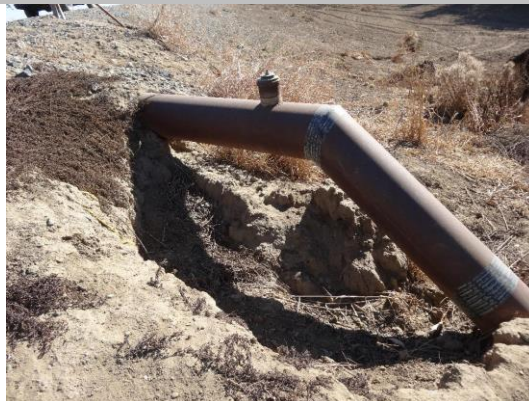
Photo 1 of 3 : UCIP_SP_2017_50191_44262.jpg

FS_ID:50191
DS_ID:24740
EP_NO: 3492
Repair Type: Non-Urgent
Crossing Status: Found
UCIP Comments: 06/21/2016 Rock revetment placed along WS slope beneath and around pipe; this corrected the levee erosion but still unclear whether the cause of the erosion was addressed. I found no evidence of siphon breaker leakage cited previously. Eddy Cardoza of RD2075 mentioned he saw no leak in and around pipe when the levee slope was repaired. Crossing was been downgraded from Urgent to Non-Urgent. (K. Fazel - UCIP)11/13/2013 Huge erosion on waterside levee slope due to siphon breaker leakage. It is not 16-inch but 12-inch steel pipe. Pump not mounted on pile structure but mounted on concrete sump. Siphon breaker not in concrete riser but on steel pipe. Pipe is not 8 ft. below the crown but 4 ft below the crown. Looks original pipe was replaced with new crossing. Needs more information from LMA or DWR Inspector. (P. Amatya - DWR)

FIELD_STRUCT_DESC: 12-inch (not 14-inch as referenced in Permit No. 3492-A) asphalt coated steel pipe through the levee, 4 feet below the crown. Pump mounted on a concrete sump in a drain ditch approximately 200 feet off the landside (LS) toe. Siphon breaker on the apex of the pipe through the waterside (WS) slope. (Permit No. 3492, 1962 - RD2075) (Additional Related Permit(s): 3492-A, 1969 - RD2075). [Additional Reference(s): DWR Levee Log, 2005. USACE San Joaquin O&M Manual 003, Dec 1968 (HLM 5.52)]. Note O&M Manual references a 16-inch pipe with a depth of 8 feet at this location, which was replaced under Permit No. 3492 with a 6-inch pipe, which was replaced with a 14-inch pipe under Permit No. 3492-A.
FS Date: 6/21/2016

WS view: siphon breaker on steel pipe on levee slope. Huge soil erosion due to siphon breaker leakage.

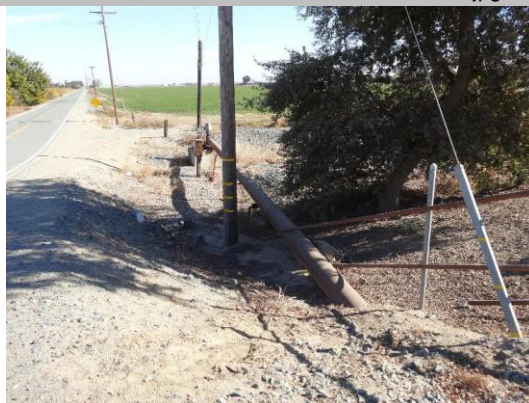
Photo 2 of 3 : UCIP_SP_2017_50191_44261.jpg

LS view: pipe, pump and concrete sump in the drain ditch.

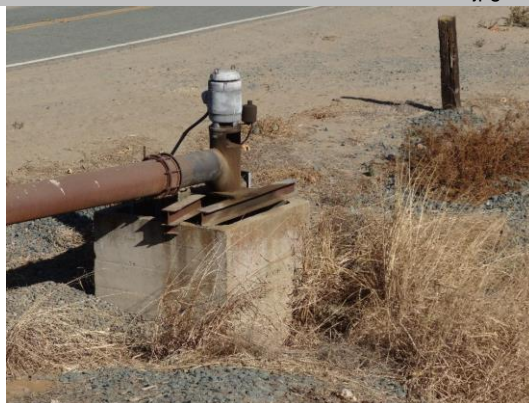
Photo 3 of 3 : UCIP_SP_2017_50191_44260.jpg

LS view: closer view of pipe, pump and concrete sump in the drain ditch.

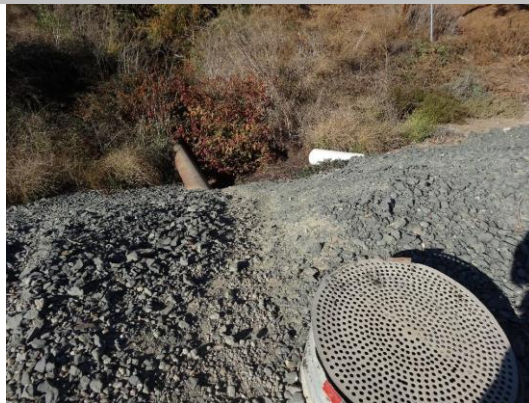
Photo 1 of 3 : UCIP_SP_2017_50213_45613.jpg

FS_ID:50213
DS_ID:24742
EP_NO: 4051
Repair Type: Non-Urgent
Crossing Status: Found
UCIP Comments: 06/21/2016: Erosion repaired with rock revetment and crown regraded. Pipe is crushed and deformed on LS. PVC pipe has been removed. Crossing has been downgraded from Urgent to Non-Urgent. 11/13/2013:- exposed deformed pipe on landside slope. Soil erosion also occurred around the deformed pipe. Walkway at pump on LS toe in poor structural condition.- a temporary 12-inch PVC pipe also found on both sides of the levee.
FIELD_STRUCT_DESC: 12-inch drainage pipe through the levee, 5.5 feet below the crown. Pump mounted over concrete sump at the landside (LS) toe. Siphon breaker in corrugated metal riser unit on the waterside (WS) shoulder. 12-inch polyvinyl chloride (PVC) pipe 1 foot below the crown, installed through the levee for emergency use during 1986 floods (not found in 2016). (Permit No. 4051, 1962 - RD2075).

WS view: CMP riser (bottom) on levee shoulder. Steel pipe (top) and temporary pvc pipe on levee slope.

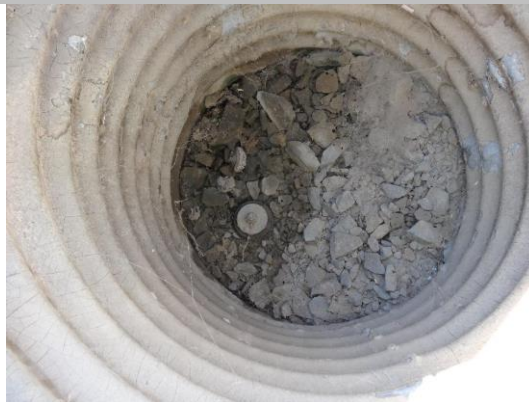
Photo 2 of 3 : UCIP_SP_2017_50213_45612.jpg

WS view: siphon breaker in CMP riser on levee shoulder.

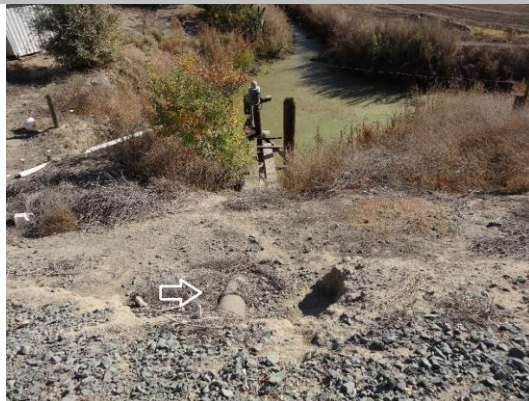
Photo 3 of 3 : UCIP_SP_2017_50213_45614.jpg

FS_ID:50213
DS_ID:24742
EP_NO: 4051
Repair Type: Non-Urgent
Crossing Status: Found
UCIP Comments: 06/21/2016: Erosion repaired with rock revetment and crown regraded. Pipe is crushed and deformed on LS. PVC pipe has been removed. Crossing has been downgraded from Urgent to Non-Urgent. 11/13/2013:- exposed deformed pipe on landside slope. Soil erosion also occurred around the deformed pipe. Walkway at pump on LS toe in poor structural condition.- a temporary 12-inch PVC pipe also found on both sides of the levee.
FIELD_STRUCT_DESC: 12-inch drainage pipe through the levee, 5.5 feet below the crown. Pump mounted over concrete sump at the landside (LS) toe. Siphon breaker in corrugated metal riser unit on the waterside (WS) shoulder. 12-inch polyvinyl chloride (PVC) pipe 1 foot below the crown, installed through the levee for emergency use during 1986 floods (not found in 2016). (Permit No. 4051, 1962 - RD2075).

LS view: deformed pipe and soil erosion around it (marked bottom). Pipe and pump on pile structure in drain ditch.
