**Flood Control Project Maintenance
Levee Inspections**

Maintenance Issue Types Only, Levee Inspection Report By Mile - Spring 2018

Reclamation District No. 2075 McMullin

Waterway	Bank	Unit Miles	Inspection Start/End	Inspector
Unit No. 01 San Joaquin River	Right	7.45	05/24/2018 05/24/2018	Richard Willoughby

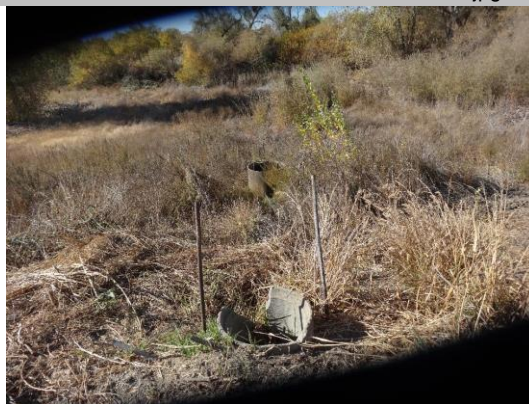
Photo 1 of 3 : UCIP_SP_2018_24663_44022.jpg

FS_ID:24663
DS_ID:24735
EP_NO: 4736
Repair Type: Non-Urgent
Crossing Status: Found
UCIP Comments: - pipe not visible on waterside.- no access to concrete riser on waterside.- blocked siphon breaker.
FIELD_STRUCT_DESC: 14-inch coated steel drainage discharge pipe through the levee, 4 feet below the crown. Two concrete cutoff walls. Pump mounted on a pile structure in the drainage ditch on the landside (LS). Siphon breaker in a concrete riser on the waterside (WS) slope. Concrete distribution box at the WS toe. (Plans for removing and replacing an existing drainage pipe through the levee authorized under Permit No. 4736, 1964 - Reclamation District No. 2075). [Additional Reference(s): DWR Levee Log, 2005, 12-inch pipe referenced. USACE San Joaquin O&M Manual 3, December 1968, (HLM 0.12), 12-inch pipe referenced].
FS Date: 11/13/2013

WS view: concrete standpipe (top) and concrete pipe riser (bottom) on levee slope.

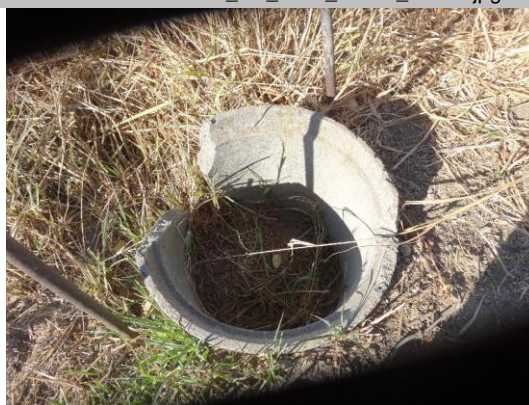
Photo 2 of 3 : UCIP_SP_2018_24663_44021.jpg

WS view: concrete pipe riser with siphon breaker on levee slope.

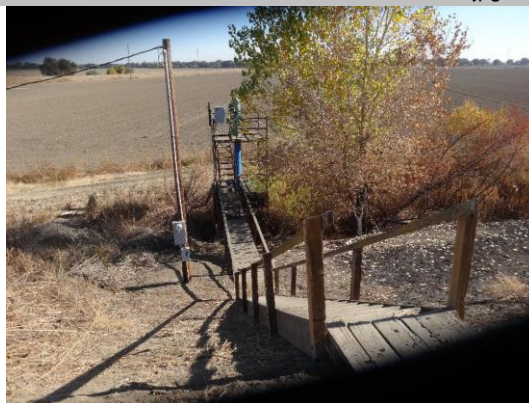
Photo 3 of 3 : UCIP_SP_2018_24663_44020.jpg

Comment Code						
Inspector Comment						
FS_ID:24663 DS_ID:24735 EP_NO: 4736 Repair Type: Non-Urgent Crossing Status: Found UCIP Comments: - pipe not visible on waterside.- no access to concrete riser on waterside.- blocked siphon breaker. FIELD_STRUCT_DESC: 14-inch coated steel drainage discharge pipe through the levee, 4 feet below the crown. Two concrete cutoff walls. Pump mounted on a pile structure in the drainage ditch on the landside (LS). Siphon breaker in a concrete riser on the waterside (WS) slope. Concrete distribution box at the WS toe. (Plans for removing and replacing an existing drainage pipe through the levee authorized under Permit No. 4736, 1964 - Reclamation District No. 2075). [Additional Reference(s): DWR Levee Log, 2005, 12-inch pipe referenced. USACE San Joaquin O&M Manual 3, December 1968, (HLM 0.12), 12-inch pipe referenced]. FS Date: 11/13/2013

LS view: walkway, pump, service pole, and intake structure.

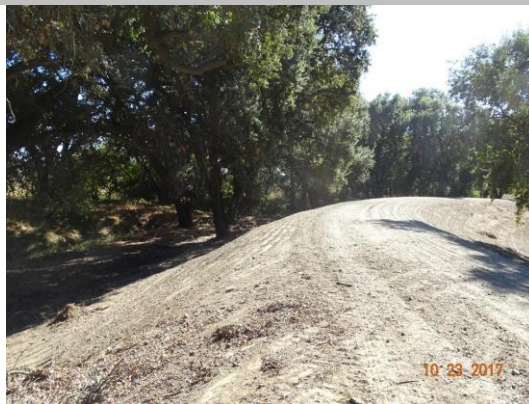
Photo 1 of 1 : SP_2018_RD2075_315_13_20180503_00008.jpg

LM Start	0.99	Rating **	A/W	Issue No.	13
LM End	1.00	Issue Type +	Ma	Location *	LS
Category	Earthen Levee			GPS Latitude/Longitude	
				Start	End
Item	Trim / Thin Trees			37.740015 °	37.739830 °
				-121.281243 °	-121.281217 °
DWR ID	DWR_RD2075_01_f_2016_13				
Comment Code					
T4 : Trim trees over roadway to at least 12 feet above ground level.					
Inspector Comment					
Trees have been trimmed to allow inspection and access.

Trees have been trimmed to allow inspection and access.

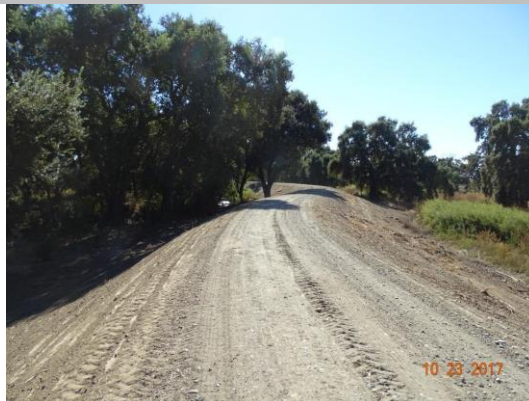
Photo 1 of 1 : SP_2018_RD2075_315_17_20180503_00021.jpg

Trees trimmed to allow inspection and access.

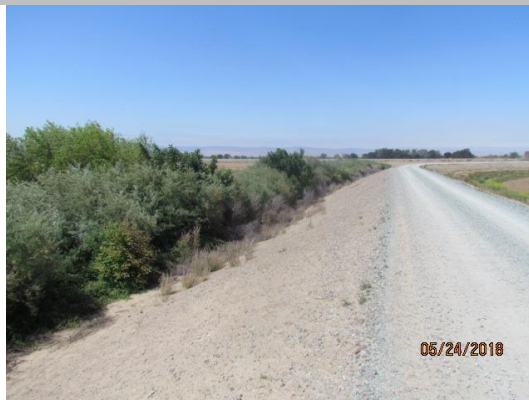
Photo 1 of 3 : SP_2018_RD2075_315_29_20180525_00065.jpg

LM Start	1.55	Rating **	U	Issue No.	29
LM End	1.63	Issue Type +	Ma	Location *	LS
Category	Earthen Levee			GPS Latitude/Longitude	
				Start	End
Item	Vegetation			37.734470 °	37.734213 °
				-121.286230 °	-121.287660 °
DWR ID	DWR_RD2075_01_s_2018_29				
Comment Code					
V2 : Remove the wild growth other than native grasses from the levee slopes.					
Inspector Comment					
Wild growth at landward toe blocking view and should cleared fifteen feet for landward toe.

Looking west at dense veg at landward toe. (Spring 2018)

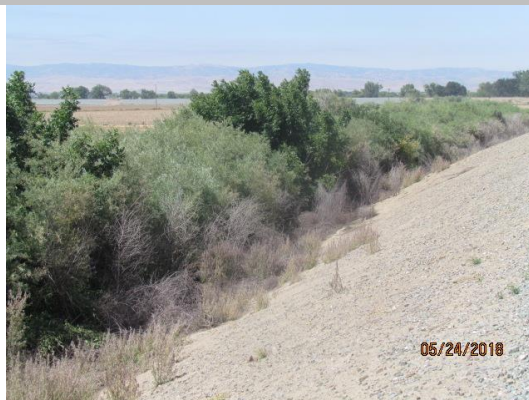
Photo 2 of 3 : SP_2018_RD2075_315_29_20180525_00064.jpg

Looking west at dense veg. at landward toe. (Spring 2018)

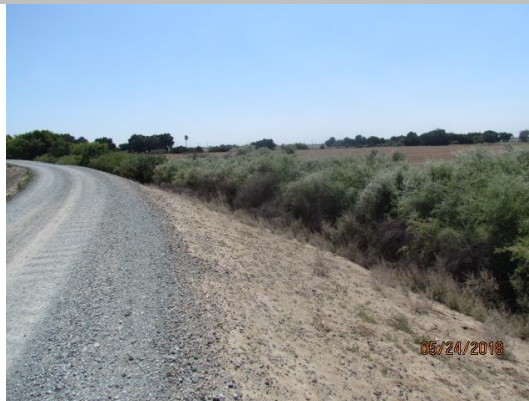
Photo 3 of 3 : SP_2018_RD2075_315_29_20180525_00066.jpg

Looking northeast at dense veg at landward toe. (Spring 2018)

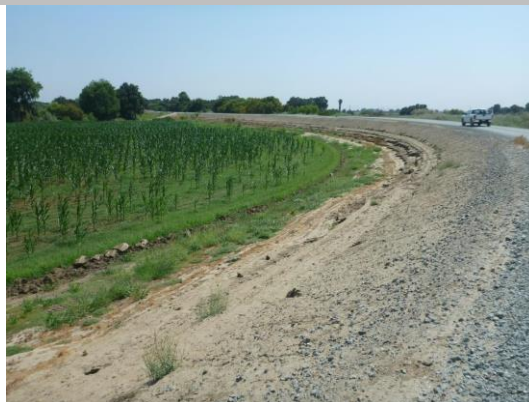
Photo 1 of 4 : LEVAL_SP_2018_575_4241.jpg

Comment Code					
Inspector Comment					
Levee Evaluation Comments					
Description:Slope protection repairs are needed along the waterside slope due to erosion and riprap displacement from high water. Based upon levee inspections, it was determined the waterside levee slope is eroding, deteriorating, and degrading. The eroded levee sections need to be restored back to design standards to prevent further deterioration and damage.					
Site ID No:575					
Site Designation:LMA-481					
Repair Type: Erosion					
Rating:Area of Concern					
Field Date:8/10/2017					
Notes: 10/23/17: According to LMA and my observations at LM 1.63, this site never had riprap (contrary to previous comments). Erosion has encroached into levee prism. Future high water and wavewash will likely advance erosion further into prism. Repairs should be made prior to next high water.

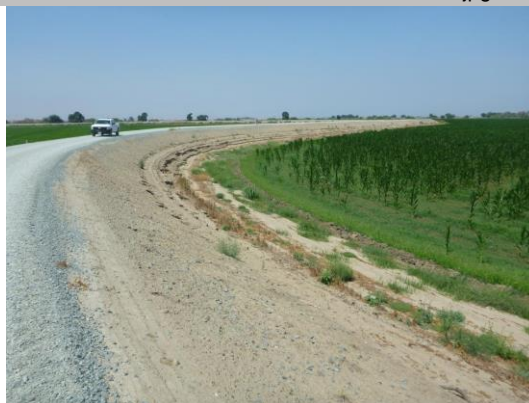
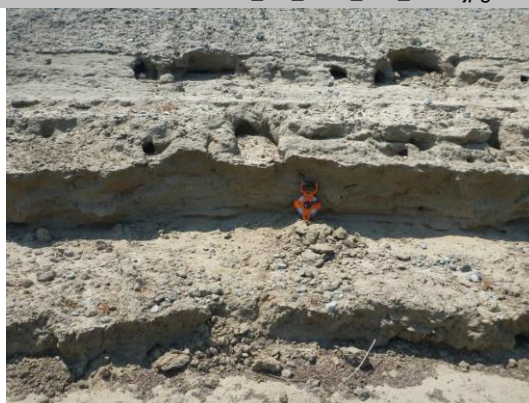
Description: Slope protection repairs are needed along the waterside slope due to erosion and riprap displacement from high water. Based upon levee inspections, it was determined the waterside levee slope is eroding, deteriorating, and degrading. The eroded levee sections need to be restored back to design standards to prevent further deterioration and damage.

Notes: 10/23/17: According to LMA and my observations at LM 1.63, this site never had riprap (contrary to previous comments). Erosion has encroached into levee prism. Future high water and wavewash will likely advance erosion further into prism. Repairs should be made prior to next high water.

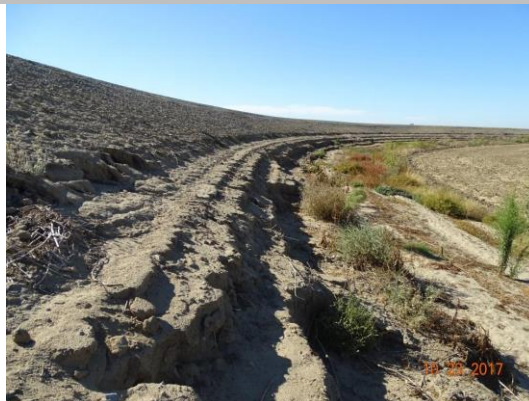
Photo 4 of 4 : SP_2018_RD2075_315_12_20180503_00007.jpg

Description: Slope protection repairs are needed along the waterside slope due to erosion and riprap displacement from high water. Based upon levee inspections, it was determined the waterside levee slope is eroding, deteriorating, and degrading. The eroded levee sections need to be restored back to design standards to prevent further deterioration and damage.

10/23/17: According to LMA and my observations at LM 1.63, this site never had riprap (contrary to previous comments). Erosion has encroached into levee prism. Future high water and wavewash will likely advance erosion further into prism. Repairs should be made prior to next high water.

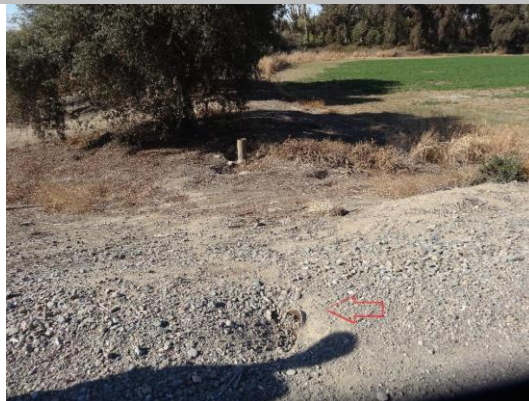
Photo 1 of 3 : UCIP_SP_2018_24666_45600.jpg

FS_ID:24666
DS_ID:24737
EP_NO: N/A
Repair Type: Non-Urgent
Crossing Status: Found
UCIP Comments: - service pole on landside.- looks abandoned.
Walkway in dilapidated condition.
FIELD_STRUCT_DESC: 16-inch steel drainage discharge pipe through the levee, 4.5 feet below the crown. Corrugated metal cutoff wall. Pump mounted on a pile structure in a drainage ditch on the landside (LS).
Siphon breaker in a corrugated metal pipe (CMP) riser on the waterside (WS) slope. [Additional Reference(s): DWR Levee Log, 2005. USACE San Joaquin O&M Manual 3, December 1968, (HLM 2.30)].
FS Date: 11/13/2013

WS view: concrete standpipe (top) and steel pipe riser (bottom marked) on levee slope.

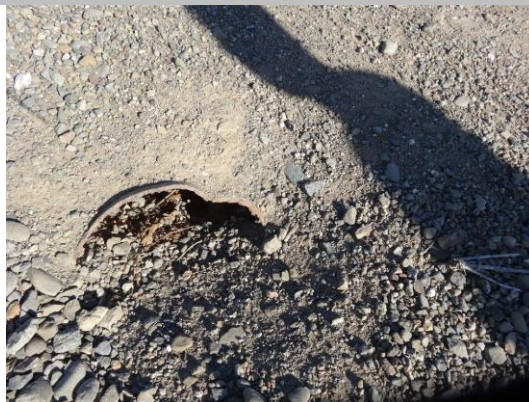
Photo 2 of 3 : UCIP_SP_2018_24666_44030.jpg

WS view: blocked siphon breaker in steel pipe riser on levee slope.

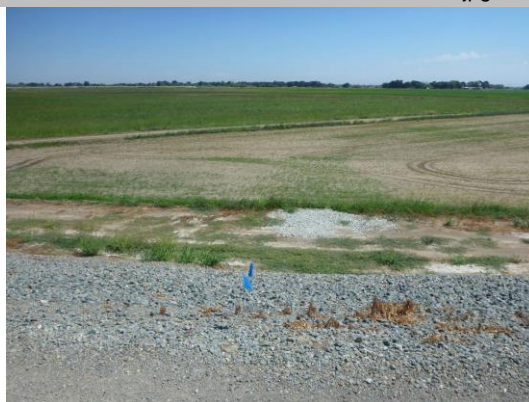
Photo 1 of 3 : LEVAL_SP_2018_479_2203.jpg

Comment Code					
Inspector Comment					
Levee Evaluation Comments					
Description:Sinkholes have formed along the landside levee toe as a result of the high water. The cause of the sinkholes is not clear, but a similar phenomenon in this area is believed to have caused the levee breach earlier this year. Further geotechnical investigation is needed.					
Site ID No:479					
Site Designation:LMA-306					
Repair Type: Stability					
Rating:Area of Concern					
Field Date:7/26/2017					
Notes: Sink holes appear to have already been filled. 10/23/17: LMA has removed pipes (parallel to levee) in this area, and drainage ditch has been relocated to approx 60 feet away from levee toe. Known sandy soils in region may contribute to sinkholes.

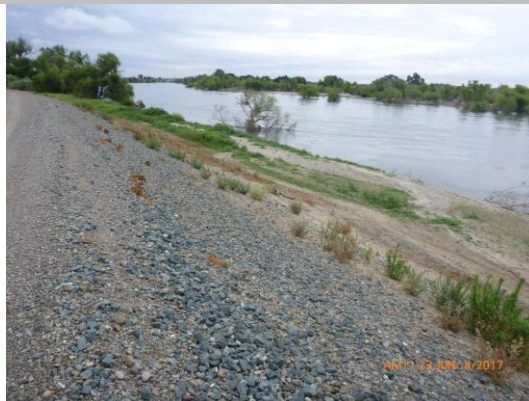
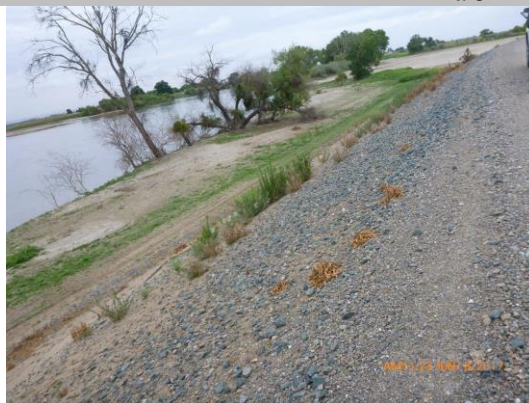
LM Start	2.77	Rating **	A/W	Issue No.	14 (cont)
LM End	2.83	Issue Type +	Ma	Location *	
Category	Supplemental			GPS Latitude/Longitude	
				Start	End
Item	2017 Storm Damage			37.724810 °	37.724207 °
				-121.294150 °	-121.293308 °
DWR ID	DWR_RD2075_01_f_2017_14				
Comment Code					
Inspector Comment					
Levee Evaluation Comments					
Description:					
Site ID No:81					
Site Designation:LMA-35					
Repair Type: Erosion					
Rating:Area of Concern					
Field Date:6/8/2017					
Notes: no damage present 10/23/17: Photos taken of vertical eroded low-flow bank approximately 20 feet from waterside levee toe. Area is composed of loose sand. Sandbar in channel may direct current toward this area.

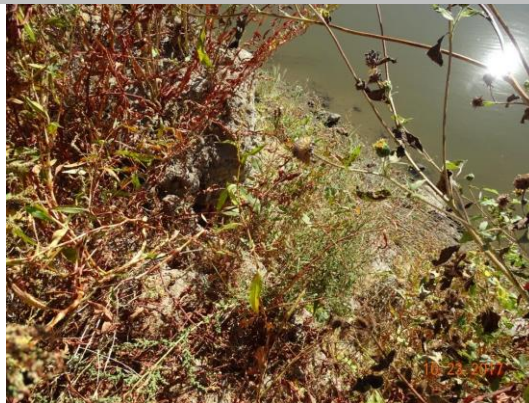
Photo 4 of 6 : SP_2018_RD2075_315_14_20180503_00012.jpg

View down through erosion rut in bank. 10/23/17: Photos taken of vertical eroded low-flow bank approximately 20 feet from waterside levee toe. Area is composed of loose sand. Sandbar in channel may direct current toward this area.

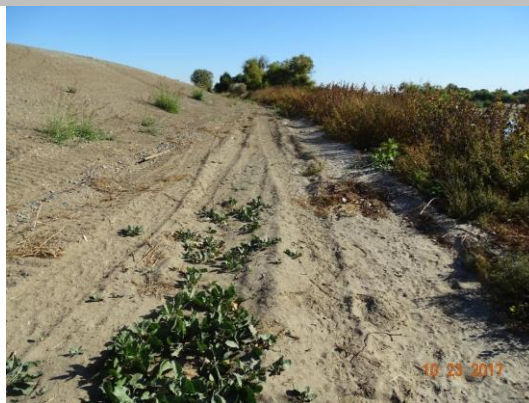
Photo 5 of 6 : SP_2018_RD2075_315_14_20180503_00013.jpg

View upstream showing narrow distance between levee toe and vertical bank. 10/23/17: Photos taken of vertical eroded low-flow bank approximately 20 feet from waterside levee toe. Area is composed of loose sand. Sandbar in channel may direct current toward this area.

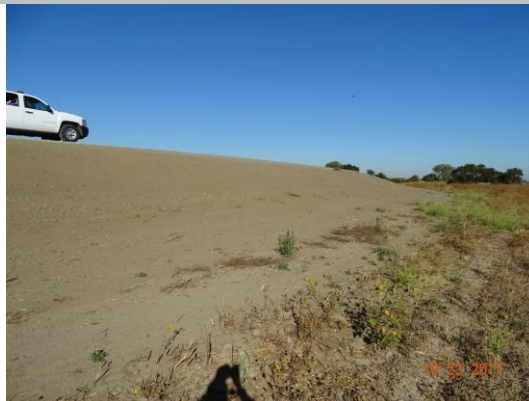
Photo 4 of 4 : SP_2018_RD2075_315_18_20180503_00025.jpg

Item	2017 Storm Damage		37.713388 °	37.713492 °						
			-121.280018 °	-121.278982 °						
DWR ID	DWR_RD2075_01_f_2017_18									
Comment Code										
Inspector Comment										
Levee Evaluation Comments Description: Slope protection repairs are needed along the waterside slope due to erosion and riprap displacement from high water. Based upon levee inspections, it was determined the waterside levee slope is eroding, deteriorating, and degrading. The eroded levee sections need to be restored back to design standards to prevent further deterioration and damage. Site ID No: 576 Site Designation: LMA-482 Repair Type: Erosion Rating: Area of Concern Field Date: 8/10/2017 Notes: 10/23/17: There was no riprap in this area. Erosion sites have been repaired by LMA.

10/23/17: There was no riprap in this area (contrary to previous comment). Erosion sites have been repaired by LMA.

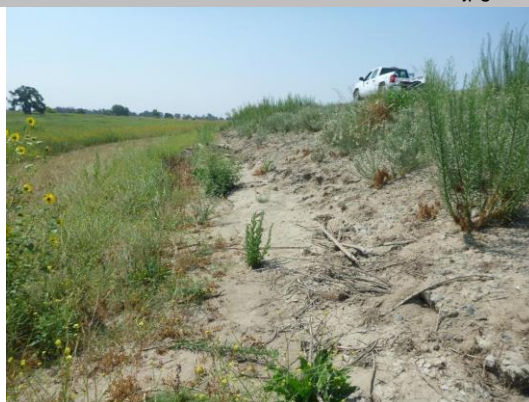
Photo 1 of 3 : LEVAL_SP_2018_577_4471.jpg

LM Start	4.00	Rating **	A/W	Issue No.	19					
LM End	4.04	Issue Type +	Ma	Location *						
Category	Supplemental		GPS Latitude/Longitude							
			Start	End						
Item	2017 Storm Damage		37.714048 °	37.714630 °						
			-121.278363 °	-121.278263 °						
DWR ID	DWR_RD2075_01_f_2017_19									
Comment Code										
Inspector Comment										
Levee Evaluation Comments Description: Slope protection repairs are needed along the waterside slope due to erosion and riprap displacement from high water. Based upon levee inspections, it was determined the waterside levee slope is eroding, deteriorating, and degrading. The eroded levee sections need to be restored back to design standards to prevent further deterioration and damage. Site ID No: 577 Site Designation: LMA-483 Repair Type: Erosion Rating: Area of Concern Field Date: 8/10/2017 Notes:

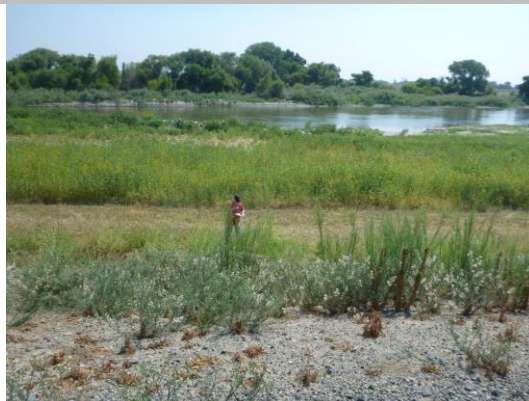
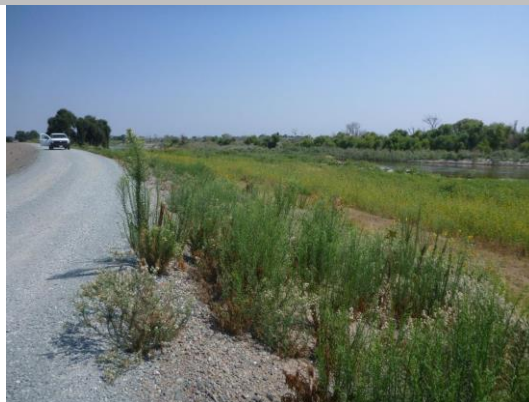
LM Start	4.00	Rating **	A/W	Issue No.	19 (cont)
LM End	4.04	Issue Type +	Ma	Location *	
Category	Supplemental			GPS Latitude/Longitude	
				Start	End
Item	2017 Storm Damage			37.714048 °	37.714630 °
				-121.278363 °	-121.278263 °
DWR ID	DWR_RD2075_01_f_2017_19				
Comment Code					
Inspector Comment					
Levee Evaluation Comments					
Description:Slope protection repairs are needed along the waterside slope due to erosion and riprap displacement from high water. Based upon levee inspections, it was determined the waterside levee slope is eroding, deteriorating, and degrading. The eroded levee sections need to be restored back to design standards to prevent further deterioration and damage.					
Site ID No:577					
Site Designation:LMA-483					
Repair Type: Erosion					
Rating:Area of Concern					
Field Date:8/10/2017					
Notes:

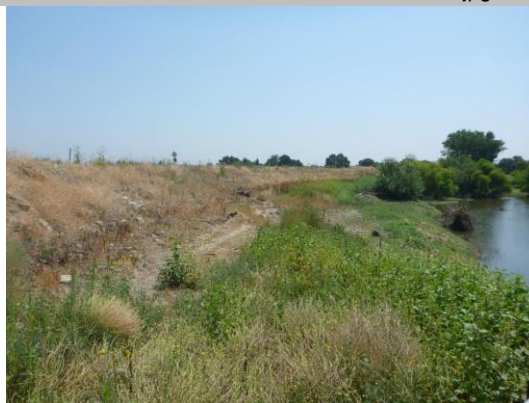
Photo 1 of 3 : LEVAL_SP_2018_578_4248.jpg

LM Start	5.24	Rating **	A/W	Issue No.	21
LM End	5.29	Issue Type +	Ma	Location *	
Category	Supplemental			GPS Latitude/Longitude	
				Start	End
Item	2017 Storm Damage			37.728460 °	37.727799 °
				-121.274671 °	-121.274252 °
DWR ID	DWR_RD2075_01_f_2017_21				
Comment Code					
Inspector Comment					
Levee Evaluation Comments					
Description:Slope protection repairs are needed along the waterside slope due to erosion and riprap displacement from high water. Based upon levee inspections, it was determined the waterside levee slope is eroding, deteriorating, and degrading. The eroded levee sections need to be restored back to design standards to prevent further deterioration and damage.					
Site ID No:578					
Site Designation:LMA-484					
Repair Type: Erosion					
Rating:Area of Concern					
Field Date:8/10/2017					
Notes: Paved road on levee.

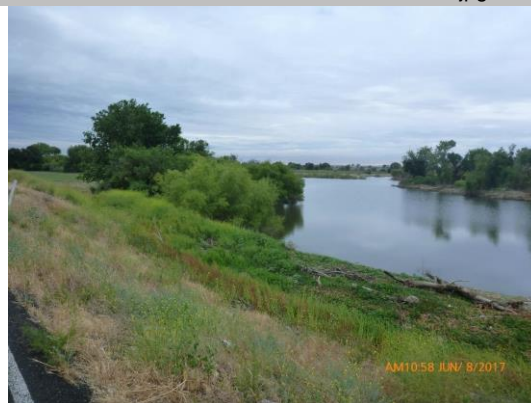
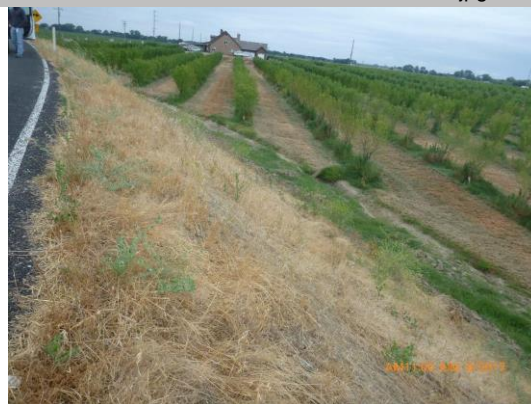
LM Start	5.26	Rating **	A/W	Issue No.	23 (cont)	
LM End		Issue Type +	Ma	Location *		
Category	Supplemental			GPS Latitude/Longitude		
				Start	End	
Item	2017 Storm Damage			37.728216 °		°
				-121.274434 °		°
DWR ID	DWR_RD2075_01_f_2017_23					
Comment Code						
Inspector Comment						
Levee Evaluation Comments						
Description:						
Site ID No:79						
Site Designation:LMA-33						
Repair Type: Erosion						
Rating:Area of Concern						
Field Date:6/8/2017						
Notes: no damage present

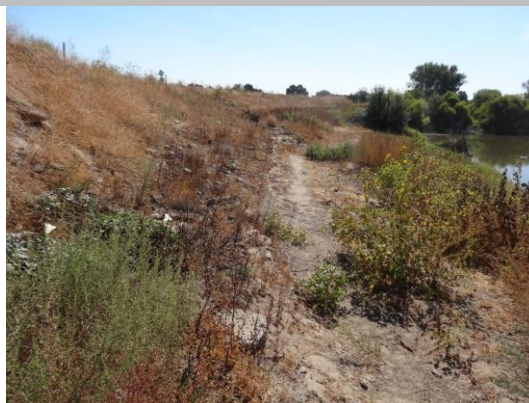
Photo 1 of 3 : SP_2018_RD2075_315_1_20180503_00001.jpg

09/13/2017: No significant change observed.
 07/12/2016: No significant change observed.
 08/28/2015: No significant change observed. Loose material is visible at the upper levee slope. The loose soil may have been caused by runoff.
 08/18/2014: No significant change observed.
 09/10/2013: No significant change observed.
 09/13/2012: No significant change observed.
 08/18/2011: No significant change observed. Some new material added to the water side levee slope, but the added material is loose and seems not helping the levee protection.
 10/05/2010: No significant change observed. Levee slope has minimal vegetation and lacks rip rap protection. Sandy material found on the lower and middle slope is an undesirable material to have on a levee.
 08/05/2010: Recommended for annual assessment and monitoring during flood events, per CLRO.
 08/20/2009: No major change since last visit; site is located in an oxbow; slope surface consists of very sandy material; there is a tree on site leaning and with exposed tree roots; site is recommended as a local maintenance issue, per CLRO CES Evaluation 2008 Report; Eddy Cordoza from the district is aware of the site and is looking for recommendation; site is previously rated "U".

Upstream view of the erosion site.

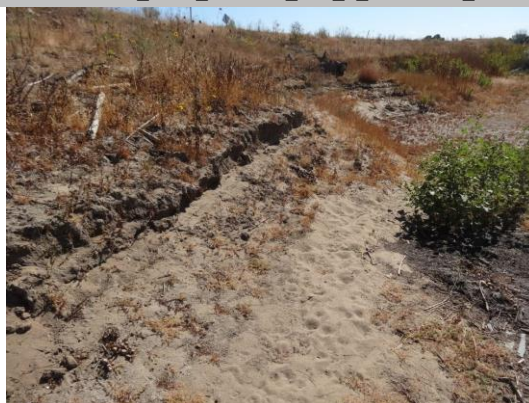
Photo 2 of 3 : SP_2018_RD2075_315_1_20180503_00002.jpg

Close view of the site.

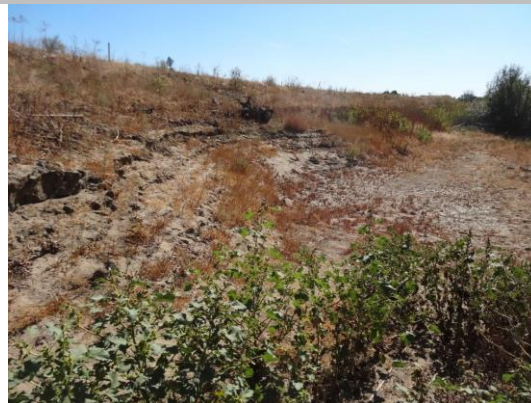
Photo 3 of 3 : SP_2018_RD2075_315_1_20180503_00003.jpg

Item	DWR Erosion Survey			37.727933 °		37.727933 °
				-121.274491 °		-121.274491 °
DWR ID	RD2075U01RM64.34					
Comment Code						
Inspector Comment						
09/13/2017: No significant change observed.						
07/12/2016: No significant change observed.						
08/28/2015: No significant change observed. Loose material is visible at the upper levee slope. The loose soil may have been caused by runoff.						
08/18/2014: No significant change observed.						
09/10/2013: No significant change observed.						
09/13/2012: No significant change observed.						
08/18/2011: No significant change observed. Some new material added to the water side levee slope, but the added material is loose and seems not helping the levee protection.						
10/05/2010: No significant change observed. Levee slope has minimal vegetation and lacks rip rap protection. Sandy material found on the lower and middle slope is an undesirable material to have on a levee.

08/05/2010: Recommended for annual assessment and monitoring during flood events, per CLRO.						
08/20/2009: No major change since last visit; site is located in an oxbow; slope surface consists of very sandy material; there is a tree on site leaning and with exposed tree roots; site is recommended as a local maintenance issue, per CLRO CES Evaluation 2008 Report; Eddy Cordoza from the district is aware of the site and is looking for recommendation; site is previously rated "U".						
08/17/2007: Site is close to an irrigation pump inlet. [2017 Site ID:RD2075U01RM64.34]

Looking upstream at the site.

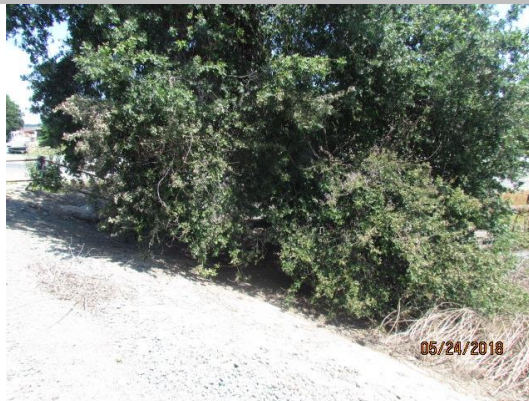
Photo 1 of 1 : SP_2018_RD2075_315_22_20180525_00067.jpg

Looking downstream at untrimmed tree on landward toe. (Spring 2018)

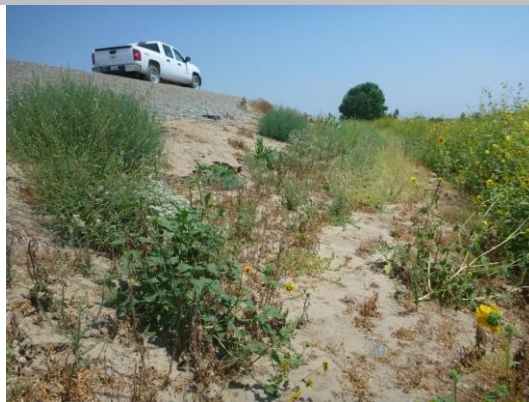
Photo 1 of 3 : LEVAL_SP_2018_579_4263.jpg

LM Start	5.87	Rating **	A/W	Issue No.	28
LM End	6.33	Issue Type +	Ma	Location *	
Category	Supplemental			GPS Latitude/Longitude	
				Start	End
Item	2017 Storm Damage			37.721710 °	37.720960 °
				-121.267490 °	-121.259830 °
DWR ID	DWR_RD2075_01_f_2017_28				
Comment Code					
Inspector Comment					
Levee Evaluation Comments					
Description:Slope protection repairs are needed along the waterside slope due to erosion and riprap displacement from high water. Based upon levee inspections, it was determined the waterside levee slope is eroding, deteriorating, and degrading. The eroded levee sections need to be restored back to design standards to prevent further deterioration and damage.					
Site ID No:579					
Site Designation:LMA-485					
Repair Type: Erosion					
Rating:Area of Concern					
Field Date:8/10/2017					
Notes: Berm present on LS. LMA 486 is combined with this site.

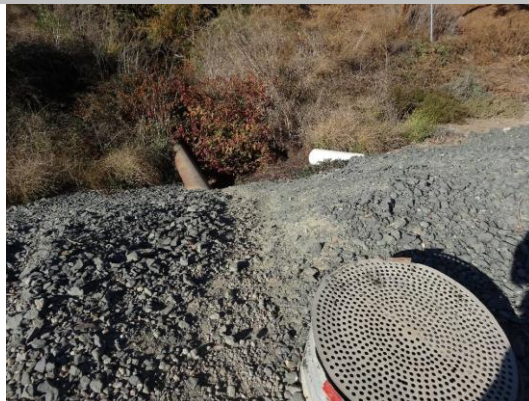
Photo 1 of 3 : UCIP_SP_2018_50213_45613.jpg

WS view: CMP riser (bottom) on levee shoulder. Steel pipe (top) and temporary pvc pipe on levee slope.

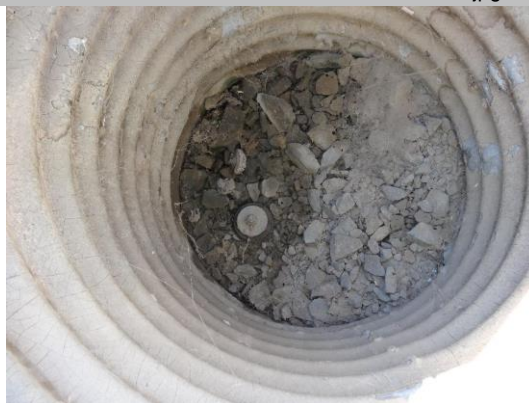
Photo 2 of 3 : UCIP_SP_2018_50213_45612.jpg

WS view: siphon breaker in CMP riser on levee shoulder.
