**Flood Control Project Maintenance
Levee Inspections**

Maintenance Issue Types Only, Levee Inspection Report By Mile - Spring 2019

Reclamation District No. 2075 McMullin

Waterway	Bank	Unit Miles	Inspection Start/End	Inspector
Unit No. 01 San Joaquin River	Right	7.45	05/15/2019 05/15/2019	Alberto De Leon

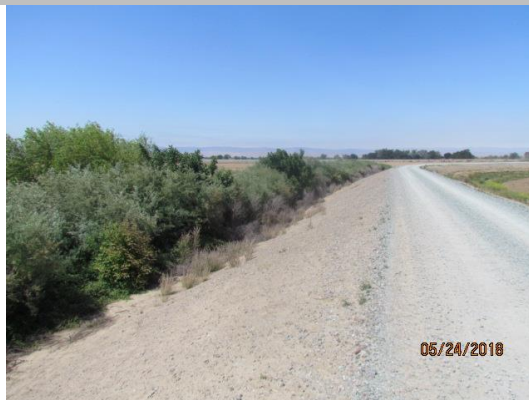
Photo 1 of 3 : SP_2019_RD2075_315_29_20190313_00040.jpg

LM Start	1.43	Rating **	U	Issue No.	29
LM End	1.63	Issue Type +	Ma	Location *	LS
Category	Earthen Levee			GPS Latitude/Longitude	
				Start	End
Item	Vegetation			37.735061 °	37.734213 °
				-121.284269 °	-121.287660 °
DWR ID	DWR_RD2075_01_s_2018_29				
Comment Code					
V2 : Remove the wild growth other than native grasses from the levee slopes.					
Inspector Comment					
Wild growth at the landward toe is blocking the view and should be cleared to fifteen feet from the landward toe.

Looking west at dense veg at landward toe. (Spring 2018)

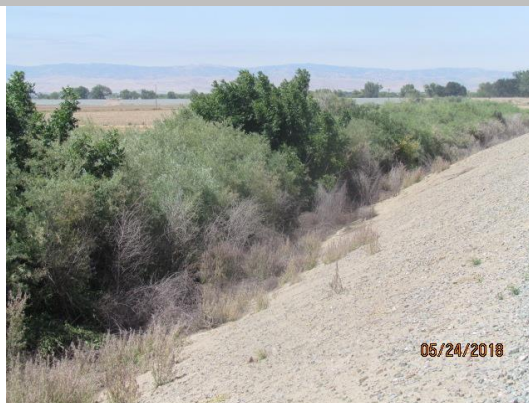
Photo 2 of 3 : SP_2019_RD2075_315_29_20190313_00041.jpg

Looking west at dense veg. at landward toe. (Spring 2018)

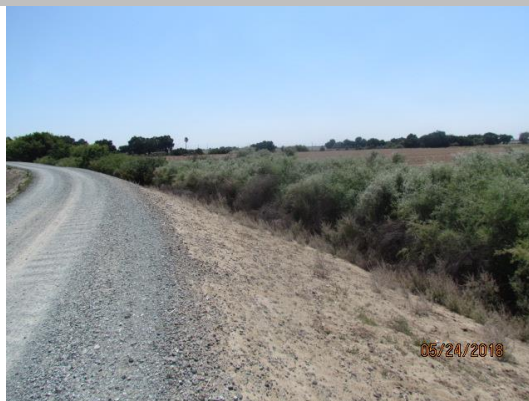
Photo 3 of 3 : SP_2019_RD2075_315_29_20190313_00042.jpg

Looking northeast at dense veg at landward toe. (Spring 2018)

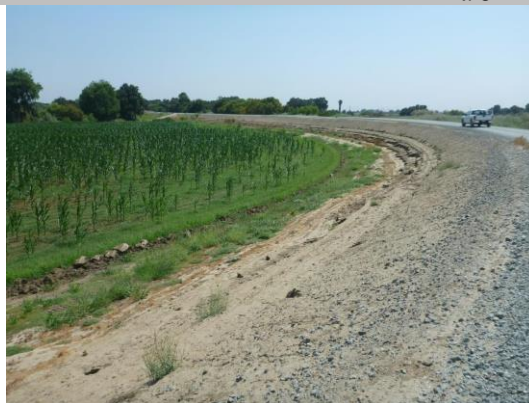
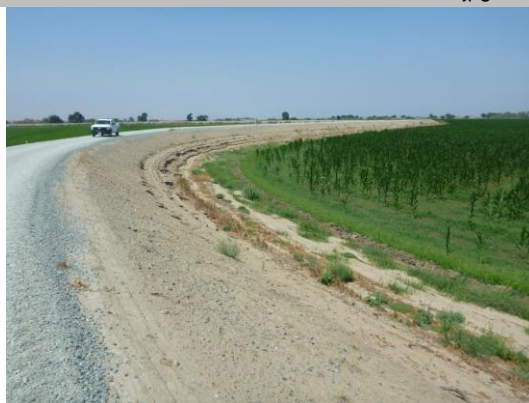
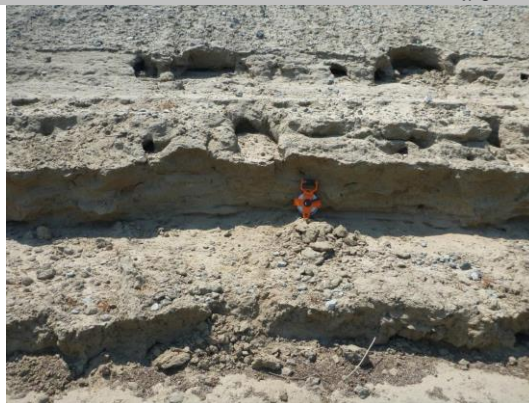
Inspector Comment					
<p>Levee Evaluation Comments</p> <p>Description: Slope protection repairs are needed along the waterside slope due to erosion and riprap displacement from high water. Based upon levee inspections, it was determined the waterside levee slope is eroding, deteriorating, and degrading. The eroded levee sections need to be restored back to design standards to prevent further deterioration and damage.</p> <p>Site ID No: 575</p> <p>Site Designation: LMA-481</p> <p>Repair Type: Erosion</p> <p>Rating: Area of Concern</p> <p>Field Date: 8/10/2017</p> <p>Notes: 10/23/17: According to LMA and my observations at LM 1.63, this site never had riprap (contrary to previous comments). Erosion has encroached into levee prism. Future high water and wavewash will likely advance erosion further into prism. Repairs should be made prior to next high water.</p>

Description: Slope protection repairs are needed along the waterside slope due to erosion and riprap displacement from high water. Based upon levee inspections, it was determined the waterside levee slope is eroding, deteriorating, and degrading. The eroded levee sections need to be restored back to design standards to prevent further deterioration and damage.

Notes: 10/23/17: According to LMA and my observations at LM 1.63, this site never had riprap (contrary to previous comments). Erosion has encroached into levee prism. Future high water and wavewash will likely advance erosion further into prism. Repairs should be made prior to next high water.

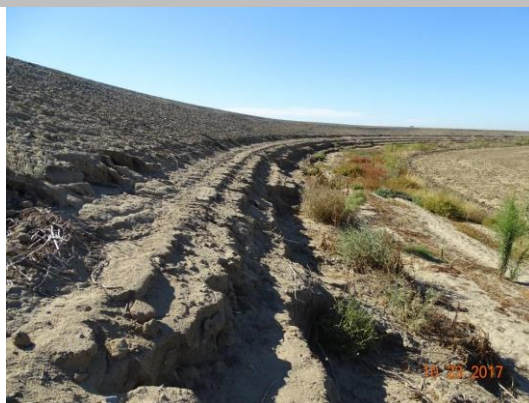
Photo 4 of 4 : SP_2019_RD2075_315_12_20190313_00007.jpg

10/23/17: According to LMA and my observations at LM 1.63, this site never had riprap (contrary to previous comments). Erosion has encroached into levee prism. Future high water and wavewash will likely advance erosion further into prism. Repairs should be made prior to next high water.

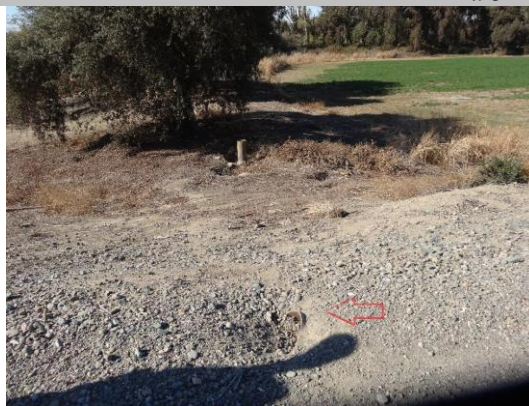
Photo 1 of 3 : UCIP_SP_2019_24666_45600.jpg

LM Start	2.32	Rating **	M	Issue No.	36
LM End	2.32	Issue Type +	Ma	Location *	
Category	Supplemental			GPS Latitude/Longitude	
				Start	End
Item	DWR UCIP LMA Responsibility			37.731314 °	37.731314 °
				-121.293713 °	-121.293713 °
DWR ID	24737				
Comment Code					
Inspector Comment					
FS_ID:24666 DS_ID:24737 EP_NO: N/A Repair Type: Non-Urgent Crossing Status: Found UCIP Comments: - service pole on landside.- looks abandoned. Walkway in dilapidated condition. FIELD_STRUCT_DESC: 16-inch steel drainage discharge pipe through the levee, 4.5 feet below the crown. Corrugated metal cutoff wall. Pump mounted on a pile structure in a drainage ditch on the landside (LS). Siphon breaker in a corrugated metal pipe (CMP) riser on the waterside (WS) slope. [Additional Reference(s): DWR Levee Log, 2005. USACE San Joaquin O&M Manual 3, December 1968, (HLM 2.30)]. FS Date: 11/13/2013

WS view: concrete standpipe (top) and steel pipe riser (bottom marked) on levee slope.

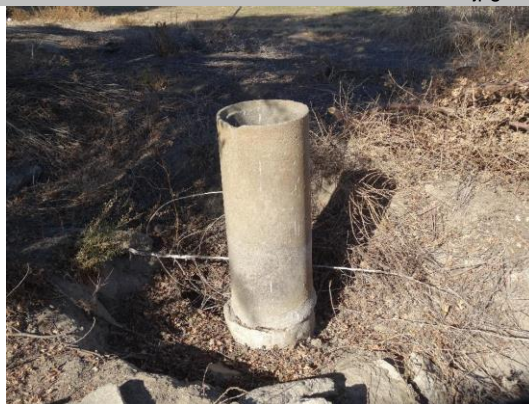
Photo 3 of 3 : UCIP_SP_2019_24666_44029.jpg

WS view: concrete standpipe on levee toe.

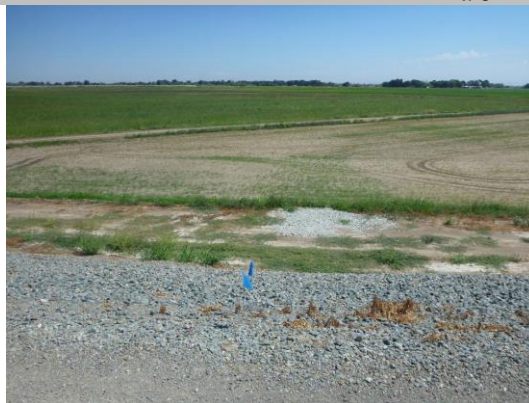
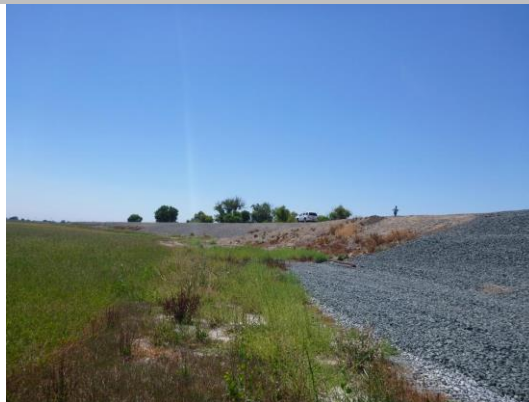
Comment Code					
Inspector Comment					
Levee Evaluation Comments					
Description:Sinkholes have formed along the landside levee toe as a result of the high water. The cause of the sinkholes is not clear, but a similar phenomenon in this area is believed to have caused the levee breach earlier this year. Further geotechnical investigation is needed.					
Site ID No:479					
Site Designation:LMA-306					
Repair Type: Stability					
Rating:Area of Concern					
Field Date:7/26/2017					
Notes: Sink holes appear to have already been filled. 10/23/17: LMA has removed pipes (parallel to levee) in this area, and drainage ditch has been relocated to approx 60 feet away from levee toe. Known sandy soils in region may contribute to sinkholes.

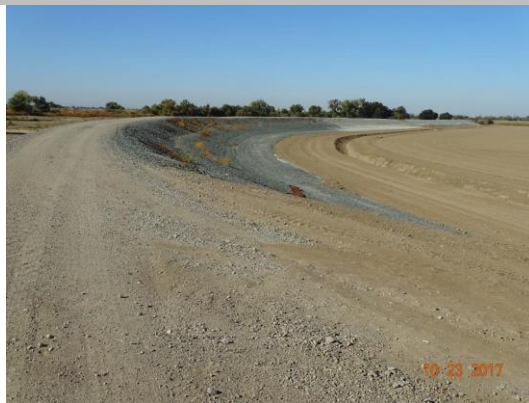
Photo 3 of 3 : SP_2019_RD2075_315_15_20190313_00016.jpg

Comment Code					
Inspector Comment					
Levee Evaluation Comments					
Description:Sinkholes have formed along the landside levee toe as a result of the high water. The cause of the sinkholes is not clear, but a similar phenomenon in this area is believed to have caused the levee breach earlier this year. Further geotechnical investigation is needed.					
Site ID No:479					
Site Designation:LMA-306					
Repair Type: Stability					
Rating:Area of Concern					
Field Date:7/26/2017					
Notes: Sink holes appear to have already been filled. 10/23/17: LMA has removed pipes (parallel to levee) in this area, and drainage ditch has been relocated to approx 60 feet away from levee toe. Known sandy soils in region may contribute to sinkholes.

10/23/17: LMA has removed pipes (parallel to levee) in this area, and drainage ditch has been relocated to approx 60 feet away from levee toe. Known sandy soils in region may contribute to sinkholes.

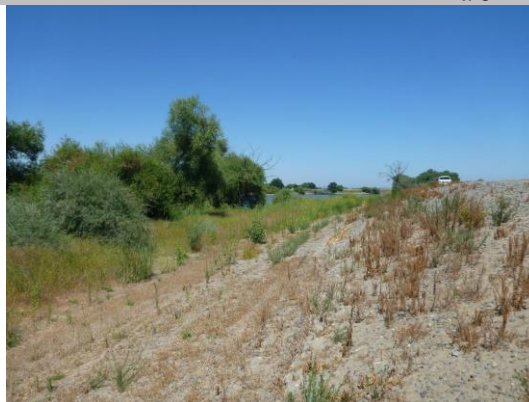
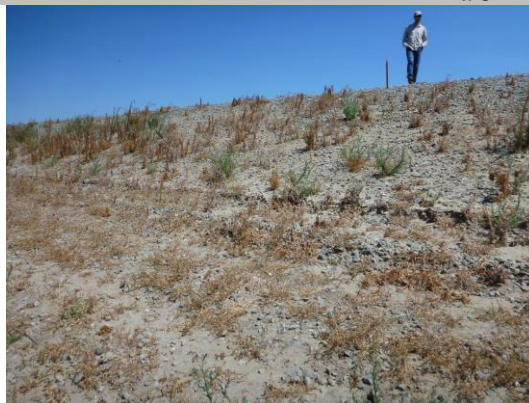
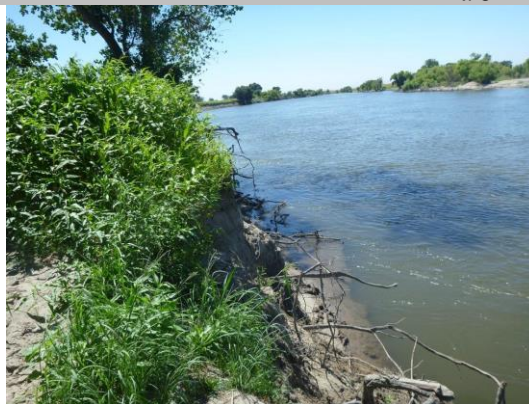
Comment Code					
Inspector Comment					
Levee Evaluation Comments					
Description:Slope protection repairs are needed along the waterside slope due to erosion. Based upon levee inspections, it was determined the waterside levee slopes were eroding, deteriorating and degrading in concave pocket sections at various locations along this levee reach. The eroded levee sections need to be restored back to design standards to prevent further deterioration of the damaged levee sections.					
Site ID No:480					
Site Designation:LMA-307					
Repair Type: Erosion					
Rating:Area of Concern					
Field Date:7/26/2017					
Notes: Low priority because of the wide berm. Could not see all of the bank because of vegetation. Rock was placed on LS here during this years (2017) storms.

Description: Slope protection repairs are needed along the waterside slope due to erosion. Based upon levee inspections, it was determined the waterside levee slopes were eroding, deteriorating and degrading in concave pocket sections at various locations along this levee reach. The eroded levee sections need to be restored back to design standards to prevent further deterioration of the damaged levee sections.

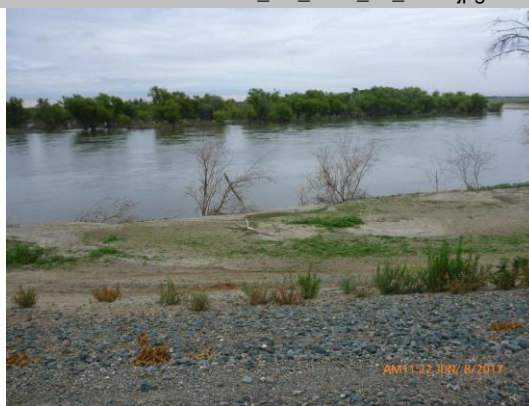
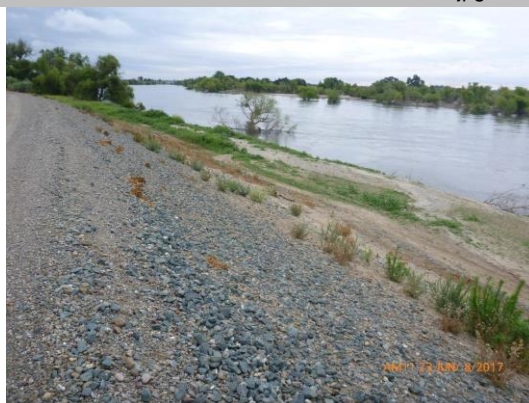
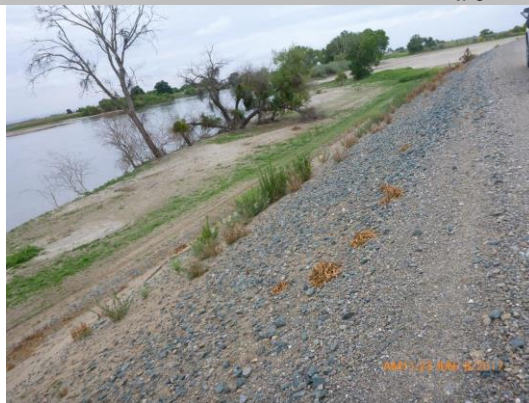
LM Start	2.77	Rating **	A/W	Issue No.	14
LM End	2.83	Issue Type +	Ma	Location *	WS
Category	Supplemental			GPS Latitude/Longitude	
				Start	End
Item	2017 Storm Damage			37.724810 °	37.724207 °
				-121.294150 °	-121.293308 °
DWR ID	DWR_RD2075_01_f_2017_14				
Comment Code					
Inspector Comment					
Levee Evaluation Comments					
Description:					
Site ID No:81					
Site Designation:LMA-35					
Repair Type: Erosion					
Rating:Area of Concern					
Field Date:6/8/2017					
Notes: no damage present 10/23/17: Photos taken of vertical eroded low-flow bank approximately 20 feet from waterside levee toe. Area is composed of loose sand. Sandbar in channel may direct current toward this area.

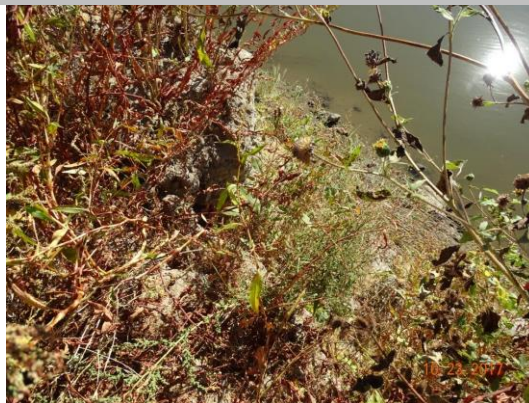
Photo 4 of 6 : SP_2019_RD2075_315_14_20190313_00011.jpg

View down through erosion rut in bank. 10/23/17: Photos taken of vertical eroded low-flow bank approximately 20 feet from waterside levee toe. Area is composed of loose sand. Sandbar in channel may direct current toward this area.

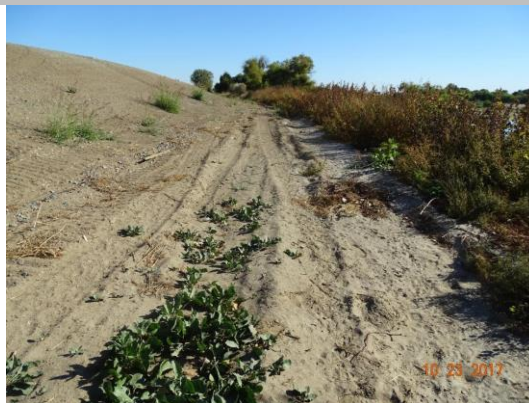
Photo 5 of 6 : SP_2019_RD2075_315_14_20190313_00012.jpg

View upstream showing narrow distance between levee toe and vertical bank. 10/23/17: Photos taken of vertical eroded low-flow bank approximately 20 feet from waterside levee toe. Area is composed of loose sand. Sandbar in channel may direct current toward this area.

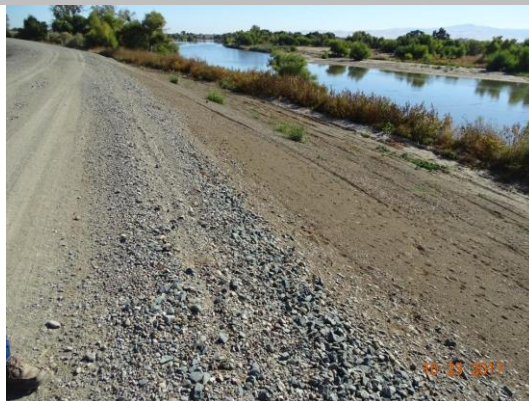
Photo 6 of 6 : SP_2019_RD2075_315_14_20190313_00013.jpg

View upstream showing narrow distance between levee toe and vertical bank. 10/23/17: Photos taken of vertical eroded low-flow bank approximately 20 feet from waterside levee toe. Area is composed of loose sand. Sandbar in channel may direct current toward this area.

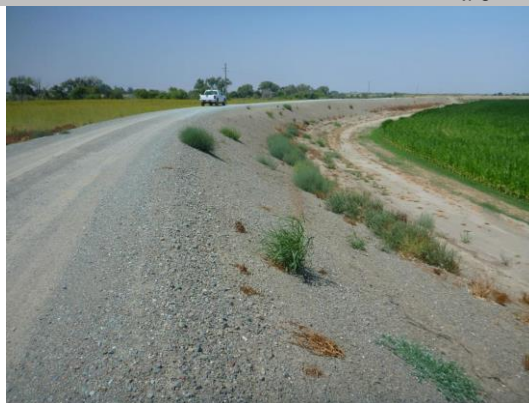
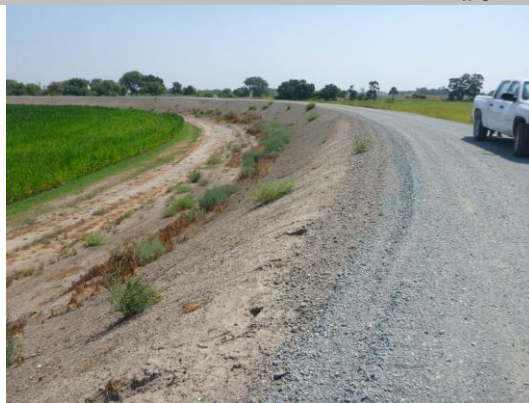
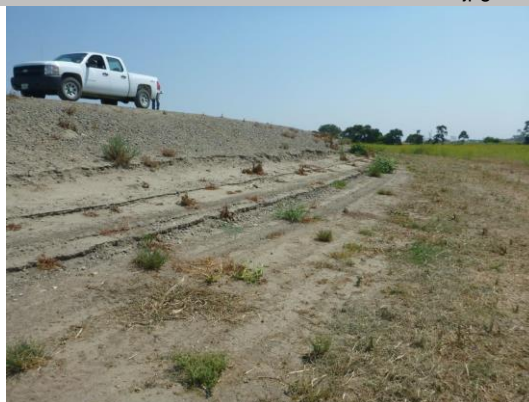
Comment Code					
Inspector Comment					
Levee Evaluation Comments					
Description:Slope protection repairs are needed along the waterside slope due to erosion and riprap displacement from high water. Based upon levee inspections, it was determined the waterside levee slope is eroding, deteriorating, and degrading. The eroded levee sections need to be restored back to design standards to prevent further deterioration and damage.					
Site ID No:576					
Site Designation:LMA-482					
Repair Type: Erosion					
Rating:Area of Concern					
Field Date:8/10/2017					
Notes: 10/23/17: There was no riprap in this area. Erosion sites have been repaired by LMA.

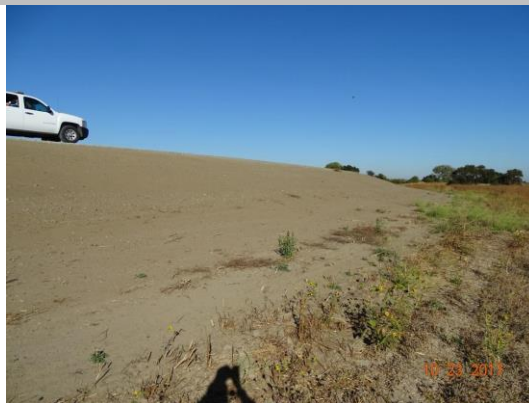
Photo 4 of 4 : SP_2019_RD2075_315_18_20190313_00023.jpg

Comment Code					
Inspector Comment					
<p>Levee Evaluation Comments</p> <p>Description: Slope protection repairs are needed along the waterside slope due to erosion and riprap displacement from high water. Based upon levee inspections, it was determined the waterside levee slope is eroding, deteriorating, and degrading. The eroded levee sections need to be restored back to design standards to prevent further deterioration and damage.</p> <p>Site ID No: 576</p> <p>Site Designation: LMA-482</p> <p>Repair Type: Erosion</p> <p>Rating: Area of Concern</p> <p>Field Date: 8/10/2017</p> <p>Notes: 10/23/17: There was no riprap in this area. Erosion sites have been repaired by LMA.</p>

10/23/17: There was no riprap in this area (contrary to previous comment). Erosion sites have been repaired by LMA.

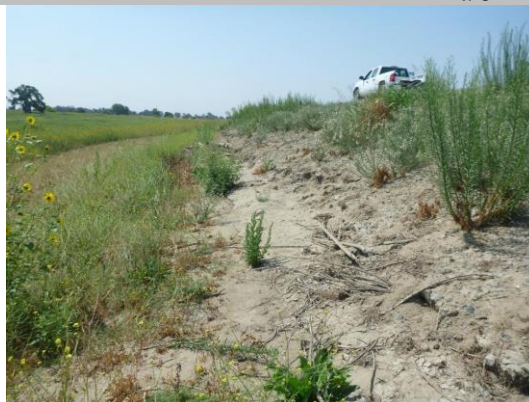
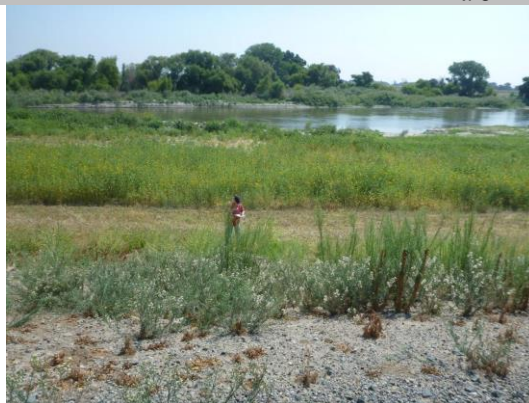
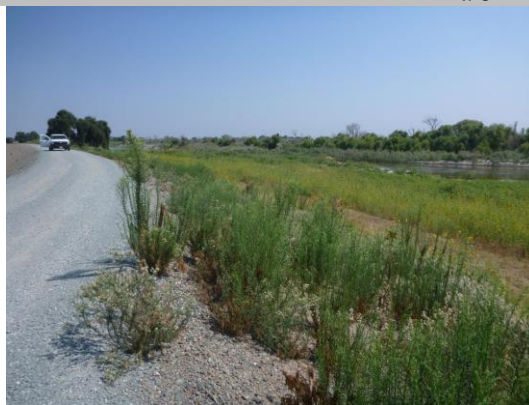
LM Start	4.00	Rating **	A/W	Issue No.	19
LM End	4.04	Issue Type +	Ma	Location *	WS
Category	Supplemental		GPS Latitude/Longitude		
			Start	End	
Item	2017 Storm Damage		37.714048 °	37.714630 °	
			-121.278363 °	-121.278263 °	
DWR ID	DWR_RD2075_01_f_2017_19				
Comment Code					
Inspector Comment					
<p>Levee Evaluation Comments</p> <p>Description: Slope protection repairs are needed along the waterside slope due to erosion and riprap displacement from high water. Based upon levee inspections, it was determined the waterside levee slope is eroding, deteriorating, and degrading. The eroded levee sections need to be restored back to design standards to prevent further deterioration and damage.</p> <p>Site ID No: 577</p> <p>Site Designation: LMA-483</p> <p>Repair Type: Erosion</p> <p>Rating: Area of Concern</p> <p>Field Date: 8/10/2017</p> <p>Notes:</p>

LM Start	4.00	Rating **	A/W	Issue No.	19 (cont)
LM End	4.04	Issue Type +	Ma	Location *	WS
Category	Supplemental			GPS Latitude/Longitude	
				Start	End
Item	2017 Storm Damage			37.714048 °	37.714630 °
				-121.278363 °	-121.278263 °
DWR ID	DWR_RD2075_01_f_2017_19				
Comment Code					
Inspector Comment					
Levee Evaluation Comments					
Description:Slope protection repairs are needed along the waterside slope due to erosion and riprap displacement from high water. Based upon levee inspections, it was determined the waterside levee slope is eroding, deteriorating, and degrading. The eroded levee sections need to be restored back to design standards to prevent further deterioration and damage.					
Site ID No:577					
Site Designation:LMA-483					
Repair Type: Erosion					
Rating:Area of Concern					
Field Date:8/10/2017					
Notes:

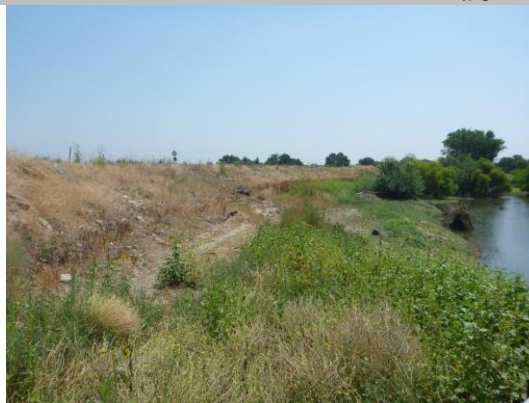
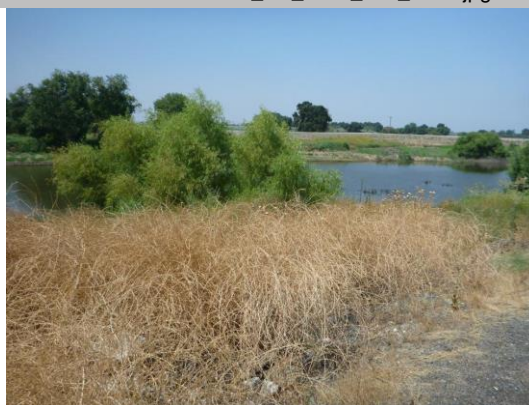
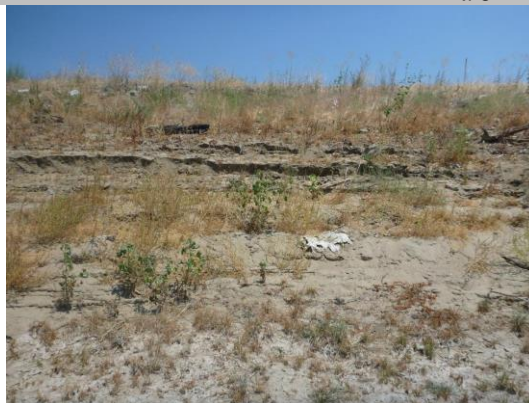
LM Start	5.24	Rating **	A/W	Issue No.	21
LM End	5.29	Issue Type +	Ma	Location *	WS
Category	Supplemental			GPS Latitude/Longitude	
				Start	End
Item	2017 Storm Damage			37.728460 °	37.727799 °
				-121.274671 °	-121.274252 °
DWR ID	DWR_RD2075_01_f _ 2017_21				
Comment Code					
Inspector Comment					
Levee Evaluation Comments					
Description:Slope protection repairs are needed along the waterside slope due to erosion and riprap displacement from high water. Based upon levee inspections, it was determined the waterside levee slope is eroding, deteriorating, and degrading. The eroded levee sections need to be restored back to design standards to prevent further deterioration and damage.					
Site ID No:578					
Site Designation:LMA-484					
Repair Type: Erosion					
Rating:Area of Concern					
Field Date:8/10/2017					
Notes: Paved road on levee.

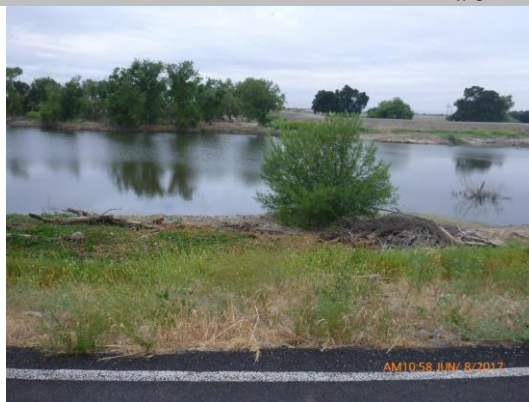
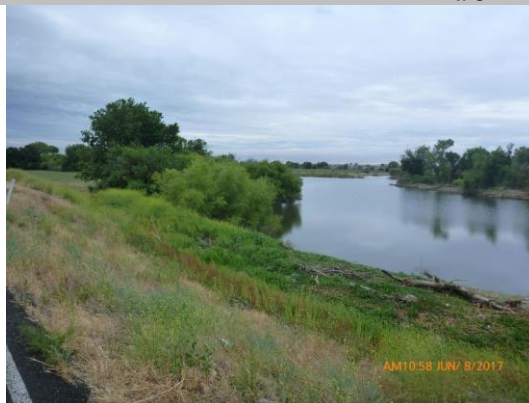
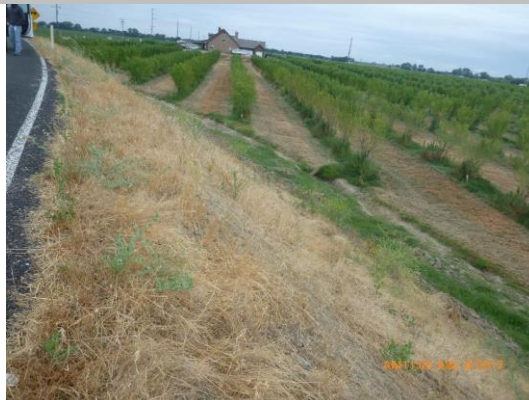
LM Start	5.26	Rating **	A/W	Issue No.	23
LM End		Issue Type +	Ma	Location *	WS
Category	Supplemental			GPS Latitude/Longitude	
				Start	End
Item	2017 Storm Damage			37.728216 °	°
				-121.274434 °	°
DWR ID	DWR_RD2075_01_f_2017_23				
Comment Code					
Inspector Comment					
Levee Evaluation Comments					
Description:					
Site ID No:79					
Site Designation:LMA-33					
Repair Type: Erosion					
Rating:Area of Concern					
Field Date:6/8/2017					
Notes: no damage present

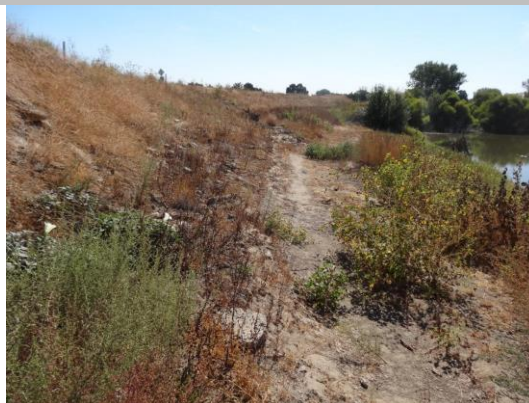
Photo 1 of 3 : SP_2019_RD2075_315_1_20190313_00001.jpg

09/13/2017: No significant change observed.
 07/12/2016: No significant change observed.
 08/28/2015: No significant change observed. Loose material is visible at the upper levee slope. The loose soil may have been caused by runoff.
 08/18/2014: No significant change observed.
 09/10/2013: No significant change observed.
 09/13/2012: No significant change observed.
 08/18/2011: No significant change observed. Some new material added to the water side levee slope, but the added material is loose and seems not helping the levee protection.
 10/05/2010: No significant change observed. Levee slope has minimal vegetation and lacks rip rap protection. Sandy material found on the lower and middle slope is an undesirable material to have on a levee.
 08/05/2010: Recommended for annual assessment and monitoring during flood events, per CLRO.
 08/20/2009: No major change since last visit; site is located in an oxbow; slope surface consists of very sandy material; there is a tree on site leaning and with exposed tree roots; site is recommended as a local maintenance issue, per CLRO CES Evaluation 2008 Report; Eddy Cordoza from the district is aware of the site and is looking for recommendation; site is previously rated "U".

Upstream view of the erosion site.

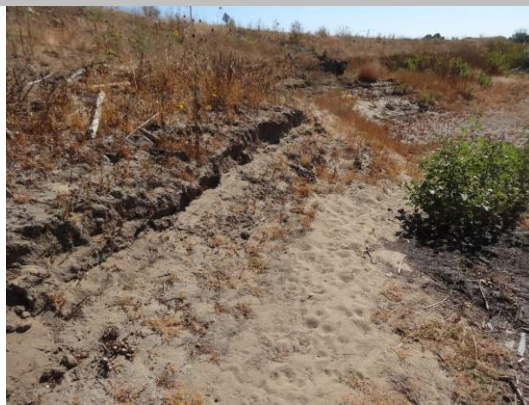
Photo 2 of 3 : SP_2019_RD2075_315_1_20190313_00002.jpg

Close view of the site.

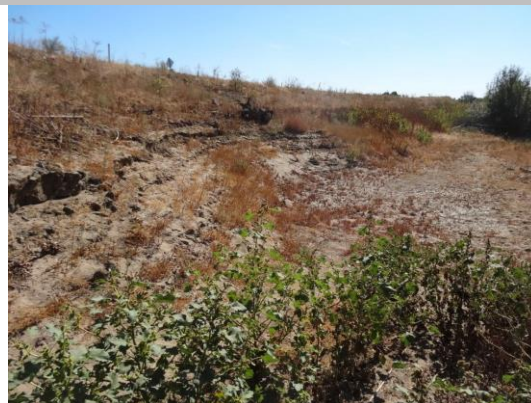
Photo 3 of 3 : SP_2019_RD2075_315_1_20190313_00003.jpg

Item	DWR Erosion Survey			37.727933 °	37.727933 °	
				-121.274491 °	-121.274491 °	
DWR ID	RD2075U01RM64.34					
Comment Code						
Inspector Comment						
09/13/2017: No significant change observed.						
07/12/2016: No significant change observed.						
08/28/2015: No significant change observed. Loose material is visible at the upper levee slope. The loose soil may have been caused by runoff.						
08/18/2014: No significant change observed.						
09/10/2013: No significant change observed.						
09/13/2012: No significant change observed.						
08/18/2011: No significant change observed. Some new material added to the water side levee slope, but the added material is loose and seems not helping the levee protection.						
10/05/2010: No significant change observed. Levee slope has minimal vegetation and lacks rip rap protection. Sandy material found on the lower and middle slope is an undesirable material to have on a levee.

08/05/2010: Recommended for annual assessment and monitoring during flood events, per CLRO.						
08/20/2009: No major change since last visit; site is located in an oxbow; slope surface consists of very sandy material; there is a tree on site leaning and with exposed tree roots; site is recommended as a local maintenance issue, per CLRO CES Evaluation 2008 Report; Eddy Cordoza from the district is aware of the site and is looking for recommendation; site is previously rated "U".						
08/17/2007: Site is close to an irrigation pump inlet. [2017 Site ID:RD2075U01RM64.34]

Looking upstream at the site.

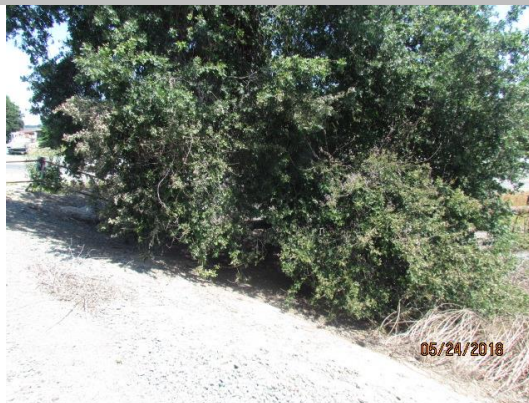
Photo 1 of 1 : SP_2019_RD2075_315_22_20190313_00033.jpg

Looking downstream at untrimmed tree on landward toe. (Spring 2018)
