**Flood Control Project Maintenance
Levee Inspections**

Maintenance Issue Types Only, Levee Inspection Report By Mile - Spring 2020

Reclamation District No. 2075 McMullin

Waterway	Bank	Unit Miles	Inspection Start/End	Inspector
Unit No. 01 San Joaquin River	Right	7.45	03/25/2020 03/25/2020	Alberto De Leon

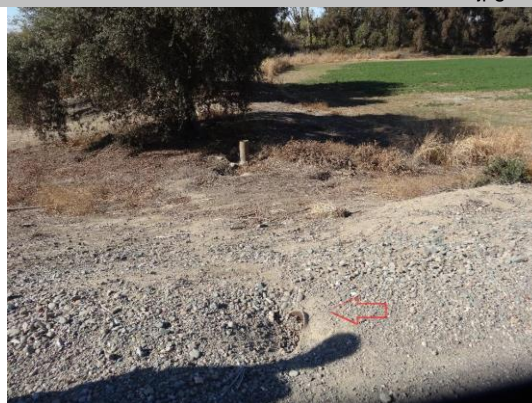
Photo 1 of 3 : UCIP_SP_2020_24666_45600.jpg

LM Start	2.32	Rating **	M	Issue No.	50	
LM End	2.32	Issue Type +	Ma	Location *		
Category	Supplemental			GPS Latitude/Longitude		
				Start		End
Item	DWR UCIP LMA Responsibility			37.731314 °		37.731314 °
				-121.293713 °		-121.293713 °
DWR ID	24737					
Comment Code						
Inspector Comment						
DS_ID:24737 FS_ID:24666 EP_NO: N/A Repair Type: Non-Urgent Crossing Status: Found UCIP Comments: - service pole on landside.- looks abandoned. Walkway in dilapidated condition. FIELD_STRUCT_DESC: 16-inch steel drainage discharge pipe through the levee, 4.5 feet below the crown. Corrugated metal cutoff wall. Pump mounted on a pile structure in a drainage ditch on the landside (LS). Siphon breaker in a corrugated metal pipe (CMP) riser on the waterside (WS) slope. [Additional Reference(s): DWR Levee Log, 2005. USACE San Joaquin O&M Manual 3, December 1968, (HLM 2.30)]. FS Date: 11/13/2013

WS view: concrete standpipe (top) and steel pipe riser (bottom marked) on levee slope.

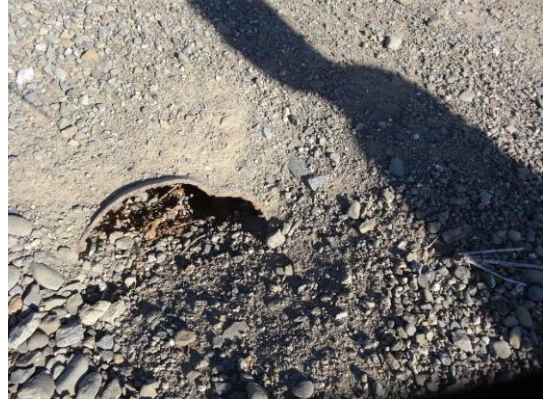
Photo 2 of 3 : UCIP_SP_2020_24666_44030.jpg

WS view: blocked siphon breaker in steel pipe riser on levee slope.

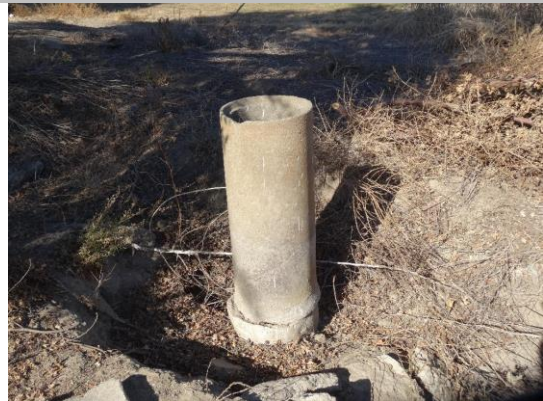
Photo 3 of 3 : UCIP_SP_2020_24666_44029.jpg

WS view: concrete standpipe on levee toe.

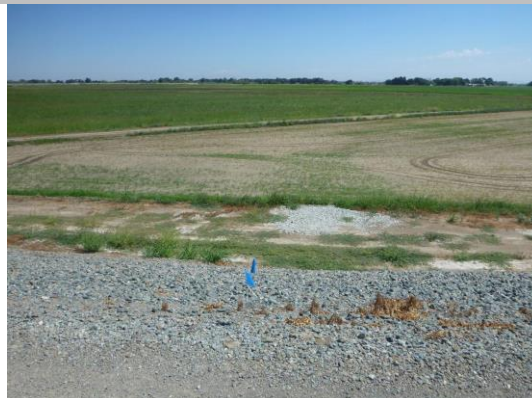
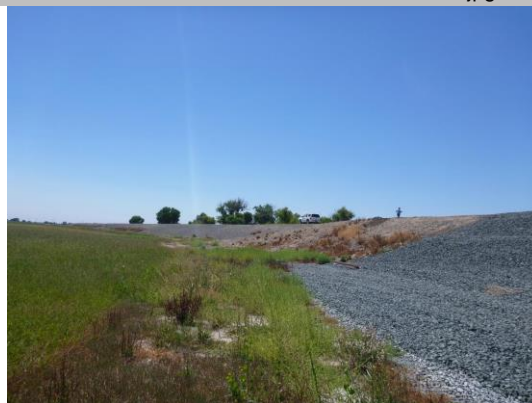
Planned For PL 84-99 Repair in 2020.
Sinkholes have formed along the landside levee toe as a result of the high water. The cause of the sinkholes is not clear, but a similar phenomenon in this area is believed to have caused the levee breach earlier this year. Further geotechnical investigation is needed. Sink holes appear to have already been filled. 10/23/17: LMA has removed pipes (parallel to levee) in this area, and drainage ditch has been relocated to approx 60 feet away from levee toe. Known sandy soils in region may contribute to sinkholes
Site ID No:479 Site Designation:LMA-306

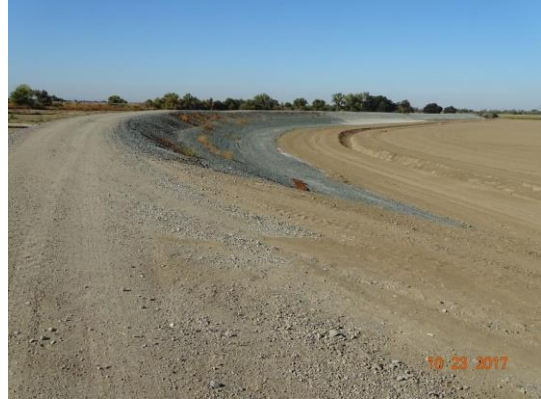
Photo 3 of 4 : SP_2020_RD2075_315_15_20200228_00013.jpg

10/23/17: LMA has removed pipes (parallel to levee) in this area, and drainage ditch has been relocated to approx 60 feet away from levee toe. Known sandy soils in region may contribute to sinkholes.

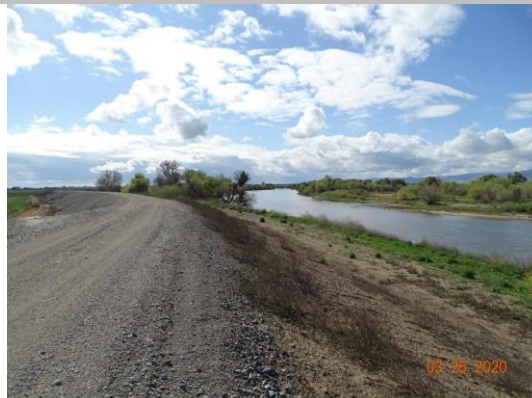
Photo 1 of 2 : SP_2020_RD2075_315_16_20200327_00064.jpg

E1 : Note and monitor erosion site.

Slope protection repairs are needed along the waterside slope due to erosion. Based upon levee inspections, it was determined the waterside levee slopes were eroding, deteriorating and degrading in concave pocket sections at various locations along this levee reach. The eroded levee sections need to be restored back to design standards to prevent further deterioration of the damaged levee sections. Low priority because of the wide berm. Could not see all of the bank because of vegetation. Rock was placed on LS here during this years (2017) storms

View of waterside slope looking upstream. Spring 2020

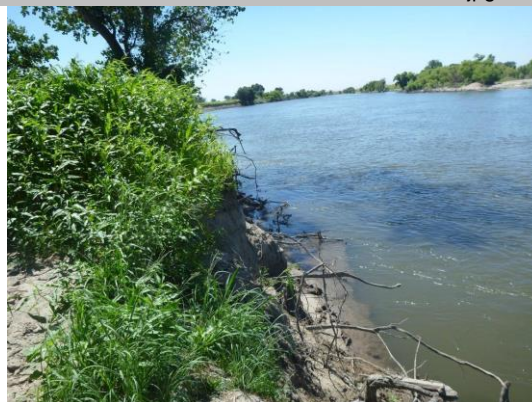
Photo 2 of 2 : LEVAL_SP_2020_480_2209.jpg

View of erosion on channel bank.

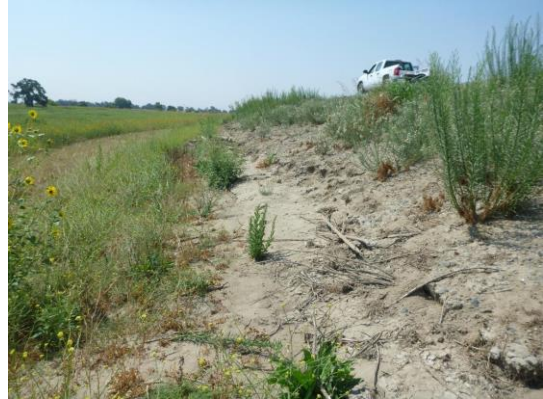
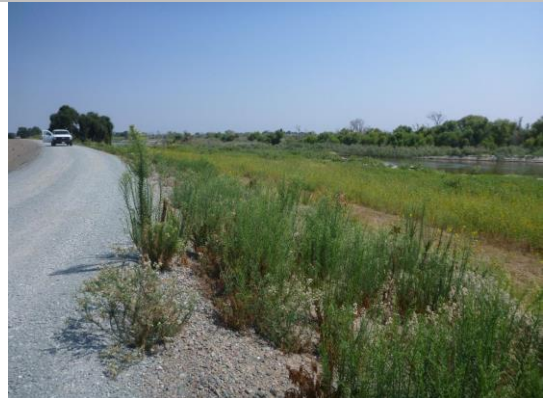
LM Start	3.90	Rating **	A/W	Issue No.	19
LM End	4.04	Issue Type +	Ma	Location *	WS
Category	Earthen Levee			GPS Latitude/Longitude	
				Start	End
Item	Erosion / Bank Caving			37.713388 °	37.714630 °
				-121.280018 °	-121.278263 °
DWR ID	LMA-483				
Comment Code					
E1 : Note and monitor erosion site.					
Inspector Comment					
Slope protection repairs are needed along the waterside slope due to erosion and riprap displacement from high water. Based upon levee inspections, it was determined the waterside levee slope is eroding, deteriorating, and degrading. The eroded levee sections need to be restored back to design standards to prevent further deterioration and damage.					
Site ID No: 576 & 577, Site Designation: LMA-482 & LMA-483

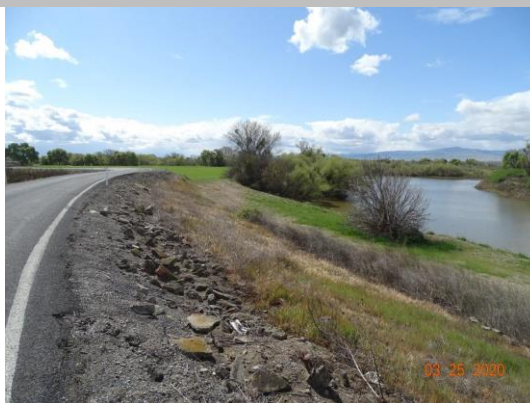
Photo 1 of 2 : SP_2020_RD2075_315_23_20200402_00065.jpg

LM Start	5.24	Rating **	A/W	Issue No.	23
LM End	5.29	Issue Type +	Ma	Location *	WS
Category	Earthen Levee			GPS Latitude/Longitude	
				Start	End
Item	Erosion / Bank Caving			37.728460 °	37.727799 °
				-121.274670 °	-121.274250 °
DWR ID	LMA-33				
Comment Code					
E1 : Note and monitor erosion site.					
Inspector Comment					
Slope protection repairs are needed along the waterside slope due to erosion and riprap displacement from high water. Based upon levee inspections, it was determined the waterside levee slope is eroding, deteriorating, and degrading. The eroded levee sections need to be restored back to design standards to prevent further deterioration and damage. Site ID No: 578 & 79, Site Designation: LMA-484 & LMA-33

View of 2017 storm damage waterside erosion-area of concern. Spring 2020

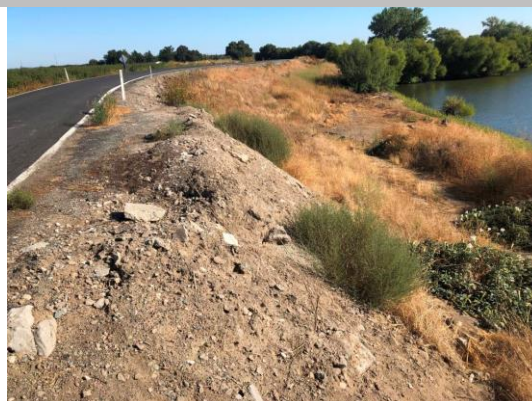
Photo 1 of 3 : SP_2020_RD2075_315_1_20200228_00001.jpg

Site ID: RD2075U01RM64.34
 09/17/2019: No significant change observed.
 09/13/2017: No significant change observed.
 07/12/2016: No significant change observed.
 08/28/2015: No significant change observed. Loose material is visible at the upper levee slope. The loose soil may have been caused by runoff.
 08/18/2014: No significant change observed.
 09/10/2013: No significant change observed.
 09/13/2012: No significant change observed.
 08/18/2011: No significant change observed. Some new material added to the water side levee slope, but the added material is loose and seems not helping the levee protection.
 10/05/2010: No significant change observed. Levee slope has minimal vegetation and lacks rip rap protection. Sandy material found on the lower and middle slope is an undesirable material to have on a levee.
 08/05/2010: Recommended for annual assessment and monitoring during flood events, per CLRO.

08/20/2009: No major change since last visit; site is located in an oxbow; slope surface consists of very sandy material; there is a tree on site leaning and with exposed tree roots; site is recommended as a local maintenance issue, per CLRO CES Evaluation 2008 Report; Eddy Cordoza from the district is aware of the site and is looking for recommendation; site is previously rated "U".
 08/17/2007: Site is close to an irrigation pump inlet.

Upstream view of the erosion site.

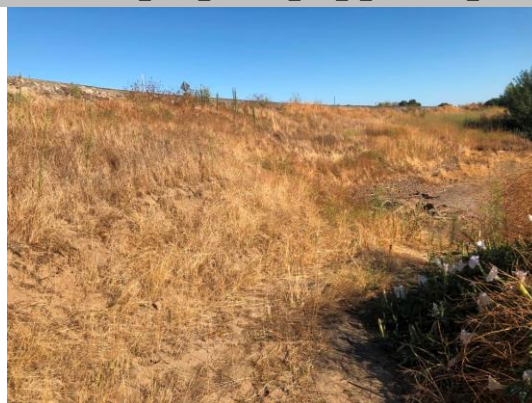
Photo 2 of 3 : SP_2020_RD2075_315_1_20200228_00002.jpg

Close-up view of the site.

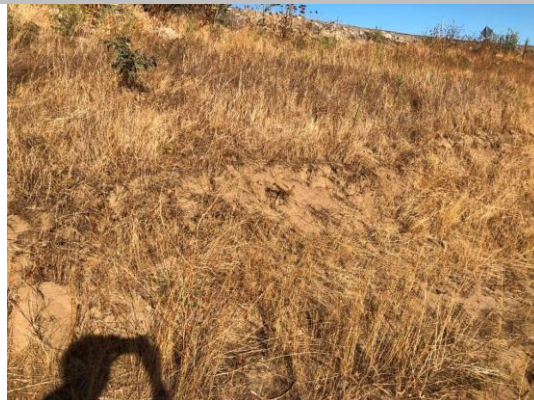
Photo 3 of 3 : SP_2020_RD2075_315_1_20200228_00003.jpg

Looking at the eroded levee slope.

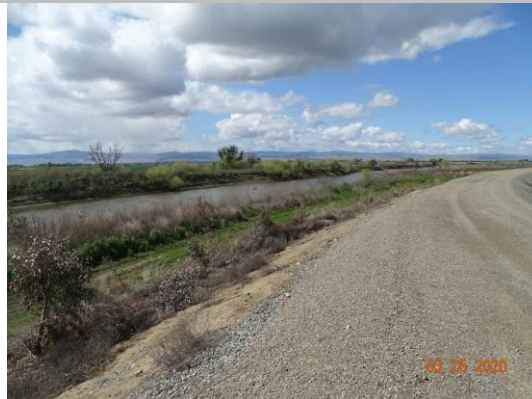
Photo 1 of 2 : SP_2020_RD2075_315_28_20200402_00067.jpg

LM Start	5.87	Rating **	A/W	Issue No.	28							
LM End	6.33	Issue Type +	Ma	Location *	WS							
Category	Earthen Levee		GPS Latitude/Longitude									
			Start	End								
Item	Erosion / Bank Caving		37.721710 °	37.720960 °								
			-121.267490 °	-121.259830 °								
DWR ID	LMA-485											
Comment Code												
E1 : Note and monitor erosion site.												
Inspector Comment												
Slope protection repairs are needed along the waterside slope due to erosion and riprap displacement from high water. Based upon levee inspections, it was determined the waterside levee slope is eroding, deteriorating, and degrading. The eroded levee sections need to be restored back to design standards to prevent further deterioration and damage. Site ID No: 579 & 580, Site Designation: LMA-485 & LMA-486

View of waterside slope looking downstream. Spring 2020

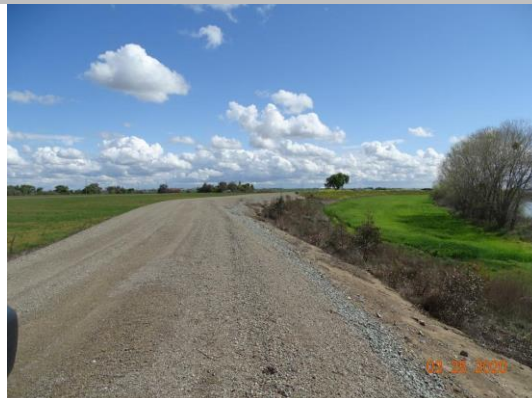
Photo 2 of 2 : SP_2020_RD2075_315_28_20200402_00068.jpg

View of waterside slope looking upstream. Spring 2020
