**Flood Control Project Maintenance
Levee Inspections**

Maintenance Issue Types Only, Levee Inspection Report By Mile - Spring 2021

Reclamation District No. 2075 McMullin

Waterway	Bank	Unit Miles	Inspection Start/End	Inspector
Unit No. 01 San Joaquin River	Right	7.45	04/13/2021 04/13/2021	Alberto De Leon

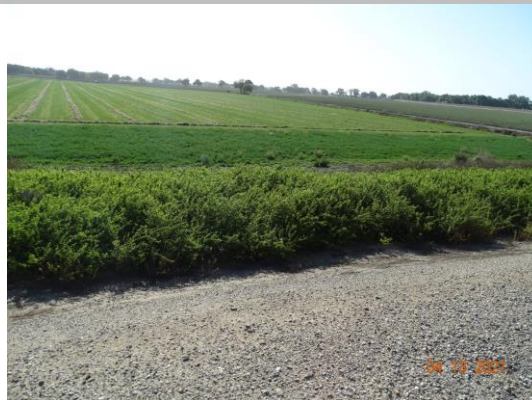
Photo 1 of 1 : SP_2021_RD2075_315_18_20210419_00042.jpg

LM Start	0.12	Rating **	M	Issue No.	18
LM End	0.23	Issue Type +	Ma	Location *	LS
Category	Earthen Levee			GPS Latitude/Longitude	
				Start	End
Item	Vegetation			37.748152 °	37.746547 °
				-121.289682 °	-121.289465 °
DWR ID	DWR_RD2075_01_f_2020_18				
Comment Code					
V2 : Remove the wild growth other than native grasses from the levee slopes.					
Inspector Comment					
Berry bushes are obstructing visibility of landside easement.

View of berry bushes along the landside easement. Spring 2021

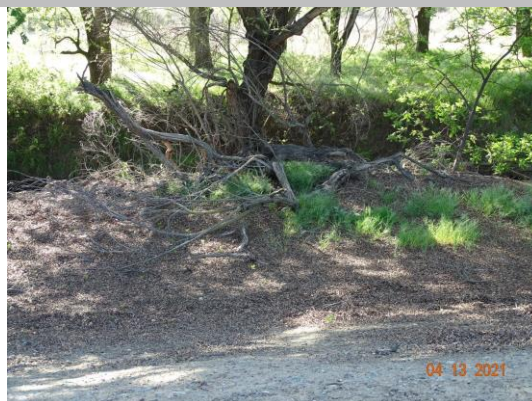
Photo 1 of 1 : SP_2021_RD2075_315_50_20210419_00043.jpg

LM Start	1.05	Rating **	M	Issue No.	50							
LM End	1.05	Issue Type +	Ma	Location *	LS							
Category	Earthen Levee		GPS Latitude/Longitude									
			Start	End								
Item	Encroachments		37.739255 °	37.739255 °								
			-121.281484 °	-121.281484 °								
DWR ID	DWR_RD2075_01_s_2021_50											
Comment Code												
TR : Tree or limb												
Inspector Comment

View of tree limb along the within the landside easement. Spring 2021

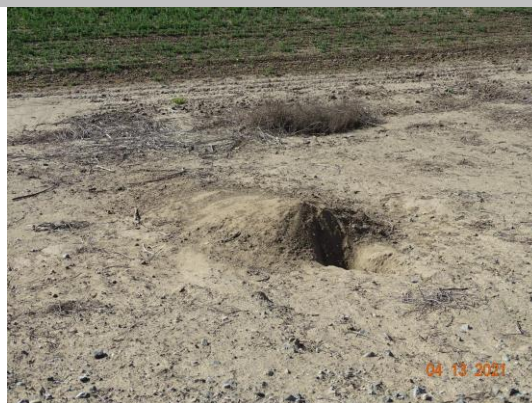
Photo 1 of 1 : SP_2021_RD2075_315_52_20210419_00045.jpg

LM Start	1.93	Rating **	U	Issue No.	52
LM End	1.93	Issue Type +	Ma	Location *	LS
Category	Earthen Levee		GPS Latitude/Longitude		
			Start	End	
Item	Animal Control		37.735849 °	37.735849 °	
			-121.291765 °	-121.291765 °	
DWR ID	DWR_RD2075_01_s _ 2021_52				
Comment Code					
A3 : No rodents visible, but rodent burrows visible; need to backfill and compact or grout burrows.					
Inspector Comment

View of large animal burrows on the landside slope. Spring 2021

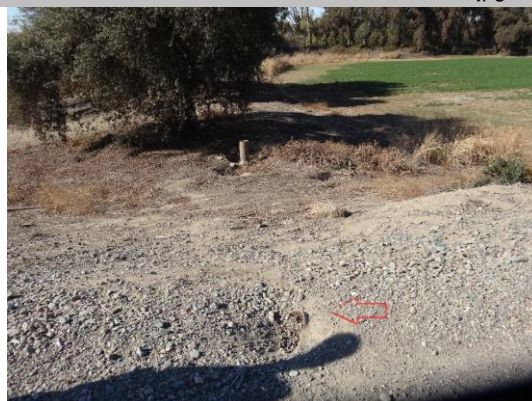
Photo 1 of 3 : UCIP_SP_2021_24666_45600.jpg

Comment Code						
Inspector Comment						
FS_ID:24666						
DS_ID:24737						
EP_NO: N/A						
Repair Type: Non-Urgent						
Crossing Status: Found						
UCIP Comments: - service pole on landside.- looks abandoned.						
Walkway in dilapidated condition.						
FIELD_STRUCT_DESC: 16-inch steel drainage discharge pipe through the levee, 4.5 feet below the crown. Corrugated metal cutoff wall. Pump mounted on a pile structure in a drainage ditch on the landside (LS).						
Siphon breaker in a corrugated metal pipe (CMP) riser on the waterside (WS) slope. [Additional Reference(s): DWR Levee Log, 2005. USACE San Joaquin O&M Manual 3, December 1968, (HLM 2.30)].						
FS Date: 11/13/2013

WS view: concrete standpipe (top) and steel pipe riser (bottom marked) on levee slope.

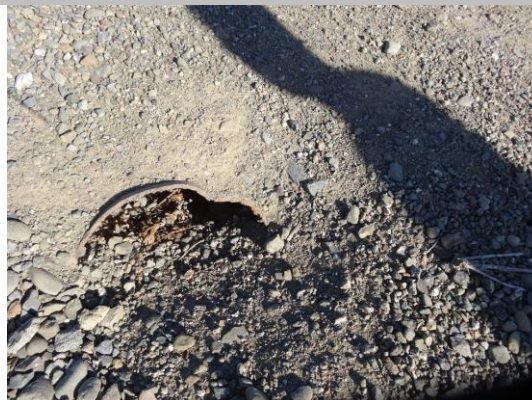
Photo 2 of 3 : UCIP_SP_2021_24666_44030.jpg

WS view: blocked siphon breaker in steel pipe riser on levee slope.

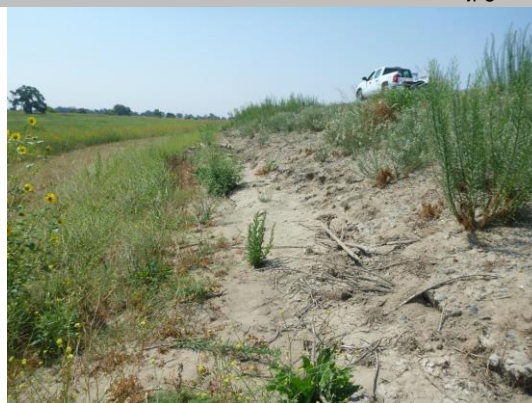
Photo 1 of 1 : LEVAL_SP_2021_577_4471.jpg

LM Start	3.90	Rating **	A/W	Issue No.	19							
LM End	4.04	Issue Type +	Ma	Location *	WS							
Category	Earthen Levee		GPS Latitude/Longitude									
			Start	End								
Item	Erosion / Bank Caving		37.713388 °	37.714630 °								
			-121.280018 °	-121.278263 °								
DWR ID	LMA-483											
Comment Code												
E1 : Note and monitor erosion site.												
Inspector Comment												
Slope protection repairs are needed along the waterside slope due to erosion and riprap displacement from high water. Based upon levee inspections, it was determined the waterside levee slope is eroding, deteriorating, and degrading. The eroded levee sections need to be restored back to design standards to prevent further deterioration and damage.												
Site ID No: 576 & 577, Site Designation: LMA-482 & LMA-483

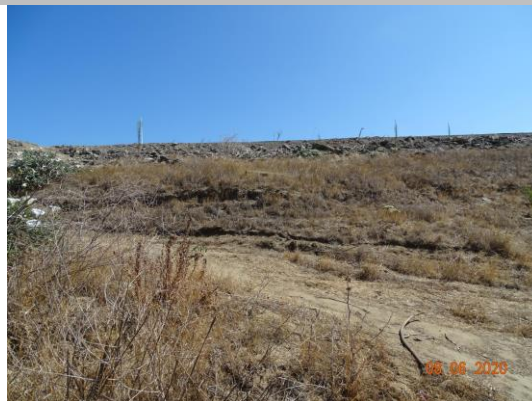
Photo 1 of 2 : SP_2021_RD2075_315_2_20210210_00004.jpg

LM Start	5.24	Rating **	M	Issue No.	2							
LM End	5.25	Issue Type +	Ma	Location *	WS							
Category	Supplemental		GPS Latitude/Longitude									
			Start	End								
Item	DWR Erosion Survey		37.728460 °	37.728460 °								
			-121.274670 °	-121.274670 °								
DWR ID	RD2075U01RM64.36											
Comment Code												
Inspector Comment												
Site ID: RD2075U01RM64.36 08/06/2020: This site is a 2017 Storm Damage Site (LMA-33). The erosion has cut into the levee prism.

8/6/2020: View of the erosion scarp from the berm.

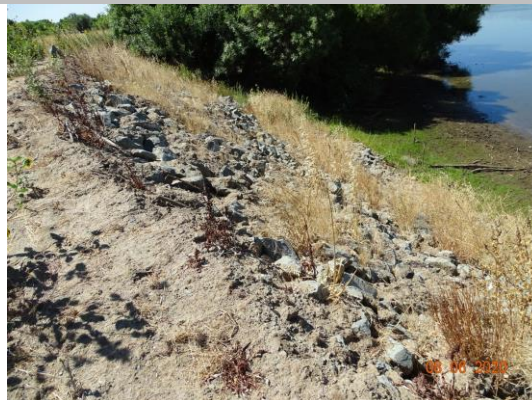
Photo 1 of 3 : SP_2021_RD2075_315_1_20210210_00001.jpg

Comment Code					
Inspector Comment					
<p>Site ID: RD2075U01RM64.34</p> <p>08/06/2020: From 2016 to present, no significant changes were observed during the annual survey.</p> <p>08/28/2015: Loose material is visible at the upper levee slope. The loose soil may have been caused by runoff.</p> <p>08/18/2014: From 2012 to present, no significant changes were observed during the annual survey.</p> <p>08/18/2011: Some new material added to the water side levee slope, but the added material is loose and seems not helping the levee protection.</p> <p>10/05/2010: No significant change observed. Levee slope has minimal vegetation and lacks rip rap protection. Sandy material found on the lower and middle slope is an undesirable material to have on a levee.</p> <p>08/05/2010: Recommended for annual assessment and monitoring during flood events, per CLRO.</p> <p>08/20/2009: No major change since last visit; site is located in an oxbow; slope surface consists of very sandy material; there is a tree on site leaning and with exposed tree roots; site is recommended as a local maintenance issue, per CLRO CES Evaluation 2008 Report; Eddy Cordoza from the district is aware of the site and is looking for recommendation; site is previously rated "U".</p> <p>08/17/2007: Site is close to an irrigation pump inlet.</p>

8/6/2020: View of the erosion and riprap just below the levee crown.

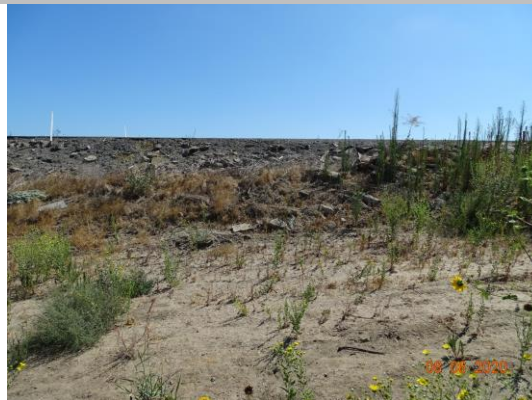
Photo 2 of 3 : SP_2021_RD2075_315_1_20210210_00002.jpg

8/6/2020: View of the erosion on the levee slope.

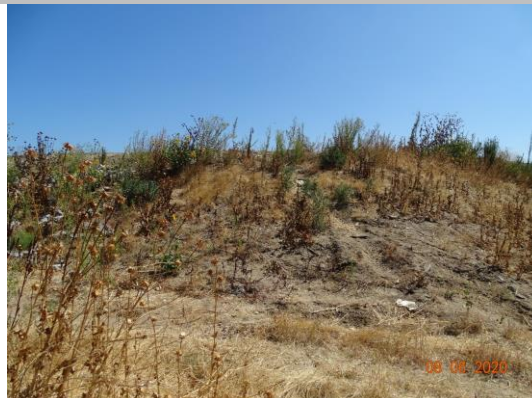
Photo 3 of 3 : SP_2021_RD2075_315_1_20210210_00003.jpg

8/6/2020: Another view of the eroded levee slope.

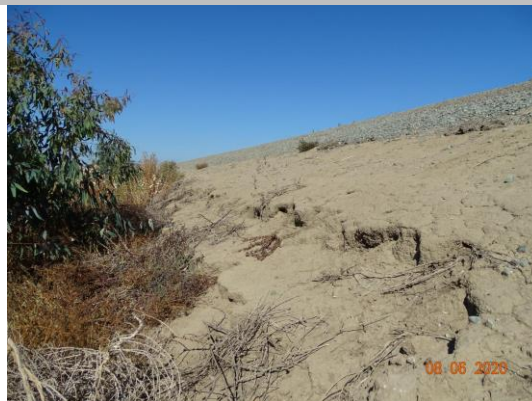
Photo 1 of 3 : SP_2021_RD2075_315_3_20210210_00006.jpg

LM Start	5.80	Rating **	M	Issue No.	3
LM End	5.95	Issue Type +	Ma	Location *	WS
Category	Supplemental			GPS Latitude/Longitude	
				Start	End
Item	DWR Erosion Survey			37.721710 °	37.721710 °
				-121.267490 °	-121.267490 °
DWR ID	RD2075U01RM64.64				
Comment Code					
Inspector Comment					
Site ID: RD2075U01RM64.64					
08/06/2020: This site is a 2017 Storm Damage Site (LMA-485). The erosion has cut into the levee toe, with a scarp height of up to 3 ft in some areas. The upper levee slope is covered with gravel and the lower slope is mostly bare soil. The berm width ranges from 30 to 50 ft. There is a seepage-stability berm just upstream on the landside.

8/6/2020: View of the toe erosion looking downstream.

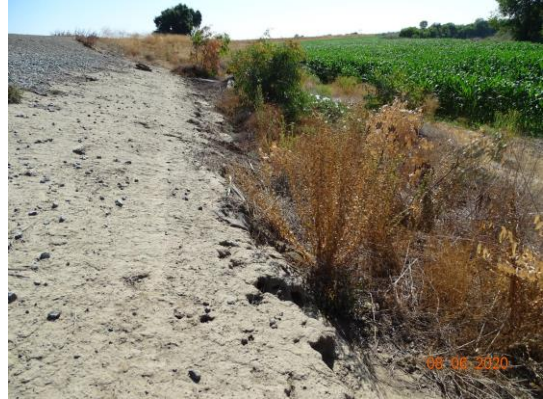
Photo 2 of 3 : SP_2021_RD2075_315_3_20210210_00007.jpg

8/6/2020: View of the erosion looking upstream. The scarp height is up to 3 ft in some areas.

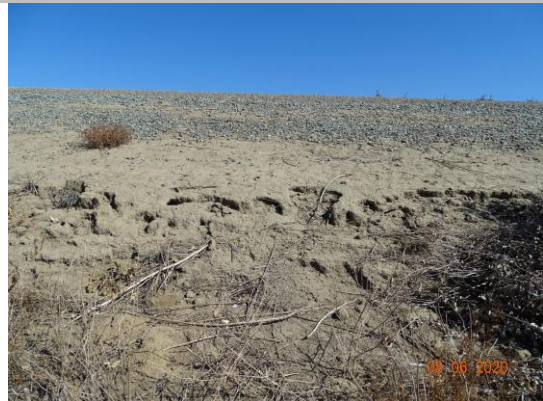
Photo 3 of 3 : SP_2021_RD2075_315_3_20210210_00008.jpg

8/6/2020: Front view of the toe erosion. There is some gravel on the upper levee slope.

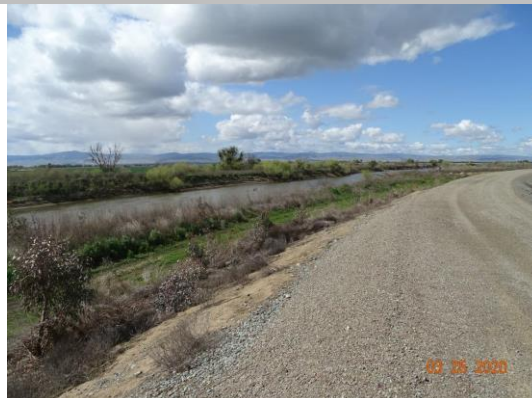
Photo 1 of 1 : SP_2021_RD2075_315_28_20210210_00018.jpg

LM Start	5.95	Rating **	A/W	Issue No.	28
LM End	6.33	Issue Type +	Ma	Location *	WS
Category	Earthen Levee			GPS Latitude/Longitude	
				Start	End
Item	Erosion / Bank Caving			37.721710 °	37.720960 °
				-121.267490 °	-121.259830 °
DWR ID	LMA-485				
Comment Code					
E1 : Note and monitor erosion site.					
Inspector Comment					
Slope protection repairs are needed along the waterside slope due to erosion and riprap displacement from high water. Based upon levee inspections, it was determined the waterside levee slope is eroding, deteriorating, and degrading. The eroded levee sections need to be restored back to design standards to prevent further deterioration and damage. Site ID No: 579 & 580, Site Designation: LMA-485 & LMA-486

View of waterside slope looking downstream. Spring 2020

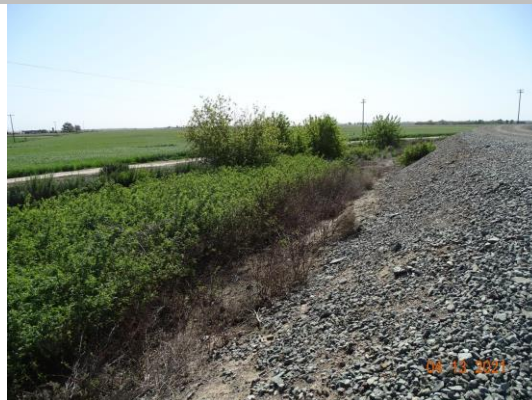
Photo 1 of 1 : SP_2021_RD2075_315_54_20210419_00051.jpg

LM Start	6.35	Rating **	U	Issue No.	54
LM End	6.35	Issue Type +	Ma	Location *	LS
Category	Earthen Levee			GPS Latitude/Longitude	
				Start	End
Item	Vegetation			37.720800 °	37.720800 °
				-121.259529 °	-121.259529 °
DWR ID	DWR_RD2075_01_s_2021_54				
Comment Code					
V2 : Remove the wild growth other than native grasses from the levee slopes.					
Inspector Comment

View of wild growth vegetation within the landside easement. Spring 2021

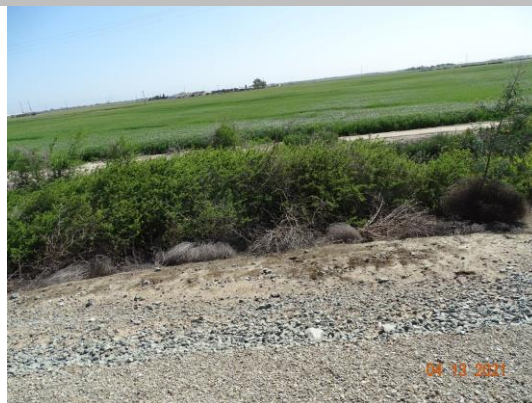
Photo 1 of 1 : SP_2021_RD2075_315_45_20210419_00052.jpg

LM Start	6.44	Rating **	M	Issue No.	45
LM End	6.44	Issue Type +	Ma	Location *	LS
Category	Earthen Levee			GPS Latitude/Longitude	
				Start	End
Item	Vegetation			37.719788 °	37.719788 °
				-121.258813 °	-121.258813 °
DWR ID	DWR_RD2075_01_f_2019_45				
Comment Code					
V2 : Remove the wild growth other than native grasses from the levee slopes.					
Inspector Comment

View of wild growth vegetation within the landside easement. Spring 2021
