**Flood Control Project Maintenance
Levee Inspections**

Maintenance Issue Types Only, Levee Inspection Report By Mile - Spring 2022

Reclamation District No. 2075 McMullin

Waterway	Bank	Unit Miles	Inspection Start/End	Inspector
Unit No. 01 San Joaquin River	Right	7.45	04/28/2022 04/28/2022	Alberto De Leon

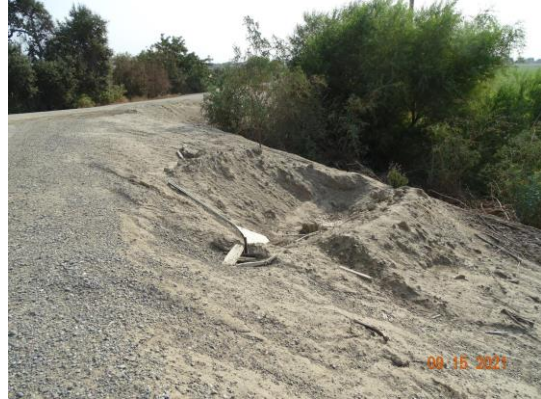
Photo 1 of 1 : SP_2022_RD2075_315_17_20220406_00010.jpg

LM Start	0.02	Rating **	M	Issue No.	17
LM End	0.02	Issue Type +	Ma	Location *	LS
Category	Earthen Levee			GPS Latitude/Longitude	
				Start	End
Item	Erosion / Bank Caving			37.749410 °	37.749410 °
				-121.288975 °	-121.288975 °
DWR ID	DWR_RD2075_01_f_2021_17				
Comment Code					
E2 : Schedule repair of erosion site prior to the next inspection.					
Inspector Comment					
There is caving within the overbuilt landside slope. The caving has not extended into levee prism.

View of landside slope caving. Fall 2021

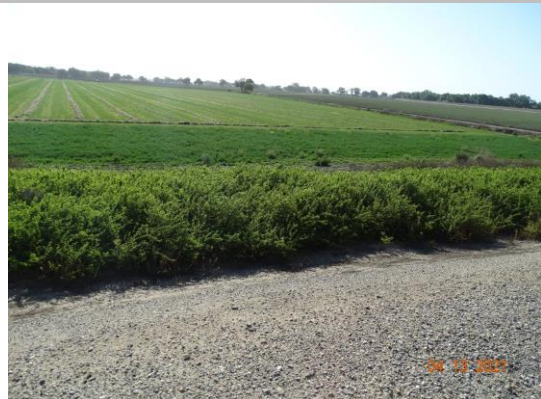
Photo 1 of 1 : SP_2022_RD2075_315_18_20220406_00011.jpg

LM Start	0.10	Rating **	M	Issue No.	18
LM End	0.23	Issue Type +	Ma	Location *	LS
Category	Earthen Levee			GPS Latitude/Longitude	
				Start	End
Item	Vegetation			37.748428 °	37.746547 °
				-121.289766 °	-121.289465 °
DWR ID	DWR_RD2075_01_f_2020_18				
Comment Code					
V2 : Remove the wild growth and woody vegetation other than native grasses from the levee slopes.					
Inspector Comment					
Berry bushes are obstructing visibility of landside easement.

View of berry bushes along the landside easement. Spring 2021

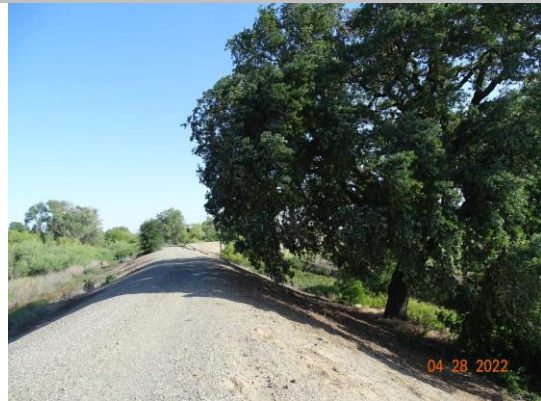
Photo 1 of 1 : SP_2022_RD2075_315_44_20220428_00038.jpg

LM Start	0.16	Rating **	M	Issue No.	44
LM End	0.16	Issue Type +	Ma	Location *	LS
Category	Earthen Levee			GPS Latitude/Longitude	
				Start	End
Item	Trim / Thin Trees			37.747633 °	37.747633 °
				-121.289462 °	-121.289462 °
DWR ID	DWR_RD2075_01_s_2021_44				
Comment Code					
T1 : Trim and thin trees to at least five feet above ground level to allow visibility of the ground and room to flood fight.					
Inspector Comment

View of untrimmed tree along the landside slope. Spring 2022

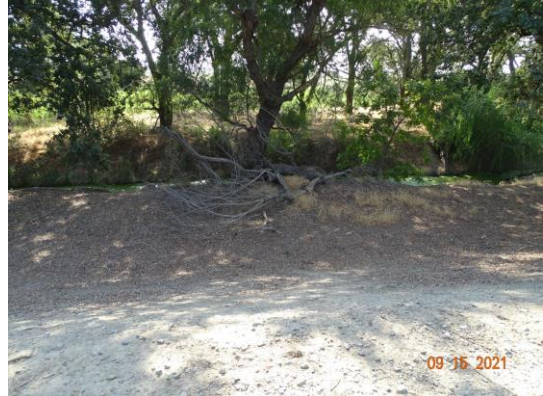
Photo 1 of 1 : SP_2022_RD2075_315_50_20220406_00021.jpg

LM Start	1.05	Rating **	M	Issue No.	50
LM End	1.05	Issue Type +	Ma	Location *	LS
Category	Earthen Levee			GPS Latitude/Longitude	
				Start	End
Item	Encroachments			37.739255 °	37.739255 °
				-121.281484 °	-121.281484 °
DWR ID	DWR_RD2075_01_s_2021_50				
Comment Code					
TR : Tree or limb					
Inspector Comment

View of tree limb along the landside easement. Fall 2021

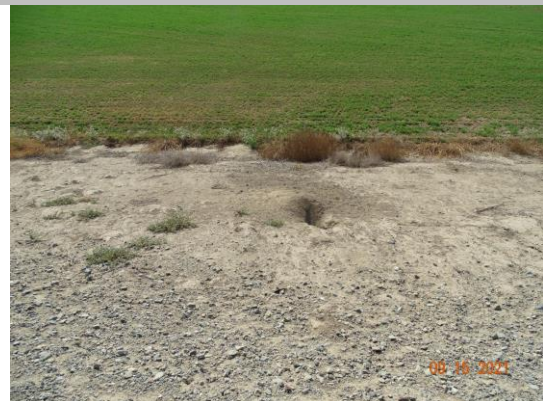
Photo 1 of 1 : SP_2022_RD2075_315_52_20220406_00022.jpg

LM Start	1.93	Rating **	U	Issue No.	52
LM End	1.93	Issue Type +	Ma	Location *	LS
Category	Earthen Levee			GPS Latitude/Longitude	
				Start	End
Item	Animal Control			37.735849 °	37.735849 °
				-121.291765 °	-121.291765 °
DWR ID	DWR_RD2075_01_s_2021_52				
Comment Code					
A3 : No rodents visible, but rodent burrows visible; need to backfill and compact or grout burrows.					
Inspector Comment

View of large animal burrows on the landside slope. Fall 2021

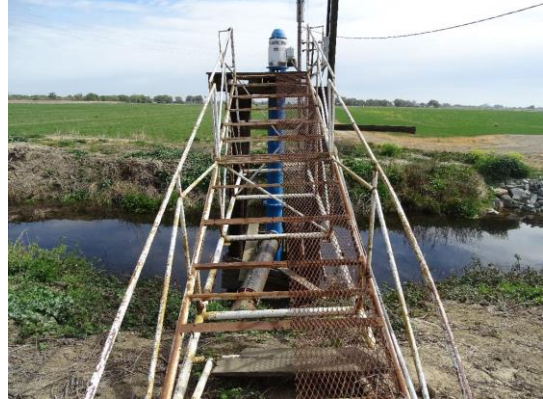
Photo 2 of 3 : UCIP_SP_2022_72707_108969.jpg

Land-Side: view of stairs to pump on toe.

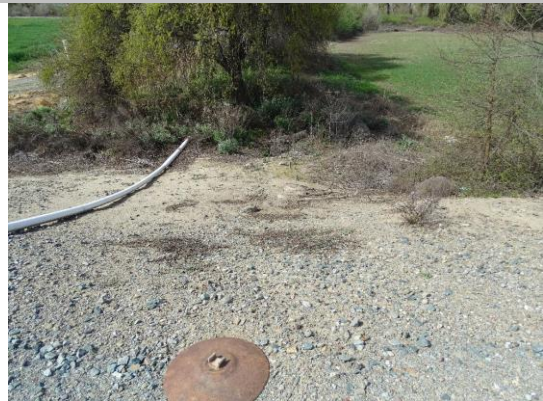
Photo 3 of 3 : UCIP_SP_2022_72707_108970.jpg

Land-Side: view of slope.

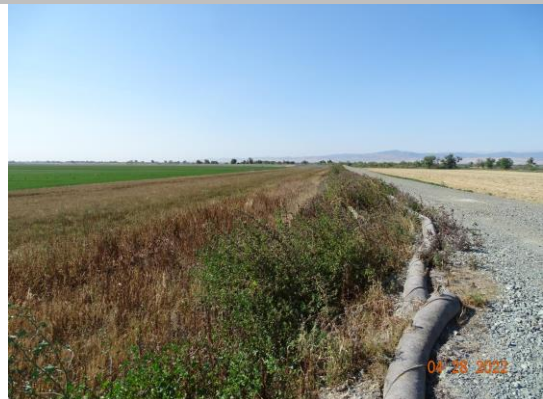
Photo 1 of 1 : SP_2022_RD2075_315_23_20220428_00040.jpg

LM Start	2.33	Rating **	M	Issue No.	23
LM End	2.62	Issue Type +	Ma	Location *	LS
Category	Earthen Levee			GPS Latitude/Longitude	
				Start	End
Item	Vegetation			37.731164 °	37.726931 °
				-121.293729 °	-121.294492 °
DWR ID	DWR_RD2075_01_s_2022_23				
Comment Code					
V1 : Control annual grass and weeds on the levee slopes and easements.					
Inspector Comment

View of vegetation along the landside slope. Spring 2022

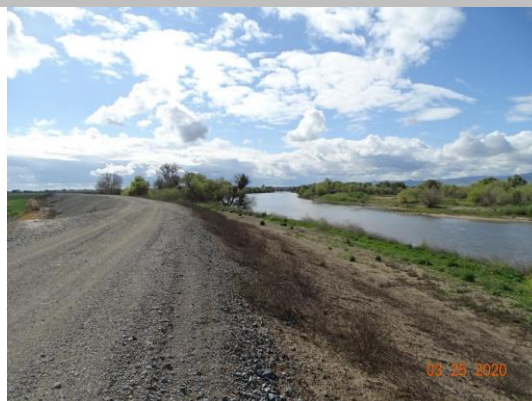
Photo 1 of 1 : SP_2022_RD2075_315_16_20220406_00009.jpg

LM Start	2.74	Rating **	A/W	Issue No.	16
LM End	2.84	Issue Type +	Ma	Location *	WS
Category	Earthen Levee			GPS Latitude/Longitude	
				Start	End
Item	Erosion / Bank Caving			37.725200 °	37.724000 °
				-121.294400 °	-121.293200 °
DWR ID	LMA-307				
Comment Code					
E1 : Note and monitor erosion site.					
Inspector Comment					
Channel bank has signs of erosion and is degrading in concave pocket sections. It is recommended the LMA continue to monitor and document the rate of erosion. Rock was placed on LS here during the 2017 storms. Site ID No:480 & 81, Site Designation: LMA-307 & LMA-35

View of waterside slope looking upstream. Spring 2020

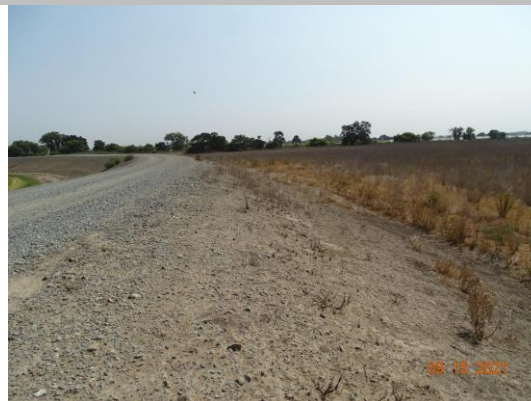
Photo 1 of 1 : SP_2022_RD2075_315_19_20220406_00012.jpg

LM Start	3.90	Rating **	A/W	Issue No.	19
LM End	4.04	Issue Type +	Ma	Location *	WS
Category	Earthen Levee			GPS Latitude/Longitude	
				Start	End
Item	Erosion / Bank Caving			37.713388 °	37.714630 °
				-121.280018 °	-121.278263 °
DWR ID	LMA-483				
Comment Code					
E1 : Note and monitor erosion site.					
Inspector Comment					
Channel banks has signs of erosion and is degrading in concave pocket sections. It is recommended the LMA continue to monitor and document the rate of erosion. Rock was placed on LS here during the 2017 storms.					
Site ID No: 576 & 577, Site Designation: LMA-482 & LMA-483

View of waterside slope. Fall 2021

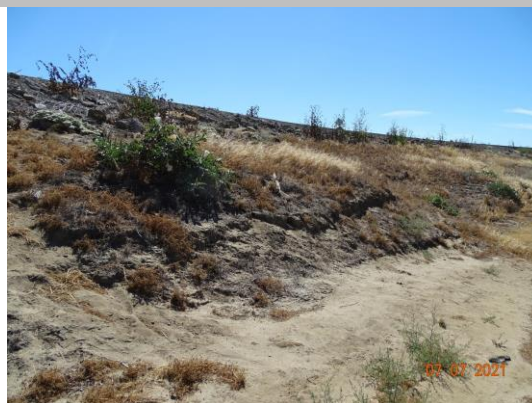
Photo 1 of 2 : SP_2022_RD2075_315_1_20220406_00001.jpg

LM Start	5.24	Rating **	M	Issue No.	1
LM End	5.25	Issue Type +	Ma	Location *	WS
Category	Supplemental			GPS Latitude/Longitude	
				Start	End
Item	DWR Erosion Survey			37.728460 °	37.728460 °
				-121.274670 °	-121.274670 °
DWR ID	RD2075U01RM64.36				
Comment Code					
Inspector Comment					
Site ID: RD2075U01RM64.36 07/07/2021: The erosion length was updated to 30 ft based on more accurate field measurements. Otherwise, no significant changes were observed since the previous inspection. 08/06/2020: This site is a 2017 Storm Damage Site (LMA-33). The erosion has cut into the levee prism.

7/7/2021: Close-up view of the erosion pocket.

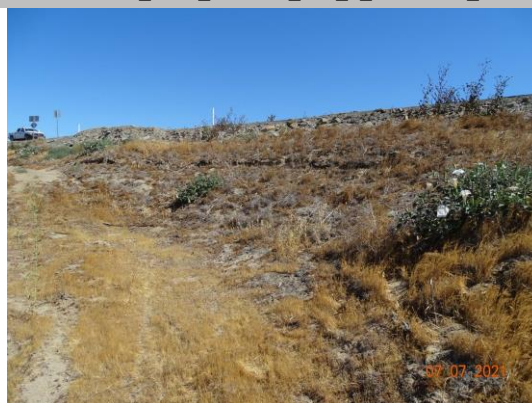
Photo 2 of 2 : SP_2022_RD2075_315_1_20220406_00002.jpg

7/7/2021: Another view of the erosion pocket.

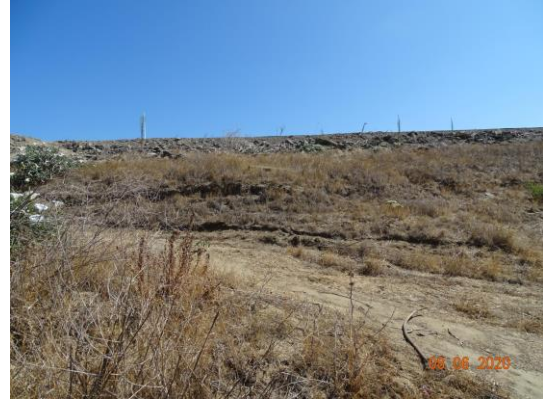
Photo 1 of 2 : SP_2022_RD2075_315_2_20220406_00003.jpg

LM Start	5.24	Rating **	A/W	Issue No.	2
LM End	5.25	Issue Type +	Ma	Location *	WS
Category	Earthen Levee			GPS Latitude/Longitude	
				Start	End
Item	Erosion / Bank Caving			37.728460 °	37.728460 °
				-121.274670 °	-121.274670 °
DWR ID	DWR_RD2075_01_f_2021_2				
Comment Code					
E1 : Note and monitor erosion site.					
Inspector Comment					
ite ID: RD2075U01RM64.36					
08/06/2020: This site is a 2017 Storm Damage Site (LMA-33). Recommend the LMA continue to monitor and document rate of erosion. Erosion currently is on the river bank.

8/6/2020: View of the erosion scarp from the berm.

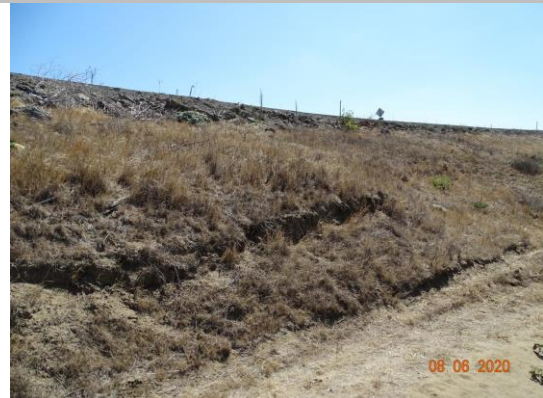
Photo 2 of 2 : SP_2022_RD2075_315_2_20220406_00004.jpg

8/6/2020: Close-up view of the scarp. The erosion has cut into the levee prism.

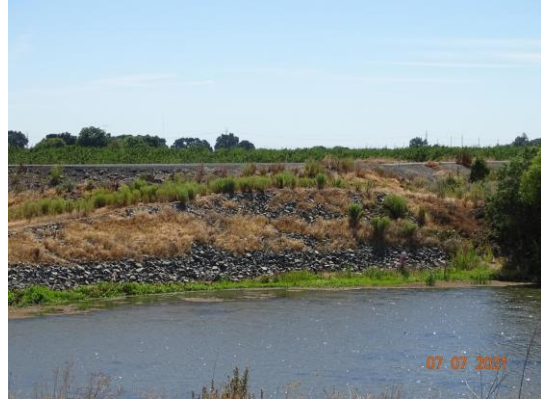
Photo 1 of 2 : SP_2022_RD2075_315_30_20220406_00015.jpg

Comment Code					
Inspector Comment					
Site ID: RD2075U01RM64.34					
07/07/2021: From 2016 to present, no significant changes were observed during the annual survey.					
08/28/2015: Loose material is visible at the upper levee slope. The loose soil may have been caused by runoff.					
08/18/2014: From 2012 to present, no significant changes were observed during the annual survey.					
08/18/2011: Some new material added to the water side levee slope, but the added material is loose and seems not helping the levee protection.					
10/05/2010: No significant change observed. Levee slope has minimal vegetation and lacks rip rap protection. Sandy material found on the lower and middle slope is an undesirable material to have on a levee.					
08/05/2010: Recommended for annual assessment and monitoring during flood events, per CLRO.					
08/20/2009: No major change since last visit; site is located in an oxbow; slope surface consists of very sandy material; there is a tree on site leaning and with exposed tree roots; site is recommended as a local maintenance issue, per CLRO CES Evaluation 2008 Report; Eddy Cordoza from the district is aware of the site and is looking for recommendation; site is previously rated "U".

7/7/2021: View of the erosion and riprap from across the bend.

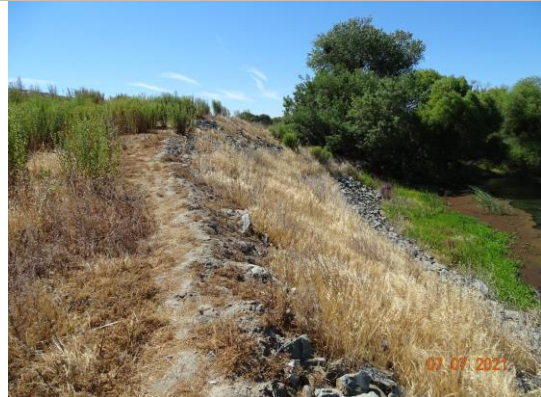
Photo 2 of 2 : SP_2022_RD2075_315_30_20220406_00016.jpg

7/7/2021: Close-up view of the erosion.

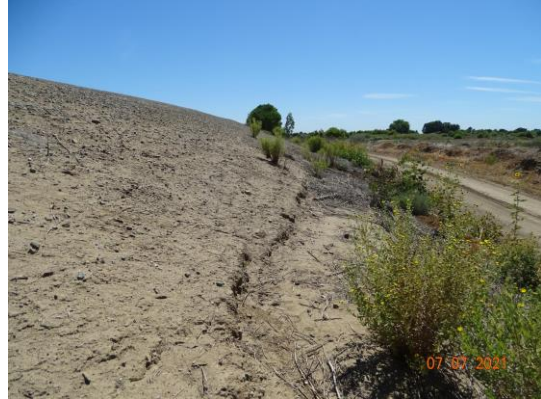
Photo 1 of 3 : SP_2022_RD2075_315_3_20220406_00005.jpg

08/06/2020: This site is a 2017 Storm Damage Site (LMA-485). The erosion has cut into the levee toe, with a scarp height of up to 3 ft in some areas. The upper levee slope is covered with gravel and the lower slope is mostly bare soil. The berm width ranges from 30 to 50 ft. There is a seepage-stability berm just upstream on the landside.

7/7/2021: View of the erosion on the levee toe at the downstream end.

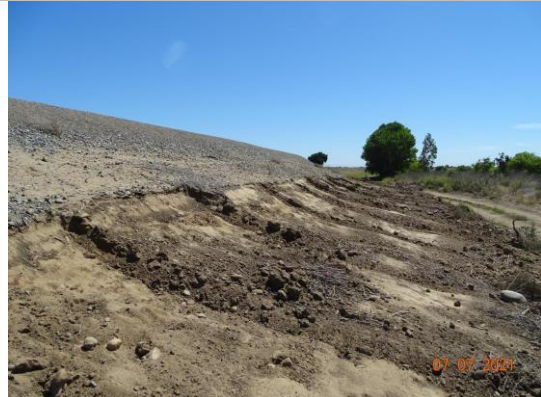
Photo 2 of 3 : SP_2022_RD2075_315_3_20220406_00006.jpg

7/7/2021: View of the cleared area looking upstream.

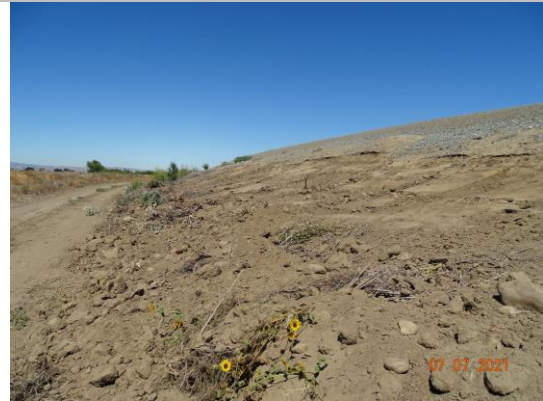
Photo 3 of 3 : SP_2022_RD2075_315_3_20220406_00007.jpg

7/7/2021: View of the cleared area looking downstream.

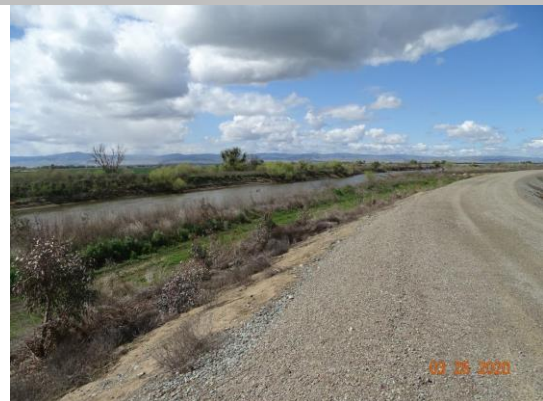
Photo 1 of 1 : SP_2022_RD2075_315_28_20220406_00014.jpg

Channel bank has signs of erosion and is degrading in concave pocket sections. It is recommended the LMA continue to monitor and document the rate of erosion. Rock was placed on LS here during the 2017 storms. Site ID No: 579 & 580, Site Designation: LMA-485 & LMA-486

View of waterside slope looking downstream. Spring 2020

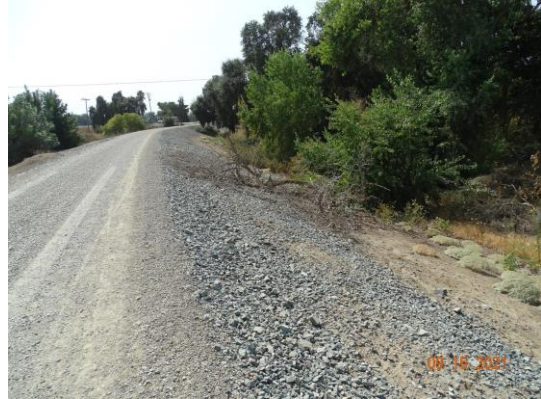
Photo 1 of 1 : SP_2022_RD2075_315_47_20220406_00020.jpg

LM Start	6.73	Rating **	M	Issue No.	47
LM End	6.73	Issue Type +	Ma	Location *	WS
Category	Earthen Levee			GPS Latitude/Longitude	
				Start	End
Item	Encroachments			37.715480 °	37.715480 °
				-121.258442 °	-121.258442 °
DWR ID	DWR_RD2075_01_f _ 2019_47				
Comment Code					
PR : Prunings					
Inspector Comment

View of prunings on the waterside slope. Fall 2021

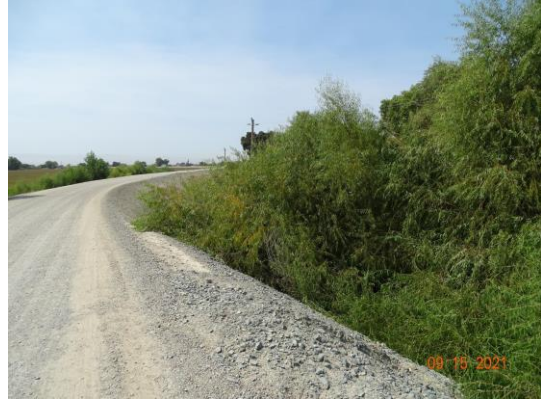
Photo 1 of 1 : SP_2022_RD2075_315_40_20220406_00018.jpg

LM Start	6.84	Rating **	U	Issue No.	40
LM End	6.84	Issue Type +	Ma	Location *	WS
Category	Earthen Levee			GPS Latitude/Longitude	
				Start	End
Item	Trim / Thin Trees			37.714123 °	37.714123 °
				-121.259279 °	-121.259279 °
DWR ID	DWR_RD2075_01_f_2020_40				
Comment Code					
T1 : Trim and thin trees to at least five feet above ground level to allow visibility of the ground and room to flood fight.					
Inspector Comment

View of trees on waterside slope obstructing visibility. Fall 2021
