**Flood Control Project Maintenance
Levee Inspections**

Maintenance Issue Types Only, Levee Inspection Report By Mile - Spring 2023

Reclamation District No. 2075 McMullin

Waterway	Bank	Unit Miles	Inspection Start/End	Inspector
Unit No. 01 San Joaquin River	Right	7.45	05/01/2023 05/01/2023	Alberto De Leon

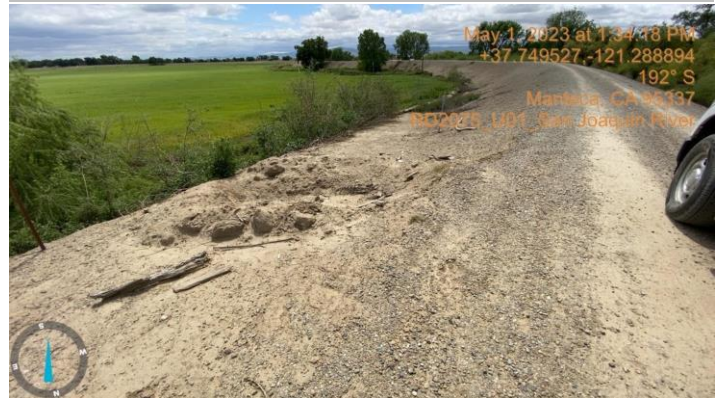
Photo 1 of 1 : SP_2023_RD2075_315_17_20230515_00020.jpg

LM Start	0.02	Rating **	M	Issue No.	17
LM End	0.02	Issue Type +	Ma	Location *	LS
Category	Earthen Levee			GPS Latitude/Longitude	
				Start	End
Item	Erosion / Bank Caving			37.749410°	37.749410°
				-121.288975°	-121.288975°
DWR ID	DWR_RD2075_01_f_2021_17				
Comment Code					
E2 : Schedule repair of erosion site prior to the next inspection.					
Inspector Comment					
There is caving within the overbuilt landside slope. The caving has not extended into the levee prism.

View of landside slope caving. Spring 2023

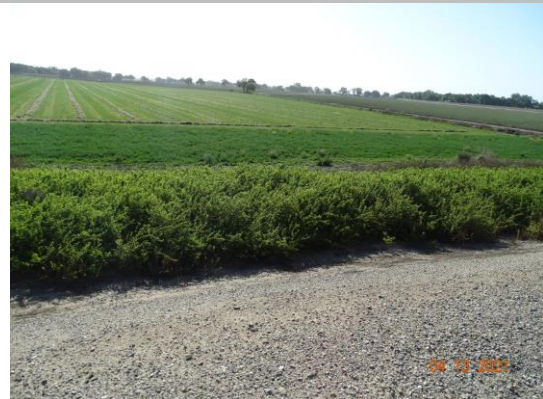
Photo 1 of 1 : SP_2023_RD2075_315_18_20230306_00005.jpg

LM Start	0.10	Rating **	M	Issue No.	18
LM End	0.23	Issue Type +	Ma	Location *	LS
Category	Earthen Levee			GPS Latitude/Longitude	
				Start	End
Item	Vegetation			37.748428°	37.746547°
				-121.289766°	-121.289465°
DWR ID	DWR_RD2075_01_f_2020_18				
Comment Code					
V2 : Remove the wild growth and woody vegetation other than native grasses from the levee slopes.					
Inspector Comment					
Berry bushes are obstructing visibility of the landside easement.

View of berry bushes along the landside easement. Spring 2021

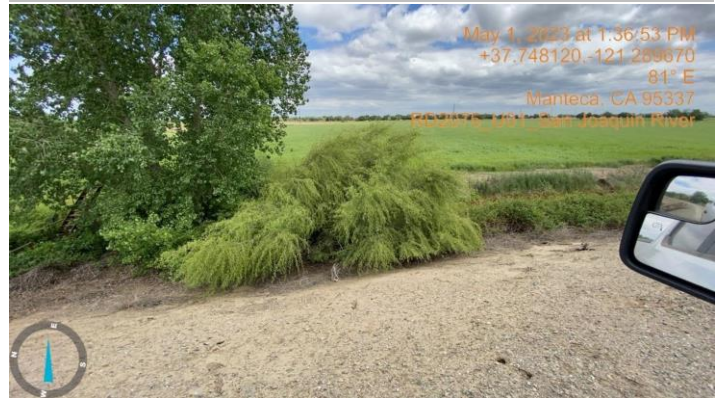
Photo 1 of 1 : SP_2023_RD2075_315_22_20230515_00021.jpg

LM Start	0.12	Rating **	U	Issue No.	22
LM End	0.12	Issue Type +	Ma	Location *	LS
Category	Earthen Levee			GPS Latitude/Longitude	
				Start	End
Item	Trim / Thin Trees			37.748139°	37.748139°
				-121.289666°	-121.289666°
DWR ID	DWR_RD2075_01_f_2022_22				
Comment Code					
T1 : Trim and thin trees to at least five feet above ground level to allow visibility of the ground and room to flood fight.					
Inspector Comment

View of trees on the landside slope. Spring 2023

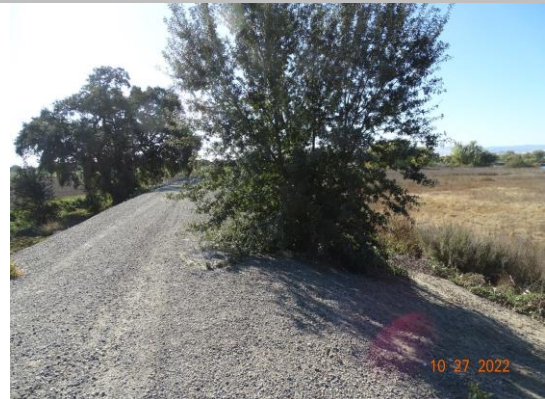
Photo 1 of 1 : SP_2023_RD2075_315_41_20230306_00011.jpg

LM Start	0.13	Rating **	U	Issue No.	41
LM End	0.13	Issue Type +	Ma	Location *	WS
Category	Earthen Levee			GPS Latitude/Longitude	
				Start	End
Item	Trim / Thin Trees			37.748072°	37.748072°
				-121.289657°	-121.289657°
DWR ID	DWR_RD2075_01_s_2021_41				
Comment Code					
T1 : Trim and thin trees to at least five feet above ground level to allow visibility of the ground and room to flood fight.					
Inspector Comment

View of untrimmed tree on the waterside slope. Fall 2022

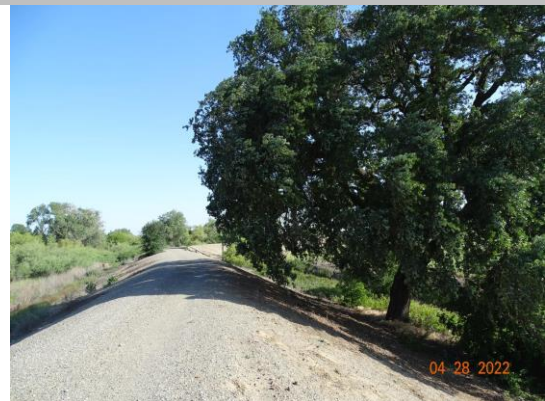
Photo 1 of 1 : SP_2023_RD2075_315_44_20230306_00012.jpg

LM Start	0.16	Rating **	M	Issue No.	44
LM End	0.16	Issue Type +	Ma	Location *	LS
Category	Earthen Levee			GPS Latitude/Longitude	
				Start	End
Item	Trim / Thin Trees			37.747633°	37.747633°
				-121.289462°	-121.289462°
DWR ID	DWR_RD2075_01_s_2021_44				
Comment Code					
T1 : Trim and thin trees to at least five feet above ground level to allow visibility of the ground and room to flood fight.					
Inspector Comment

View of untrimmed tree along the landside slope. Spring 2022

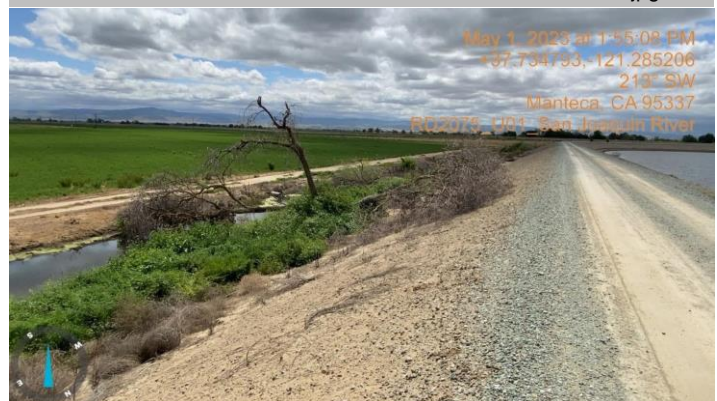
Photo 1 of 1 : SP_2023_RD2075_315_3_20230515_00024.jpg

LM Start	1.50	Rating **	U	Issue No.	3
LM End	1.50	Issue Type +	Ma	Location *	LS
Category	Earthen Levee			GPS Latitude/Longitude	
				Start	End
Item	Trim / Thin Trees			37.734737°	37.734737°
				-121.285422°	-121.285422°
DWR ID	DWR_RD2075_01_s_2023_3				
Comment Code					
T2 : Tree or limb.					
Inspector Comment

View of tree branches along the landside slope and easement. Spring 2023

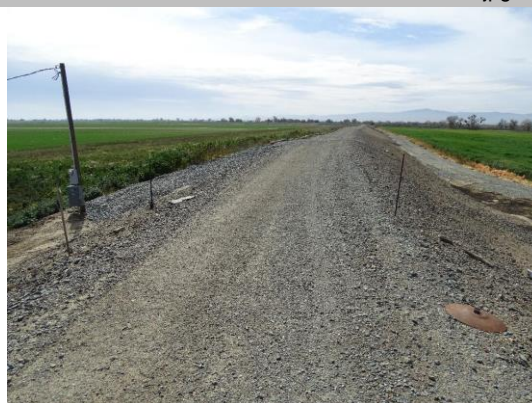
Photo 1 of 3 : UCIP_SP_2023_72707_108968.jpg

Comment Code						
Inspector Comment						
DS_ID:24737 FS_ID:72707 EP_NO: N/A Repair Type: Non-Urgent EVAL Issue: Crossing Status: Found UCIP Comments: 03/17/2022 Record remains Non-Urgent. No permit has been identified authorizing pipe. New pump and pipe at pump, and siphon breaker cleared out. (D.Sanoski - DWR UCIP) 11/13/2013 Service pole on landside, looks abandoned, and walkway in dilapidated condition. (P. Khoi - DWR UCIP) FIELD_STRUCT_DESC: 16-inch steel drainage discharge pipe through the levee, 4.5 feet below the crown. Corrugated metal cutoff wall. Pump mounted on a pile structure in a drainage ditch on the landside (LS). Siphon breaker in a corrugated metal pipe (CMP) riser on the waterside (WS) slope. [Additional Reference(s): DWR Levee Log, 2005. USACE San Joaquin O&M Manual 3, December 1968, (HLM 2.30)]. FS Date: 3/17/2022 2:55:20 PM

Top of Levee: view of crown.

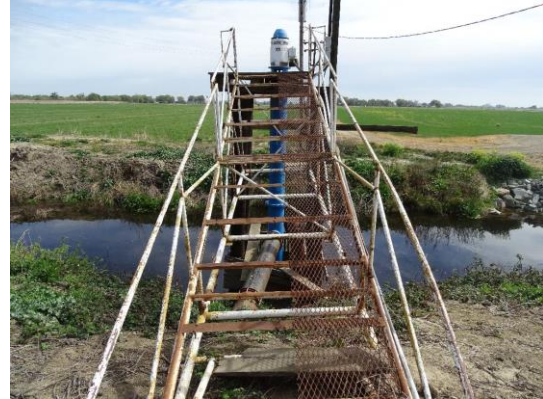
Photo 2 of 3 : UCIP_SP_2023_72707_108969.jpg

Land-Side: view of stairs to pump on toe.

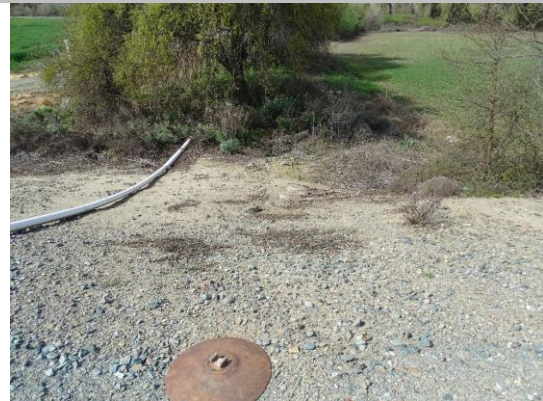
Photo 3 of 3 : UCIP_SP_2023_72707_108970.jpg

Land-Side: view of slope.

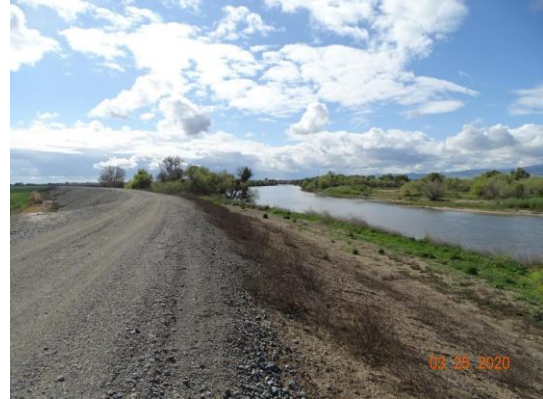
Photo 1 of 1 : SP_2023_RD2075_315_16_20230306_00003.jpg

LM Start	2.74	Rating **	A/W	Issue No.	16
LM End	2.84	Issue Type +	Ma	Location *	WS
Category	Earthen Levee			GPS Latitude/Longitude	
				Start	End
Item	Erosion / Bank Caving			37.725200°	37.724000°
				-121.294400°	-121.293200°
DWR ID	LMA-307				
Comment Code					
E1 : Note and monitor erosion site.					
Inspector Comment					
Channel bank has signs of erosion and is degrading in concave pocket sections. It is recommended the LMA continue to monitor and document the rate of erosion. Rock was placed on LS here during the 2017 storms. This was a 2017 Storm Damage site. Site ID No:480 & 81, Site Designation: LMA-307 & LMA-35

View of waterside slope looking upstream. Spring 2020

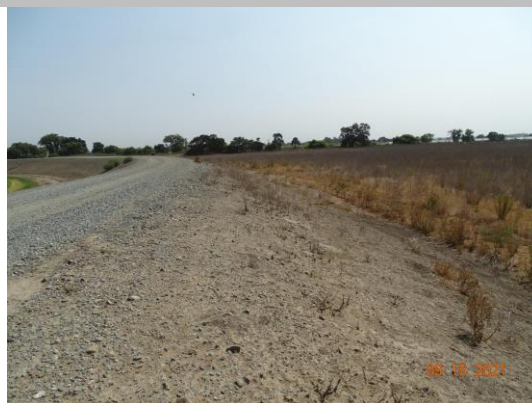
Photo 1 of 1 : SP_2023_RD2075_315_19_20230306_00006.jpg

LM Start	3.90	Rating **	A/W	Issue No.	19
LM End	4.04	Issue Type +	Ma	Location *	WS
Category	Earthen Levee			GPS Latitude/Longitude	
				Start	End
Item	Erosion / Bank Caving			37.713388°	37.714630°
				-121.280018°	-121.278263°
DWR ID	LMA-483				
Comment Code					
E1 : Note and monitor erosion site.					
Inspector Comment					
Channel banks has signs of erosion and is degrading in concave pocket sections. It is recommended the LMA continue to monitor and document the rate of erosion. Rock was placed on LS here during the 2017 storms. This was a 2017 Storm Damage site. Site ID No: 576 & 577, Site Designation: LMA-482 & LMA-483

View of waterside slope. Fall 2021

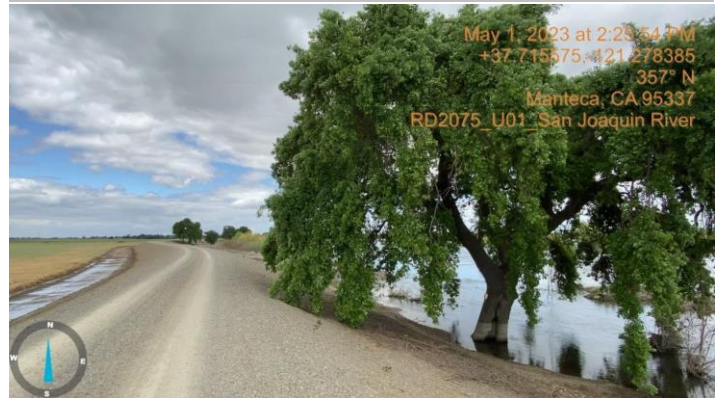
Photo 1 of 1 : SP_2023_RD2075_315_35_20230515_00029.jpg

LM Start	4.11	Rating **	M	Issue No.	35
LM End	4.11	Issue Type +	Ma	Location *	WS
Category	Earthen Levee			GPS Latitude/Longitude	
				Start	End
Item	Trim / Thin Trees			37.715603°	37.715603°
				-121.278441°	-121.278441°
DWR ID	DWR_RD2075_01_f_2020_35				
Comment Code					
T1 : Trim and thin trees to at least five feet above ground level to allow visibility of the ground and room to flood fight.					
Inspector Comment

View of an untrimmed tree on the waterside slope. Spring 2023

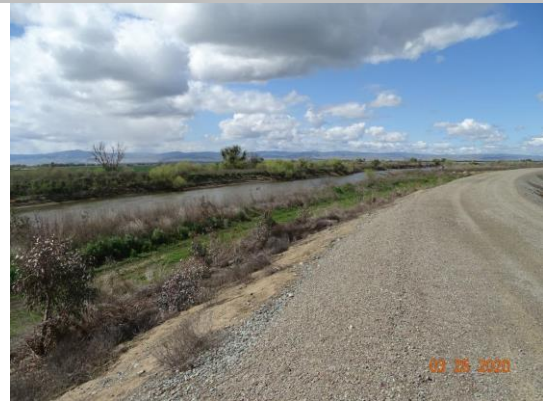
Photo 1 of 1 : SP_2023_RD2075_315_28_20230306_00008.jpg

LM Start	5.95	Rating **	A/W	Issue No.	28
LM End	6.33	Issue Type +	Ma	Location *	WS
Category	Earthen Levee			GPS Latitude/Longitude	
				Start	End
Item	Erosion / Bank Caving			37.721710°	37.720960°
				-121.267490°	-121.259830°
DWR ID	LMA-485				
Comment Code					
E1 : Note and monitor erosion site.					
Inspector Comment					
Channel bank has signs of erosion and is degrading in concave pocket sections. It is recommended the LMA continue to monitor and document the rate of erosion. Rock was placed on LS here during the 2017 storms. This was a 2017 Storm Damage site. Site ID No: 579 & 580, Site Designation: LMA-485 & LMA-486

View of waterside slope looking downstream. Spring 2020

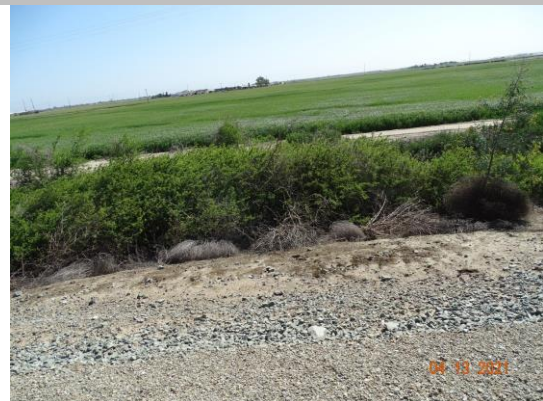
Photo 1 of 1 : SP_2023_RD2075_315_45_20230306_00013.jpg

LM Start	6.43	Rating **	M	Issue No.	45
LM End	6.43	Issue Type +	Ma	Location *	LS
Category	Earthen Levee			GPS Latitude/Longitude	
				Start	End
Item	Vegetation			37.719801°	37.719801°
				-121.258814°	-121.258814°
DWR ID	DWR_RD2075_01_f_2019_45				
Comment Code					
V2 : Remove the wild growth and woody vegetation other than native grasses from the levee slopes.					
Inspector Comment

View of wild growth vegetation within the landside easement. Spring 2021

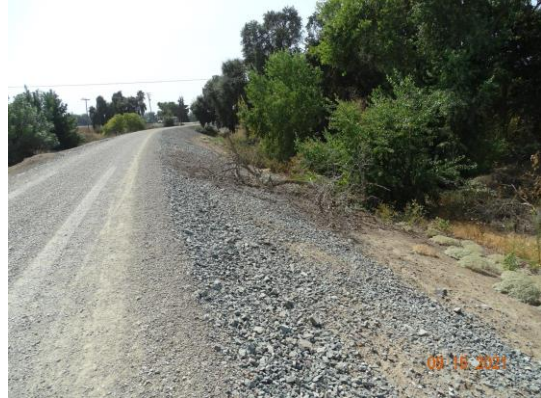
Photo 1 of 1 : SP_2023_RD2075_315_47_20230306_00014.jpg

LM Start	6.73	Rating **	M	Issue No.	47
LM End	6.73	Issue Type +	Ma	Location *	WS
Category	Earthen Levee			GPS Latitude/Longitude	
				Start	End
Item	Encroachments			37.715480°	37.715480°
				-121.258442°	-121.258442°
DWR ID	DWR_RD2075_01_f_2019_47				
Comment Code					
PR : Prunings					
Inspector Comment

View of prunings on the waterside slope. Fall 2021

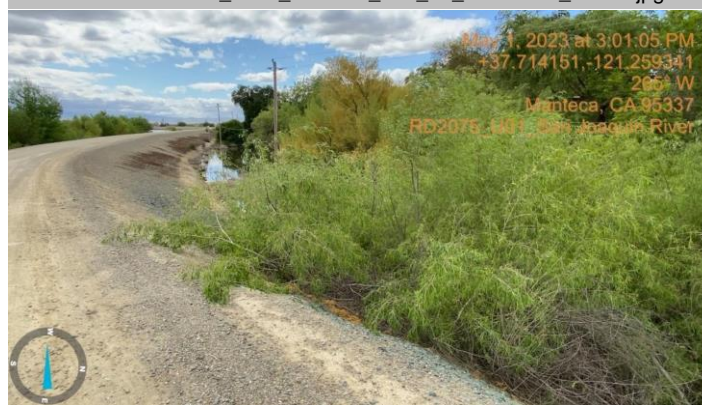
Photo 1 of 1 : SP_2023_RD2075_315_40_20230515_00031.jpg

LM Start	6.84	Rating **	U	Issue No.	40
LM End	6.84	Issue Type +	Ma	Location *	WS
Category	Earthen Levee			GPS Latitude/Longitude	
				Start	End
Item	Trim / Thin Trees			37.714123°	37.714123°
				-121.259279°	-121.259279°
DWR ID	DWR_RD2075_01_f_2020_40				
Comment Code					
T1 : Trim and thin trees to at least five feet above ground level to allow visibility of the ground and room to flood fight.					
Inspector Comment

View of trees on waterside slope obstructing visibility. Spring 2023

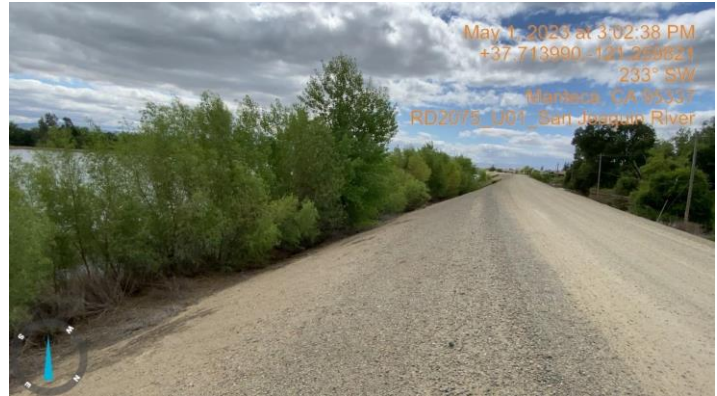
Photo 1 of 1 : SP_2023_RD2075_315_63_20230515_00032.jpg

LM Start	6.87	Rating **	U	Issue No.	63
LM End	6.94	Issue Type +	Ma	Location *	LS
Category	Earthen Levee			GPS Latitude/Longitude	
				Start	End
Item	Trim / Thin Trees			37.713961°	37.713765°
				-121.259676°	-121.260914°
DWR ID	DWR_RD2075_01_f_2022_63				
Comment Code					
T1 : Trim and thin trees to at least five feet above ground level to allow visibility of the ground and room to flood fight.					
Inspector Comment

View of untrimmed trees along the landside easement. Spring 2023
